Fairview Park

Phase 2 Archaeological Survey Report

NYCDPR Contract No. CNYG-311MR

Prepared for New York City Department of Parks and Recreation
Through Hargreaves Jones Landscape Architecture DPC (Hargreaves Associates NY)
Prepared by Joan H. Geismar, Ph.D., LLC
May 2016

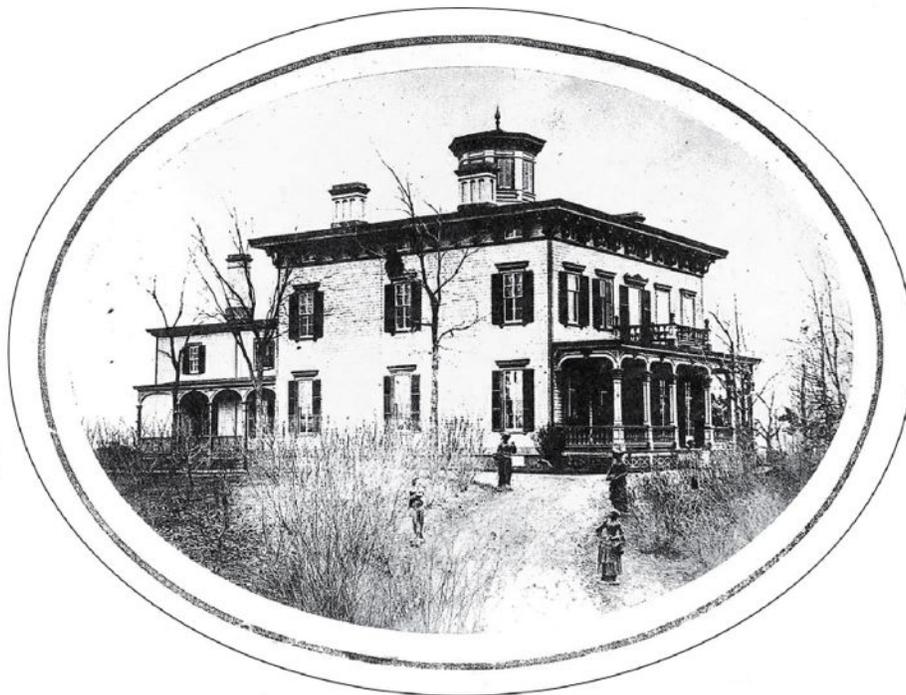
Photo 5. The north (center) and west (right) facades of "Fairview." The 1880s photo is the same view as Figure 7 (above). Note the difference in the grounds. (Xerox copy courtesy of the SIHS)

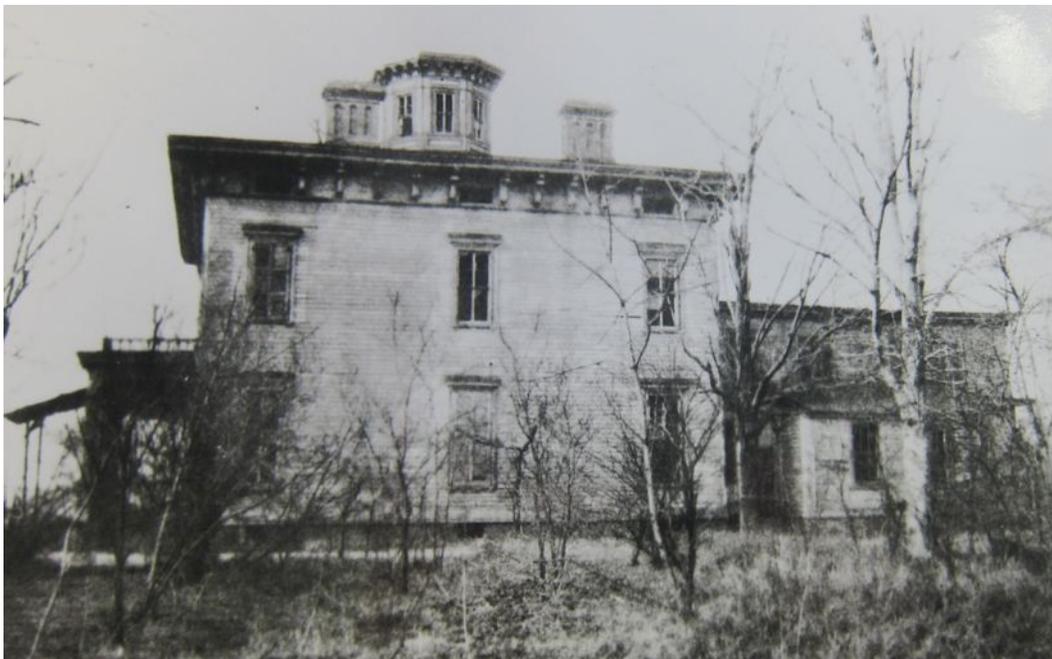
Photo 14. This 1920s view of Fairview, at the time abandoned, documents a 2 1/2-story eastern extension (right) with a 1-story appendage (C4) on its south side. (Photo from the collection of the SIHS)
