BARTOW-PELL ESTATE CARRIAGE HOUSE SITE ARCHAEOLOGICAL REPORT

Prepared by HISTORICAL PERSPECTIVES For the International Garden Club And Beyer Blinder Belle September 10, 1985

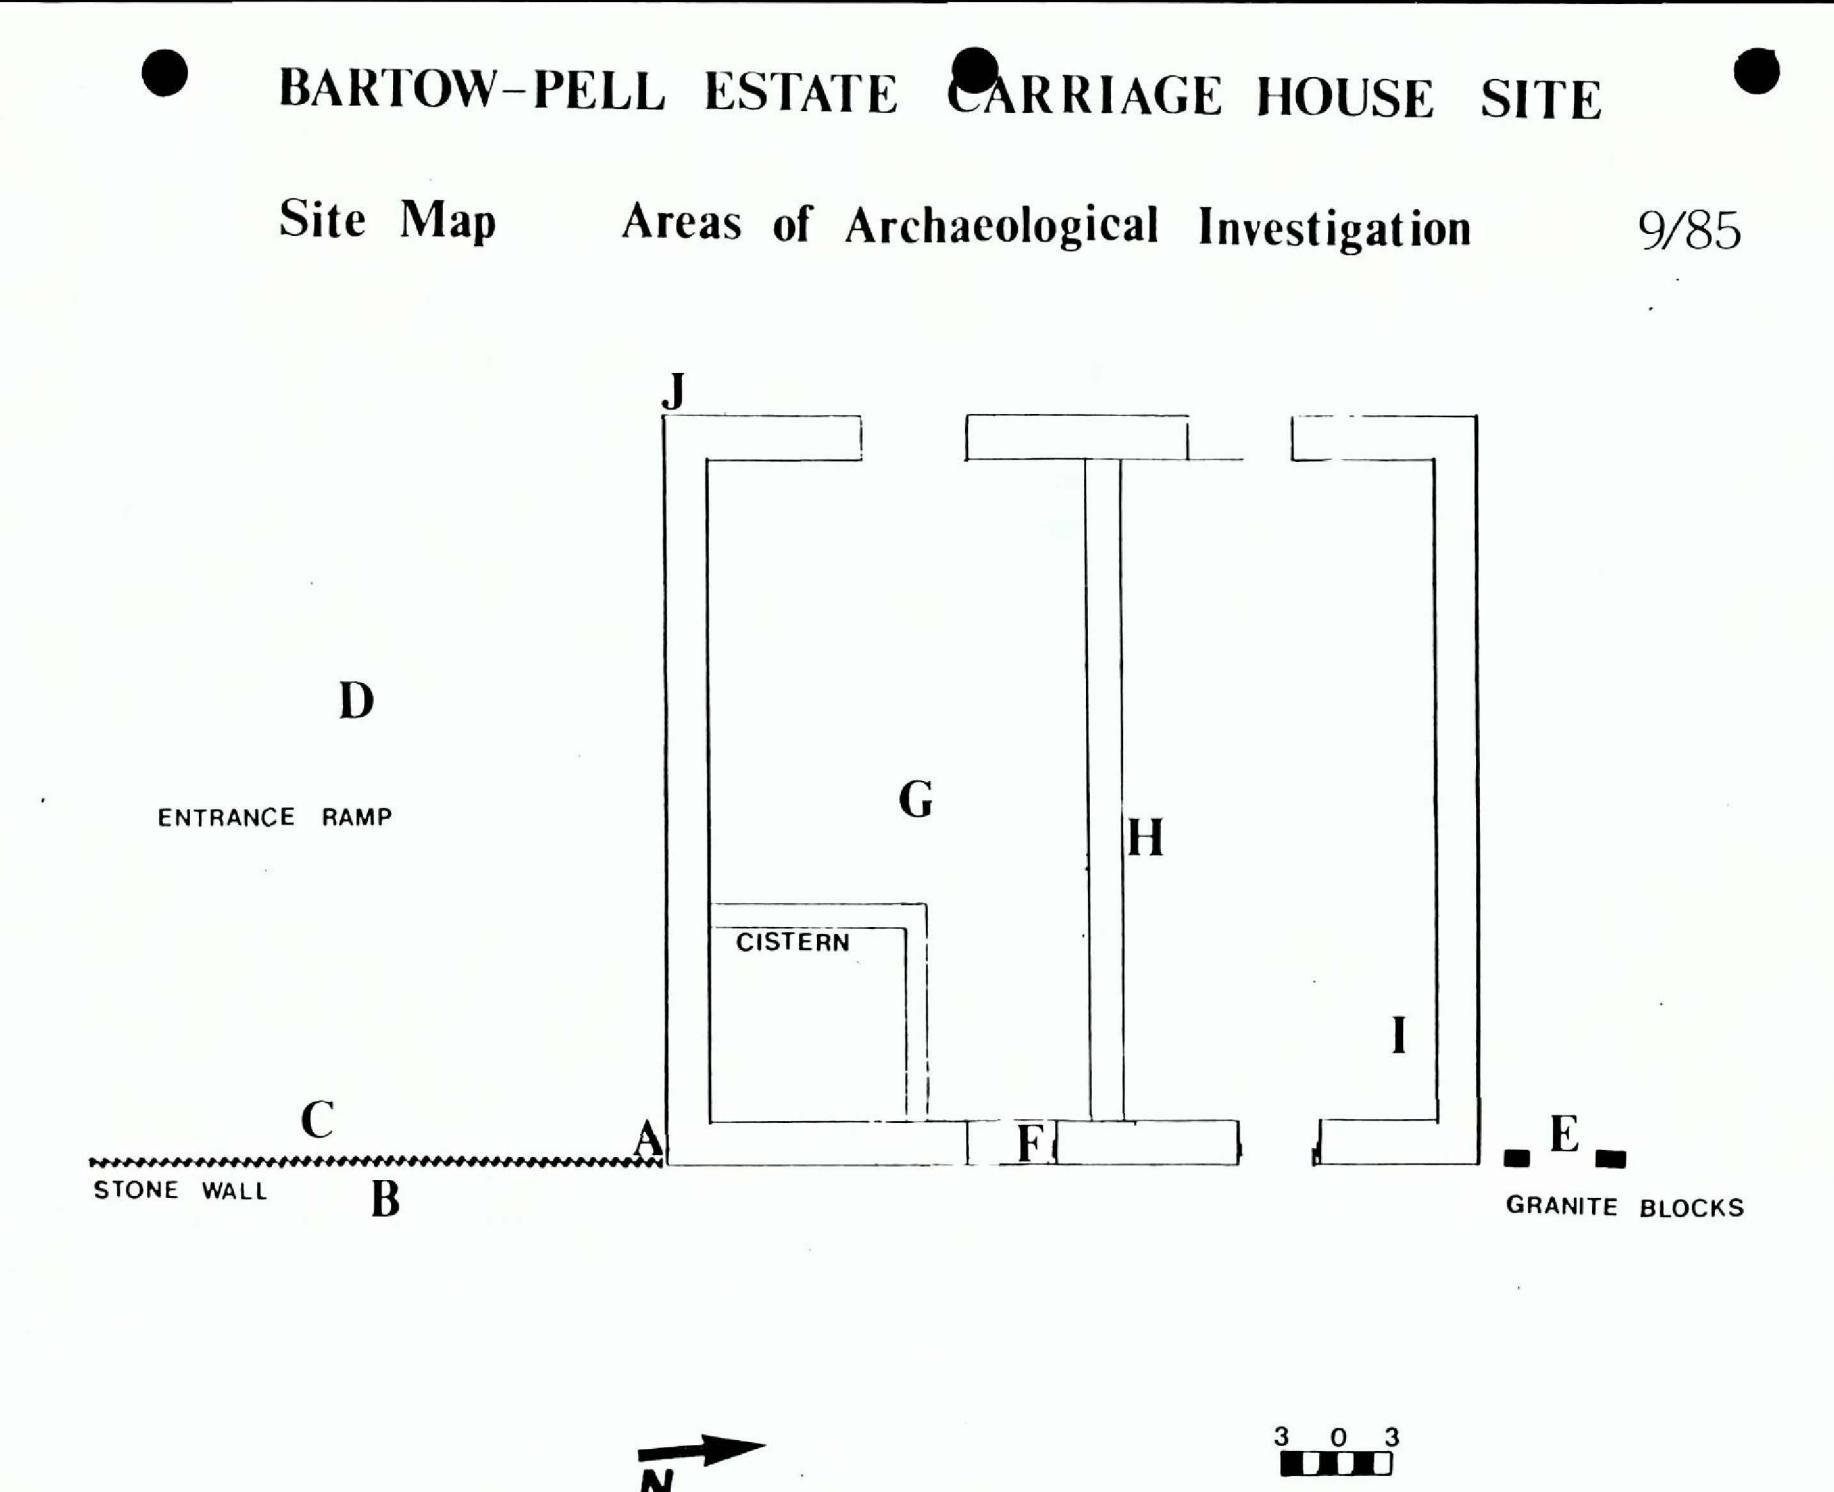
A walk-over of the entire carriage house site was conducted prior to selecting specific areas for closer examination. Nine areas were chosen and a tenth (area F) was examined when part of a drainage system was discovered by Ted Ewen during the course of his masonry restoration work. (See Figure 1, site map) Areas E and I entailed exposing shallow wide sections while others were test units. Artifact retrieval was limited due to prior disturbance in all areas. Those artifacts retained were either 1) an unmeasured sample from land fill, 2) of possible value to the architects (e.g. a small slab of finely cut and polished marble found just inside the doorway footing in the southern section of the basement), or 3) of possible historic or intrinsic interest such as a ceramic doll's head. It should be emphasized that such artifacts have no archaeological integrity having come from somewhere else at an unknown time, and with no proven link to inhabitants of the Bartow-Pell estate.

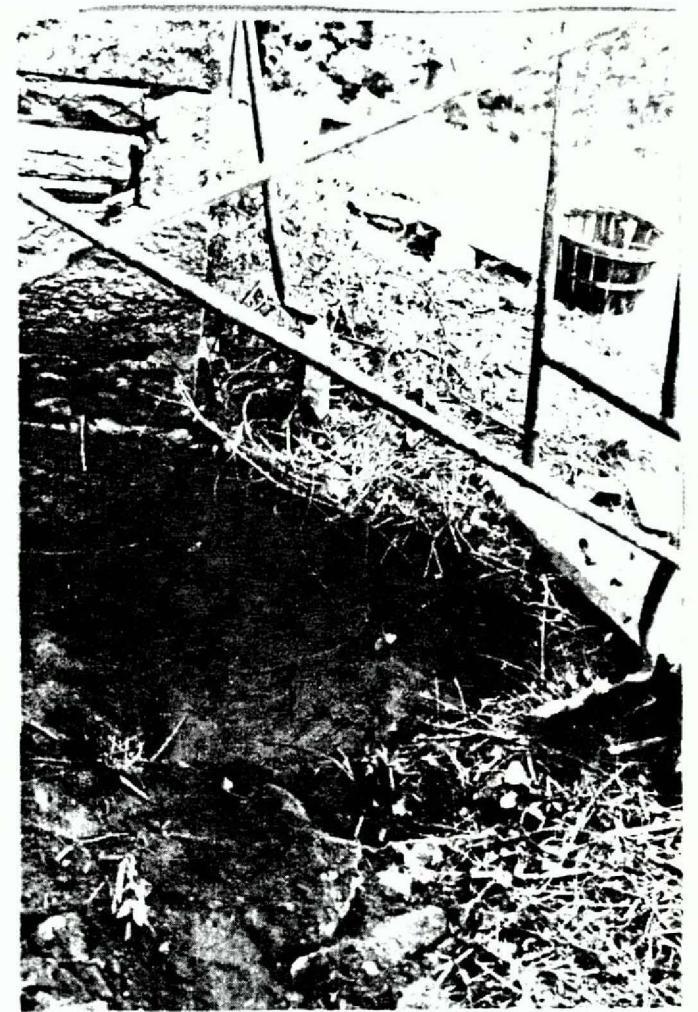
RIGHT: Area J Looking Southeast Photograph 23

What is apparently a natural rock outcropping was found at the southwest corner of the carriage house. (See Photographs 22 and 23) It begins 8 inches west of the southwest corner of the building and extends 32 inches directly west and at least 42 inches south - the southern extremity could not be uncovered because of the scaffolding. The northwest corner of the rock may have been dressed, but the surface is uneven and there is no indication of anything having affixed to it.
