FINAL REPORT

UNDERWATER INSPECTION OF TARGETS BORROW AREA 2 ATLANTIC COAST OF LONG ISLAND EAST ROCKAWAY INLET TO ROCKAWAY INLET QUEENS COUNTY, NEW YORK STORM DAMAGE REDUCTION PROJECT

Prepared for: Environmental Analysis Section U.S. Army Corps of Engineers, New York District 26 Federal Plaza • New York, New York 10278

September 2003

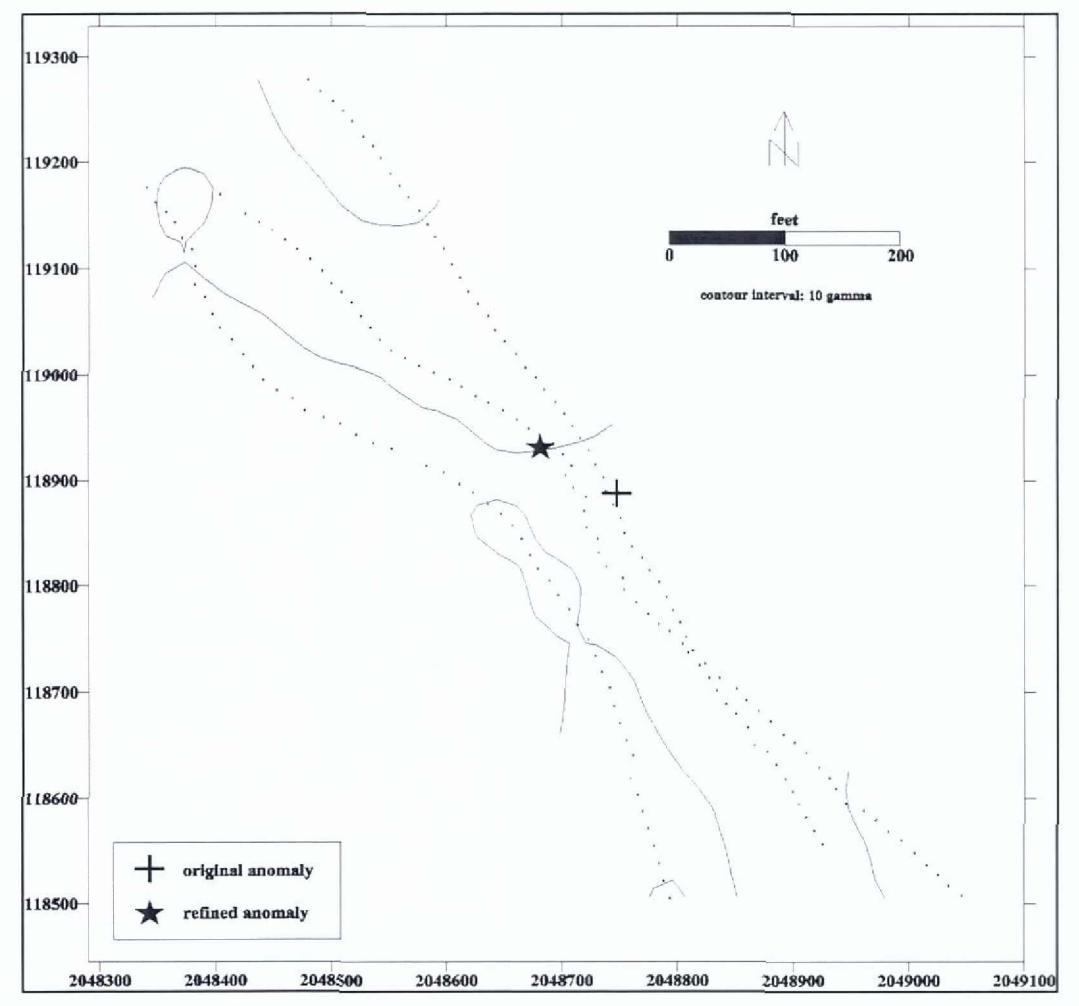
Figure 20. Magnetic refinement map of Target 1.

Previously identified as a single 46-gamma magnetic anomaly, Target 1 was reported to have 2-3 small circular associated side-scan sonar returns. A buoy was placed over coordinates provided by Riess, in approximately 39 feet of water. Refinement of the target (with the magnetometer) produced a 22-gamma dipole anomaly (Figure 20). Only three transects were run over the area before the target was adequately relocated and refined with an additional buoy.

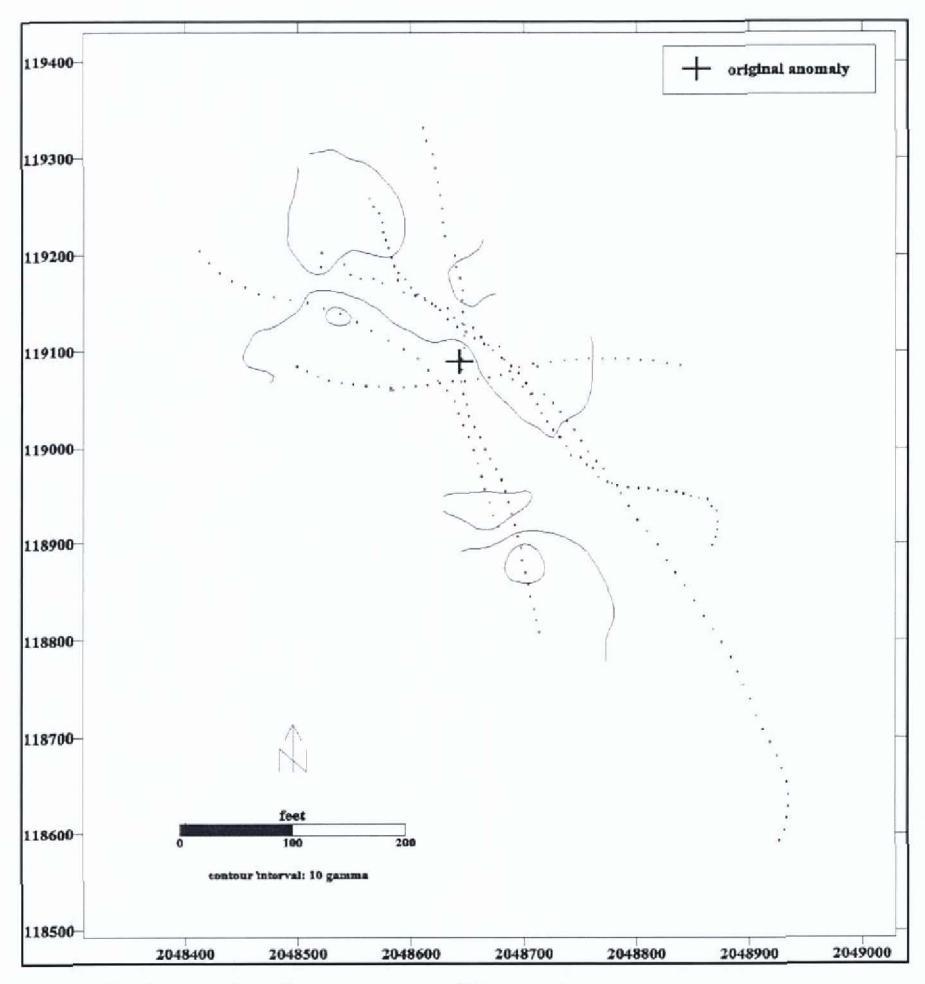
Figure 21. Magnetic refinement map of Target 2.

Riess reported Target 2 to be a single source, 21-gamma magnetic anomaly with an associated side-scan sonar image (elongate target, 10-20 ft. long). Five refinement runs were made over the target location prescribed by Riess (1994:7). Magnetic refinement of the target area did not indicate the presence of any magnetic anomaly (Figure 21). This anomaly appears to have been mobilized from its original location and was not relocated during any of the refinement runs. From Riess' description of this object (Riess 1994b:7), it could have been an exposed piece of debris located on the ocean bottom which has since been moved from its original location either by trawling/surf clam dredging activities (Figure 22), anchoring, and/or environmental factors (currents, surge, tidal influences). No diver investigations were conducted at this site.

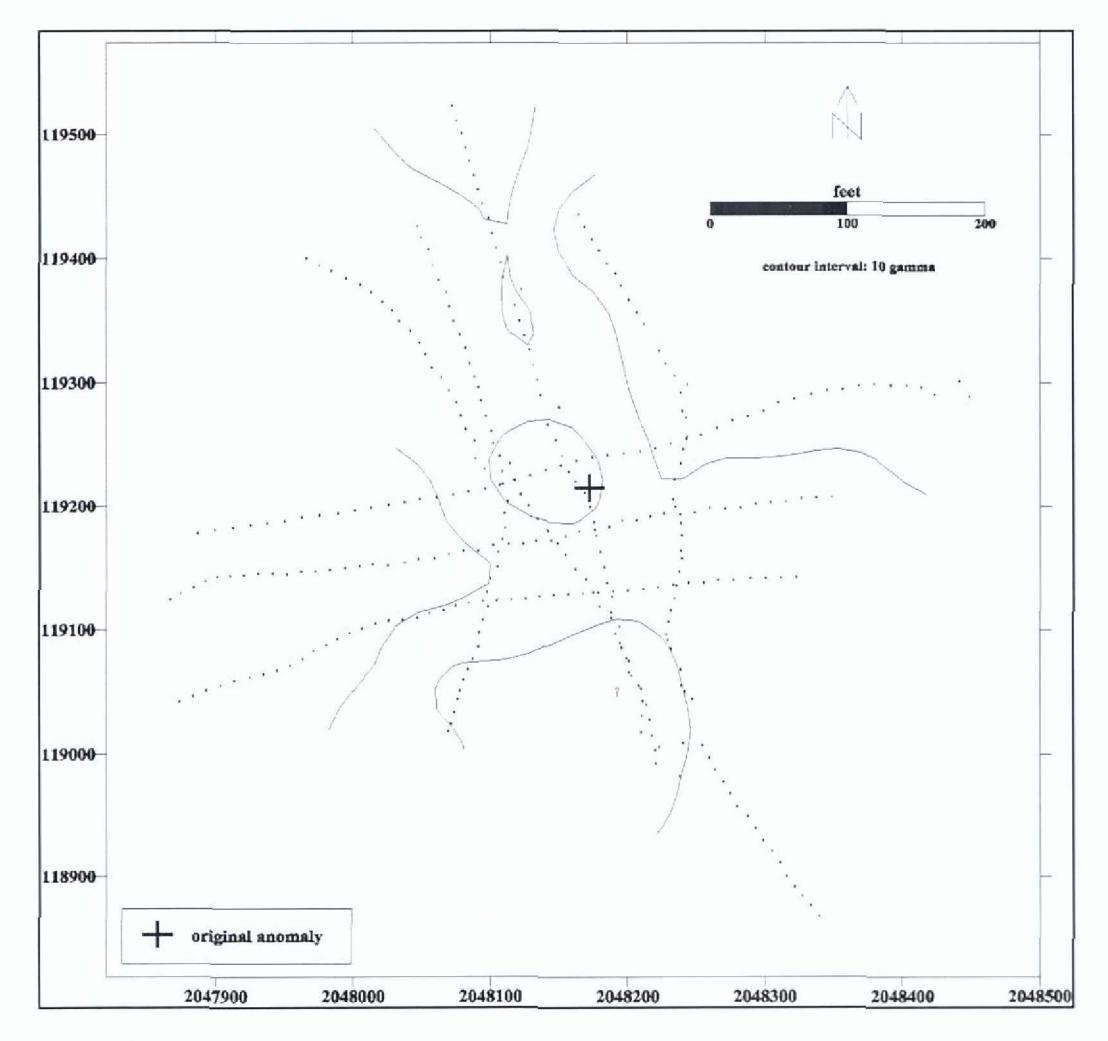
Figure 23. Magnetic refinement map of Target 3.

Reported by Riess as a single 61-gamma magnetic anomaly, Target 3 also had an associated side-scan sonar return (one or more circular targets, 2-4 ft. diameter, 1-3 ft. relief). A buoy was placed over coordinates designated by Riess (1994:7). Seven refinement passes were made with the magnetometer. Magnetic refinement of the target area did not identify the presence of any anomaly source within the refinement square (Figure 23). Only a small, single point, 10-gamma anomaly was recorded approximately 180 feet east of the buoyed location. This anomaly was not considered significant enough (due to its single point signature) to warrant diver investigation. It appears that Target 3 has also been moved from its original location since located in 1993. No diver investigations were conducted at this site.

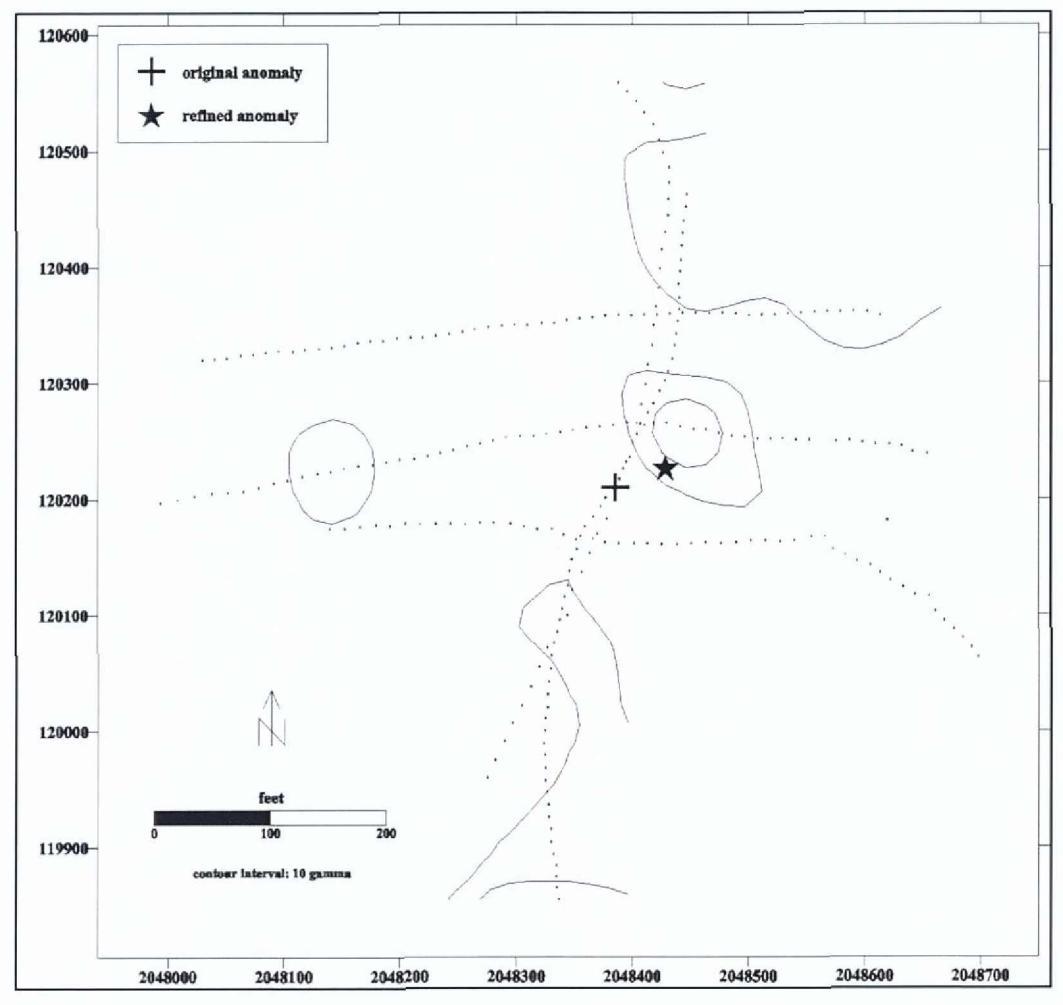
Figure 24. Magnetic refinement map of Target 4.

Target 4 was reported as a single, 15-gamma magnetic anomaly with an associated elongate sidescan sonar return, approximately 10-15 feet in length, 1-3 feet in width with 1-3 feet of relief (1994:7). A reference buoy was dropped at the location designated by Riess in approximately 45 feet of water, and five passes were made over the location before the target was adequately refined. An additional refinement buoy was placed at the location of the anomaly. Magnetic refinement of the target area indicated the presence of a 34-gamma magnetic anomaly (Figure 24). During refinement runs an exposed feature, three to four feet in height, was noted on the *Venture III*'s fathometer, and depth on site was 46 feet. Target 4 was one of the deeper targets encountered during the project. This is believed to be due to the close proximity of the target to the inshore area previously dredged by the Corps (as noted by Riess 1994b:9).

Diver investigation indicated the source of the anomaly as a large block of concrete and rebar. Three other smaller sections of broken concrete and rebar, associated with the larger block, were observed in close proximity. Observations by the diver indicate that these targets are associated with dismantled bridge span components from an unknown source. Measurements of the largest section indicated that the target was 28 feet in length with a maximum width of five feet. The large concrete span was roughly trapezoidal ("T") in shape, lying mostly flat on the ocean bottom (Figure 25). A large concave depression was recorded running along a majority of the centerline length of the span, approximately two feet in depth and two feet across. The raised sides of the depression were approximately one foot in width. One side of the span was exposed 1' 6" above the ocean bottom, while the opposite side was exposed 2' 6".

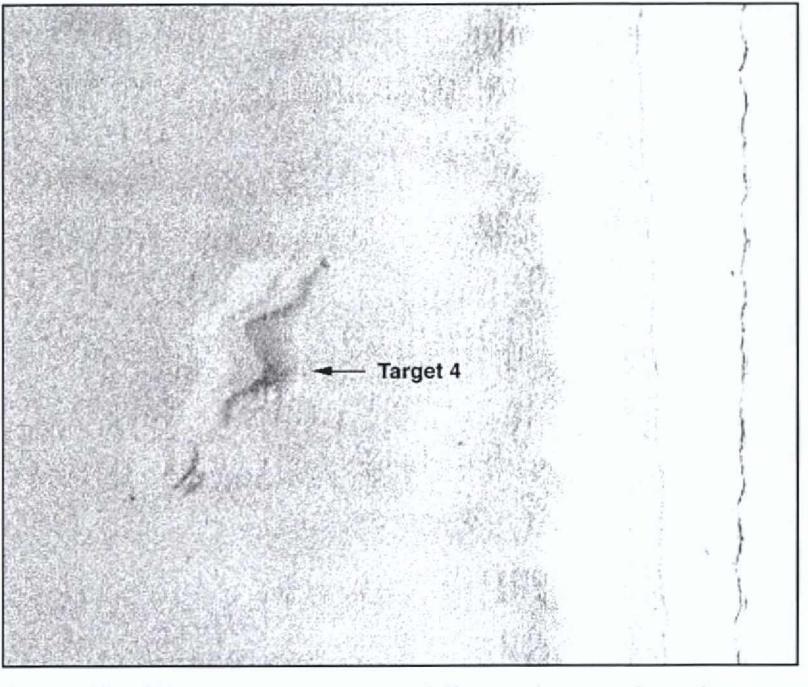
and Figure 27. Side-scan sonar image of Target 4 exposed on the ocean rded floor.

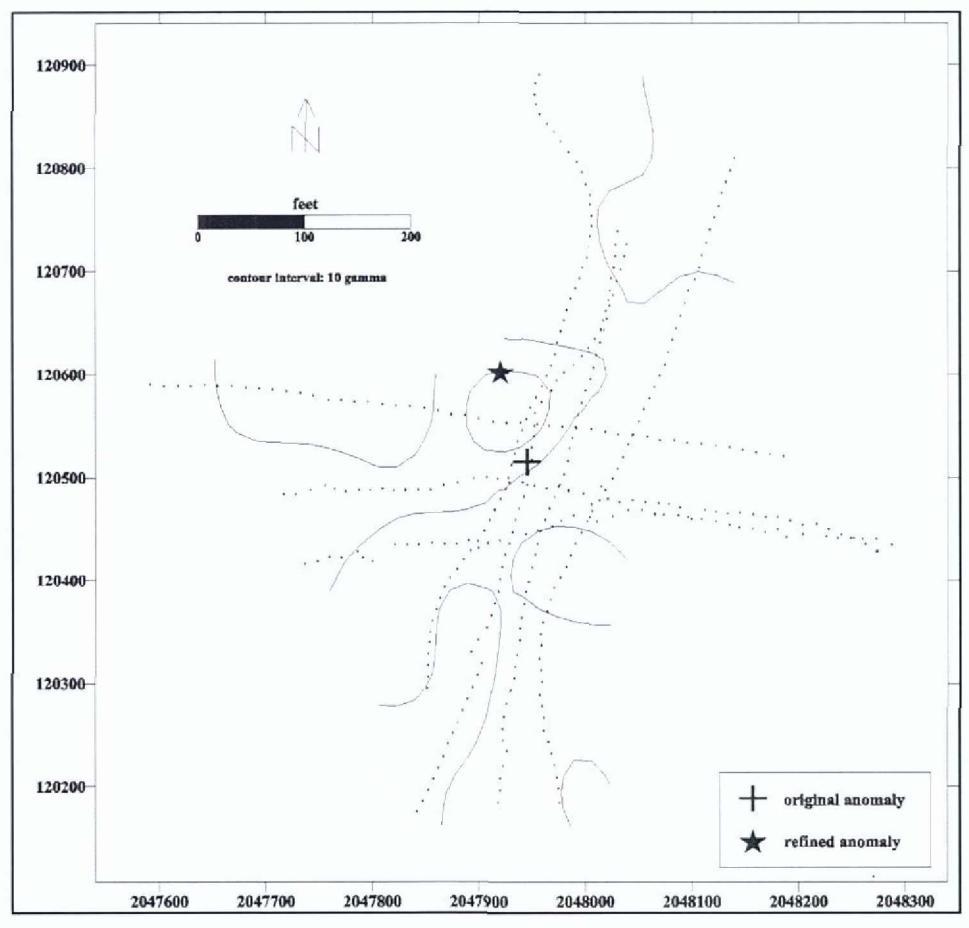
Figure 29. Magnetic refinement map of Target 5.

Riess describes Target 5 as a magnetic anomaly with a 51gamma deviation recorded on two survey transect lines. A marker buoy was placed within five feet of the coordinates provided and the magnetometer deployed in an effort to relocate the target. Seven transect lines were run over the target area before the magnetic target was adequately refined buoyed. Panamerican recorded a dipole anomaly of roughly 53 gammas within 50 feet of original location Riess' (Figure 29). Once the diver reached bottom, a pneumogauge reading showed a depth of 40 feet.

The diver conducted a series of arcs (spaced 20 feet apart) around the location of the refinement buoy and quickly located the source of the anomaly. The diver reported at least two sections of exposed, heavily-armored wire cable. One section pulled off the bottom was shaped in an arc similar to the St. Louis Arch. This section of cable is arched off the bottom approximately six feet with an exposed length

of seven feet. It appears that a dragged anchor is the cause of this portion of cable being exposed.

The next section of exposed cable is lying horizontal to the bottom and is exposed for four feet. Both sections of this large, heavily-armored cable are the same cable oriented roughly parallel to shore. The diver reported similarities between this cable and the one identified as Target 1. After videotaping the exposed sections of cable (Figure 28), the diver placed a refinement buoy at the center of the target for exact positioning This site is not considered significant for the purposes of this investigation.

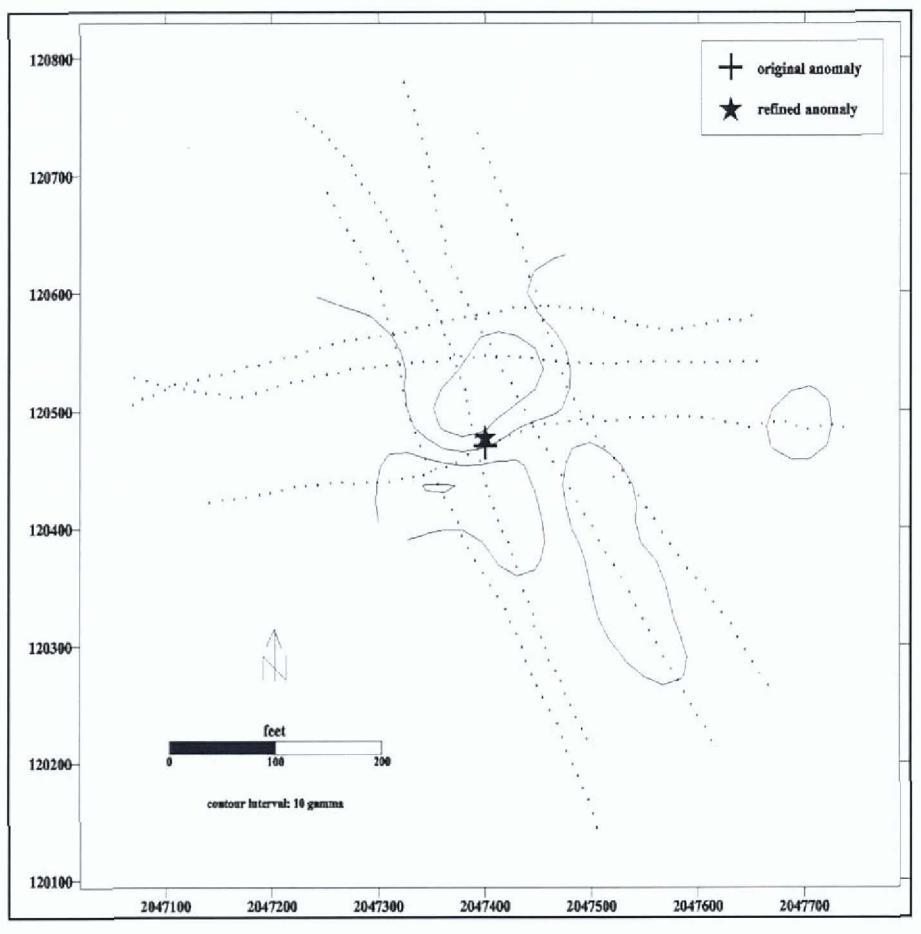
Figure 30. Magnetic refinement map of Target 6.

Riess reported Target 6 as a magnetic anomaly with a maximum magnetic deviation of 69gammas recorded on three survey transect lines. A reference buoy placed within approximately two feet of Riess' numbers allowed the refinement survey to begin. Seven transect lines were run over the target area until the anomaly was adequately refined and a buoy dropped. Magnetic data indicated the presence of an anomaly source with a total magnetic deviation of 90 gammas (Figure 30).

The next day hydro-probing was conducted at 10-foot intervals to a depth of 10 feet over the entire area (50 feet by 60 feet) of Target 6. No positive contacts were made on any of the hydro-probes. At one probe location near the refinement buoy the diver reported a black/rust coloration of sediment blowing out of the probe hole. It is assumed that the source of the anomaly is either deeply buried or more likely a buried wire cable.

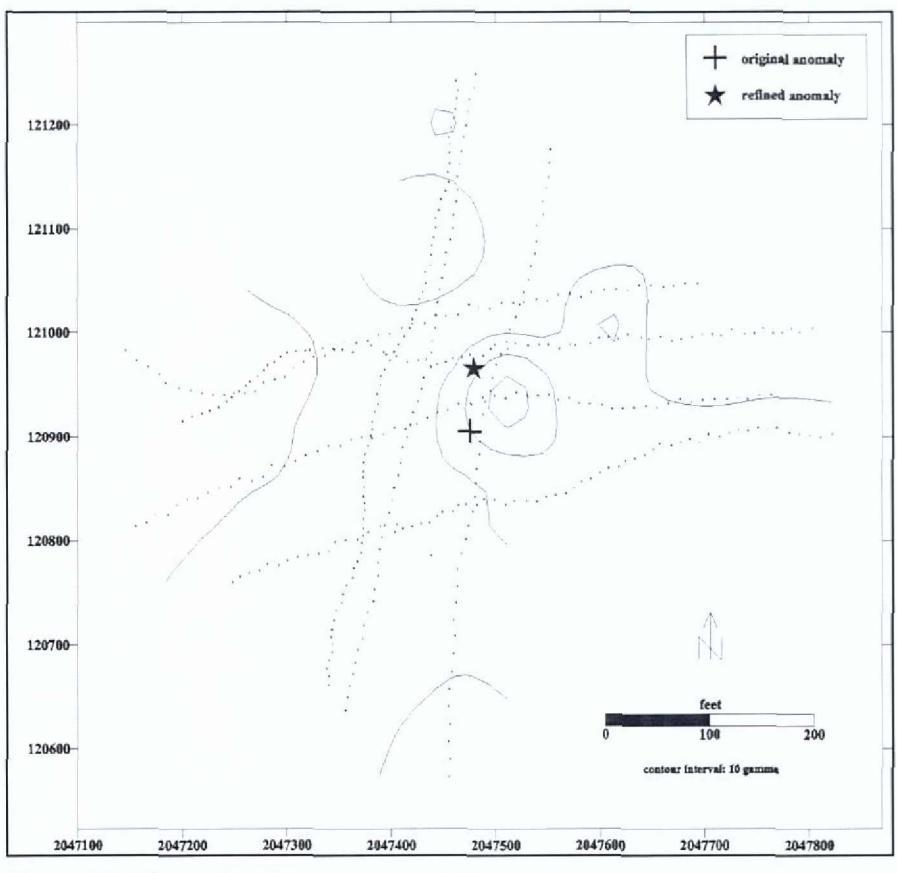
Riess reported Target 7 as a magnetic anomaly of 51 gammas with an associated side-scan sonar return of an object 4 x 8 feet in size, apparently partially buried (1994:7). A buoy placed on Riess' coordinates preceded a series of seven refinement runs made over the target area. Refinement of the target located a 59-gamma, monopole anomaly (Figure 31). A refinement buoy was deployed over the source of the anomaly and a diver prepared for investigation of the site. Water depth over the target area was 39 feet.

Initial diver investigation of the target area identified two granite Figure 31. Magnetic refinement map of Target 7. blocks no larger than 2-

by 3 feet on the sea bed. Two of the blocks (located about seven feet apart) had one foot of relief above the sand bottom. The metal detector and 3-foot hand probe were sent to the diver for additional testing of the target area. While the metal detector pegged out at "10" directly over the granite blocks, it was not considered the source of the magnetic anomaly. Some additional diver sweeps were made with the metal detector in the area at 20-foot intervals. An additional magnetic anomaly was identified approximately 40 feet from the blocks, covering a localized area, approximately 20 feet in diameter.

Hydro-probing was conducted at 10-foot intervals to a depth of 10 feet over the additional magnetic area with no positive returns. Similar to Target 6, this target was easily discernible with the hand-held metal detector over a rather localized area. However, probing of the area produced no positive returns to 10 feet below the sand bottom. Therefore, it is assumed that the source of the anomaly is likely a wire cable or other small ferrous metal object which is very difficult to locate with either a hand probe or hydro probe (as stated earlier, the metal detector does not penetrate to deeper than 2-3 feet). This site is not considered significant for the purposes of this investigation as it likely represents misplaced modern debris deposited during the construction or addition of artificial reef material (i.e., granite blocks) off Rockaway Beach.

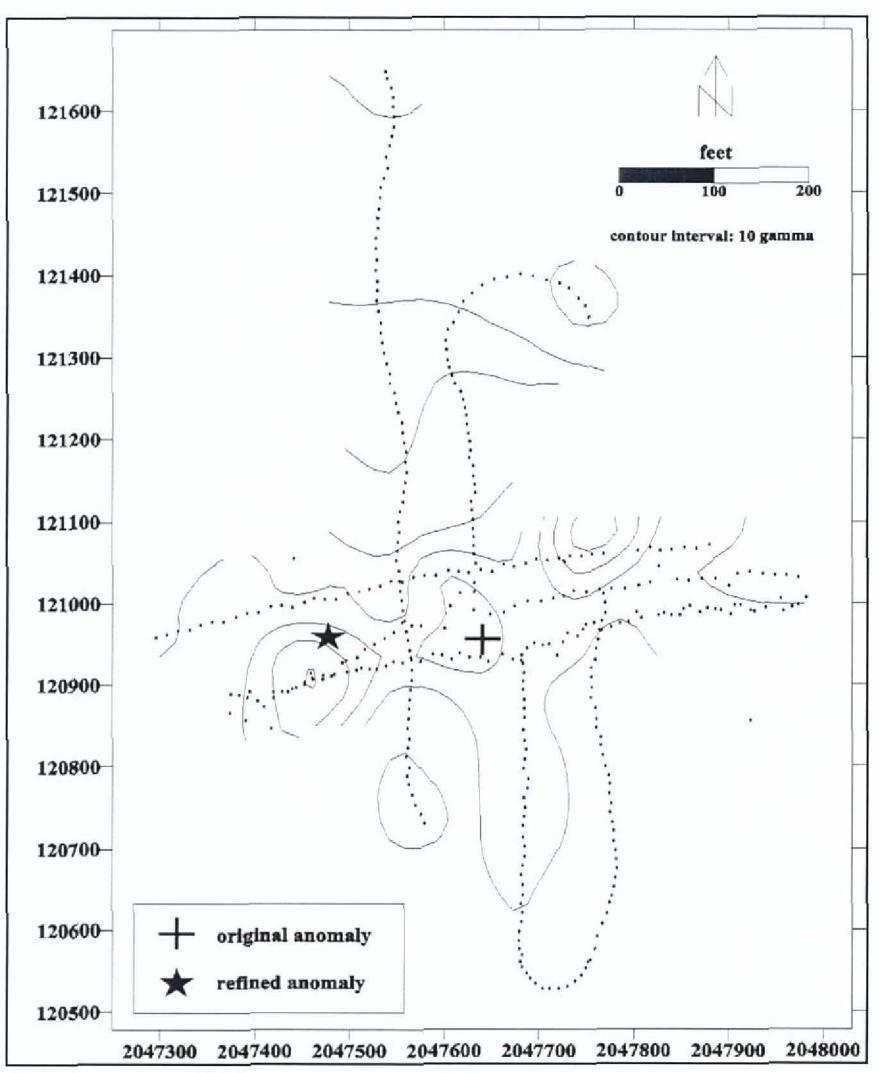
of Target 8. Refinement Figure 32. Magnetic refinement map of Target 8.

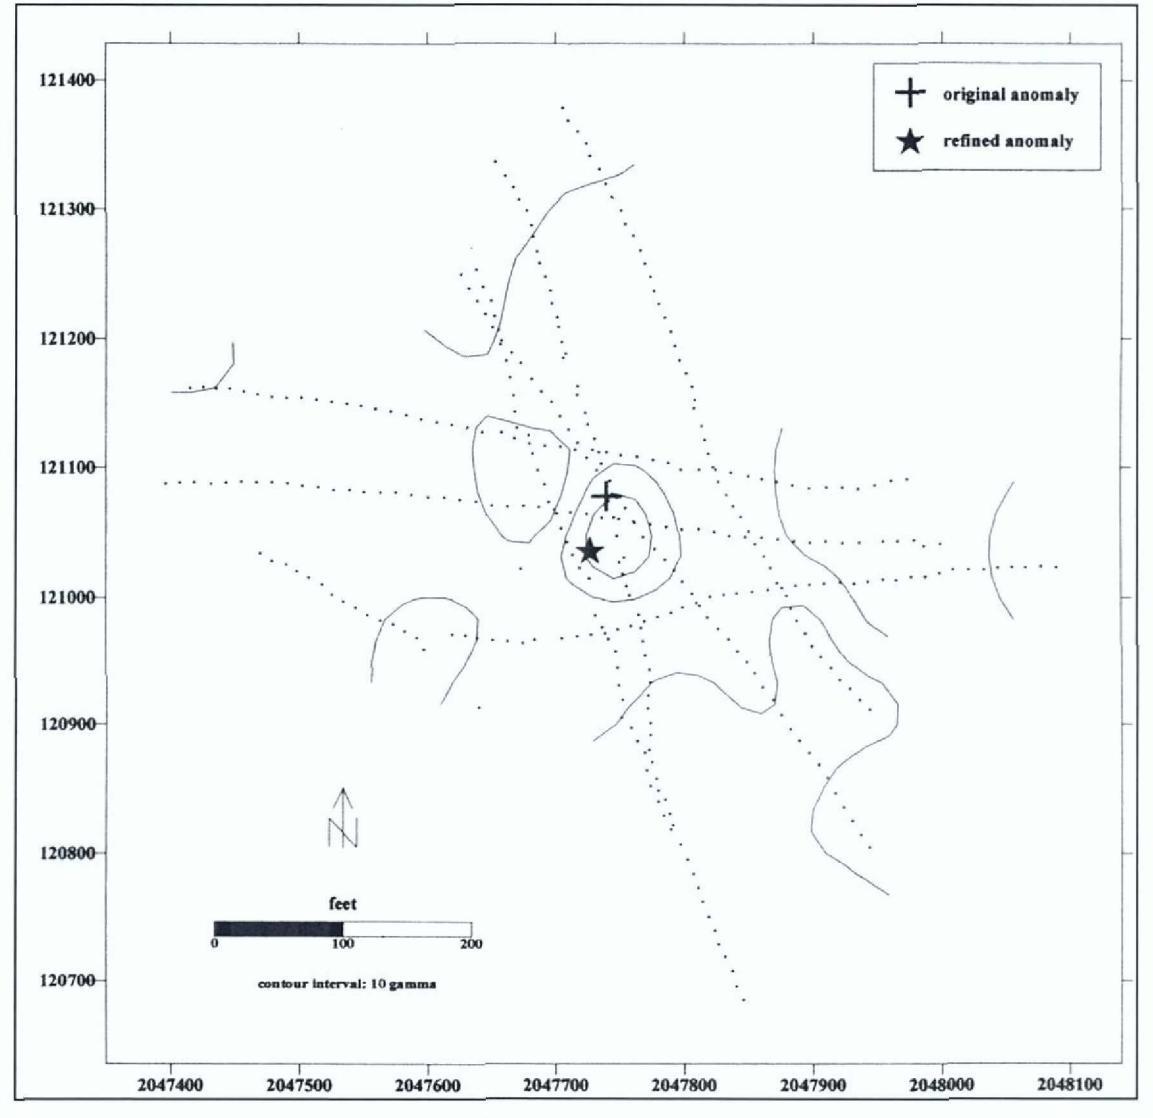
Figure 33. Magnetic refinement map of Target 9.

of the target with the magnetometer relocated a 68-gamma magnetic anomaly (Figure 33). Seven passes were made over the targeted location to adequately refine the magnetic target. A refinement buoy was dropped close to the target and the dive vessel anchored for diving operations. Captain Hepler noted a sizable feature rising approximately four feet off the sea floor close to the refinement buoy. A grapple was successfully deployed to the unidentified feature in an effort to guide the diver to the target.

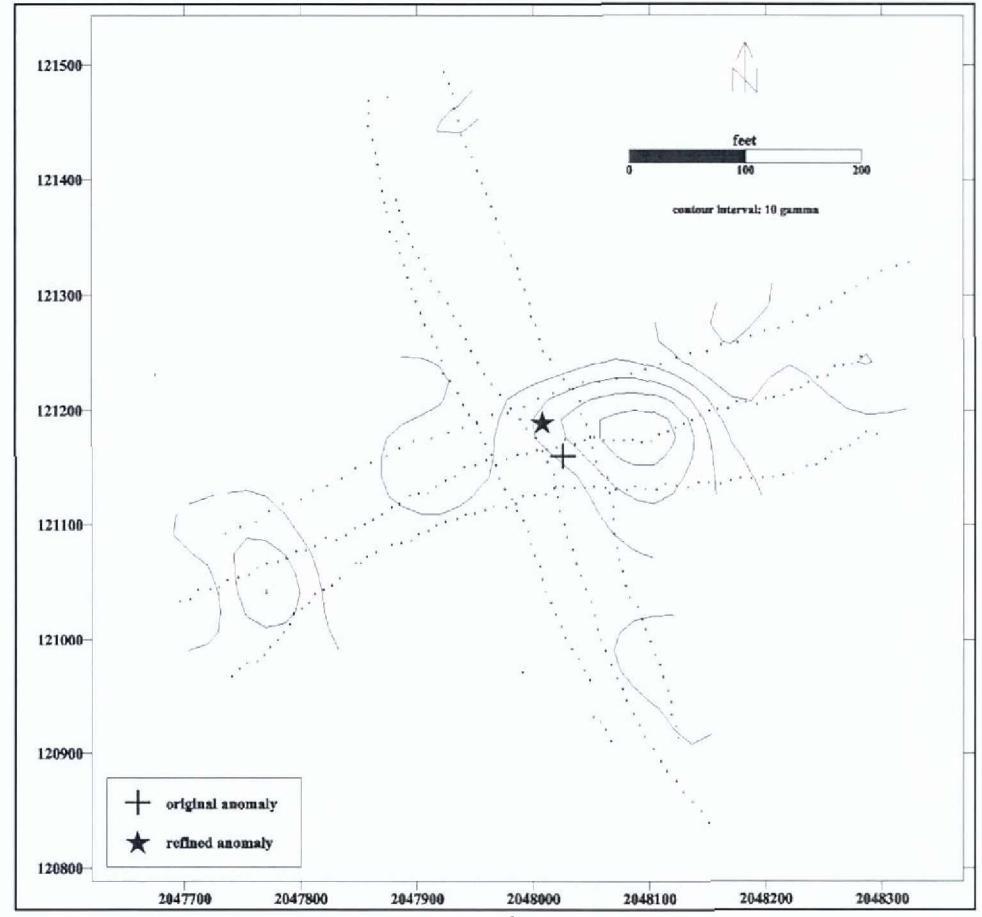
rebar and angle Figure 36. Magnetic refinement map of Target 10.

Refinement of Target 10 located a 76-gamma dipole anomaly (Figure 36) in approximately 45 feet of water. Captain Hepler again observed a feature on his fathometer rising off the ocean

Upon reaching the bottom the diver took a pneumo reading (45 feet) quickly and identified a large piece of rock or concrete. There was no identifiable source of iron at this feature. The diver continued out the grapple line and quickly located two parallel concrete pillars reinforced with both iron iron. One exposed

concrete pillar was 10 inches by 10 inches faced and had an exposed length of 16 feet. The other parallel pillar, located approximately one foot away, was much less exposed. The angle iron, attached to the larger concrete pillar, measured 3" by 3". Although mostly buried, the exposed features of this modern debris are similar to both Targets 4 and 9 and likely represent bridge span remains from the same source. While underwater video footage was shot at this location (even though visibility was only four feet), the footage proved unusable. Subsequent side-scan sonar investigations indicated the exposed features of the target (Figure 37). This site represents the remains of modern debris likely deposited as artificial reef material and is not considered significant for the purposes of this investigation.

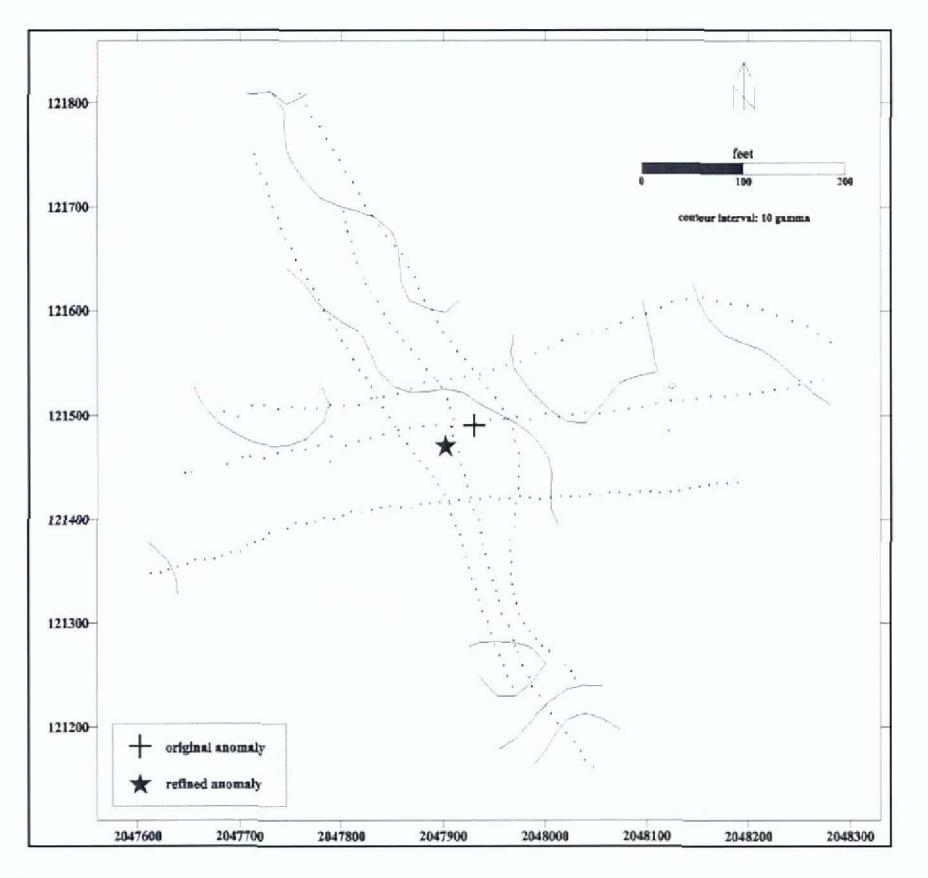
Figure 38. Magnetic refinement map of Target 11.

Initially reported by Riess as a magnetic anomaly with a maximum 25-gamma deviation (recorded on only a single survey trackline), Target 11 had no associated side-scan image (1994:7). A buoy was placed over the coordinates and six tracklines were run over the location for refinement purposes. Refinement of the target identified a 27-gamma magnetic anomaly (Figure 38).

The object uncovered was a braided wire cable barely buried underneath the sediment. One end of the cable was frayed, consisting of 6-8 individually woven strands. The coupling was located at the center of the exposed cable. The other end of the cable was followed out for approximately six feet before it was determined that the cable was an isolated piece of modern debris and was not significant for the purposes of this investigation. Due to a lack of visibility no underwater video footage was taken at this site. Comparing coordinates from Riess' report (1994:7) with those refined by Panamerican, Target 11 was 33 feet (to the southwest) from its reported location.

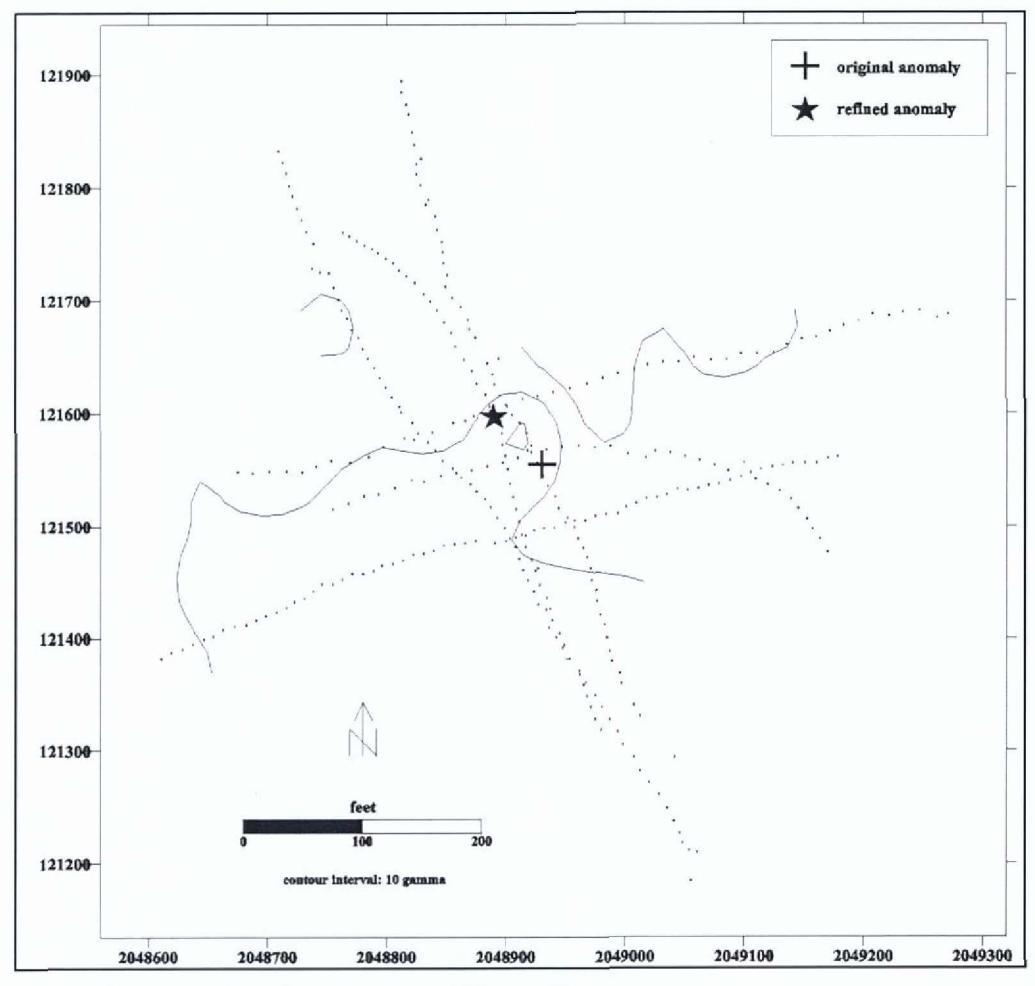
Figure 39. Magnetic refinement map of Target 12.

Target 12, with a maximum magnetic strength of 16 gammas, had an associated side-scan sonar return identified as an "elongate target, 8 x 20 ft. size, 2-4 ft. relief" (Riess 1994b:7). After dropping a buoy at the location of Target 12, the magnetometer refinement of the target area began. Six refinement runs were made to adequately relocate the anomaly. Refinement of Target 12 indicated a maximum deviation of 38 gammas (Figure 39). Target 12 was visible above the seafloor on Captain Hepler's fathometer during the refinement runs.

located the source of the anomaly. Diver investigation identified the remains of a concrete and rebar bridge span exposed approximately five feet off the bottom. Overall length of the bridge span was 38 feet. Compared to Targets 4 and 9, this identical style of bridge span is more exposed and intact than those previously identified. Lying flat on the bottom, the span has a piece of angle iron, 3" by 3", attached to its top face (identical in dimensions to the angle iron recorded at Target 10).

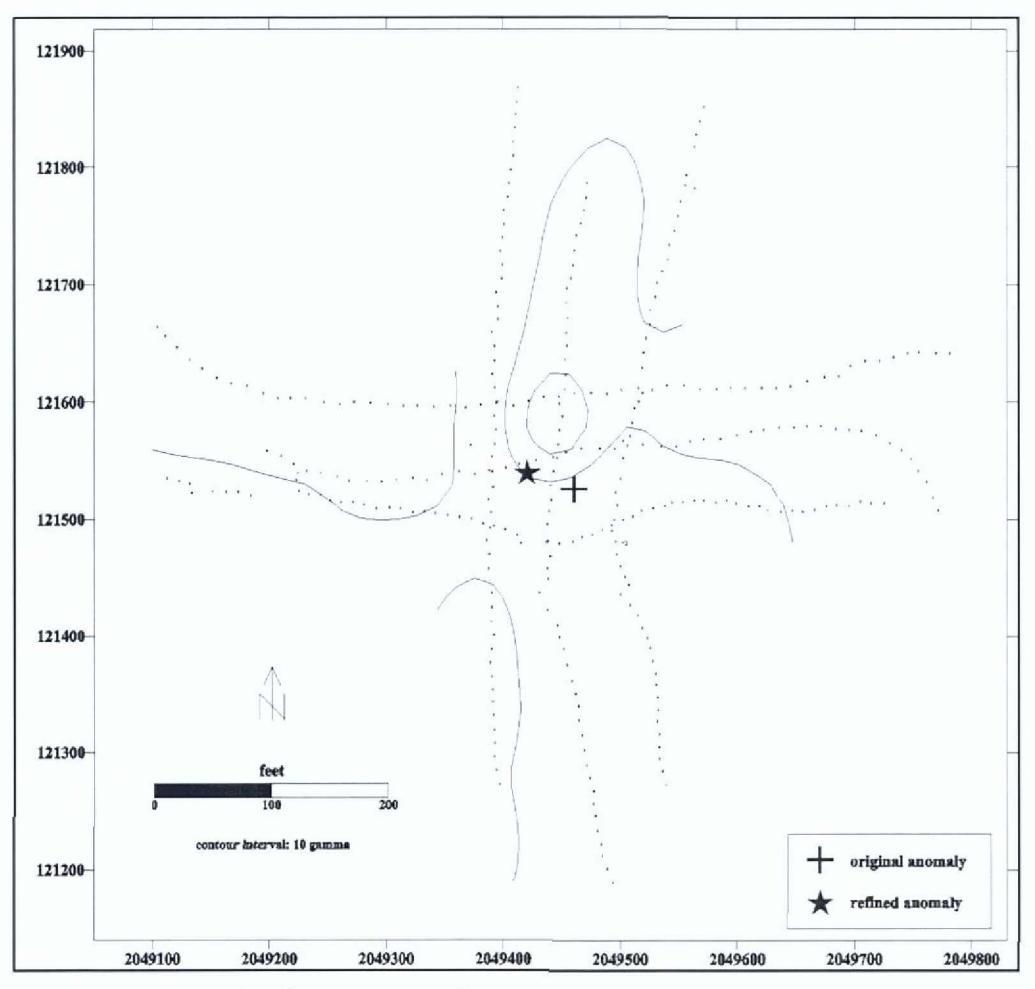
Figure 43. Magnetic refinement map of Target 14.

Target 14 was originally described as a single 61-gamma magnetic anomaly with an associated side-scan sonar image (10-15 feet in length, 1-3 feet in width) with some relief above the ocean bottom (Riess 1994b:7). A buoy placed on site allowed for the magnetometer refinement runs to begin. After six refinement runs the highest magnetic reading obtained was 44 gammas (Figure 43). It was not necessary to drop a refinement buoy as the location of the anomaly was easily discernible approximately 40 feet to the northwest of the buoyed location. During the refinement runs, Captain Hepler noted a rise off the ocean bottom with his fathometer, in the location of the magnetic anomaly. Once anchored near the site a grapple hook was placed on the anomaly and a diver prepared for investigation of the target.

The diver, after descending the grapple line, quickly identified the source of the magnetic anomaly as another concrete and rebar bridge span likely deposited in the area as an artificial reef. Water depth at the target was 39 feet. Initially the target appeared to be two separate parallel sections of concrete and rebar. The first exposed section was 2 feet 6 inches in width, 5 feet 6 inches in length, and extended off the bottom at its highest point approximately 3 feet 6 inches. The second exposed section was approximately 14 feet in length. Closer examination by the diver determined the two parallel sections of concrete to be one section of bridge span instead of two individual pillars. While underwater footage of this target was taken, the relatively poor visibility made the footage unusable.

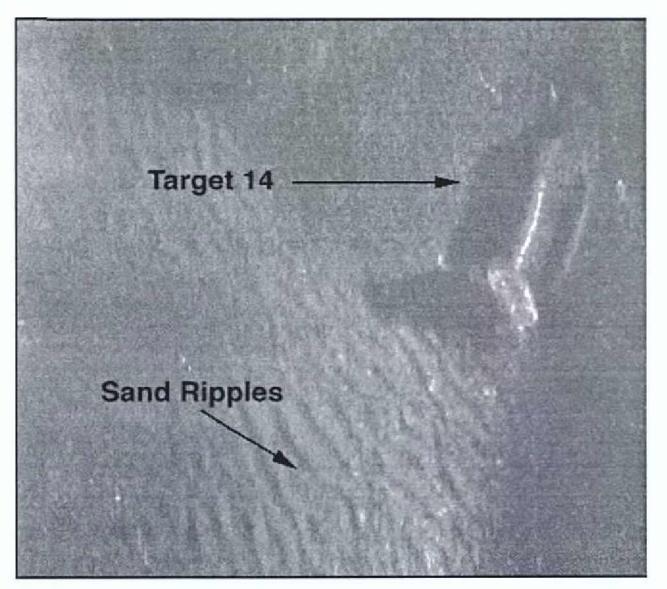
The diver then placed a refinement buoy on top of the concrete span and returned to the surface. Subsequent side-scan sonar investigations show the exposed sections of Target 14 (Figure 44). This target is not significant for the purposes of this investigation.

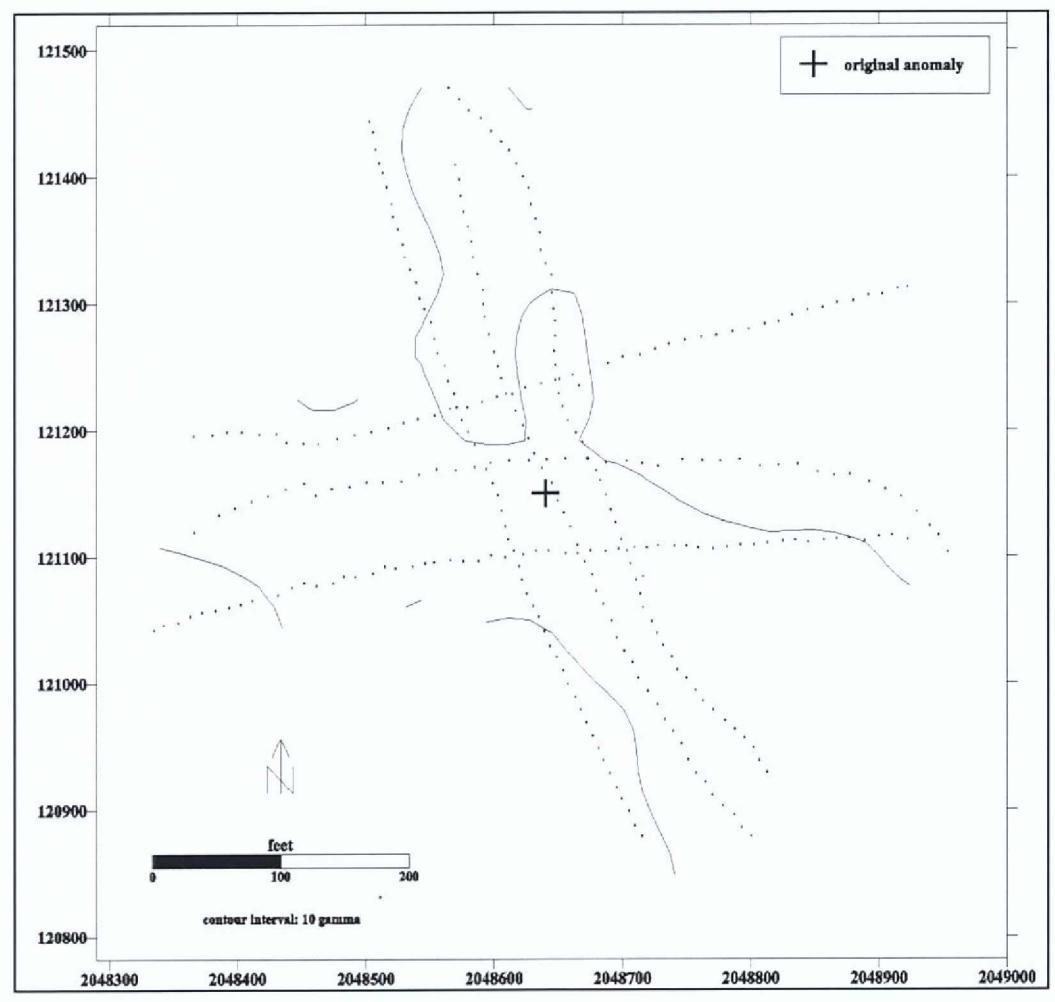
Figure 45. Magnetic refinement map of Target 15.

Recorded on only one trackline, Target 15 was described as a magnetic anomaly with a maximum deviation of 17 gammas (Riess 1994b:7). After dropping the buoy on site, refinement with the magnetometer began. Six tracklines were run around the buoyed location (Figure 45). On one pass with the magnetometer, a very localized 6-gamma anomaly was noted. Additional refinement Figure 44. Side-scan sonar image of Target 14.

passes failed to locate any other magnetic anomalies within the general area. Since the anomaly appeared to be no longer present within the general area prescribed by Riess or was too minimal in gamma strength to warrant subsequent identification, no further investigations were conducted.

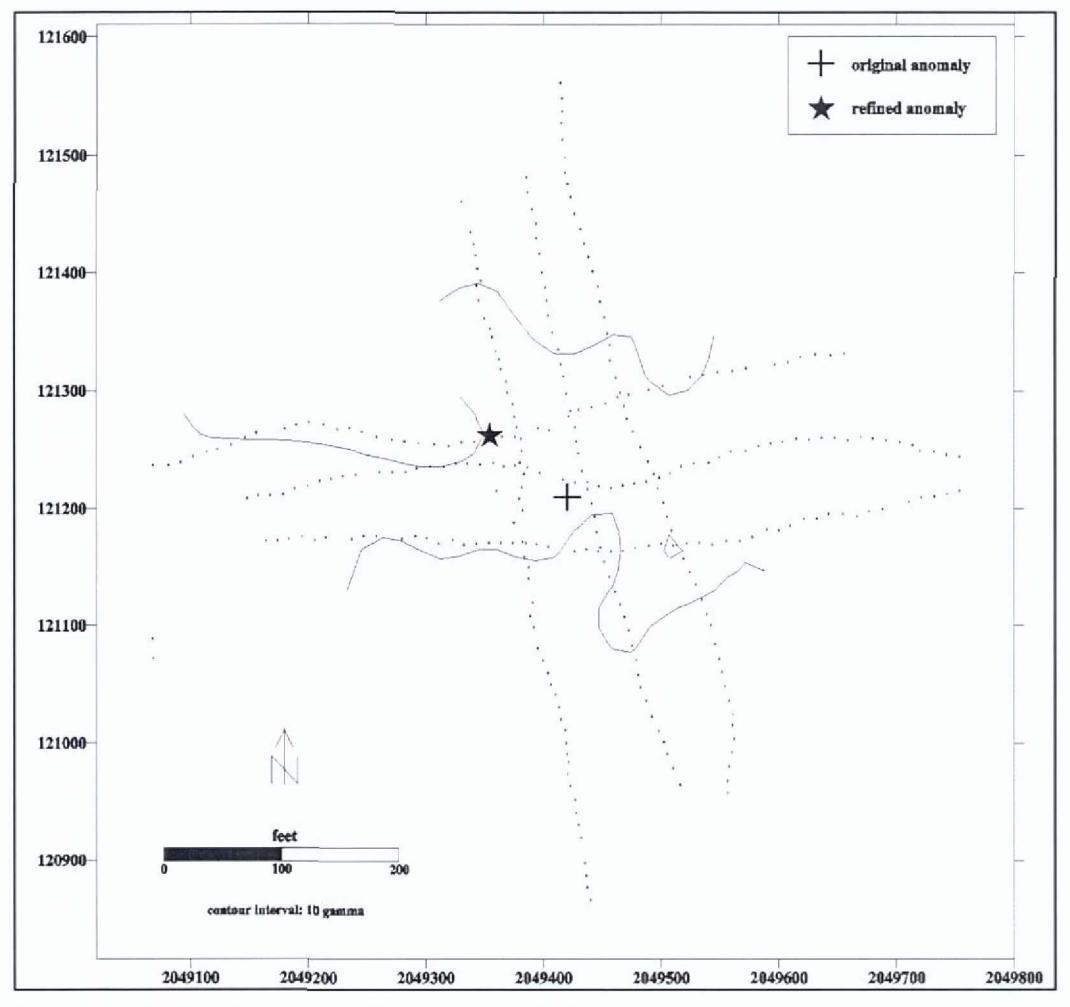
Figure 46. Magnetic refinement map of Target 16.

Initially identified as a 16-gamma magnetic anomaly recorded on one trackline, Target 16 had an associated side-scan sonar return, 10-15 feet in length, 1-3 feet in width, with 2-4 feet of relief (Riess 1994b:7). A buoy was deployed within 12 feet of the coordinates provided by Riess (1994:7). Six refinement runs were made over the buoyed location with the magnetometer (Figure 46). Examination of the magnetometer data indicated a relatively small anomaly (10 gammas); however, it was discernible over a number of the tracklines. After dropping a refinement buoy, the dive vessel was anchored and a diver suited up for target identification.

Using the metal detector to re-acquire the highest magnetic area of the anomaly, the diver was then given the water jet to trench across the area in an effort to identify Target 16. After using the water jet for only six minutes the diver located the source of the anomaly; a woven, iron cable running in an east-west direction. The cable was nine inches below the sand bottom (41-foot depth). No underwater video of Target 16 was taken because of a lack of visibility. Before departing the target, a refinement buoy was placed on the cable and its exact position shot in with the DGPS. Target 16 is modern and not considered significant.

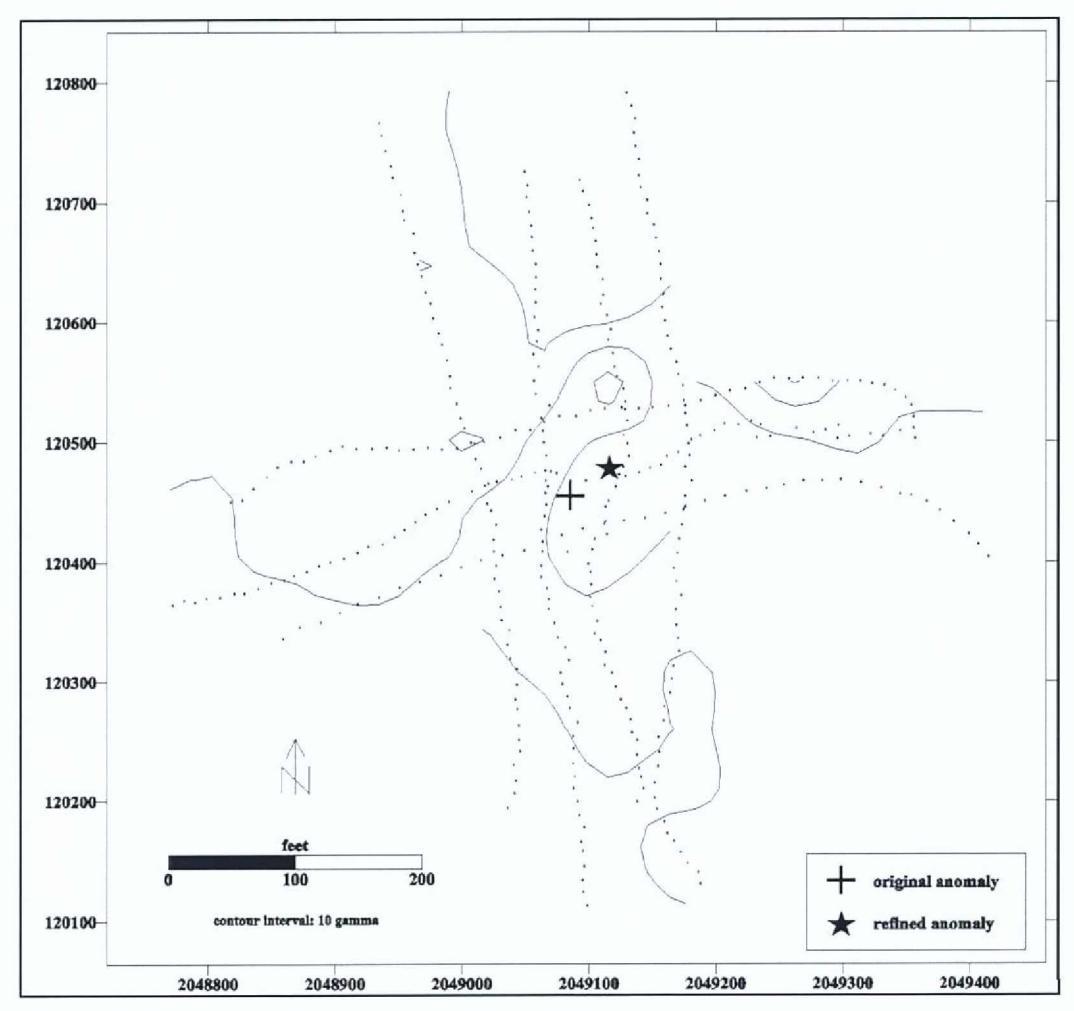
Figure 47. Magnetic refinement map of Target 17.

Recorded on eight survey tracklines, Riess indicates Target 17 as the largest magnetic anomaly (approximately 147 gammas) located during the 1993 survey. Riess' side-scan sonar returns included a "series of point returns along same alignment, each 1-3 ft. dia., 1-2 ft. relief, possibly cable or pipe?" (1994:7) After six passes with the magnetometer, the anomaly was sufficiently refined and an additional buoy placed on site (Figure 47). The largest magnetic deviation

recorded during the refinement survey over Target 17 was 46 gammas. During refinement runs Captain Hepler noted a rise off the ocean bottom in the location of the magnetic anomaly. After anchoring the dive vessel, Hepler successfully placed a grapple hook on the target as a diver suited up.
