FINAL REPORT

UNDERWATER INSPECTION OF TARGETS BORROW AREA 2 ATLANTIC COAST OF LONG ISLAND EAST ROCKAWAY INLET TO ROCKAWAY INLET QUEENS COUNTY, NEW YORK STORM DAMAGE REDUCTION PROJECT

Prepared for: Environmental Analysis Section U.S. Army Corps of Engineers, New York District 26 Federal Plaza • New York, New York 10278

September 2003

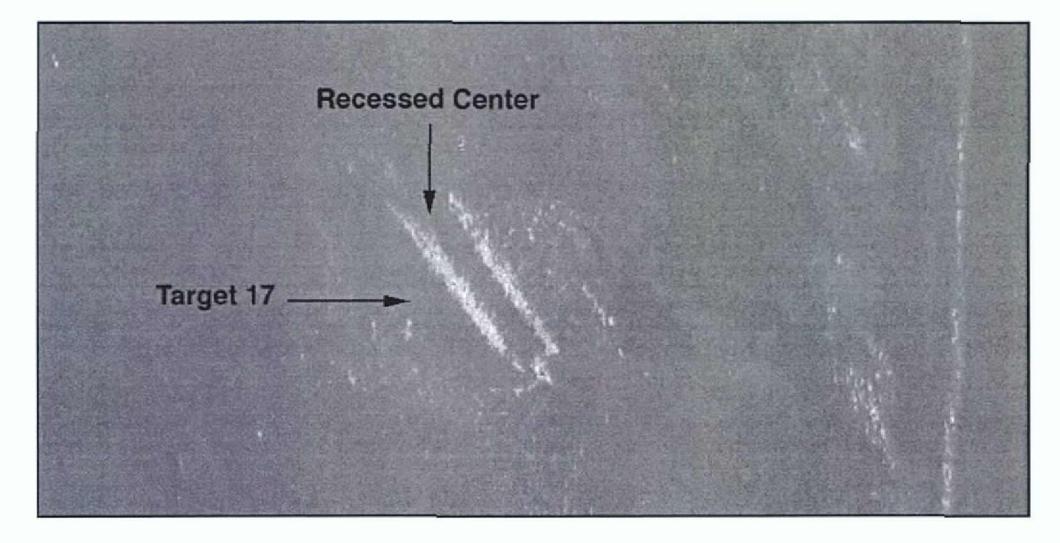
Figure 49. Side-scan sonar image of Target 17.

The diver took a pneumo-gauge reading after reaching the bottom at 41 feet. Afterwards the diver followed out the grapple hook line and quickly identified Target 17 as another section of concrete and rebar bridge span. The exposed span measured 26 feet in length with a maximum width of five feet. A pneumo-gauge reading taken at the most exposed end of the span was 39 feet 6 inches (for an exposed height of 1 foot 6 inches). The diver was given the underwater video camera and proceeded to record the target (Figure 48). The side-scan sonar image of Target 17 distinctly shows two parallel linear features distinguishing the exposed longitudinal features of the bridge span (Figure 49). Likely intended for the Rockaway Beach Artificial Reef or the Atlantic Beach Artificial Reef, Target 17 is considered modern and therefore not considered significant for the purposes of this investigation.

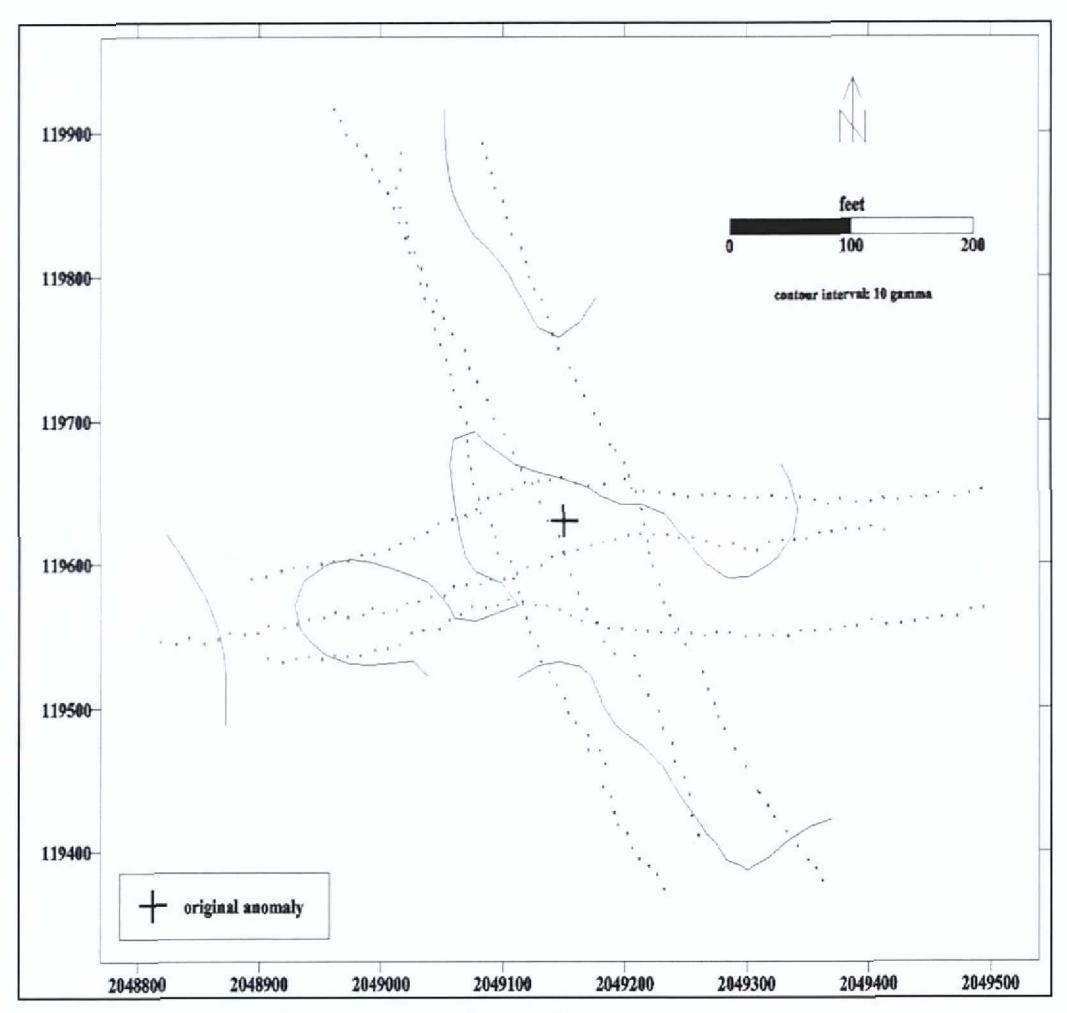
Figure 50. Magnetic refinement map of Target 18.

Riess reported Target 18 as a magnetic anomaly with a maximum, 23-gamma deviation documented on two survey tracklines. A buoy was deployed within 14 feet of the coordinates provided by Riess (1994:7). Water depth over the target area was 36 feet. The magnetometer was deployed and six 500-foot long tracklines were run over the area (Figure 50). Magnetic refinement of the target area indicated only a 5-gamma anomaly on one of the tracklines. Additional refinement passes failed to recreate the anomaly. Since the anomaly appeared to be no longer present within the general area prescribed by Riess or was too minimal in gamma strength to warrant subsequent identification, no further investigations were conducted.

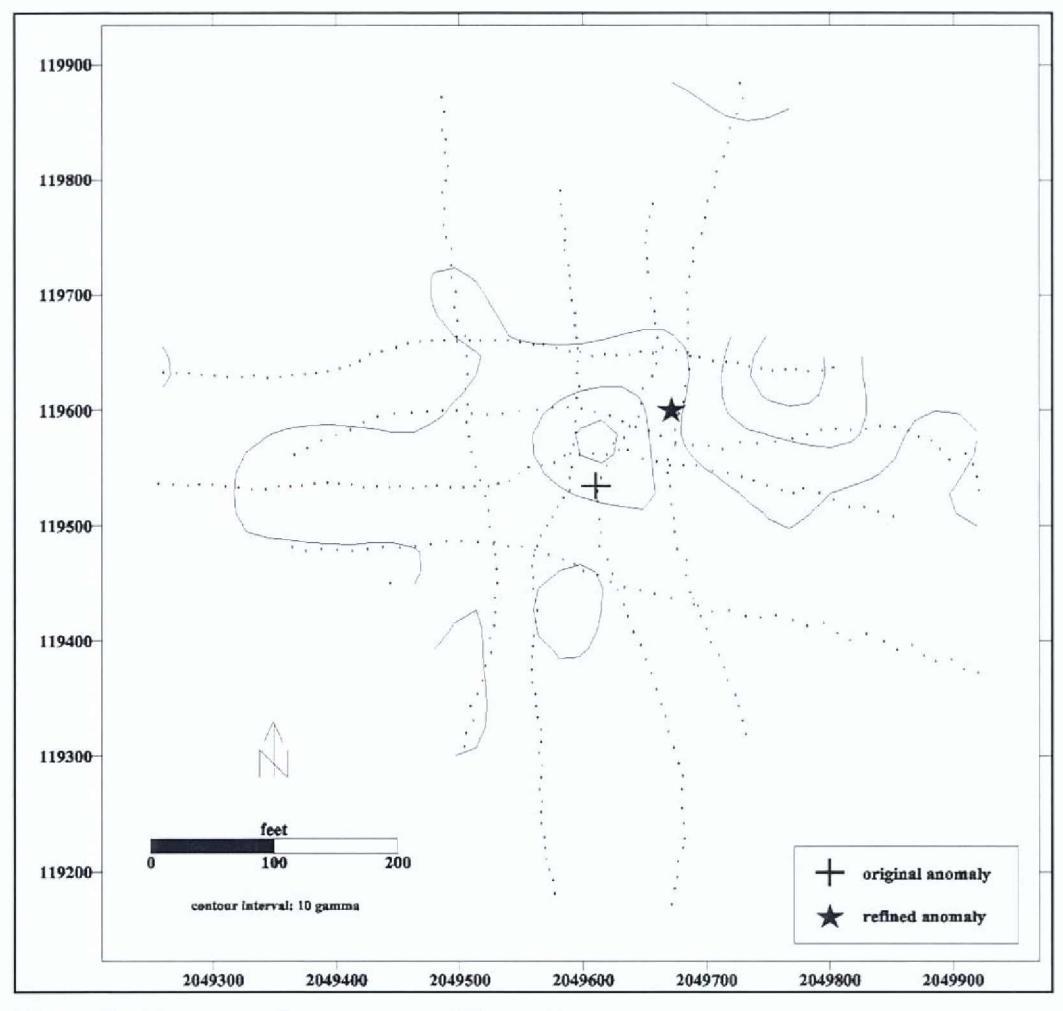
Figure 51. Magnetic refinement map of Target 19.

Riess identified Target 19 as a magnetic anomaly with a maximum deviation of 40 gammas (recorded on 2 survey tracklines) with no associated side-scan sonar return. After deploying a buoy within 12 feet of the target area, a series of eight magnetometer refinement runs were made around the target area. Magnetic refinement of the target area indicated a dipole anomaly with a maximum deviation of 50 gammas (Figure 51).

After placing a refinement buoy the dive vessel anchored over the refined target area and a diver suited up to investigate the target. Upon reaching the ocean bottom the diver's pneumo gauge registered a depth of 38 feet. After a series of arched sweeps around the refined area the diver reported no exposed target above the ocean bottom. In an effort to quickly locate the anomaly the diver was given the underwater metal detector to determine the spatial extent of the site. Proceeding in cardinal directions the diver's first transect extended from the refinement buoy to the west. The metal detector pegged out at "10" (the maximum magnetic reading) for approximately 100 feet. From the refinement buoy to the east the metal detector was still reading 8-9 for close to 95 feet. The diver then proceeded on two transects extending to the north and south of the refinement buoy. The metal detector remained pegged out at ten for 100 feet in either direction.

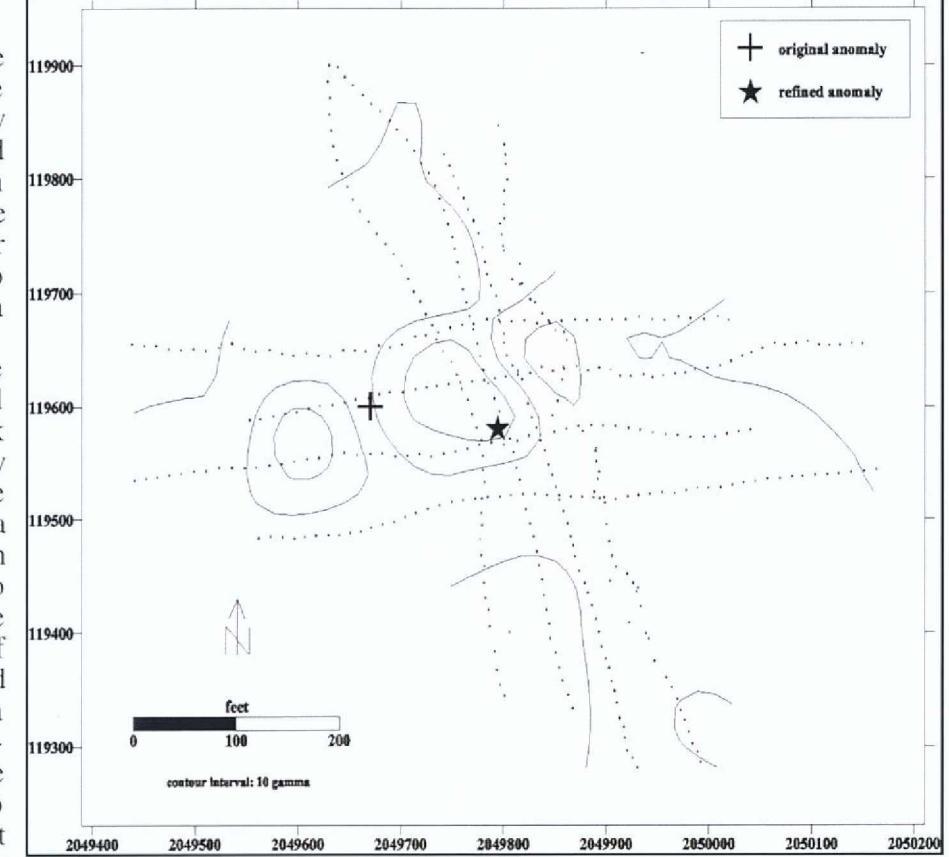
Figure 52. Magnetic refinement map of Target 20.

Initially recorded on three tracklines, Target 20 had a magnetic signature with a maximum gamma strength of 64 gammas and an associated side-scan sonar return. The side-scan sonar return was an "elongate target, 50-70 ft. long, 1-4 ft. wide, 1-3 ft. relief" (Riess 1994b:8). After the successful deployment of the magnetometer, eight refinement runs were made around the buoyed target (Figure 52). The magnetometer registered a dipole anomaly with a maximum deflection of 87 gammas. During the passes with the magnetometer, Captain Hepler noted an object exposed above the ocean floor with his fathometer (within close proximity of the refinement buoy).

After anchoring the dive vessel, the captain and crew successfully placed the grapple hook on the anomaly. Once suited up the diver proceeded straight to the bottom and took a pneumo-gauge reading (36 feet). The diver then proceeded out the grapple hook line and quickly identified the source of the anomaly as a large, woven iron cable identical to Target 19. The exposed portion of the cable extended out of the sand in a large loop, roughly 4-5 feet in length. The underwater video camera was then sent down the diver's rig to document the target (Figure 53).

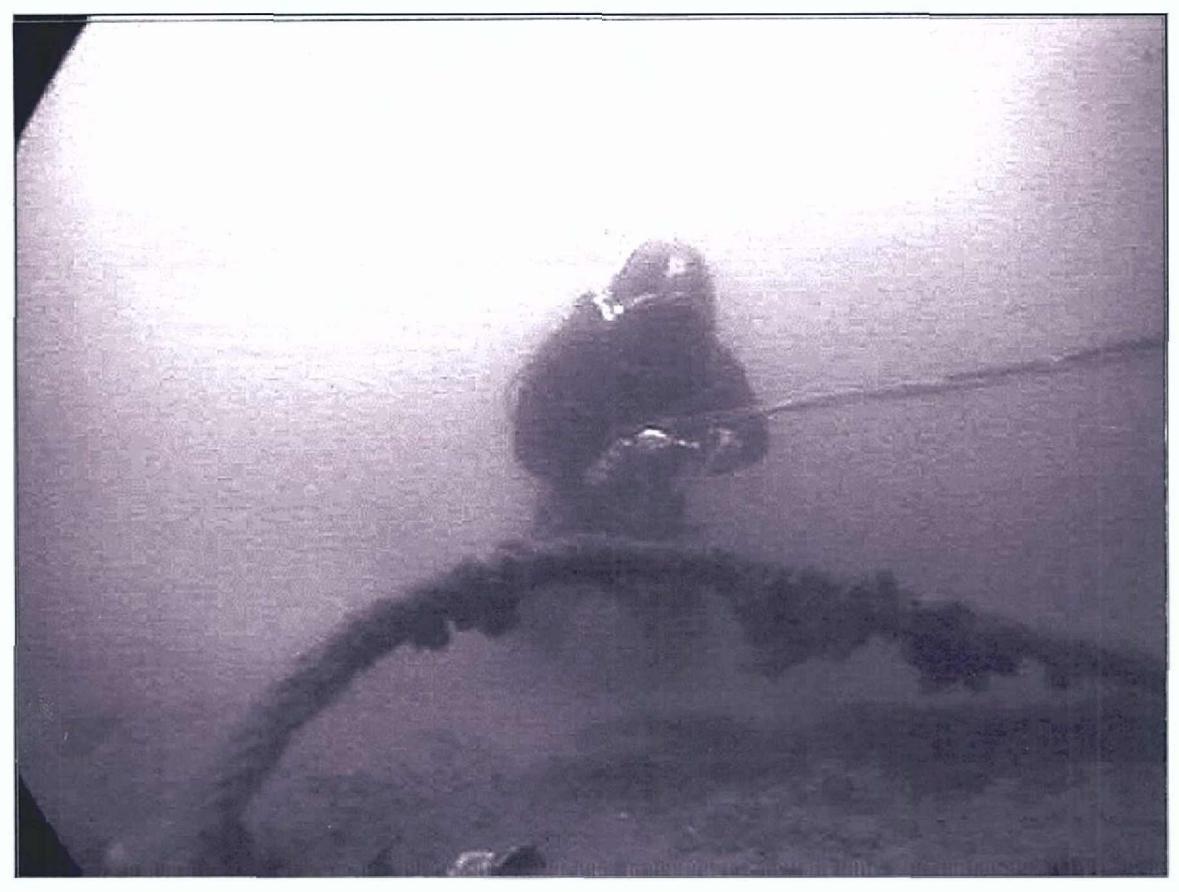
Figure 53. Diver preparing to take a measurement of Target 20.

Reviewing the refined coordinates for Targets 19 and 20, it is apparent that both targets are the same. In fact, the refined location of Target 19 is almost identical to the coordinates provided by Riess for Target 20. It is evident that the cable, exposed at both locations, is extremely lengthy. This is a clear example of the value of contouring magnetic data. If the data had been contoured during the initial remote-sensing survey, it would have been evident that Targets 19 and 20 are the same magnetic anomaly.

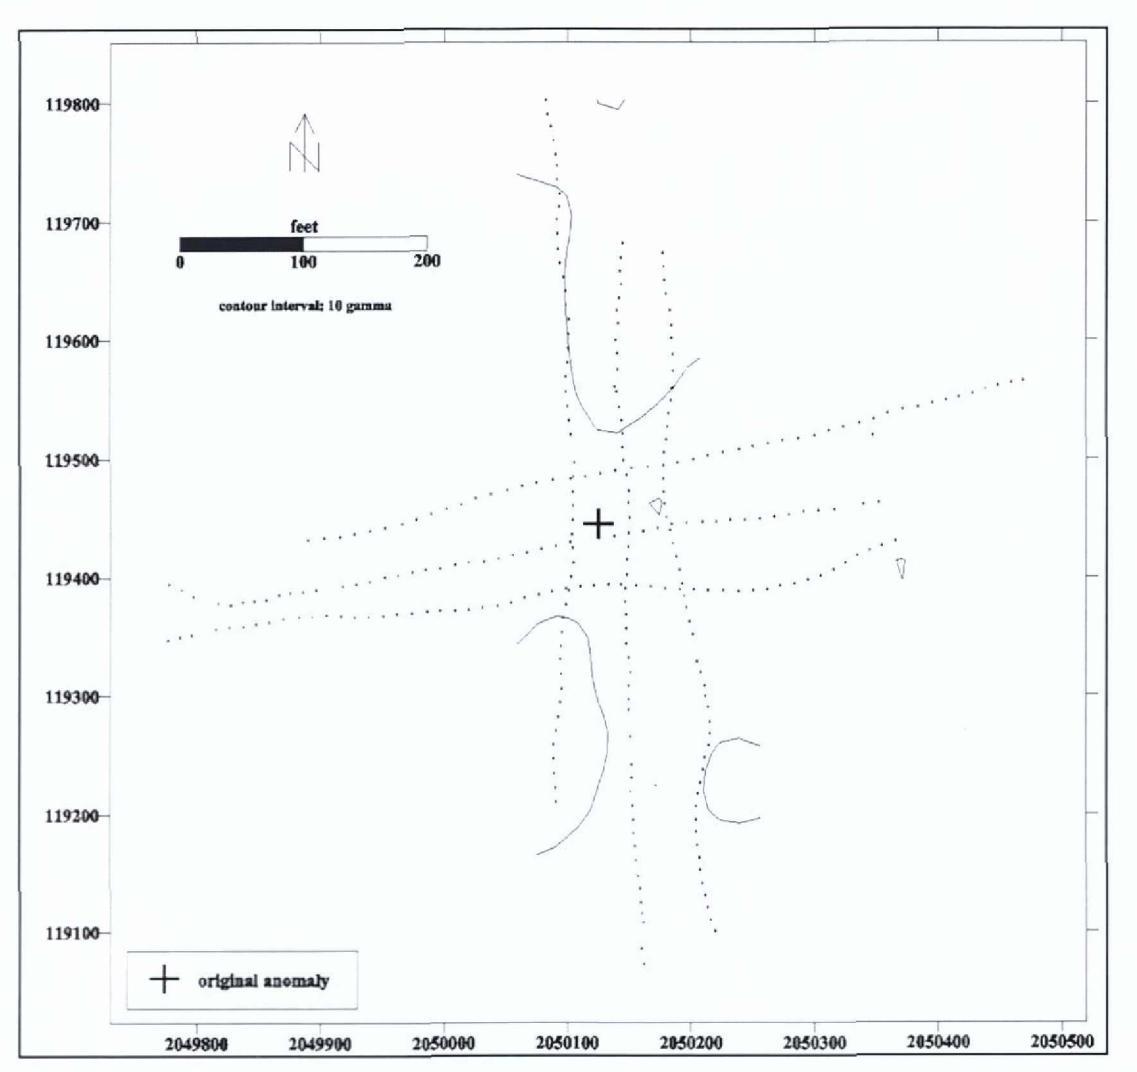
Figure 54. Magnetic refinement map of Target 21.

Riess identified Target 21 as a 19-gamma magnetic anomaly recorded over two survey tracklines with an associated side-scan sonar return (1994:8). After dropping a buoy within eight feet of Riess' coordinates, the magnetometer towfish was deployed and the running of tracklines initiated. Depth of water over the target area was approximately 35 feet. After running six refinement runs over the general area (Figure 54), it is clear that Target 21 is no longer present at its prescribed location. After Captain Hepler noted a scour in the target area, an additional set of refinement runs were made in the area. However, the magnetometer recorded no associated anomalies within the area. Due to the relative paucity of magnetics within the general area, it was decided that Target 21 did not warrant diver investigations.

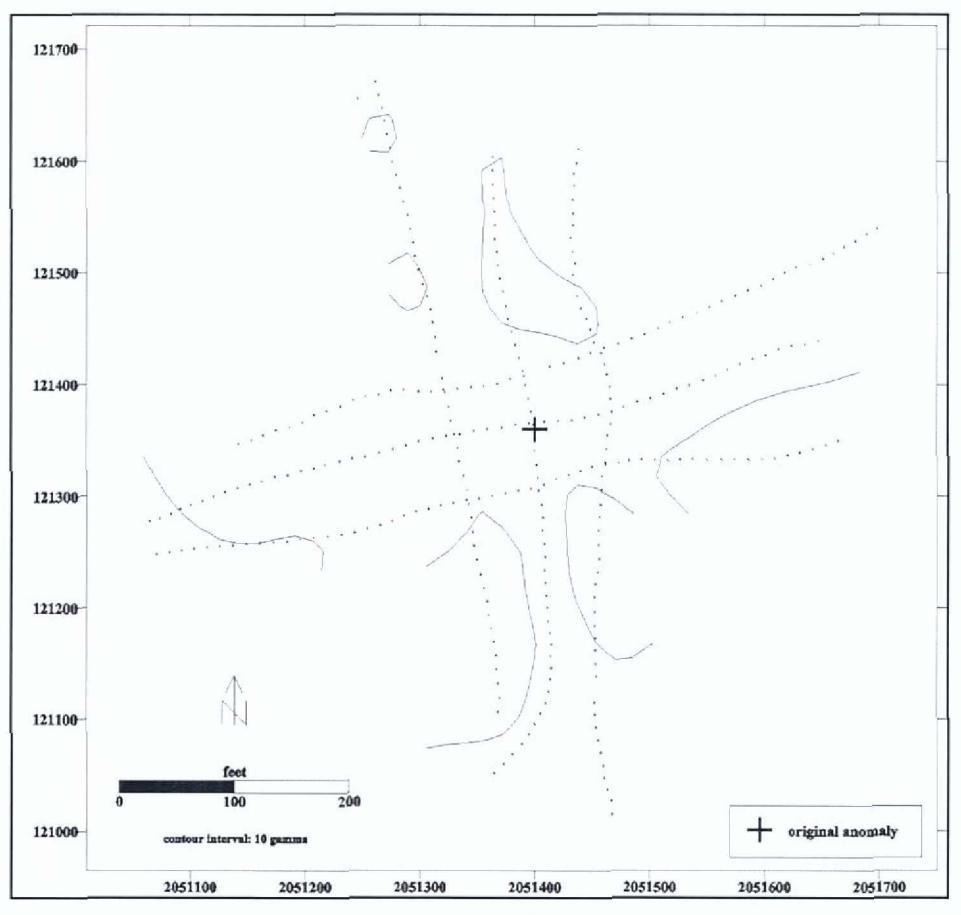
Figure 55. Magnetic refinement map of Target 22.

Described as an anomaly with a maximum 22-gamma magnetic deviation, Target 22 was previously recorded on two tracklines. The magnetic refinement of the target area began after dropping a buoy on the coordinates provided by Riess (1994:8). Depth of water over the target area was 35 feet. Six refinement runs over the area with the magnetometer identified no definitive magnetic anomalies within the area (Figure 55). While the magnetometer recorded a couple of small magnetic "hits" (less than 10 gammas) within the area, these were small single-point sources and not definable anomalies. No additional investigations were undertaken at this location.

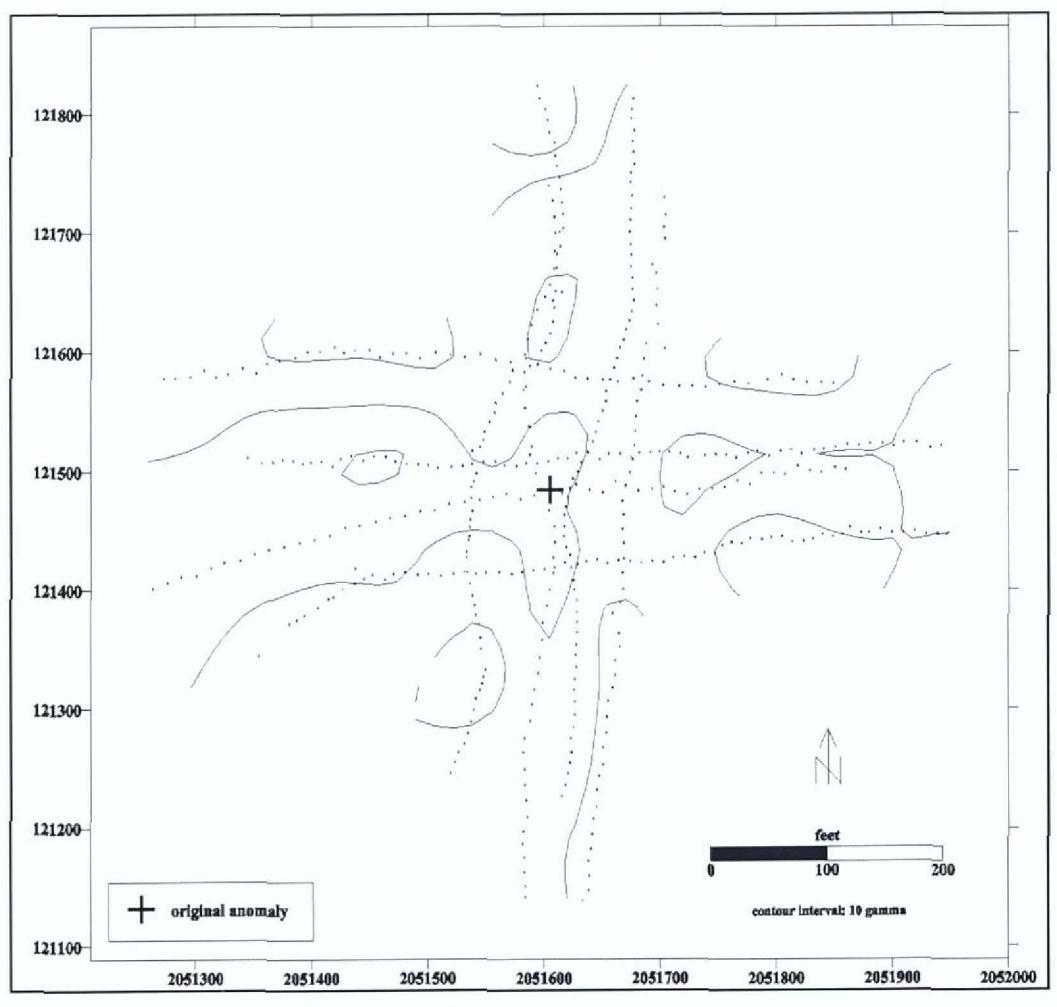
Identified as a magnetic anomaly (with a maximum gamma deviation of 53 gammas) on three tracklines, Target 23 had no associated side-scan sonar return. After deploying a buoy within 14 feet of Riess' coordinates (1994:8), magnetic refinement runs with the magnetometer were undertaken. No discernible magnetic anomalies were identified within the area after eight successive passes with the magnetometer (Figure 56). It is apparent that Target 23 is no longer present within the general area prescribed by Riess and has likely been relocated from the area since the initial remote-sensing survey in 1993. Due to the lack of discernible magnetics within the general area, no diver investigations were undertaken at this location.

Figure 56. Magnetic refinement map of Target 23.

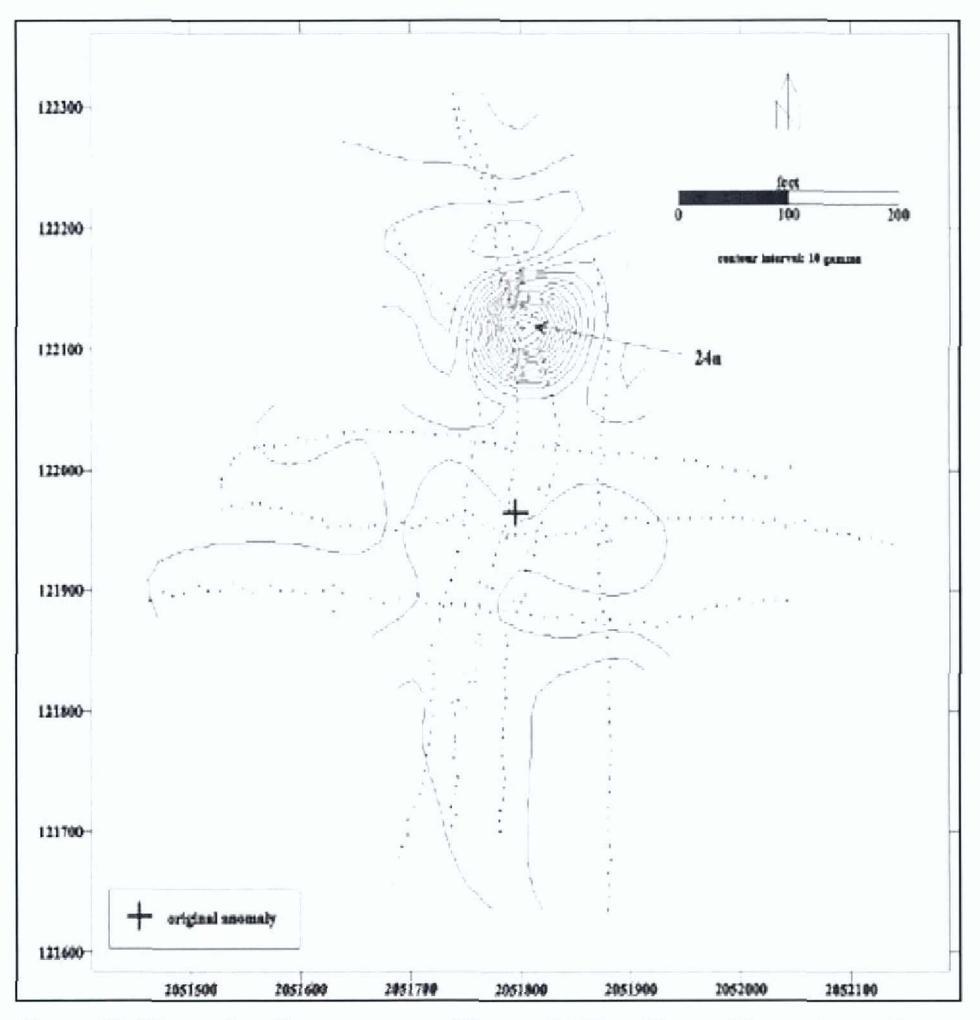
Recorded on only one trackline during the previous investigation (Riess 1994b), Target 24 had a single magnetic signature of 12 gammas with no associated side-scan sonar return. Dropped within nine feet of the coordinates provided by Riess, a series of seven refinement runs were made with the magnetometer around the buoyed location (Figure 57). No definable magnetic anomalies were found within 150 feet of the buoyed location. No diver investigations were undertaken at this location due to a lack of magnetics within the area.

Although there were no discernible magnetic anomalies within 200 feet of the Target 24 coordinates, the magnetometer and Captain Hepler's fathometer recorded a large anomaly approximately 217 feet immediately to the north of Target 24 (see Figure 57). The anomaly had a much larger magnetic signature than Target 24, recorded during the previous remote-sensing survey (Riess 1994b). Therefore it was determined that the anomaly (not documented by Riess) was likely deposited in the area after Riess's survey in 1993. While this target was not slated for diver investigation, it was decided to conduct a diver investigation of the target for identification purposes.

Figure 57. Magnetic refinement map of Target 24. Note Target 24a to the north.

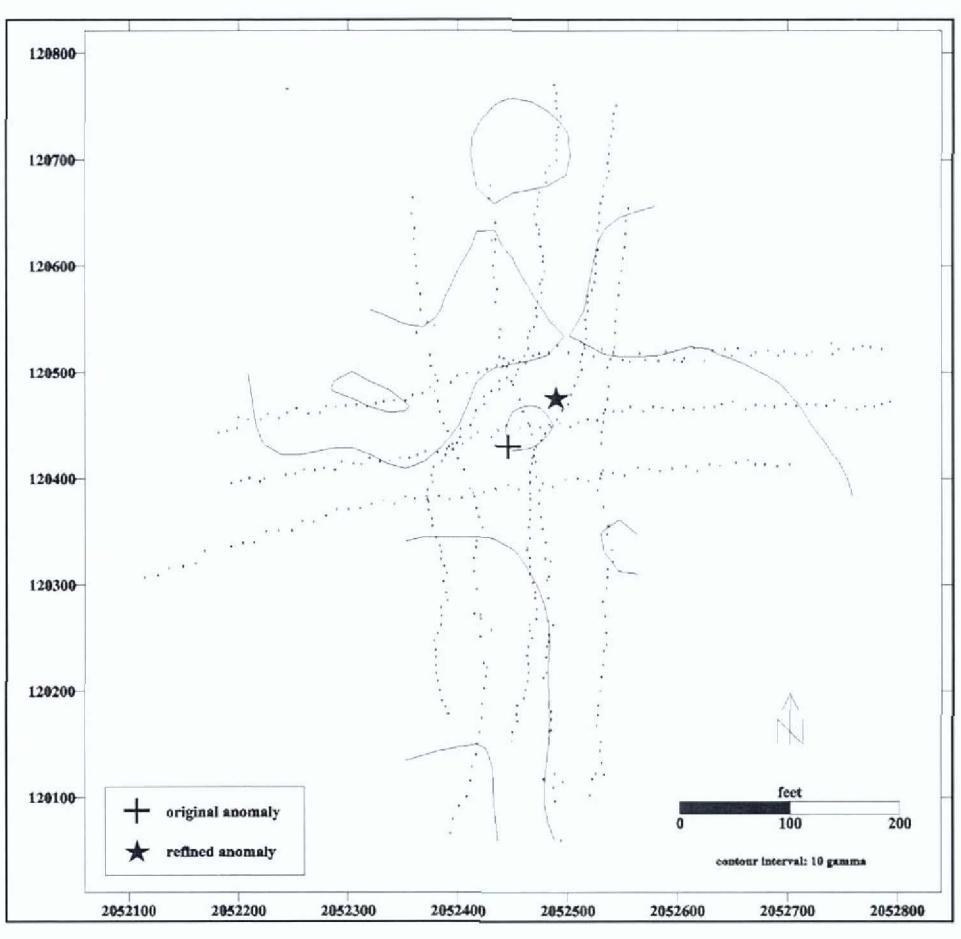
Riess reported Target 25 to be a magnetic anomaly with a maximum magnetic deviation of 23 gammas recorded on three tracklines (1994:8). Eight refinement runs were made over the target area with the magnetometer. Magnetic refinement of the area located the presence of an anomaly with a magnetic deviation of 14 gammas (Figure 59). After placing a refinement buoy over the source of the anomaly the dive vessel anchored near the site and the diver suited up.

A pneumo-gauge reading upon reaching the bottom registered 40 feet. Outfitted with the underwater metal detector, the diver proceeded to begin diver sweeps around the refinement area. The center of high magnetics was buoyed after localizing the target area. While waiting for the water jet the diver noted a small object protruding from the sand. Closer examination of the object identified the frayed end of a wire cable (approximately one inch in diameter). The diver exposed approximately three feet of the cable (buried 3-5 inches below the sand bottom) while the underwater video camera was being readied. The section of cable was documented and the diver returned to the surface (Figure 60). Target 25 is identified as a relatively isolated piece of small-diameter wire cable. This target is not considered significant for the purposes of this investigation.

Figure 59. Magnetic refinement map of Target 25.

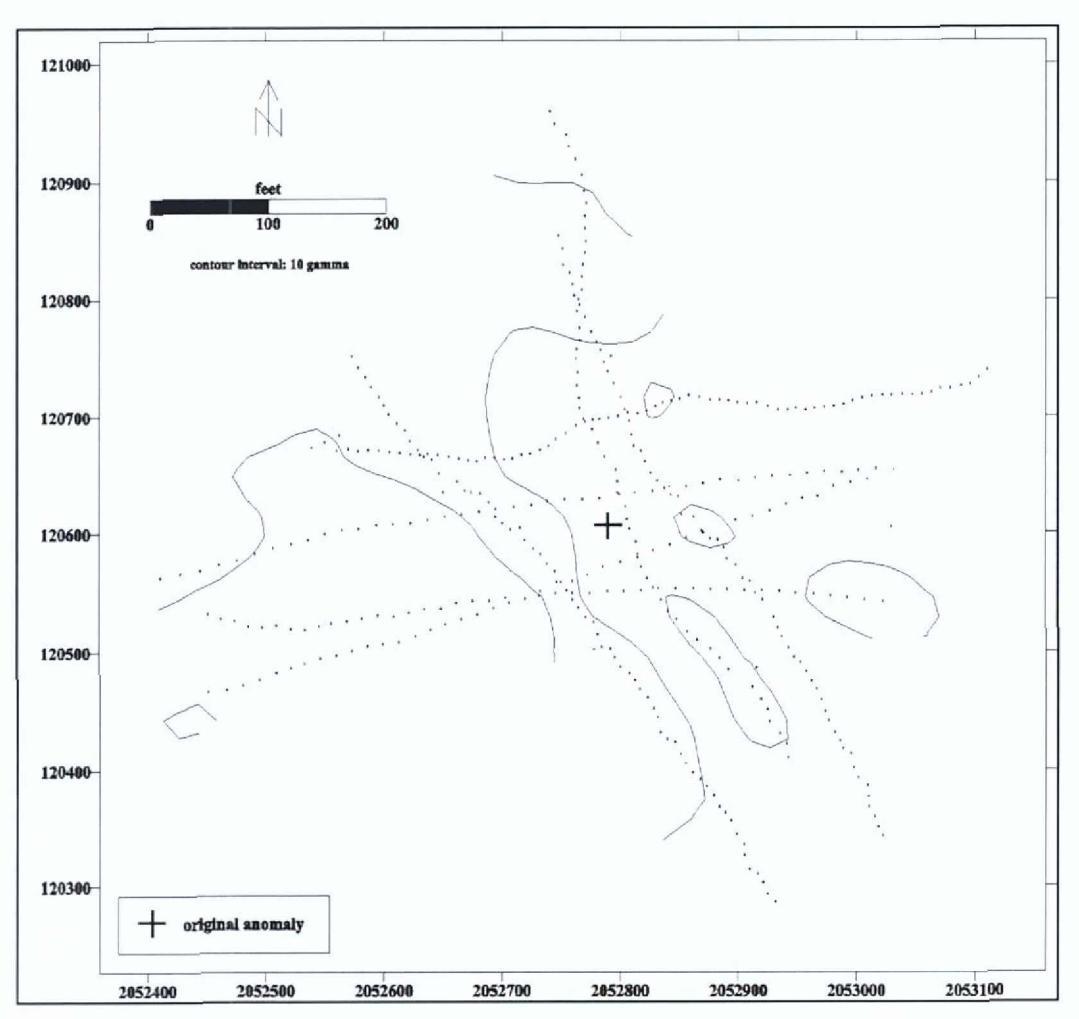
The 1993 survey identified Target 26 as a magnetic anomaly (19 gammas) with an associated side-scan sonar return which was an "elongate target, 20-50 ft. long, 1-3 ft. wide, 1-3 ft. relief, possible cable?" (Riess 1994b:8) After placing a reference buoy (six feet from Riess' coordinates) on site, the dive vessel proceeded to make seven consecutive passes around the buoy (Figure 61). Water depth over the target area during the refinement survey was 38 feet. A review of the magnetometer data identified no magnetic anomalies within the general area. No diver investigations were undertaken at this location.

Figure 61. Magnetic refinement map of Target 26.

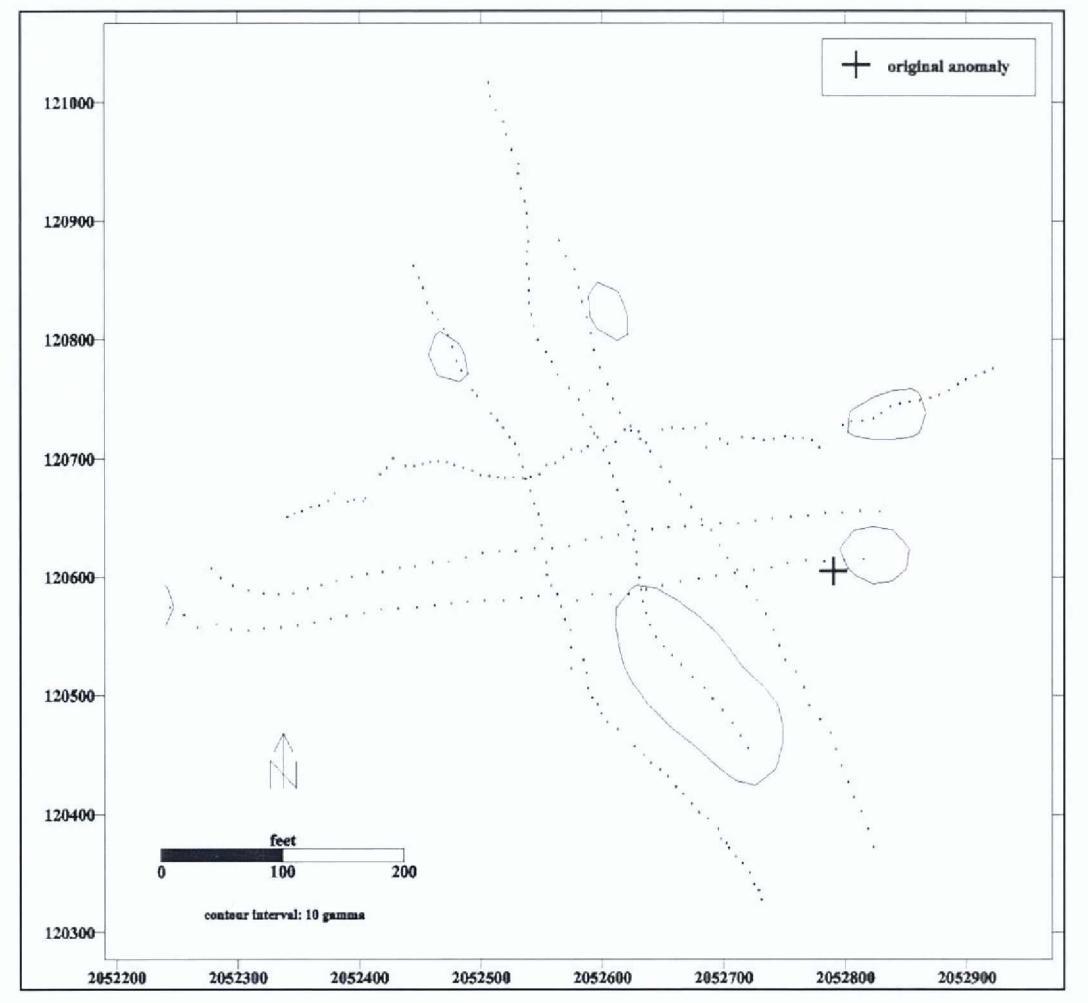
Only recorded on one trackline during the previous remote-sensing survey (Riess 1994b:8), Target 27 had a magnetic deviation of 16 gammas. Upon locating the target area a reference buoy was deployed 12 feet due north of Riess' coordinates. Refinement runs commenced after successfully deploying the magnetometer. Six tracklines were run past the target area (Figure 62). Water depth over the target area was approximately 36 feet. A single-point, 5-gamma hit was the only magnetic anomaly within the entire area surveyed. This anomaly could not be re-

acquired on any other tracklines. Due to the relative dearth of magnetics within the refinement area, diver investigations were not undertaken at Target 27.

Figure 62. Magnetic refinement map of Target 27.

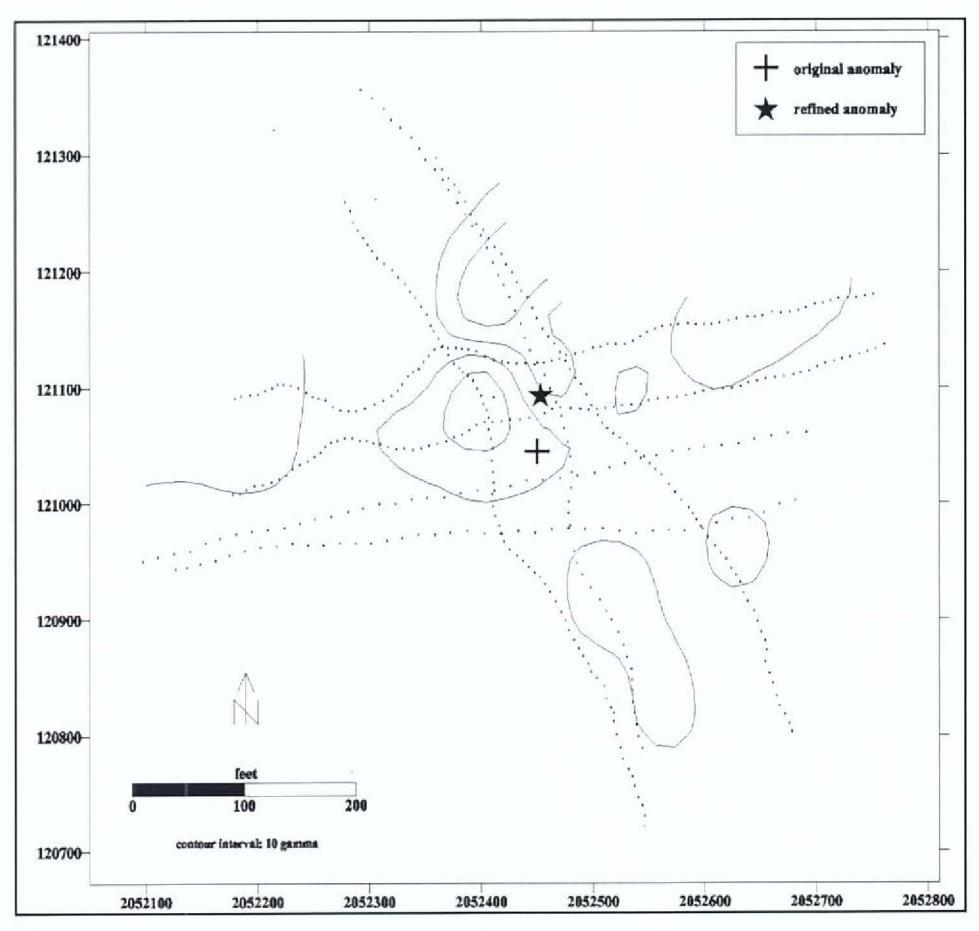
Proceeding directly from Target 27 to Target 28, a reference buoy was dropped and refinement runs with the magnetometer begun. Riess describes Target 28 as a single magnetic anomaly with a deviation of 18 gammas and no associated side-scan sonar target (1994:8). Seven refinement runs were made to sufficiently relocate the anomaly (Figure 63). After anchoring the dive vessel, the diver proceeded to the bottom and took a pneumo-gauge reading. Water depth on site was 34 feet.

The diver quickly identified the source of the anomaly as an exposed section of 2-inch diameter cable/pipe. After scraping some of the growth from the anomaly it was identified as a section of woven steel cable. The cable was exposed above the sand bottom for approximately three feet. The underwater video camera was sent down to the diver in his rig and footage of the anomaly documented (Figure 64), after which the diver then returned to the surface. This target is not considered significant.

Figure 63. Magnetic refinement map of Target 28.

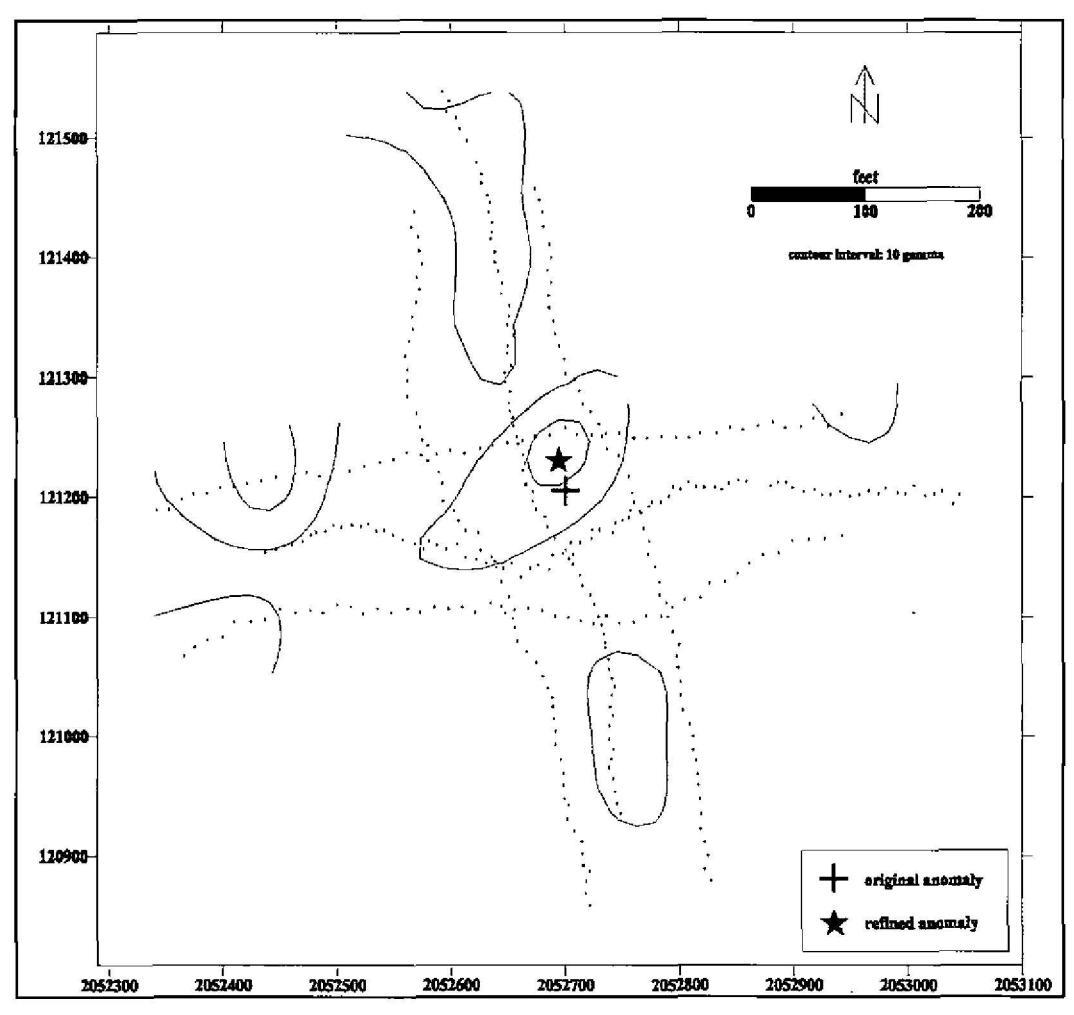
The previous investigation identified Target 29 as a magnetic anomaly with a maximum deviation of 47 gammas and no associated side-scan sonar return (Riess 1994b:8). After dropping a reference buoy within 13 feet of the prescribed coordinates, the team deployed the magnetometer and the running of refinement tracklines was undertaken. Six tracklines were run to adequately refine the anomaly (Figure 65). Once refined, the dive vessel anchored with the refinement buoy off the stern as a diver prepared to investigate the target. Depth of water on site was 40 feet.

Figure 65. Magnetic refinement map of Target 29.

After a series of arched swings around the refinement buoy the target was not exposed above the sand bottom. The diver was given the underwater metal detector in an effort to localize the anomaly. The area of magnetics extended to the north/south for approximately 60 feet and east/west for 15 feet. The diver was then given the water jet to cut a trench from east to west. Within two minutes of trenching the diver identified the source of the anomaly as a wire cable oriented north/south, located approximately 9-12 inches under the sand. A lack of adequate visibility precluded any video documentation of Target 29. This target is modern and not significant for the purposes of this investigation.

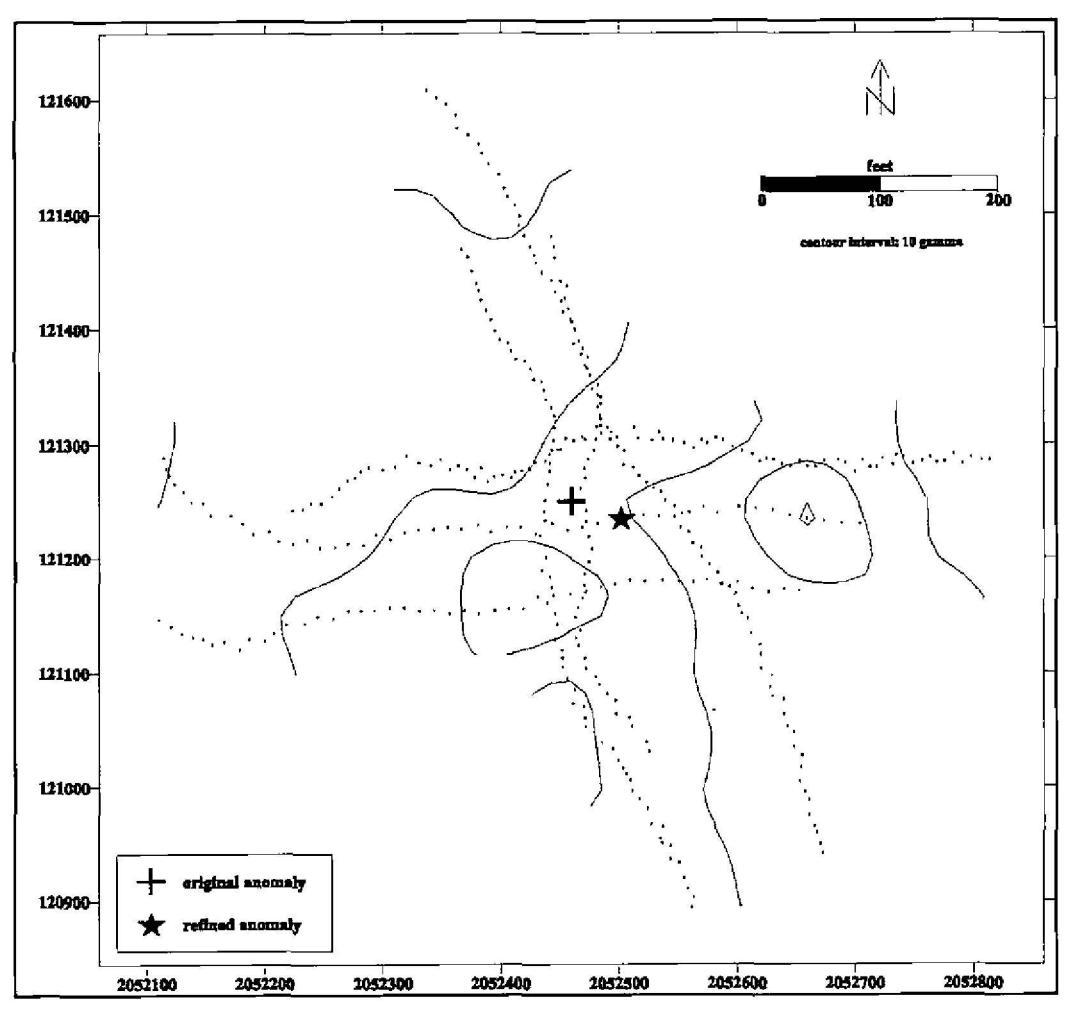
Investigations then moved on to Target 30, which was another magnetic anomaly recorded on two tracklines with no associated side-scan sonar return (Riess 1994b:8). A reference buoy was dropped on site and the magnetometer deployed in an effort to locate the anomaly. Six refinement passes over the target area were made before a refinement buoy could be placed closer to the source of the anomaly (Figure 66). Once in place, the dive vessel anchored near the refinement buoy and a diver readied for investigation.

Figure 66. Magnetic refinement map of Target 30.

Once on the sand bottom the diver's pneumo-gauge reading registered 37 feet. The diver then began delineating the target area with the underwater metal detector. The target area extended north/south for approximately 116 feet and east/west for 18 feet. Similar in orientation to Target 29, the diver then proceeded to trench across the narrow (east/west) dimension of the target area with the water jet. Within one minute of trenching the diver uncovered a wire cable, 1 1/2 inches in diameter, approximately four inches below the sand bottom. Mimicking the findings from the metal detector, the cable was oriented north/south. The diver exposed 26 feet of the cable with no additional findings before aborting the dive. No video footage of the cable was taken due to a lack of visibility. Considered modern, Target 30 is not significant for the purposes of this survey.

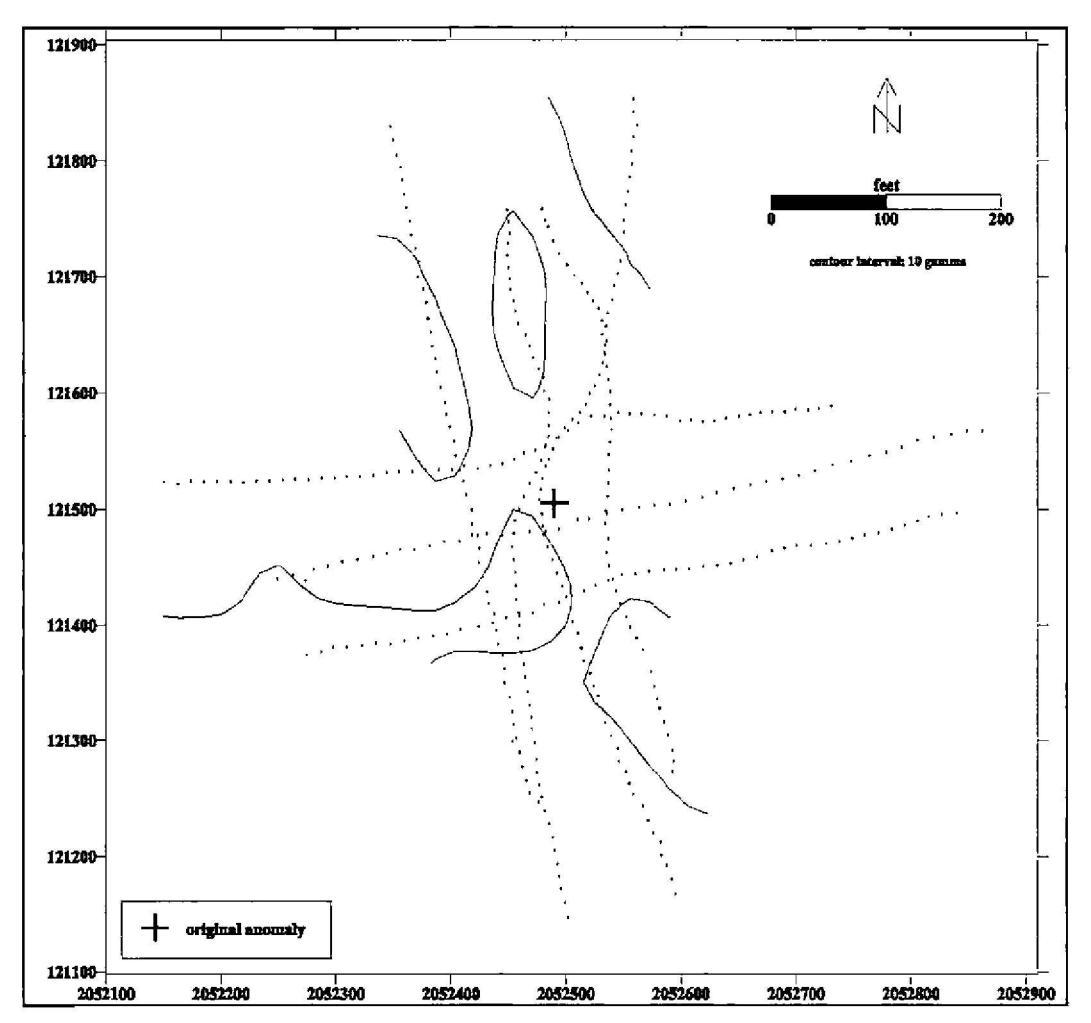
Riess identified Target 31 as a single magnetic anomaly with a deviation of 48 gammas (1994:8). There was no associated side-scan sonar image correlated with this target. After dropping a buoy four feet south of Riess' coordinates and deploying the magnetometer, a series of seven refinement runs were made over the target area (Figure 67). Water depth over the target area was approximately 39 feet. Review of the magnetometer data indicated no magnetic anomaly within the refinement area. The lack of any magnetics within the area negated the necessity for any diver investigations at this location.

Figure 67. Magnetic refinement map of Target 31.

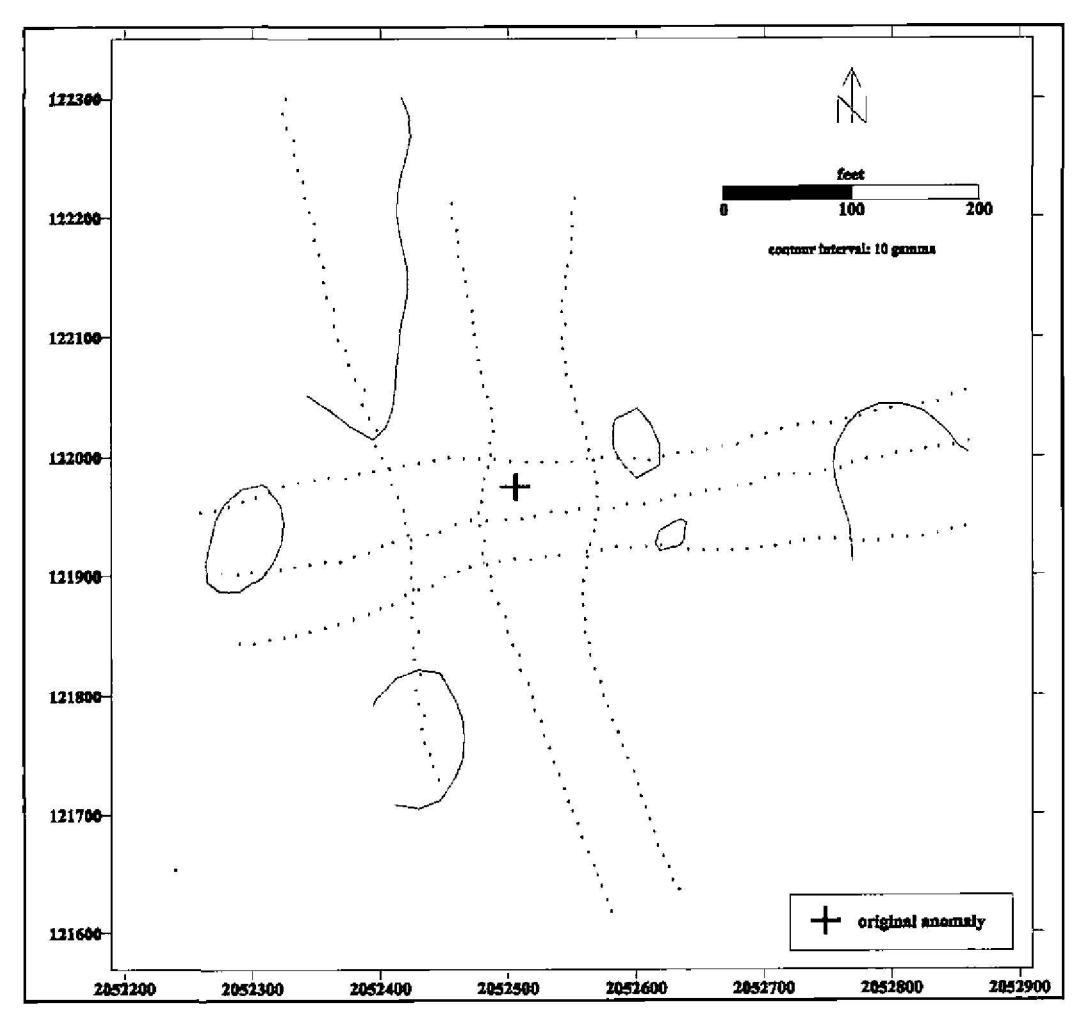
Target 32 was identified during the previous investigation as an anomaly with a maximum magnetic deviation of 18 gammas recorded on two tracklines and no associated side-scan sonar return (Riess 1994b:8). After dropping a reference buoy two feet due east of Riess' coordinates, a series of six passes were made over the area with the magnetometer (Figure 68). Similar to Target 31, the water depth on site was approximately 39 feet. Examination of the magnetometer data identified no anomalies within the general area of Target 32. No diver investigations were necessary at this location.

Figure 68. Magnetic refinement map of Target 32.
