FINAL REPORT

UNDERWATER INSPECTION OF TARGETS BORROW AREA 2 ATLANTIC COAST OF LONG ISLAND EAST ROCKAWAY INLET TO ROCKAWAY INLET QUEENS COUNTY, NEW YORK STORM DAMAGE REDUCTION PROJECT

Prepared for: Environmental Analysis Section U.S. Army Corps of Engineers, New York District 26 Federal Plaza • New York, New York 10278

September 2003

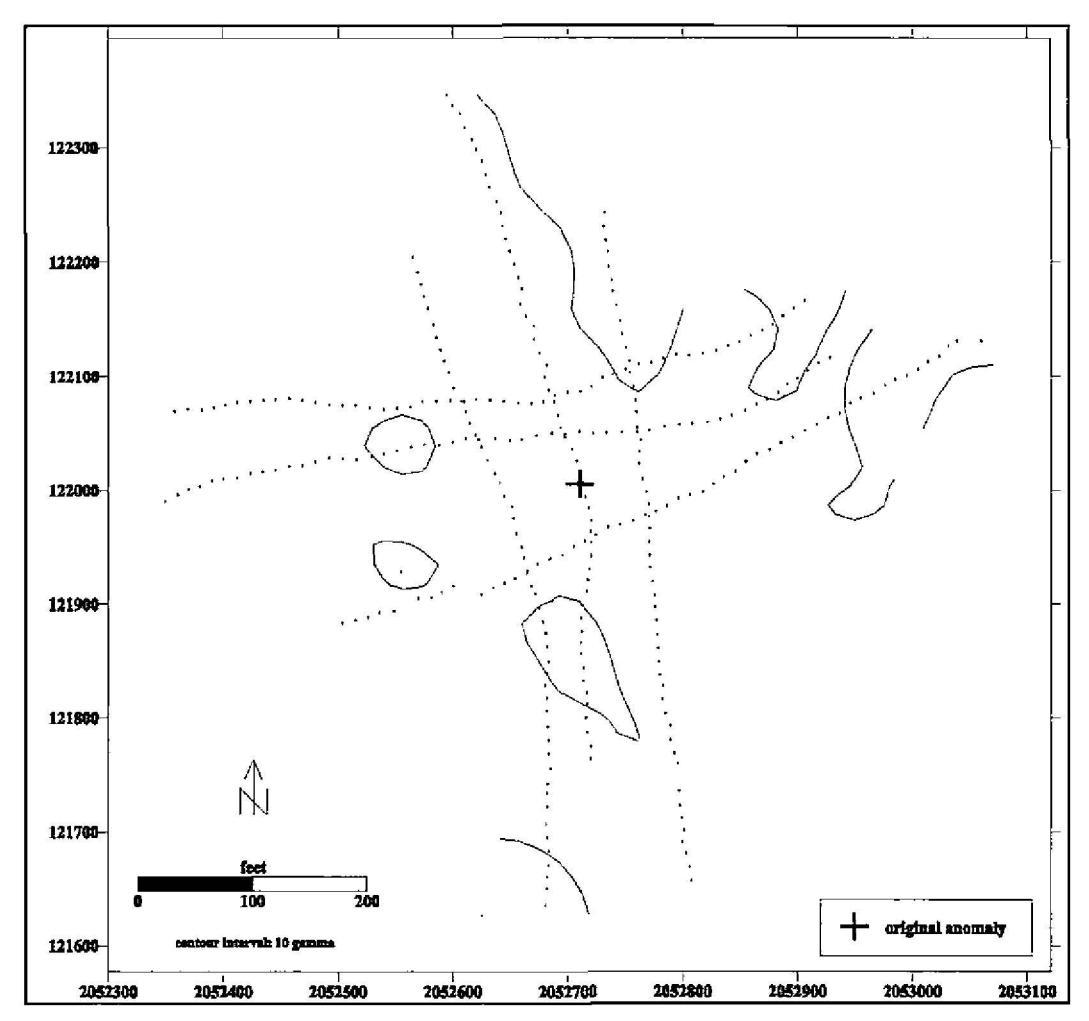
The previous investigation identified Target 33 as a magnetic anomaly with a maximum deviation (over two tracklines) of 30 gammas (Riess 1994b:8). Once the reference buoy was in place (10 feet east of Riess' coordinates) and the magnetometer deployed off the stern, the running of tracklines began. Water depth over the target area was 40 feet. After a series of six tracklines were run and the data reviewed, it was apparent that Target 33 is no longer present at its original location (Figure 69). No diver investigations were undertaken at this location.

Figure 69. Magnetic refinement map of Target 33.

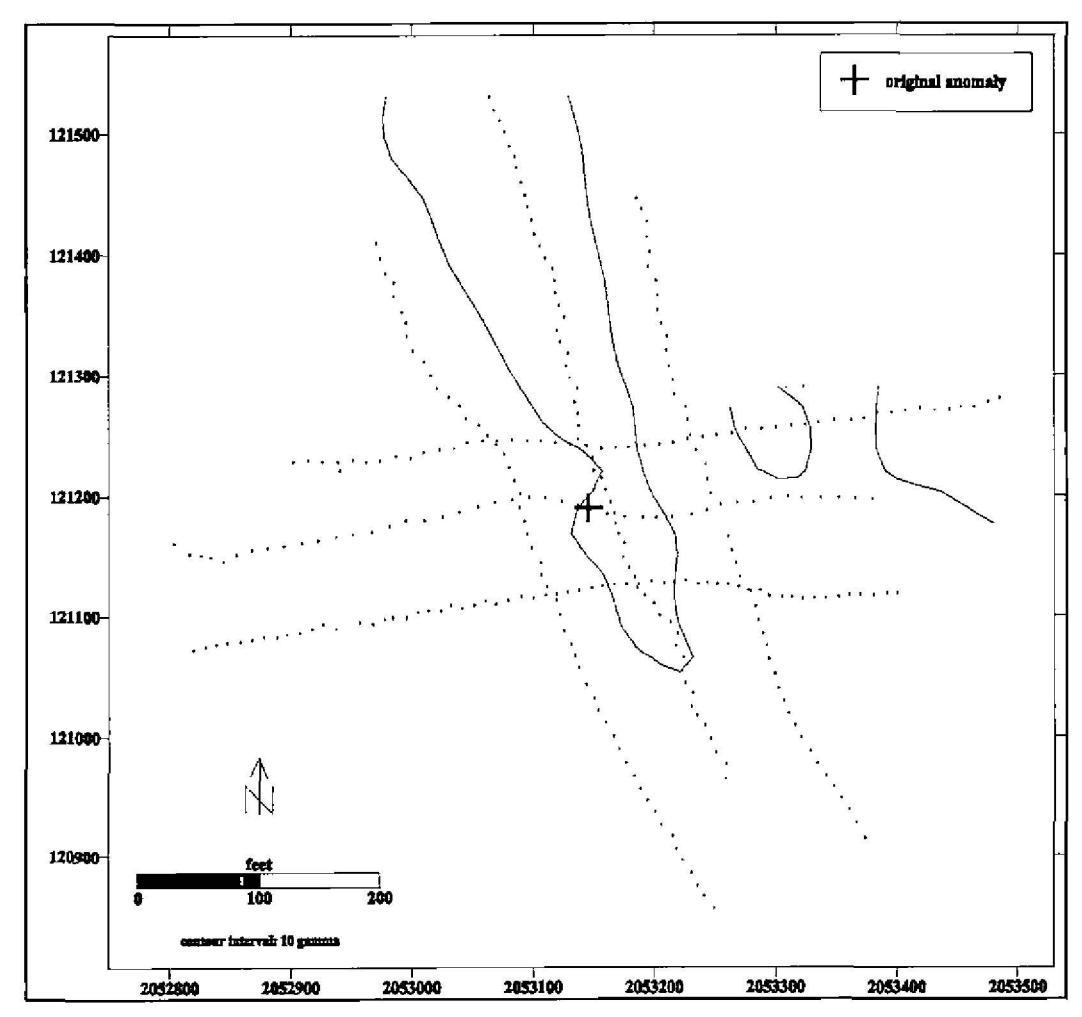
Riess identified Target 34 as a single magnetic anomaly with a maximum deviation of 13 gammas (1994:8). Six tracklines were run after dropping a buoy 14 feet to the northeast of the coordinates provided by Riess. Water depth over the target area was 40 feet. Apparent in Figure 70, no magnetic anomalies were identifiable within the general area of Target 34. No diver investigations were made at this location.

Figure 70. Magnetic refinement map of Target 34.
