REPORT ON
ARCHAEOLOGICAL TRENCHING
AT TWO LOCATIONS IN THE GOLF COURSE/
FORMER PARADE GROUND
ON GOVERNORS ISLAND
NEW YORK, NEW YORK

Prepared for: Governors Island Preservation and
Education Corporation
10 South Street, Slip 7
New York, New York 10004

Submitted by: Linda Stone, MA, RPA
249 East 48th Street, #12B
New York, New York 10017

February 19, 2007

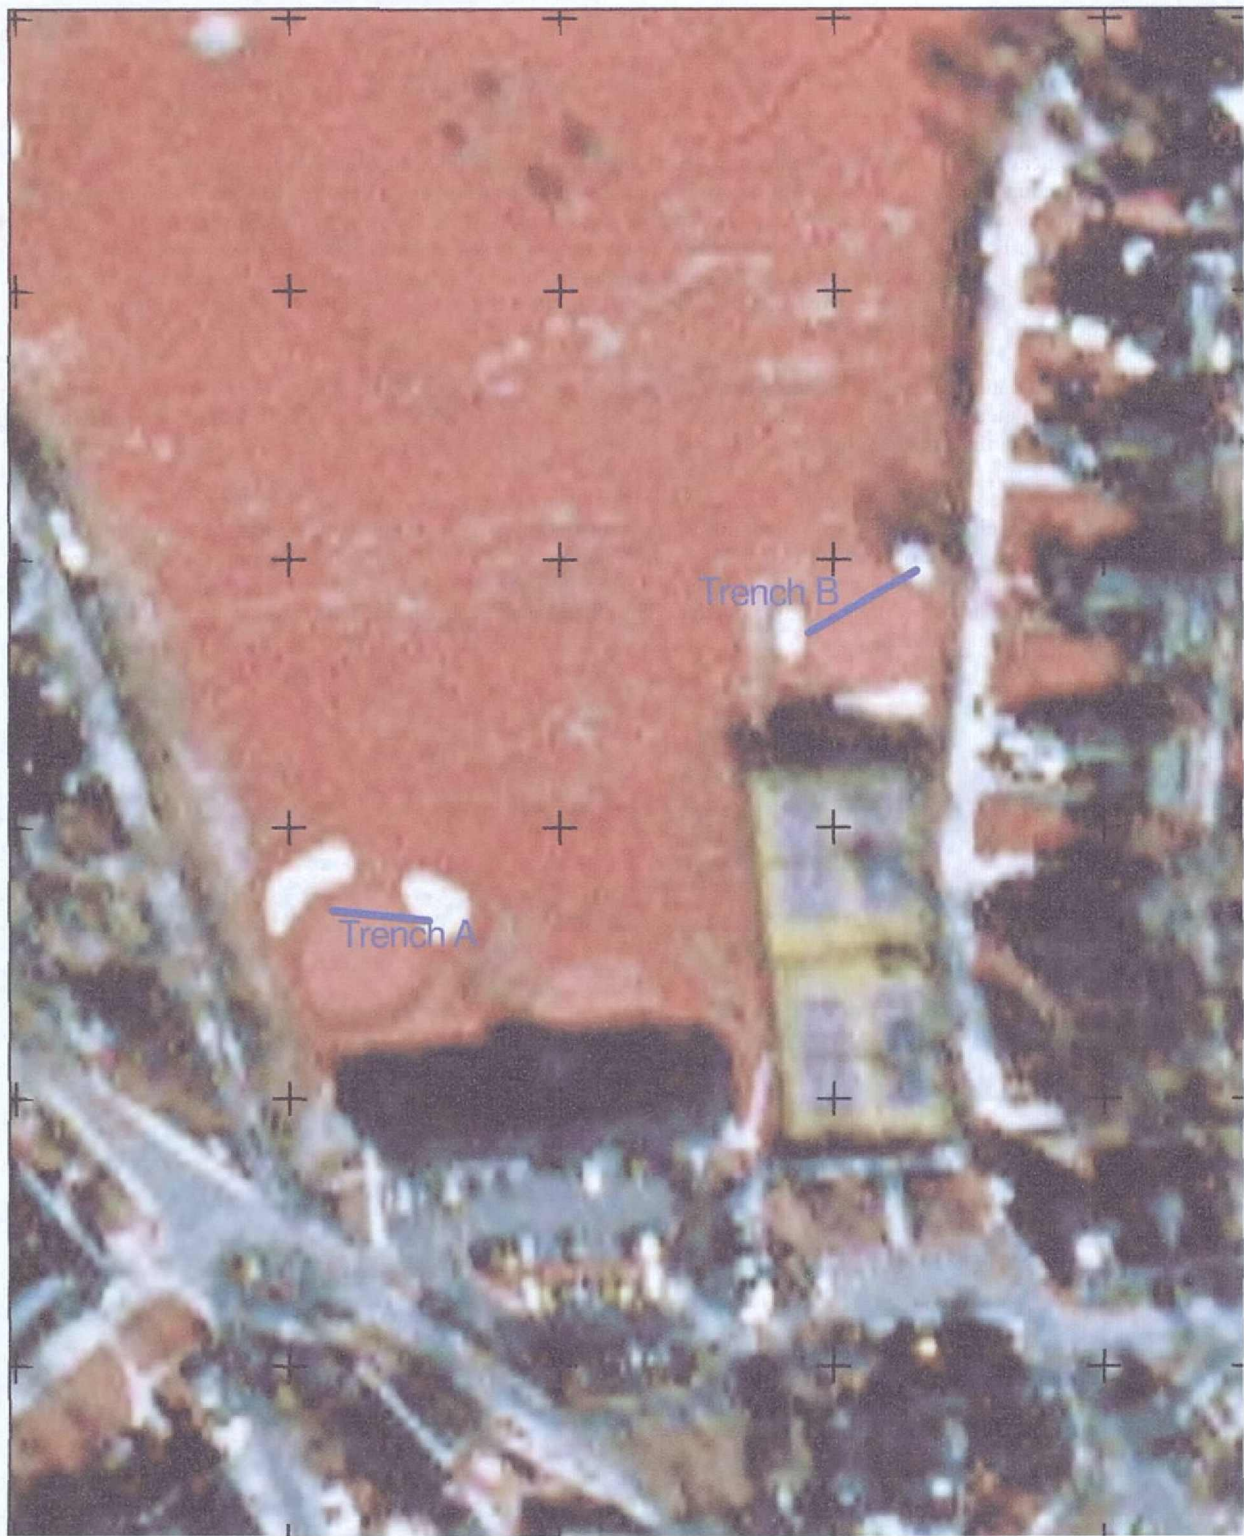
Figure 1 Location of the two trenches excavated through golf course on Governors Island.

The area of Trench B contains three sand traps (see Figure 1). The western and southern traps are almost identical in location and shape to the originals, therefore it appears no excavations were done for those to reconstruct the golf course. The northern trap is currently configured in a modified kidney shape (see Photos 9 – 10 in Appendix B), as opposed to an egg shape shown in Figure 1. Because it is currently larger and extends more toward the south, Trench B was placed to cut through it. Figure 1 depicts the location of the trench beginning to the east of the western trap and extending northeast through the green and through the southern part of the northern trap. The total length of Trench B is 88 feet (26.8 m).

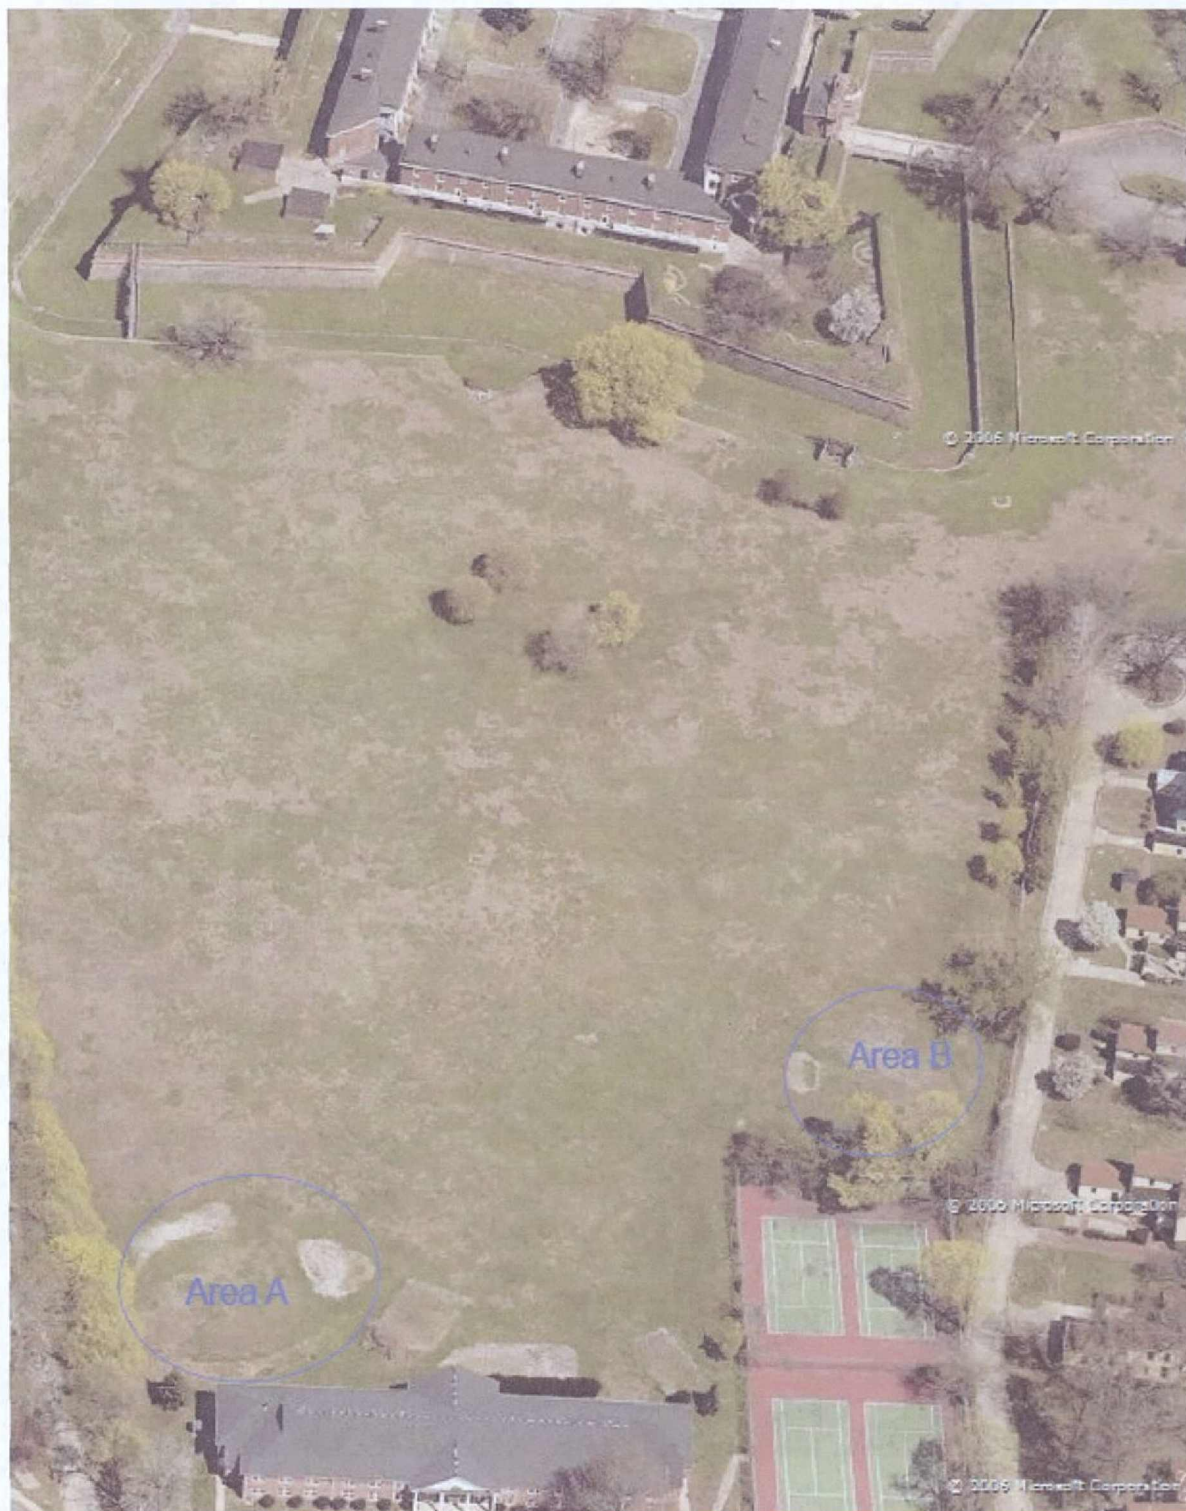
Area B contains three sand traps although Figure 1 only depicts one of them (see Figure 2 and Photos 7-8). The western and southern traps are almost identical in location and shape to the originals, therefore it appears no excavations were done for those to reconstruct the golf course. The northern trap is currently configured in a modified kidney shape (see Photos 9-10), as opposed to an egg shape shown in Figure 2. Because it is currently larger and extends more toward the south, the proposed trench will cut through it. Figure 3 depicts the location of the proposed trench beginning to the east of the western trap and extending northeast through the green and through the southern part of the northern trap. This total length is about 80 feet.

Figure 1 Location of the two areas of the former golf course where archaeological trenching is proposed.

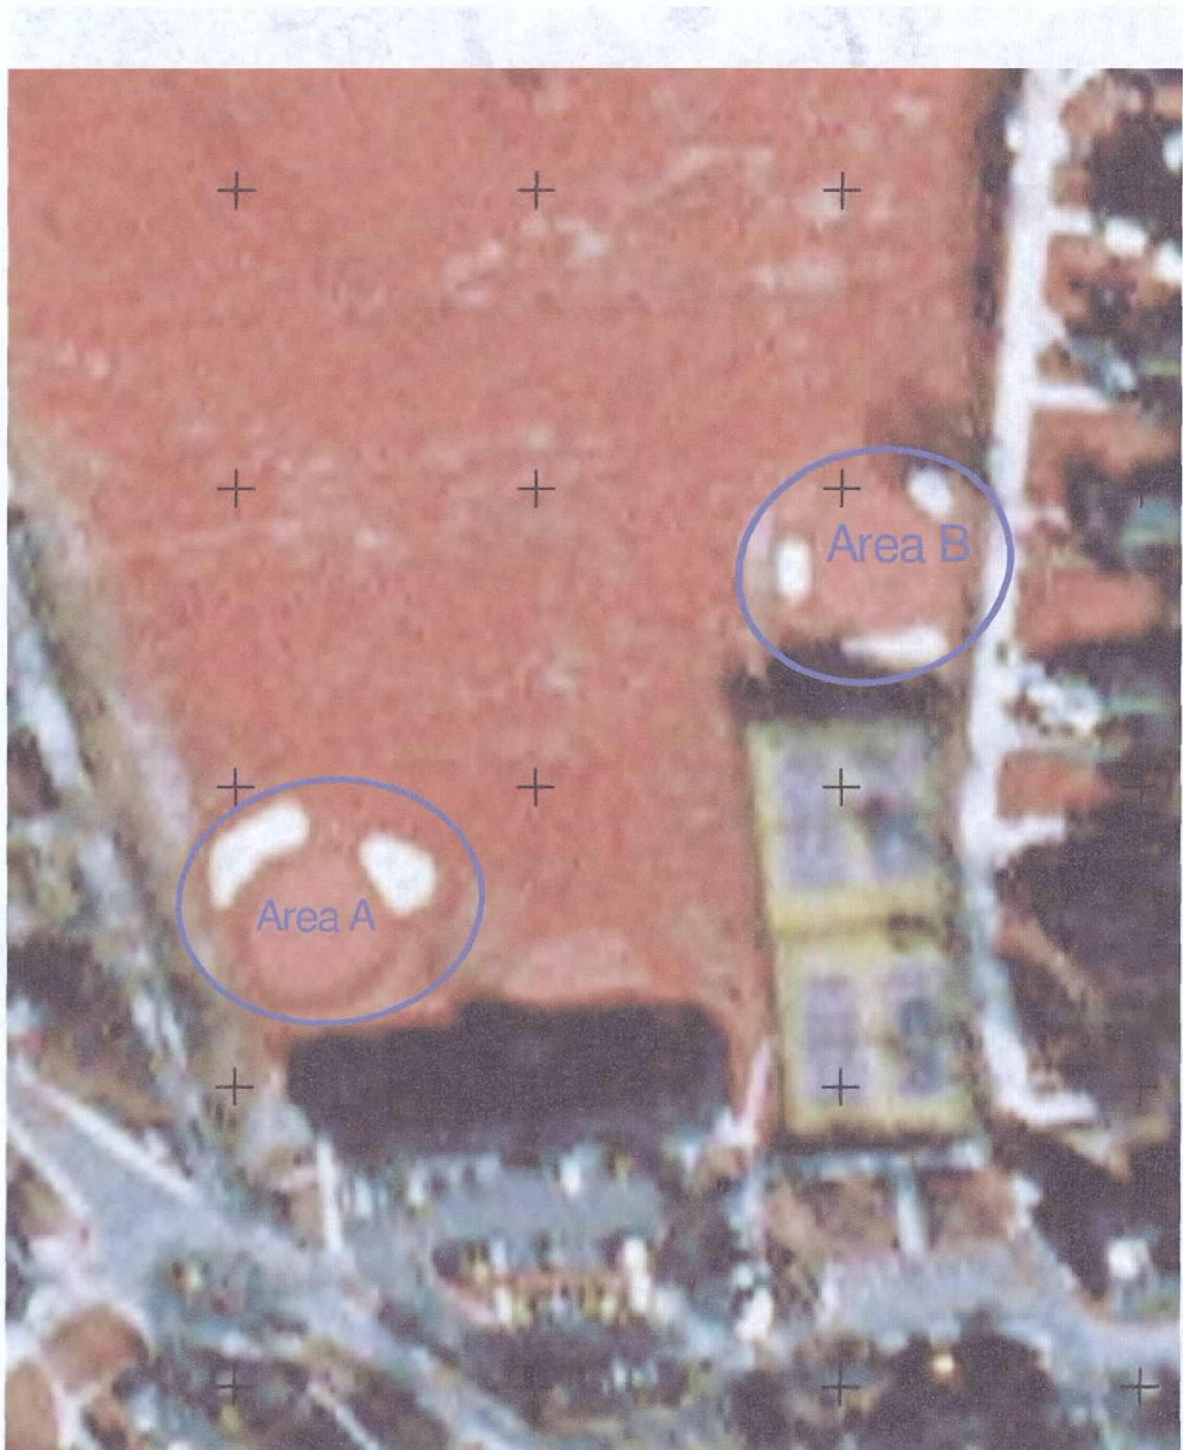
Figure 2 Infrared aerial photograph showing the location of the two areas of the former golf course where archaeological trenching is proposed.

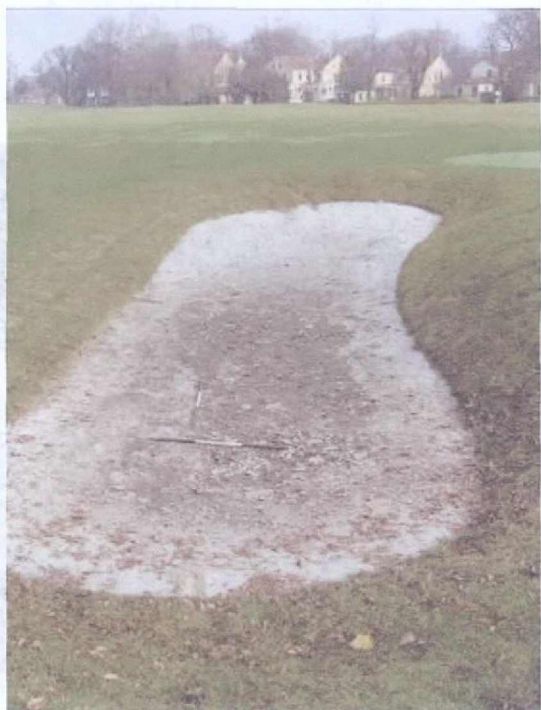
In Area A, the shape of the two traps currently appears reconfigured from the aerial photographs. The western trap is currently more dumbbell shaped and doesn't extend as far toward the southwest as the original sand trap did (see Photos 1-3). Because the western trap is smaller and within the footprint of the original, the recent reconstruction did not likely disturb the trap. Therefore there is no need to put the proposed test trench through that sand trap. The eastern trap is currently more kidney shaped than it was originally (see Photos 4-6). It also now has a sizable rise in elevation toward the south west, the inside of the kidney shape. Therefore, the proposed trench should examine that part of the trap. Figure 3 depicts the locations of the proposed trenches. Trench A is proposed to extend from a point between the western trap and the green and extend almost due eastward to the center of the eastern trap. This will allow an evaluation of the amount of disturbance the recent reconstruction caused in the eastern trap as well as in the green. This trench will be a total length of about 60 feet. There is the possibility this trench may cross the path of the sprinkler system based on the observed locations of the valve and one of the sprinklers. The pipe would be avoided.

Photo 1 Area A West Trap facing east.

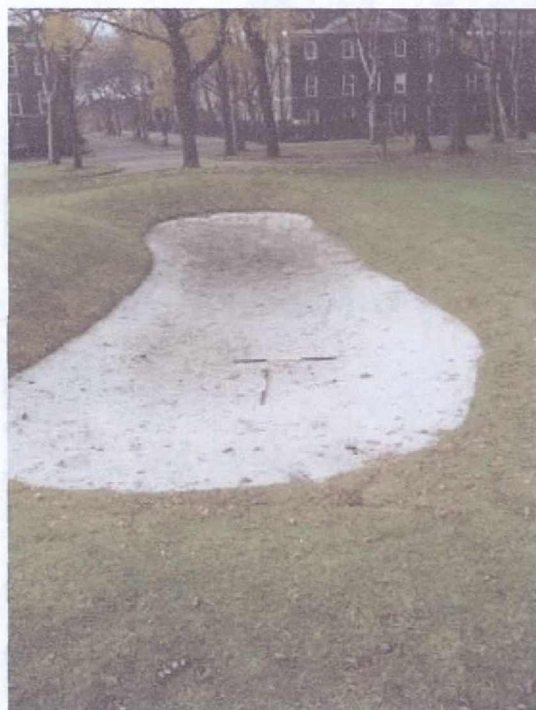
Photo 2 Area A West Trap facing west.

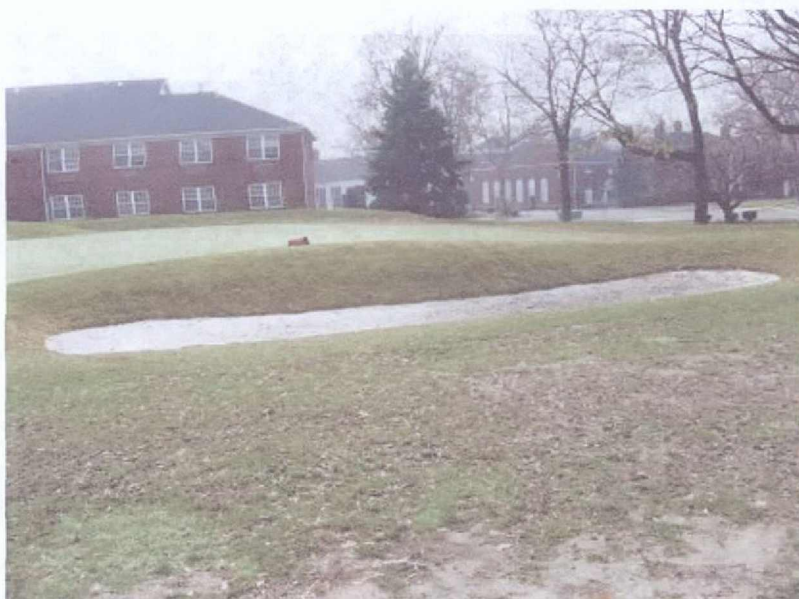
Photo 3 Area A West Trap facing south.

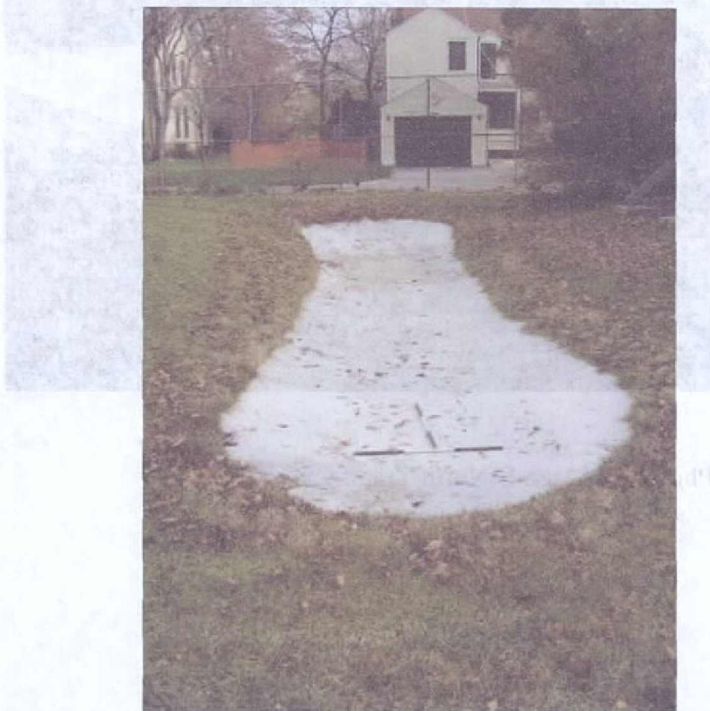
Photo 8 Area B South Trap facing southeast.
