Cragmoor Consultants

**PHASE IA ARCHAEOLOGICAL SURVEY
NATIONAL LIGHTHOUSE REDEVELOPMENT PROJECT
BLOCK 1, PORTION OF LOT 60
STATEN ISLAND
BOROUGH AND COUNTY OF RICHMOND
NEW YORK CITY**

July 2007

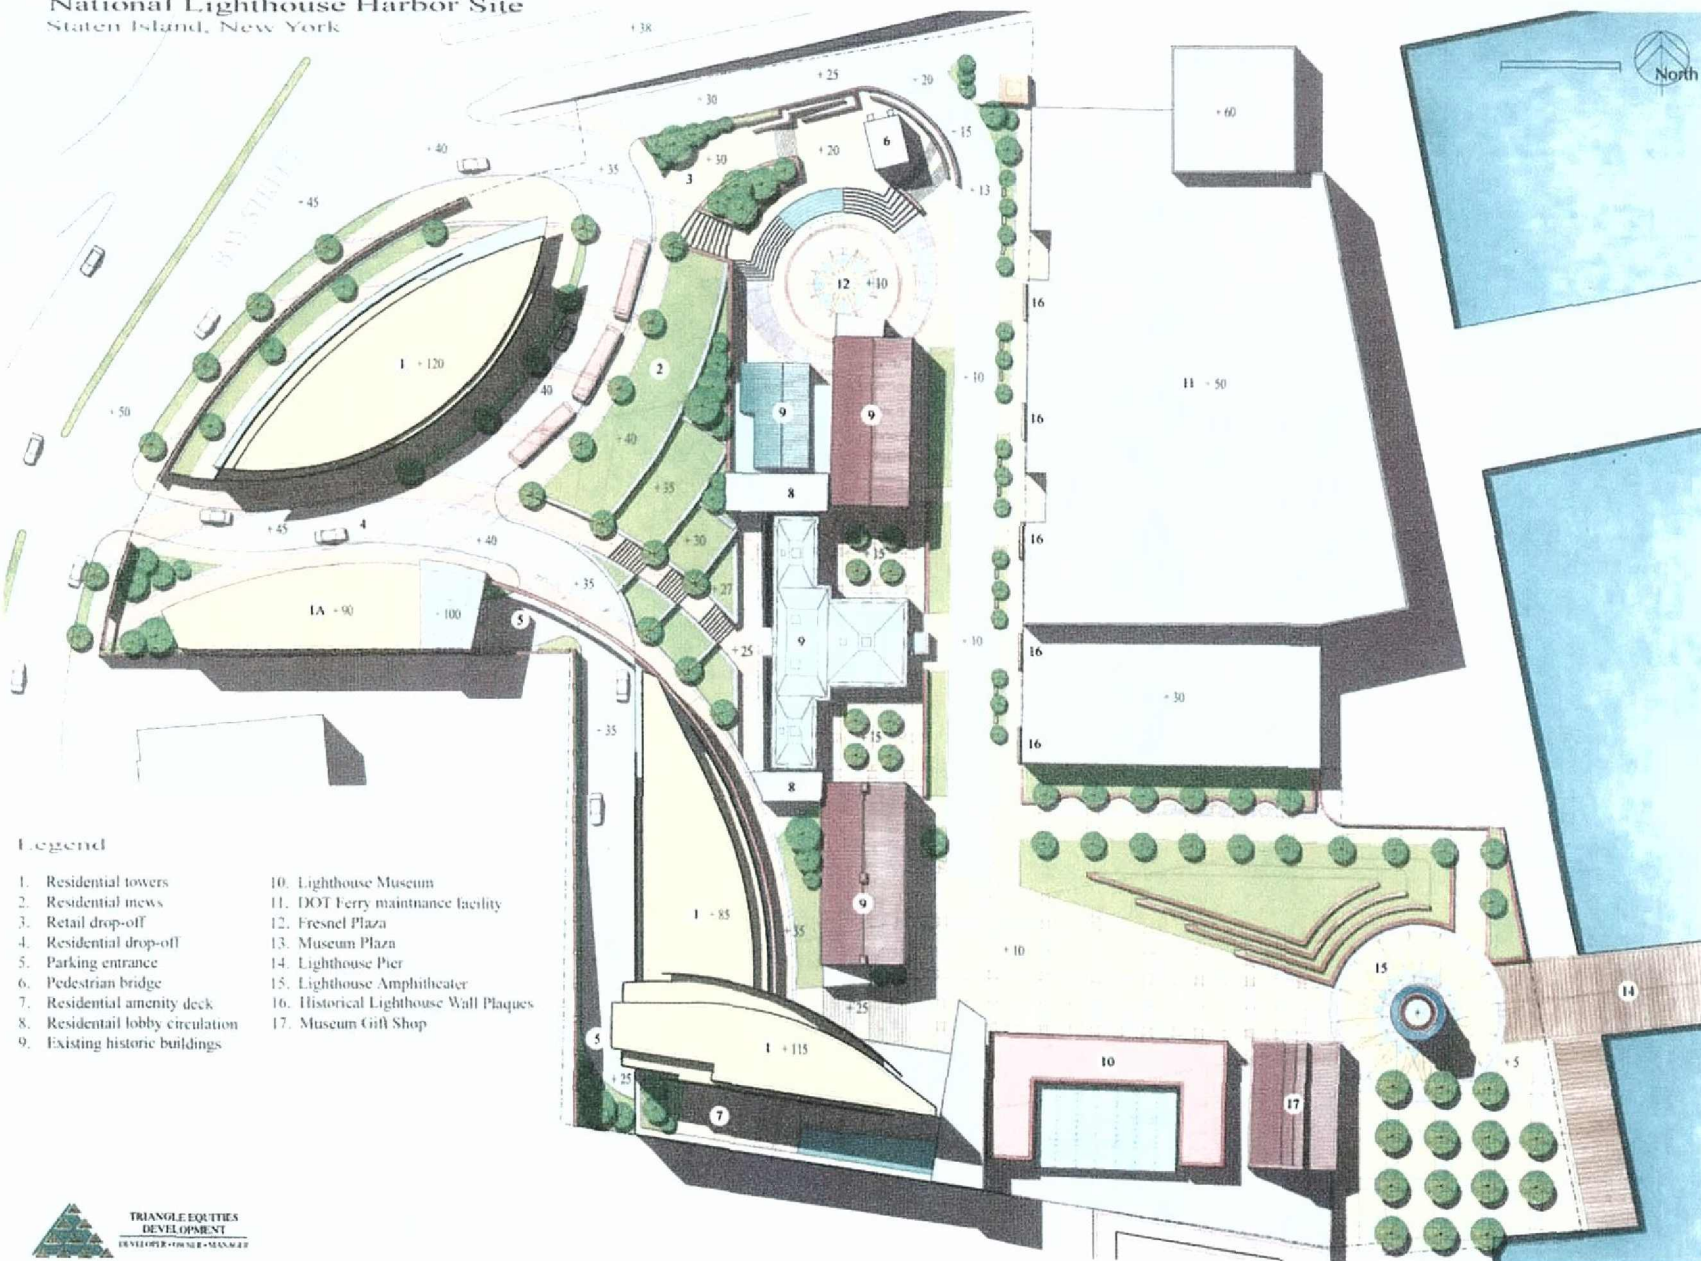
Figure 3
2007 Site Plan

The site plan (Figure 3) indicates that the central portion of the site will be affected by grading and landscaping, construction of the "Fresnel plaza," terracing of the adjacent bank, creation of walkways, and construction of "lobby structures." According to personnel of Philip Habib Associates, the project would involve excavation at the base of the bank. The grade in this portion of the site is approximately +10 feet, while indicated excavation would reach a depth of +5 feet, a five foot depth of excavation. This could substantially impact any features present.

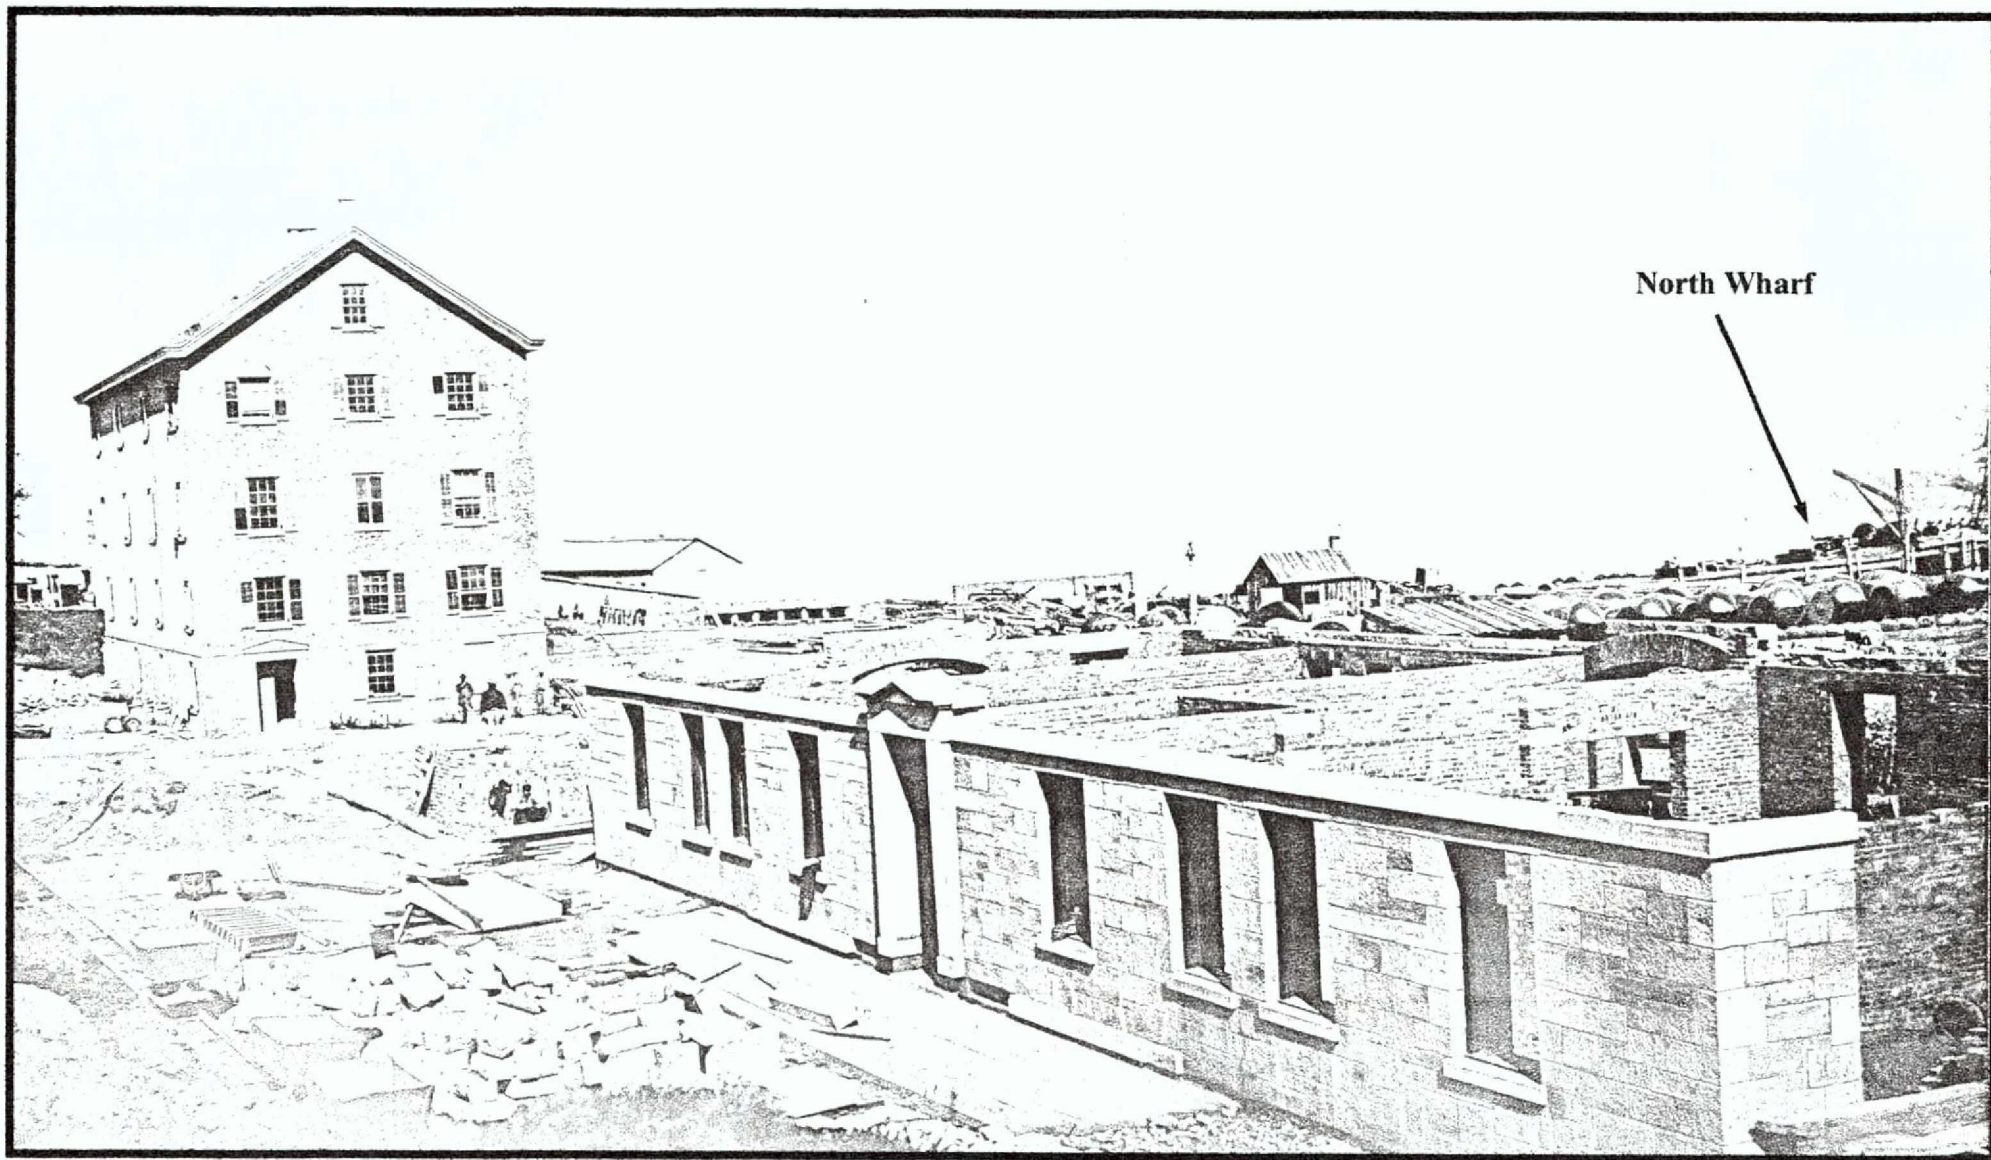
Figure 11
1868 Photo Showing Construction of the Office Building (Building 7) in Foreground
Building #6 is to the Left
View to the Northeast from Bank
The arrow indicates the Light-House Pier (North Pier) Extending Eastward from the Shoreline
Source: Photographs of the Third Light-House Depot 1868

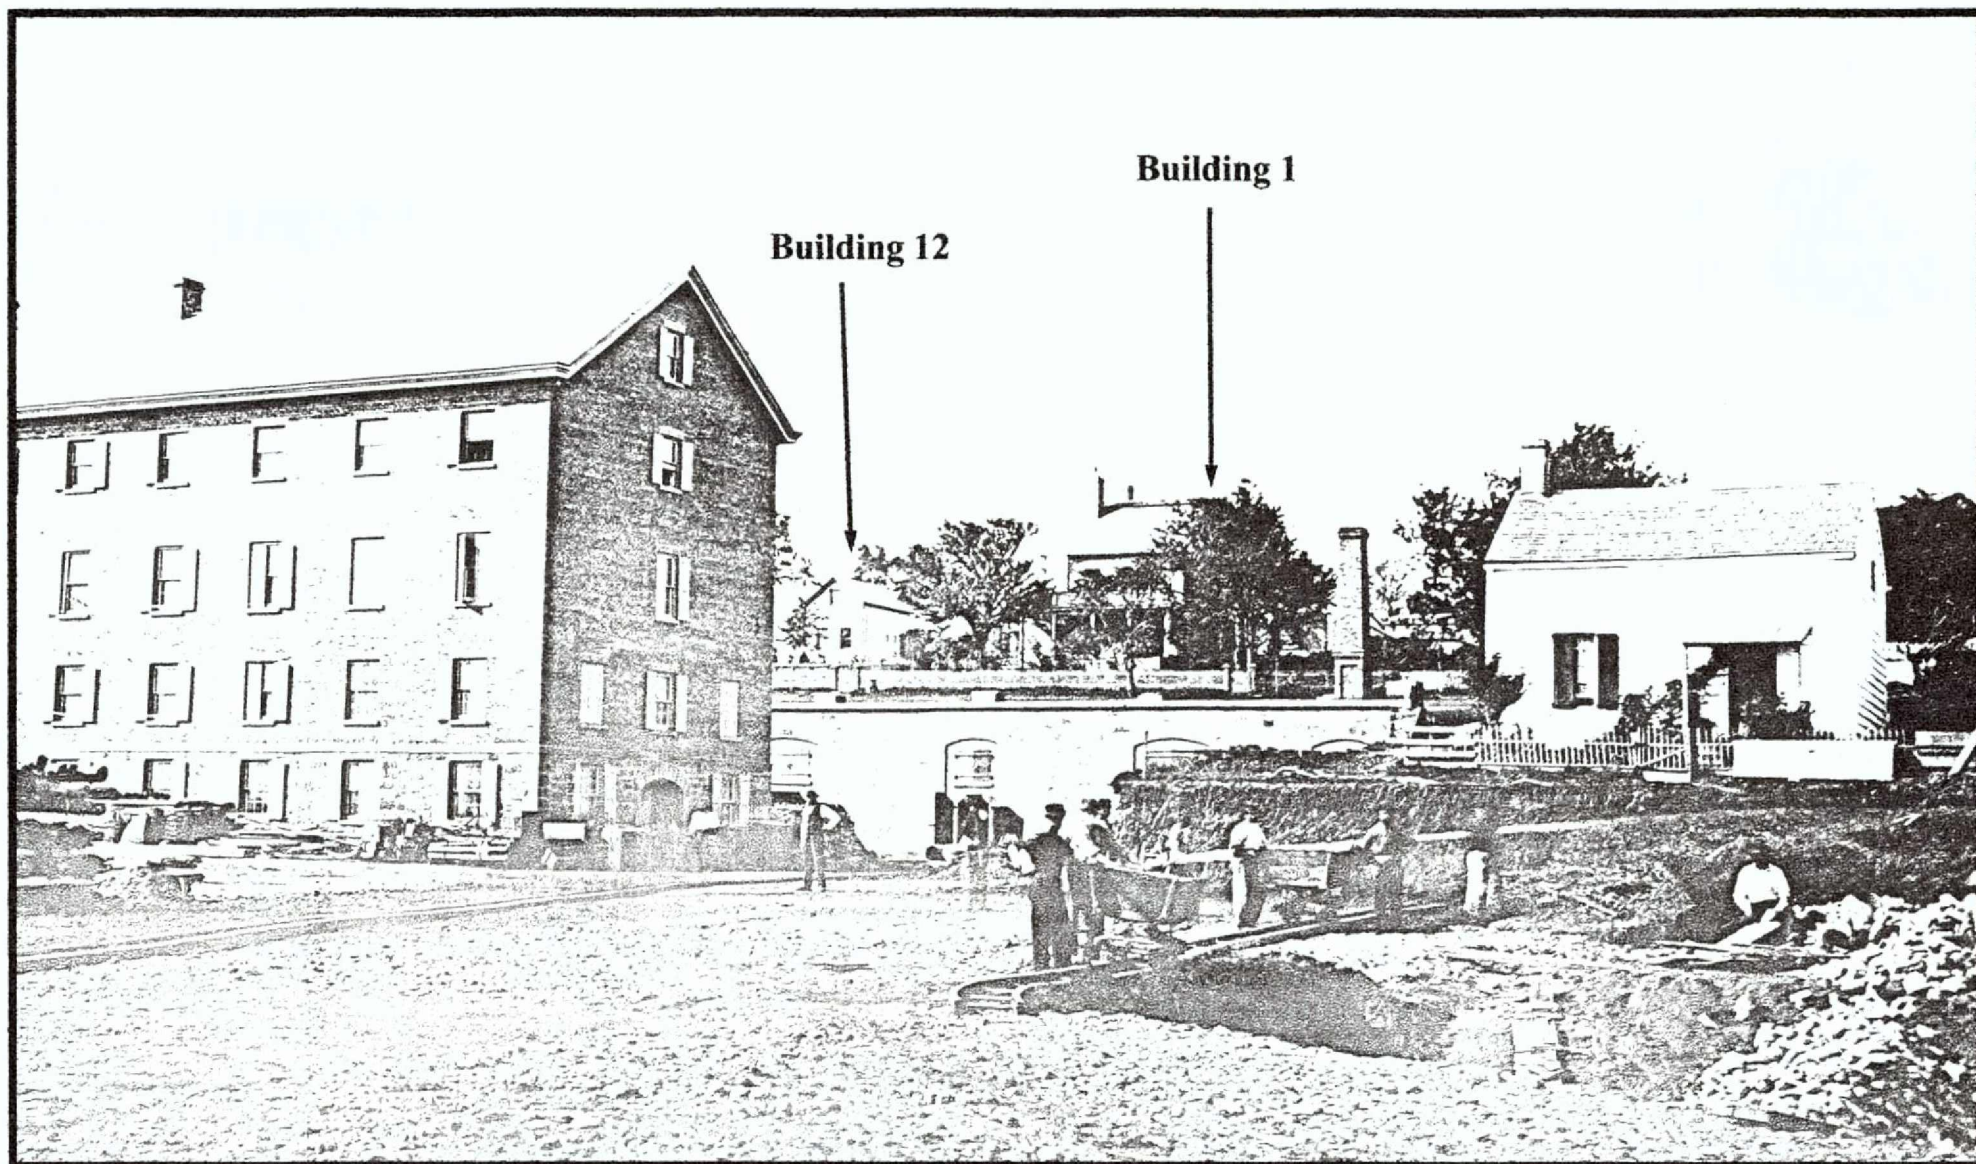
Figure 13
1868 Photo Showing Oil Vaults Under Construction
Building #6 is at Left
Arrows Indicate Building 1 (the Inspector's House) and Building 12
Source: Photographs of the Third Light-House Depot 1868

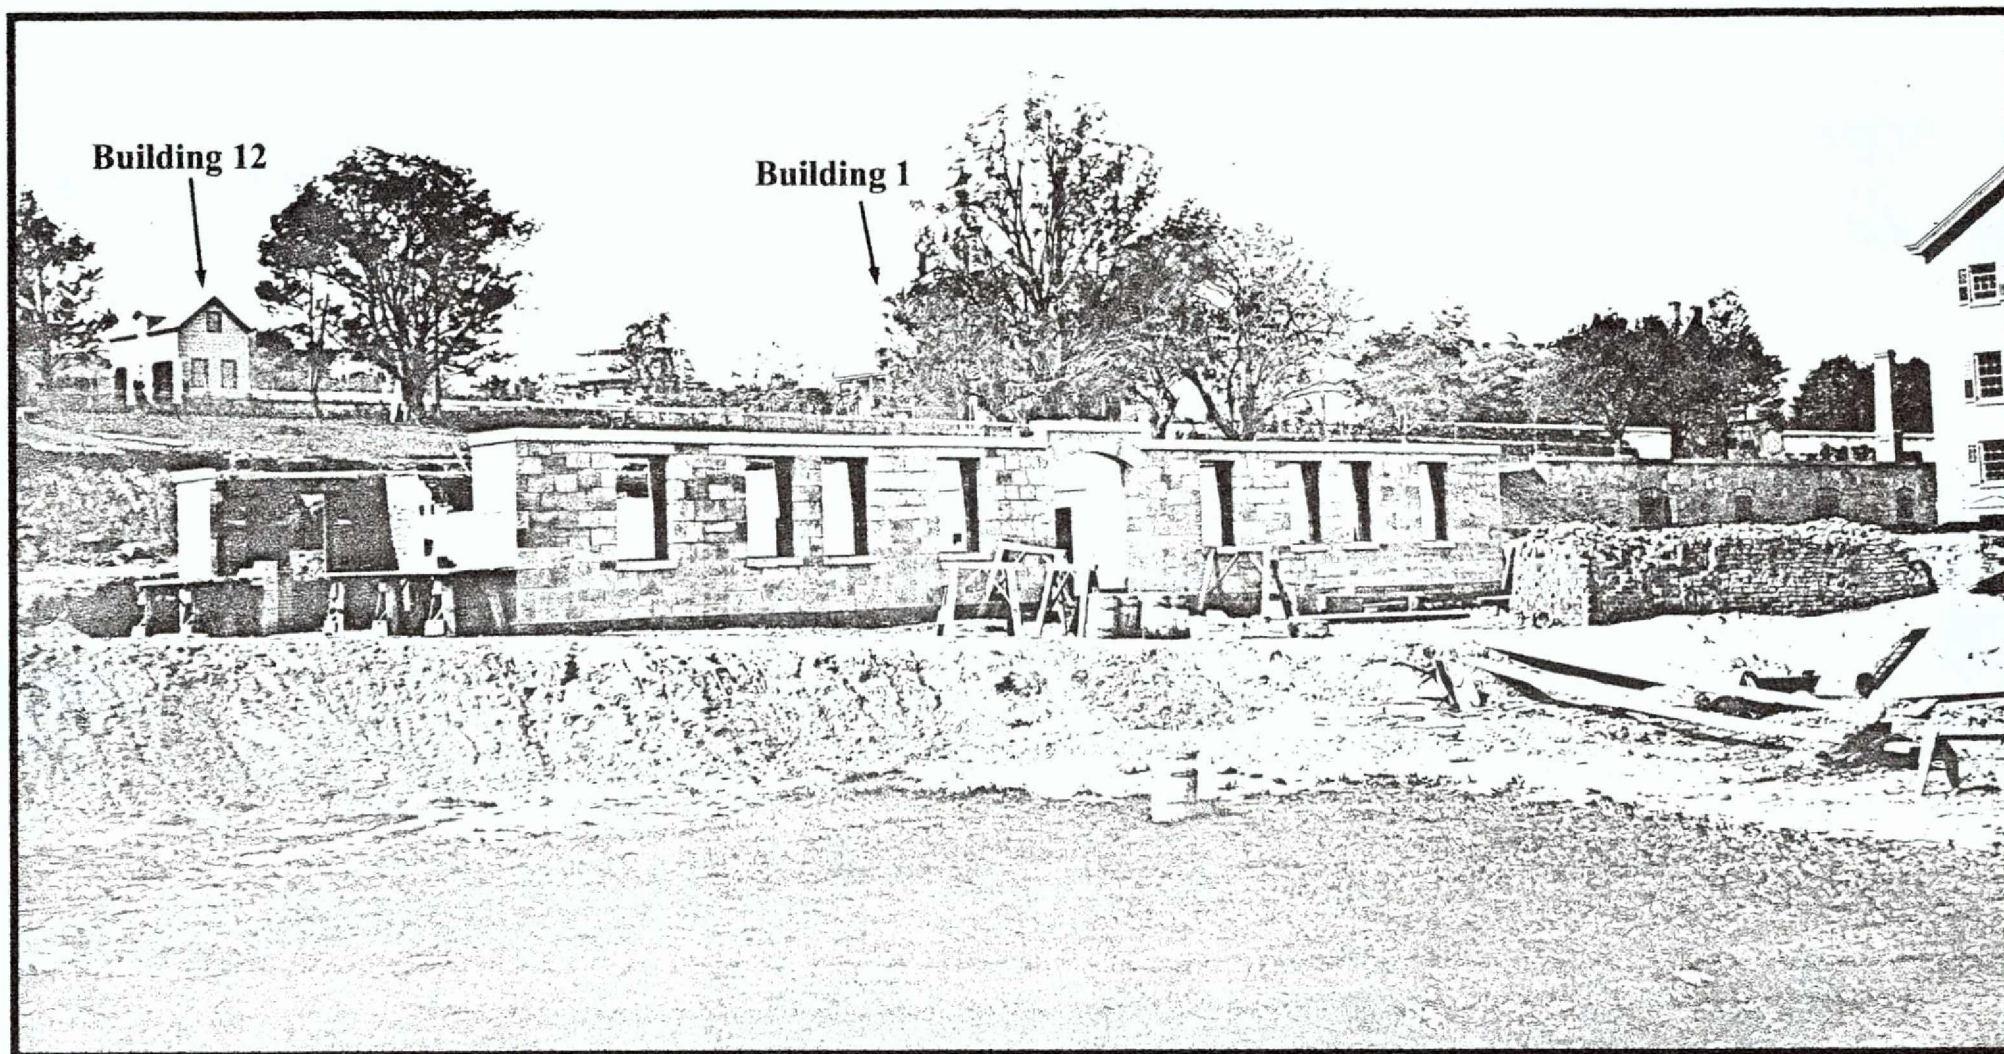
Figure 14
1868 Photo Showing Construction of the Office Building (Building 7) in Foreground
Building #6 to the Right
The arrows indicate Building 12 and Building 1 (the Inspector's House - Behind Tree)
Source: Photographs of the Third Light-House Depot 1868

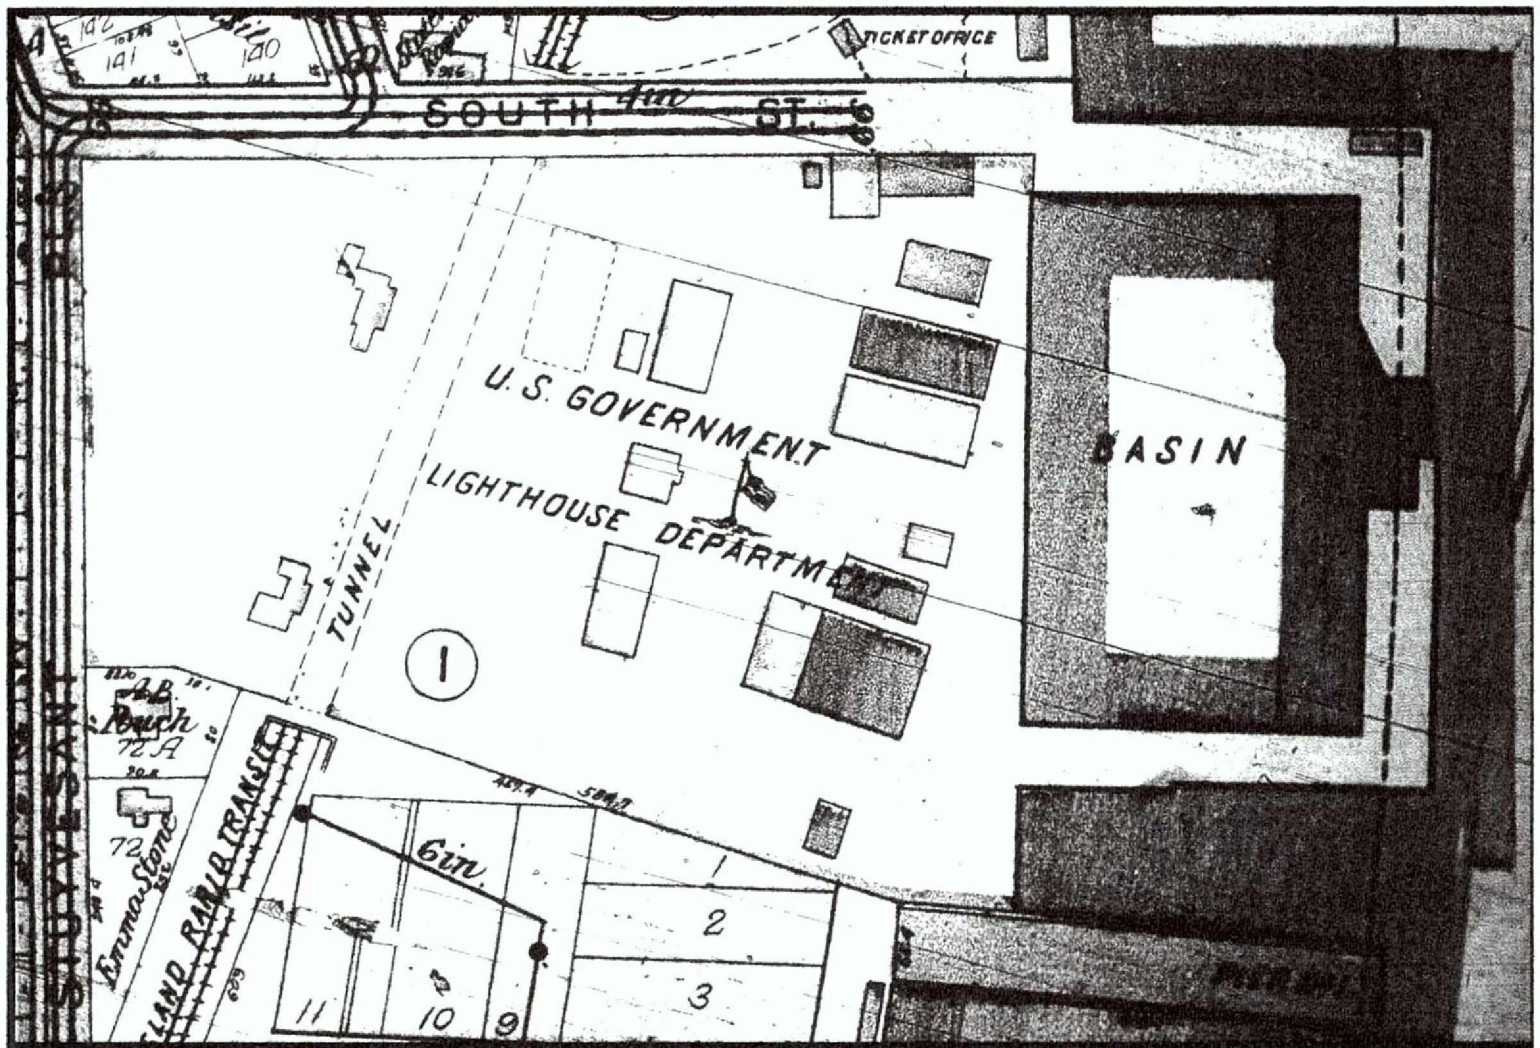
Figure 17
1898 Robinson Map
Scale: 1" = 150'

The 1898, 1907 and 1912 maps (Figures 17, 19 and 20) show two small buildings (buildings 25a and 25b) located along the wharf between buildings 19 and 21 (see Figure 44). The southernmost (building 25b) continues to be shown on the 1917 map (Figure 21), where it is indicated as a carpenters shop. In 1937 (Figure 23) the building is labeled as being used for general storage. The 1912 map shows a small structure (building #28) immediately east of building 25a. By 1937 this had become the site of a new coal shed and loading facility. This facility apparently replaced the coal shed and loading facilities shown further to the north in 1917 (see above). The northernmost of the two small buildings (building 25a) was replaced by 1917 by a new reinforced concrete powerhouse building. The Sanborn map of the latter year (Figure 21) indicates that this building had been constructed in 1911.

Building 22 was a brick structure shown on the 1898 (Figure 17) and subsequent maps. It is indicated as a stable on the 1912 map (Figure 20) and a paint shop on the 1917 Sanborn

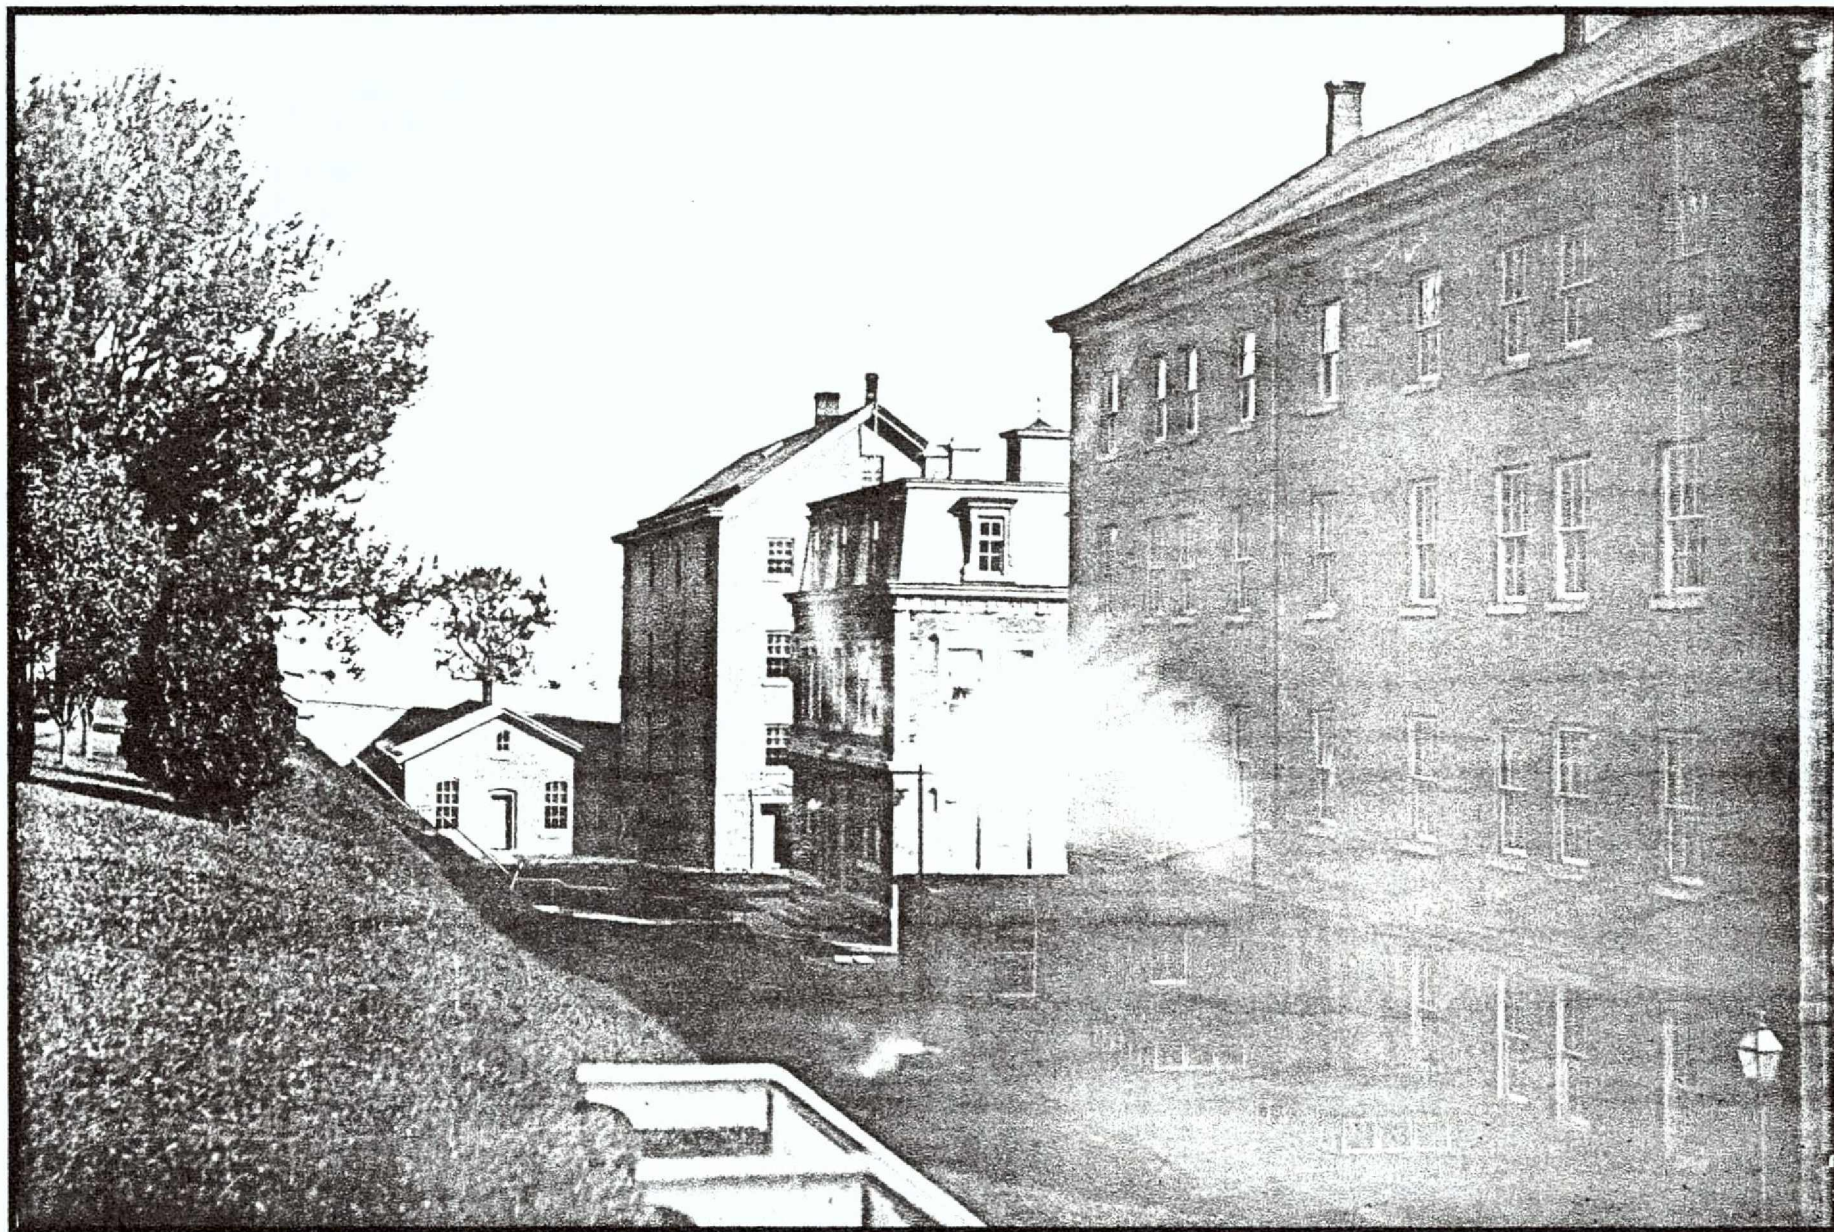
Figure 27

**1884 Photo Showing Rear of Building 8 (At Right), Building 7, and Building 6 with North Side of Building 5 at Left
View to the Northwest from Bank**

end of each of the buildings and hence to the oil vaults" (Light-House Board 1873:37). The flagstone pavements have since been replaced with asphalt or concrete slabs. However, it would appear that there is an area to the rear of the work shop (i.e. the lamp shop) (building 8) that has not been paved. This strip extends from the end of the paved area immediately adjacent to the building for approximately 15 feet to the base of the bank. Although this area is not clearly visible in an 1884 photograph (Figure 27), it would also appear to have been unpaved at that time.

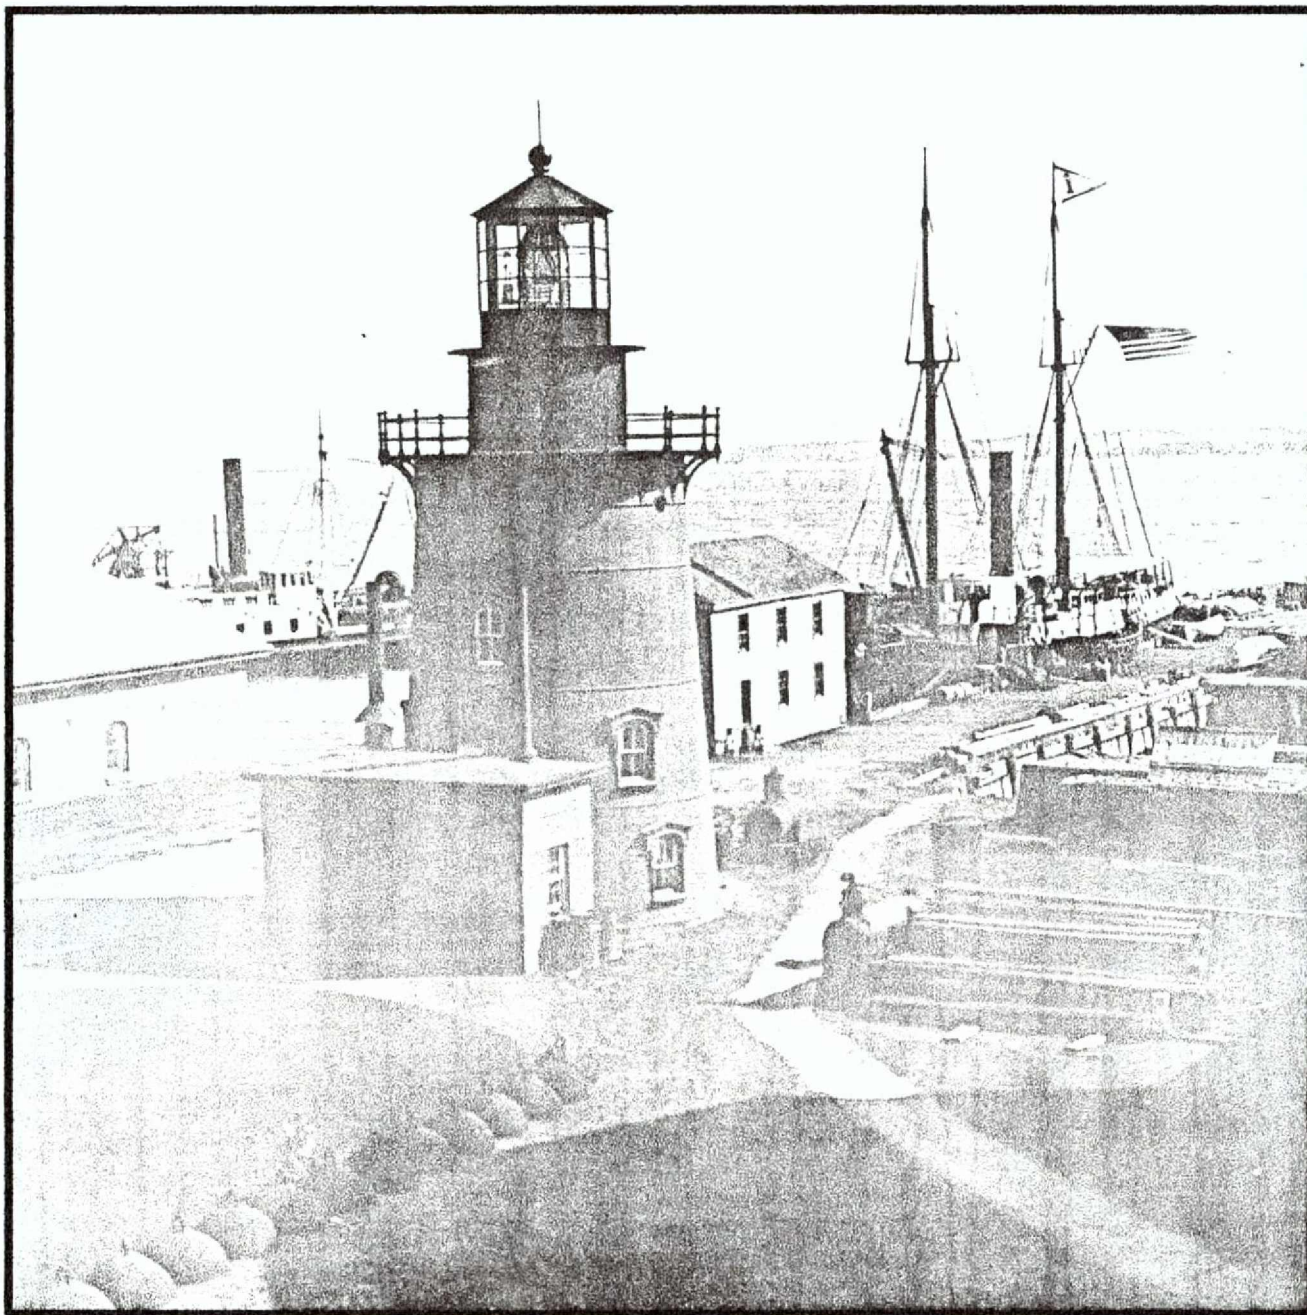
Figure 29
1884 Photograph Showing Experimental Lighthouse and South Wharf
View to the Northeast
Source: Photographs of the Third Light-House Depot 1884

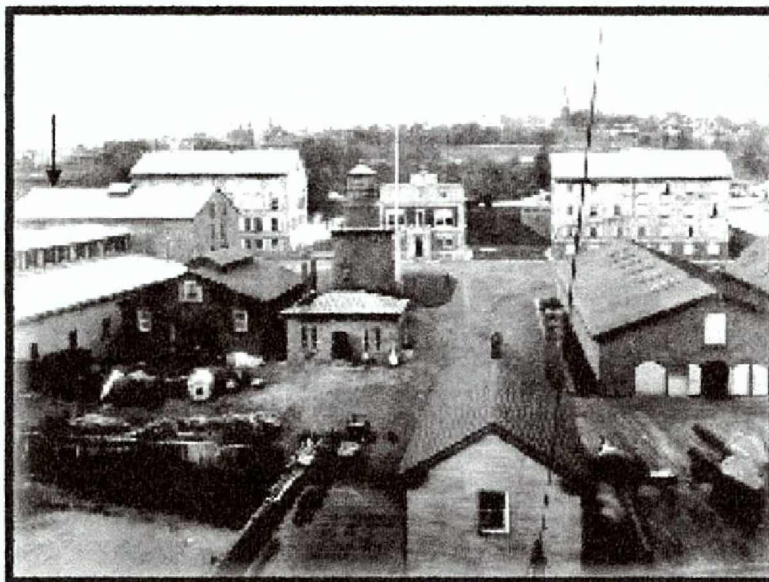
Figure 30

Ca. 1890's Photograph Showing Experimental Lighthouse and South Wharf

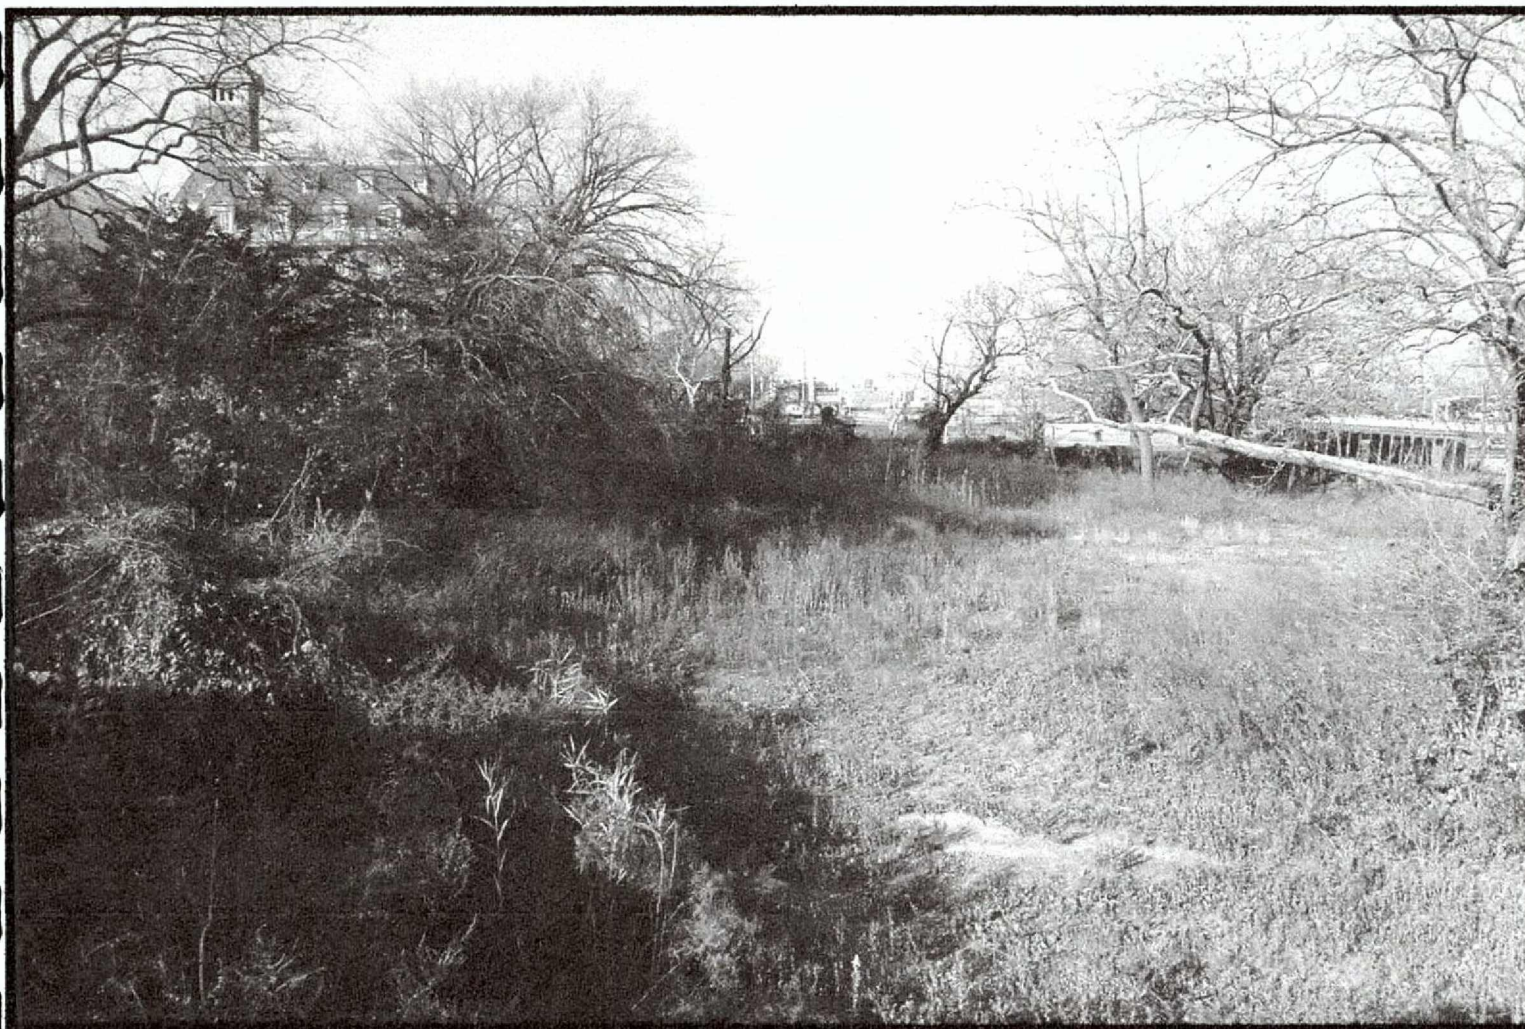
Figure 41
2003 Photograph Showing Western Portion of Site
View to North From Vicinity of Northern Boundary Wall of Post Office Property
Location of Building 1 Foundation Wall is in Background of Photograph
November 3, 2003

During a 2003 reconnaissance of the site, a portion of a foundation wall constructed of stone set in mortar was noted at the approximate location of building 1, as shown on the various historic period maps. Although some minor grading of this area has since occurred, it is considered likely that the foundation is still present in this area. Moreover, any sub-surface features of the types noted above that were present in the area should also remain intact. Deposits of domestic artifacts and other refuse within such features could provide insight into the daily lives of the occupants of the Inspector's house.

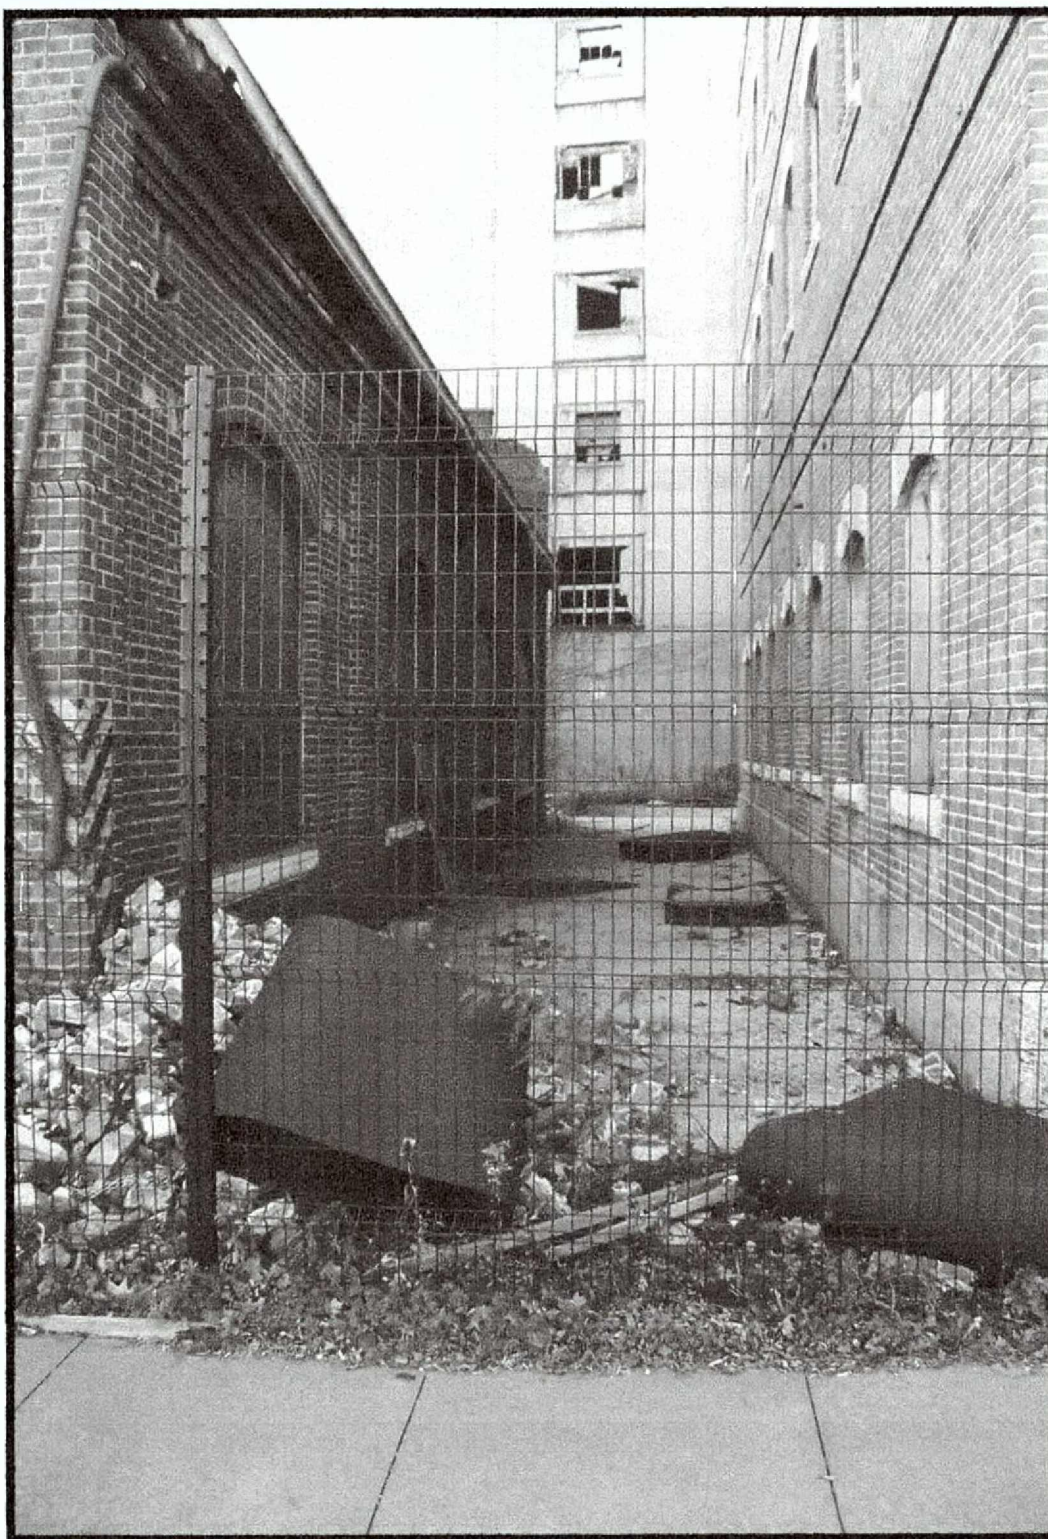
Figure 42
2003 Photograph Showing Alley Between Buildings 10 and 11
View to South
November 3, 2003

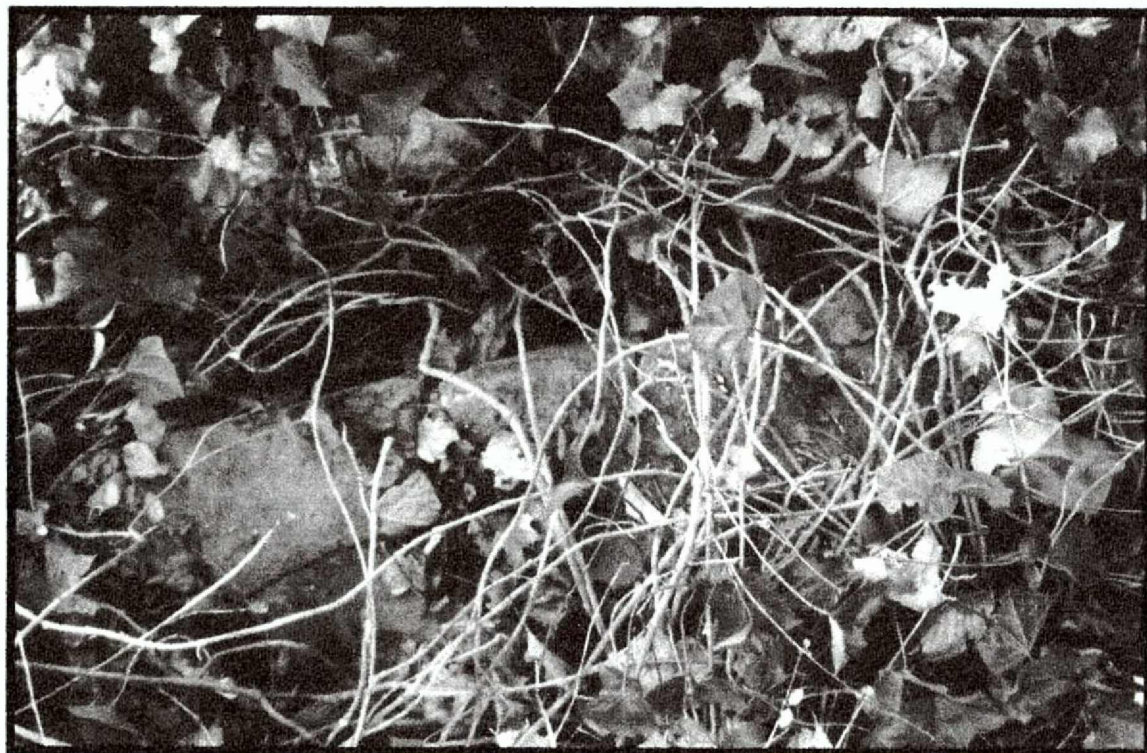
Figure 43
2003 Photograph Showing Portion of Stone Foundation wall
at Site of the "Inspector's House" (Building 1)
November 3, 2003

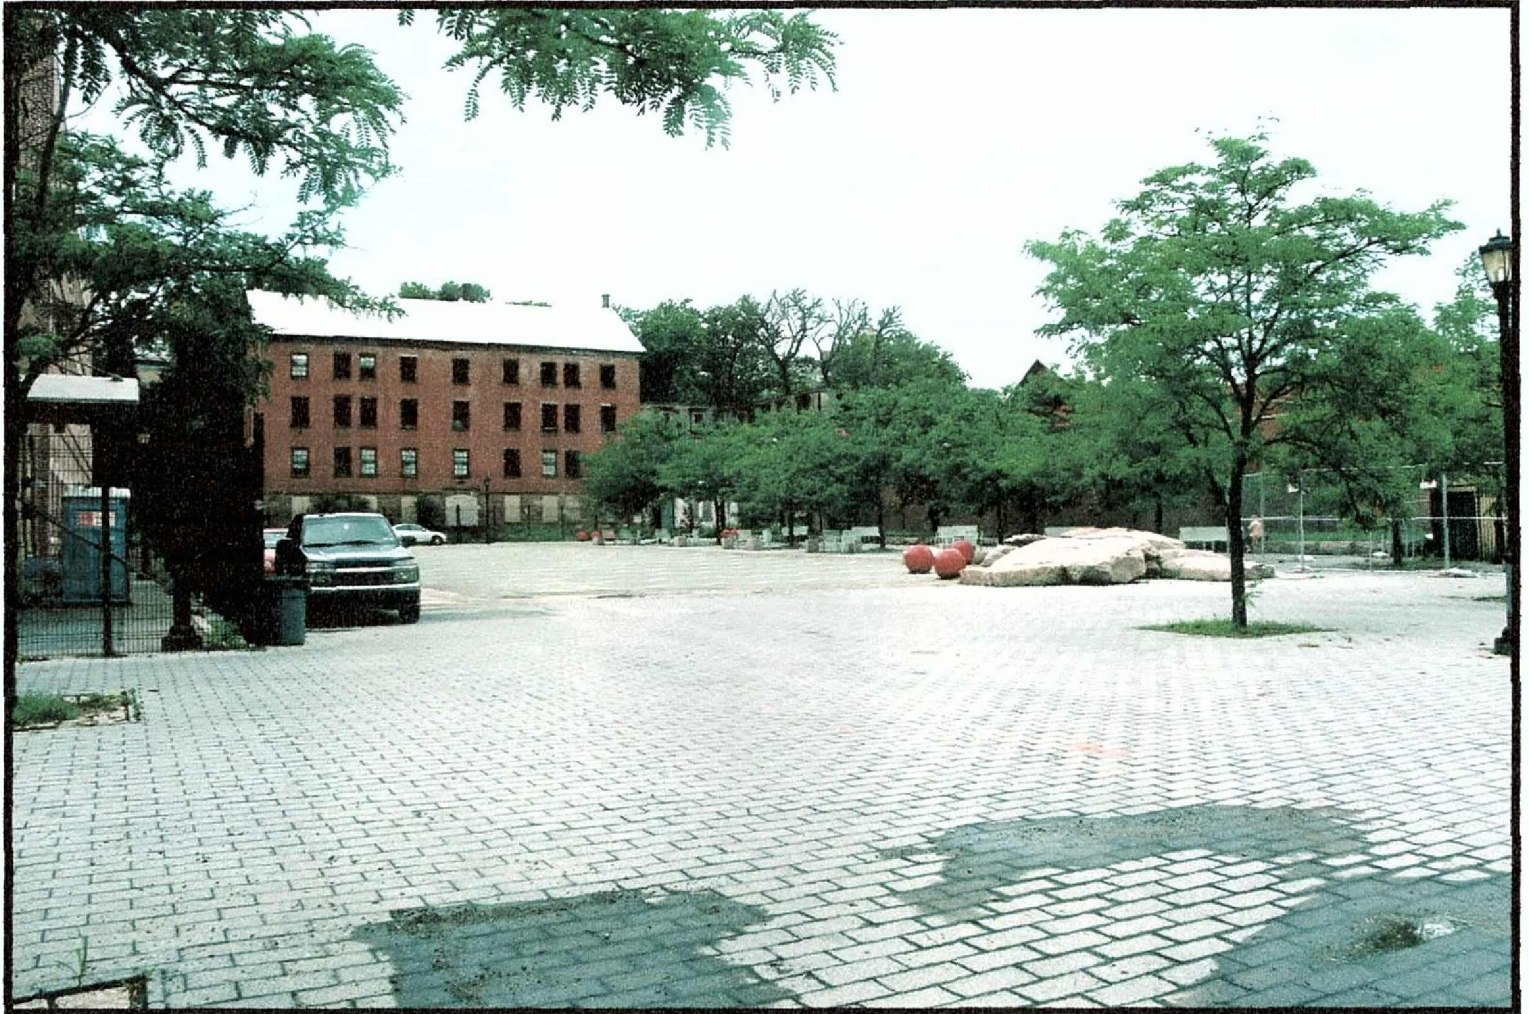
Photograph 1
Plaza Area in Southeastern Portion of Site
View To the Northwest
Building 8 in Background
June 20, 2007
