Cragmoor Consultants

**PHASE IA ARCHAEOLOGICAL SURVEY
NATIONAL LIGHTHOUSE REDEVELOPMENT PROJECT
BLOCK 1, PORTION OF LOT 60
STATEN ISLAND
BOROUGH AND COUNTY OF RICHMOND
NEW YORK CITY**

July 2007

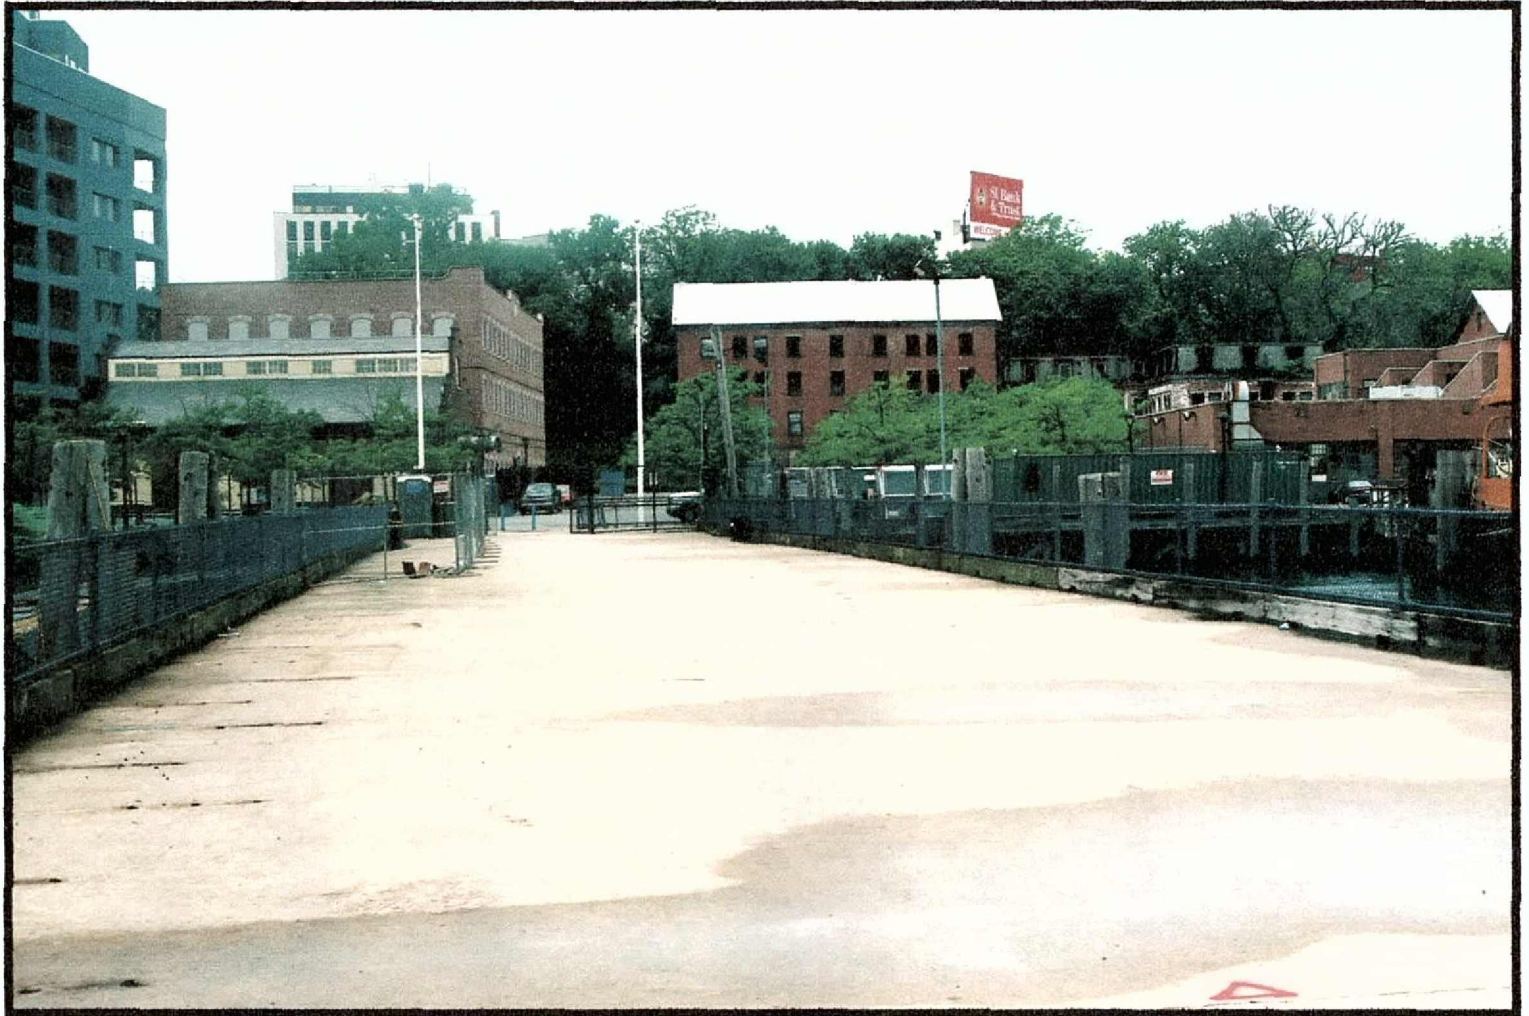
Photograph 2
Concrete Pier
View to West
Building 8 in Center Background; Buildings 10 and 11 in Left Background
June 20, 2007

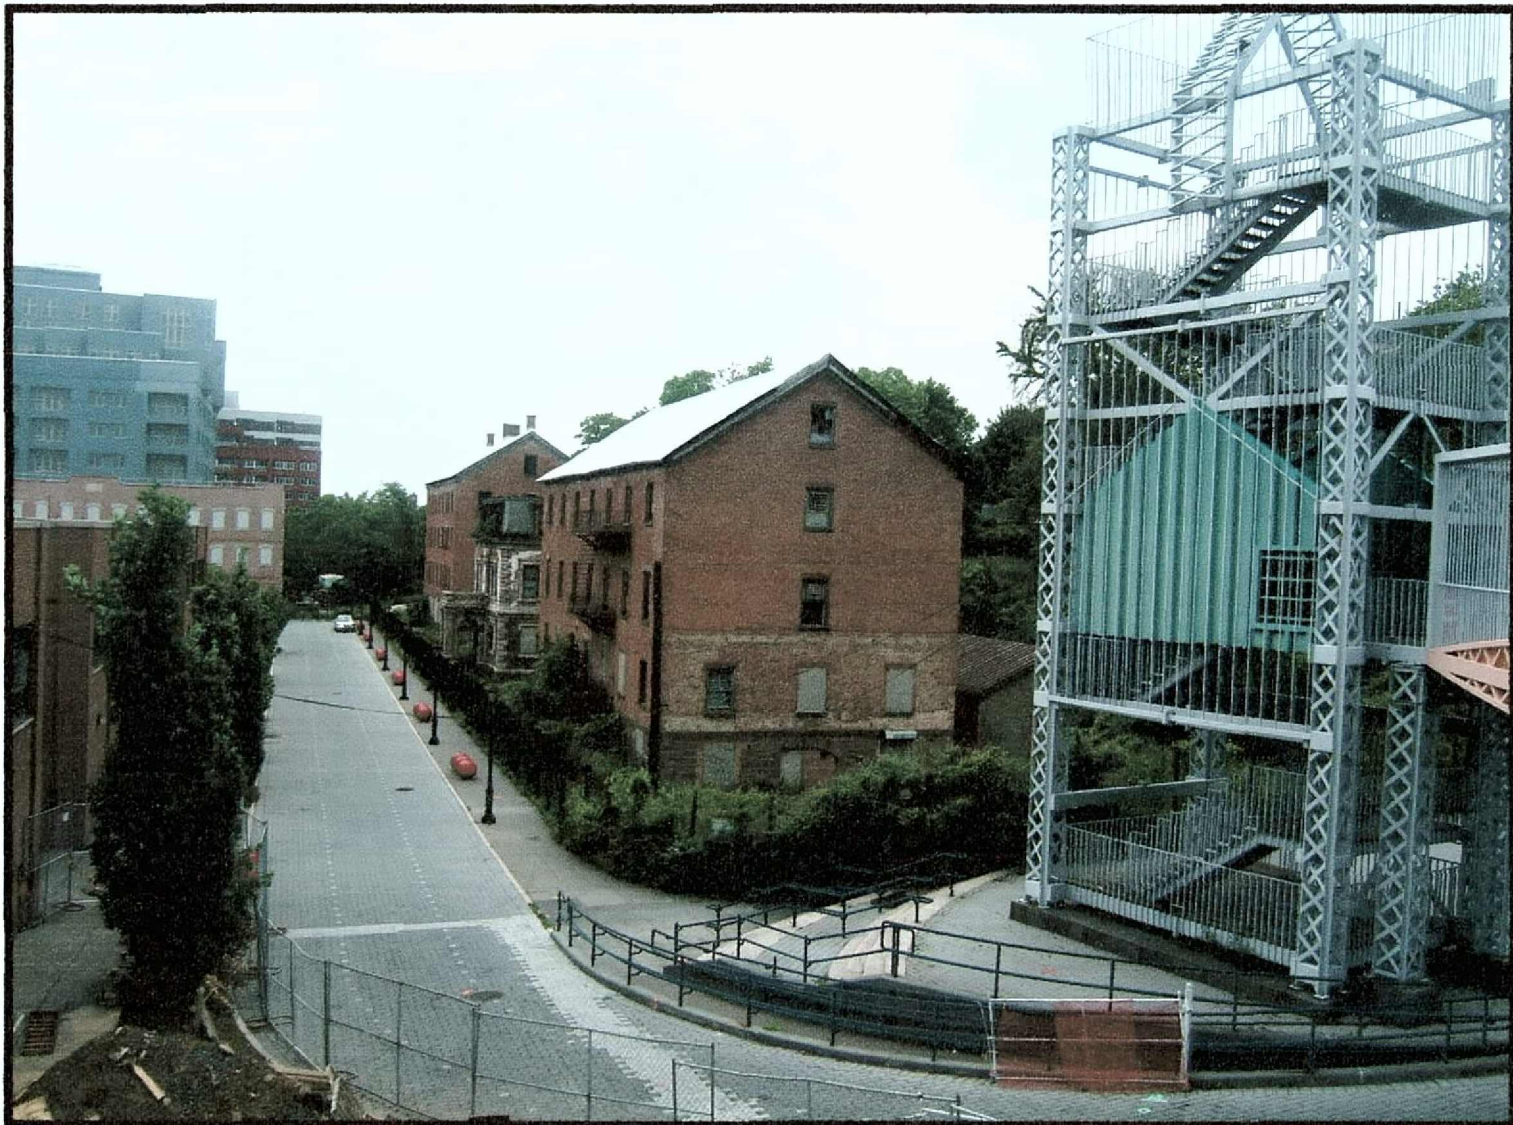
Photograph 3
Entrance Roadway with Buildings 6 - 8 at Right
Entrance Stair Tower at Right Foreground
View South from Ferry Terminal Entrance Ramp
June 20, 2007

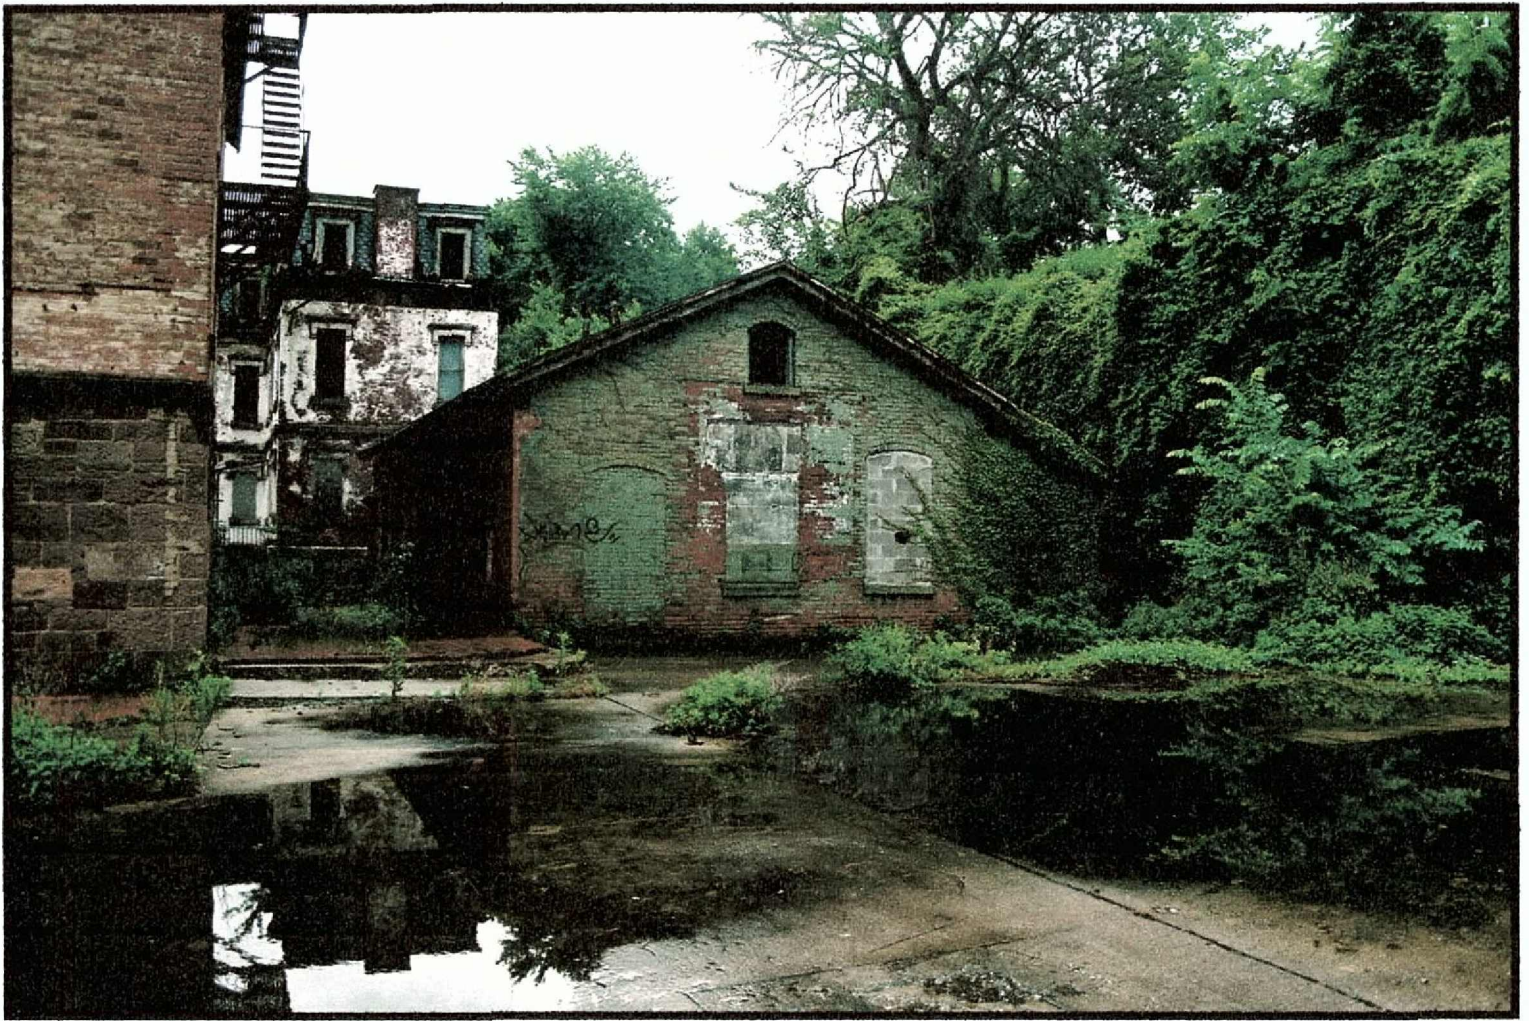
Photograph 4
Laboratory (Building 5) with Office Building in Rear
View to South
June 20, 2007

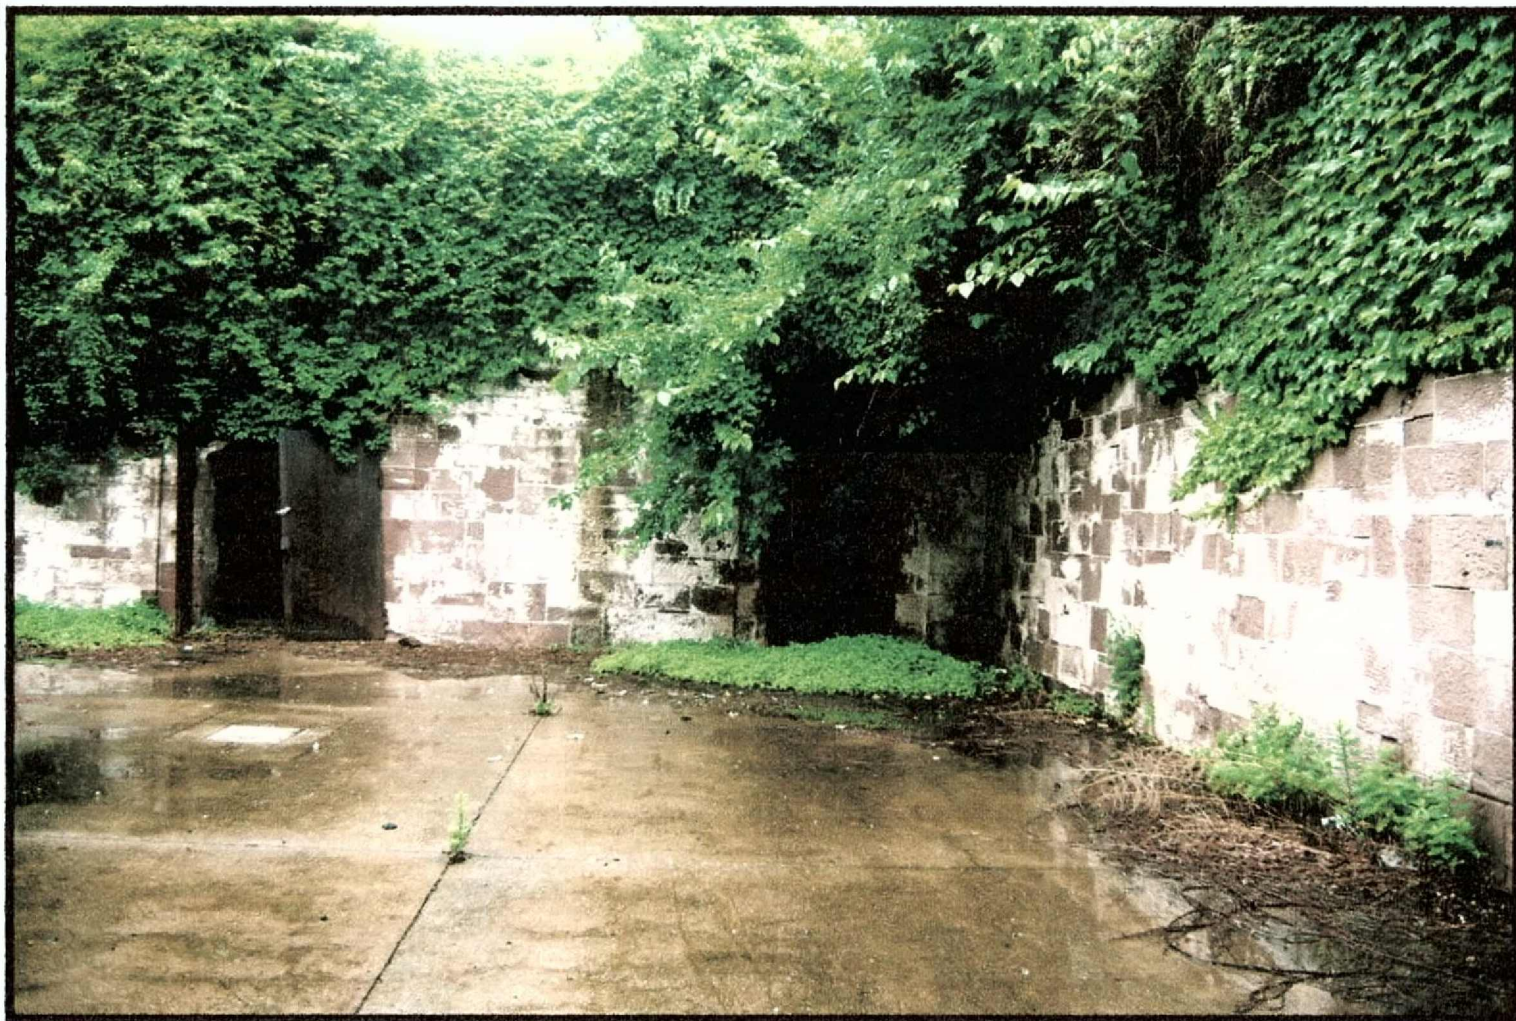
Photograph 5
Northern Portion of Oil Vaults with Retaining Wall at Right
View to West
June 20, 2007

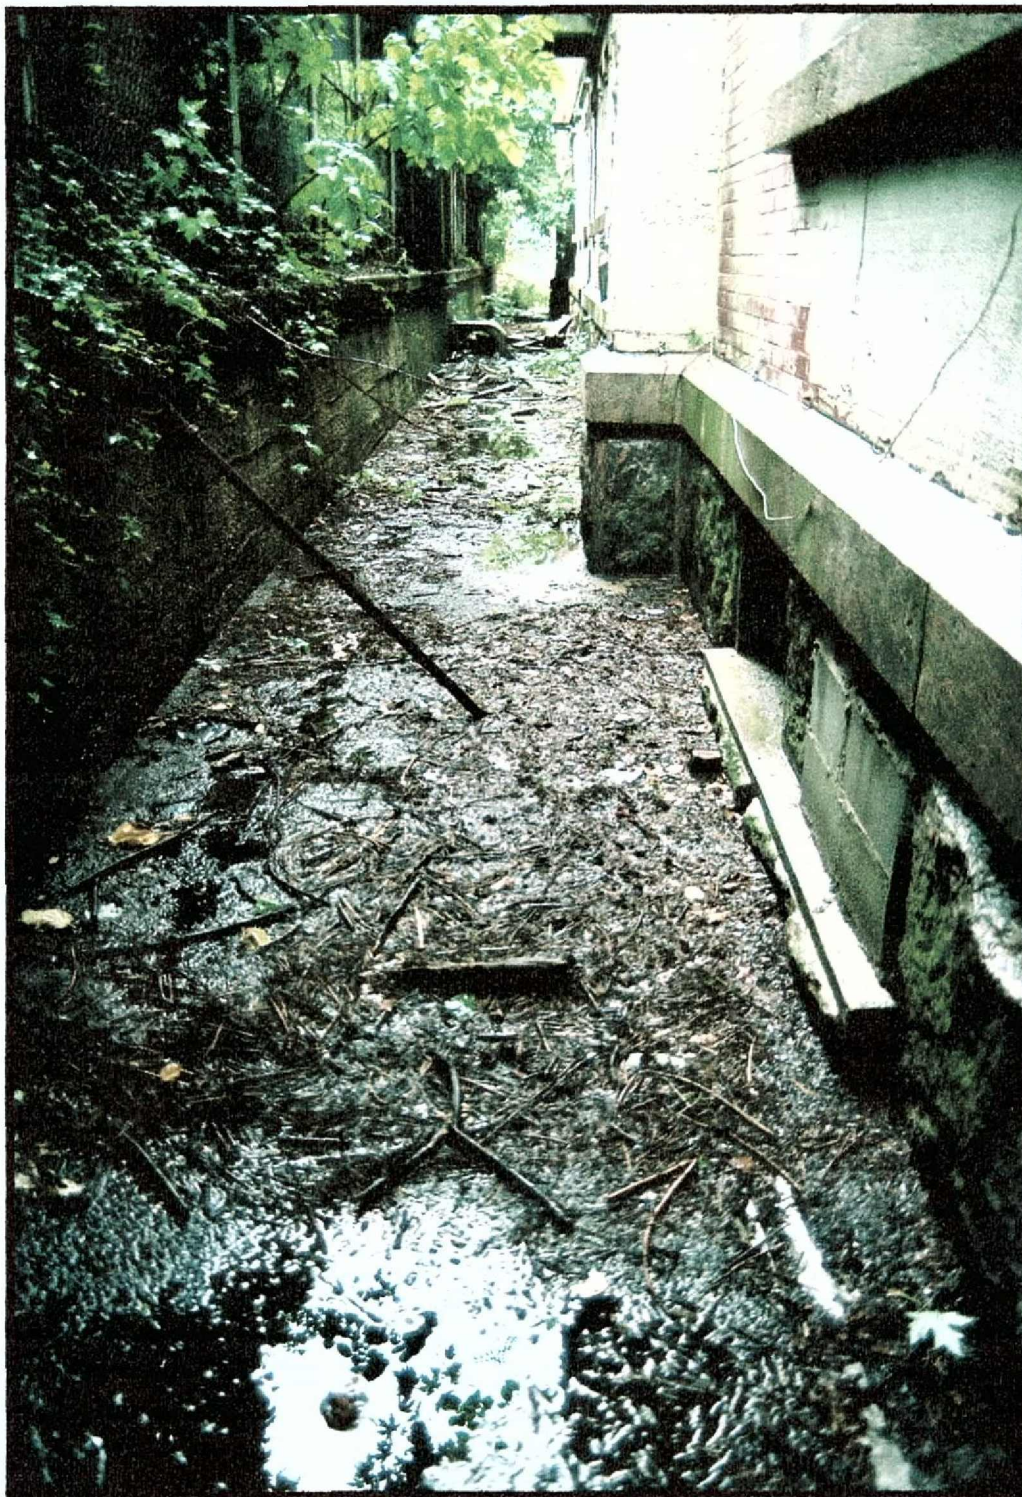
Photograph 6
Areaway and Retaining Wall at Rear of Office Building (Building 7a - 7c)
View to North
June 20, 2007

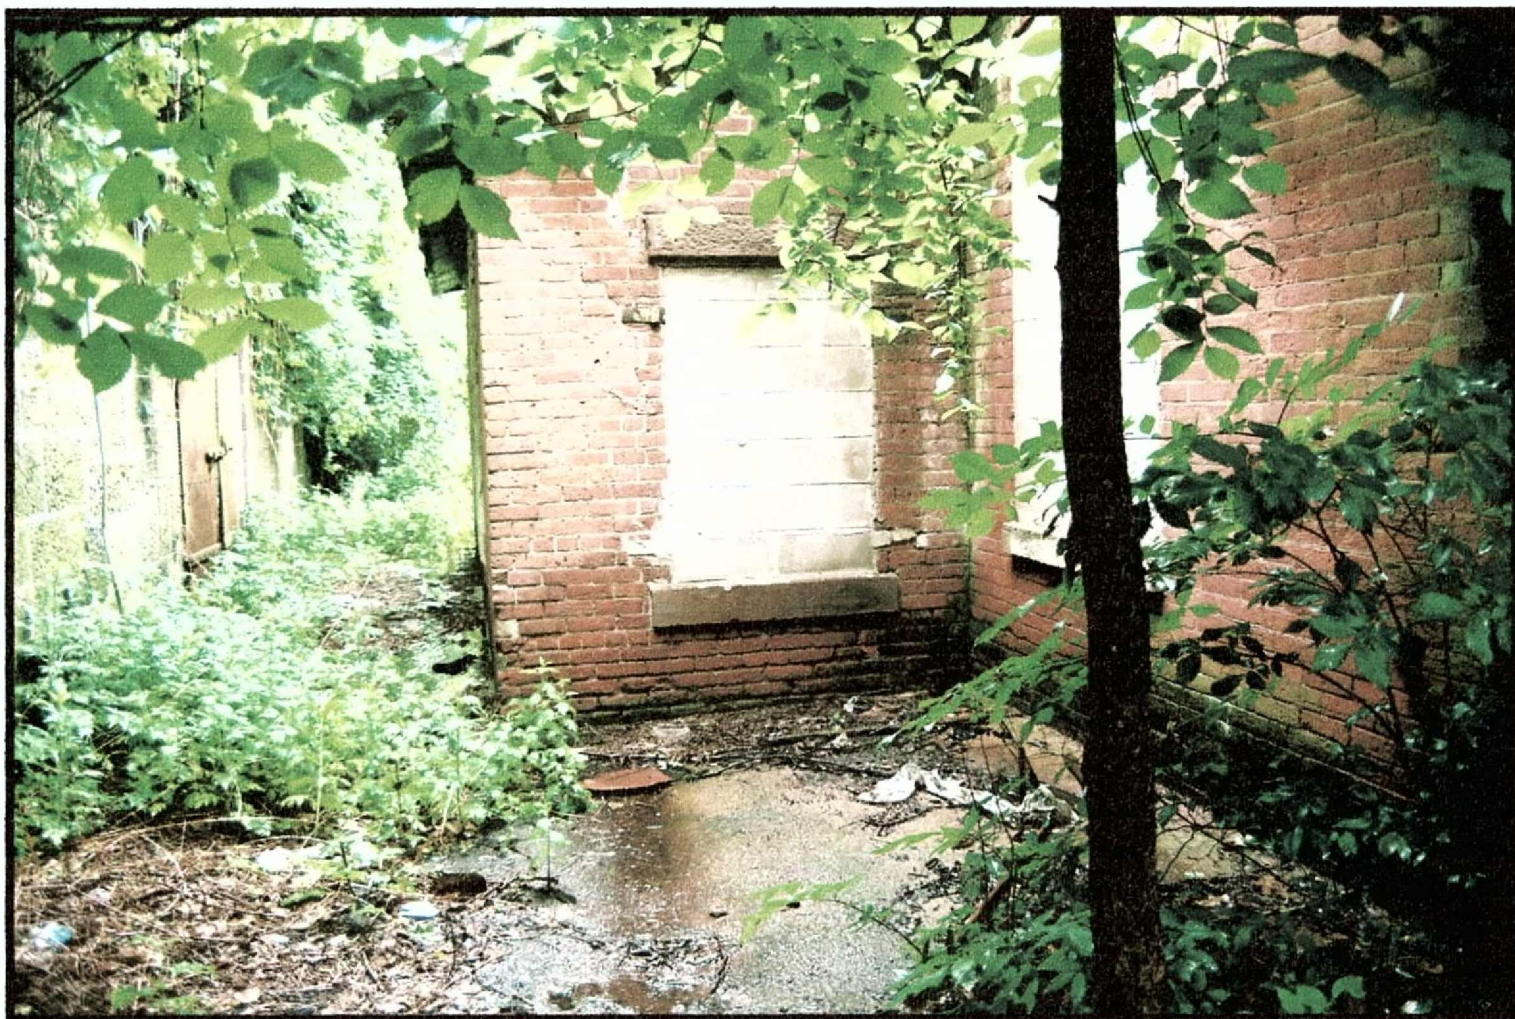
Photograph 7
Paved Area between Laboratory (Building 5 - At Right) And Oil Vaults (At Left)
View to North
June 20, 2007

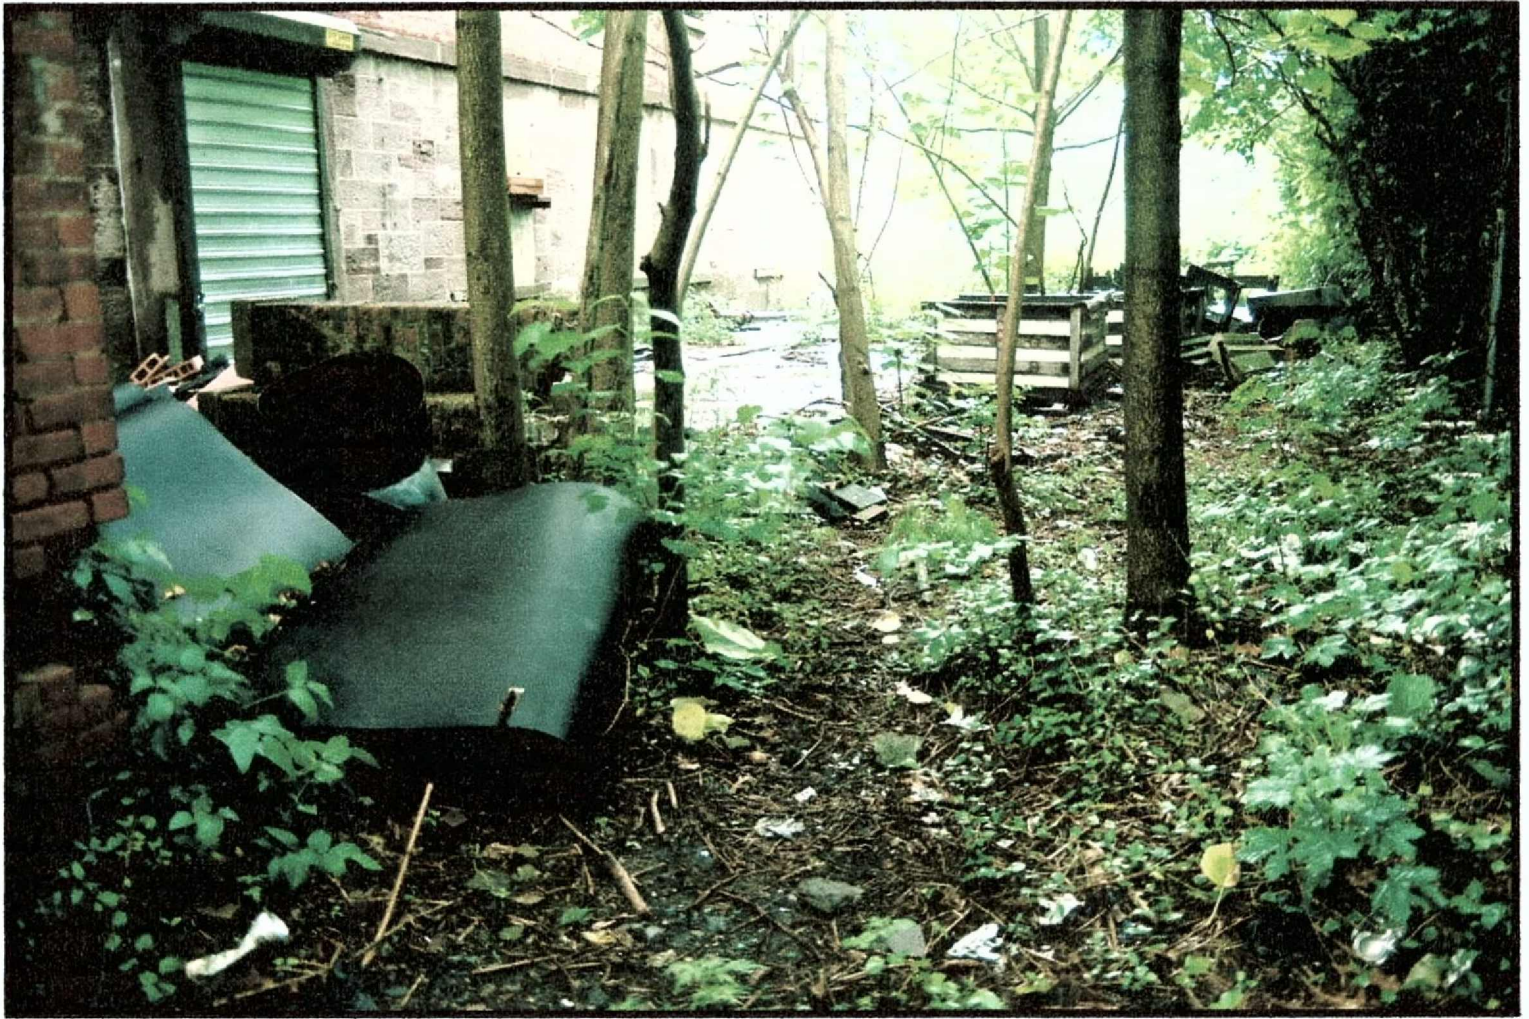
Photograph 8
Area at Rear of Workshop Building (Building 8)
Showing Unpaved Portion
Portion of Brick Extension at Left
View to South
June 20, 2007

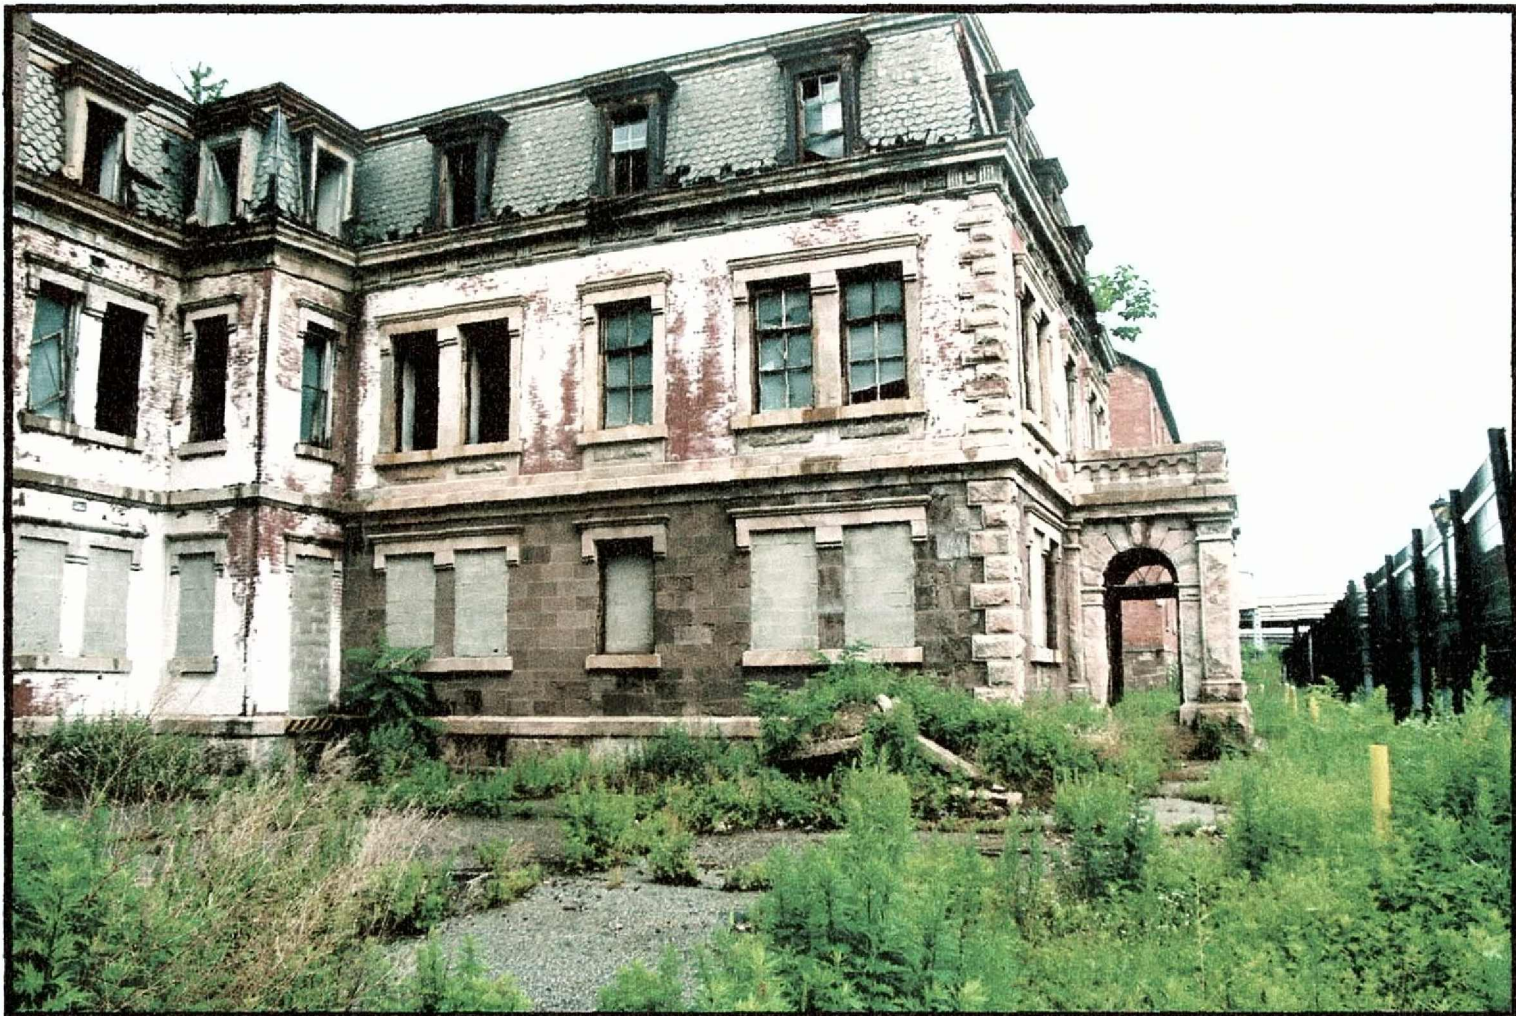
Photograph 9
Office Building (Building 7) with Portion of Southern Courtyard
View to Northwest
June 20, 2007

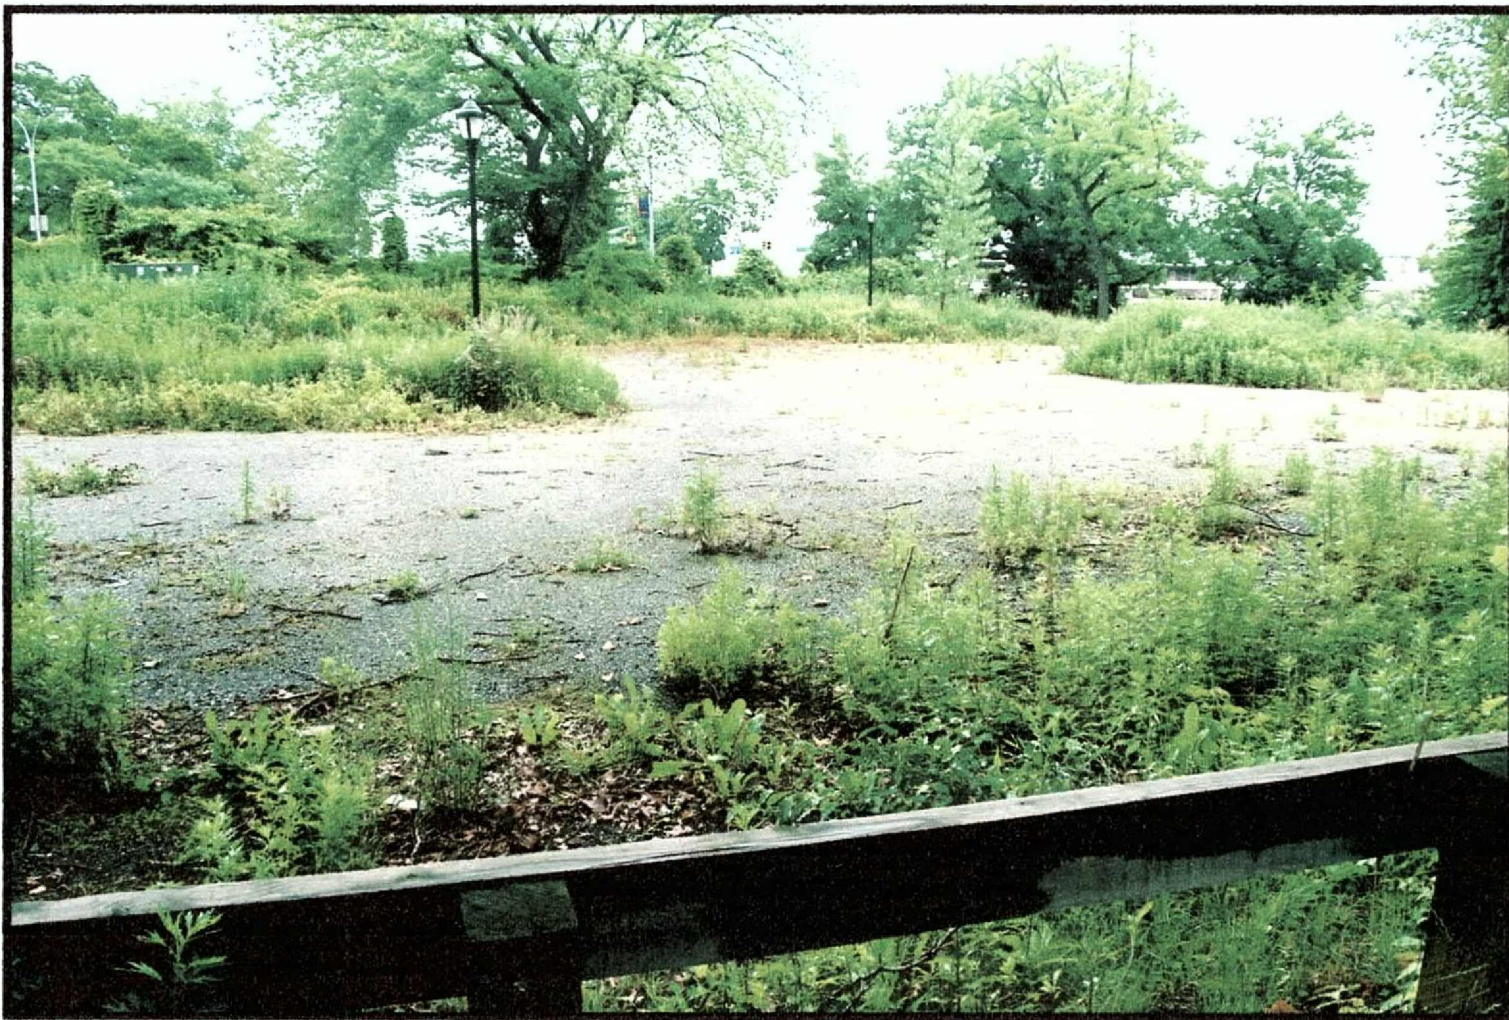
Photograph 10
Western Portion of Site Showing Lamp Posts, Parking Area Surface and Wooden Barriers
View to North From Vicinity of Northern Boundary Wall of Post Office Property
Site of Building 1 is in Background of Photograph
June 20, 2007

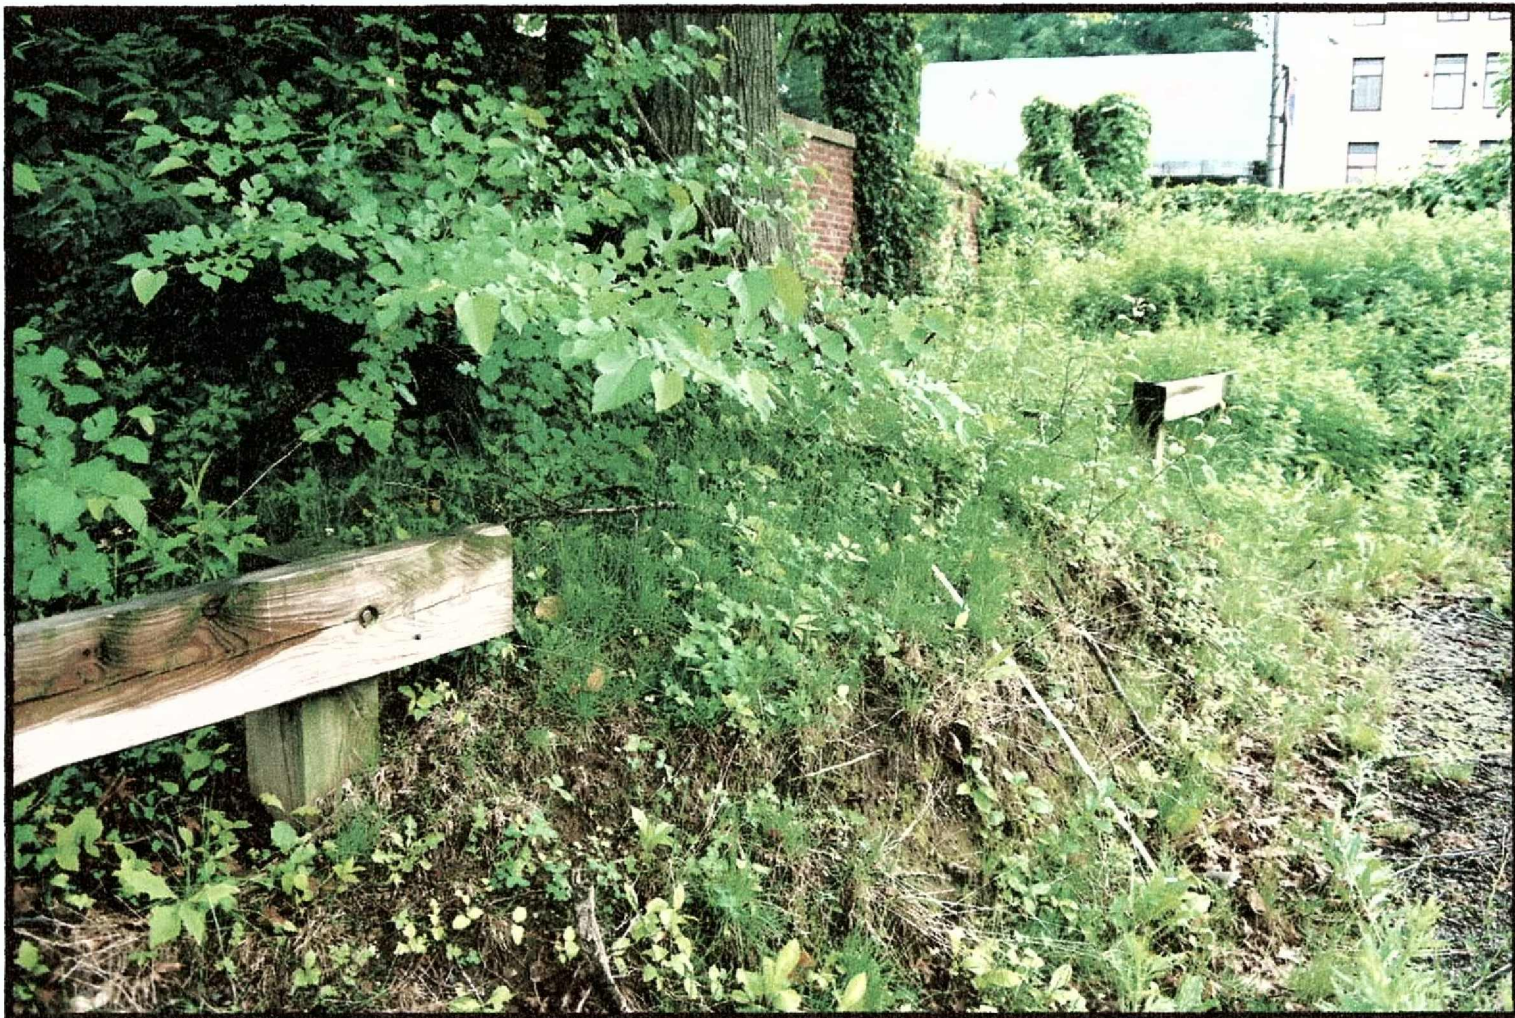
Photograph 11
Western Portion of Site
View to West Near Post Office Property with Bay Street in Background
Showing Effects of Grading and Wooden Parking Area Barriers
June 20, 2007

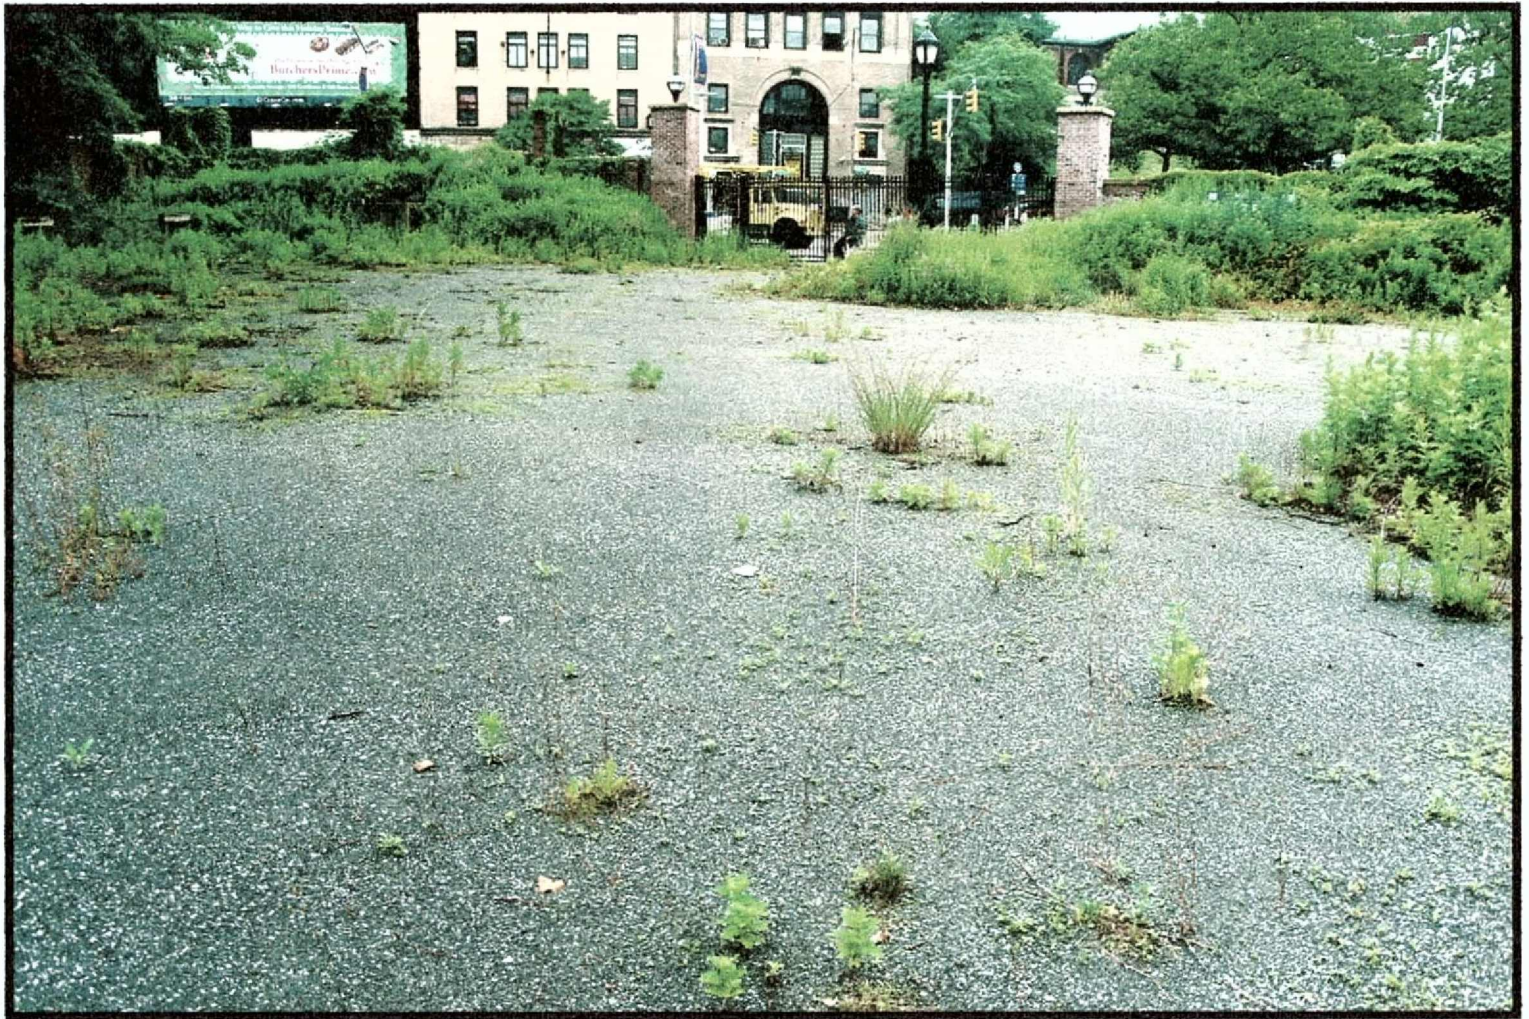
Photograph 12
Portion of Parking Area Surface, Lamp Post and New Bay Street Entrance Gate
View to West
June 20, 2007

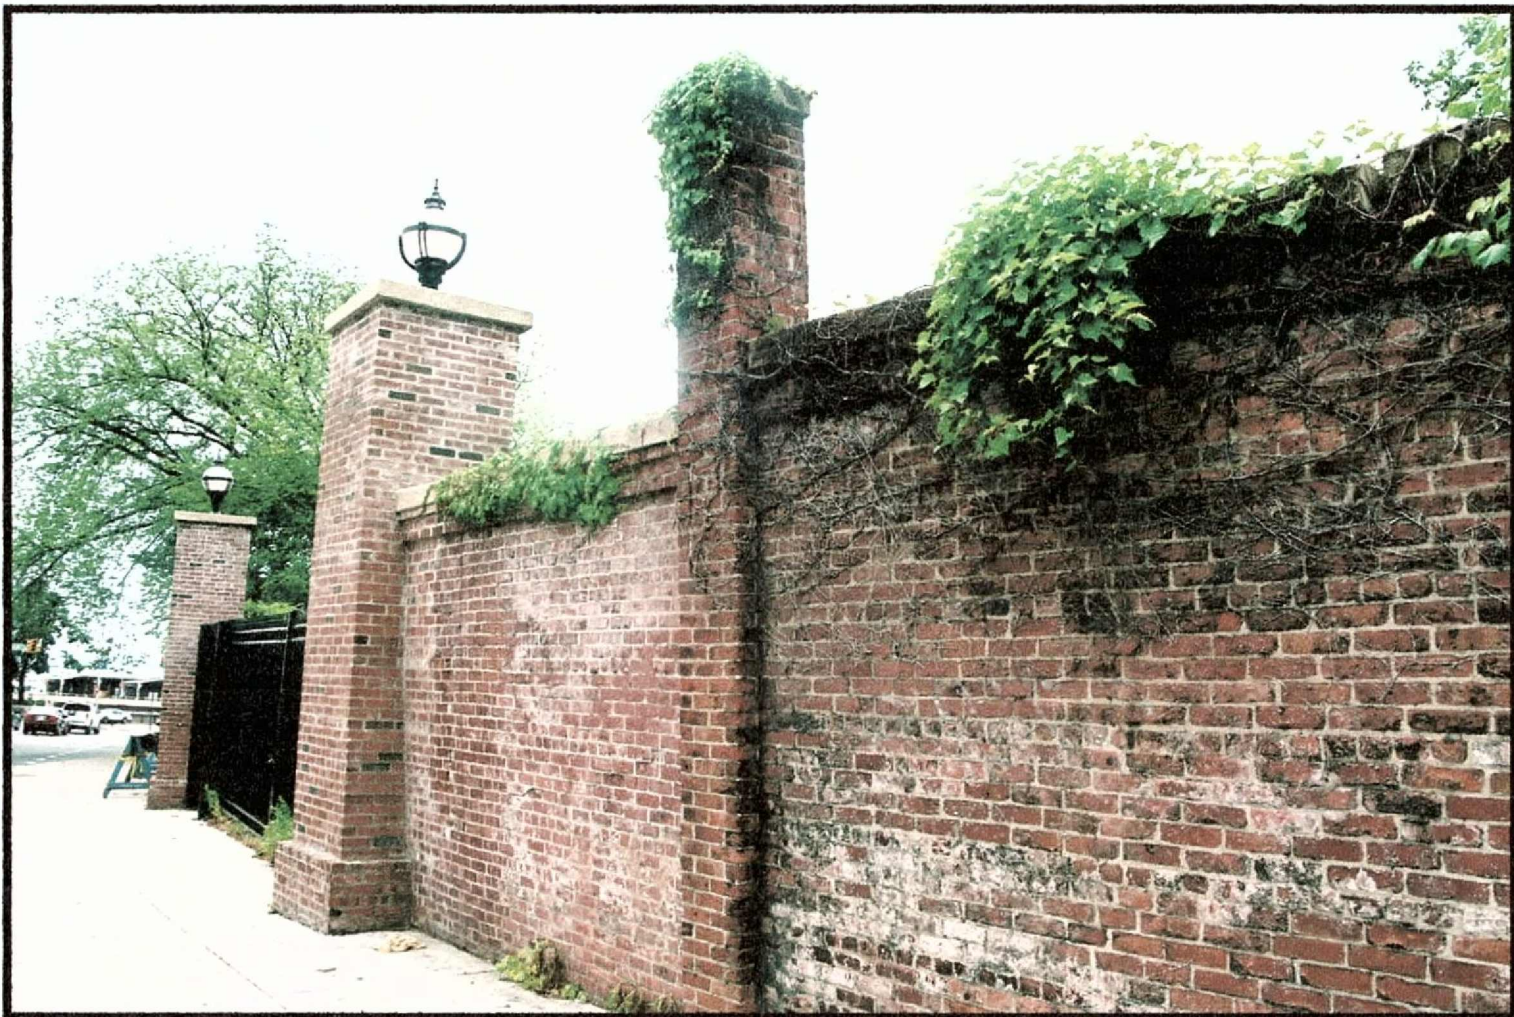
Photograph 13
View to West Along Bay Street
Showing Section of Original Brick Wall in Foreground
With Recently Reconstructed Portion and New Entrance Gates to Left
June 20, 2007

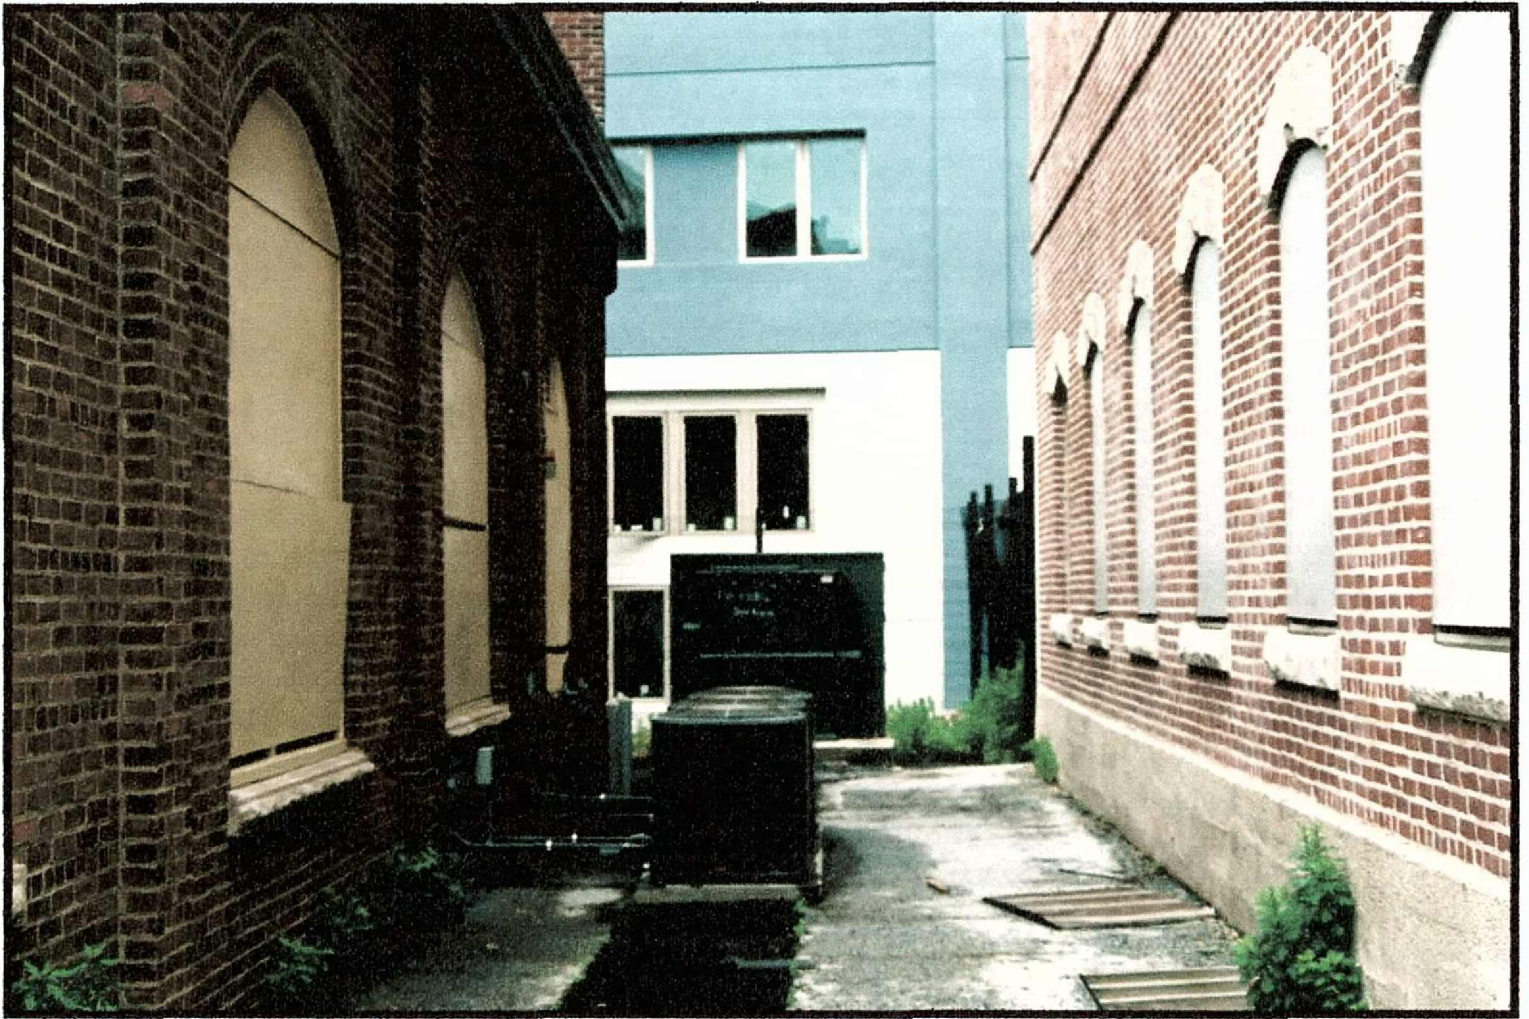
Photograph 14
Alley Between Buildings 10 and 11
Showing Recently Installed Air Conditioning Equipment
View to South
June 20, 2007

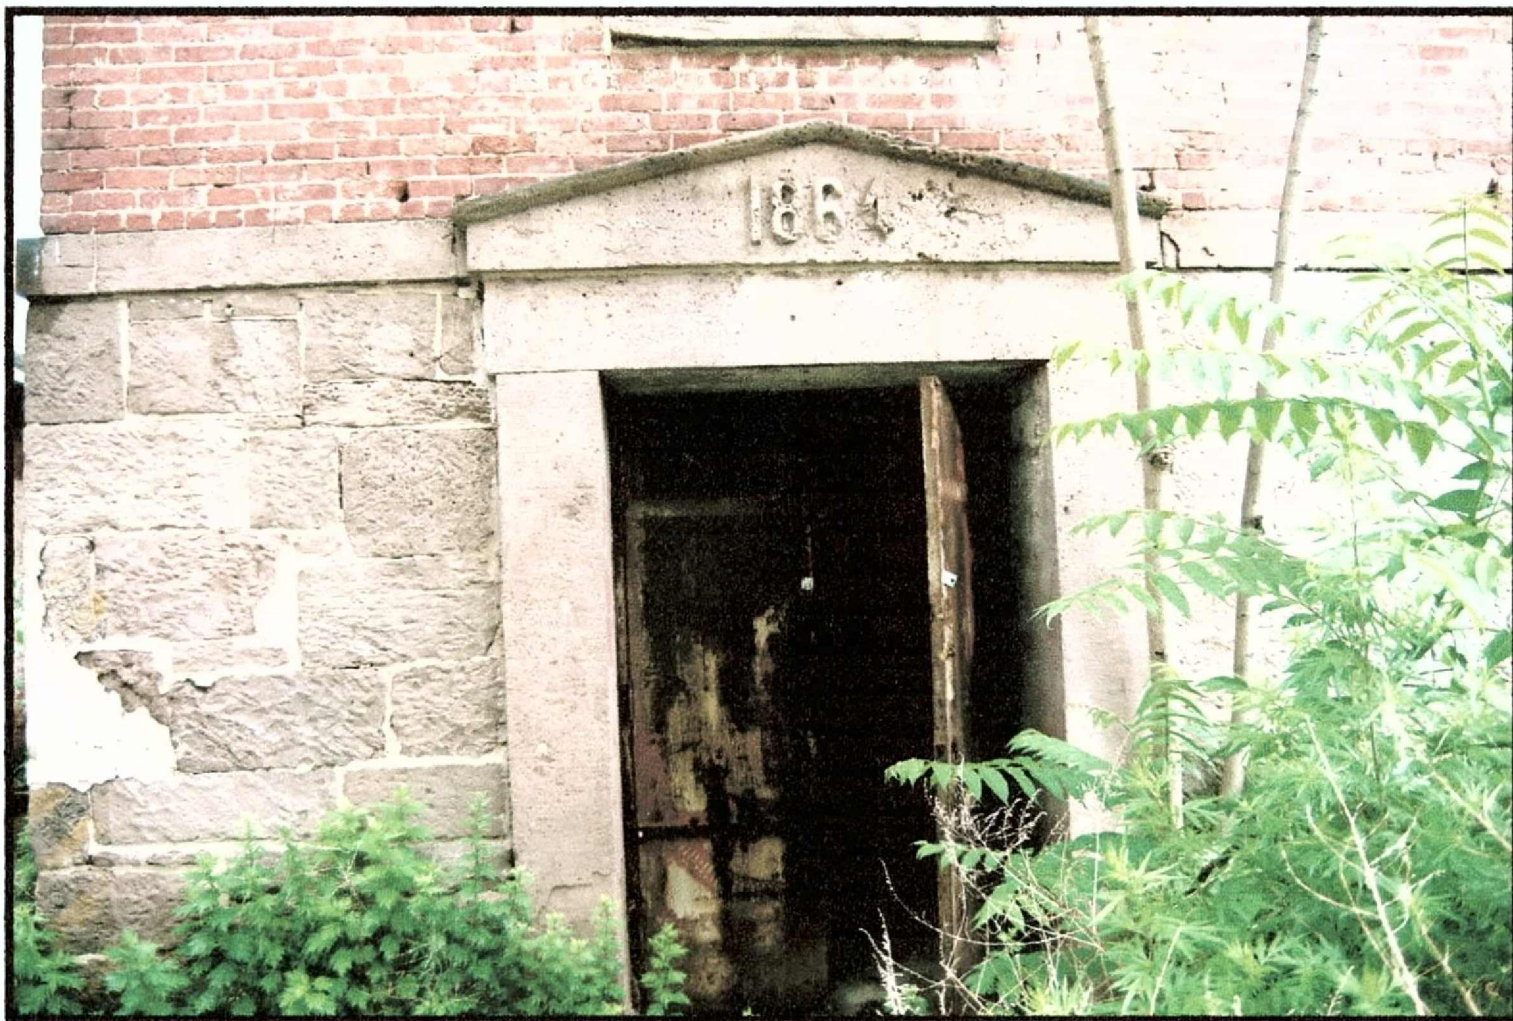
Photograph 15
Portion of Southern Façade of Store House (Building 6)
Showing Construction Date
June 20, 2007
