Cragmoor Consultants

**PHASE IA ARCHAEOLOGICAL SURVEY
NATIONAL LIGHTHOUSE REDEVELOPMENT PROJECT
BLOCK 1, PORTION OF LOT 60
STATEN ISLAND
BOROUGH AND COUNTY OF RICHMOND
NEW YORK CITY**

July 2007

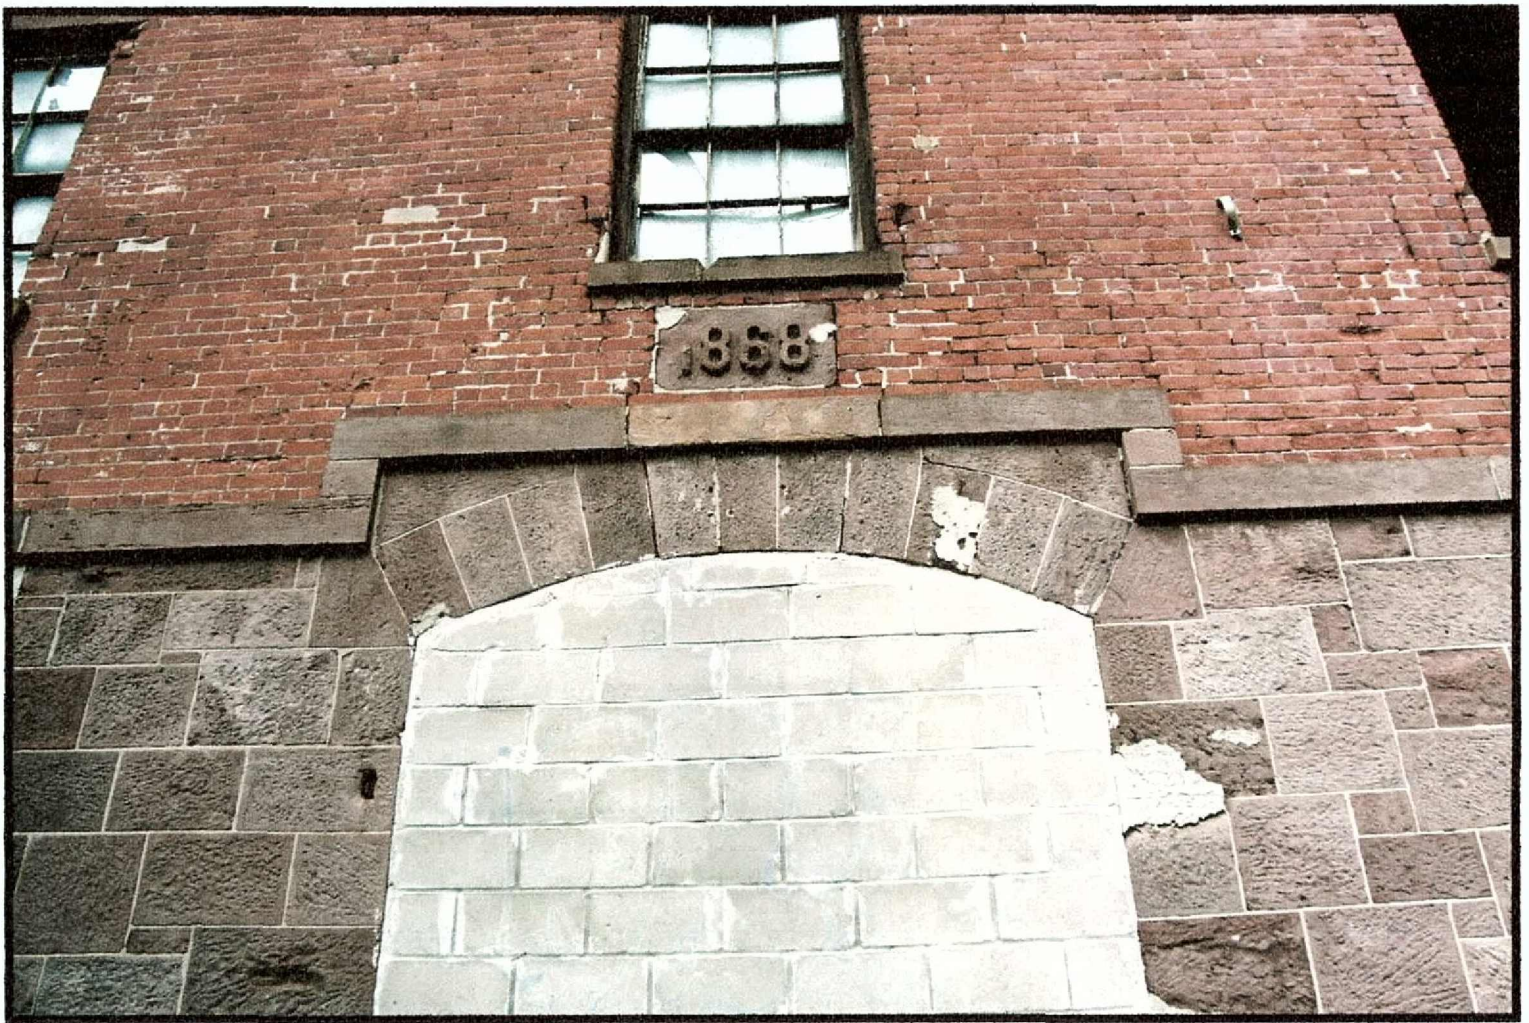
Photograph 16
Portion of Southern Façade of Work Shop Building (Building 8)
Showing Construction Date
June 20, 2007

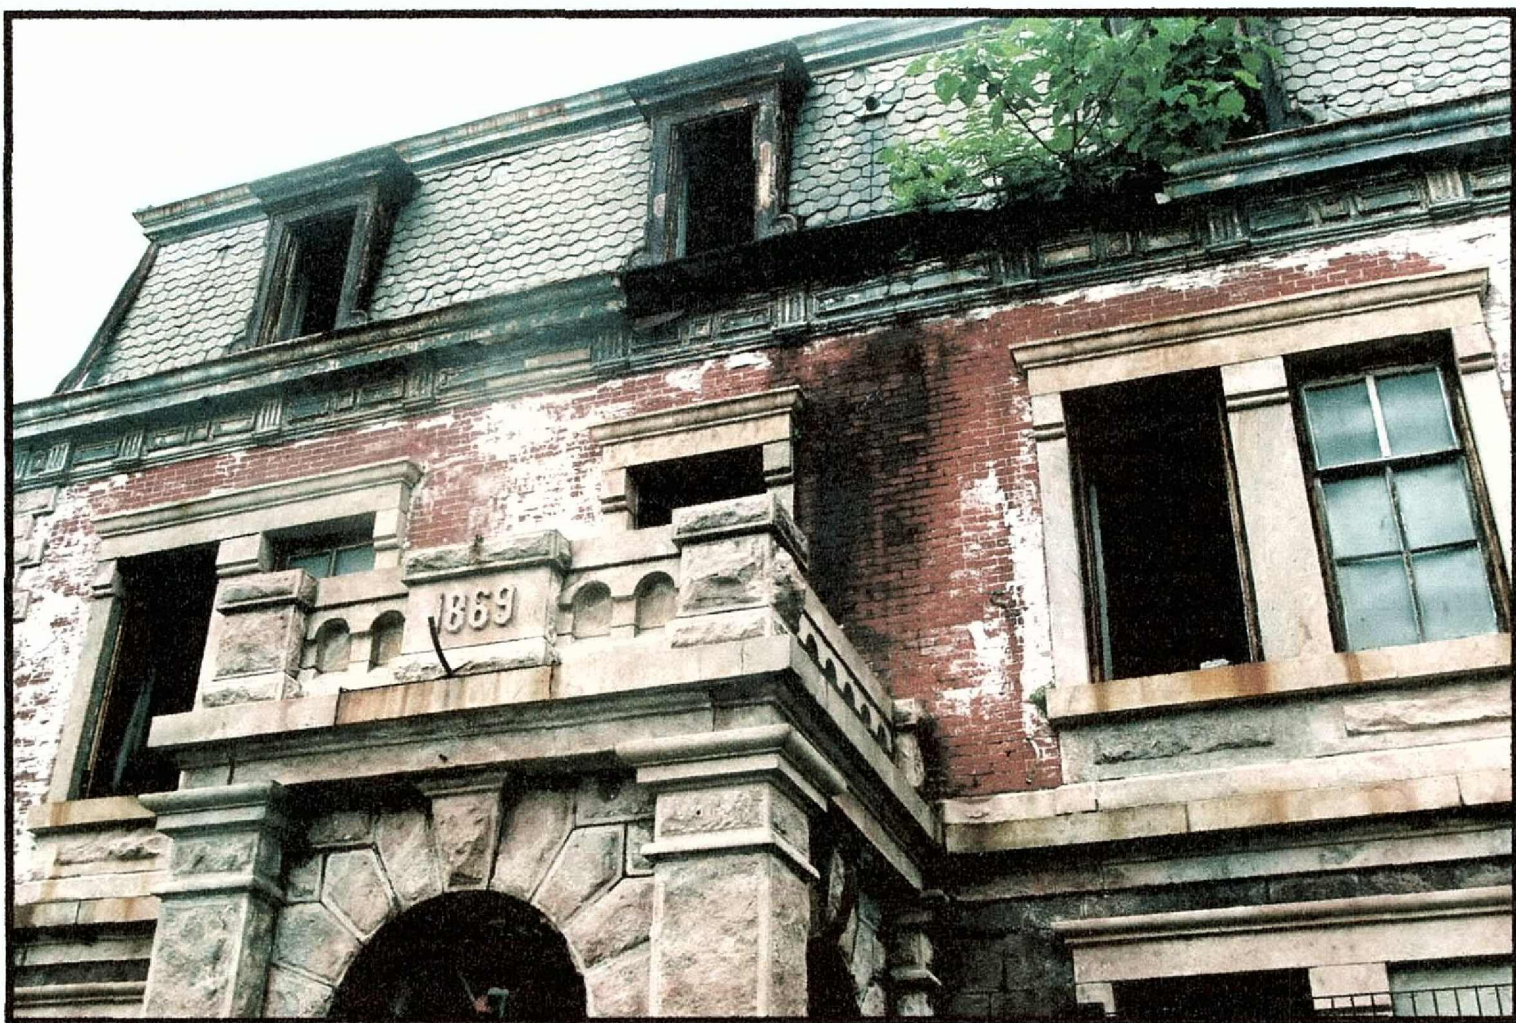
Photograph 17
Portion of Eastern Façade of Office Building (Building 7)
Showing 1869 Construction Date
June 20, 2007
