Cragsmoor Consultants

**PHASE IB ARCHAEOLOGICAL SURVEY
NATIONAL LIGHTHOUSE REDEVELOPMENT PROJECT
BLOCK 1, PORTION OF LOT 60
STATEN ISLAND
BOROUGH AND COUNTY OF RICHMOND
NEW YORK CITY
SEQRA - R**

April 2008

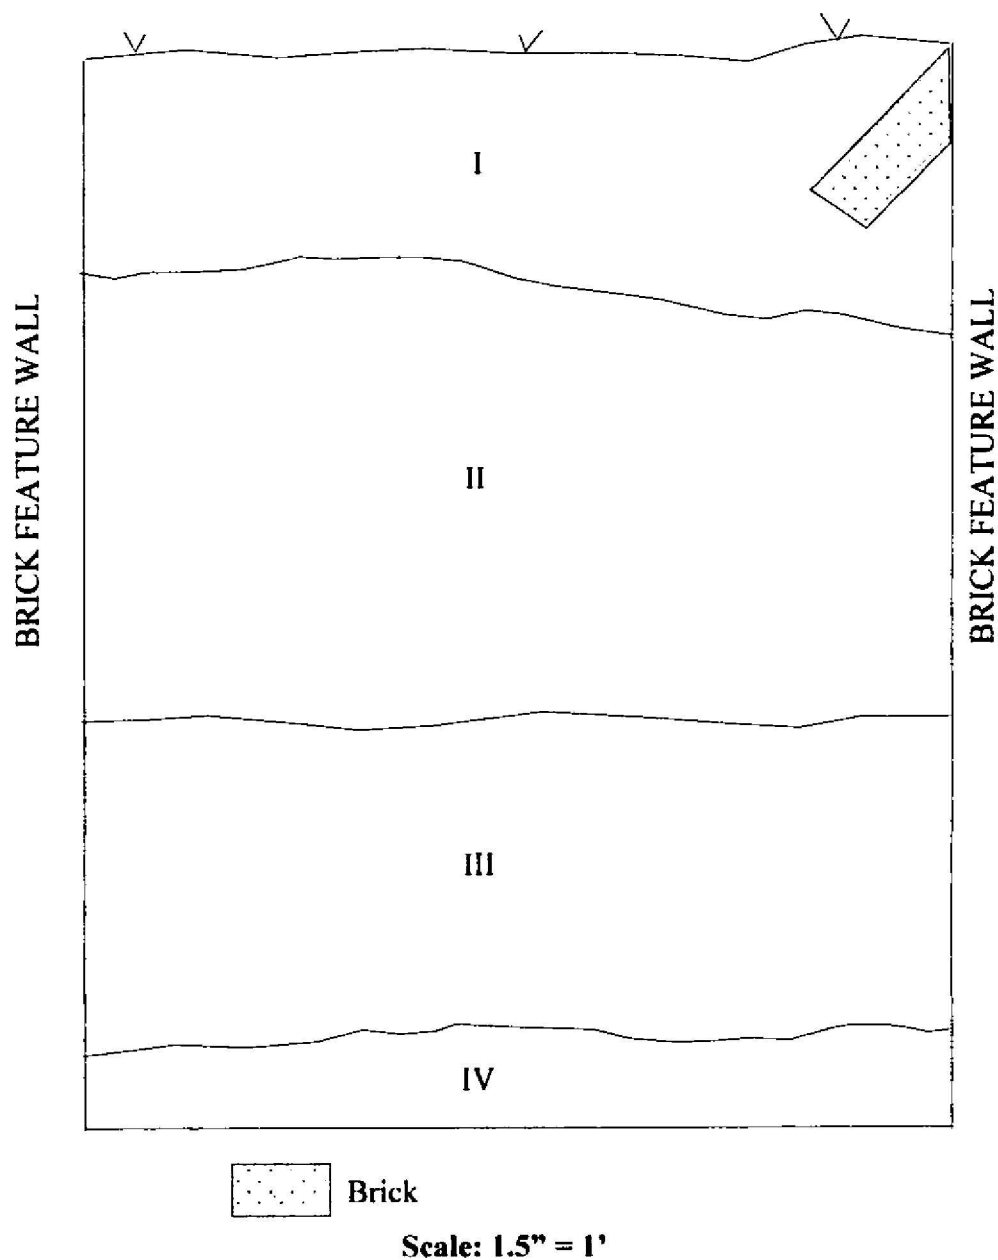
Figure 10
Feature 1 - Unit A East Wall
Profile of Feature Deposits

- I - Dark Gray/Black Sandy Silt with Yellow/Brown Mottling and Pebbles**
- II - Light Gray/Brown Sandy Silt with some Yellow/Brown Mottling**
- III - Gray/Brown Sand with Some Silt**
- IV - Black Sandy Matrix with Coal Dust and Small Coal Fragments**

To determine whether Feature 1 contained any possibly significant artifact deposits a small excavation unit (Unit A) was placed in the westernmost portion of the Feature (see Photograph 18). The Unit encompassed the westernmost 16 inches of the feature deposits, with the excavated material representing approximately 40% of the deposits within the feature. The stratigraphy encountered by the unit and the artifacts recovered are listed in Appendix A. The profile of the deposits within the feature is shown in Figure 10 and Photographs 19 and 20.

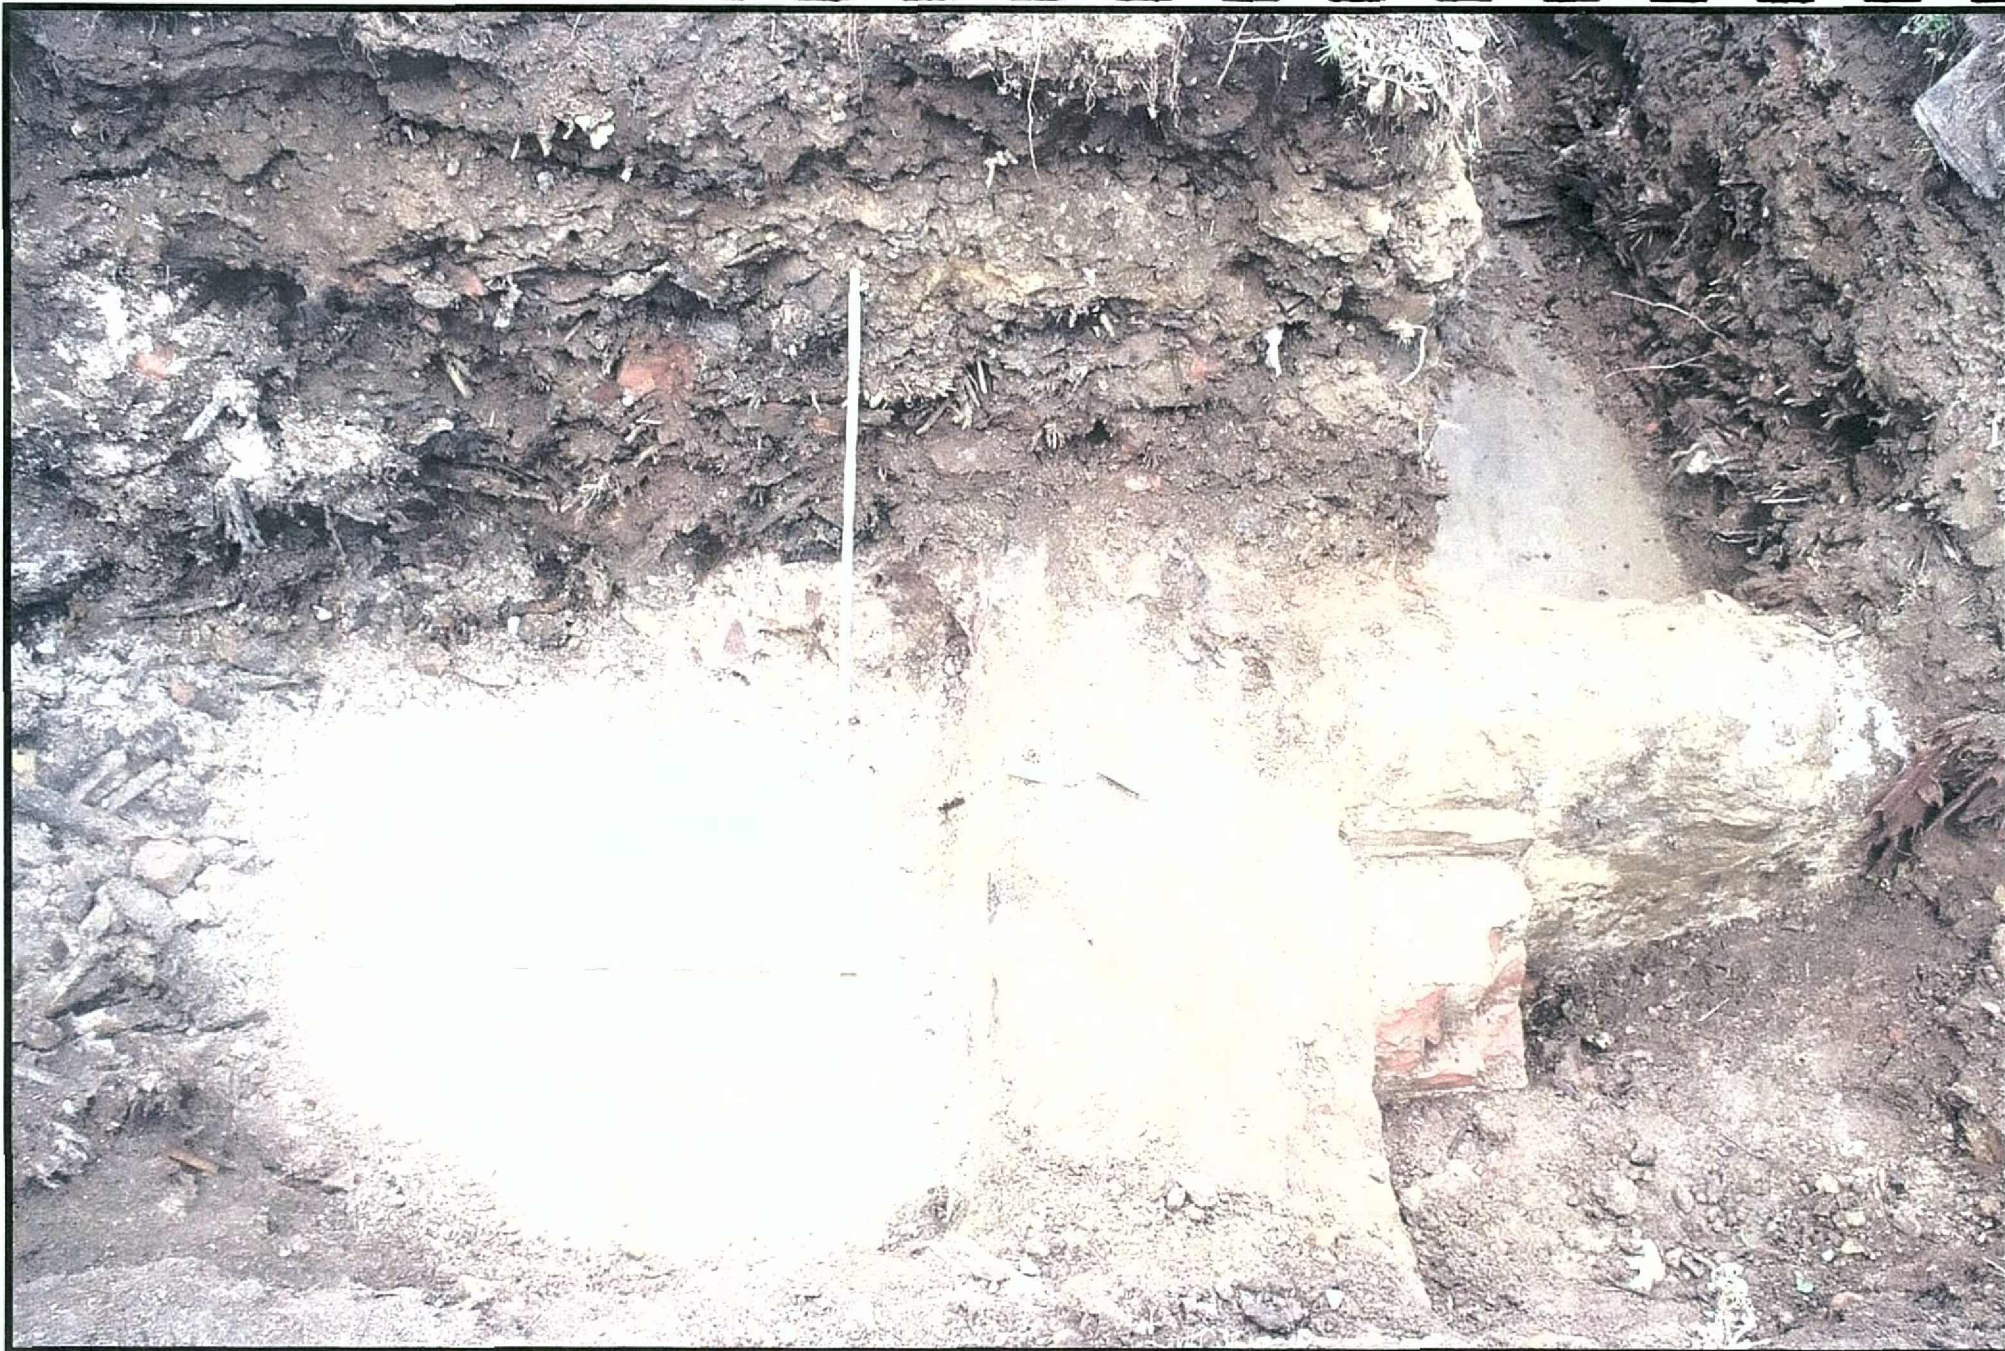
Photograph 1
Backhoe Trench 1 - Showing Intersection of Walls 1 and 2 and Adjacent Floors
View West

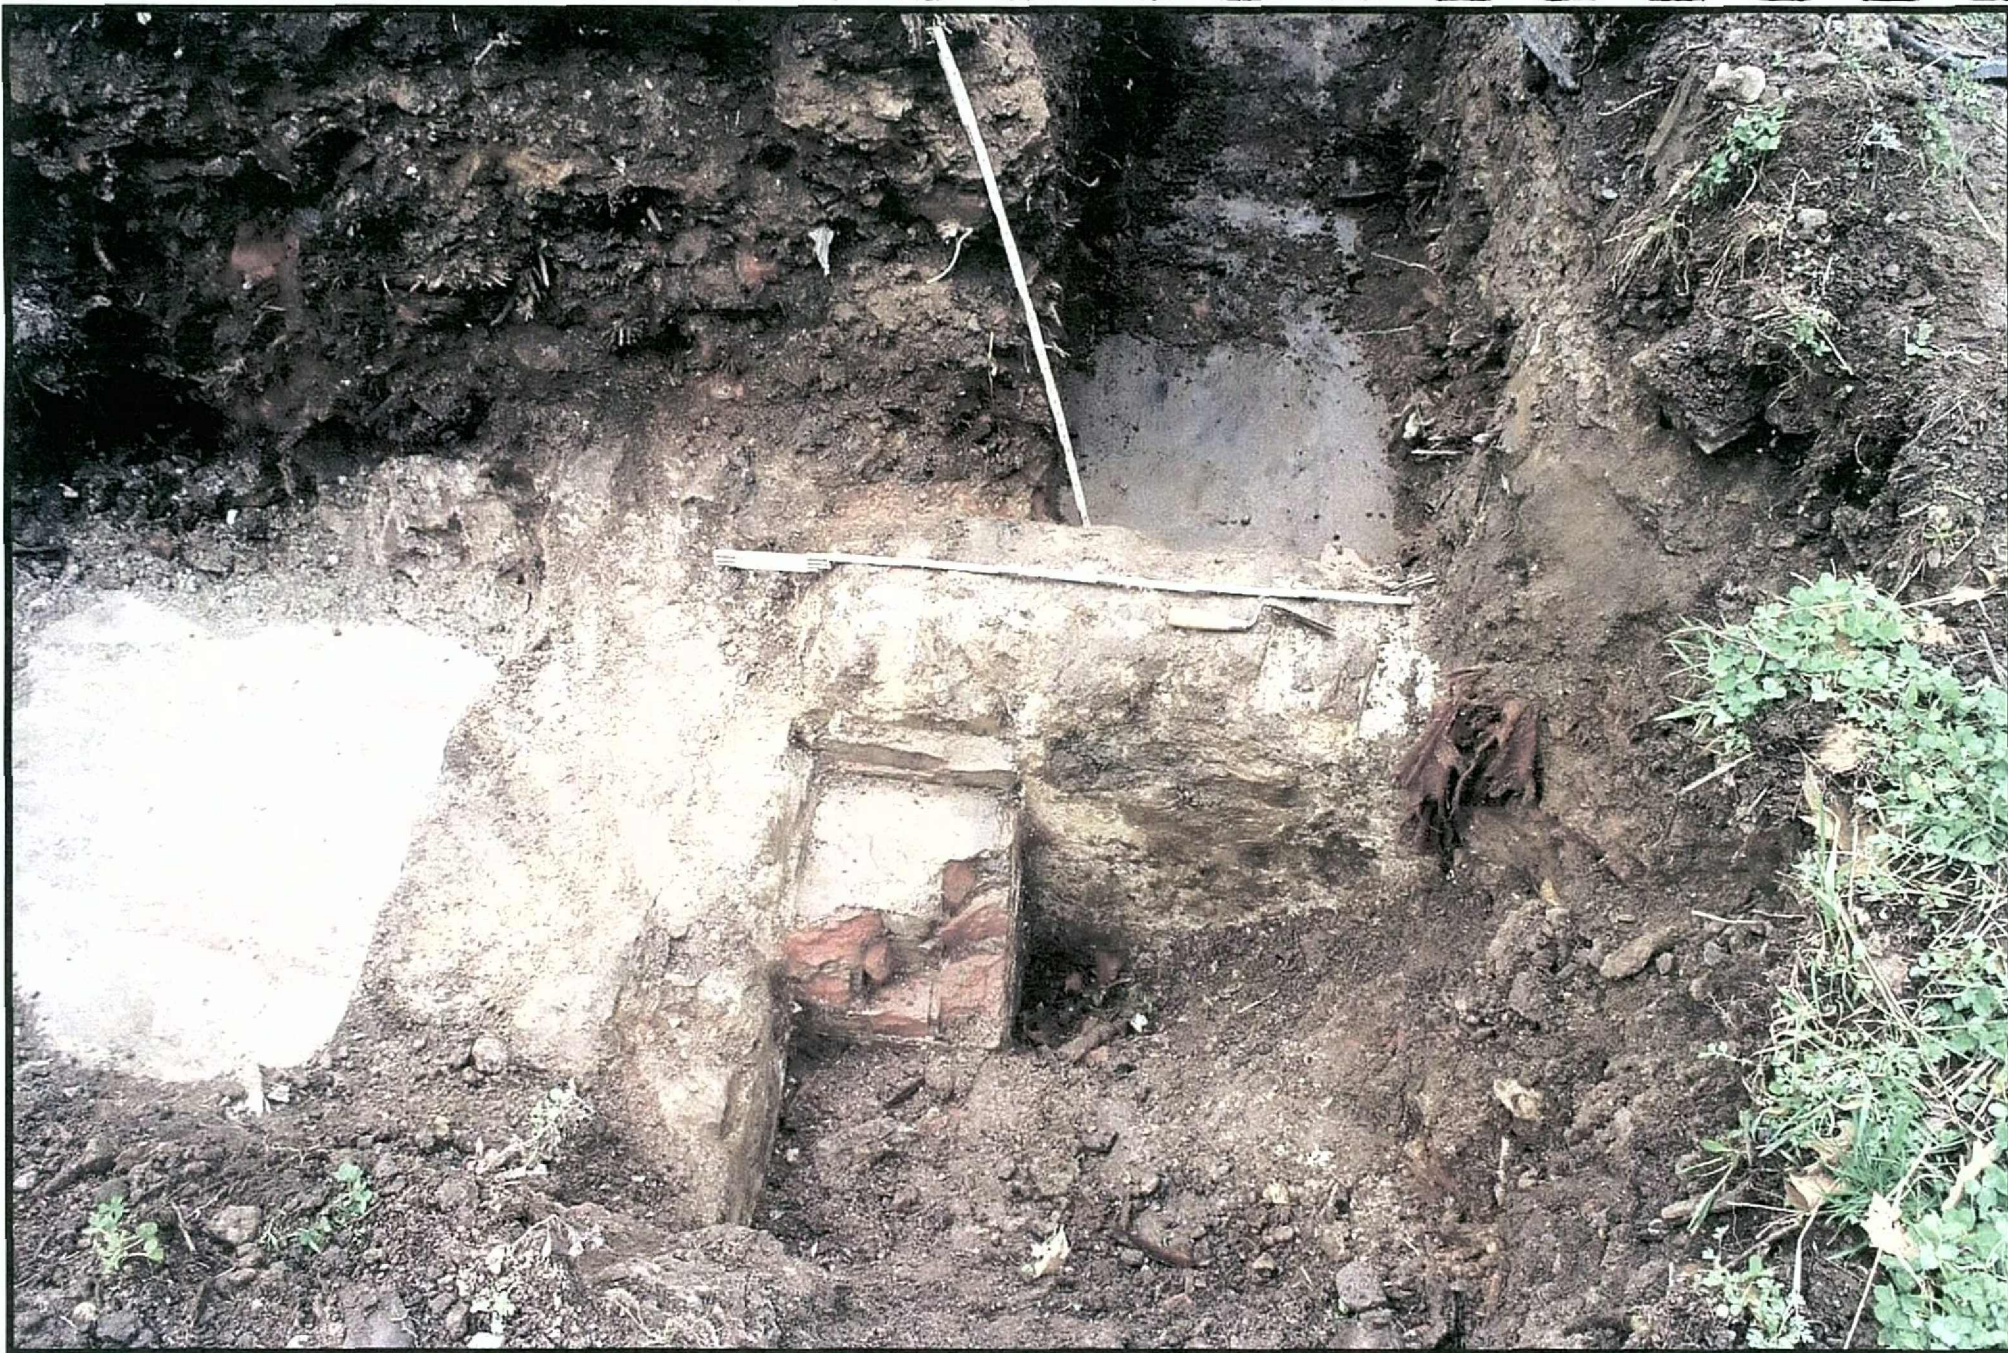
Photograph 2
Backhoe Trench 1 - East Side of Wall 1 with Mortar Facing and Pillar
View West

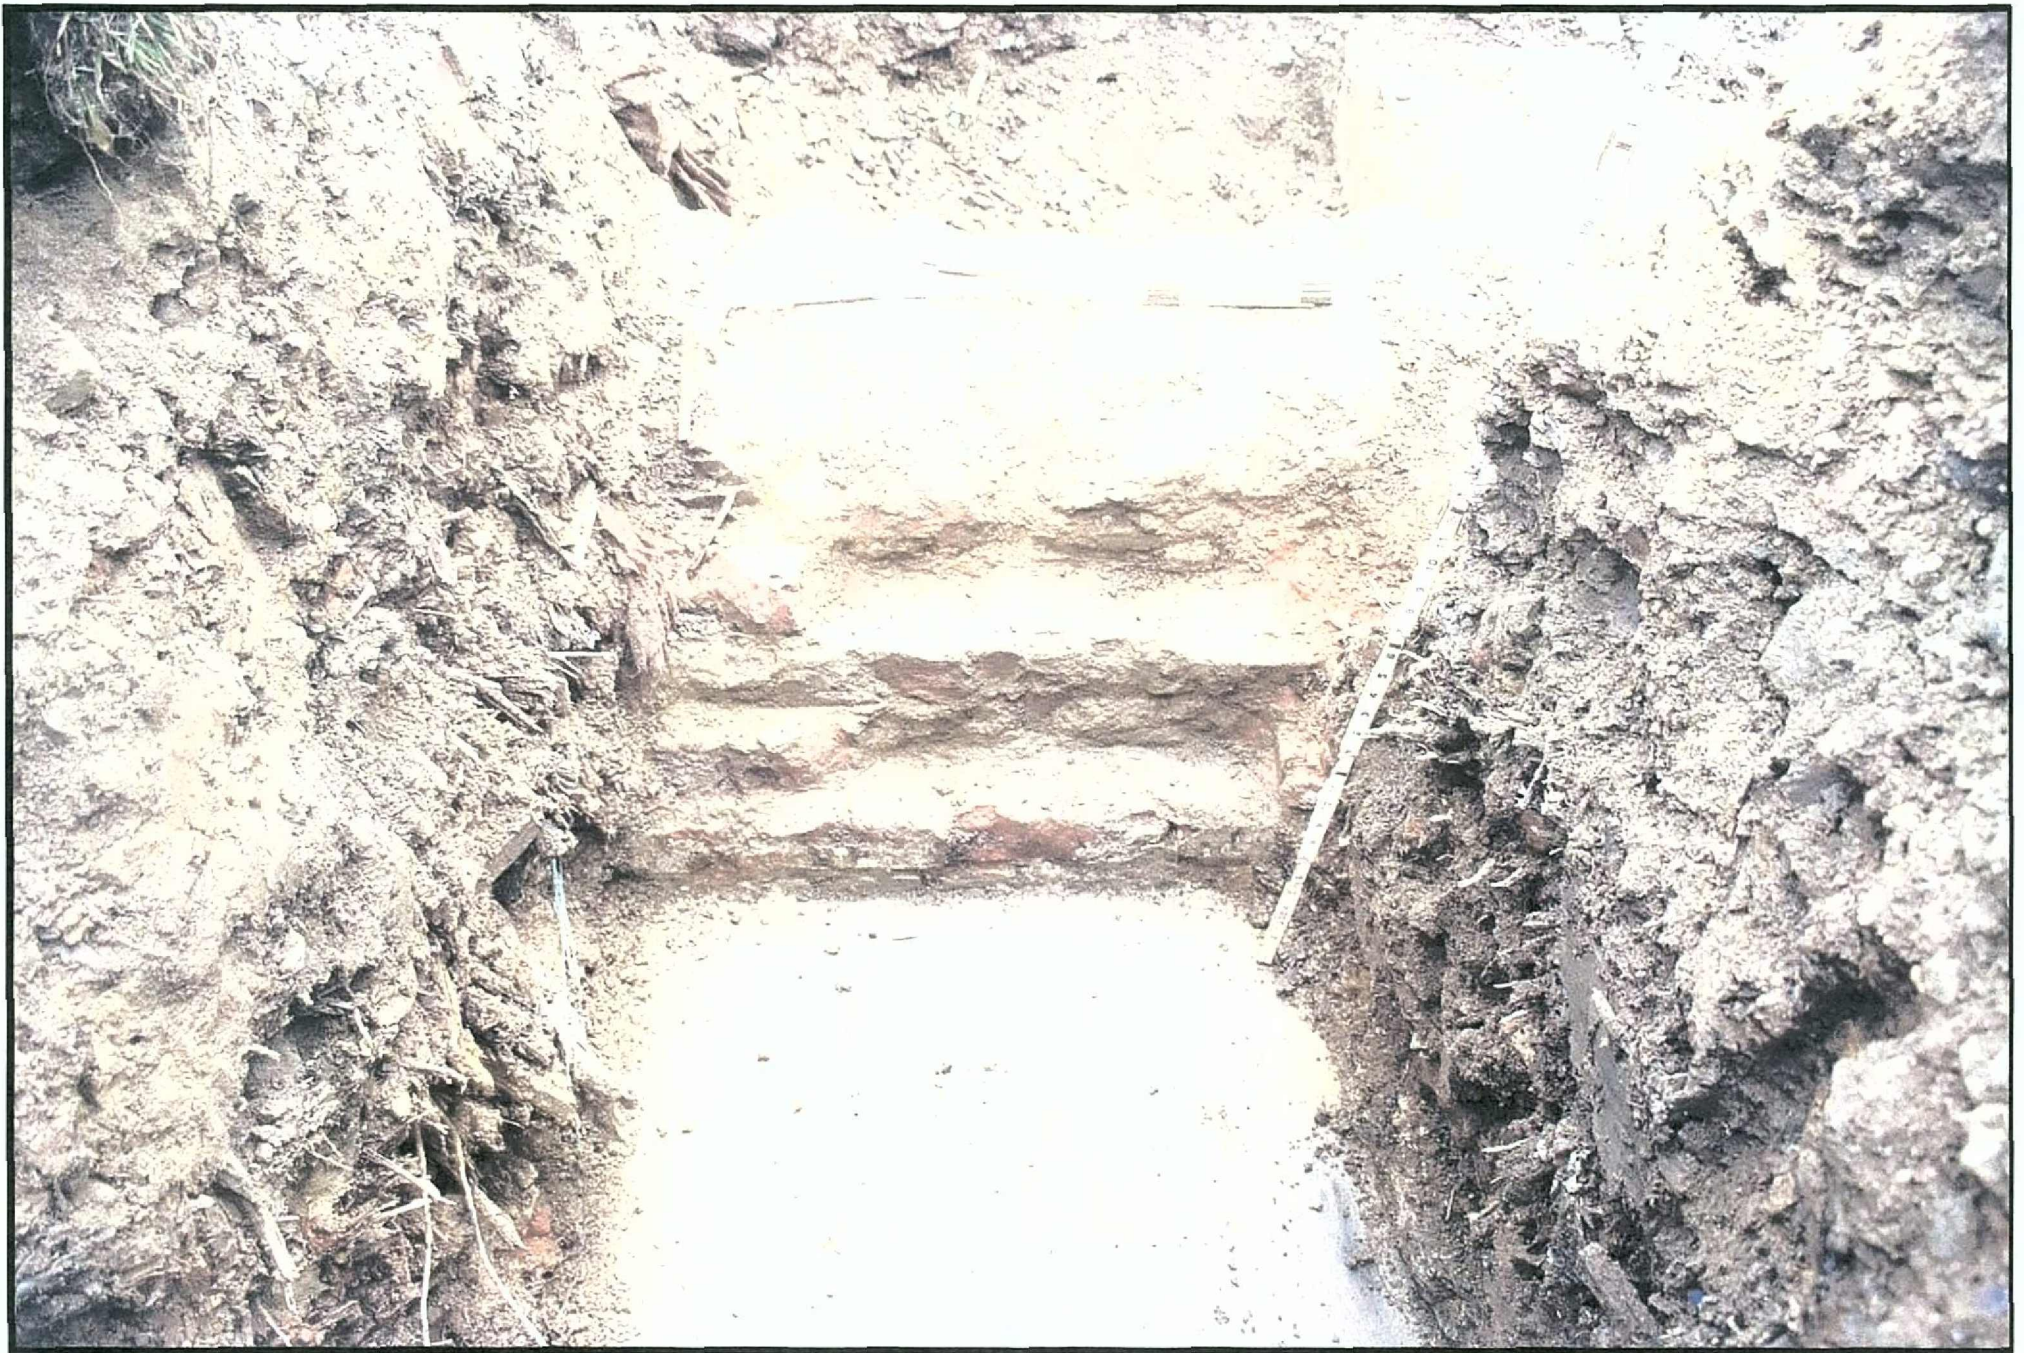
Photograph 3
Backhoe Trench 1 - Detail of East Side Wall 1 and Adjacent Floor
View East

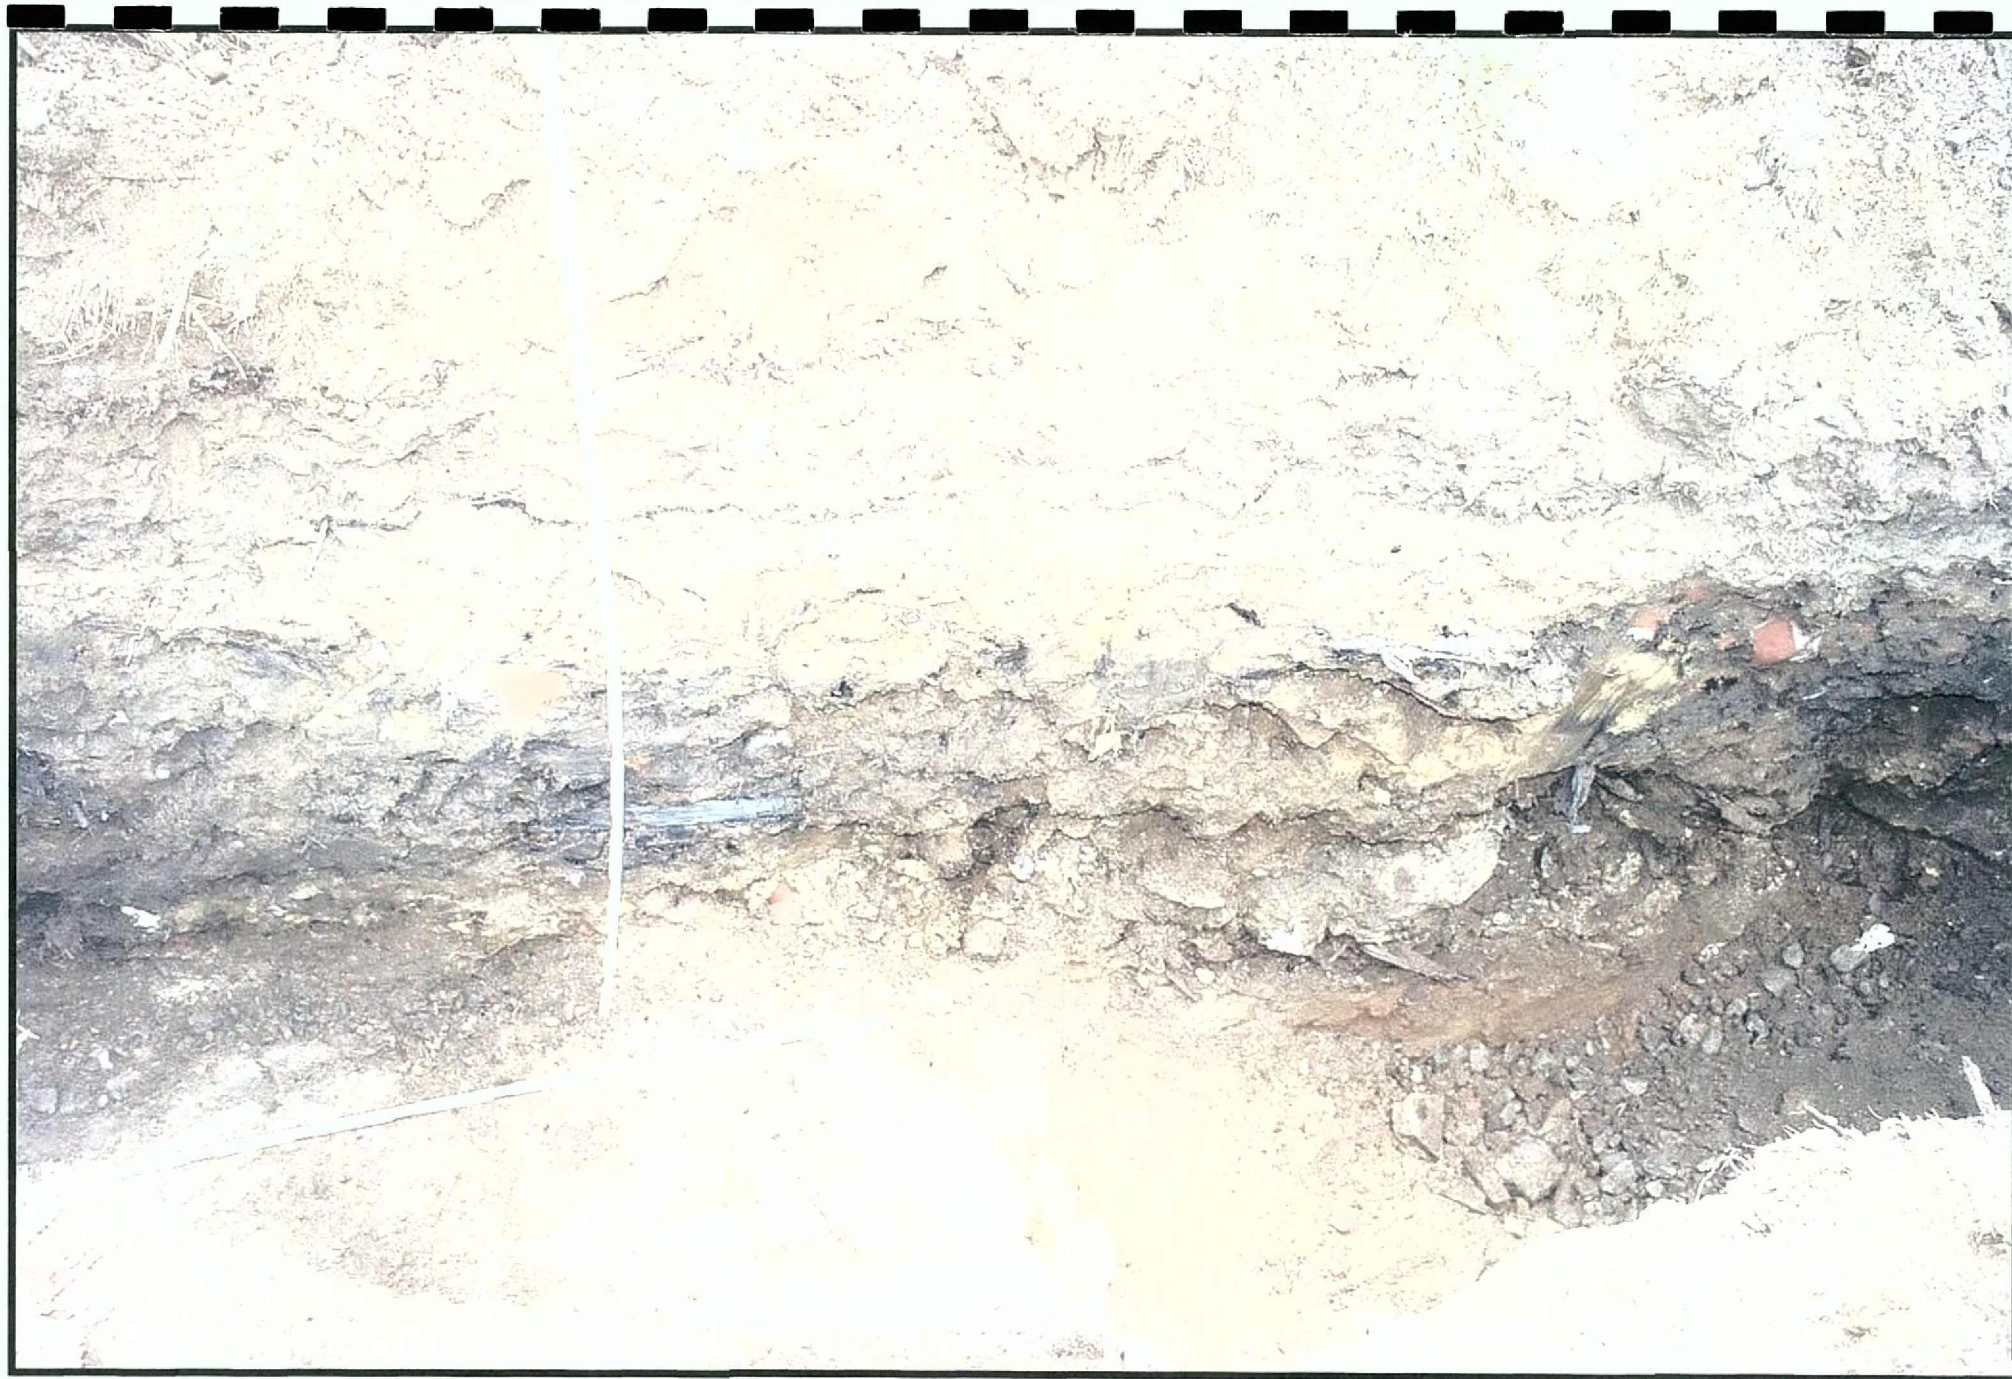
Photograph 4
Backhoe Trench 1 - Cellar Fill Above Brick/Mortar Floor
Showing Removal of Floor By Demolition With Fill and Subsoil at Right Below Brick/Mortar Floor Level
View South

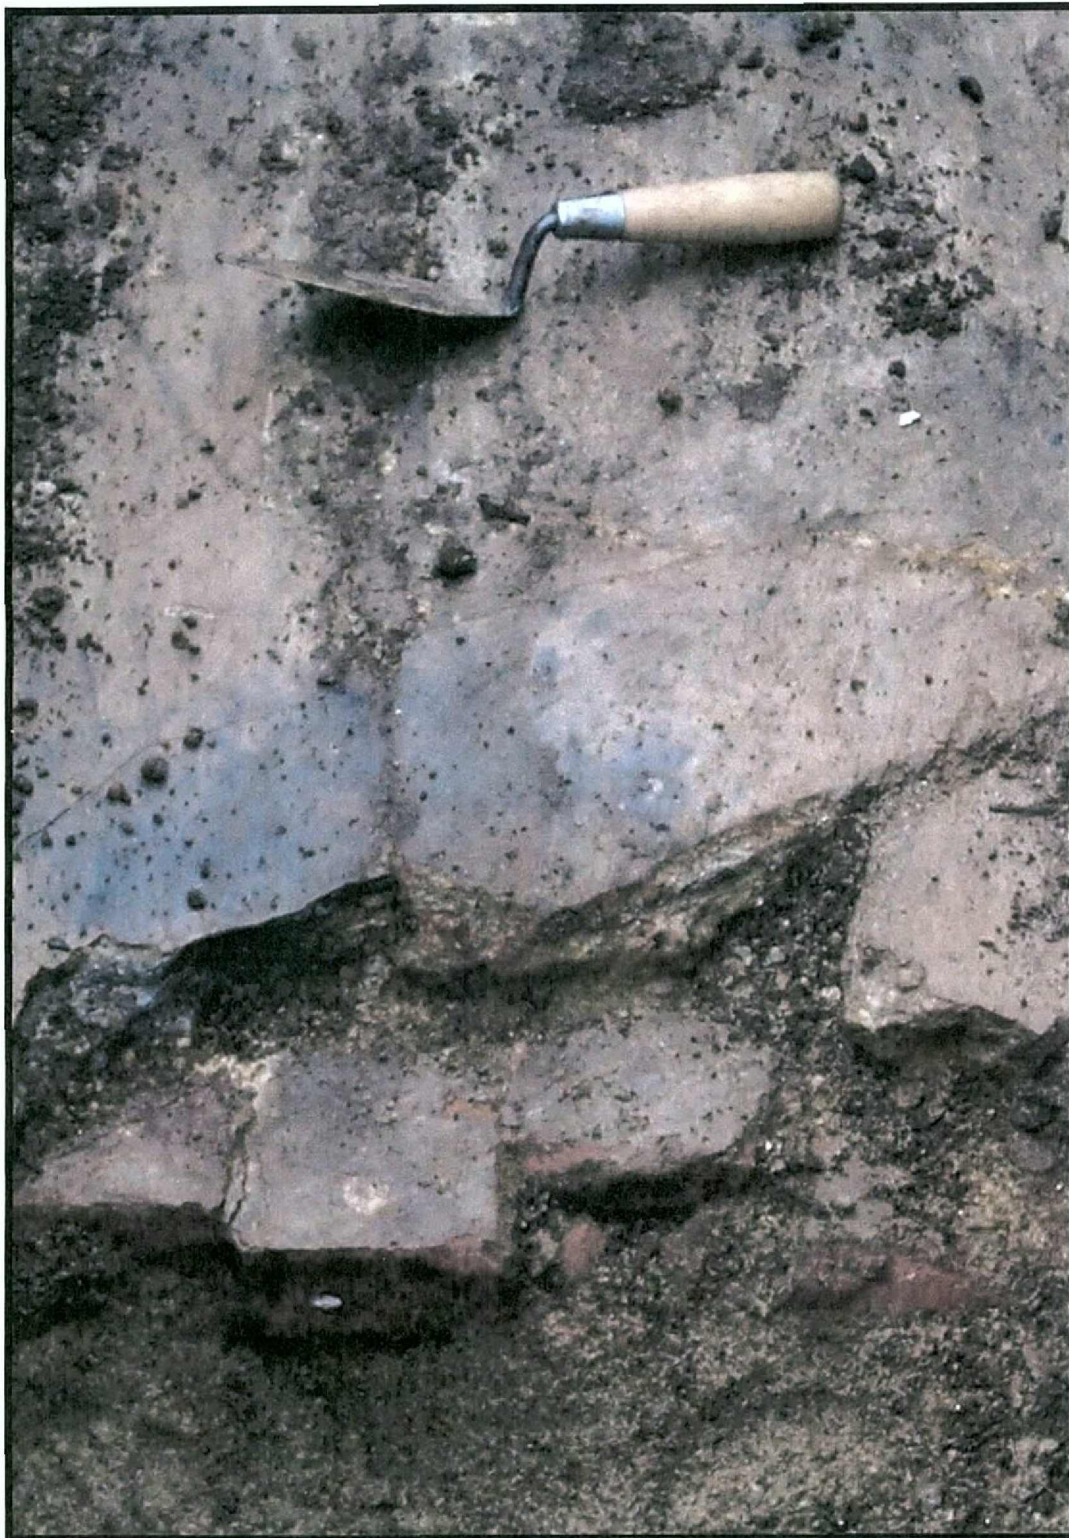
Photograph 5

**Backhoe Trench 1 - Detail of Brick/Mortar Basement Floor at Point Where Removed By Demolition
View East**

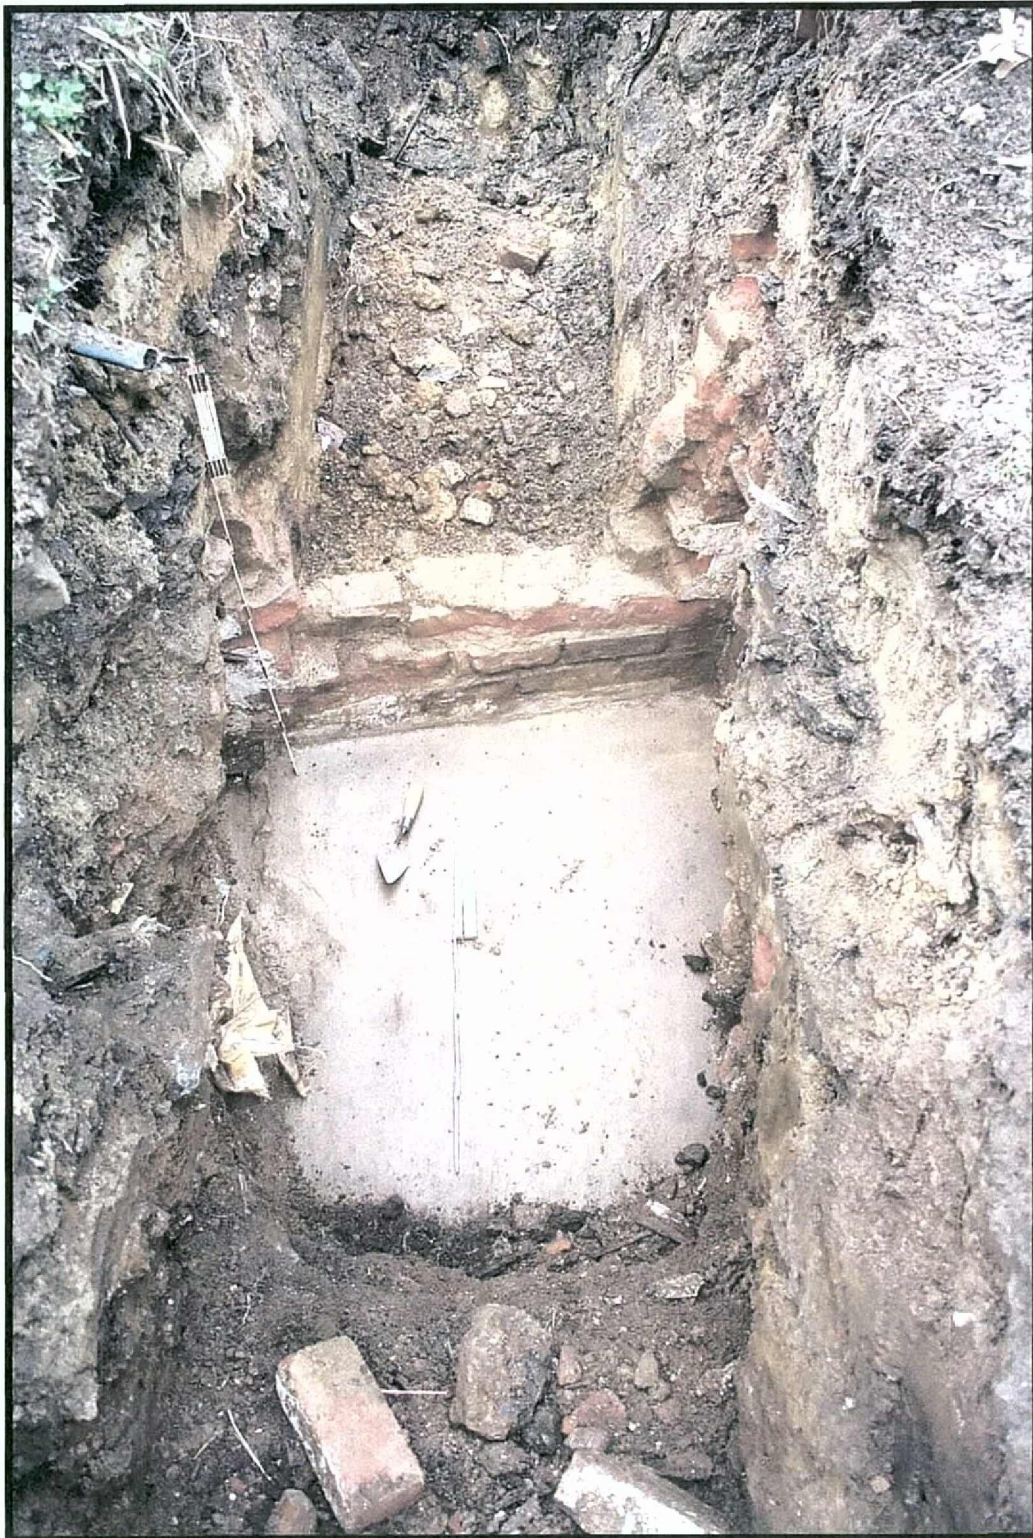
Photograph 6
Backhoe Trench 2 - Wall 3 and Adjacent Basement Floor
View West

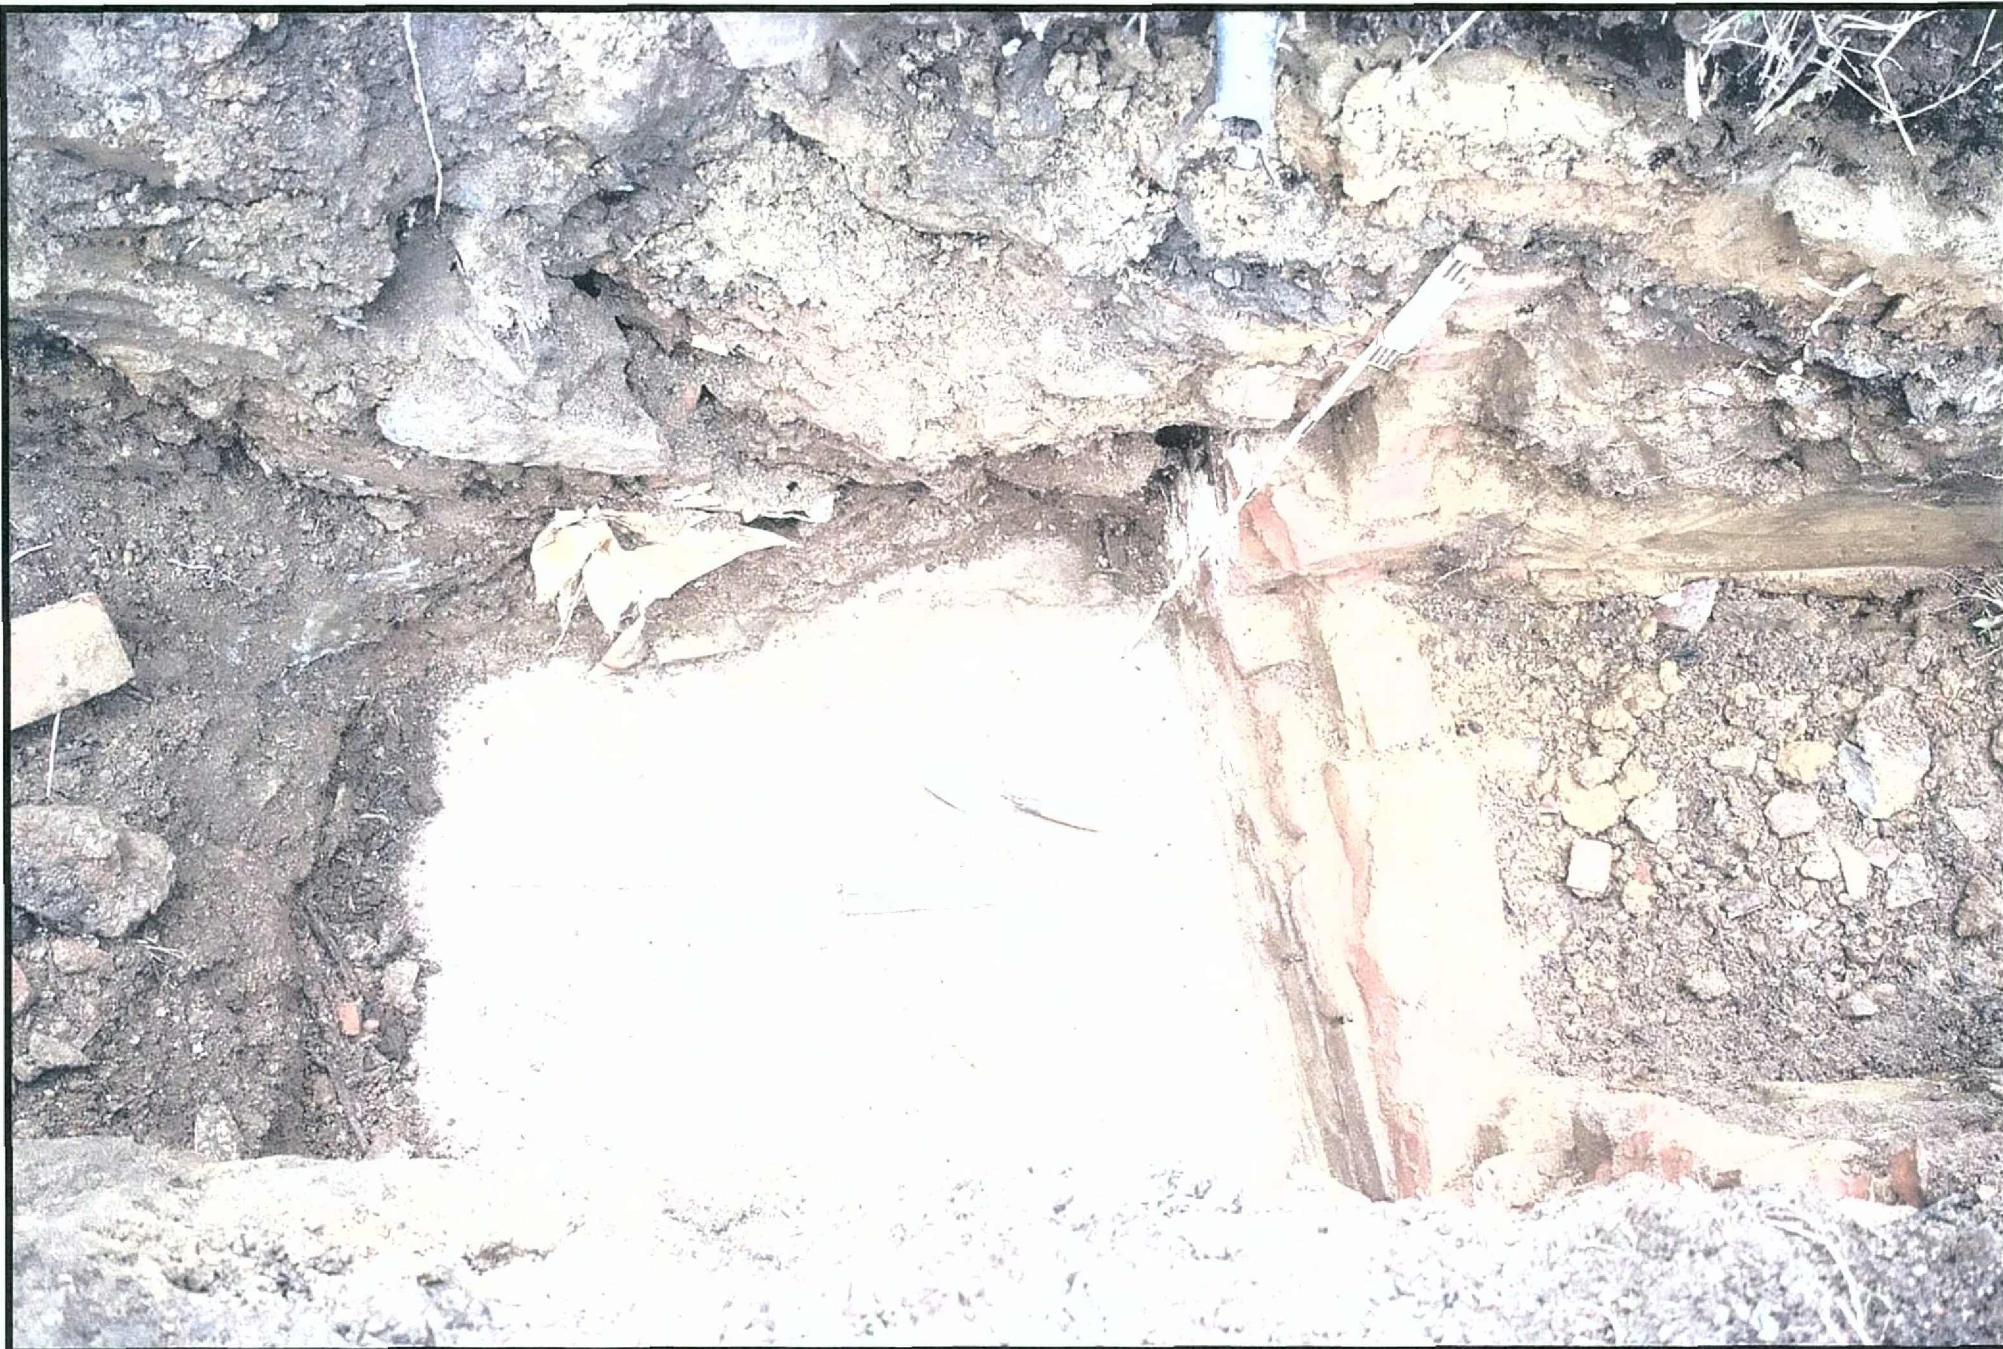
Photograph 7
Backhoe Trench 2 - Wall 3 Showing Intact Portion in Wall of Backhoe Trench
Demolition Debris/Fill Above Floor and Subsoil Adjacent to Outside of Wall
View South

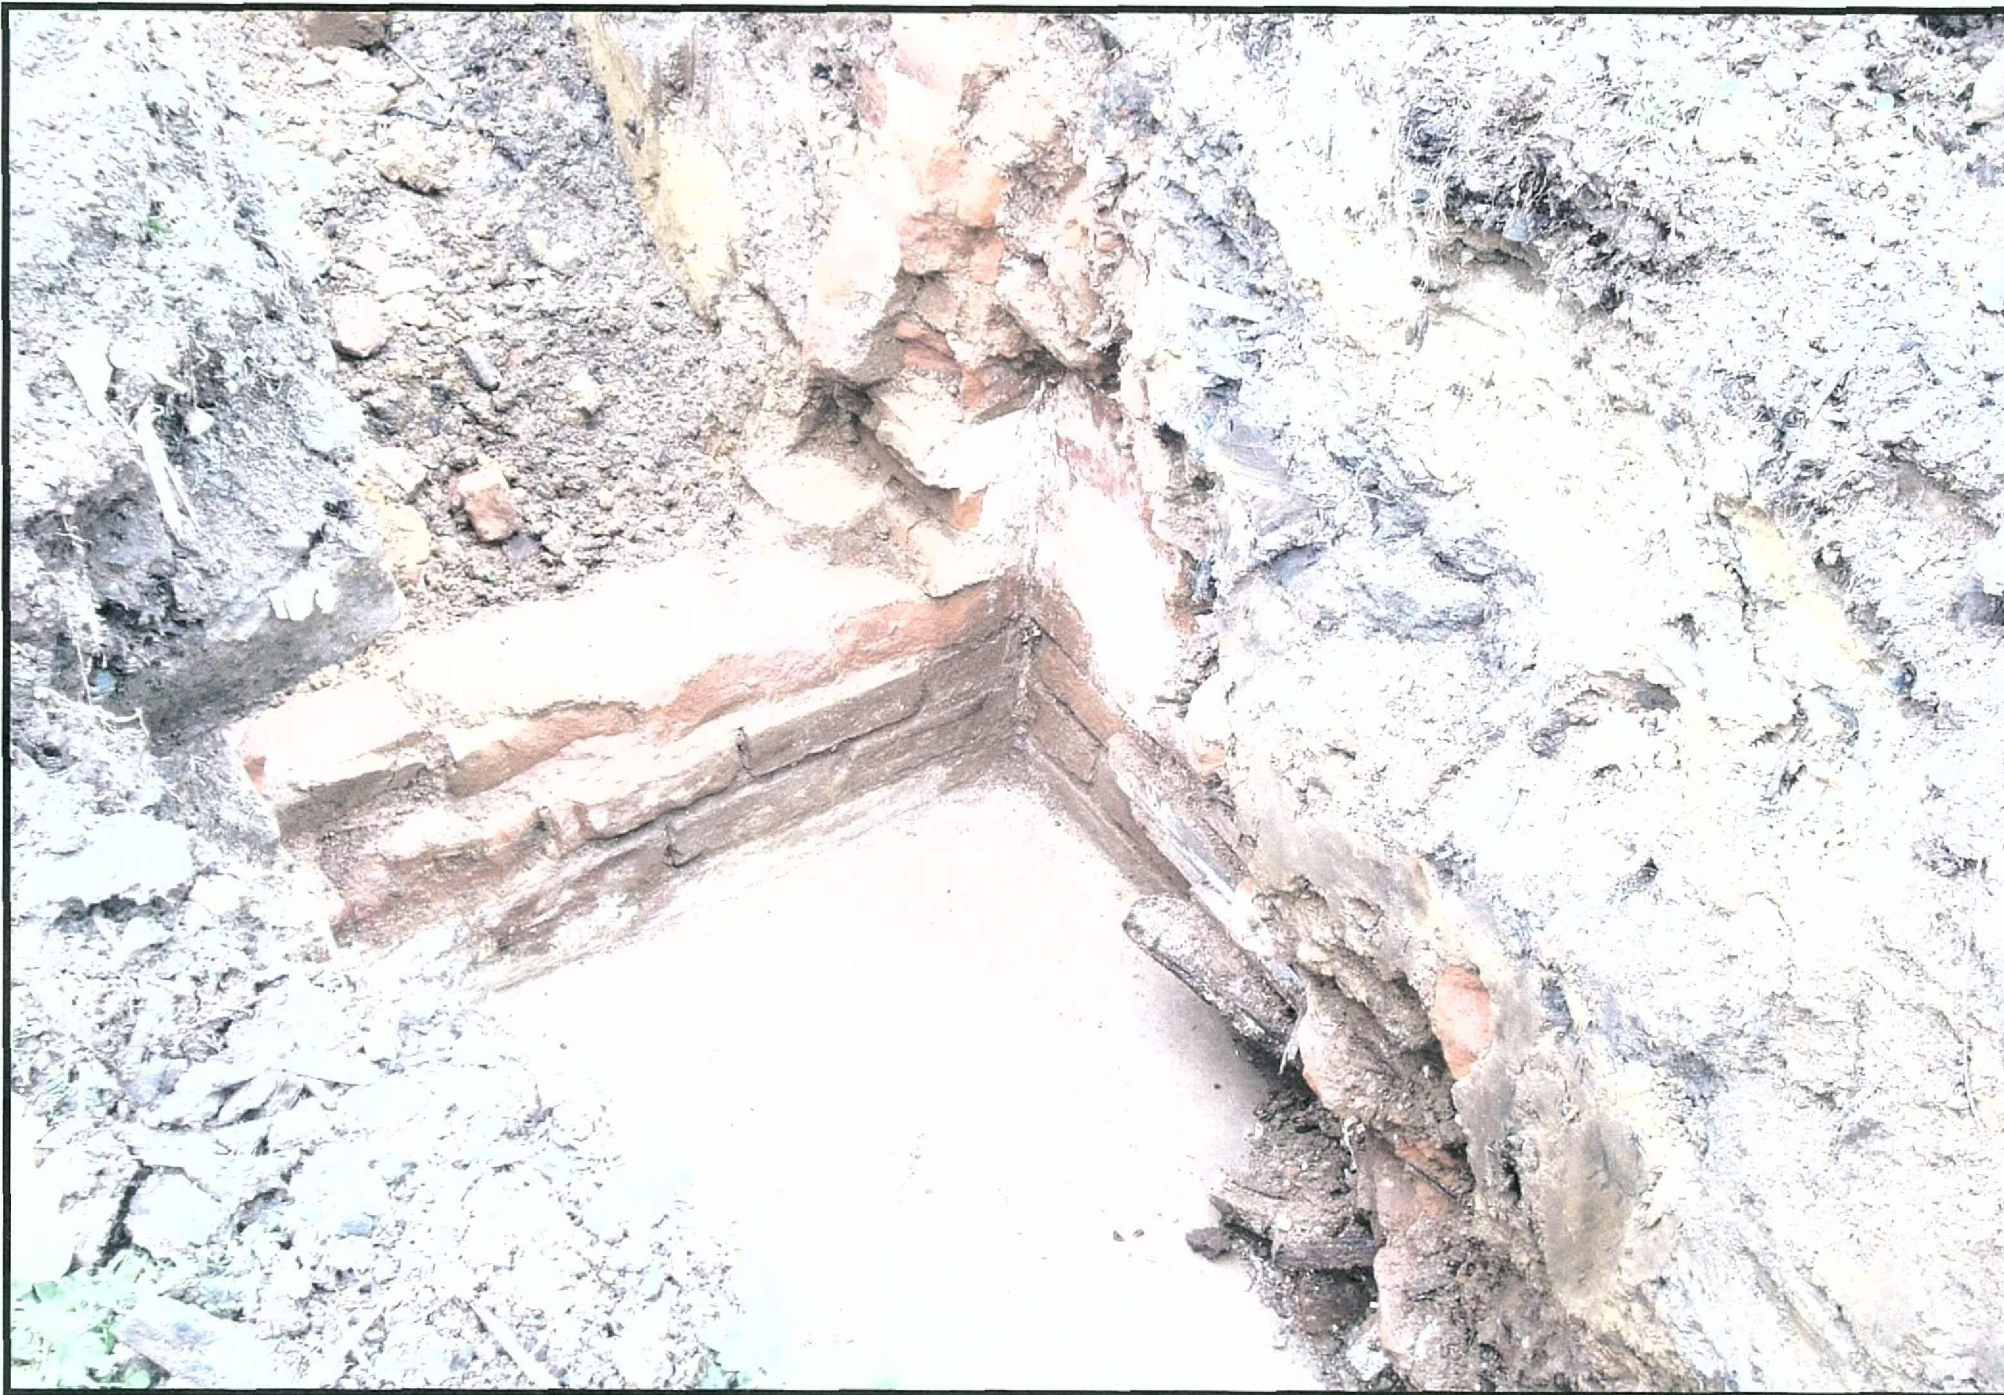
Photograph 8
Backhoe Trench 2 - Northwest Corner of Building 1 - Walls 3 and 4 - Wall 4 Exposed in North Wall of Backhoe Trench
View Northwest

A second brick wall (wall 4) was visible in the northern wall of BHTR 2 (see Photograph 8), extending east of wall 3. These walls apparently represent the northwestern corner of the northernmost section of Building 1.
