Cragsmoor Consultants

**PHASE IB ARCHAEOLOGICAL SURVEY
NATIONAL LIGHTHOUSE REDEVELOPMENT PROJECT
BLOCK 1, PORTION OF LOT 60
STATEN ISLAND
BOROUGH AND COUNTY OF RICHMOND
NEW YORK CITY
SEQRA - R**

April 2008

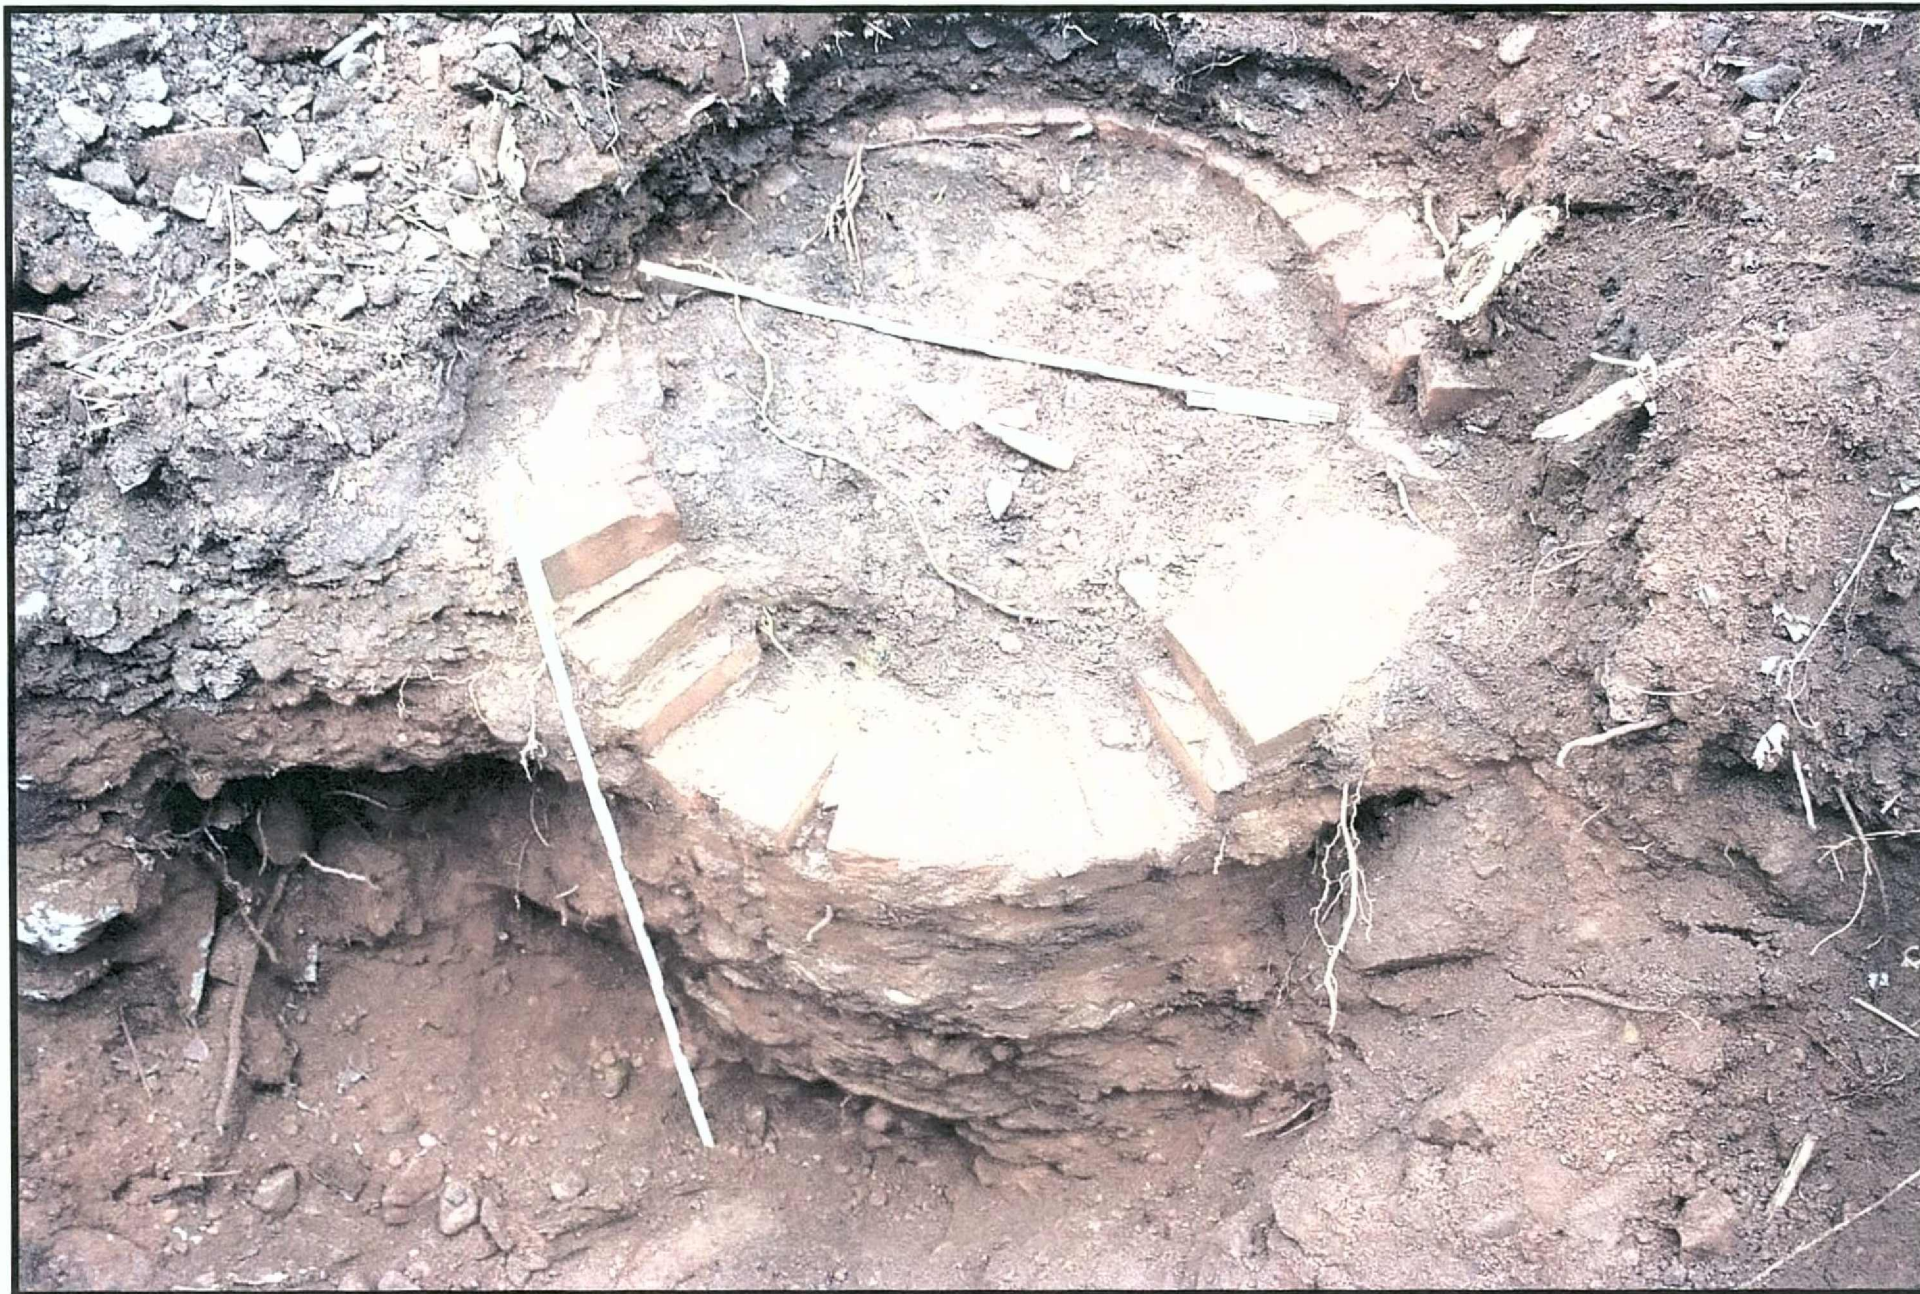
Photograph 17

Feature 1 Exposed Adjacent to East Wall of BHTR7

**Note Metal Pipe on Surface of Feature Top/Center and Ceramic Pipe Adjacent to Feature in Wall of Trench at Left/Center
View Northeast**

Feature 1 is approximately circular with an inner diameter of some three feet (see Photographs 17). It is constructed of brick set in mortar. The top of this feature was covered by approximately 5 - 10 inches of soil, which was removed by the backhoe to permit recording. Some of the bricks at the top of the western side of the feature were dislodged by the backhoe during its exposure.

The base of the feature as exposed in the wall of BHTR 7 is approximately 4 feet below the uppermost brick of the feature walls. Fourteen layers of brick form the 46 inch deep body of the cylinder with an underlying concrete floor being about one half to two thirds inch thick. Bricks forming Feature 1 and its circular opening are approximately eight by four by two and a half inches in size. A metal pipe was noted on the surface of the feature, but it is uncertain if this pipe is *in situ*. A ceramic pipe was also noted in the wall of BHTR 7 just north of Feature 1 (see Photograph 17). It is also uncertain if this pipe enters the feature.

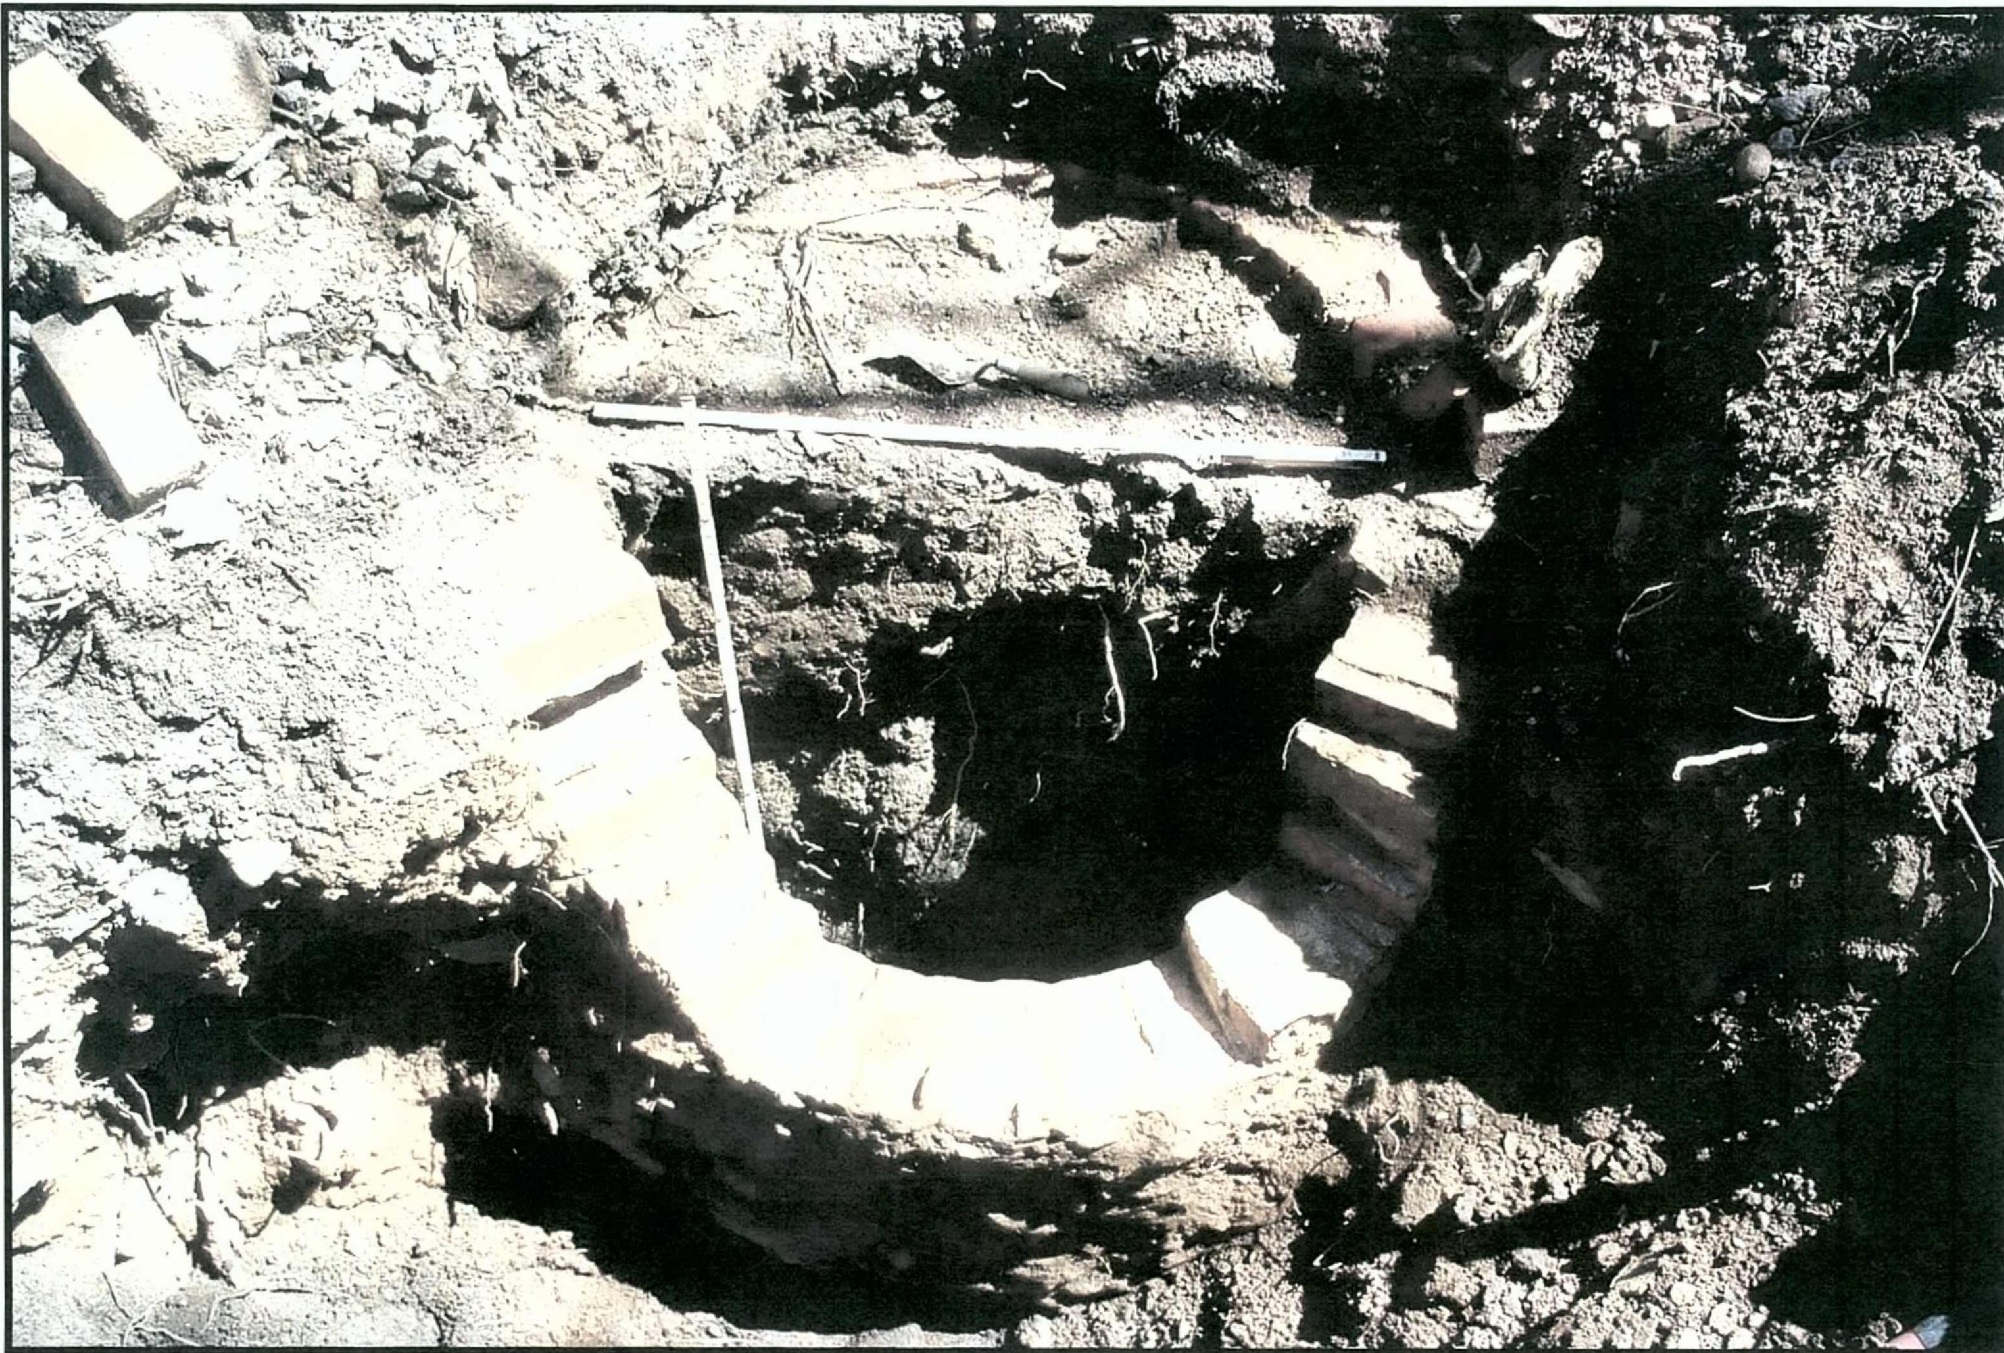
Photograph 18
Feature 1 After Excavation of Unit A
View Southeast

To determine whether Feature 1 contained any possibly significant artifact deposits a small excavation unit (Unit A) was placed in the westernmost portion of the Feature (see Photograph 18). The Unit encompassed the westernmost 16 inches of the feature deposits, with the excavated material representing approximately 40% of the deposits within the feature. The stratigraphy encountered by the unit and the artifacts recovered are listed in Appendix A. The profile of the deposits within the feature is shown in Figure 10 and Photographs 19 and 20.

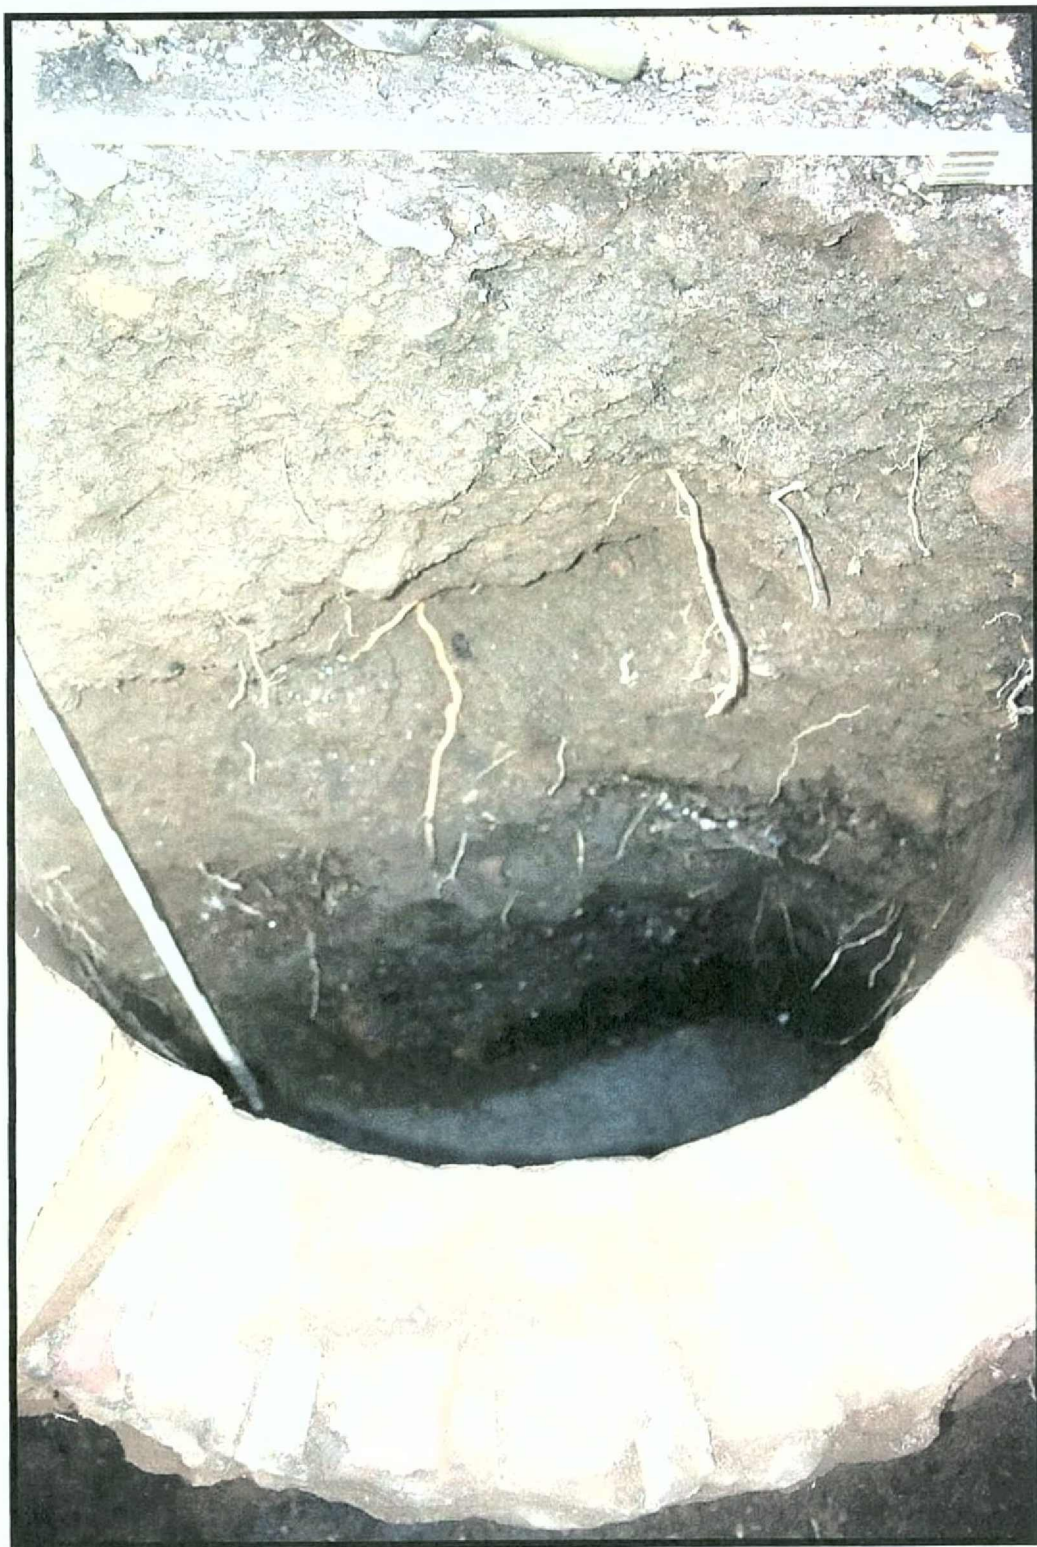
Photograph 19
Unit A Profile
View East

At the bottom of Stratum IV, at 46 inches beneath the Feature datum the concrete floor (Stratum V) of Feature 1 was exposed (see Photograph 19). The floor was not removed as part of the archaeological investigation.

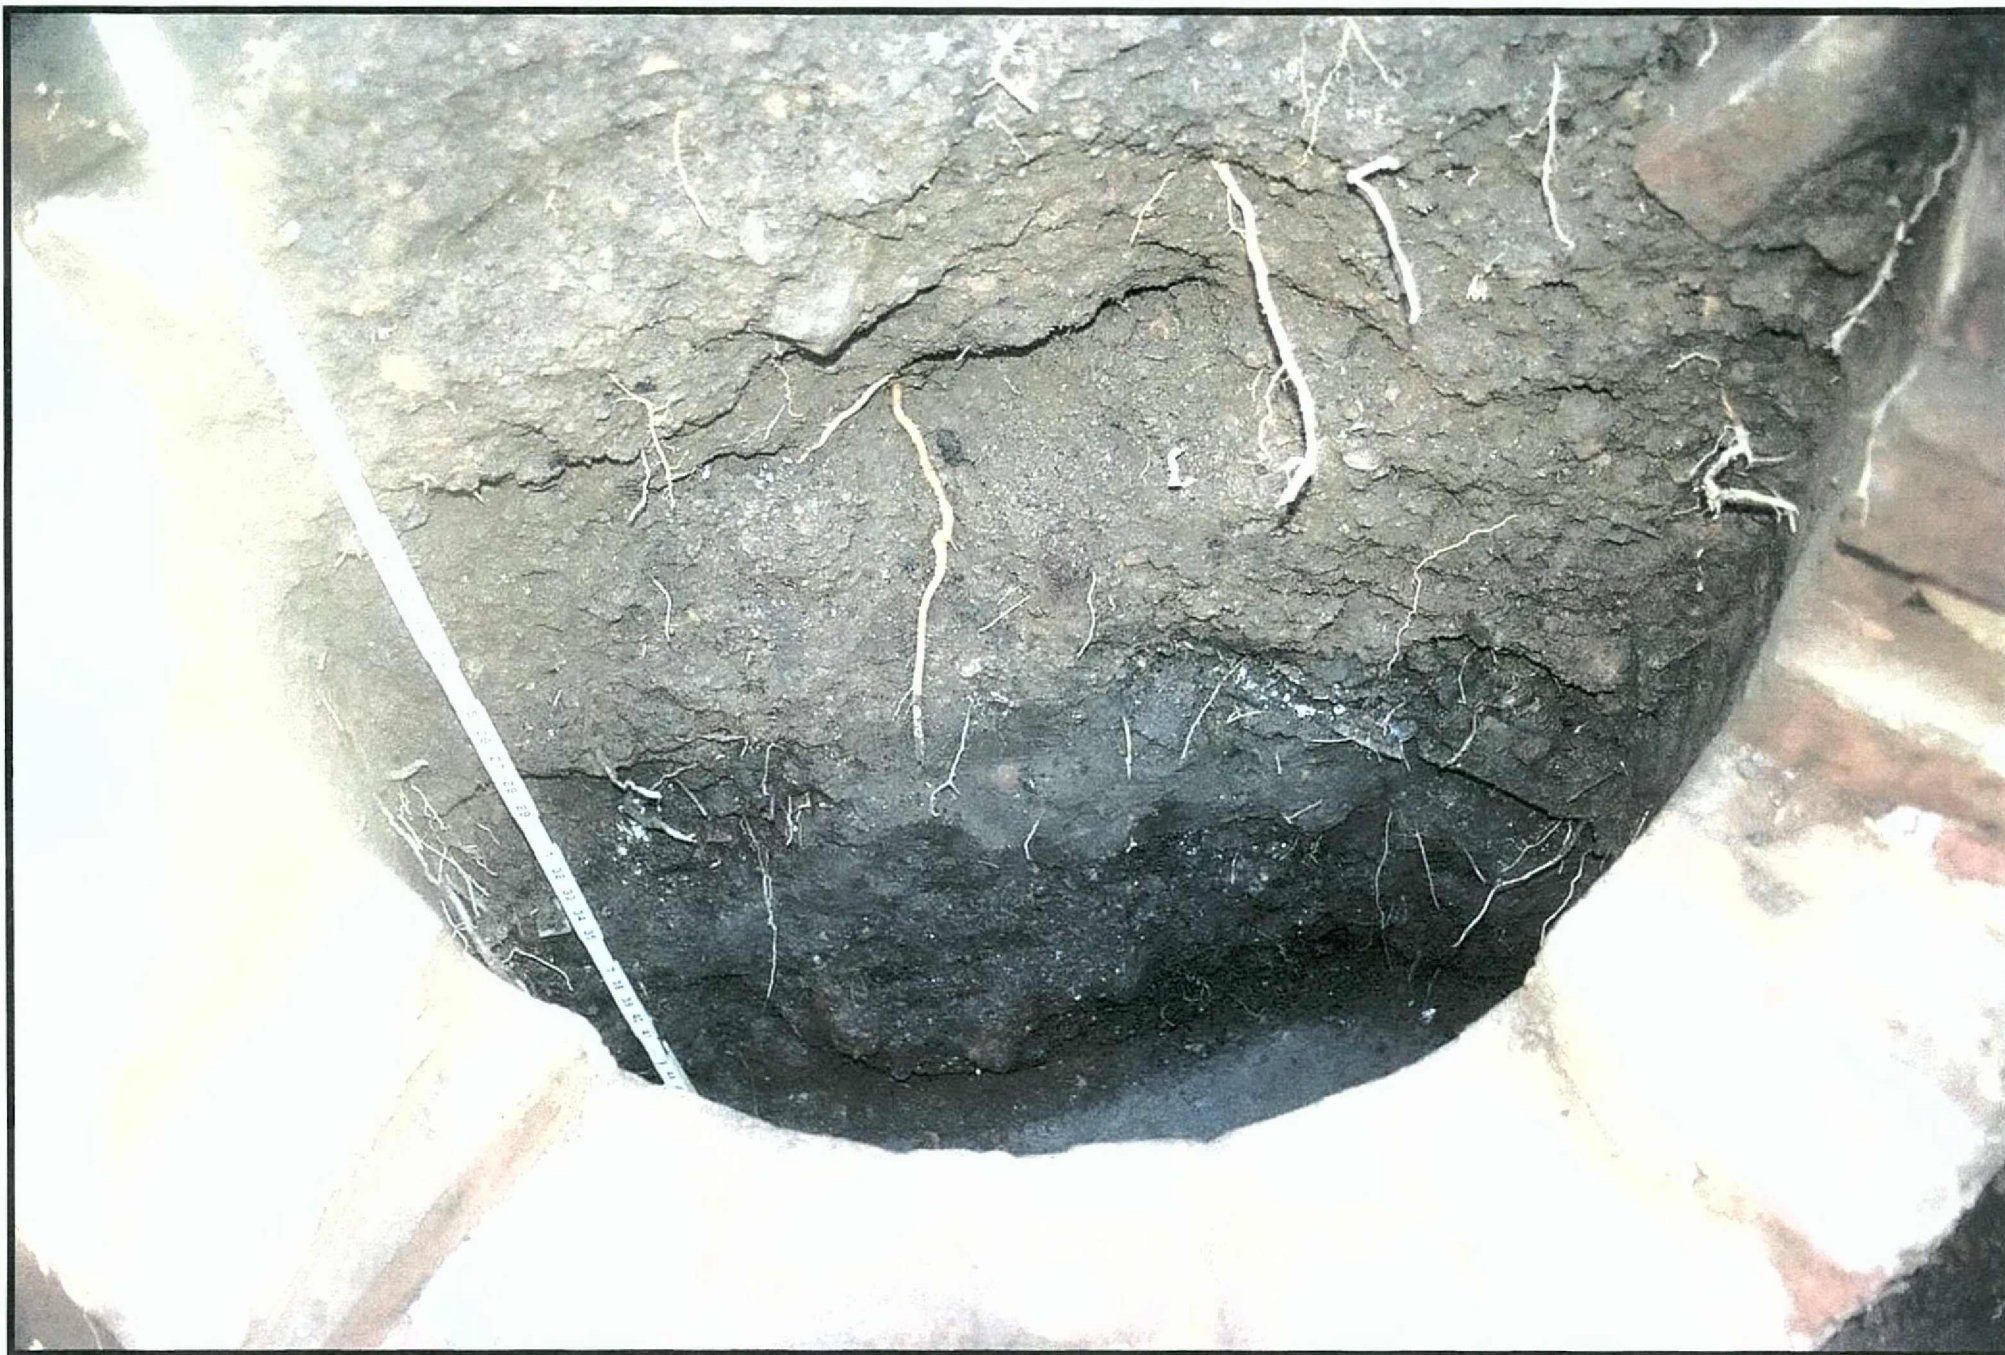
Photograph 20
Unit A Profile - Detail of Lower Portion
View East

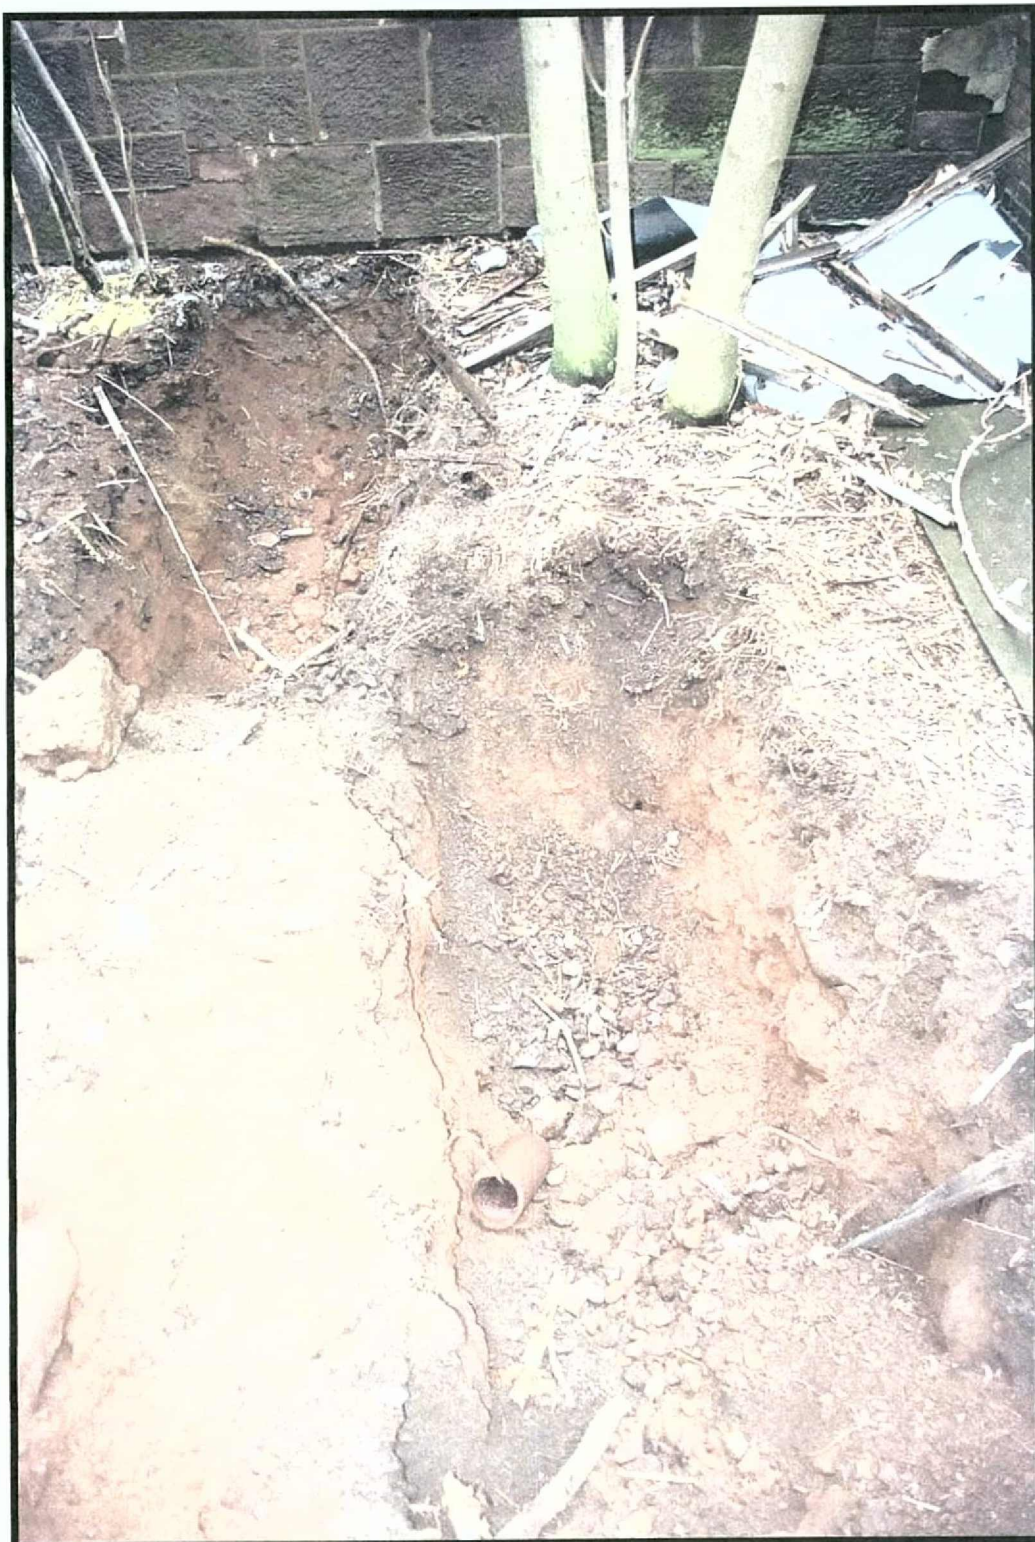
Photograph 21
Backhoe Trench 7a
View East

BHTR 7a (see Photograph 21) was extended east of the northern end of BHTR 7 to examine the deposit of rocks encountered by preliminary shovel test 14. These rocks turned out to represent fill deposited in a trench excavated to install a metal pipe that crossed the route of the backhoe trench. BHTR 7a was extended to intersect the western wall of Building 8 approximately 3½ feet south of its northwestern corner. No features were encountered here. We attempted to excavate a second trench north of the northwestern corner of the building to further examine this area. However, the backhoe was unable to break through the concrete surface in this area.

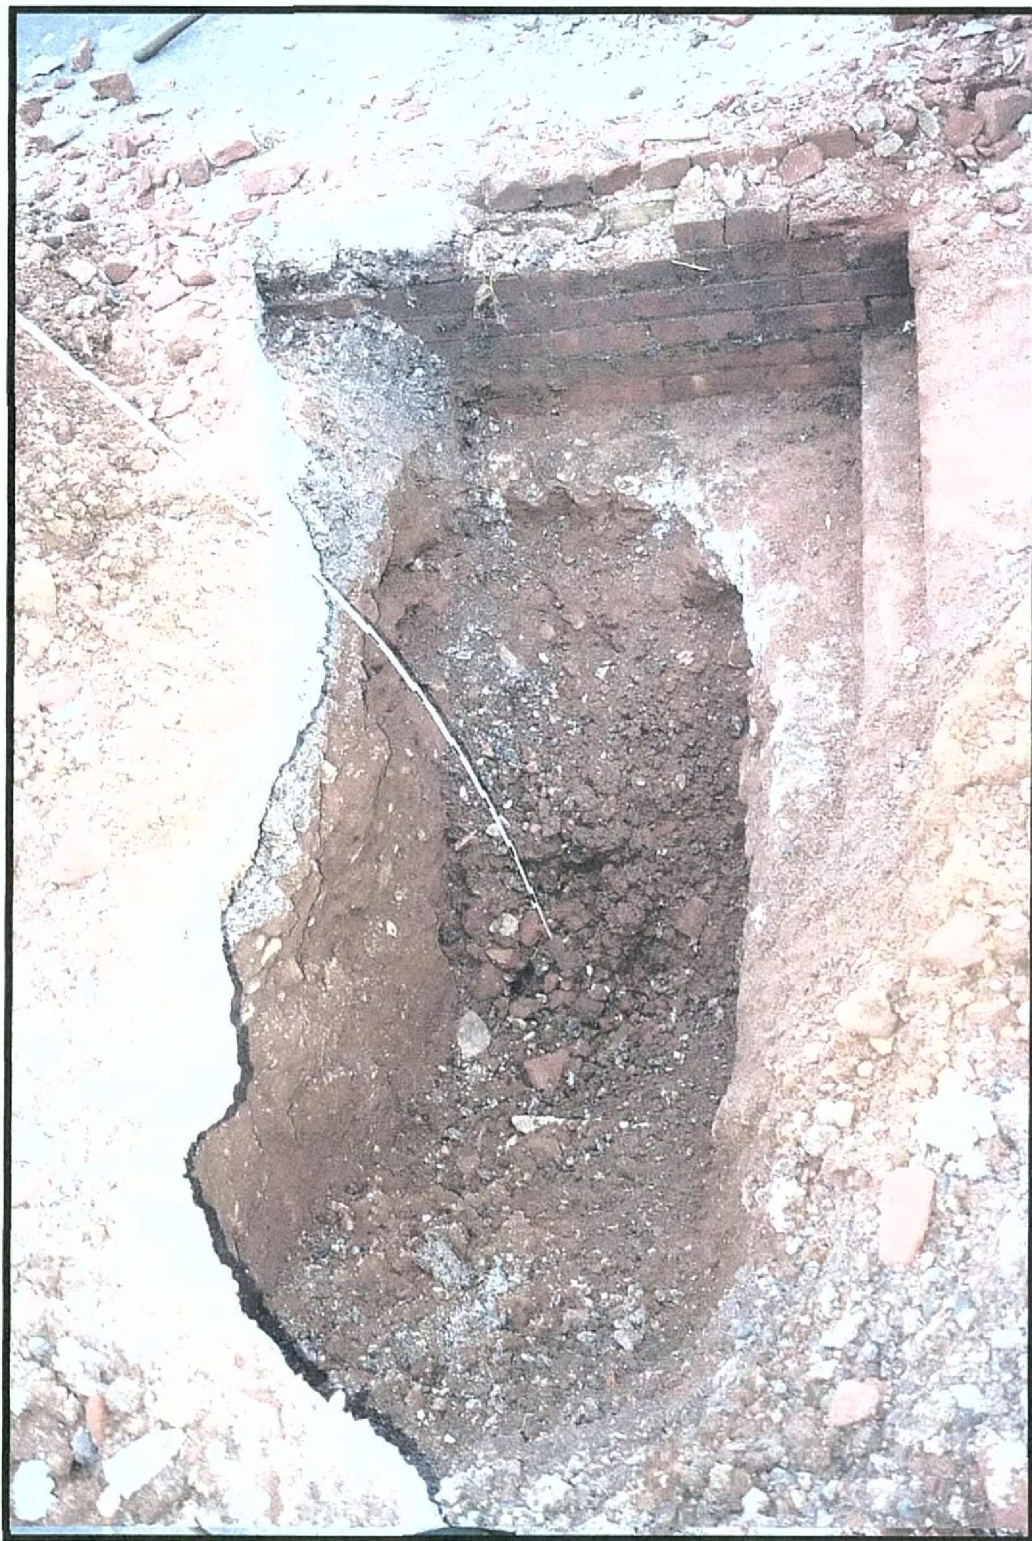
Photograph 25
Backhoe Trench 11 - Northwest Corner Building 6
View East

Backhoe Trench 11 was excavated at the northwestern corner of Building 6. The site survey indicates an L-shaped feature at this location which represents rows of bricks visible on the surface between the adjacent concrete slabs. By removing some of these bricks the backhoe was able to lift and break off a portion of one of these slabs. The results of the backhoe trenching indicated that the bricks visible on the surface represent the remaining portion of two intersecting brick walls, constructed on a concrete footing (see Photographs 25 and 26), with the top of the approximately 3½ inch thick footing at a depth of 19½ inches below the adjacent concrete slab surface. The brick walls were exposed in the east and south walls of the backhoe trench. The location of these walls corresponds with a one-story store house shown on maps beginning in 1887 (see Pickman and Harris 2007). The reddish brown subsoil was encountered beneath the concrete footings. In the north wall of the backhoe trench the subsoil was present immediately beneath the concrete slab pavement and its cinder bedding (see Photograph 25). There were no indications of any shaft features in the area exposed by the backhoe trench.

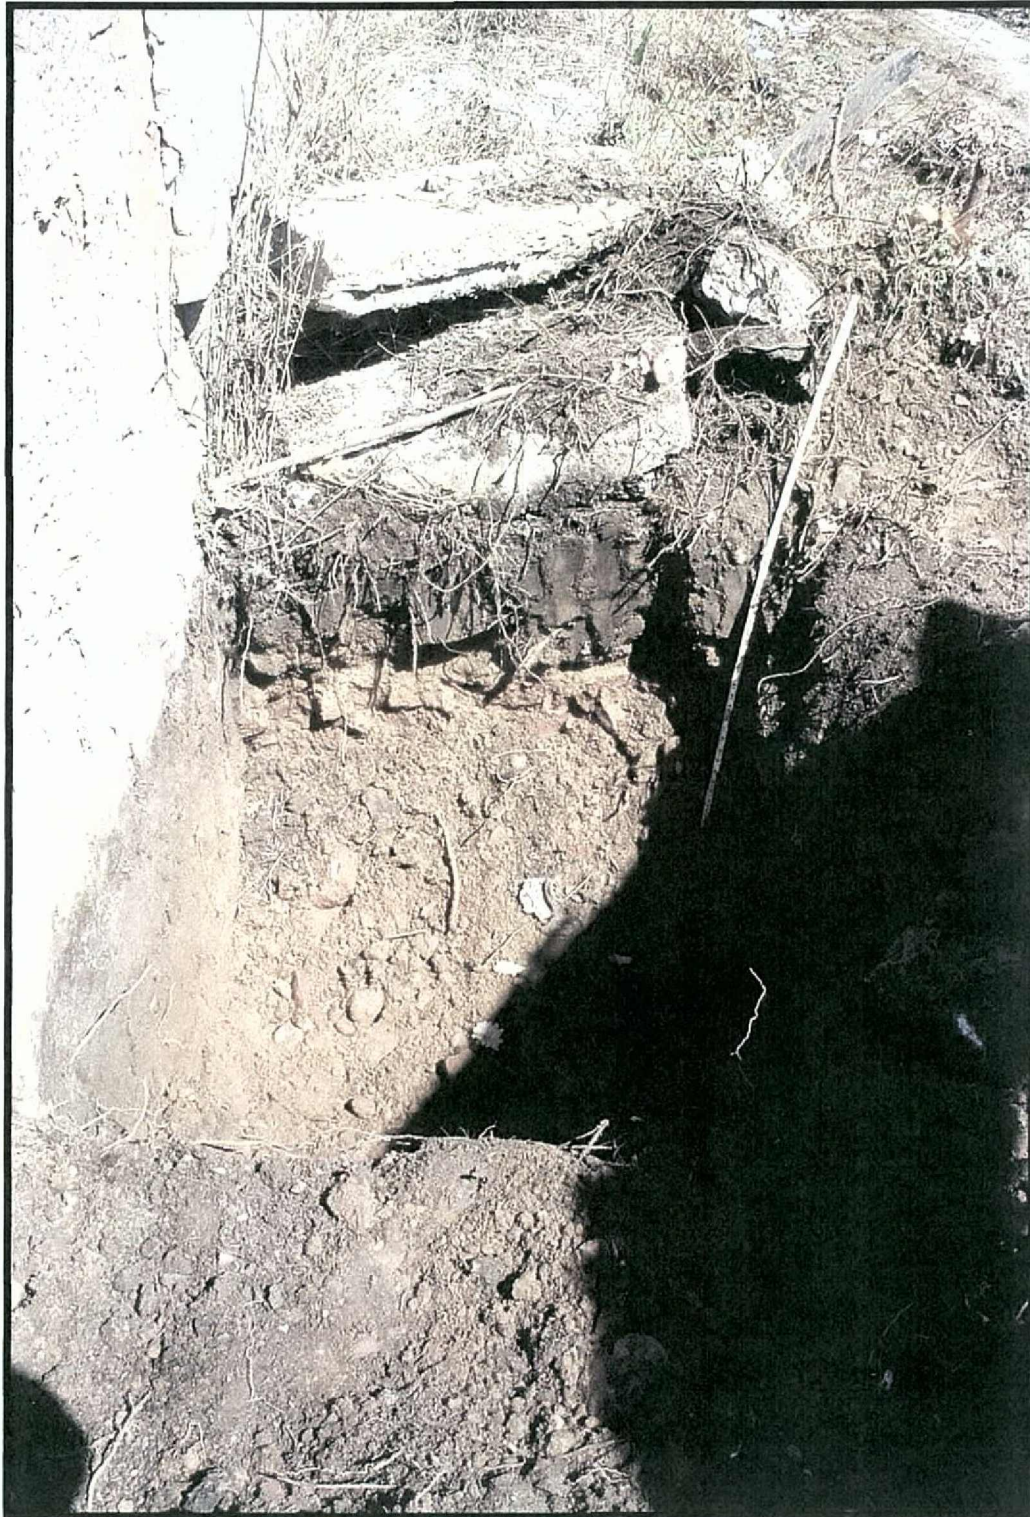
Photograph 27
Backhoe Trench 12 - Southeast Corner Building 6
View North

Backhoe trench 12 was located at the southeastern corner of Building 6 (Photograph 27). The results of this trench were similar to those noted for the backhoe trenches excavated at the corners of Building 8. The subsoil was encountered beneath the concrete slab and the cinder bedding. No shaft features were noted.

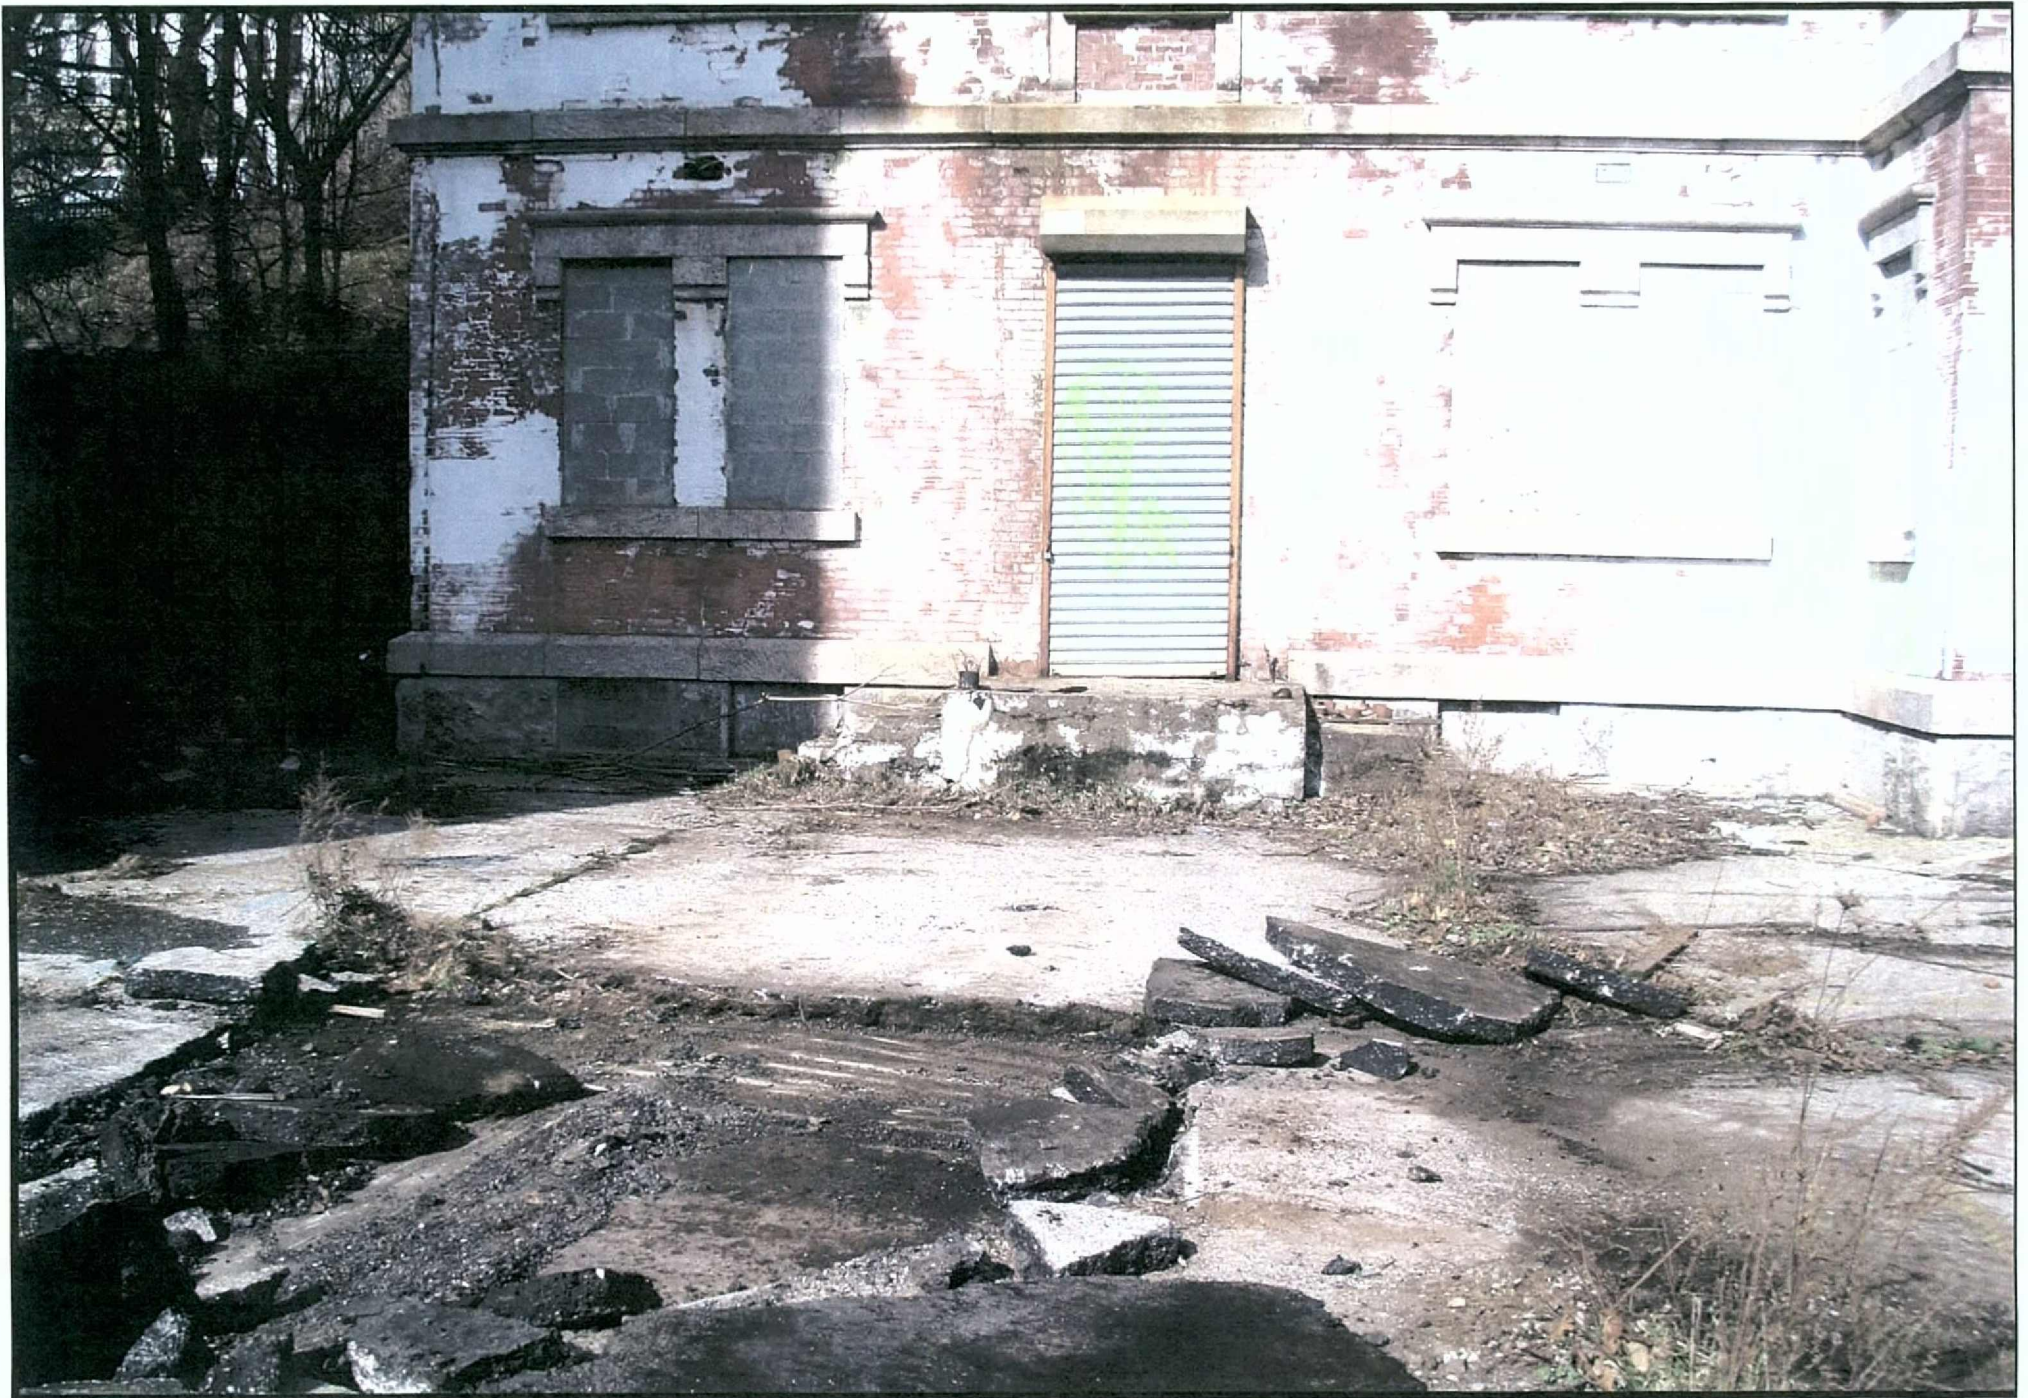
Photograph 28

**Courtyard Between Buildings 7 and 8 Showing Portion of Large Concrete Slab Exposed After Removal of Bituminous Pavement
View West**

As discussed in the Phase Ia report (Pickman and Harris 2007) and the field testing scope-of-work (Pickman 2007) a 2000 site survey (Elken 2000) indicates the presence of a large (approximately 20 x 25 feet) "cistern" in the courtyard area between buildings 6 and 7. The feature is not shown, however, on the more recent site survey (see Figure 9). Although it was considered likely that this feature would date to the period of the expansion of building 7 at the beginning of the twentieth century, the testing plan included the excavation of a backhoe trench to examine this feature. Attempts to excavate this trench were unsuccessful, however. Removal of the existing asphalt surface in this area exposed an underlying concrete surface (see Photograph 28). Unlike the smaller
