Sea Breeze Estates, City Island, Bronx County, New York

IB Memo Report

PHASE 1B MEMO REPORT

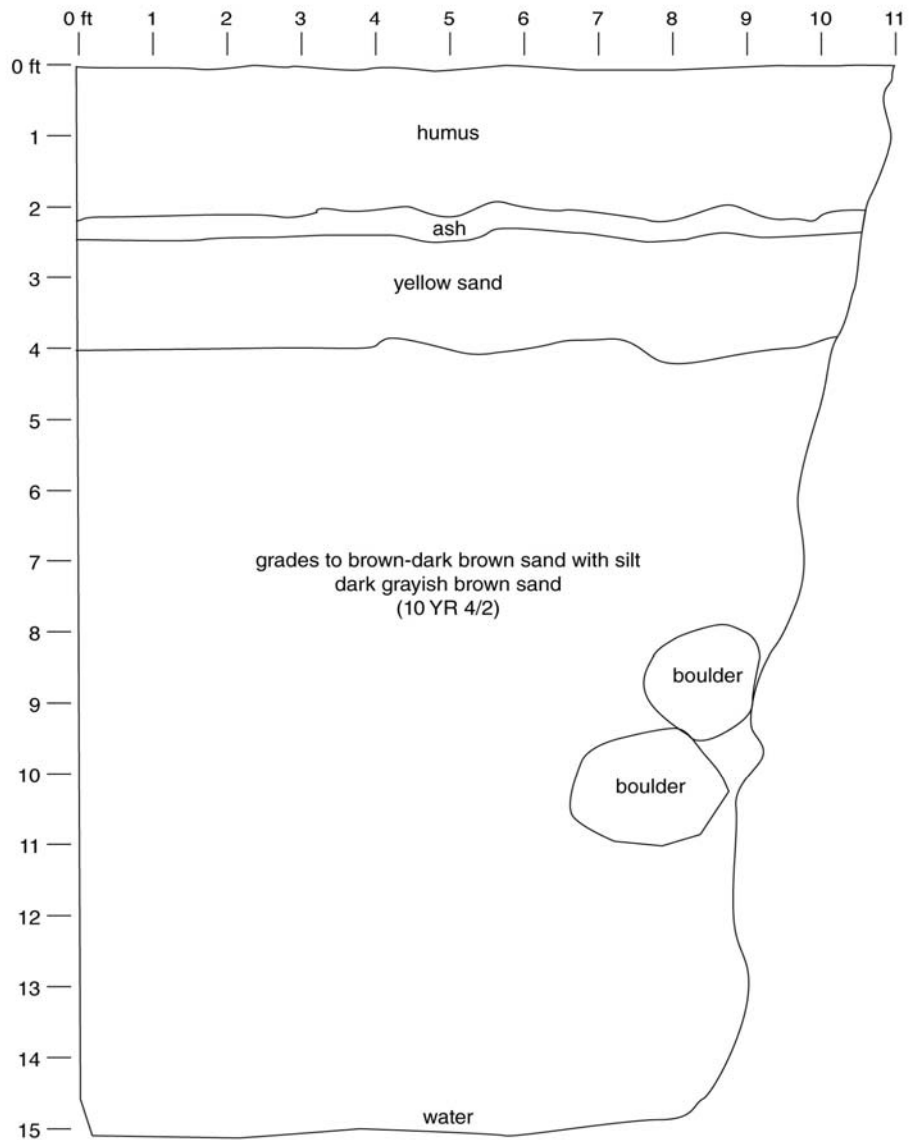
Figure 5. Test Trench 1 (TT1) South Wall Profile (Deepest Part), Schematic

Testing documented that conditions in the three trenches were variable: TT1, on the south side of what had been Marine Street and the most westerly of the test trenches, was found to contain about 15.0 feet of a relatively clean fill (see Figure 5 and Photo 5); in TT2, on the north side of the former street and east of TT1 (closer to the shore), an east-west running iron rail was exposed

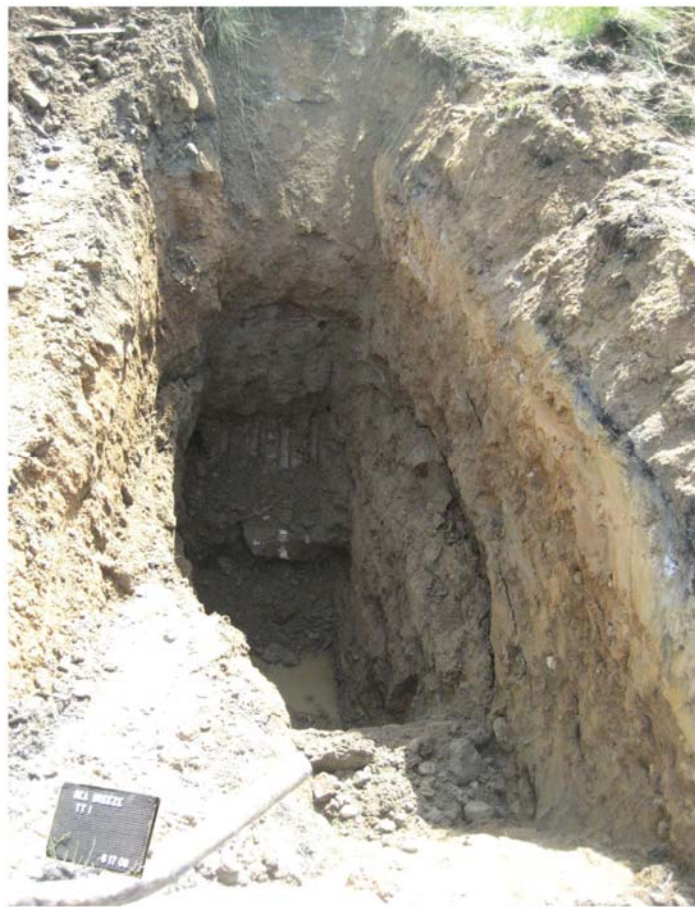
Photo 5. Test Trench 1 (TT1) with water reached at 15.0 feet BGS; view is east. (Geismar 6/17/09)

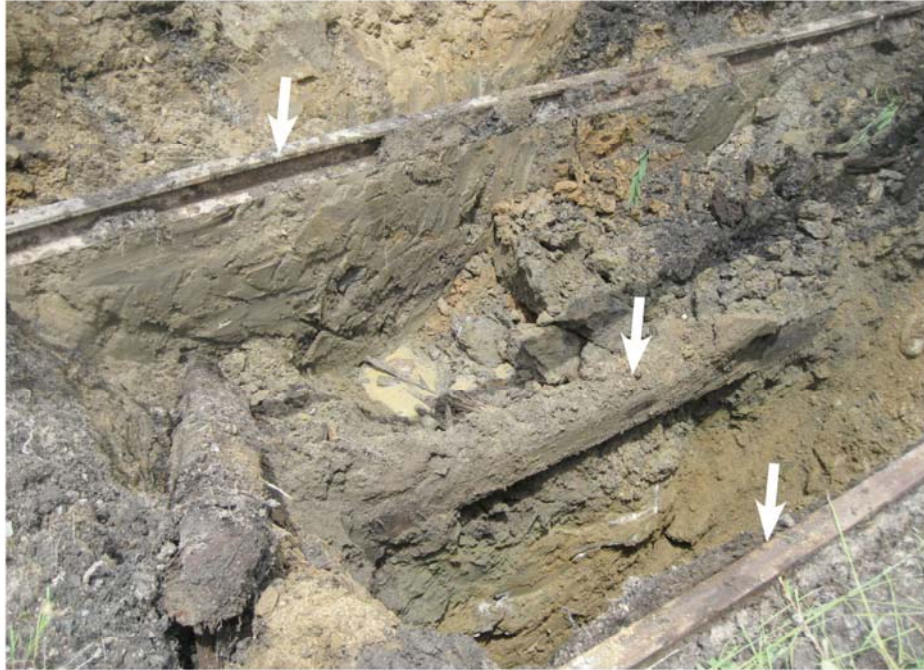
Photo 6. North wall of Test Trench 2 (TT2). Note the iron rails (upper left and right arrows) exposed just below the surface, with a single, squared-off, wooden beam (center arrow) about 5 feet beneath the rail. (Geismar 6/17/09)

almost directly under the ground surface. About 5 feet below this rail, excavation revealed a large, squared-off, metal-edged beam that also ran east-west. A second, parallel rail, also just below the surface but with no underlying beam, was then found 6 feet south of the first (see Photos 6-9). Since the distance between the rails was too wide for a standard railroad car, these features were apparently remnants of the site's ship-building past. Here, as in TT1, what appeared to be fill extended to the water table (Figure 6). In TT3 on the south side of demapped Marine Street, which was the test trench closest to the shore, boulders and the better part of a trashed automobile (axles, chassis, four narrow wheels, etc.) were components of a debris-laden fill. Running on the north side of the trench within the fill was a line of concrete pillars with wire cable protruding from the top of each pillar (Photos 10-11). The linear configuration of the pillars suggested they were remnants of a feature that was most likely related to ship construction.

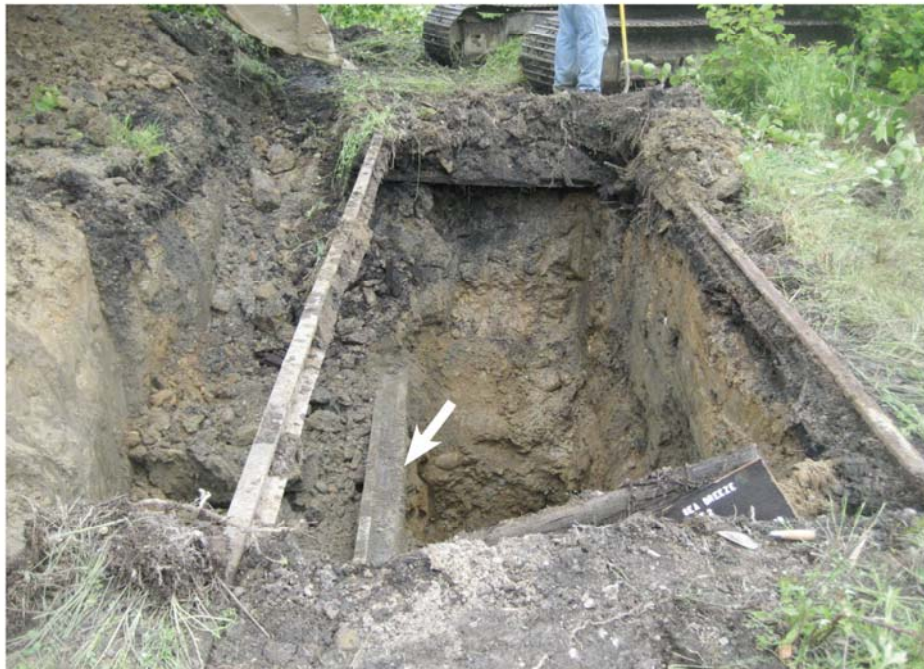
Photo 7. Test Trench 2 (TT2) with a pair of rails exposed, 6 feet apart. Note the wooden beam (arrow) 5 feet below the north rail. (Geismar 6/17/09)

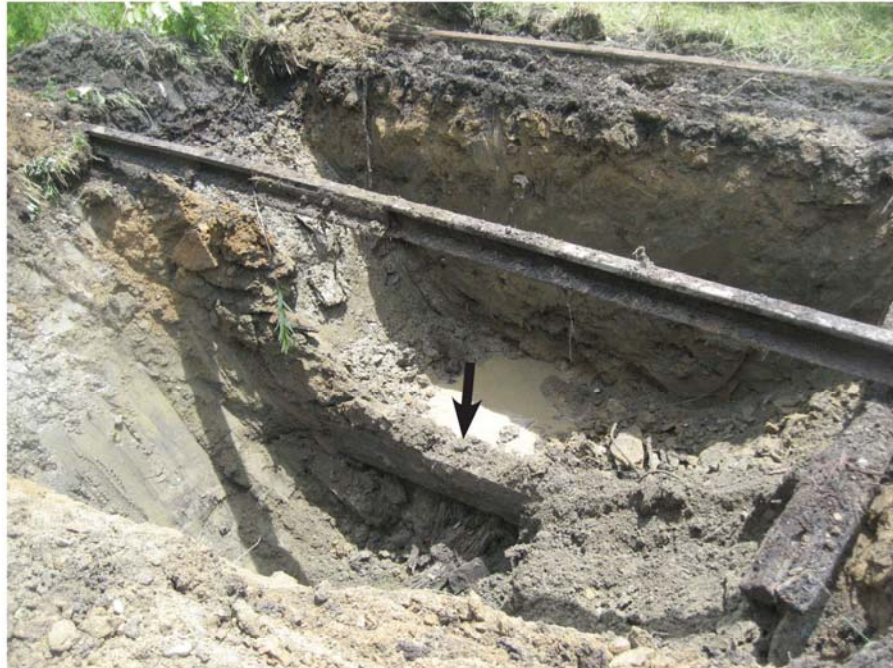
Photo 8. Relationship of iron rails and single wooden beam (arrow) in TT2. (Geismar 6/17/09)

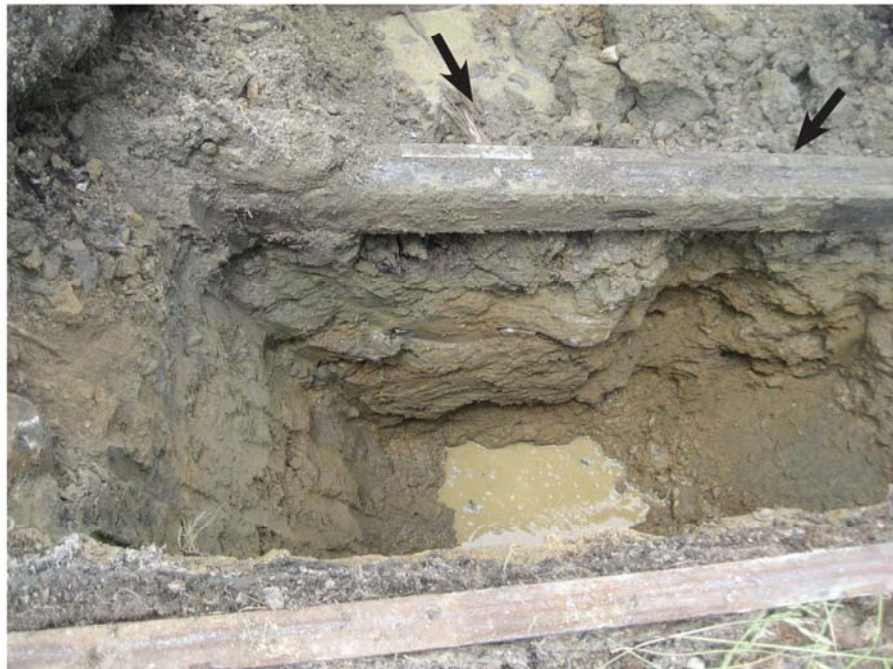
Photo 9. Test Trench 2 (TT2) with water at 12.6 feet BGS. Note metal facing (arrows) on upper edges of the wooden beam. (Geismar 6/17/09)

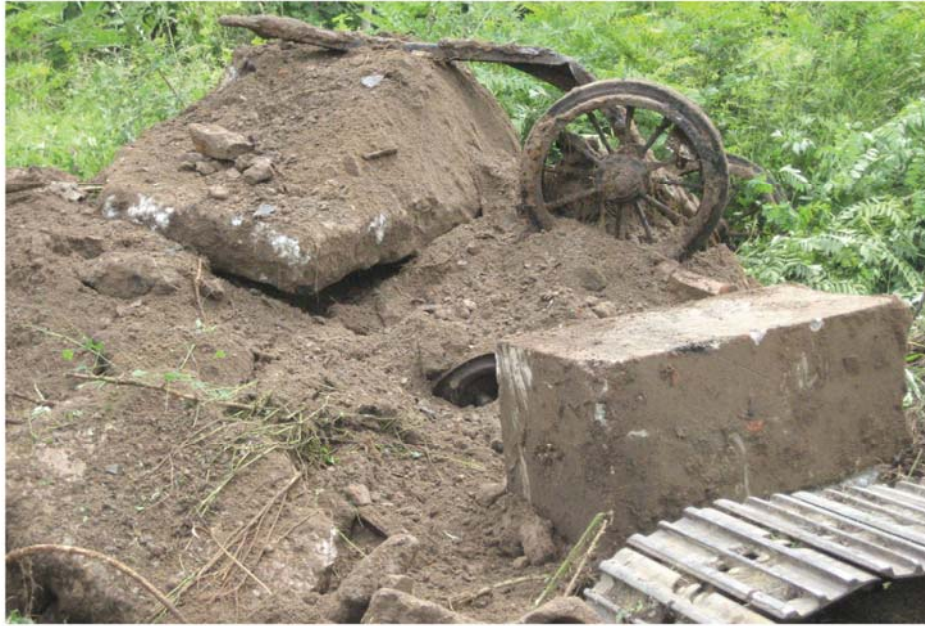
Photo 10. Fill material from Test Trench 3 (TT3), the trench nearest the shore on the south side of what was formerly Marine Street, included a car chassis and wheels. A concrete pier (right foreground) with a protruding wire cable proved to be one of many aligned in a row in this trench. (Geismar 6/17/09)

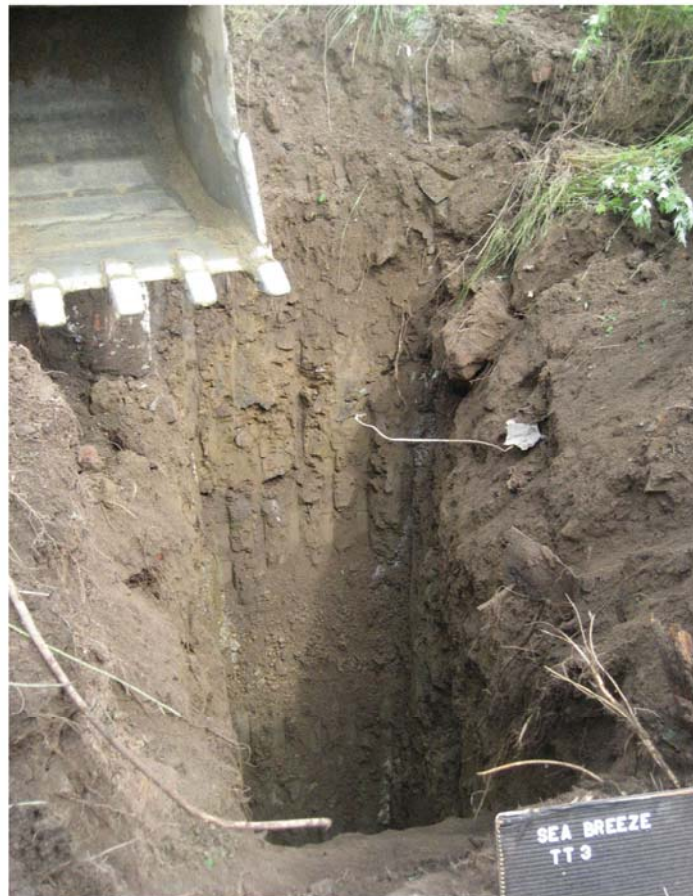
Photo 11. Test Trench 3 (TT3) looking west where water was reached at 14.5 feet BGS. (Geismar 6/17/09)
