# Phase IB Archaeological Field Test of 246 Front Street (aka 267 ½ Water Street) (Block 107, Lot 34), Manhattan (New York County), NY

Chrysalis Archaeological Consultants, Inc.

August 2012

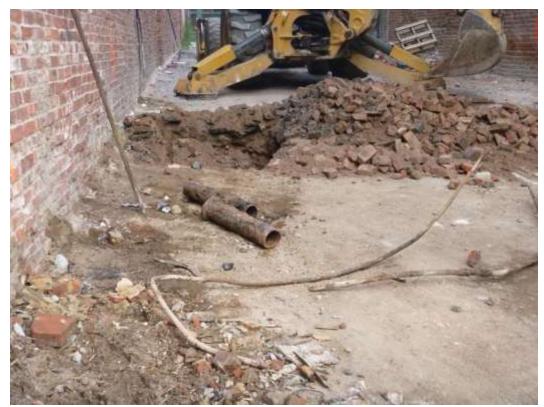
Image 04: Test Pit 1, discarded conduits from rubble fill.

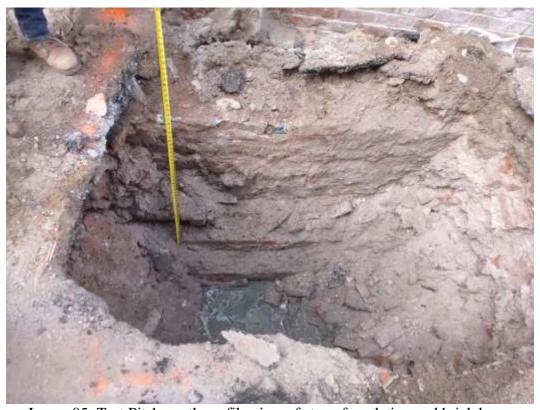
Image 05: Test Pit 1, south profile view of stone foundation and brick base.

At approximately .5' bgs, along the southern edge of the Test Pit, a mixture of concrete and sand appeared. Further excavation revealed that it was the surface of a stone foundation wall, likely belonging to 244 Front Street. The stone wall measured .7'-4' bgs and was constructed of relatively flat, long stones. The stone wall, which protruded 1.55' from 244 Front Street, sat on top of a brick base made up of two visible tiers. The uppermost tier extended 2' from 244 Front Street and extended to 5' bgs. The following tier extended .4' from the first tier and continued from 5' bgs to an indeterminate depth. Based on the way the wall protrudes from the building, it appears that the former structure at 246 Front Street shared this foundation with 244 Front Street. Excavation of Test Pit 1 continued through the demolition fill and exposed the rest of the brick foundation down to 6' bgs. At 5.6' bgs water began to seep into the Test Pit. The onsite engineer determined this to be the top of the existing water table and no further excavation was undertaken (Figure 01).

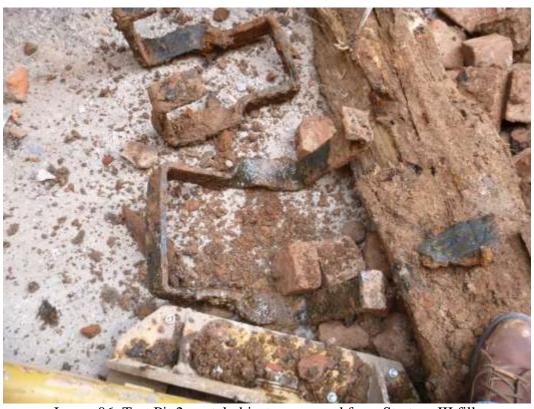
Image 06: Test Pit 2, metal objects recovered from Stratum III fill.

Test Pit 2 measured 5' x 6' and was located 32' from the southeast corner of 248 Front Street. It was excavated approximately .7' from the southern face of 248 Front Street (Map 04). The stratigraphy of this Test Pit was similar to that of Test Pit 1. About .25' of asphalt (Stratum I) and 1' of sand (Stratum II) was stripped to reveal the demolition fill of Stratum III. Among the brick and mortar fragments mixed with 5 YR 4/4 sand were discarded utilities, wood fragments, and large metal objects. Most of the metal fragments were large, thin and resembled rectangular frames. A few others fragments were hooked (Image 06). These metal objects are likely the remains of the foundry or other industry that once occupied this lot.

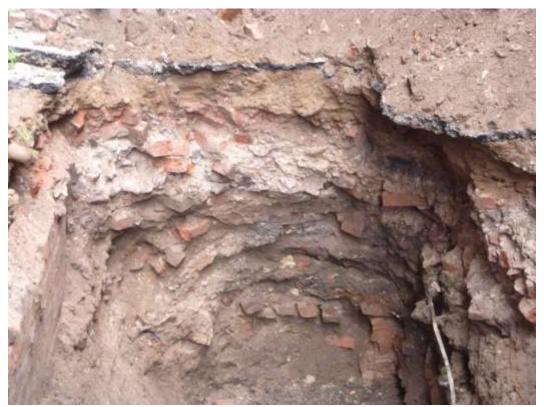
Image 08: Test Pit 3, west wall soil profile.

Test Pit 3 was located on the property lot of 267 ½ Water Street (Map 04). The Test Pit was larger than the previous two Test Pits, measuring 11.6' x 5.5'. It was excavated approximately 1' north of 265 Front Street and 54.2' east of the northwest corner of 265 Water Street. Excavation of Strata I and II proceeded as it did with the first two Test Pits, revealing demolition fill beneath Stratum II. The demolition fill in this Test Pit was different from the previous Test Pits, however, as it only represented approximately 1.6' of rubble that was not mixed with sand. The layers of crushed brick and mortar were relatively distinct from the next stratum encountered (Stratum IV) (Image 08).

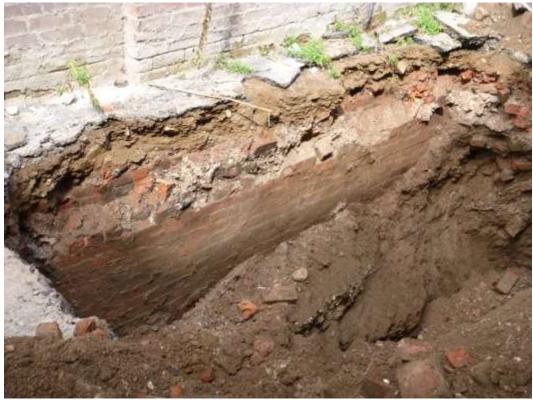
Image 09: Test Pit 3, south wall profile showing foundation wall of 265 Water Street.

Excavation of Stratum IV revealed a brick wall along the southern edge of the Test Pit. The brick wall extended approximately 1.8' from the face of 265 Water Street, indicating that it is likely part of the foundation or basement wall of that structure (Image 09). The wall was comprised of two visible tiers of brick. The first tier began at .8' bgs and consisted of only two courses of brick. The second tier began at approximately 1.6' bgs and extended to at least 4.8' bgs. Base depth of this brick wall was indeterminate as machine excavation along the structure was minimized to prevent disturbance to 265 Water Street's foundation. Final depth of excavation was 8' bgs (Figures 03 and 04).

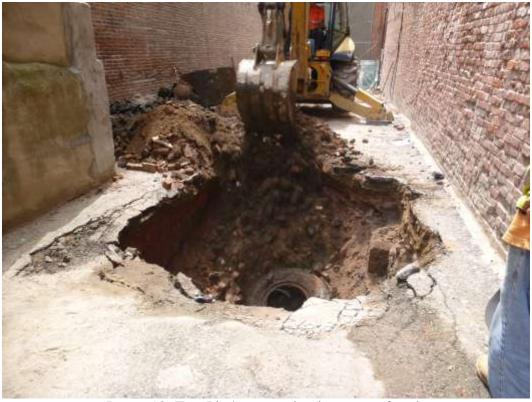
Image 10: Test Pit 4, excavation in center of project area.

Test Pit 4 measured approximately 11' x 8.6' (Map 04). Located 76.3' from the southeast corner of 269 Water Street, this Test Pit straddled both the 267 ½ Water Street and 246 Front Street lots. The Test Pit was excavated to investigate the potential backyard area between the properties. This Test Pit was larger than the other Test Pits, leaving only a 1.4' to 1.6' buffer between it and the properties on its north and south sides (Image 10).

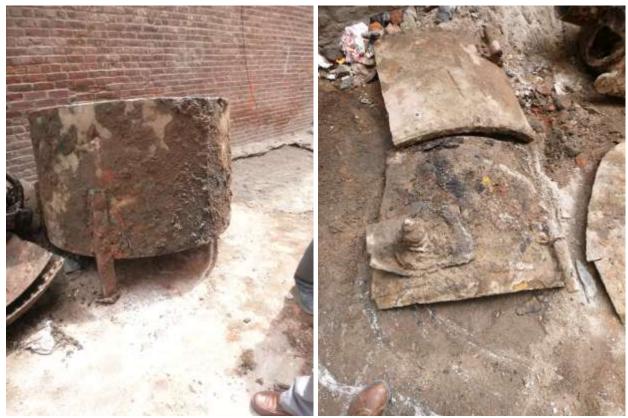
Image 11: Test Pit 4, large metal vessel (left); iron panels with hinges and possible handle (right)

As with the previous Test Pits, Strata I and II were excavated to reveal demolition fill composed of crushed brick and brick and mortar fragments mixed with sand (10 YR 4/3). Stratum III extended from 1' to 7.5' bgs and contained the most distinct evidence of the area's previous industrial use. Within this fill deposit was large equipment, including a four-legged iron vessel measuring approximately 3' high and 4.8' wide. Other objects recovered were a large rubber machine tire, a turbine-like apparatus and double-walled iron panels (Image 11). The objects were mostly intact and contained details that gave clues to their function. The large iron vessel could have been a crucible or cauldron for containing liquids. A small opening at the coned base could have served as drainage for whatever was contained in the vessel. The legs, which raised the vessel off of the ground, would also facilitate drainage and provide an open area to heat the vessel and its contents. The large metal panels could have been the doors and walls of an industrial furnace. The sides of a couple of these panels had the remains of hinges and one panel had a protrusion that could have been a handle (Image 12). These objects were possibly used during the ironworks period of occupation.

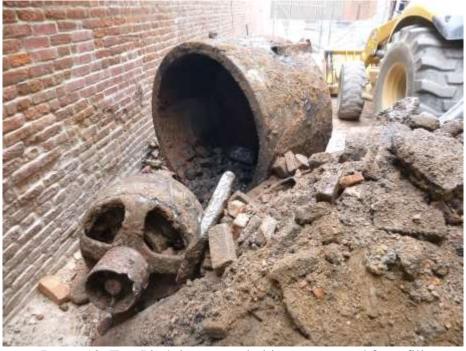
Image 12: Test Pit 4, large metal objects recovered from fill

Excavation of Test Pit 4 revealed remains associated with the former industry that once occupied this property. The large iron vat and other items including a large rubber tire were not *in situ*. No intact industry or floor surfaces were exposed. Other than the few floor boards exposed on the eastern side of the property, no evidence of interior floor surfaces were evident. This suggests that the structures did not have "finished" basements but likely had unfinished levels or crawl spaces.

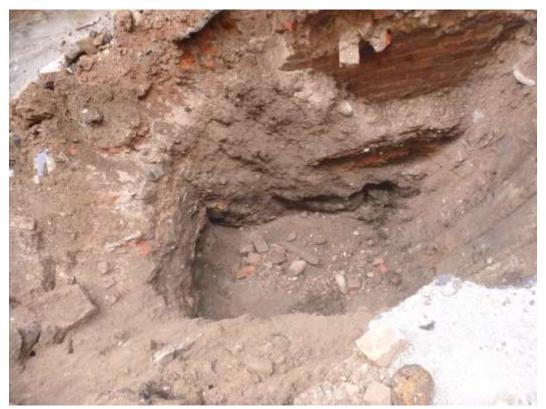
Image 14: Test Pit 5, north profile

Beneath Stratum II was a layer of demolition fill composed of brick and mortar fragments in a 10 YR 5/4 sandy matrix (Stratum III). Although the brick and concrete layers were not as distinct as those found in Test Pit 3, the stratum as a whole was distinct from Stratum IV beneath it. Stratum III terminated at approximately 1.4' bgs, atop Stratum IV and a brick wall seen in the north profile of the Test Pit (Image 14).

Extending approximately 1.2' from the south face of 269 Water Street, the brick wall likely served as the foundation to 269 Water Street and the building that once occupied this lot. What remained of this brick foundation seemed very shallow compared to the previous Test Pits. The structure was constructed of evenly laid brick from 1.4' bgs to 3.6' bgs. At the base of this brick was a very compact sand and concrete mixture that sandwiched a thin lens of crushed brick (Image 15). It is possible that this compact layer was the floor of a previous structure. Stratum V, discussed below, appeared at the base of this possible floor. Based on this profile it seems that excavation could have exposed the shallow basement of a building constructed atop the historic fill that was used to build up Peck Slip.

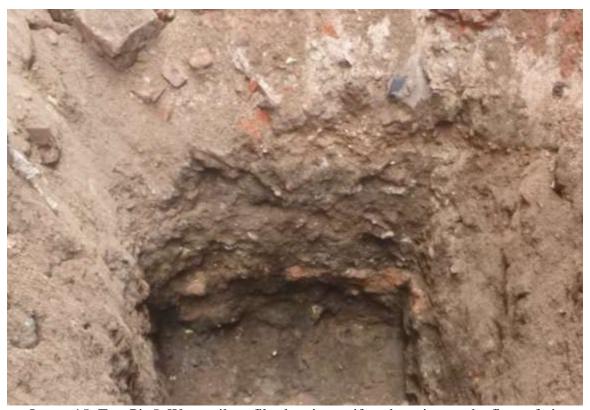
Image 15: Test Pit 5, West soil profile showing artifact deposit near the floor of pit

The fifth and final stratum was the darkest and resembled the artifact bearing soil in Test Pit 3. The stratum was stratified with 10 YR 3/3 and 10 YR 2/1 sandy loam soils. Located beneath the lens of crushed brick, this stratum produced historic artifacts including a pipe stem, grey salt glazed stoneware, a refined earthenware sherd, and a glass fragment. In the soil profile, the artifacts were mostly visible at approximately 5.5' below ground surface (Image 14). Despite the artifact deposit, this stratum could not be investigated any further due to safety concerns. From the lack of artifact density that was visible in the western profile, however, the deposit did not seem to represent a significant find. The Test Pit was terminated at 6.5' bgs (Figure 06).
