REPORT ON  
ARCHAEOLOGICAL WORK RELATED TO  
SEVERAL PROJECTS AT SOISSONS LANDING  
ON GOVERNORS ISLAND  
NEW YORK, NEW YORK  
Soissons Combined Project  
Demolition of Building #s 146, 147 and 148  
and  
Soissons Dock and Utilities Work

September 26, 2012

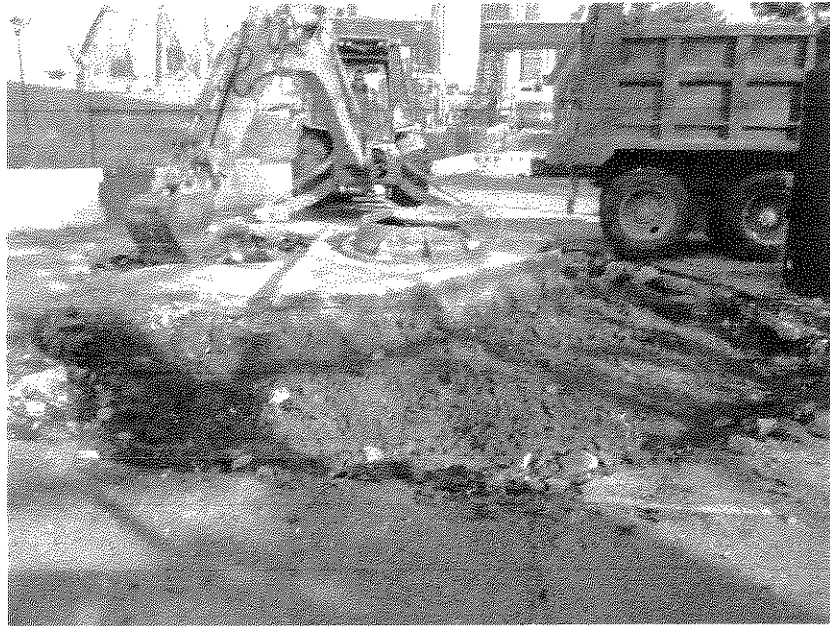
Cannon manhole exposed above ground surface, facing north (February 8, 2012).

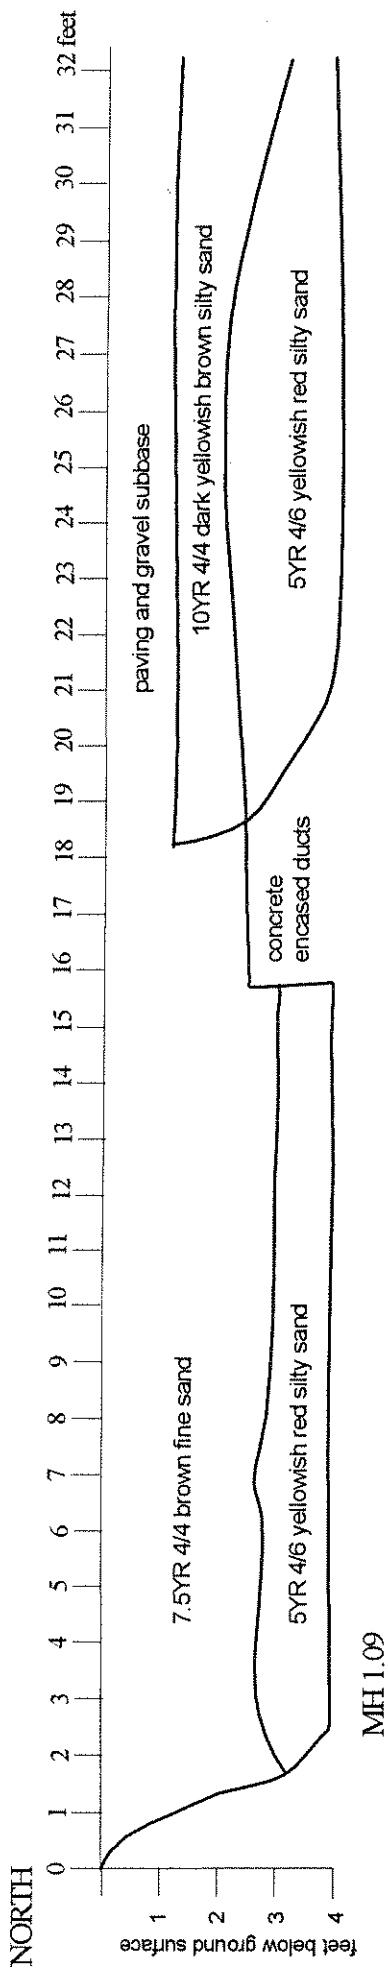
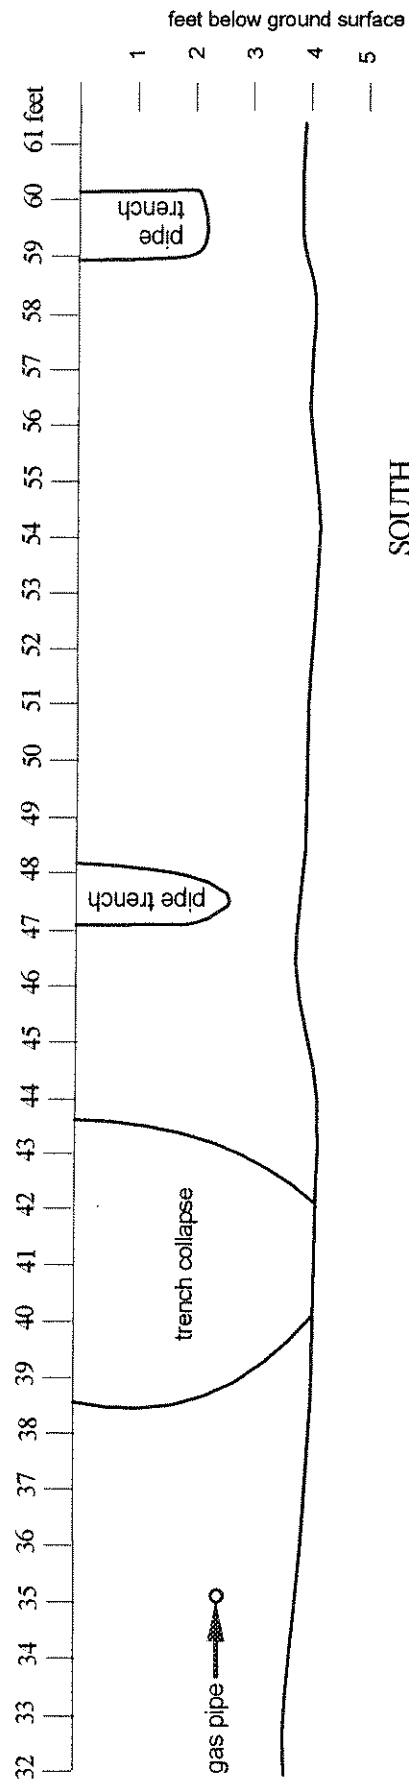
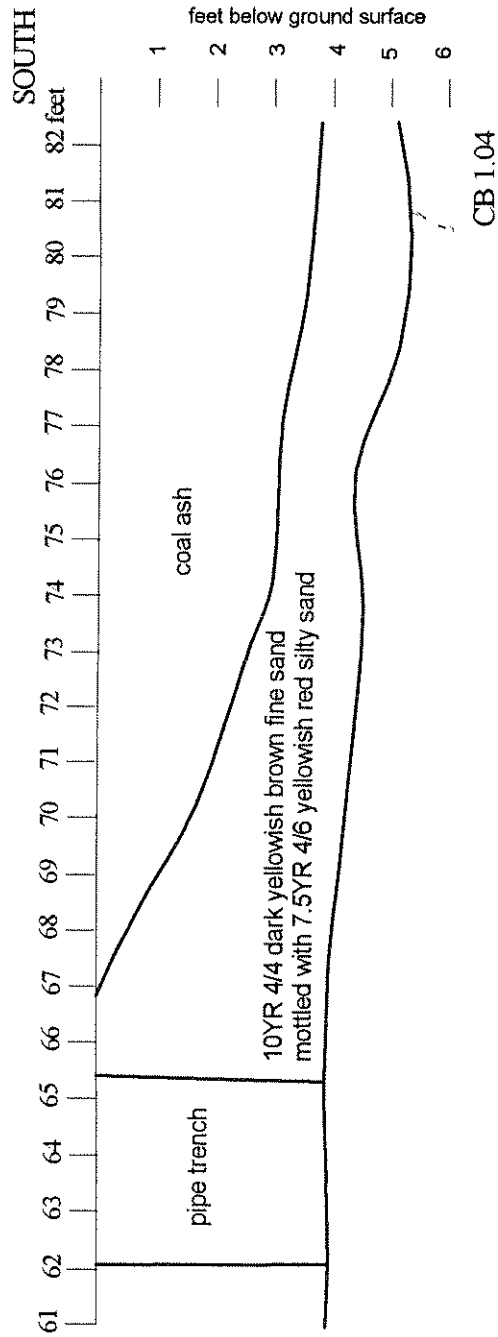
Figure 4 East profile of trench connecting CB 1.04 to MH 1.09.

The coal ash deposit found near CB 1.04 continued approximately 10 feet (305 cm) into the trench between it and MH 1.09, up Ferry Line Road. This trench was excavated up to nine feet (274 cm) below ground surface. Excavation took place in two stages and a soil profile was drawn after the first lift was removed, at approximately 4 feet (122 cm) below ground surface (see Figure 4), before shoring was added. No historic map documented structures were located in this trench segment and no potentially significant archaeological resources were identified.

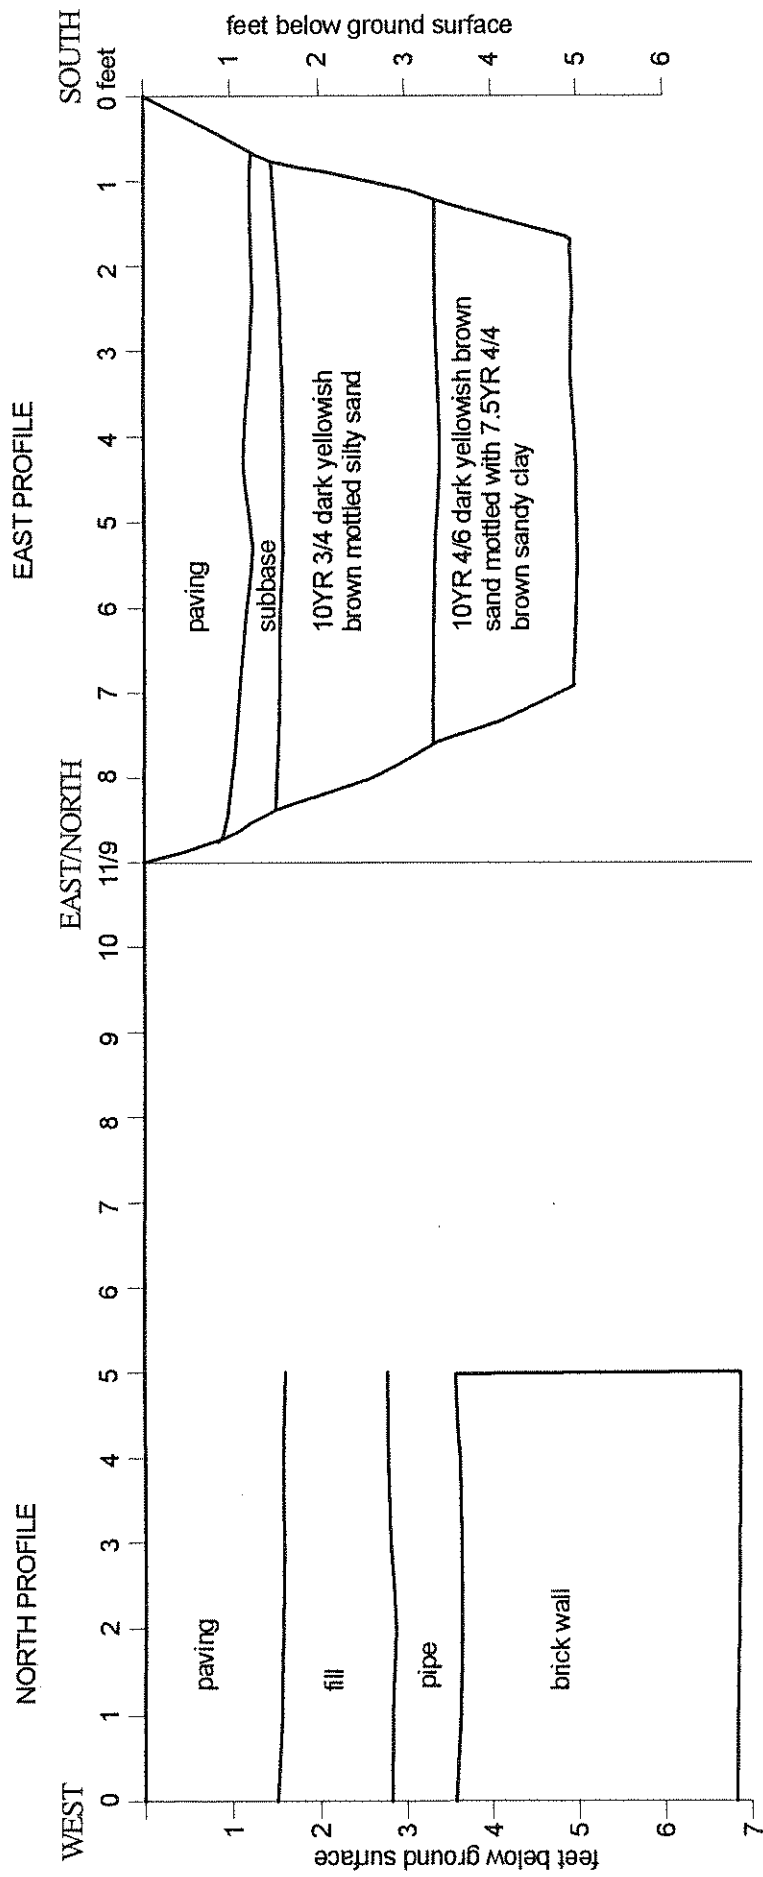
Figure 7 North and east profiles of the cut for CB 1.03.

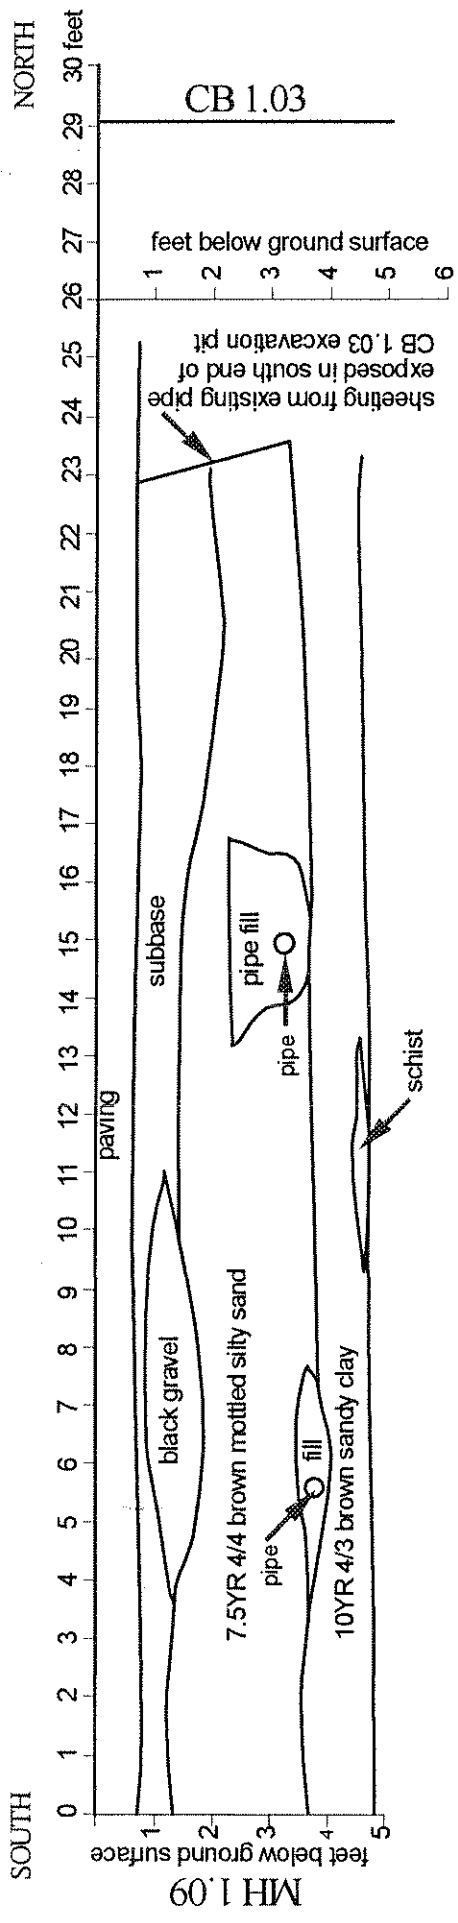
Figure 8 West profile of the trench between MH 1.09 and CB 1.03.

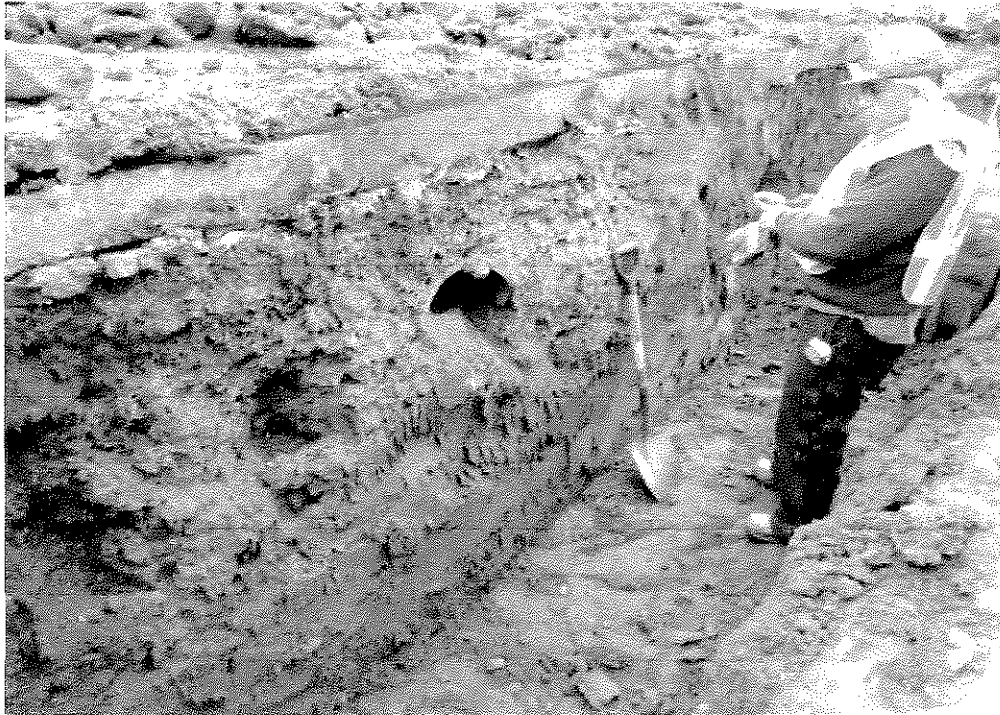
Photo 1 Trench from CB 1.04 to MH 1.14 showing coal ash deposit around defunct pipe, facing northeast (February 17, 2012).

The most distinctive aspect of this excavation area was the presence of a coal ash deposit buried under the paving and extending up to 3 feet (91 cm) below ground surface, located at and around CB 1.04 (see Figure 3 and Photo 1). This deposit was likely related to a nearby existing manhole and to a defunct catch basin that was then removed to install CB 1.04<sup>1</sup>. The coal ash could have been used as fill during the original installation of the previously existing manhole and catch basin. Once the defunct catch basin

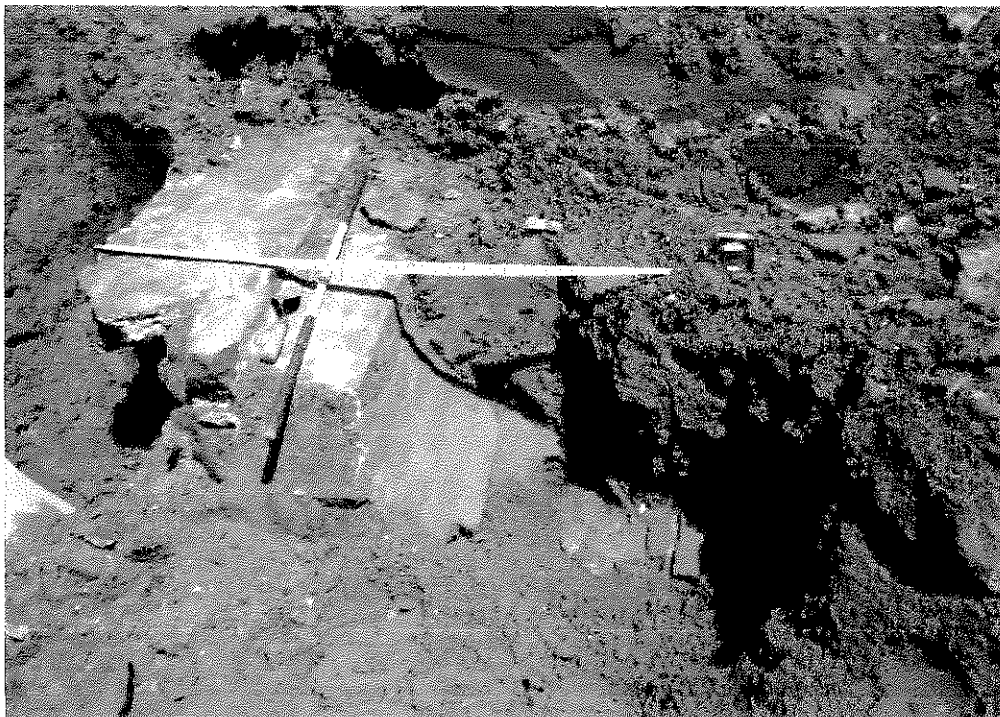
Photo 2 Part of the brick and mortar feature found in the trench between MH 1.10 to MH 1.11, facing north (May 18, 2012).

The most notable part of this trench excavation was a deposit of dark brown silty loam containing a concentration of displaced bricks and brick fragments, located approximately 2.5 to 4.5 feet (76 to 137 cm) below ground surface and 5 to 15 feet (152 to 457 cm) east of MH 1.10. A sample of the deposit was screened for artifact recovery. In addition to brick fragments, it contained a sherd of pearlware, curved glass and a copper nail head (all retained as Context #6), along with much coal and mortar and four corroded nails (not retained). As excavation monitoring continued, an electrical line was exposed and the brick concentration appeared to be part of the pipe trench fill.

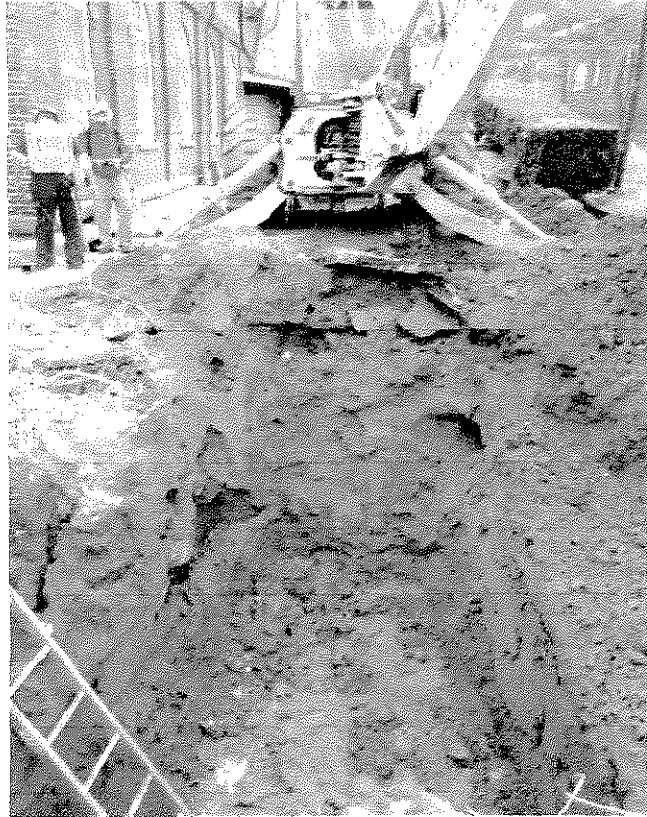
Photo 3 CB 1.06 to CB 1.03 in progress showing the red silty clay deposit at the base of excavation, facing east (March 20, 2012).

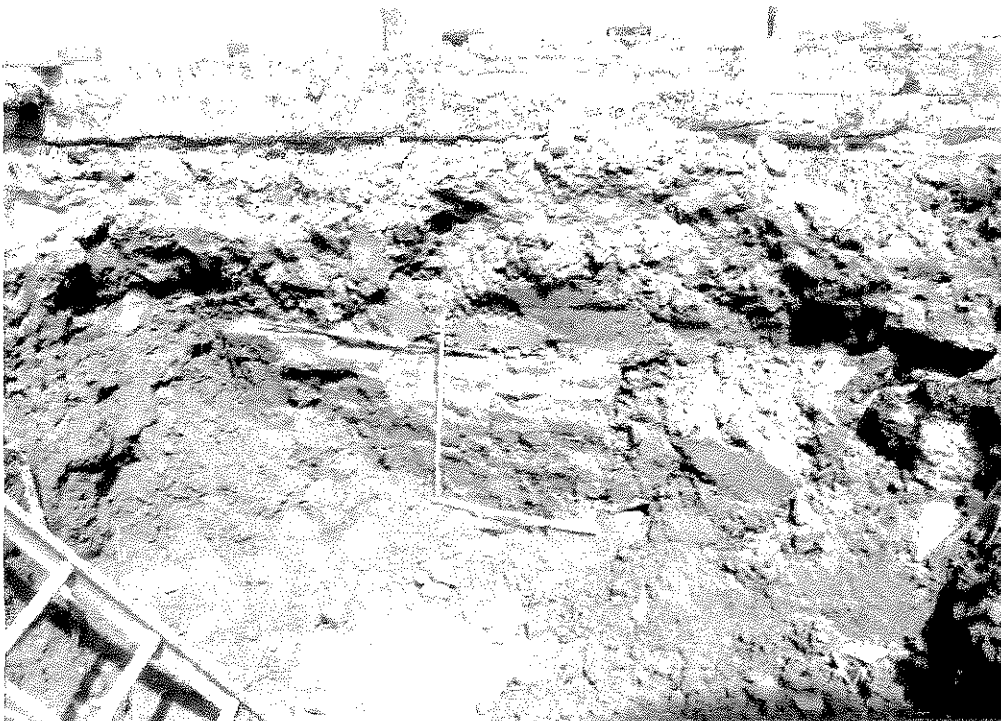
Photo 4 CB 1.03 excavation pit showing the 5-foot long brick wall, facing north (April 30, 2012).

Four areas were examined more intensively, but no significant archaeological features were identified. One of these loci was a brick feature initially identified as the south wall of a brick structure, found during excavation for a new catch basin (CB 1.03). Additional excavations revealed that feature was a defunct utility encasement. Another brick and mortar possible feature was also identified. However, this turned out to be a displaced piece of demolition debris from an unknown source (MH 1.10 - MH 1.11). A location of more intensive examination was an area in the vicinity of a historic map documented structure where red stone was observed in the utility trench. This was revealed to be a natural deposit and not related to the former structure (CB 1.06 - CB 1.03). A coal ash deposit was identified at the southern end of Ferry Line Road (around CB 1.04). Examination of that deposit revealed it was fill related to a defunct catch basin and manhole. Additionally, the presence of buried roadway in the Andes Road portion of the project (near CB 1.05) underlain by a soil type indicative of deeper deposits observed elsewhere in Andes Road could be interpreted as the absence of a buried original ground surface. If so, this would mean that portion of Andes Road was originally cut to construct the roadway.

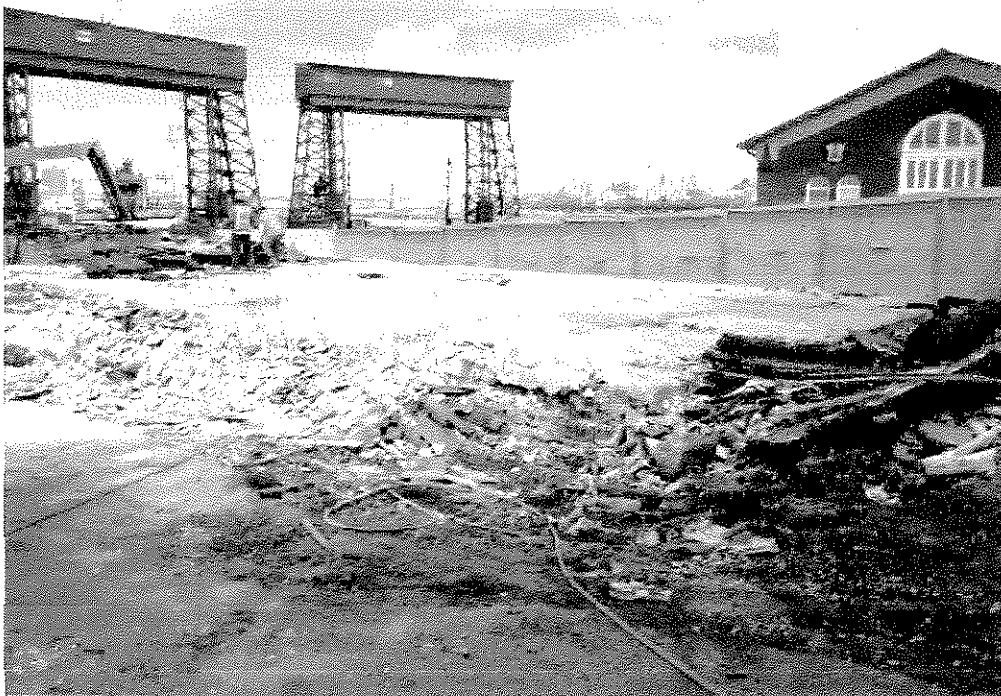
Photo 6 Concrete slab foundation of Building #148 after the superstructure was demolished, facing northeast (May 10, 2012).

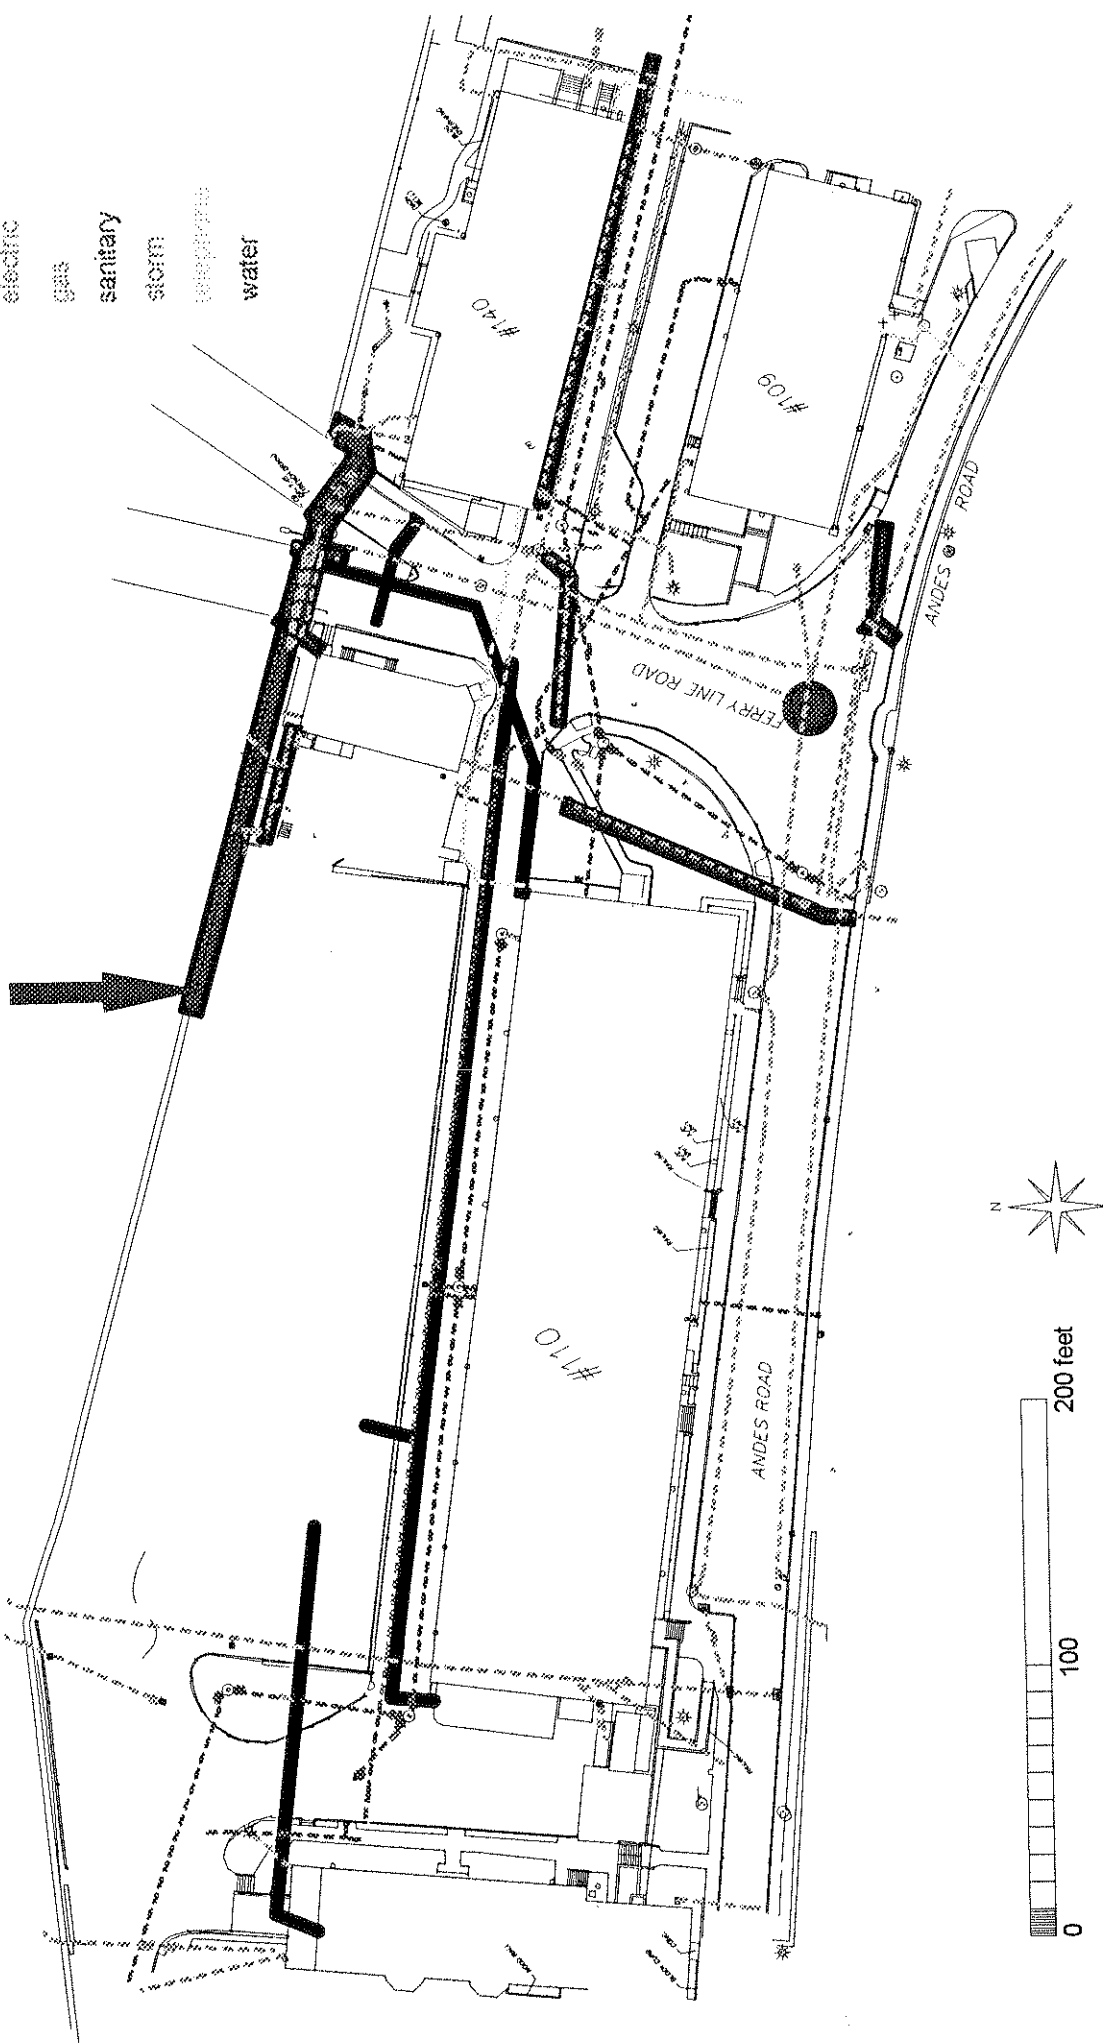
Figure 7 Part of the 2011 Langan survey of Governors Island showing the existing utilities in the vicinity of the Soissons utility project.

Disturbances over time within the Soissons utility project area are primarily due to excavations for other utility lines and, for locations near buildings, disturbances from the original building construction may also be present. Further, it is not known if an earlier structure was built in the location of Building #140. However, it cannot be discounted with the current information<sup>2</sup>. Figure 7 shows the existing utilities as they criss-cross the Soissons utility project impacts. However, the depths of these are unknown. In addition to the in kind replacements, that clearly stand out on Figure 7, it is quite clear that the new electric/gas line is flanked by other utility lines parallel to its path. The excavation trenches for those other utilities may overlap with at least part of the current work.
