# REPORT ON PHASE 1B ARCHAEOLOGICAL FIELD TESTING IN ADVANCE OF SANITARY AND STORM SEWER CONSTRUCTION WILSON AVENUE PROJECT AREA, ELTINGVILLE STATEN ISLAND, NEW YORK

Capital Project Numbers SE-604A-1 and SE-728

Submitted by: Linda Stone, MA, SOPA

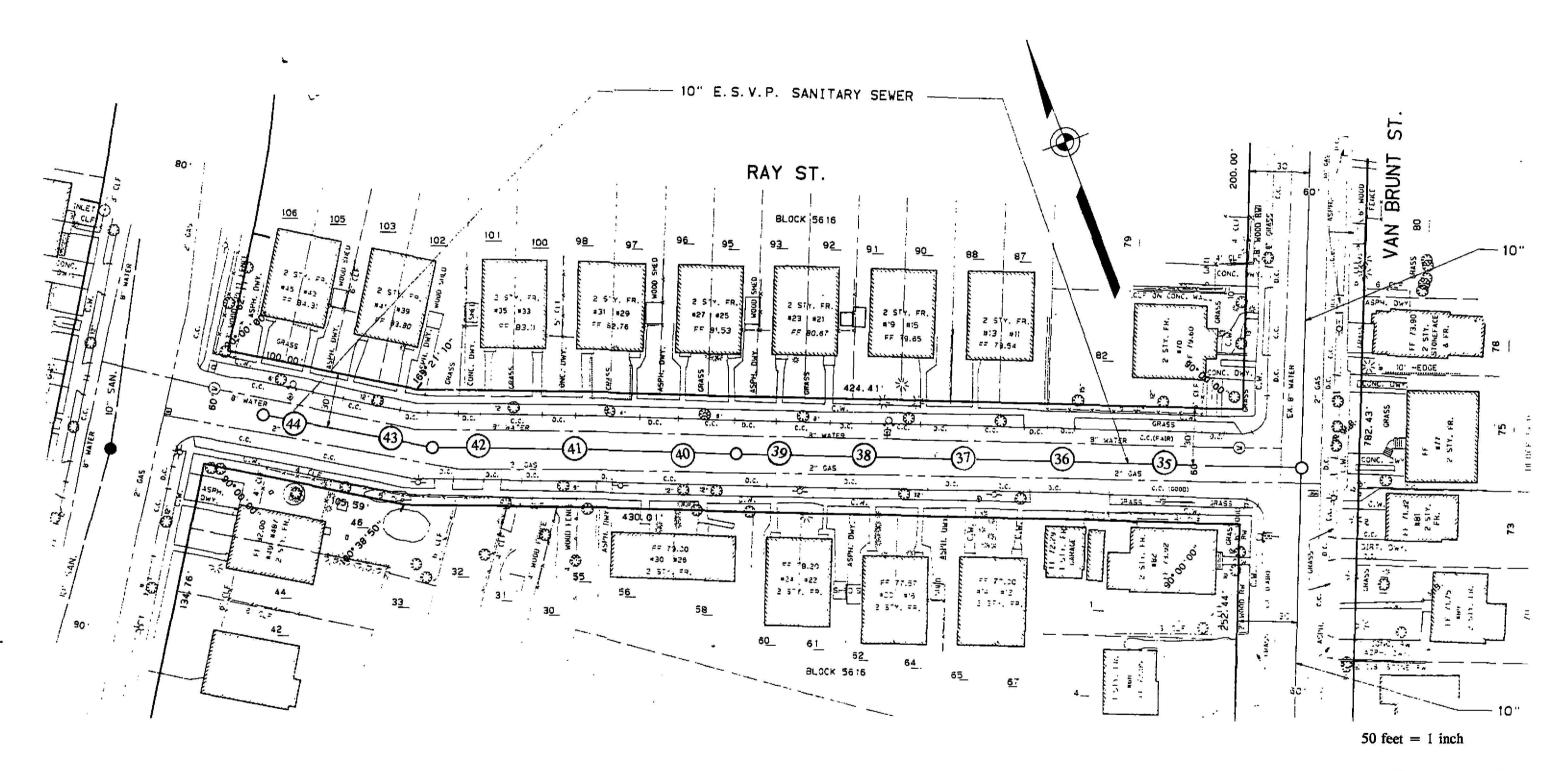
Figure 4 Planned Phase 1B shovel test locations on Ray Street.

(#) = Test Location

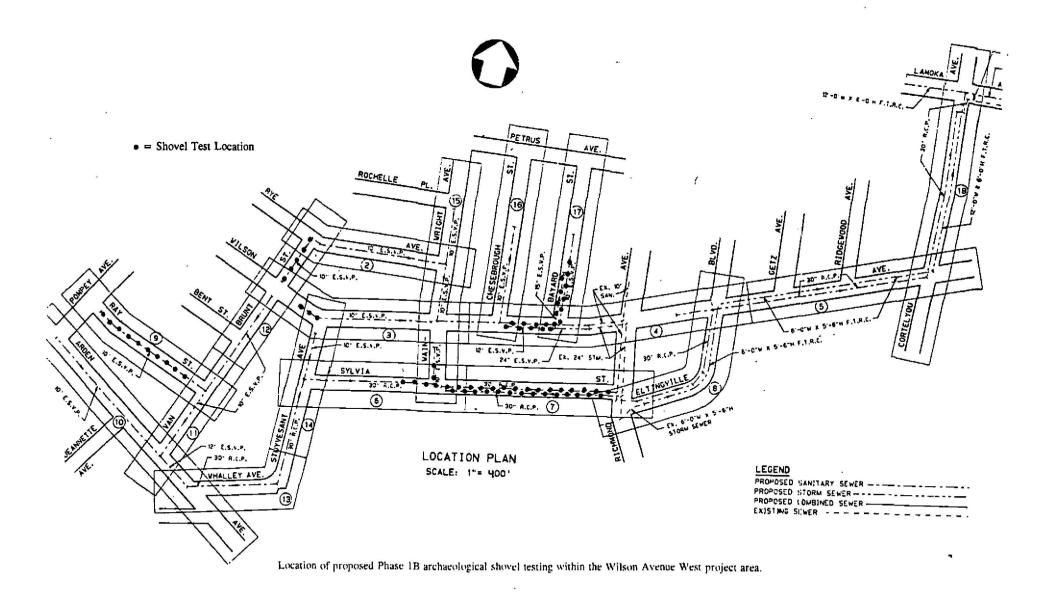
Wilson Avenue Sewer Project Phase 1B Shovel Test Stratigraphy
