**ARCHEOLOGICAL MONITORING
LIFE AND SAFETY UPGRADES
STATUE OF LIBERTY NATIONAL MONUMENT
LIBERTY ISLAND, NEW YORK CITY, NEW YORK**

**National Park Service
PMIS Number: STLI 155567
NRAP Project Number: STLI 2011B**

January 2013

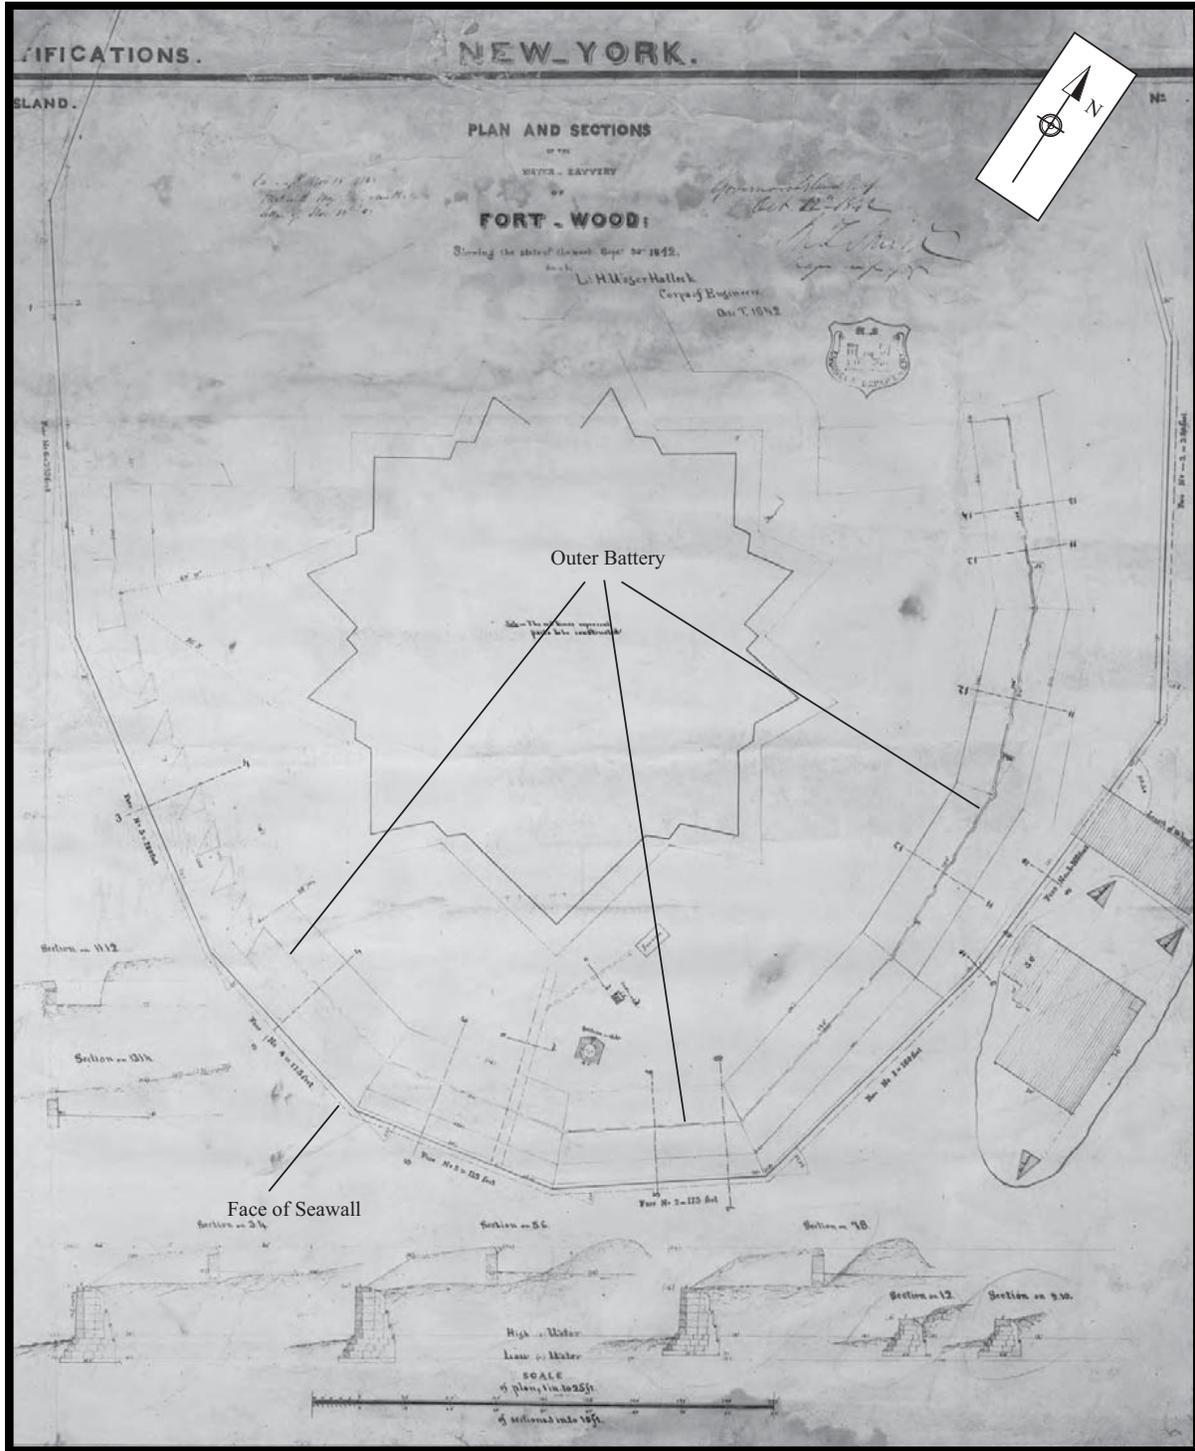
Figure 2.3. Lt. H. Wager Halleck. Plan and Sections of the Water Battery of Fort Wood showing the state of the work September 30, 1842. Reproduced from URS 2008. Copy on file at the Statue of Liberty National Monument, Ellis Island Immigration Museum Collection, Accession #35558.

Between 1815 and 1839, Fort Wood suffered from lack of maintenance as coastal fortifications became less of a priority than they had been before the War of 1812. In 1839, a War Department survey of Fort Wood noted substantial deterioration, particularly of the sandstone scarp of the fort's outer walls. From 1841 to 1850, a total of \$213,000 was appropriated for repairs to Fort Wood, as well as for upgrade of its structure and installation of heavier weaponry. The scarp was refaced with granite, the terreplain was raised several feet, a new powder magazine and bomb-proof rooms were constructed within the fort's salients, the sally port was finished, the revetments was repaired, machicolations, or musketry slots, within the parapet walls were built, machinery was added for a drawbridge, and the water battery was extended and reconfigured for more modern guns (Figure 2.3) (John G. Waite Associates n.d.:16-32).

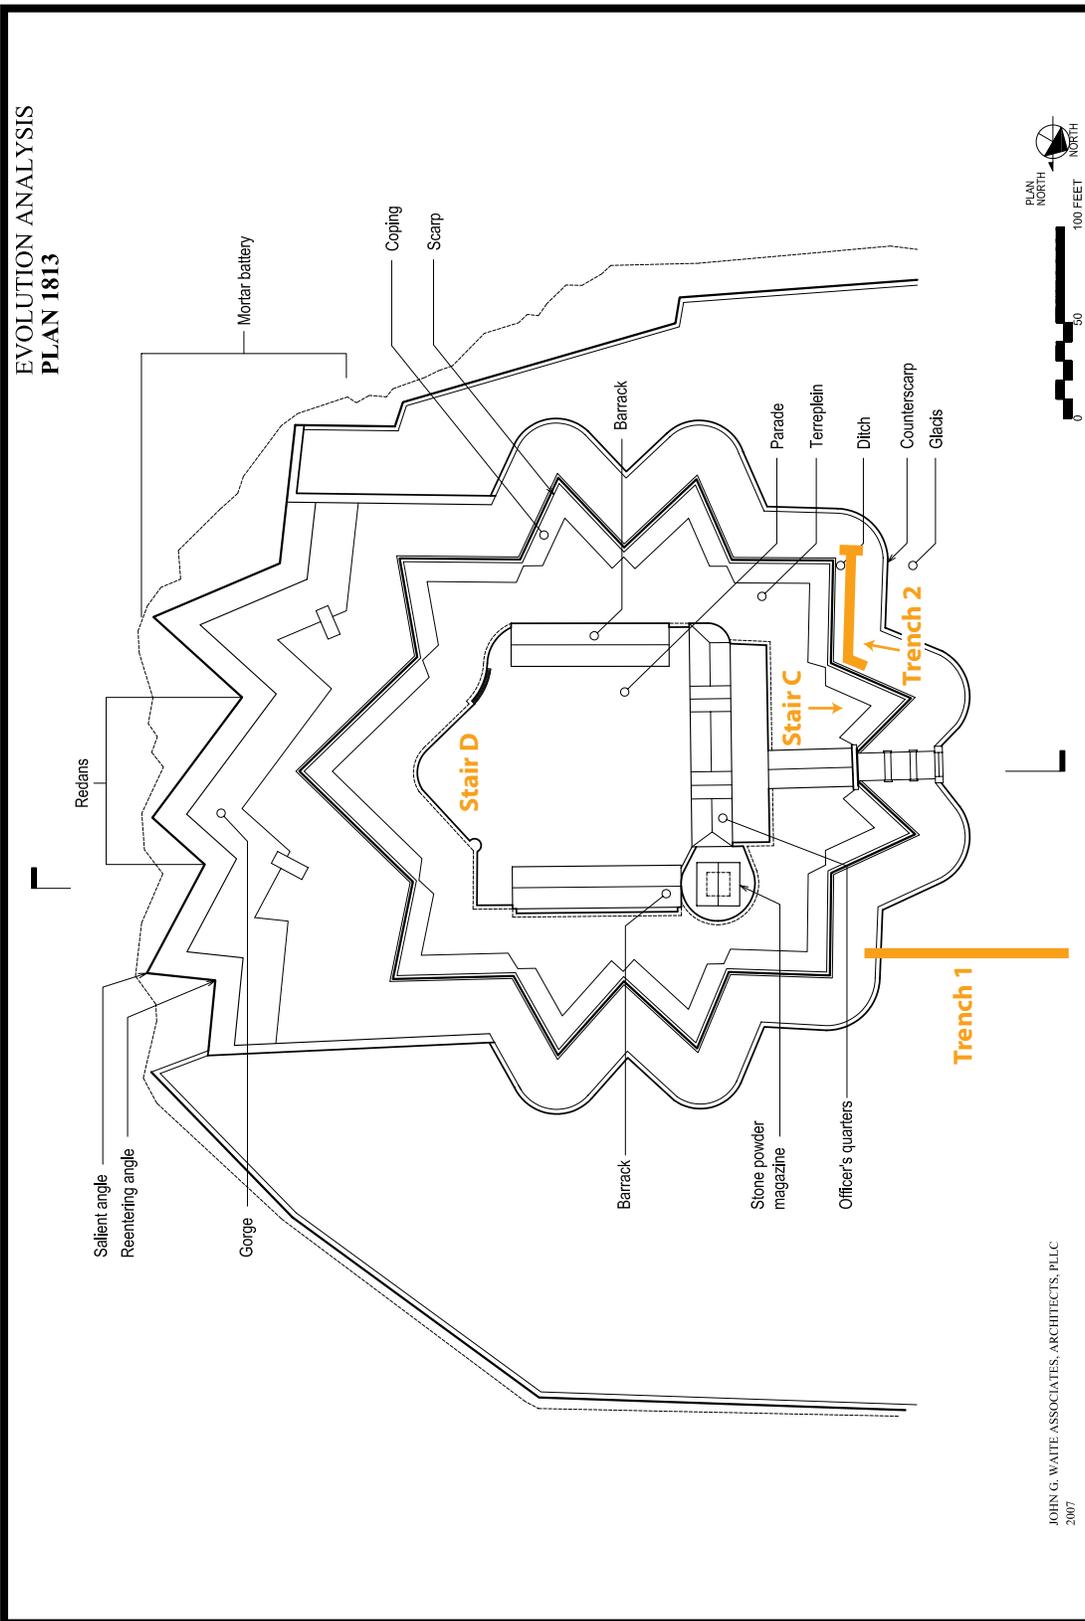
Figure 3.2. Plan of Fort Wood. 1813. Locations of Stairs C and D and Trenches 1 and 2 as indicated. Source: John G. Waite Associates n.d.

The Stair C excavation area lay within a salient of Fort Wood, located immediately west of the fort's main entry (Figure 3.2). This salient was part of the original construction of the star-shaped fort between 1808 and 1811. It underwent significant changes during the fort improvements of the mid-1840s: the original main fort wall was rebuilt with its sandstone facing being replaced with granite; a series of bomb-proof, brick-vaulted rooms were built within the ramparts around the main entry; the terreplein was raised by several feet; and stairs were built connecting the terreplein to the parade (Figure 3.3). This area remained essentially unchanged until 1907 when the parade ground surrounding the statue's pedestal was filled in. As part of this project to beautify and improve visitor access, the main entryway was reconfigured for a second-level entry with the bomb-proof rooms being repurposed as guard rooms and cells (Figure 3.4). In 1961, in preparation for the construction of the American Museum of Immigration, the fill that had been deposited in 1907 between the fort walls and the statue pedestal was removed. Remaining structures were demolished including large portions of the bomb-proof rooms, guard rooms and cells (Photographs 3.1-3.3). Following the completion of the concrete shell of the museum in late 1963, the area between the museum and the fort wall was refilled and paved to create a promenade around the statue's base (John G. Waite Associates n.d.:9-13, 16-32, 64-66, 77-79).

Trench 1's southernmost terminus is located near the outer defenses of Fort Wood, which consisted of a ditch (moat), counterscarp and glacis, constructed *circa* 1808-11 (Figure 3.2). In 1907, these defenses were largely removed to the level of the ditch as part of landscaping to make the island more appealing to visitors (John G. Waite Associates n.d.:9-13, 64-66).

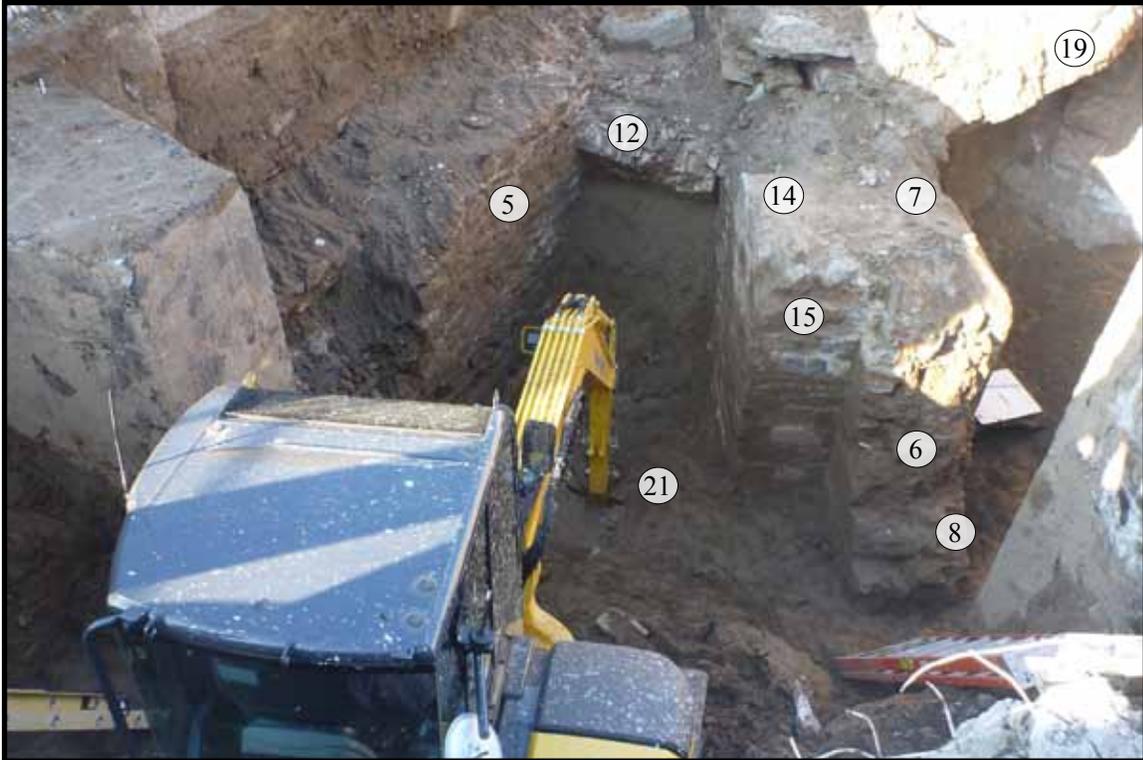
Photograph 3.4. Stair C Excavation Area: view looking north showing the interior face of the fort salient wall [5] and the multi-component dividing wall [6-8, 14 and 15] extending southward from the point of the salient (Photographer: Joshua Butchko, December 2011) [HRI Neg.#11063/D1-28].

Several structural features were revealed reflecting various phases of building and repair at Fort Wood within the Stair C excavation area (Figure 3.6; Photograph 3.4). As the contractors removed the early 1960s fill, the original interior faces of the fort's salient walls, comprised of roughly laid stone masonry [contexts 5 and 20], were identified extending along the western and eastern edges of the excavation area, converging at the point of the salient to the north of and just beyond the limit of excavation. These walls, roughly five feet thick, were clad with a granite facing [2] on the exterior. The base of the original fort wall on the west side of the salient [5] was eventually revealed as extending to almost 19 feet below the terreplein surface. The base of the corresponding wall on the east side of the salient [20] survived to a lesser degree; exposed at the point of the salient after other masonry features above it had been removed by the contractor, it mostly only survived between the depths of 14.5 and 18 feet at the base of the excavations. Both salient walls were truncated at their southern end by construction of the early 1960s.

Between these two walls, projecting southward from the point of the salient, were the remains of a multi-component wall [6-8, 14, 15, 17] reflecting several building episodes (Figure 3.6; Photograph 3.4). The

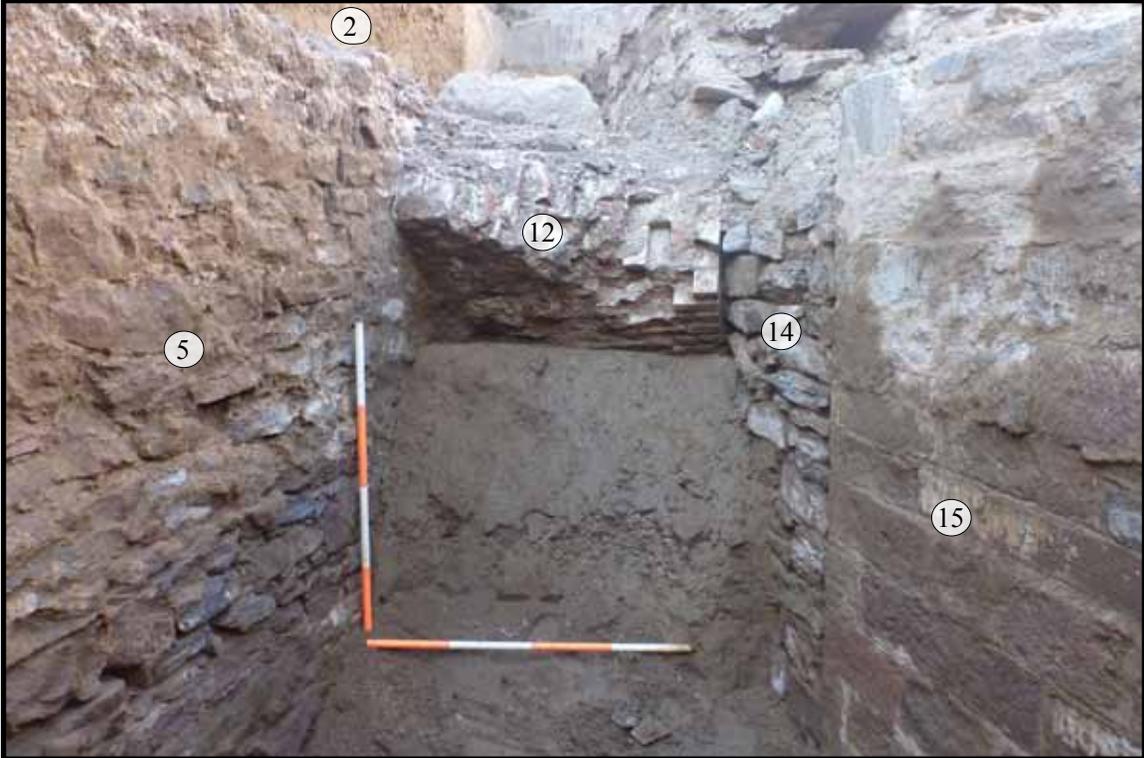
Photograph 3.5. Stair C Excavation Area: view looking north showing the main fort wall [5] (at left), the northern end of a brick vault [12], an ashlar pier [15] (at right) and a section of rough stone infilling [14], all located in the western half of the salient; scales in feet and tenths of feet (Photographer: James S. Lee, December 2011) [HRI Neg.#11063/D1-37].

west side of this north-south wall consisted of an ashlar pier [15] and a later, roughly laid stone wall [14] abutting its north side (Photograph 3.5). The ashlar pier [15] is more finely constructed and rests on top of a mortar footing. This rough gray mortar footing [17] extended west and south beyond the wall face. It had a high concentration of shell and brick and is thought to have been an early type of concrete poured into a rough excavation without the benefit of form work. The top of this footing was roughly 15.3 feet below the terreplein surface; the bottom of the footing was reached at a depth of 17.8 feet. It is similar to the stepped battered footings identified during the Stair D excavation (see below).

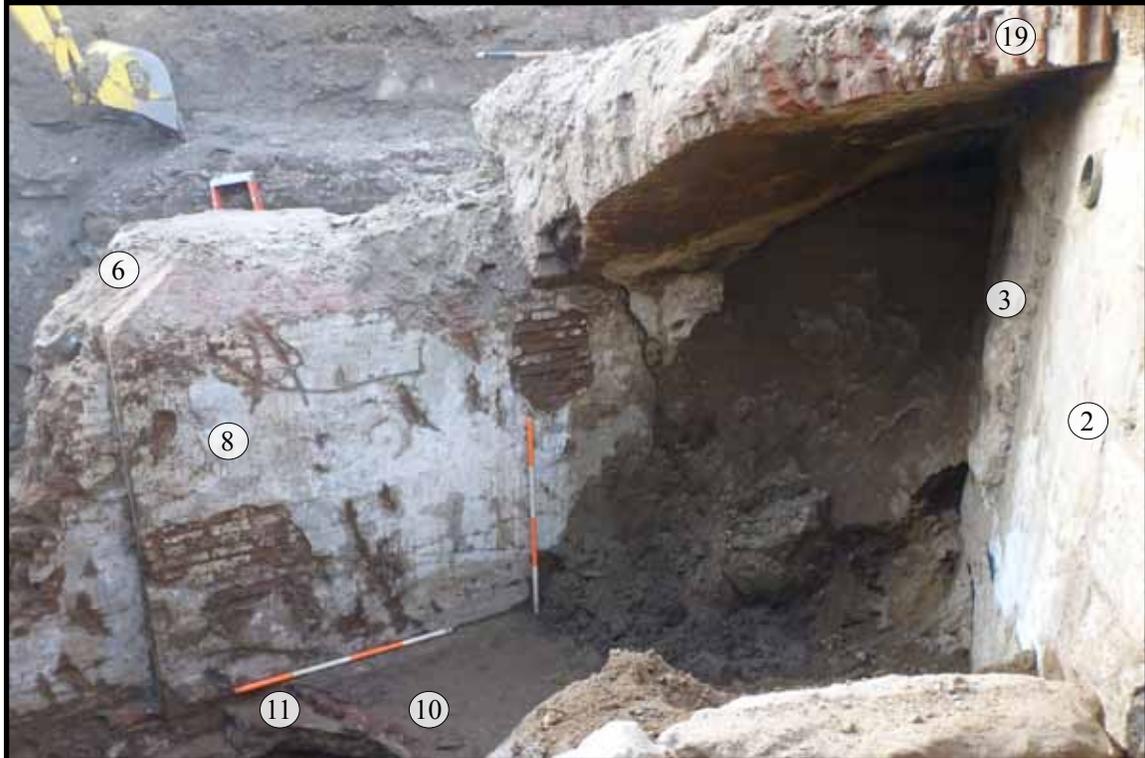
Photograph 3.6. Stair C Excavation Area: view looking west northwest showing the stuccoed brick west wall [8], brick vault [19] and brick and mortar floor [10, 11] of the bomb-proof room/guard room in the eastern half of the salient; scales in feet and tenths of feet (Photographer: Joshua Butchko, December 2011) [HRI Neg.#11063/D1-70].

Originally built in 1846 as a bomb-proof room, the eastern chamber was later converted for use first as a guard room and then as a prison cell. The rough stone wall [14] is interpreted as part of the initial construction of the bomb-proof room and the addition of stuccoed-brick cladding may mark the room's subsequent conversion into a guardhouse. Contexts 10 and 11 respectively comprise the mortared brick surface and concrete/mortar base of a floor in the bottom of the eastern chamber (John G. Waite Associates n.d.:26).

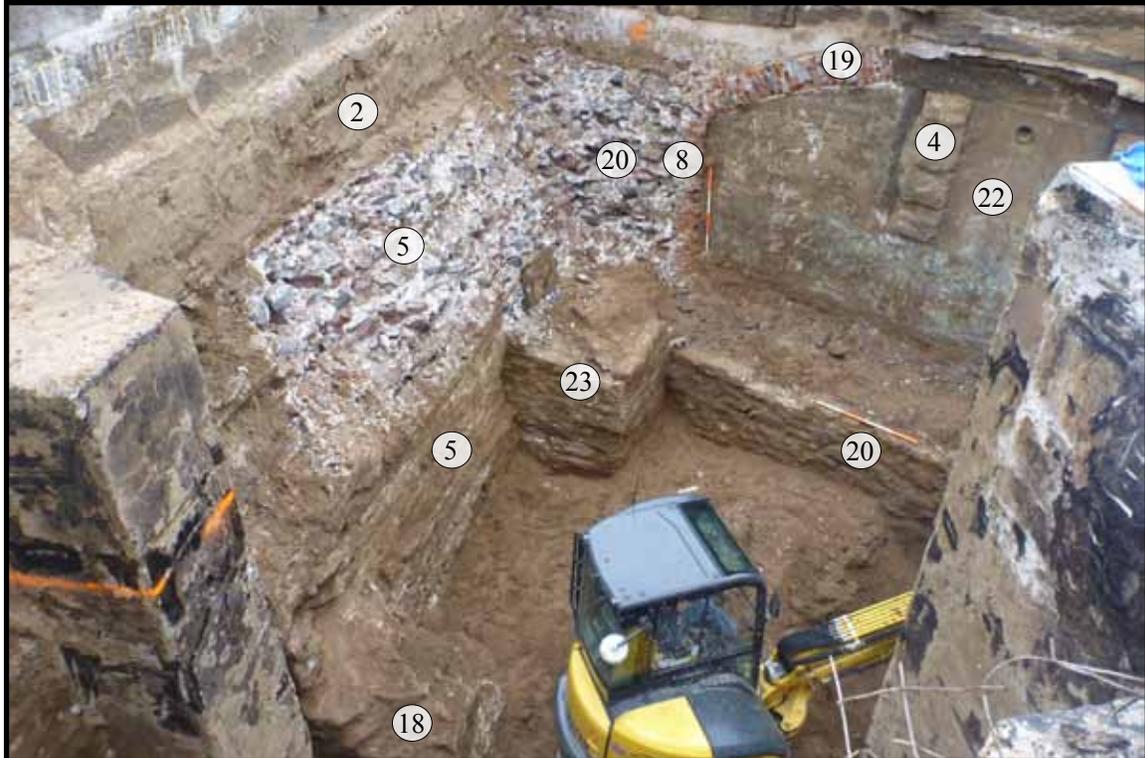
Photograph 3.8. Stair C Excavation Area: view looking north showing the full depth of the Stair C excavations, salient walls [2, 5, 20, 22] and buttresses [18, 23]; scales in feet (Photographer: Joshua Butchko, December 2011) [HRI Neg.#11063/D3-112].

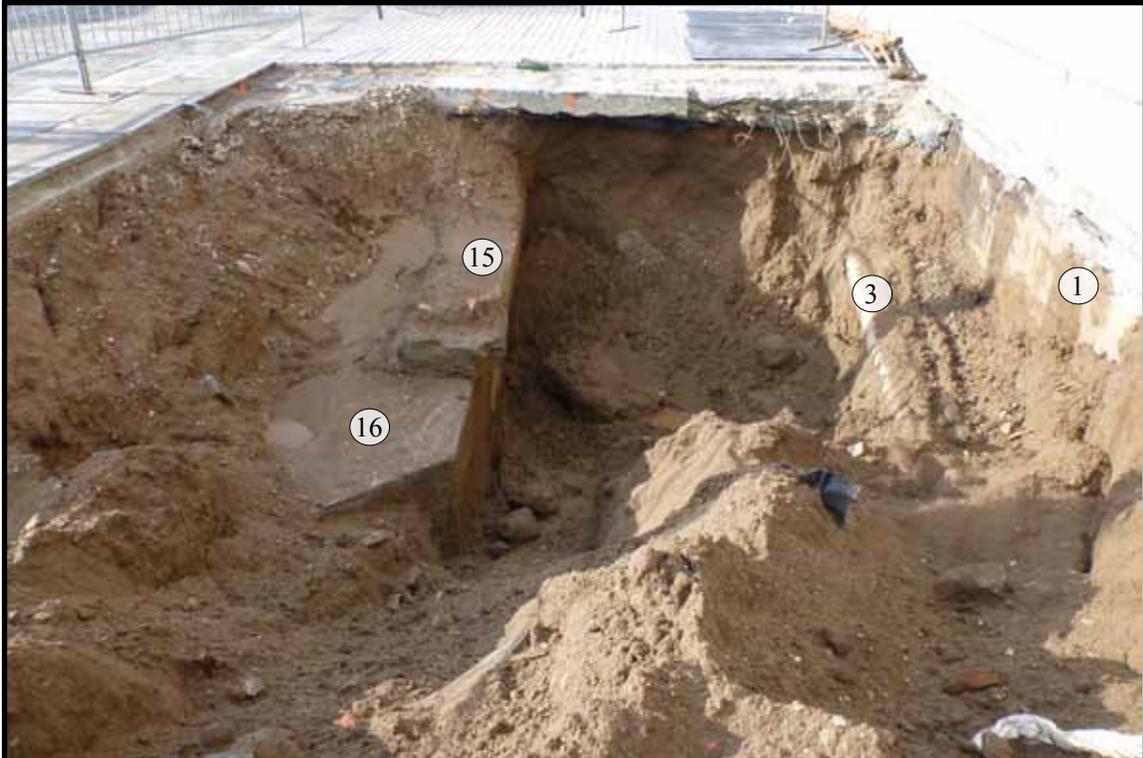
Photograph 3.10. Stair D Excavation Area: view looking west showing excavations in progress at the western end of the excavation area; 1960s-era fill is being removed and the top of the parade wall [15, 16] is in the early stages of being exposed (Photographer: Joshua Butchko, January 2012) [HRI Neg.#11063/D5-23].

Excavations proceeded from west to east within the Stair D area and buried structural remains of the fort began to be exposed almost immediately (Photographs 3.10-3.12). Roughly six feet north of the southwest corner of the excavation area, the top of a wall composed of finely dressed stone [15, 16] was identified three feet below the terreplein surface. A top course of coping stone [15] survived only partly intact, but ongoing excavation showed the substantial wall [16] beneath as extending east-west for 13 feet before angling to the southeast and continuing for another 11 feet whereupon it disappeared beyond the southern edge of the excavation area. The base of the wall was eventually established as being 14.8 feet below the terreplein surface. This wall defines the interface of the parade with the terreplein (referred to here as the parade wall) on the southern side of Fort Wood and is considered to date from 1845-46 when the terreplein was raised to a higher elevation.

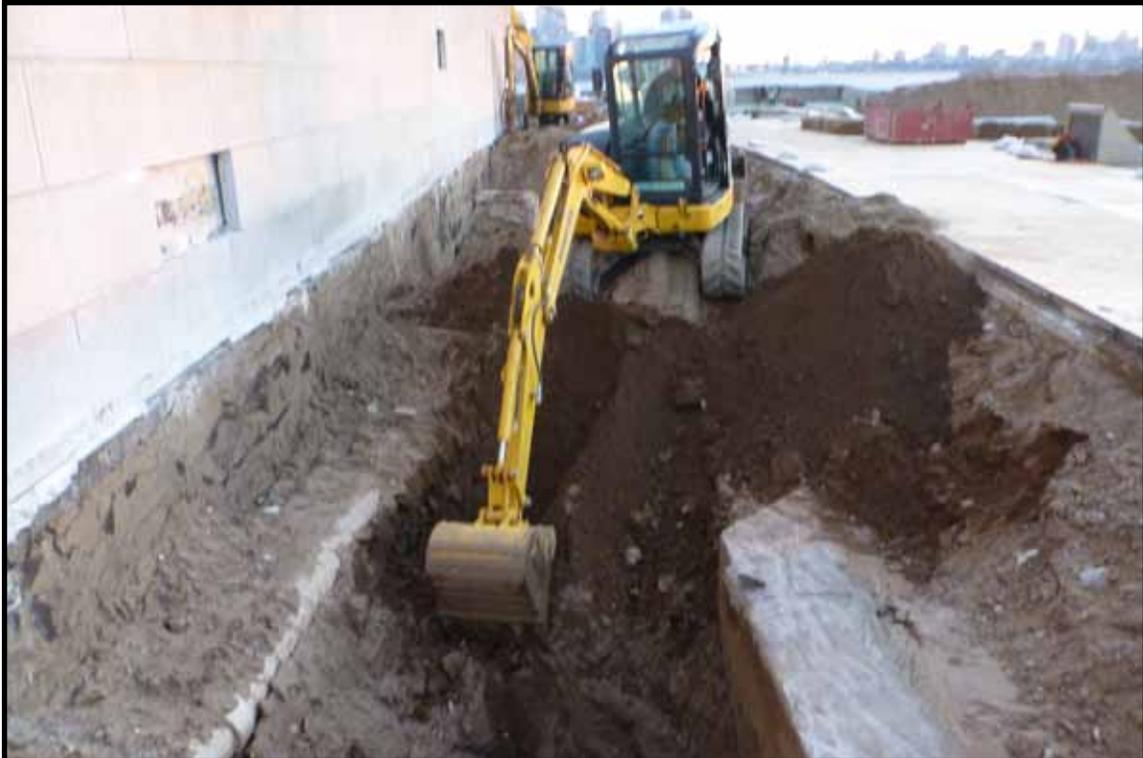
Photograph 3.11. Stair D Excavation Area: view looking east showing excavations in progress at the western end of the excavation area; 1960s-era fill is being removed and the face of the parade wall is being exposed (Photographer: Joshua Butchko, January 2012) [HRI Neg.#11063/D8-1].

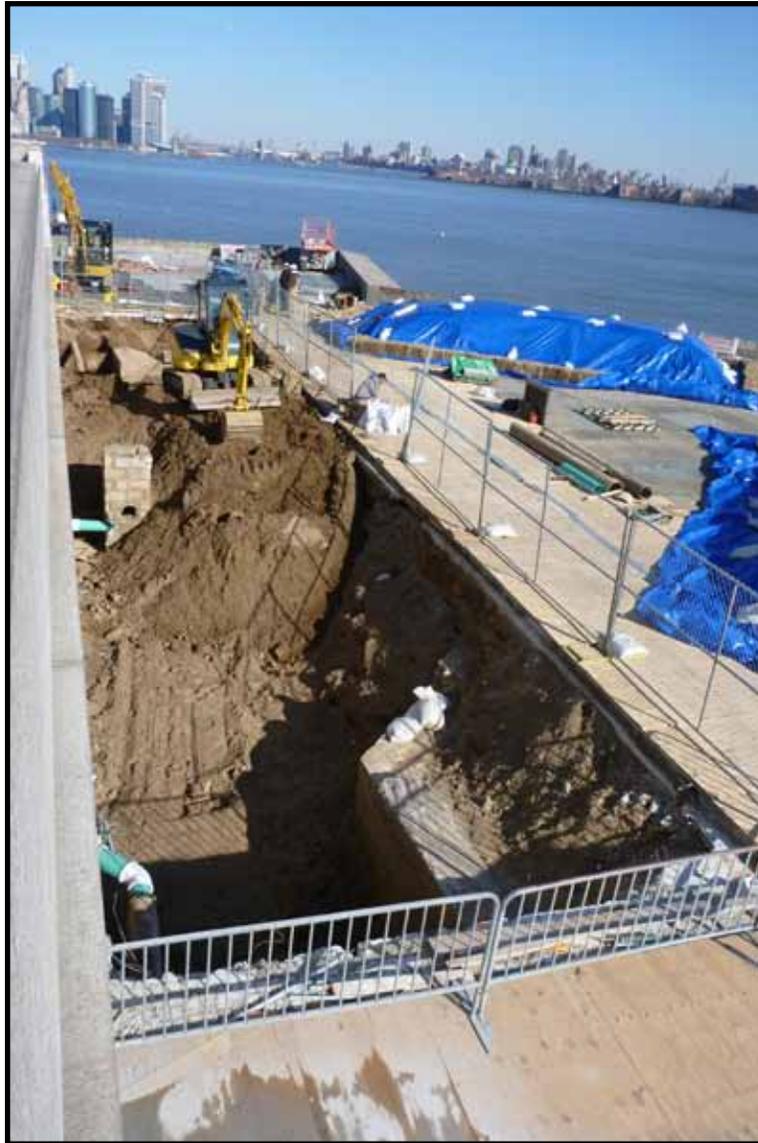
Photograph 3.13. Stair D Excavation Area: view looking east south-east showing masonry remains exposed at the western end of the excavation area; at lower right is the parade wall [15, 16] set on top of a stepped battered mortared rubble base [19]; the deeper, angled foundations [20, 21] at left center are the footings of the furnace room; at lower left is the mortared rubble base of the staircase [18] that led up from the parade to the terreplein; scales in feet (Photographer: Joshua Butchko, February 2012) [HRI Neg.#11063/D11-15].

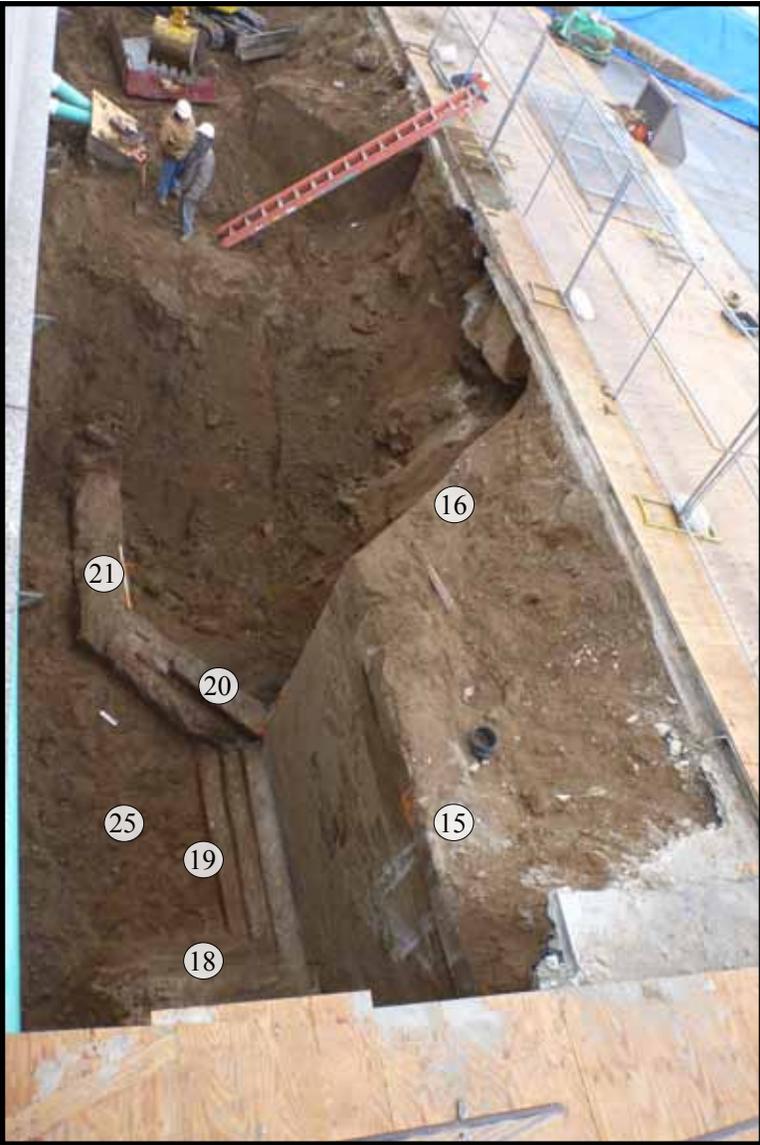
Photograph 3.14. Stair D Excavation Area: view looking west showing masonry remains exposed at the western end of the excavation area; in foreground are the foundations of the furnace room [20, 21]; beyond at left is the parade wall [15, 16] set on top of a stepped battered mortared rubble base [19]; at far end is the mortared rubble base [18] and isolated treads [17] of the staircase that led up from the parade to the terreplein; scales in feet (Photographer: Joshua Butchko, February 2012) [HRI Neg.#11063/D11-22].

plein. Although very few of the stone staircase treads remained, their underlying mortar base survived and showed that the staircase was four feet wide. No historic floor surfaces were observed abutting the steps. Like the parade wall against which it is built, the staircase is also considered to be a part of the improvements made in 1845-46.

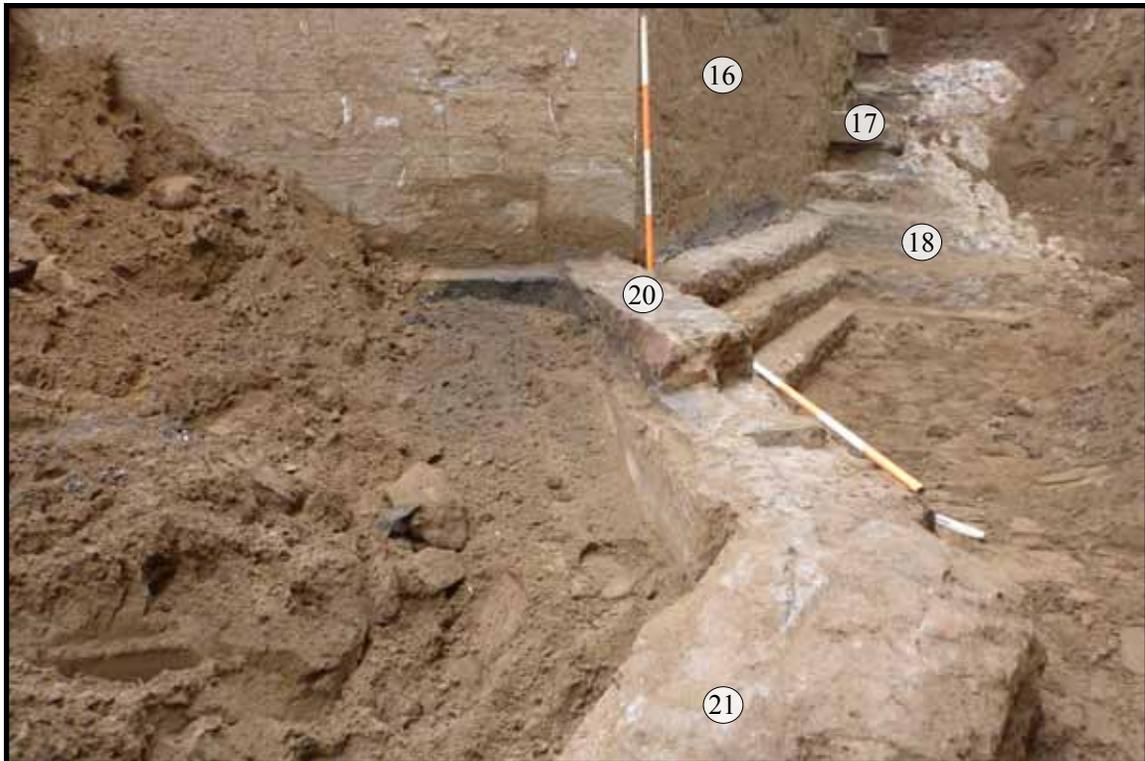
Photograph 3.15. Stair D Excavation Area: view looking west northwest showing masonry remains exposed in the center of the excavation area; at lower left is the northern corner of the powder magazine/parade wall [13]; at upper right is a cinder block utility access shaft [4]; scales in feet and tenths of feet (Photographer: Joshua Butchko, January 2012) [HRI Neg.#11063/D6-7].

As the contractor's work continued eastward into the center of the Stair D excavation area, other structural remains were revealed. Roughly 41 feet east of the southwest corner of the excavation area the corner of a lightly stuccoed, finely dressed stone wall [15] capped with coping stones [13] was found (Photograph 3.15). This masonry is another part of the parade wall and also forms the northern corner of a powder magazine. Both the parade wall and powder magazine are considered to be a part of the 1845-46 building program. The coping stones were added later in 1868 (John G. Waite Associates n.d.:39). Contractor excavations in the area of the parade wall and powder magazine only reached a depth of eight feet, so their full height was not observed. Several 20th-century utilities [1, 5, 6]

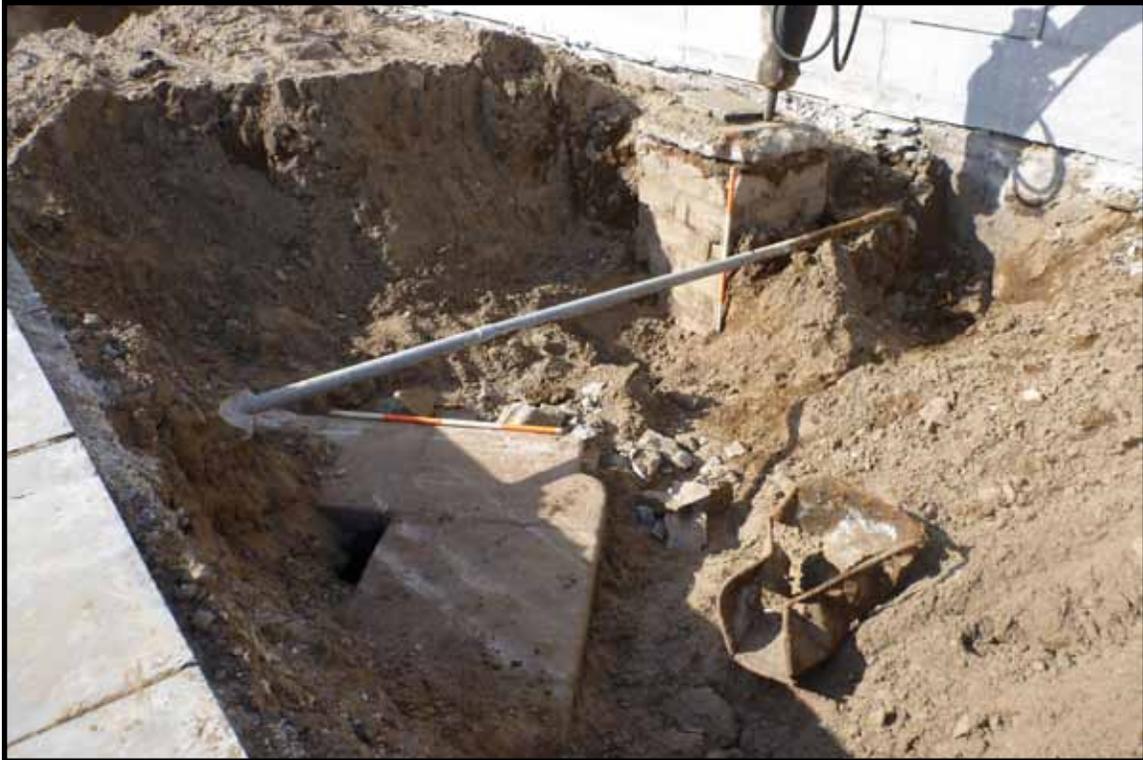
Photograph 3.16. Stair D Excavation Area: view looking southwest showing the doorway [14] exposed in the northeast face of the powder magazine/parade wall [13]; scale in feet (Photographer: Joshua Butchko, March 2012) [HRI Neg.#11063/D13-42].

In late March 2012, during a review of grading and backfilling at the Stair D location, a portion of the trench side wall collapsed revealing a doorway opening [14] in the northeast face of the powder magazine (Photographs 3.16 and 3.17). This opening, three feet wide and of unknown height, was located 9.2 feet southeast of the corner of the magazine, roughly four feet below the top of the wall. An iron pintle was noted on the left side of the opening, while the opening itself was recessed, implying that it had most likely been sealed with a cast-iron door. The inside face of the door opening (within the magazine) was brick-lined, while the interior space that formed the magazine was filled with sand and rubble (reportedly placed there in the 1960s).

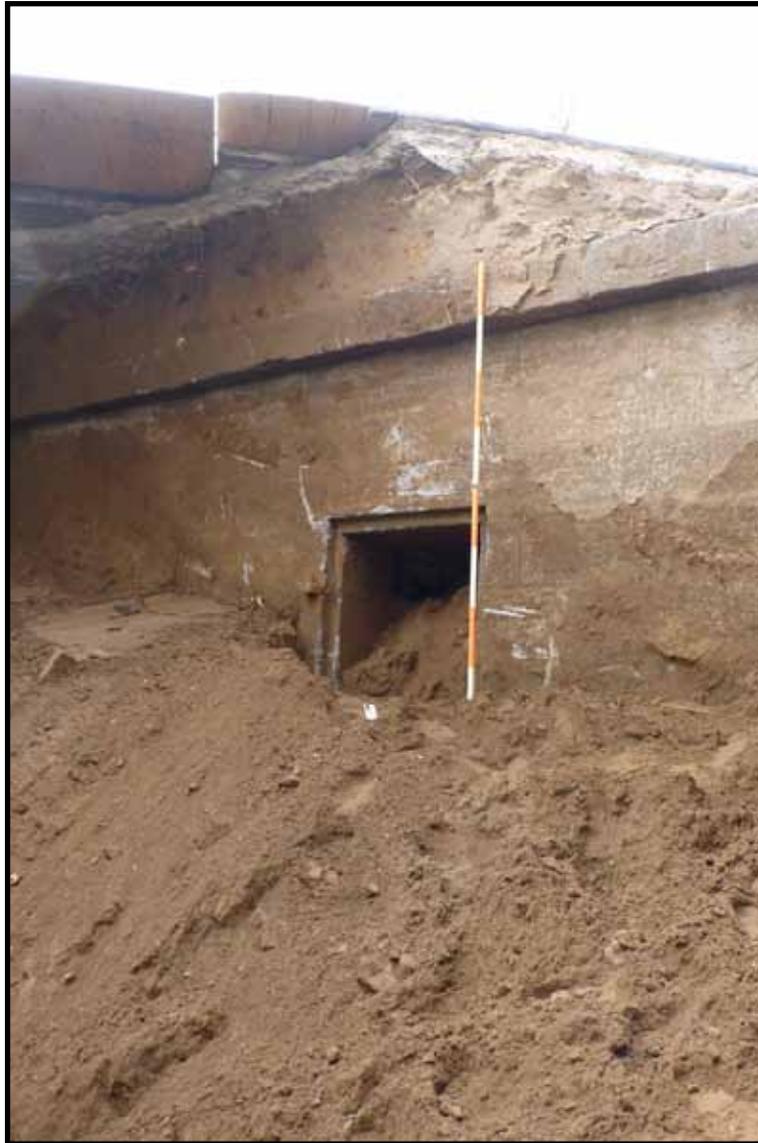
Photograph 3.17. Stair D Excavation Area: view looking southwest showing the doorway [14] exposed in the northeast face of the powder magazine/parade wall [13]; note the pintle at the upper left side of the doorway, the recessed face of the door opening and the brick lining on the door opening interior; scales in feet and tenths of feet (Photographer: Joshua Butchko, March 2012) [HRI Neg.#11063/D13-45].

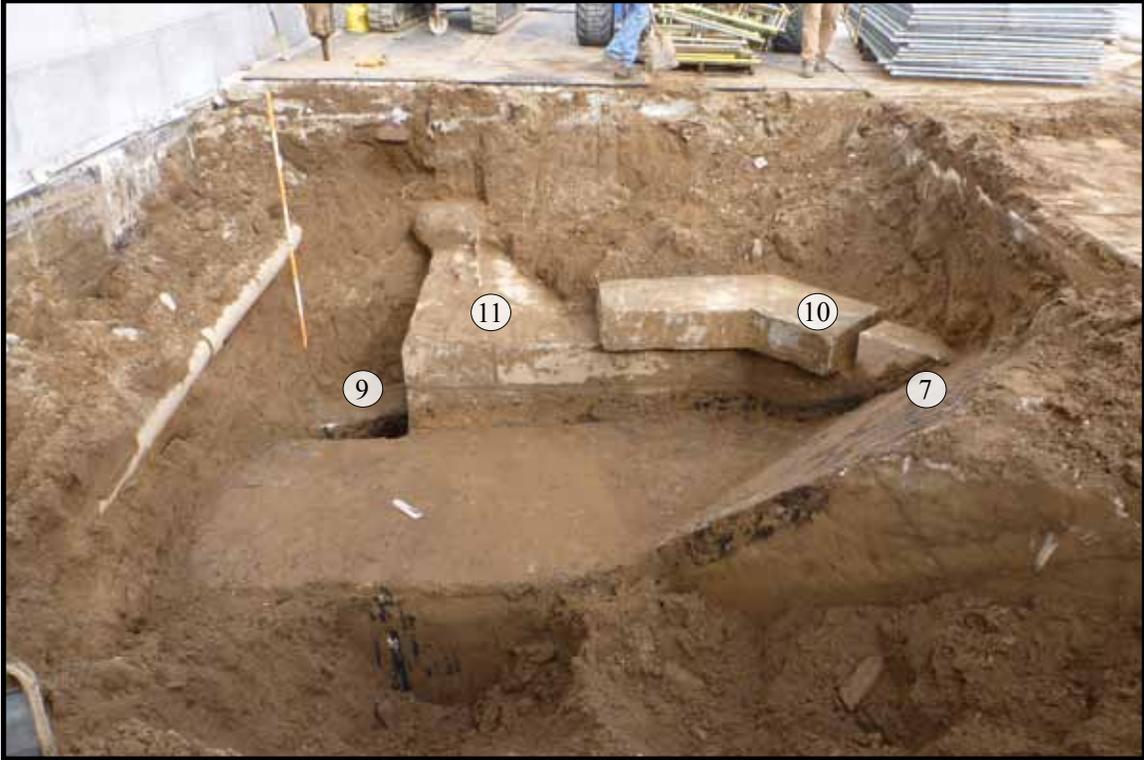
Photograph 3.19. Stair D Excavation Area: view looking south showing masonry remains exposed at the eastern end of the excavation area; at right center is the top of the tar-coated, concrete-encased passage [7] carrying a staircase up from the parade to the terreplein; adjoining to left is the top of the parade wall [11] with coping stones [10]; just visible at lower left is the tar-coated, concrete-encased passage [9] providing access to the sally port (Photographer: Joshua Butchko, February 2012) [HRI Neg.#11063/D9-87].

At the eastern end of the Stair D excavation area, removal of the 1960s fill revealed further evidence of the parade wall, which again consisted of lightly stuccoed, finely dressed stone masonry capped with coping stones (Photographs 3.18 and 3.19). The top of the coping stone course [10] was identified 3.5 feet below the terreplein surface roughly 5.5 feet south of the northeast corner of the Stair D excavation area. The underlying parade wall [11] ran east-west for nine feet from the eastern edge of the excavation area before turning 90 degrees and running south for eight feet, then angling southwest and continuing beyond the southern limit of the excavation. This wall extended to a depth of 14.5 feet below the terreplein surface and was set upon a stepped battered base of mortared rubble [12] similar to that found at the western end of the Stair D excavation area. The mortared rubble base extended to a depth of 17 feet below the terreplein surface (Photograph 3.20).

Other structural features abutted the parade wall at the eastern end of the Stair D excavation area. A concrete-encased passage [7], coated in black tar, was found six feet below the terreplein surface abutting the west side of the parade wall (Photographs 3.18 and 3.19). This feature sloped upwards to the southwest, rising to within a foot of the terreplein surface as it continued beyond the southern limit of the excavation area. The contractors eventually removed much of this feature, revealing it in cross section and showing that the passage had been filled with concrete waste and rubble (Photographs 3.20 and 3.21). At the base of the passageway, flat stones formed a floor surface or stair treads. Upon analysis of historical data, it is thought that this passage was built in 1907 in part to enclose a pre-existing staircase that rose up alongside the parade wall giving access from the parade to the terreplein. This staircase would have been constructed originally as part of the 1845-46 building program and matched the staircase documented at the opposite (western) end of the Stair D excavation area.

Also observed when the contractors reached the full excavation depth at the eastern end of the Stair D area was a second concrete-encased passageway [9] that ran north-south and connected to the parade wall (Photographs 3.18-3.20). The top of this passage was identified in the northeast corner of the excavation area at a depth of seven feet below the terreplein surface. This passage is also believed to have been constructed in 1907 and provided an enclosed route to the sally port that pierced the parade wall and the fort's main perimeter wall at this location. The sally port was originally constructed in 1845-46 and would have passed beneath the raised terreplein (John G. Waite Associates n.d.:26). The passage was not removed as part of the current construction project. A door was cut through the exposed wall of this passage enabling Stair D to connect to the sally port.

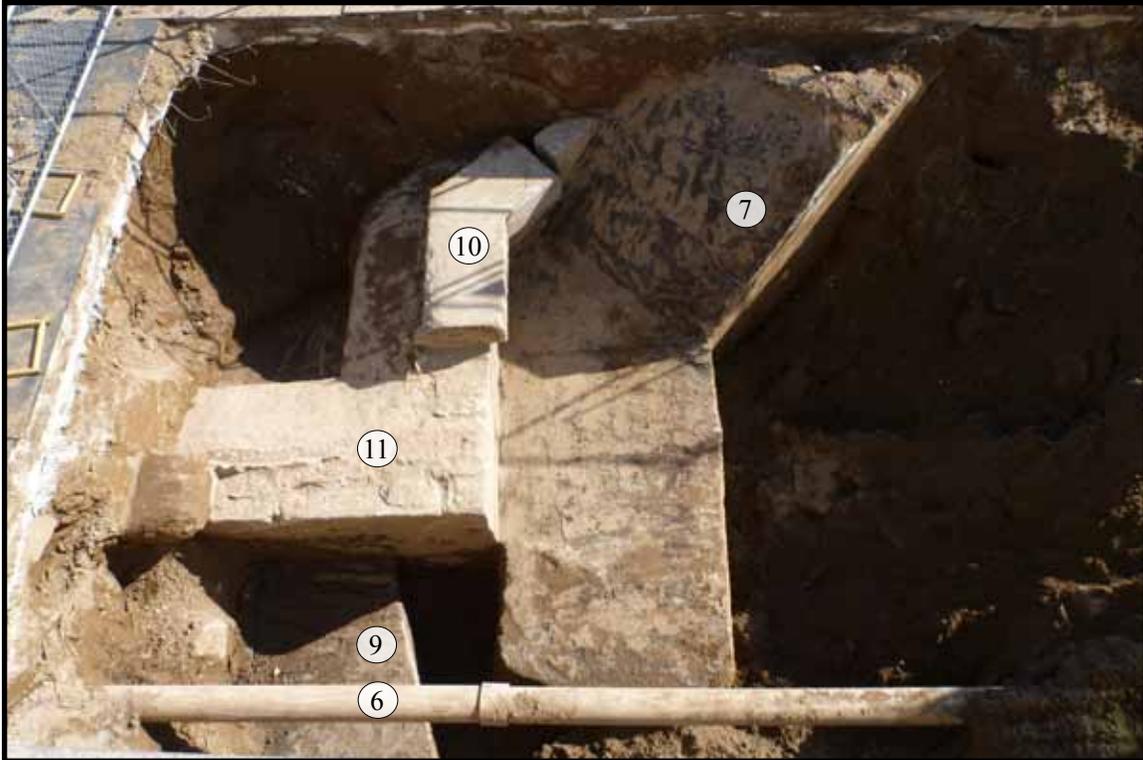
Photograph 3.20. Stair D Excavation Area: view looking east showing the east end of the excavation area at the full depth of excavation following the removal of the tar-coated, concrete-encased passage [7]; the passage can be seen in cross section at right; in right center is the parade wall [11] set on a stepped battered mortared rubble base [12] and capped with coping stones [10]; at left behind the ladder is the tar-coated, concrete-encased passage [9] providing access to the sally port (Photographer: Joshua Butchko, March 2012) [HRI Neg.#11063/D13-16].

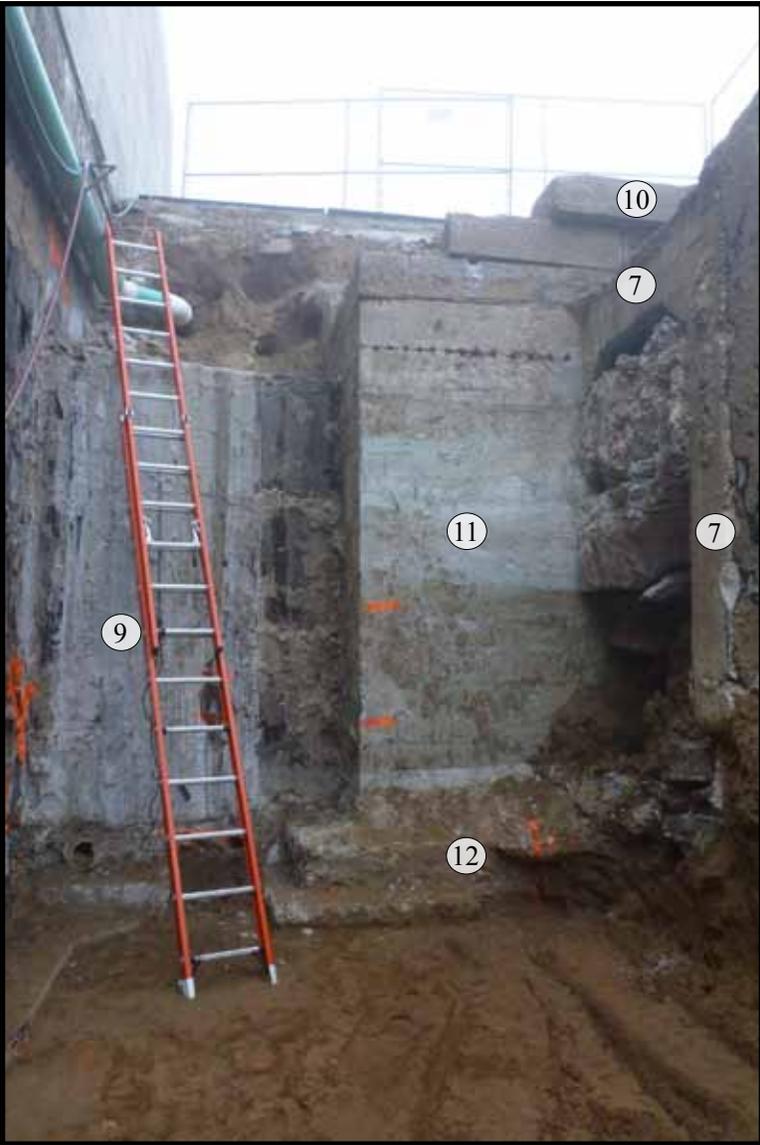
Photograph 3.21. Stair D Excavation Area: view looking southwest showing the cross-section of the tar-coated, concrete-encased, concrete-filled passage [7]; note the stone masonry at the base to the left of the scale rod; at left is the parade wall [11] set on a stepped battered mortared rubble base [12] and capped with coping stones [10]; scale in feet (Photographer: Joshua Butchko, March 2012) [HRI Neg.#11063/D13-50].
