**ARCHEOLOGICAL MONITORING
LIFE AND SAFETY UPGRADES
STATUE OF LIBERTY NATIONAL MONUMENT
LIBERTY ISLAND, NEW YORK CITY, NEW YORK**

**National Park Service
PMIS Number: STLI 155567
NRAP Project Number: STLI 2011B**

January 2013

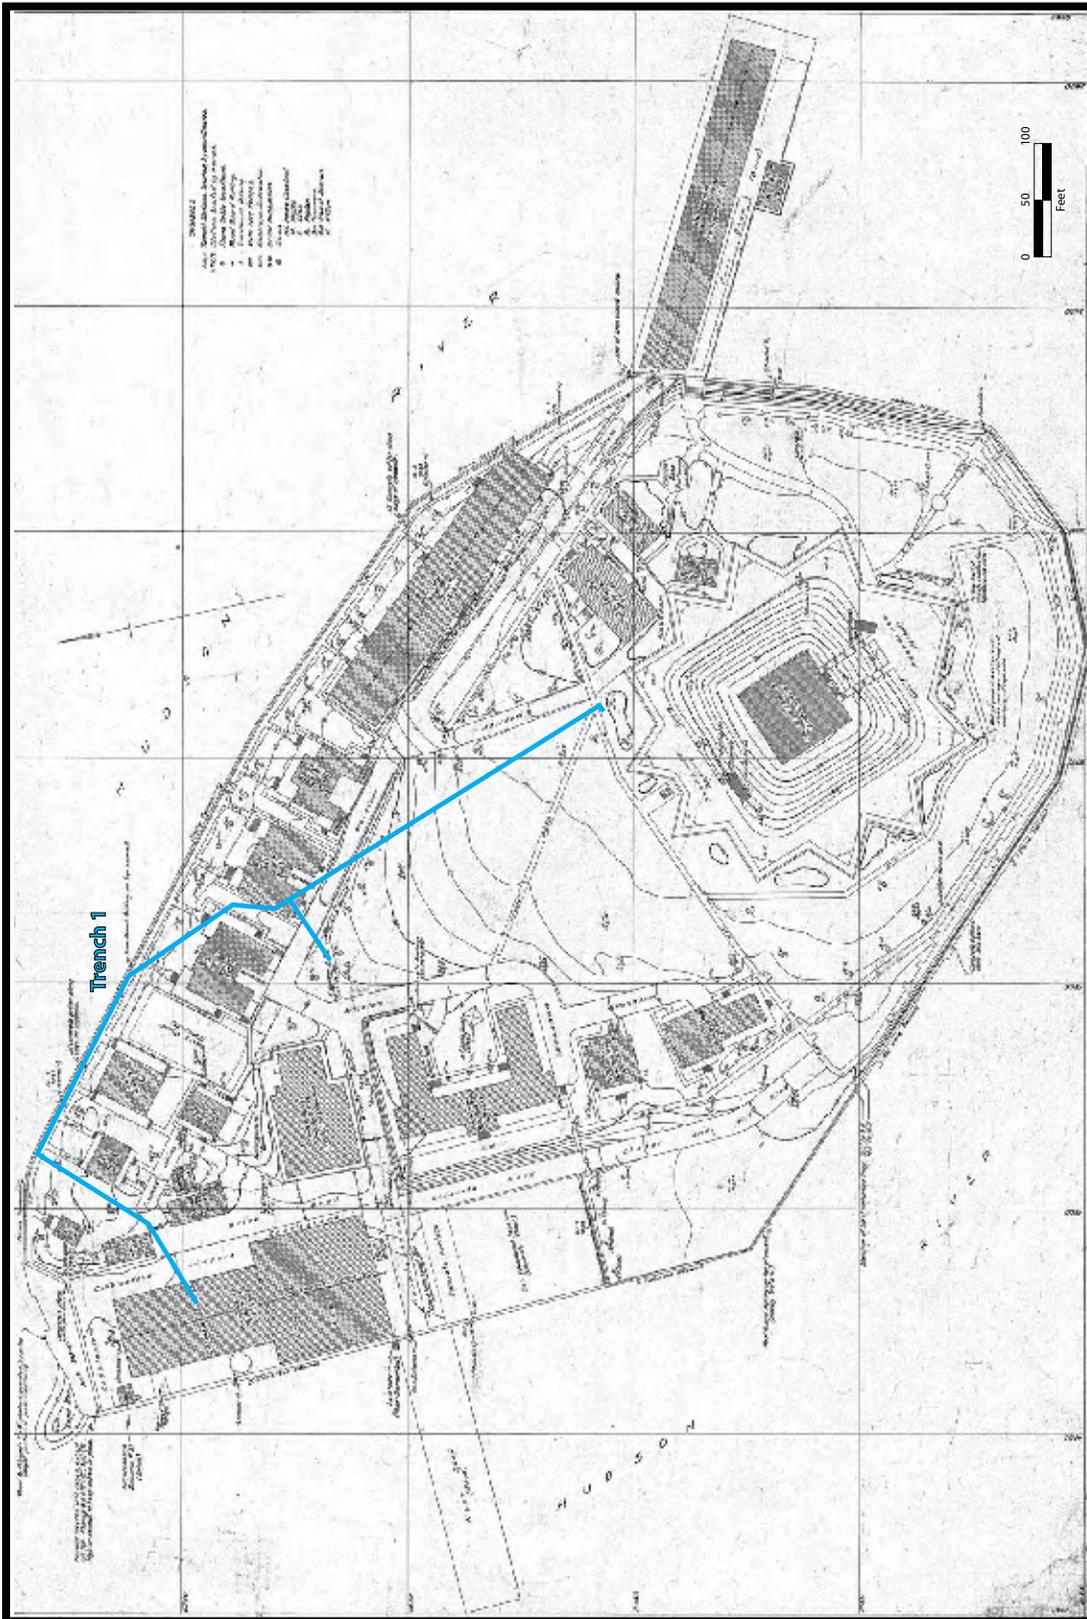
Figure 3.11. Trench 1: Site Plan Showing Photograph Locations.

Trench 1 was excavated by machine between March 1 and June 13, 2012. This trench was for a new water line connecting an existing line near the base of the statue to several buildings and facilities located at the northern end of the island (Figure 3.11). Roughly three feet wide and four feet deep, the trench commenced just outside the northeast corner of the fort and headed north for roughly 650 feet, first running parallel to and east of the main mall leading to the statue and then passing round the eastern side of the flag plaza. At the northern end of this segment, the trench was cut under the eastern walkway and ran for roughly 175 feet along the edge of the island, just inside the sea wall, before turning sharply westward for an additional 200 feet. At a point roughly 525 feet from the southern end of the trench a short westward extension was excavated to connect the line to a hydrant at a concession stand. The northern end of the trench terminated in the yard of the residence lying immediately north northwest of the flag plaza. Although further short section of trenching was undertaken beyond this point, soils in this area were already disturbed by the construction of walkways and utilities, and archeological monitoring was deemed unnecessary.

Remnants of a mortared rubble wall footing [1] were identified at the beginning point of Trench 1 when the contractor excavated to locate the existing water main to which the new line would be connected (Figures 3.11 and 3.12; Photograph 3.22). This feature, which was encountered 3.5 feet below the ground surface, ran east-west, parallel to and 26 feet north of the exterior face (or scarp) of the fort. Roughly two feet wide and one foot deep, the wall footing comprised a yellowish-tan mortared rubble with a mix of brick, shell, stone and other debris. On the eastern side of the trench the wall footing was cut and straddled by a concrete-encased conduit [3]. Several modern utilities, including a concrete junction box [2] and various lines [4, 5] crisscrossed the trench. The wall footing remnants were left intact and reburied by the contractor.

A representative soil profile of Trench 1 was documented approximately 100 feet north of the beginning point of the trench (Figure 3.11). This location was roughly 40 feet north of the northern edge of the walkway which branches off to the east from the south end of the main mall and loops around the perimeter of the fort and statue. The soil sequence commenced with a silty sandy loam A horizon [1] from 0.0 to 1.0 feet below the ground surface (Figure 3.13). This overlaid a thin sandy loam E horizon [2] that terminated at 1.3 feet below the ground surface. This, in turn, overlaid a medium sand B horizon [3] with five distinct lamellae bands, which are typically representative of undisturbed subsoil. The lamellae banding appeared roughly every 0.45 feet within this stratum to the full depth of the excavation at four feet below the ground surface.

Brick Feature 1: Two separate curving lengths of mortared brick walling [6,7], interpreted as parts of a cistern, were found crossing Trench 1 roughly 30 and 42 feet north of the northern edge of the walkway which branches off to the east from the south end of the main mall (Figures 3.11 and 3.14; Photograph 3.23). Both walls were two brick widths in thickness and had a mortar coating on their interior face. They were identified 1.7 feet below the ground surface

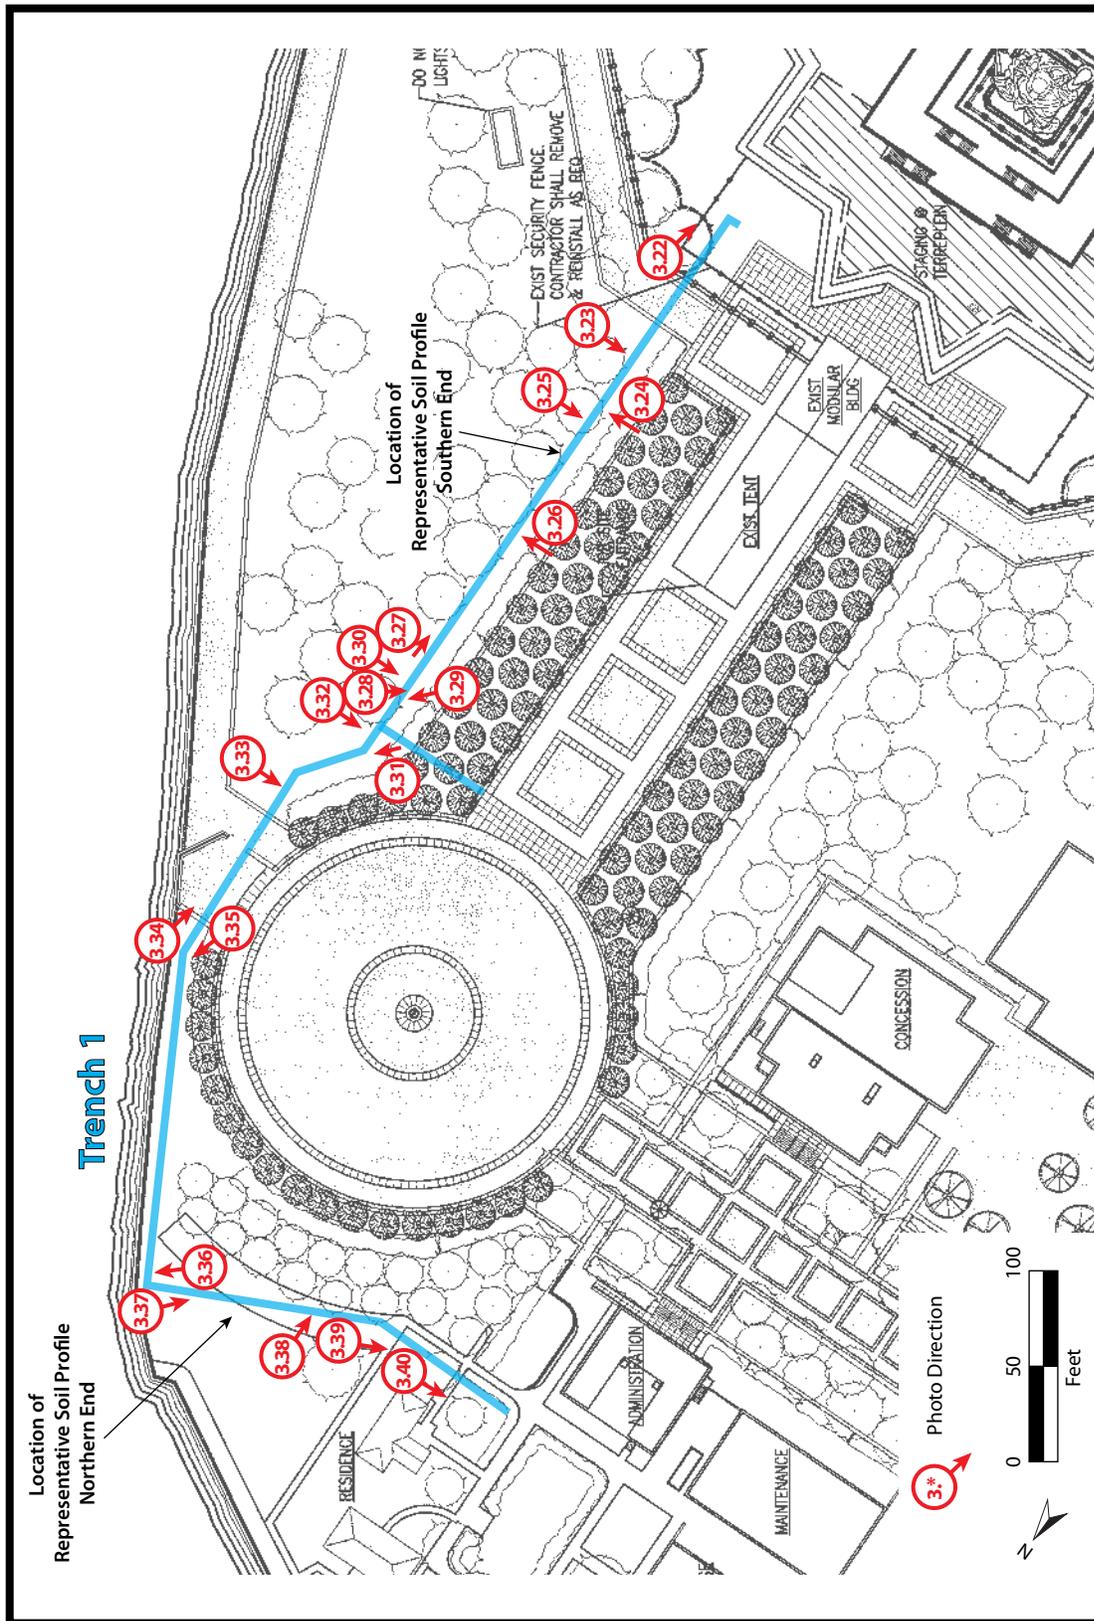
Figure 3.12. Trench 1: Site Plan with Detail of Counterscarp.

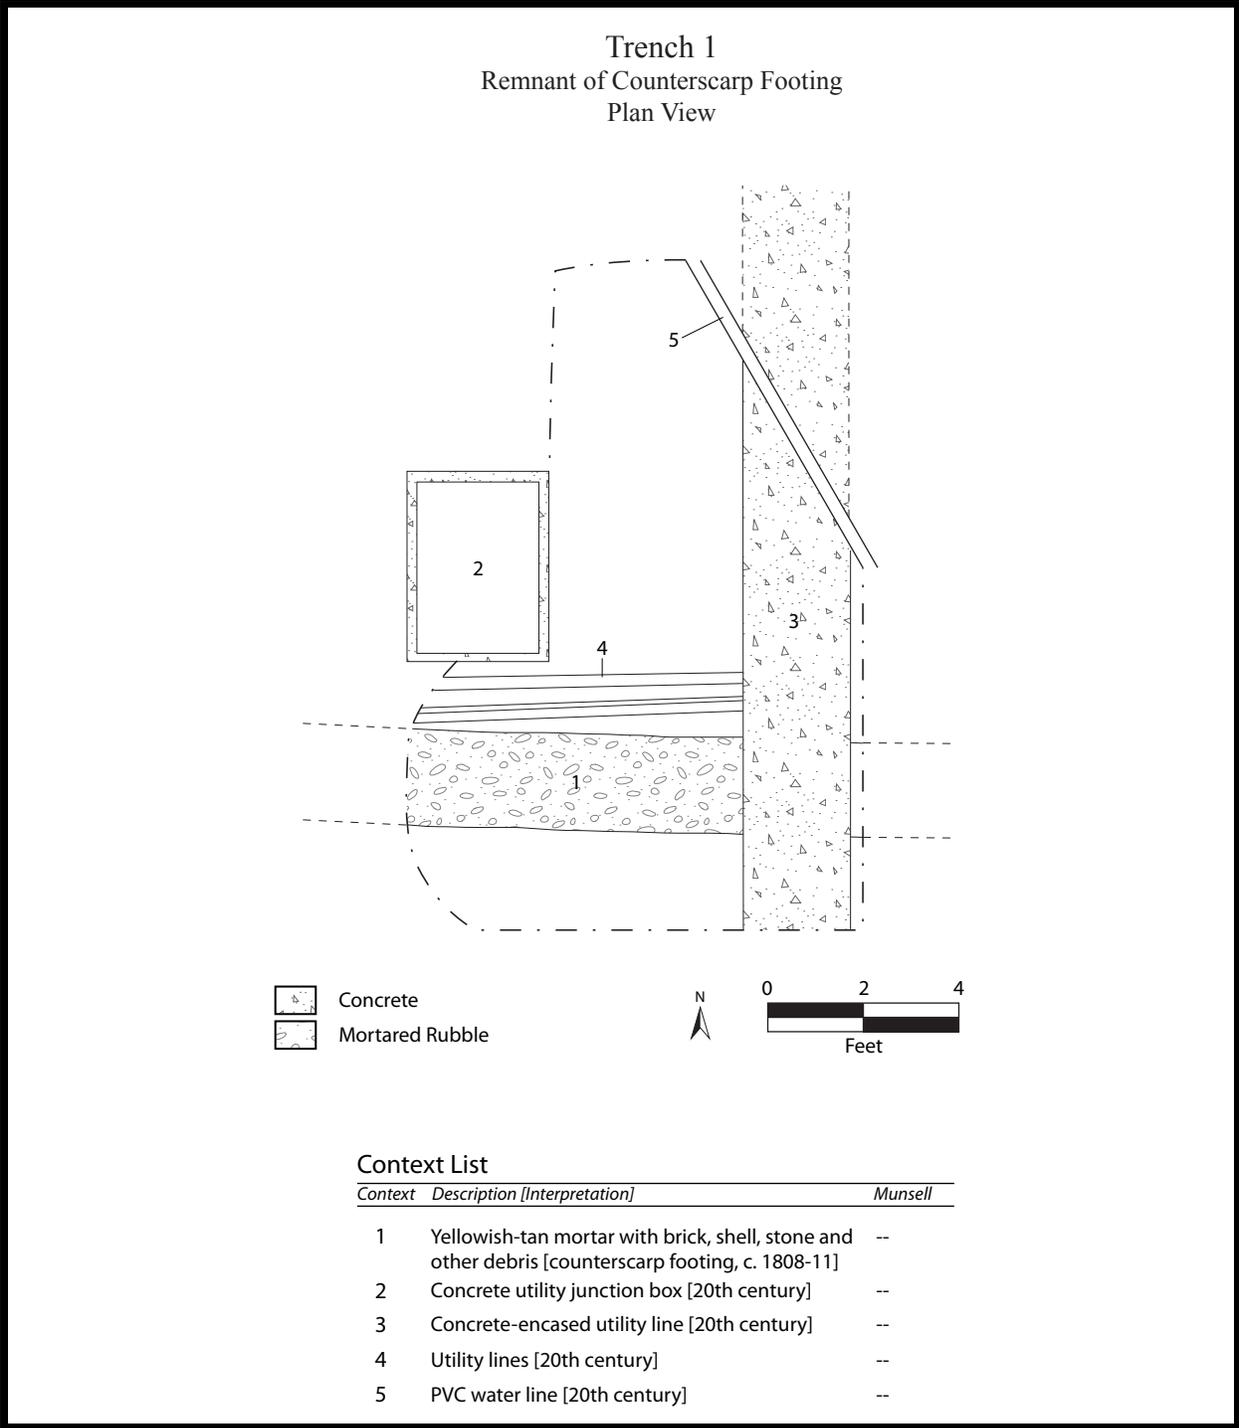
Photograph 3.22. Trench 1: view looking south showing the remains of the counterscarp footing [1] surrounded by later utilities; scales in feet (Photographer: Joshua Butchko, March 2012) [HRI Neg.#11063/D12-41].

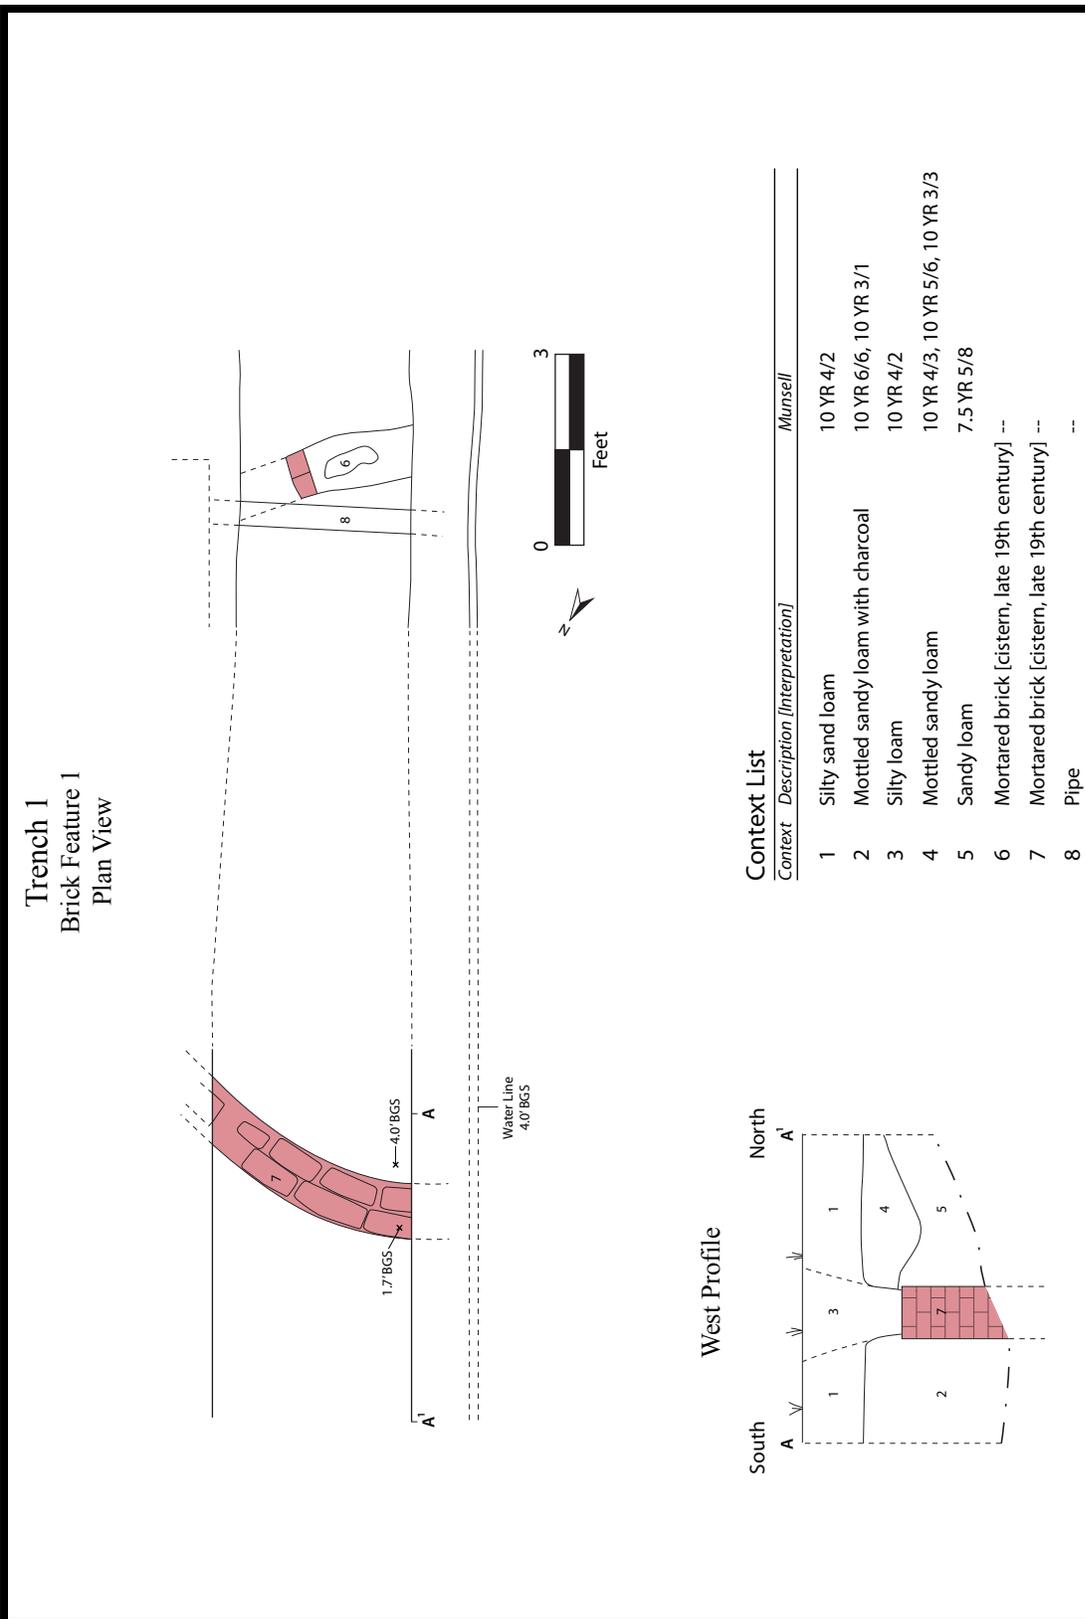
Photograph 3.23. Trench 1: view looking northwest showing Brick Feature 1, a cistern; note the mortar facing on the interior wall of the cistern [7]; scales in feet and tenths of feet (Photographer: James S. Lee, April 2012) [HRI Neg.#11063/D14-29].

and extended below the limit of excavation. It was clear from their curving alignment that the two walls would have connected beyond the limits of excavation on either side of the trench. The fill within this circular cistern consisted of a mottled sandy loam with brick debris [2]. A large concrete manhole box to the east likely impacted the feature beyond the limit of excavation and an older water line trench also likely cut through the feature to the west. The segments of cistern walling within the route of the water line were removed carefully after documentation.

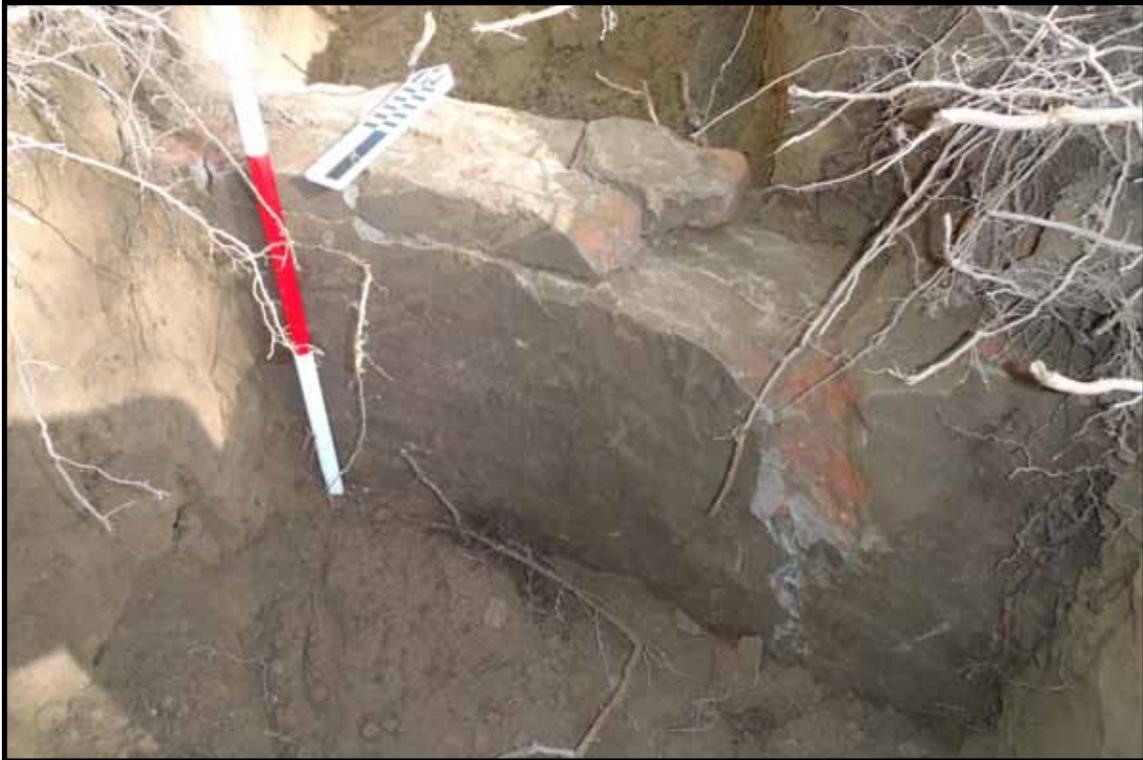
Photograph 3.24. Trench 1: view looking east showing Brick Feature 2, a fragment of masonry not in its original depositional context (Photographer: Joshua Butchko, May 2012) [HRI Neg.#11063/D15-73].

Brick Feature 2: What initially appeared to be a concrete and brick footing was identified in the east side of Trench 1 approximately 80 feet north of the northern edge of the walkway which branches off to the east from the south end of the main mall (Photograph 3.24). This feature was encountered between 1.5 and three feet below the ground surface and extended for a length of 3.5 feet. Upon closer examination it was established that this was not an intact footing and was a fragment of masonry that had likely been displaced from elsewhere and redeposited during utilities installation.

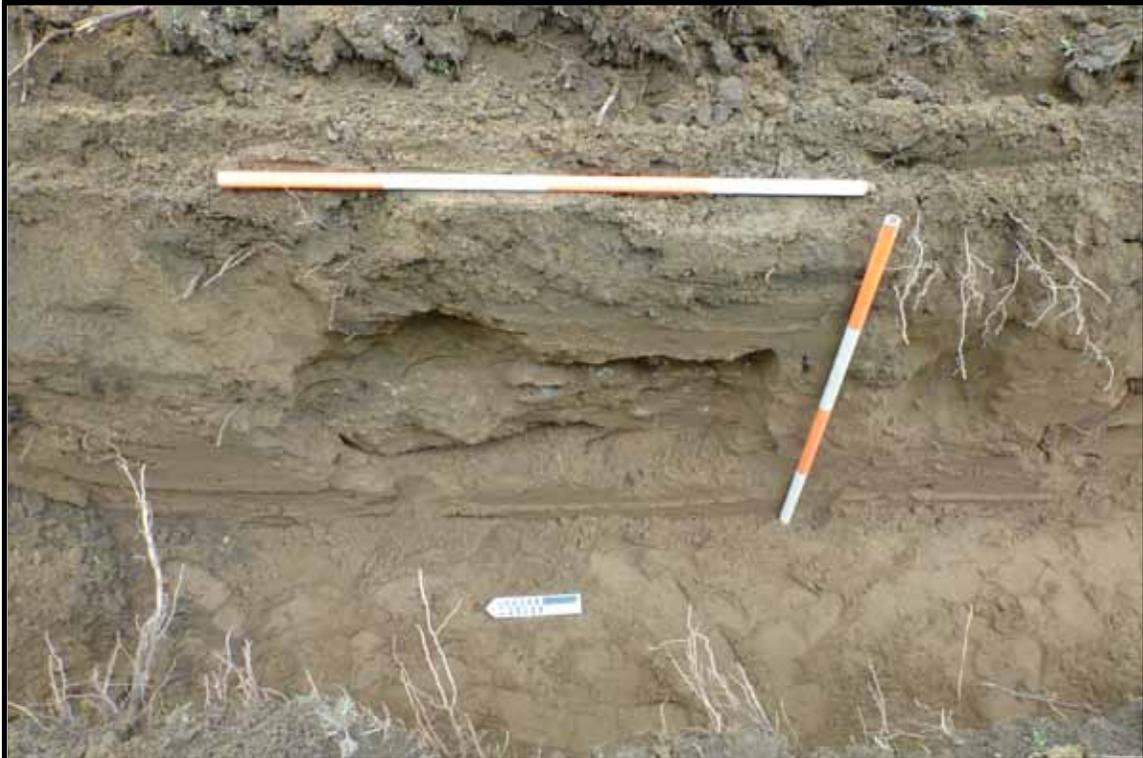
Figure 3.15. Trench 1: Profile of Brick Feature 3.

the east from the south end of the main mall (Figures 3.11 and 3.15; Photograph 3.25). This feature was encountered roughly 2.2 feet below the ground surface and extended to a depth of at least five feet (the limit of excavation of Trench 1). The external diameter of this shaft feature was projected to be at least five feet. The feature was photographed in profile and left undisturbed.

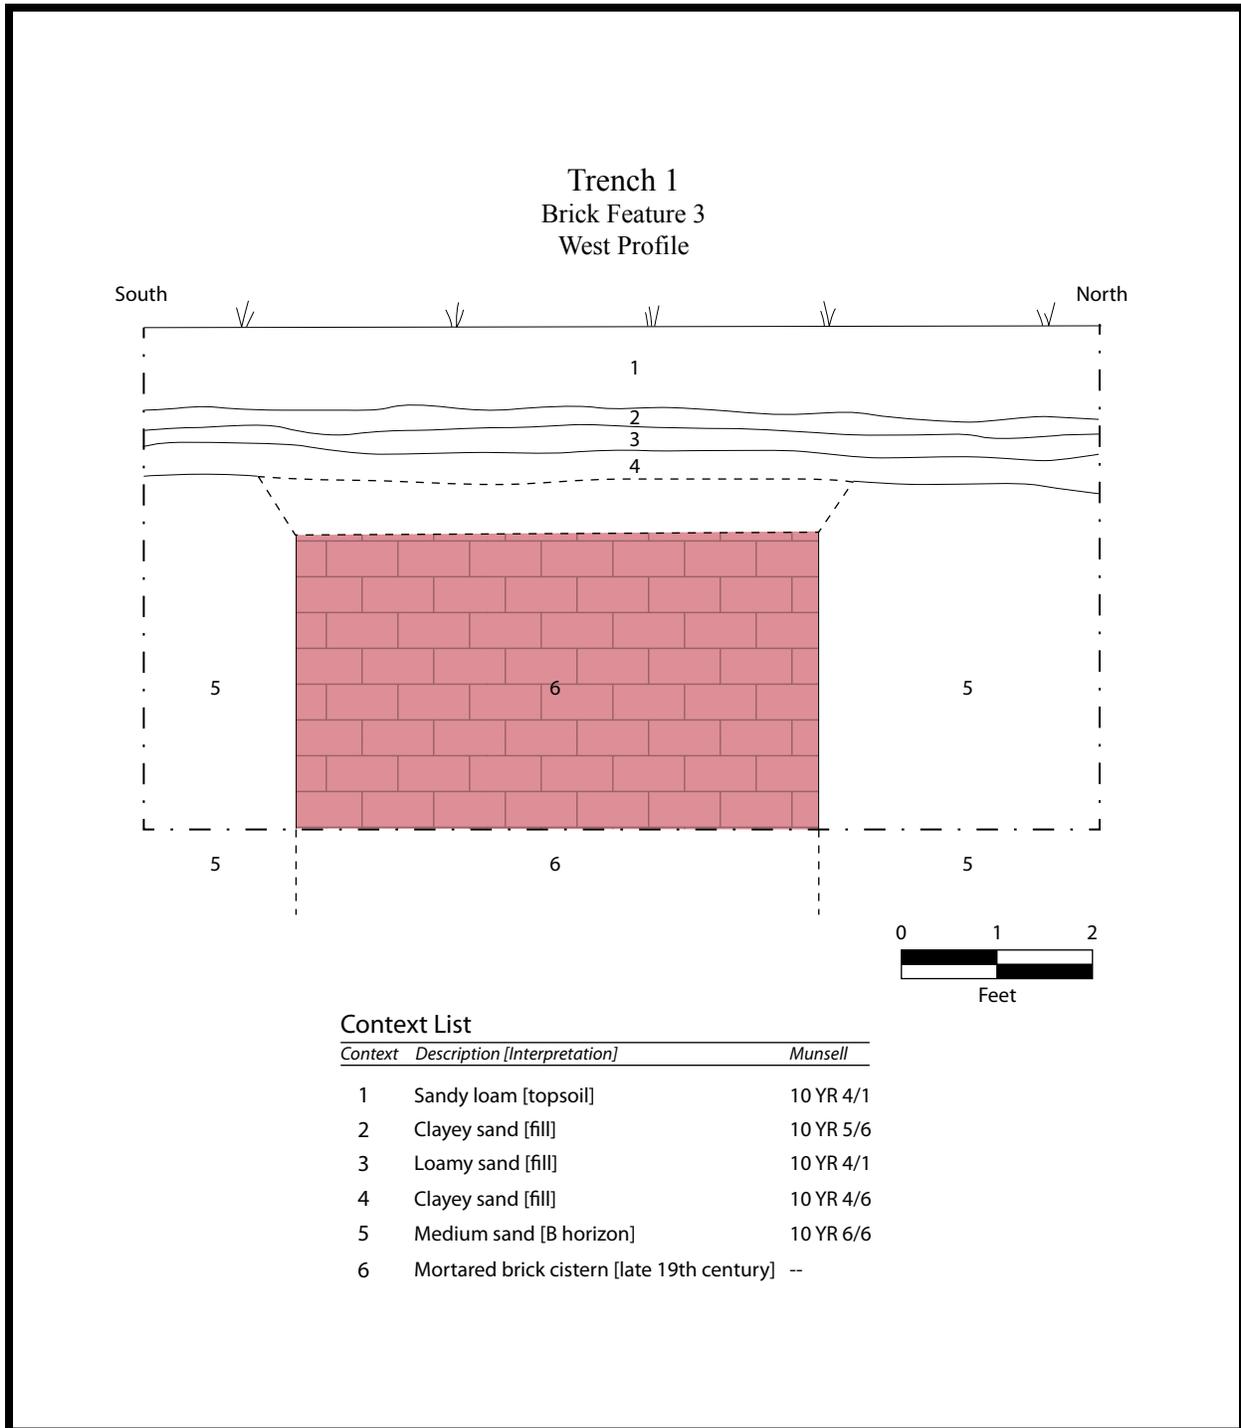
Photograph 3.25. Trench 1: view looking west showing Brick Feature 3, a cistern; the view shows the exterior face of the feature; scales in feet and tenths of feet (Photographer: Joshua Butchko, May 2012) [HRI Neg.#11063/D15-82].

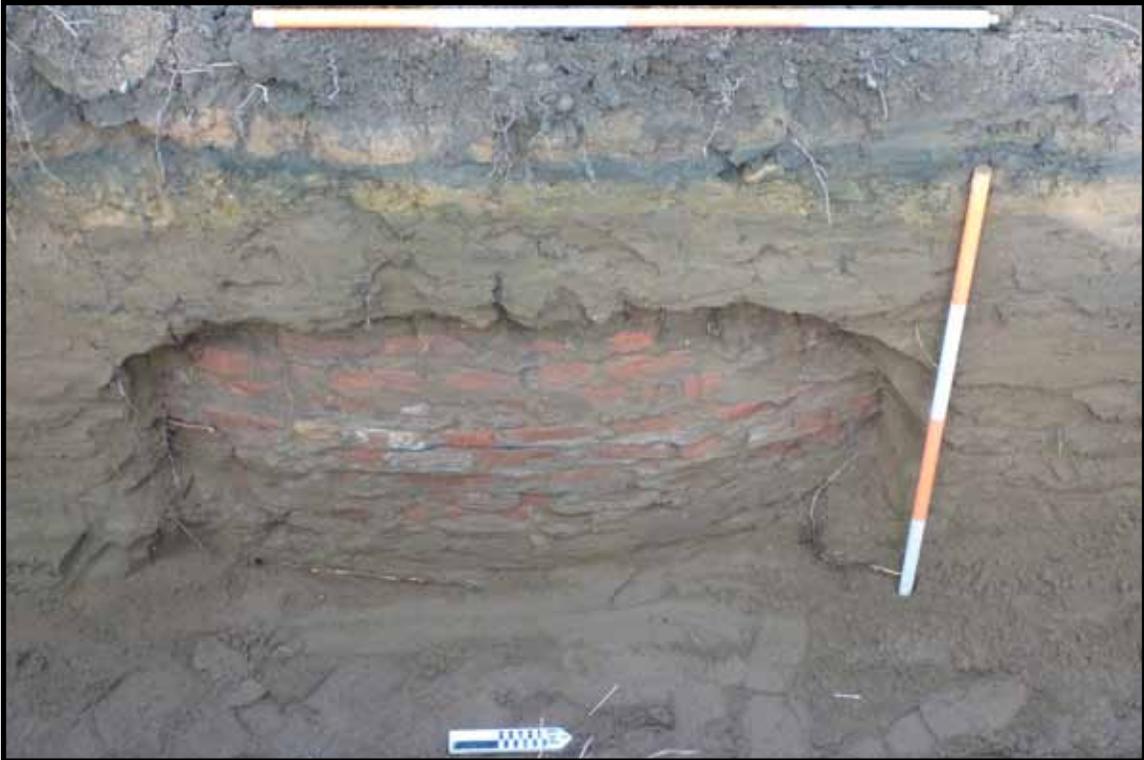
Figure 3.16. Trench 1: Plan and Profile of Brick Feature 4 (Fire Pit).

Brick Feature 4: A circular mortared brick shaft feature with a mortared floor [7], probably a fire pit, was identified within Trench 1 roughly 11.5 feet northeast of an existing sewer cap on the east side of the main mall roughly midway between the statue base and the flag plaza (Figures 3.11 and 3.16; Photograph 3.26). In this section of Trench 1 a sandy loam topsoil [1] overlaid a buried A horizon of loamy sand [2]. This in turn overlaid a mottled sand with brick and coal flecking [3], which is interpreted as evidence of a landscaping episode, probably in the late 1930s, that truncated and buried the fire pit. The brick pit [7], 3.8 feet in exterior diameter and two brick widths in thickness, was encountered roughly 2.7 feet below the ground surface and survived to a height of five brick courses. The bottom course of brick masonry extended beyond the exterior of the fire pit shaft giving a slightly wider diameter of 4.2 feet. The fire pit was removed whole by backhoe, whereupon a four-inch diameter clay pipe washout was observed on its eastern side. Most of the bricks were mold-impressed with the word “GRAY.” The base of the fire pit rested on the interface of a mottled sand fill [8] and a medium to fine sand B horizon [9]. This interface occurred at 4.3 feet below the ground surface. Based on the mold-impressed brick masonry, the fire pit was probably contemporary with the brick utility pipe enclosure and officer’s house (see below), and therefore was likely to have been in use in the early/mid-20th century.

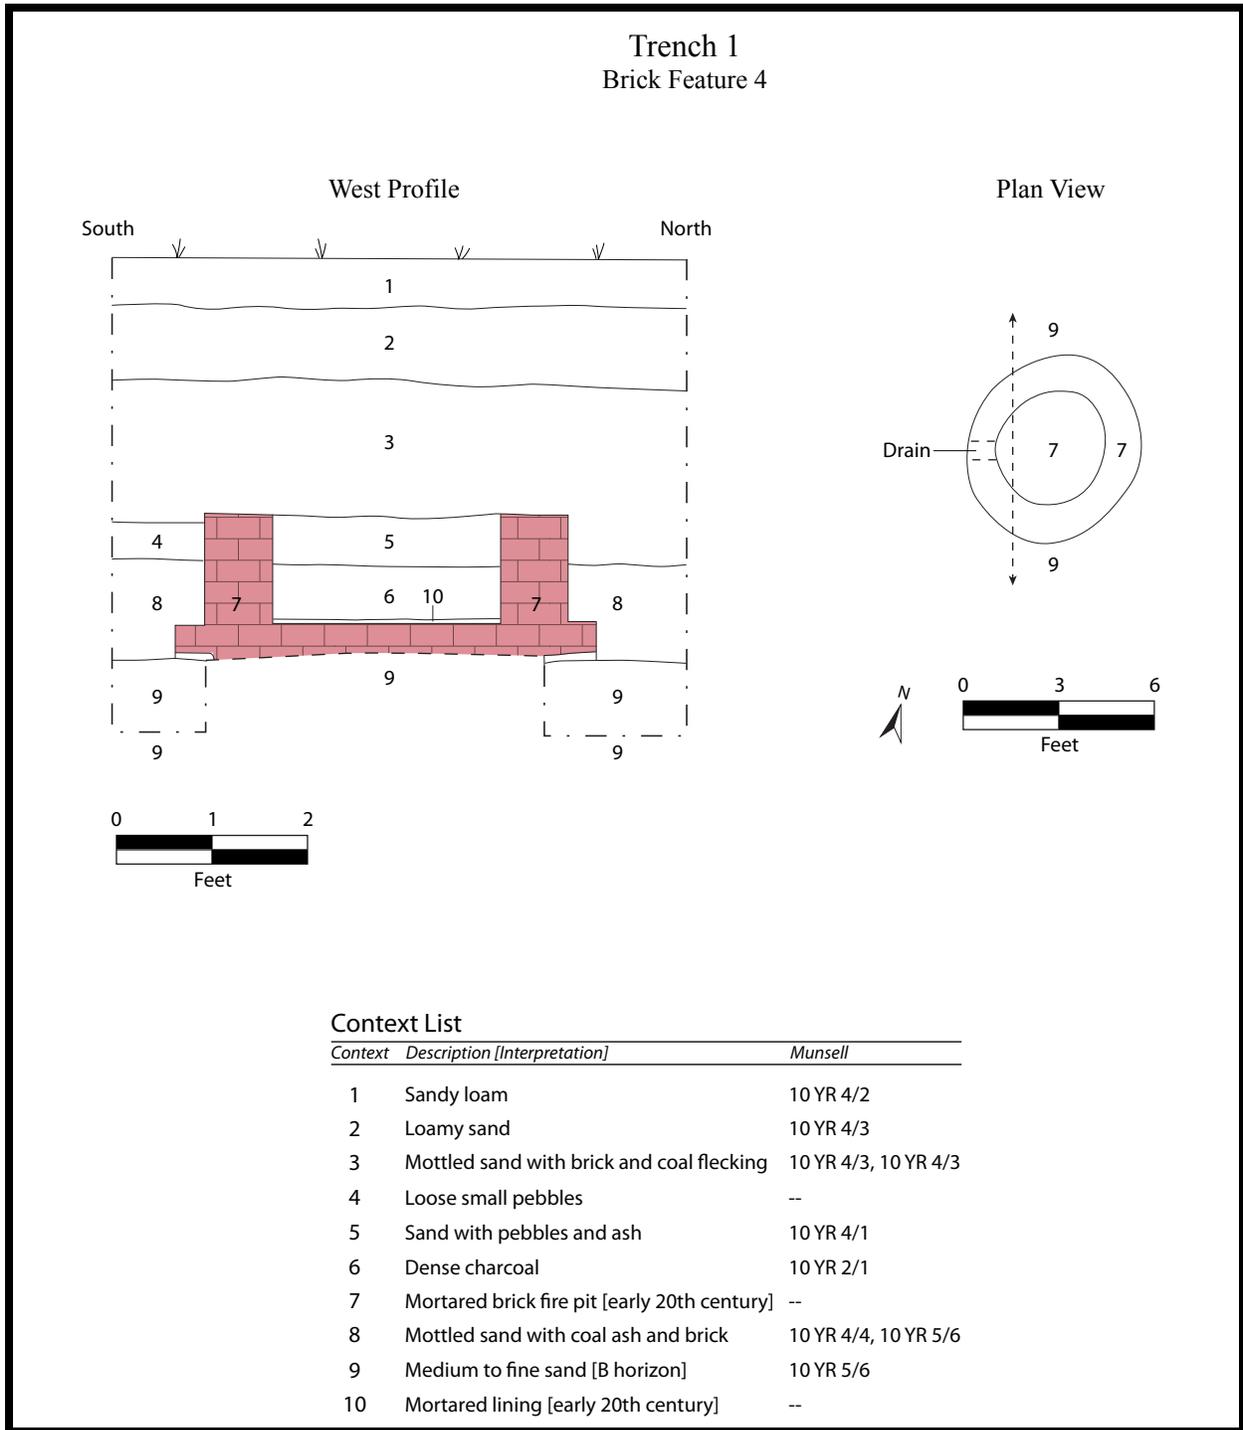
Photograph 3.26. Trench 1: view looking east showing Brick Feature 4, a fire pit; scales in feet and tenths of feet (Photographer: Joshua Butchko, May 2012) [HRI Neg.#11063/D15-100].

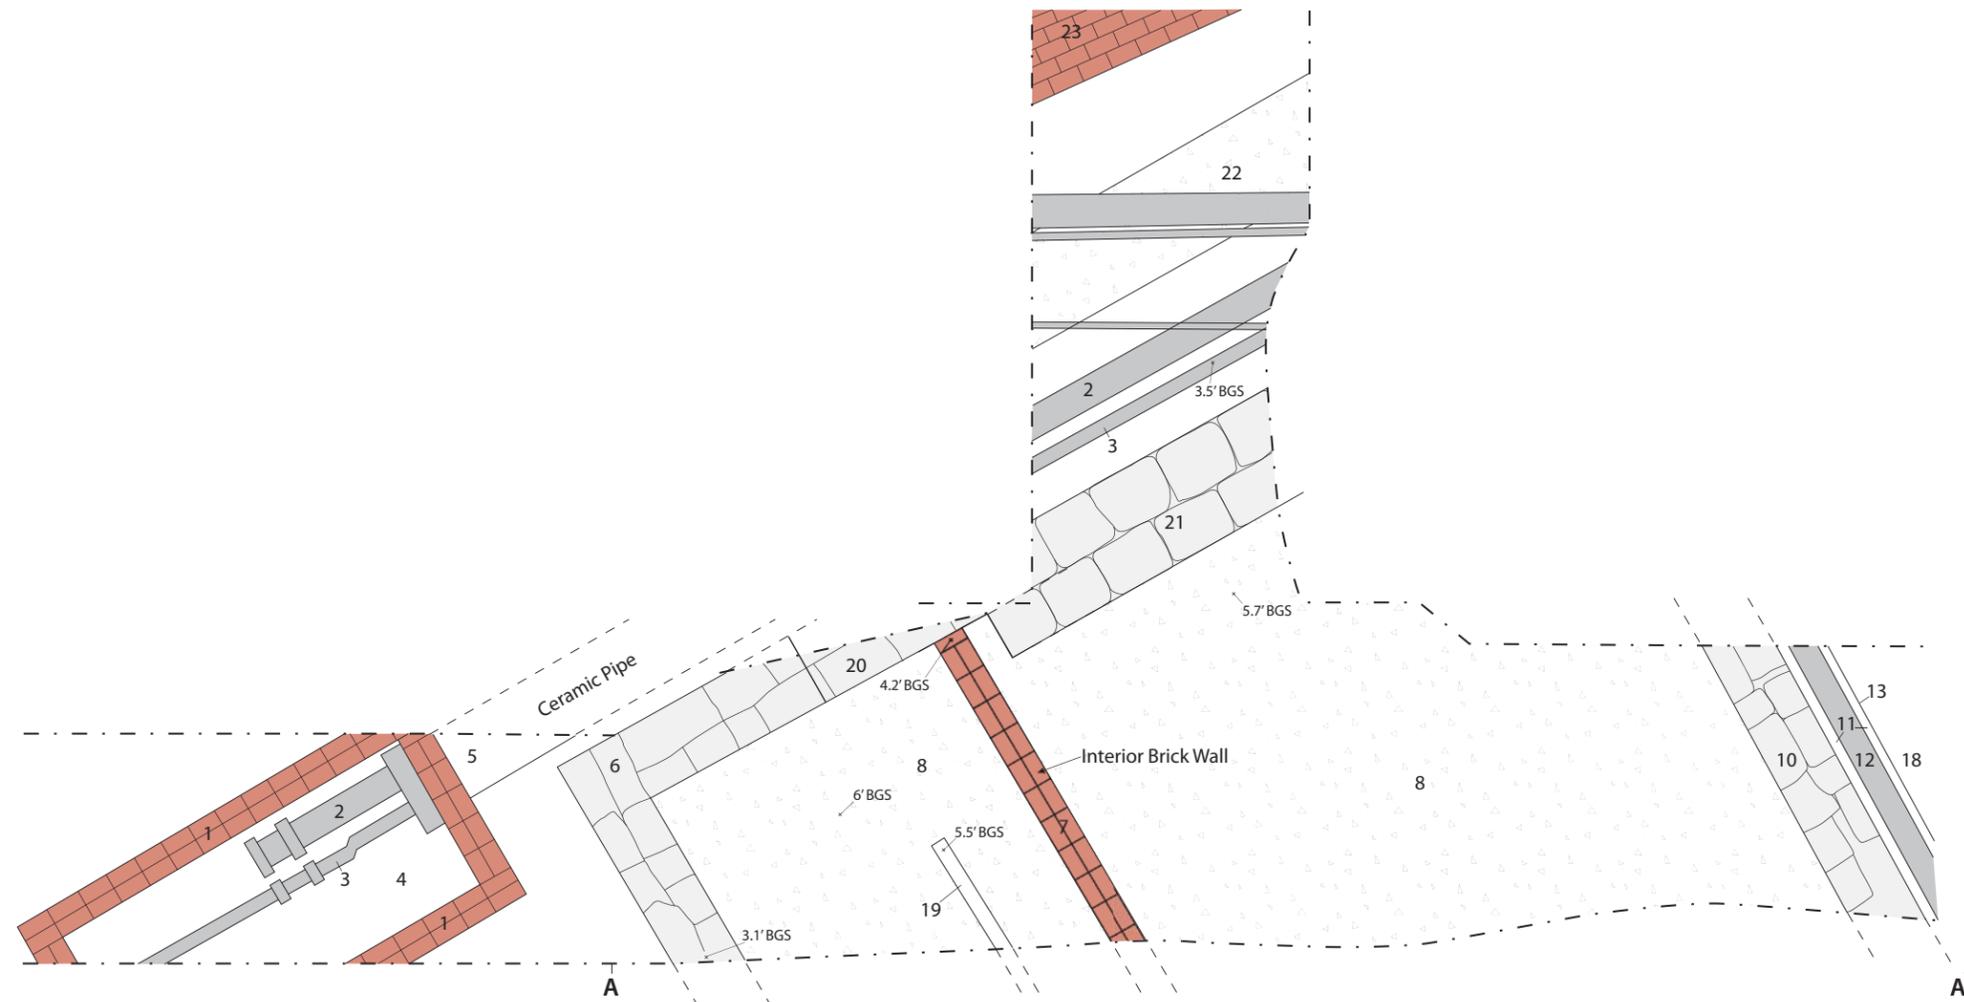
Photograph 3.27. Trench 1: view looking south southwest showing the brick utility pipe enclosure adjacent to the officer's house foundation; scales in feet and tenths of feet (Photographer: Joshua Butchko, May 2012) [HRI Neg.#11063/D15-111].

Brick Utility Pipe Enclosure: A rectangular mortared brick enclosure [1] containing two cast-iron pipes [2, 3] was identified roughly three feet below ground surface (Figures 3.11 and 3.17; Photograph 3.27). This feature measured roughly five feet by ten feet and was oriented northwest-southeast. Mostly contained within the limits of Trench 1, the northeast corner of the feature was located five feet east and 37 feet north of the sewer cap referenced in the discussion of Brick Feature 4. The masonry was two brick widths in thickness and the interior of the enclosure was filled with chunks of concrete and brick [4]. Piercing the northwestern side of the enclosure was a clay pipe [5], two feet square in cross section, which extended northwest through the enclosure wall and beyond the limit of excavation. This clay pipe served as a conduit for the two cast-iron water pipes, one of which [2] was six inches in diameter, the other [3] three inches. As with the brick fire pit, many of the bricks were mold-impressed with the word "GRAY."

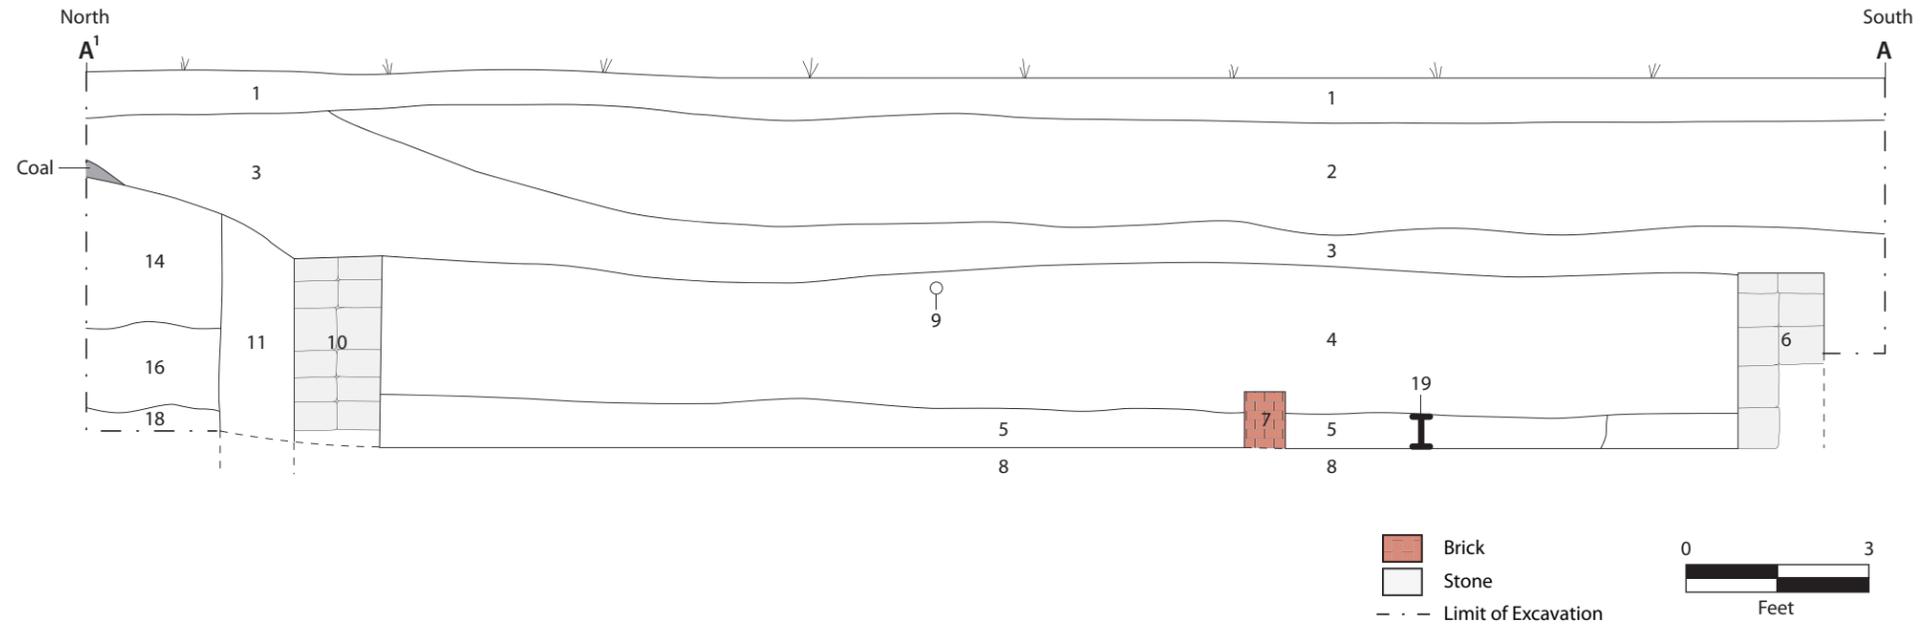
Photograph 3.28. Trench 1: view looking south southwest showing the southern corner of the officer's house foundation [6], an interior basement wall [7] and concrete floor [8]; note the steel I-beam on the basement floor; scales in feet and tenths of feet (Photographer: Joshua Butchko, May 2012) [HRI Neg.#11063/D15-124].

As recorded in the field, the southern corner of the foundation [6] was comprised of a section of a roughly 1.4-foot-thick southeast wall and a section of a 1.7-foot-thick southwest wall, both being encountered approximately three feet below the ground surface (Photographs 3.28-3.30). The corresponding northwest foundation [10] was also documented as a mortared stone wall, 1.4 feet thick, encountered roughly 3.5 feet below the ground surface (Photograph 3.31). The southwest foundation was observed again in the westward trench extension [21], but was less well preserved owing to disturbance from the construction of modern utilities in this area (Photograph 3.32).

Within the footprint of this building, a mortared brick foundation [7], two brick widths in thickness and running southwest-northeast, was uncovered 7.5 feet northwest of the main southeast foundation (Photographs 3.28-3.30). The southwestern end of this brick foundation was set against an in-filled gap in the exterior foundation [20]. This interior division of the structure created a 16-foot-wide room to the northwest and a smaller eight-foot-wide room to the southeast. A concrete floor [8] was uncovered across the full width of the building footprint at a depth of six feet below the ground surface. Within the smaller southeastern room, a steel I-beam [19] was noted on top of the concrete floor. The beam, the purpose of which is unknown, ran parallel to the southeast foundation and interior brick foundation. It may be a structural member from higher up within the building that had fallen to its presently recorded position.

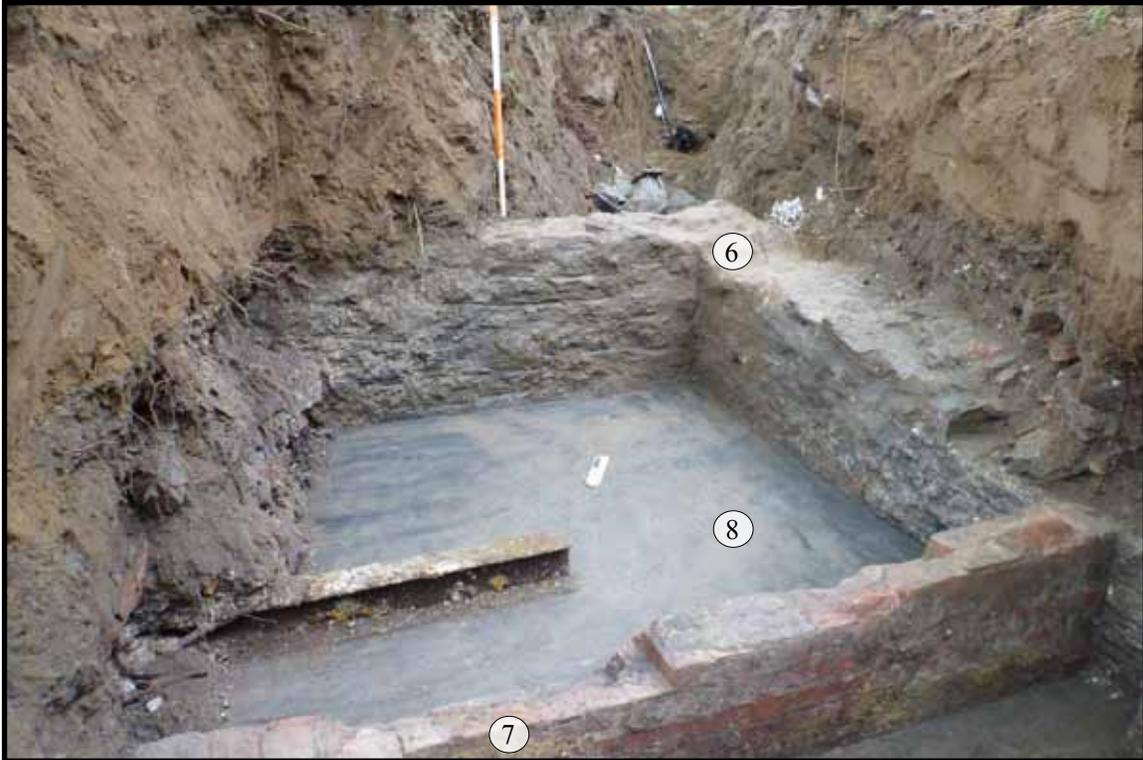
Photograph 3.29. Trench 1: view looking northeast showing the southern corner of the officer's house foundation [6], an interior basement wall [7] and concrete floor [8]; note the steel I-beam [19] on the basement floor; scales in feet and tenths of feet (Photographer: Joshua Butchko, May 2012) [HRI Neg.#11063/D15-126].

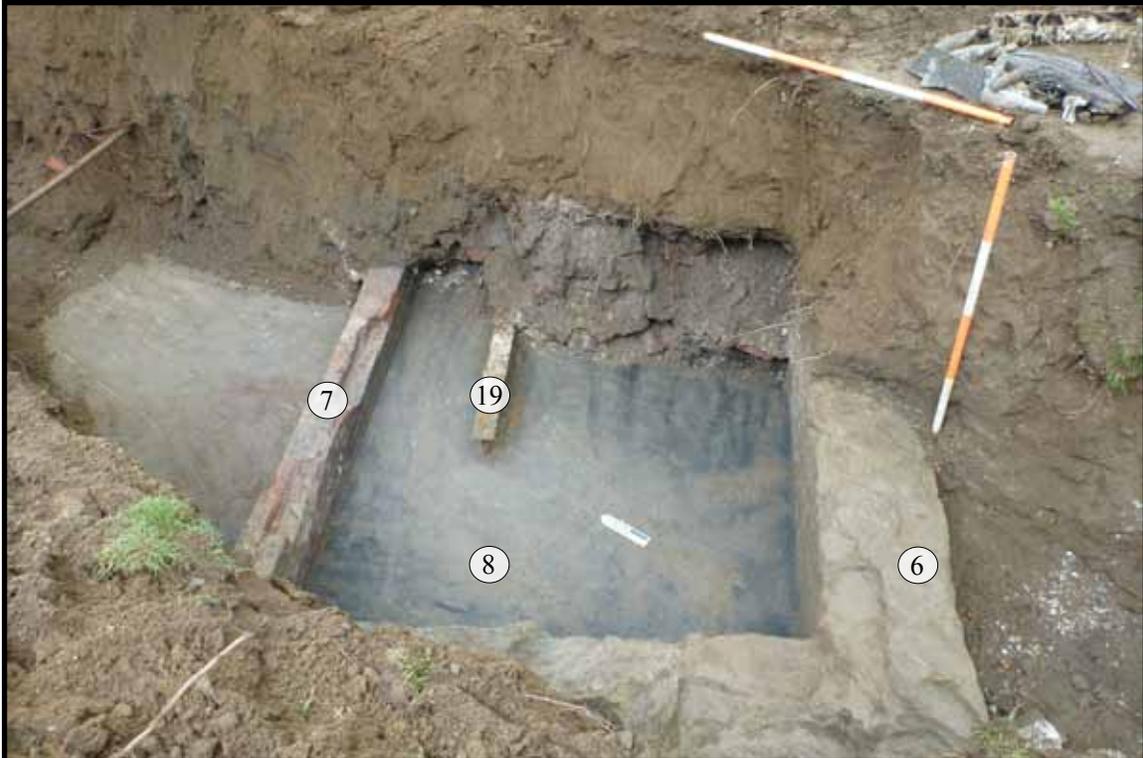
Photograph 3.30. Trench 1: view looking west showing the southern corner of the officer's house foundation [6], an interior basement wall [7] and concrete floor [8]; note the steel I-beam [19] on the basement floor; scales in feet and tenths of feet (Photographer: Joshua Butchko, May 2012) [HRI Neg.#11063/D15-136].

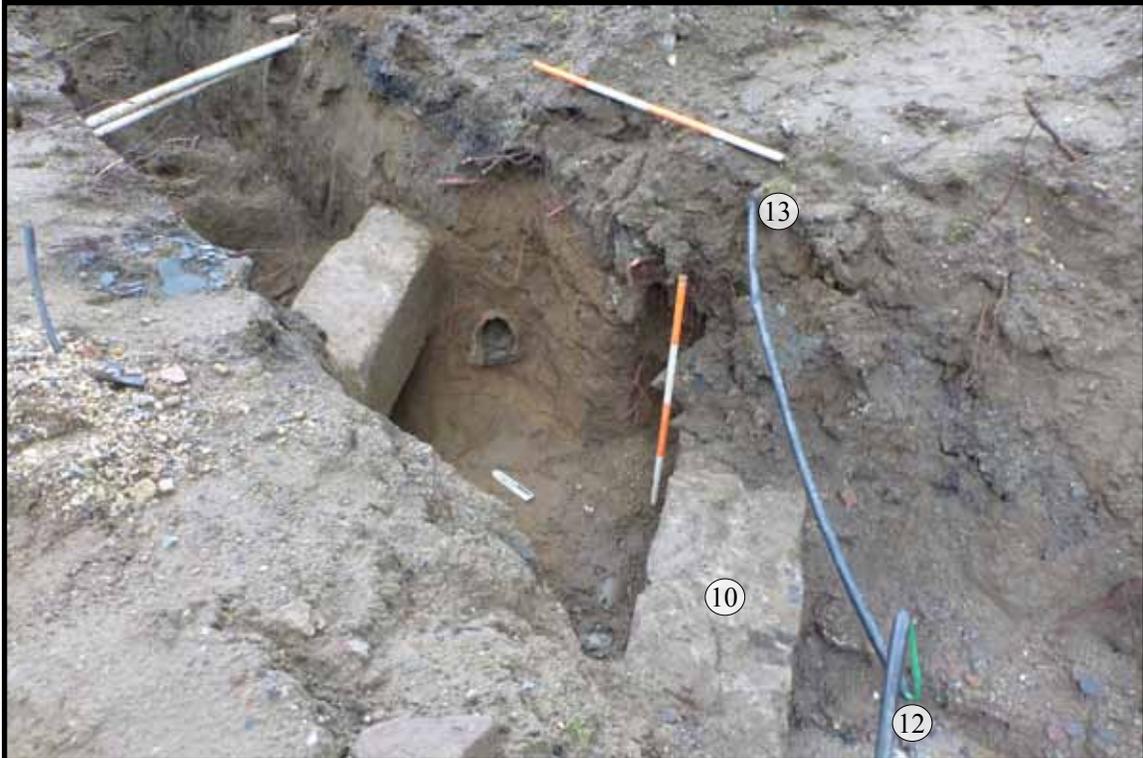
Photograph 3.31. Trench 1: view looking northeast showing the northwest foundation of the officer's house [10] with utilities passing alongside the building's exterior [12, 13]; scales in feet and tenths of feet (Photographer: Joshua Butchko, May 2012) [HRI Neg.#11063/D15-174].
