**ARCHEOLOGICAL MONITORING
LIFE AND SAFETY UPGRADES
STATUE OF LIBERTY NATIONAL MONUMENT
LIBERTY ISLAND, NEW YORK CITY, NEW YORK**

**National Park Service
PMIS Number: STLI 155567
NRAP Project Number: STLI 2011B**

January 2013

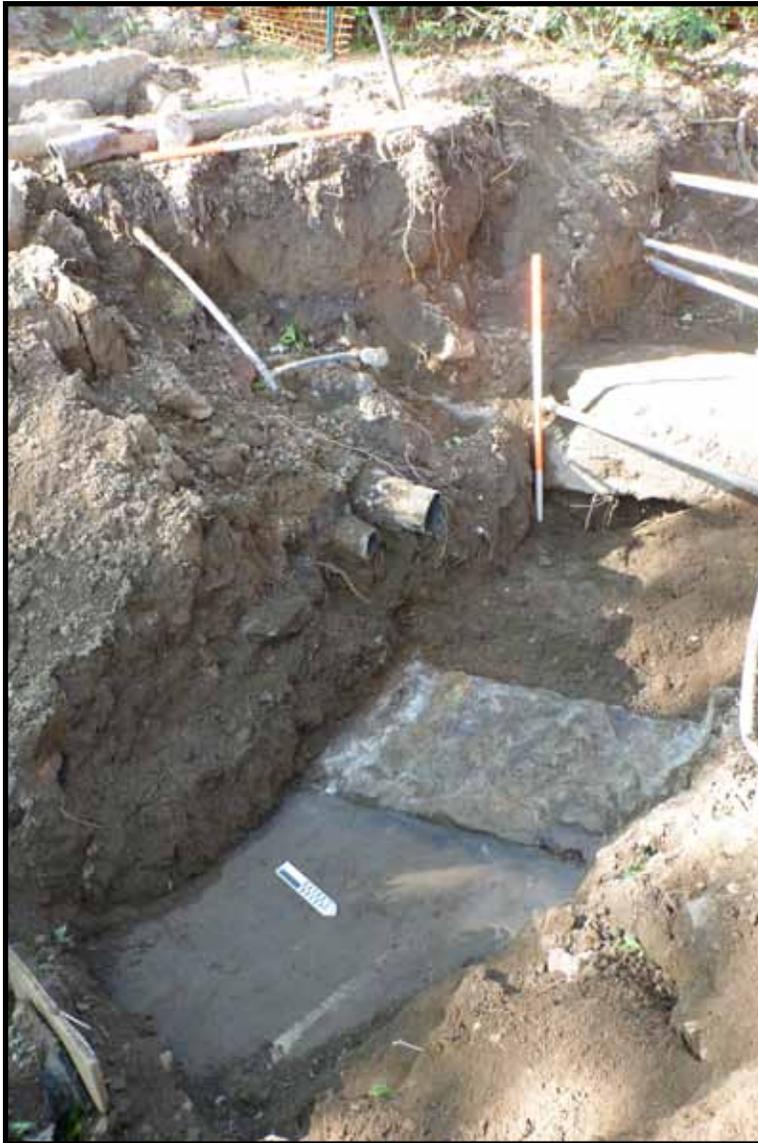
Photograph 3.32. Trench 1, Westward Extension: view looking southwest showing the southwest foundation [21] of the officer's house and a concrete-encased utility [22]; scales in feet and tenths of feet (Photographer: Joshua Butchko, May 2012) [HRI Neg.#11063/D16-40].

As recorded in the field, the southern corner of the foundation [6] was comprised of a section of a roughly 1.4-foot-thick southeast wall and a section of a 1.7-foot-thick southwest wall, both being encountered approximately three feet below the ground surface (Photographs 3.28-3.30). The corresponding northwest foundation [10] was also documented as a mortared stone wall, 1.4 feet thick, encountered roughly 3.5 feet below the ground surface (Photograph 3.31). The southwest foundation was observed again in the westward trench extension [21], but was less well preserved owing to disturbance from the construction of modern utilities in this area (Photograph 3.32).

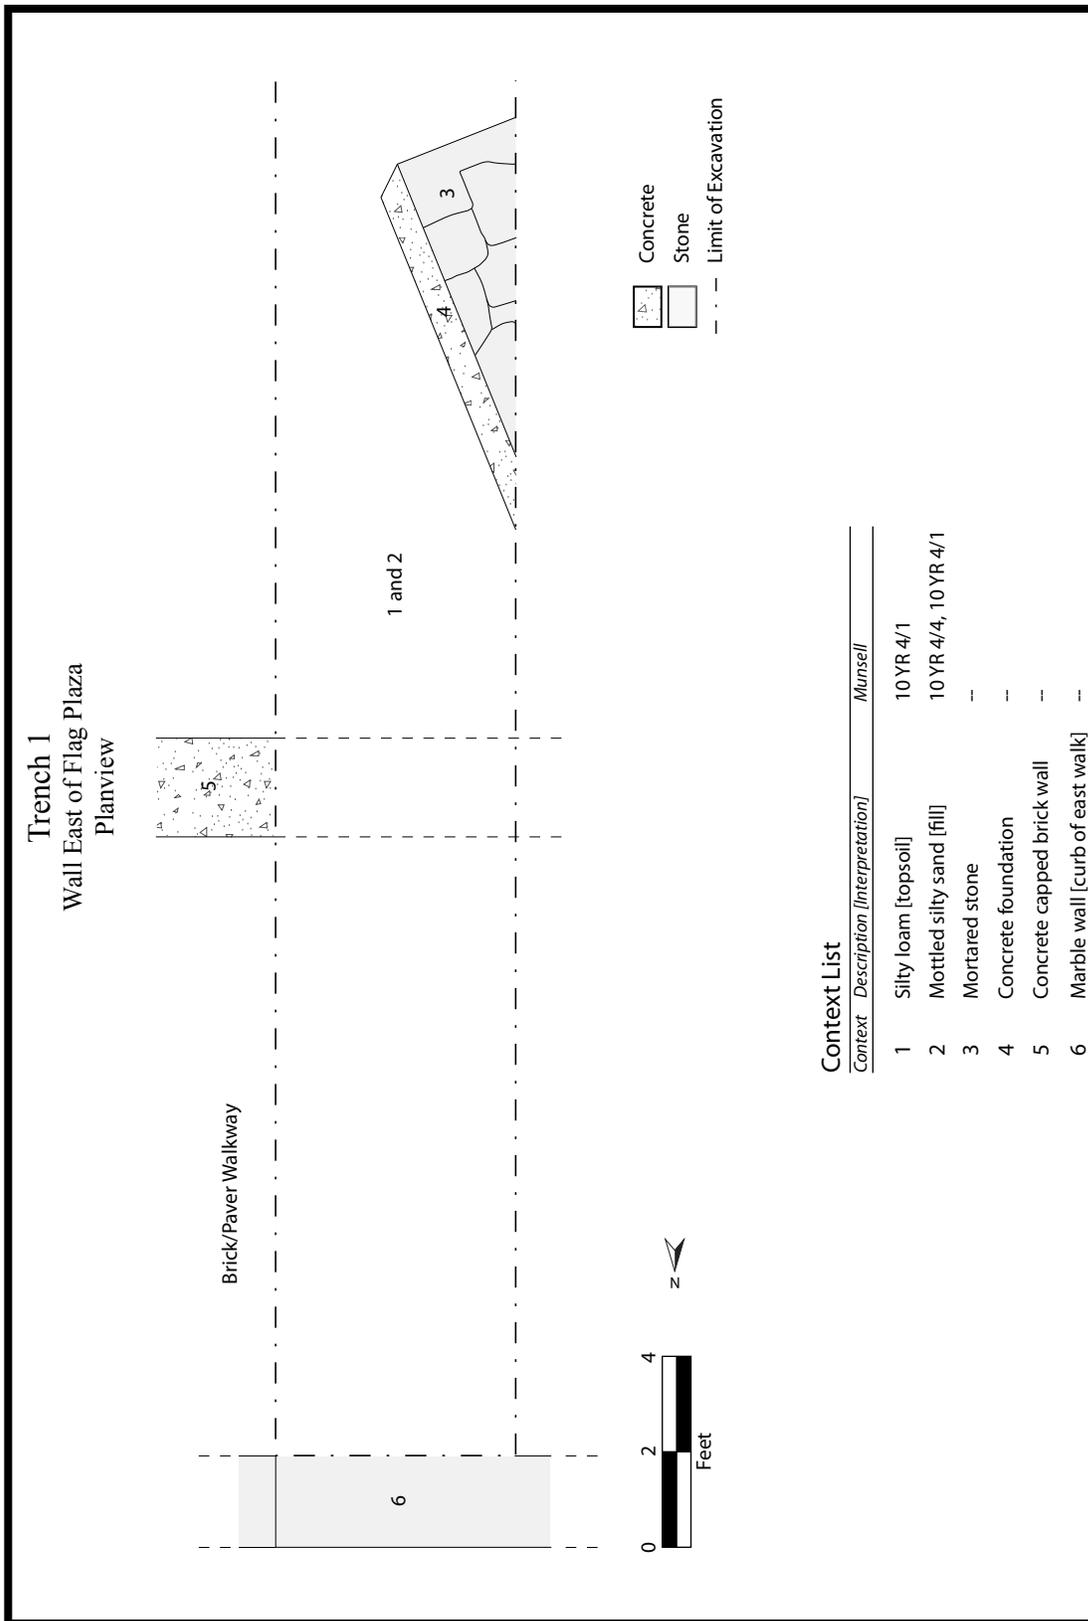
Figure 3.19. Trench 1. Plan of Wall East of Flag Plaza.

At the point roughly 20 feet south of where Trench 1 intersected the walkway heading east from the flag plaza to the edge of the island, a mortared stone footing on a concrete base was identified in the western profile (Figures 3.11 and 3.19; Photograph 3.33). The wall appeared to form the corner of a building or structure that was oriented northwest-southeast and northeast-southwest. The mortared stone masonry [3]

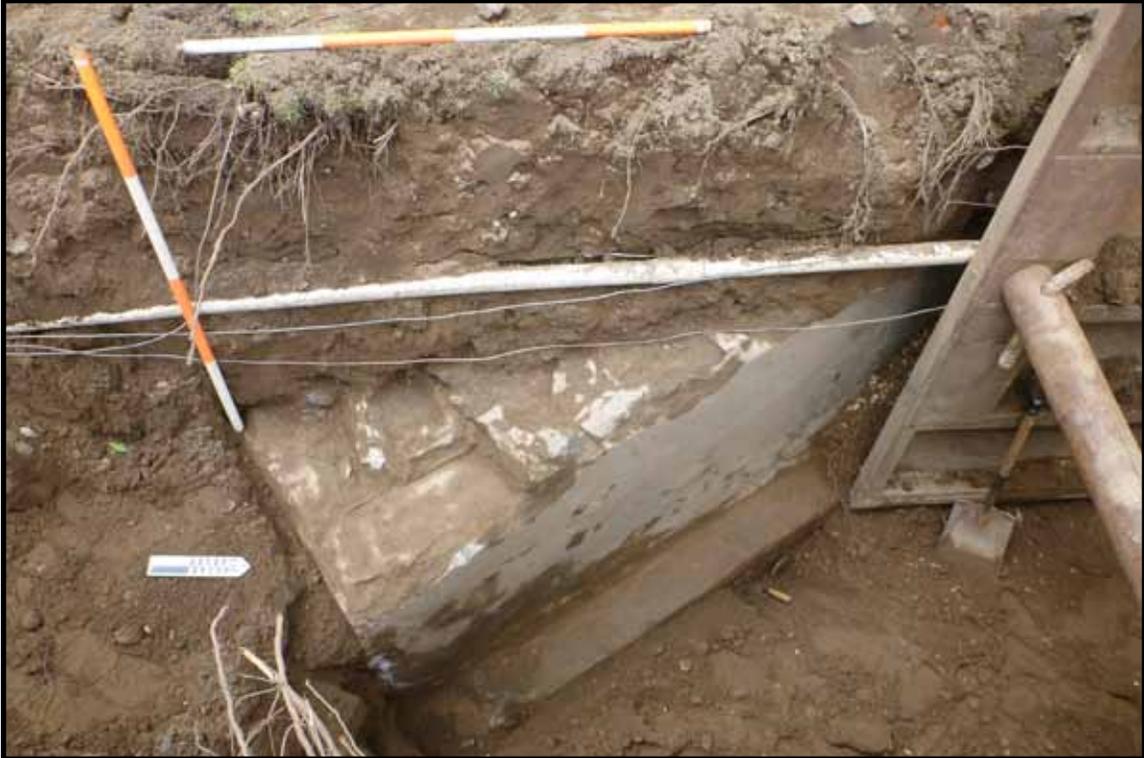
Photograph 3.33. Trench 1: view looking west showing the mortared stone wall [3] identified east of the flag plaza; note the wall is set on a concrete base [4]; scales in feet and tenths of feet (Photographer: Joshua Butchko, May 2012) [HRI Neg.#11063/D15-59].

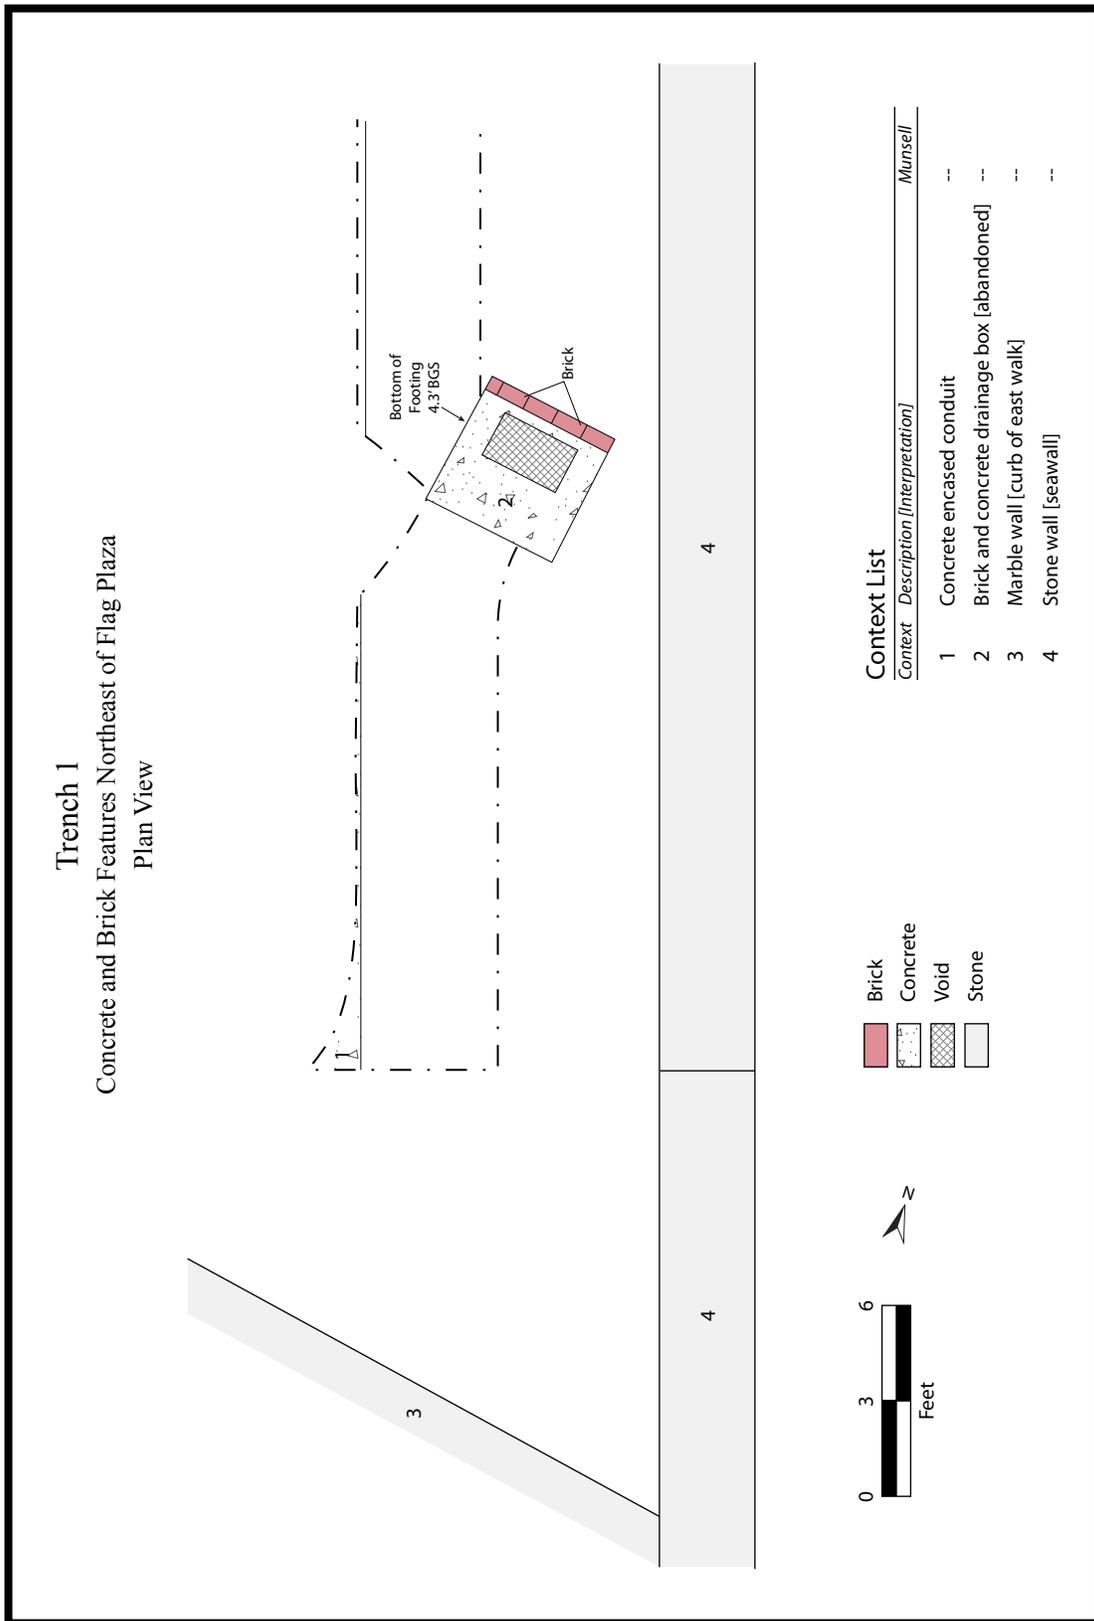
Figure 3.20. Trench 1: Plan of Concrete and Brick Features Northeast of Flag Plaza.

Concrete Footing: A rectangular concrete structure [1] was identified in the west wall of Trench 1 nine feet north of the walkway heading east from the flag plaza to the edge of the island (Figures 3.11 and 3.20; Photograph 3.34). This feature was first exposed at a depth of 3.5 feet below the ground surface and extended to a depth of approximately 5.5 feet. It is thought to be a concrete-encased electrical conduit. After documentation, it was left in place.

Brick and Concrete Drainage Box: A square concrete and mortared brick shaft feature [2] was identified in the center of Trench 1 approximately 29 feet north of the walkway heading east from the flag plaza to the edge of the island. This feature was surrounded by fill and was encountered just 0.5 feet below the ground surface (Figures 3.11 and 3.20; Photograph 3.35). Its base was recorded at 4.3 feet below the ground surface. After documentation, the contractor cut away a small portion of its northern side to accommodate the new pipe being installed, but otherwise it was left in place. This feature was an abandoned storm water drainage box, probably dating from the early 20th

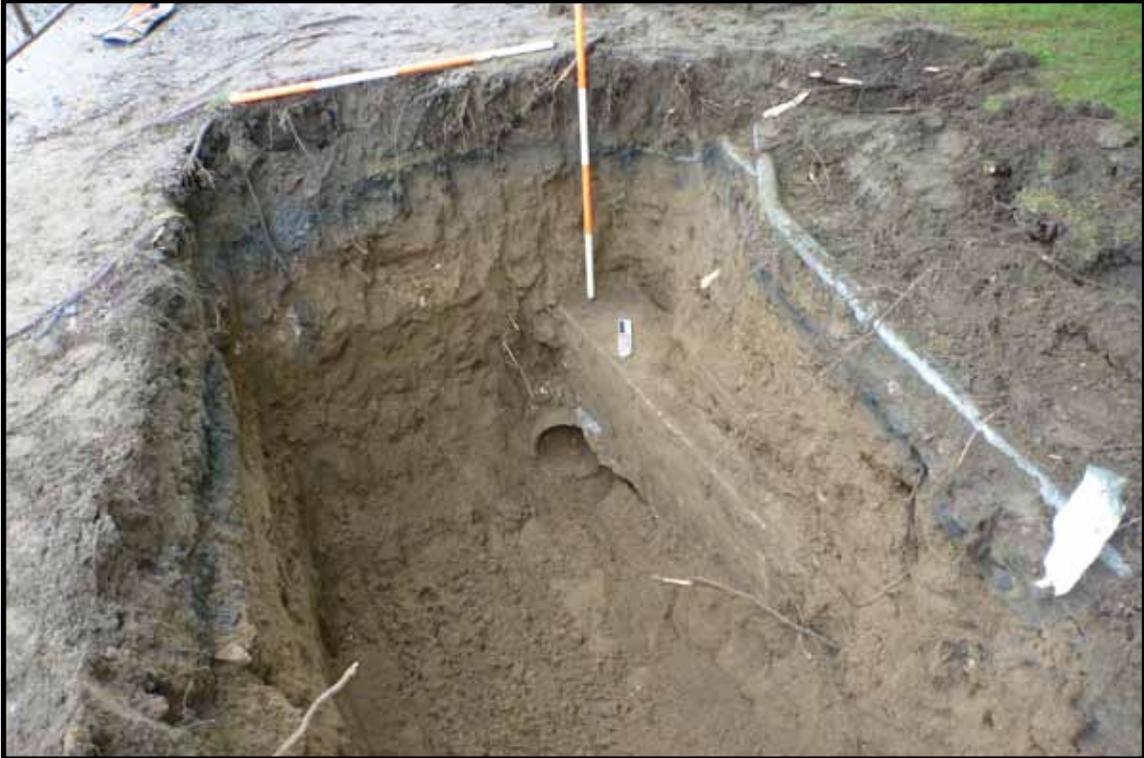
Photograph 3.34. Trench 1: view looking south showing the concrete conduit identified northeast of the flag plaza; scales in feet and tenths of feet (Photographer: Joshua Butchko, May 2012) [HRI Neg.#11063/D15-154].

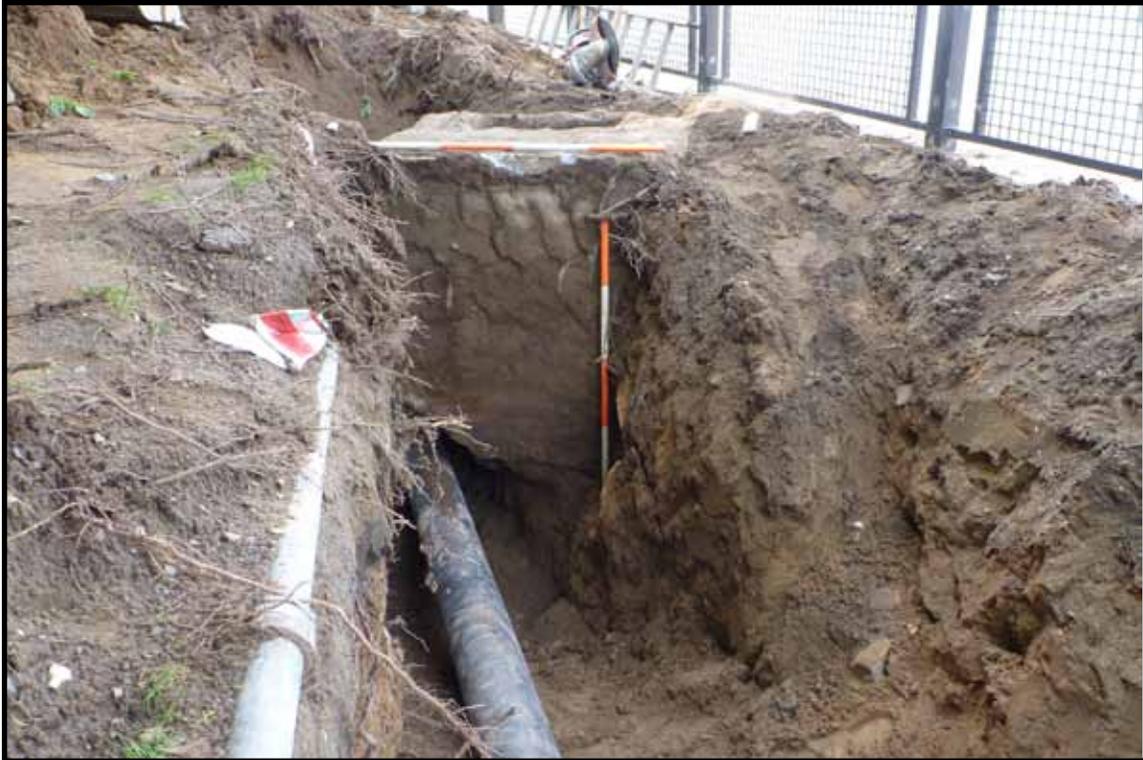
Photograph 3.35. Trench 1: view looking north northeast showing the concrete and brick storm water drainage box identified northeast of the flag plaza; scales in feet and tenths of feet (Photographer: Joshua Butchko, May 2012) [HRI Neg.#11063/D17-35].

century. It had originally gathered and funneled storm water through the nearby sea wall, but this outlet had been blocked off.

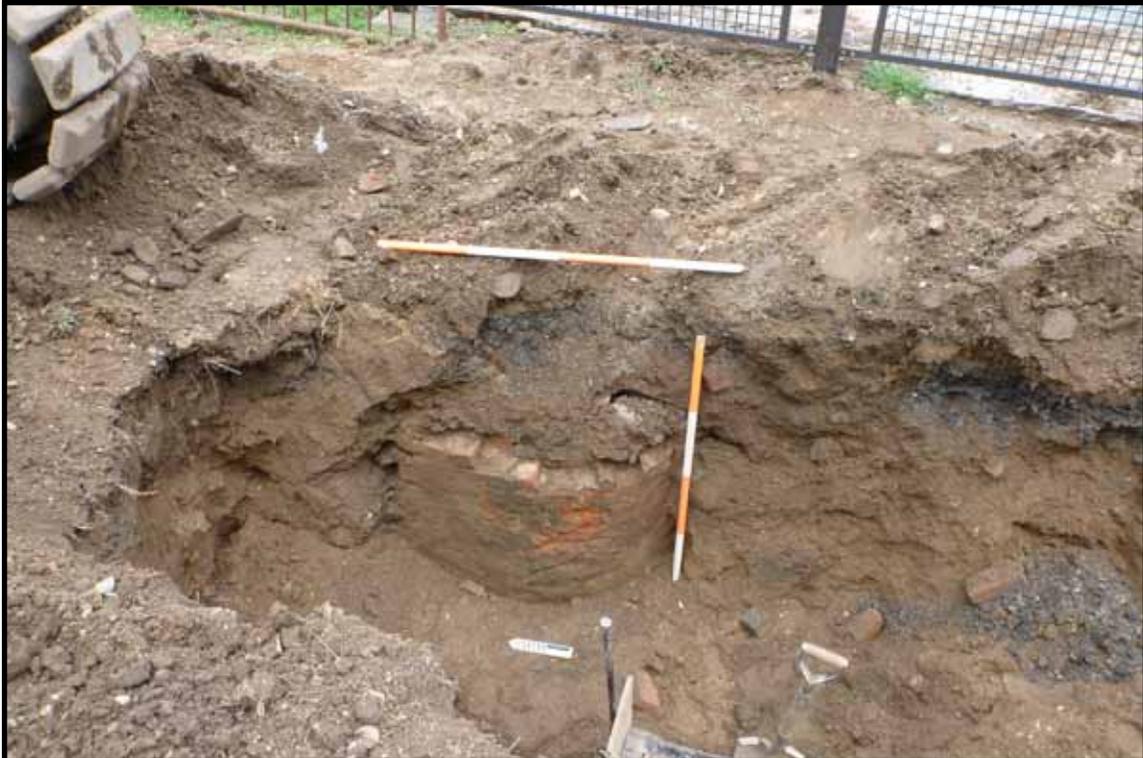
Photograph 3.36. Trench 1: view looking east northeast showing Brick Feature 5, a probable storm water drainage feature; scales in feet and tenths of feet (Photographer: Joshua Butchko, May 2012) [HRI Neg.#11063/D17-77].

Brick Feature 5: A semi-circular mortared brick feature was identified in the eastern profile of the trench adjacent and just inside the sea wall, roughly 80 feet north of the flag plaza at the point where Trench 1 turned southwest (Figure 3.11; Photograph 3.36). Examination of the exterior of the sea wall at this location at low tide found no evidence for drains that might be associated with this feature. It is most likely an abandoned element of an earlier storm water system connected with the late 19th or early 20th-century occupation of this section of the island. The feature was documented through notes and photographs and left intact.

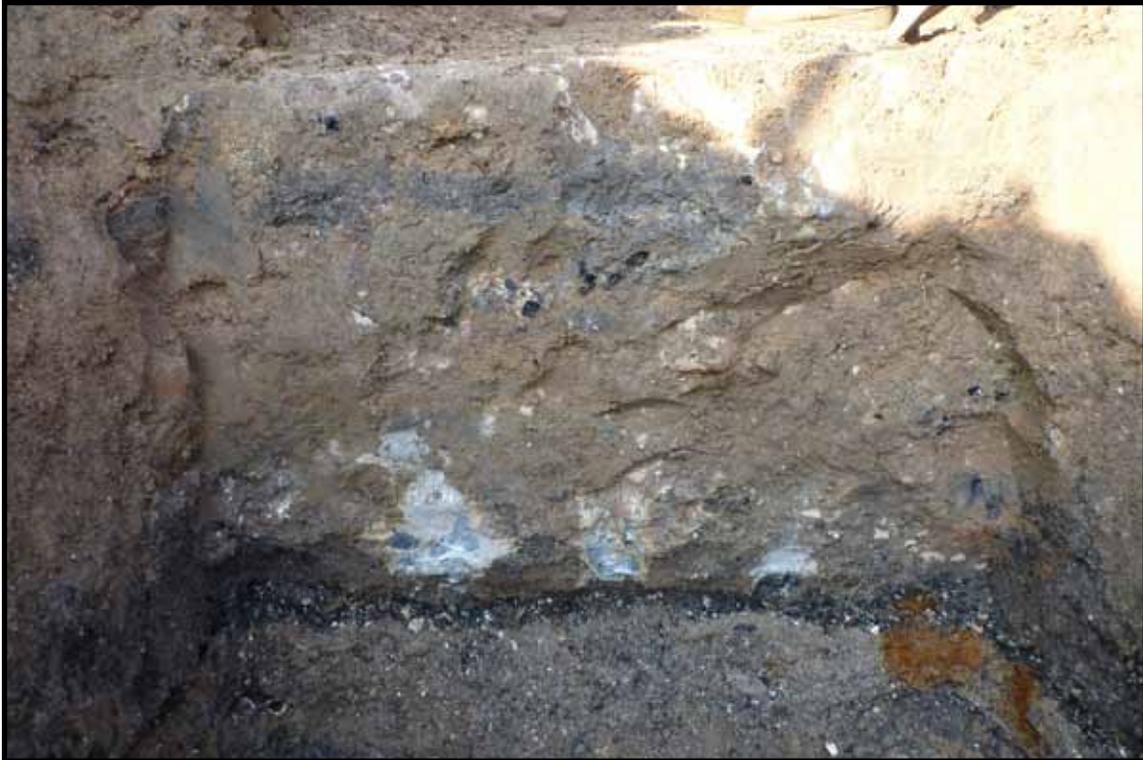
Photograph 3.37. Trench 1: view looking west southwest showing the south wall profile of Trench 1 near the radio tower north of the flag plaza (Photographer: Joshua Butchko, June 2012) [HRI Neg.#11063/D18-2].

A representative soil profile of Trench 1 was documented approximately 80 feet north of the flag plaza and 25 feet west of the point where the trench turned to the southwest passing by a radio tower (Figures 3.11 and 3.21; Photograph 3.37). The radio tower was located five feet north and 38 feet west of the location of the soil profile. The profile was recorded in an area where Trench 1 crossed an expanse of lawn in the northeast corner of the island.

At the base of the trench was a mottled loose sand with coal ash [10] which extended below the maximum depth of excavation at six feet below the ground surface. This was overlain by dense loose coal ash [9], approximately 1.3 feet thick. This fill was in turn overlain by a clay layer [8] which may represent a deliberate capping of the fill beneath. This layer was overlain by a medium sand [7] which appears to be an upcast C horizon. Above this, a compact clay layer [6], noted at a depth of 2.6 feet below the ground sur-

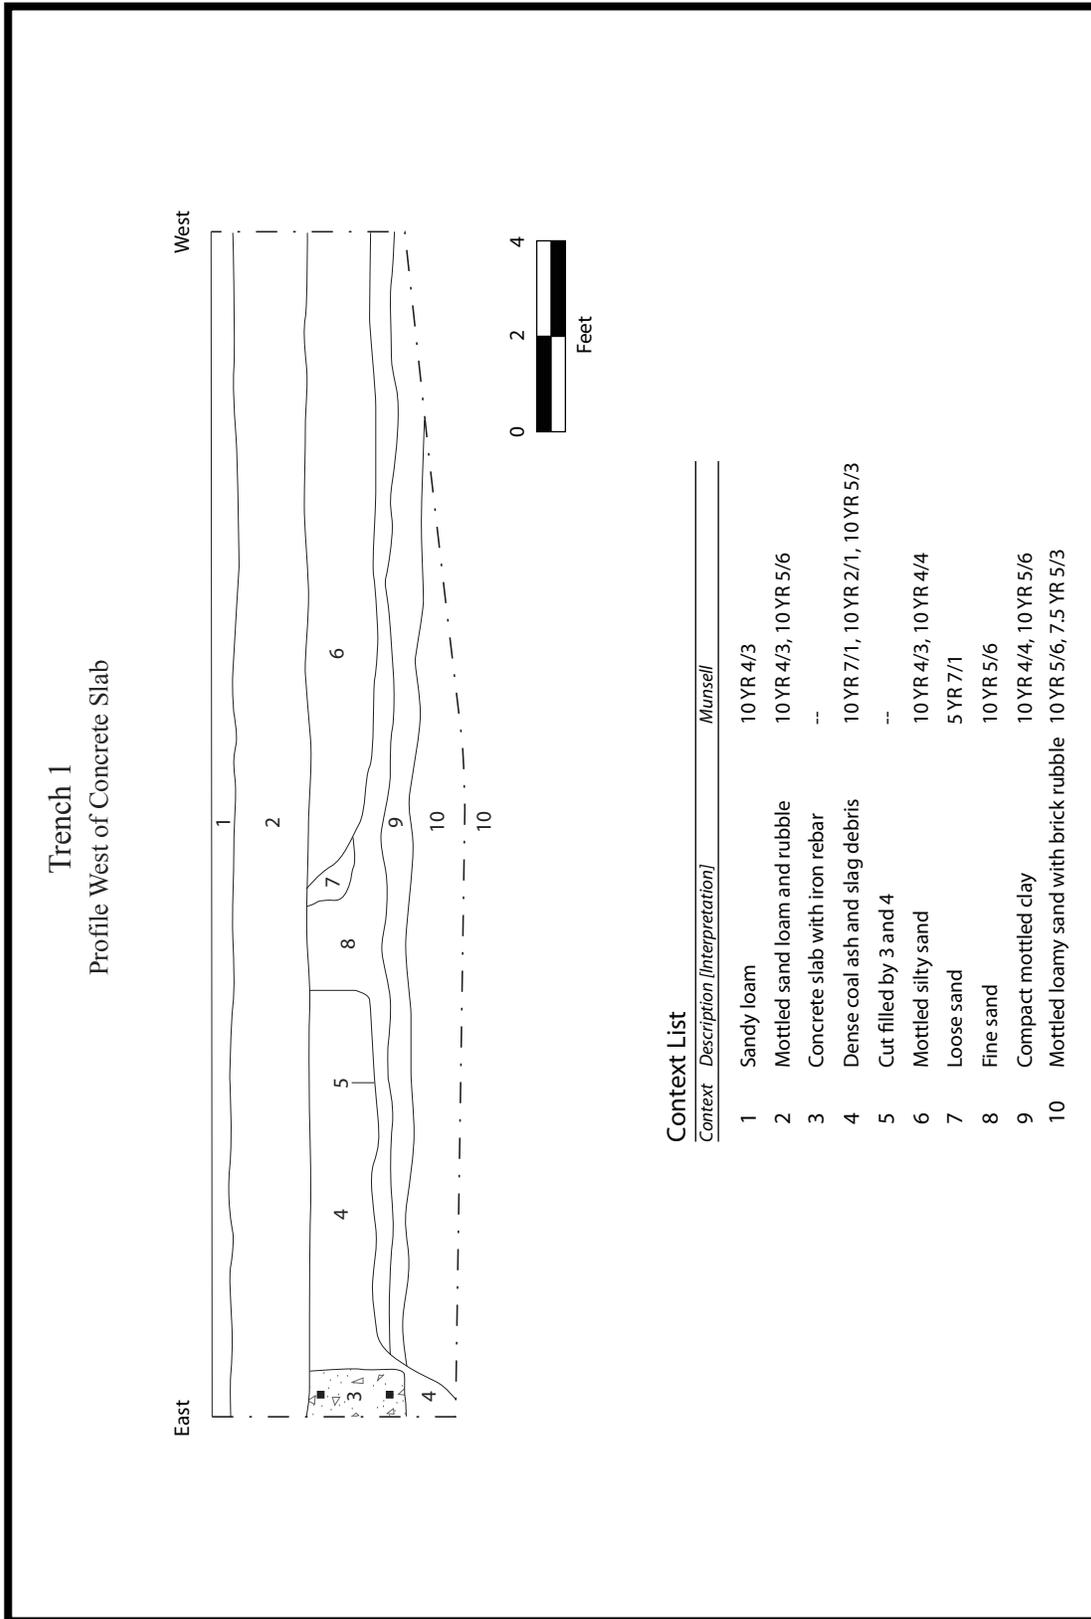
Figure 3.22. Trench 1: Profile West of Concrete Slab (West of Radio Tower).

Approximately 60 feet west of the point on the sea wall where Trench 1 turned to the southwest, a two-foot-thick concrete slab was identified two feet below the ground surface (Figures 3.11 and 3.22). The slab extended horizontally at this same depth for approximately 46 feet westward along the trench. A partial profile of Trench 1 was documented approximately 60 feet north from the main flag plaza immediately west of the western edge of the concrete slab (Photograph 3.38). The slab [3] appears to have been constructed/poured into a dense fill deposit of coal ash [4]. The coal ash itself appears to fill a cut [5] which may have held dumped waste materials from elsewhere on the island, although it is unclear how soon after the deposition the pouring of the concrete slab occurred.

Further west of the concrete slab, a deep sequence of historic fill deposits extended to six feet below the ground surface (the maximum depth of excavation of Trench 1). No intact historic ground surfaces or evidence of undisturbed subsoil were noted.

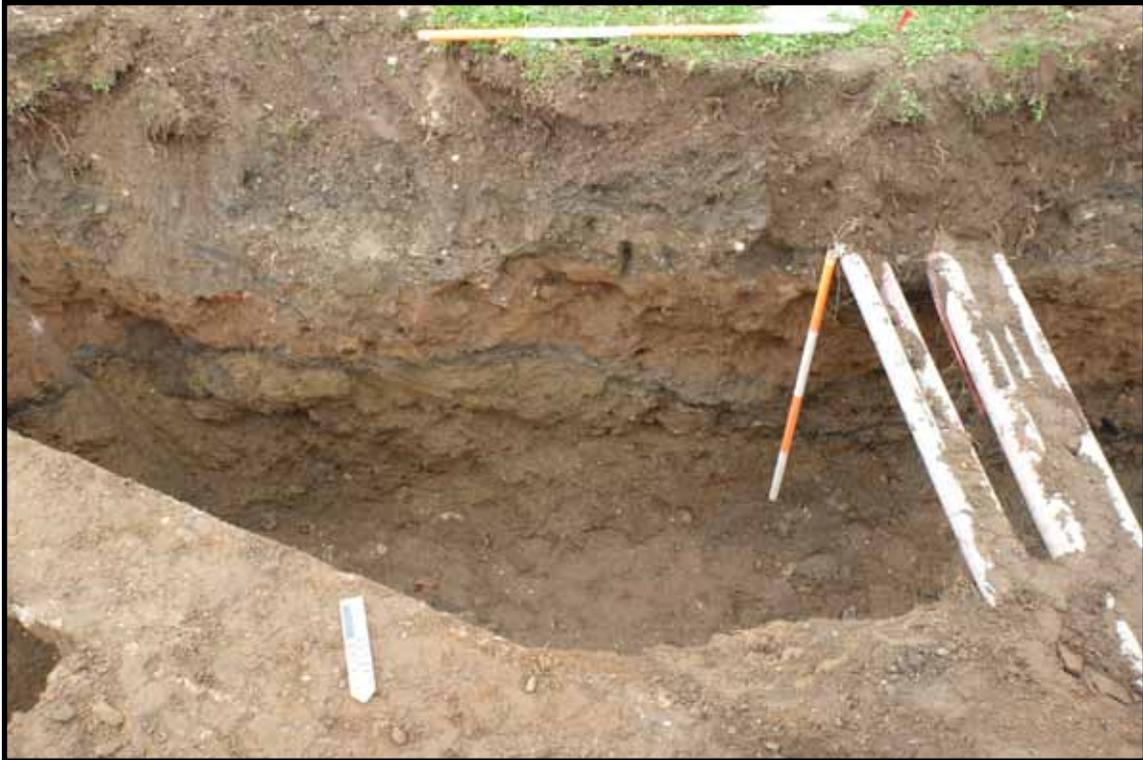
Photograph 3.38. Trench 1: view looking south showing the south wall profile of Trench 1 north northwest of the flag plaza; scales in feet and tenths of feet (Photographer: Joshua Butchko, May 2012) [HRI Neg.#11063/D17-137].

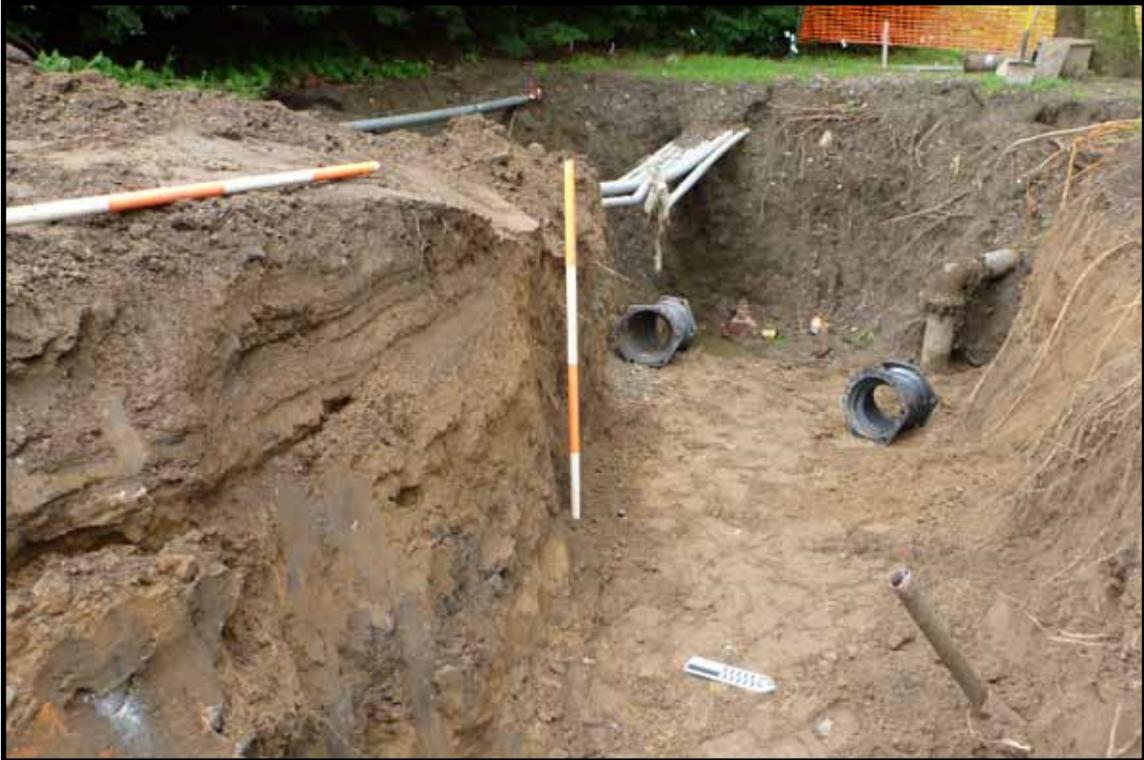
Photograph 3.39. Trench 1: view looking west southwest showing extensive disturbance from utilities installation at the western end of the trench; scales in feet and tenths of feet (Photographer: Joshua Butchko, June 2012) [HRI Neg.#11063/D21-26].

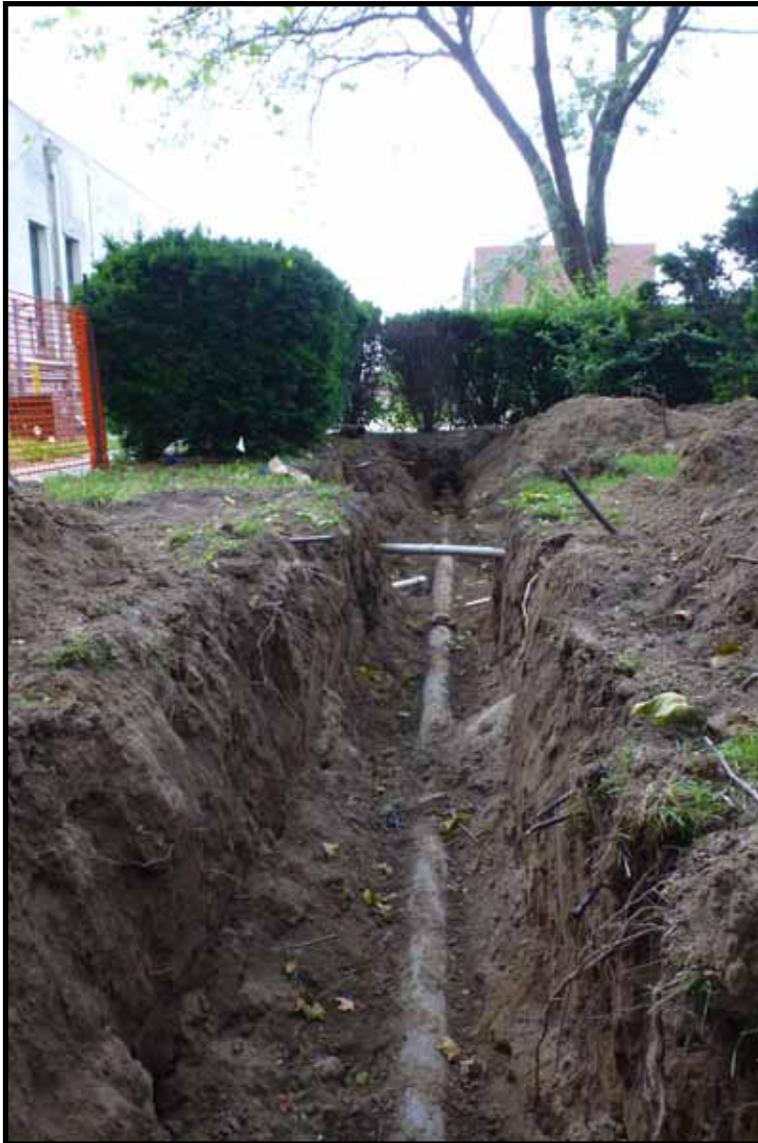
Photograph 3.40. Trench 1: view looking west showing the continuation of the trench where existing utility trenches were re-used by the contractor (Photographer: Joshua Butchko, June 2012) [HRI Neg.#11063/D20-14].

The western end of Trench 1 was southeast of a brick residence located just north of a buried water storage tank. Excavation in this area reached in excess of ten feet below the ground surface, but numerous utilities, including some that connected to the water storage tank, had disturbed earlier archeological deposits (Photograph 3.39). Limited trenching was continued to the west beyond this point to circumvent the water storage tank. However, the contractor exposed and followed existing utilities in order to accomplish this and no historic resources were observed (Photograph 3.40).

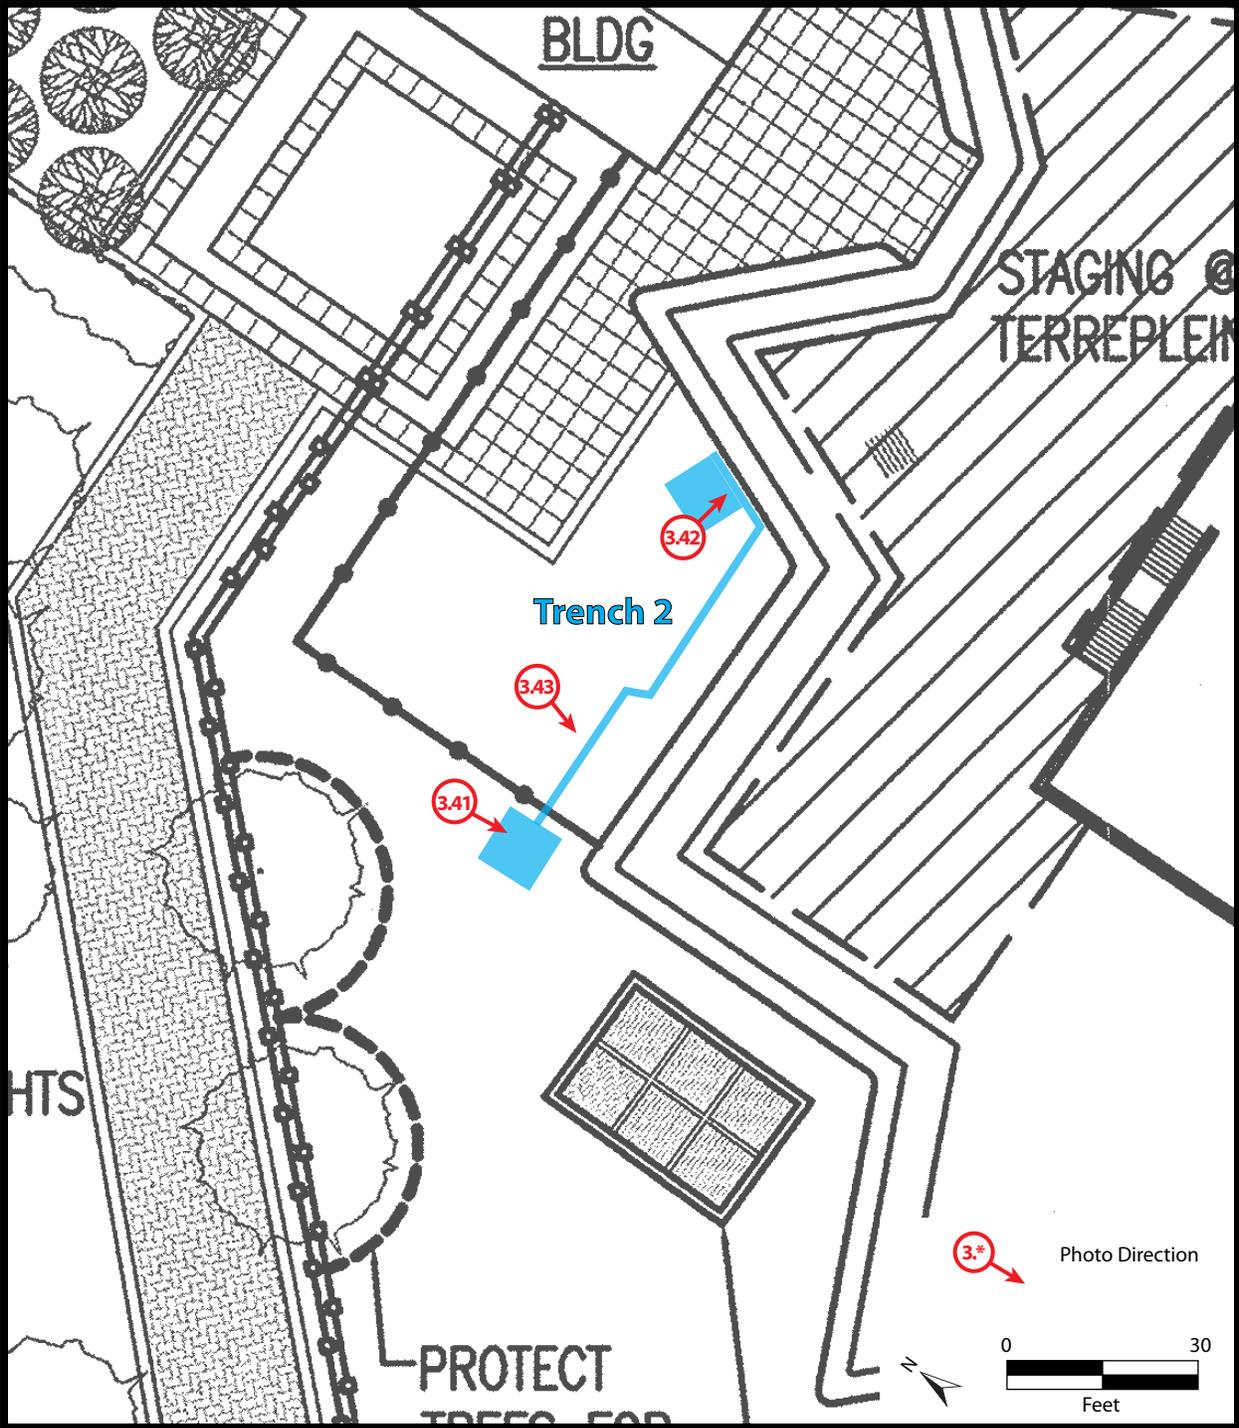
Figure 3.23. Trench 2: Site Plan Showing Photograph Locations.

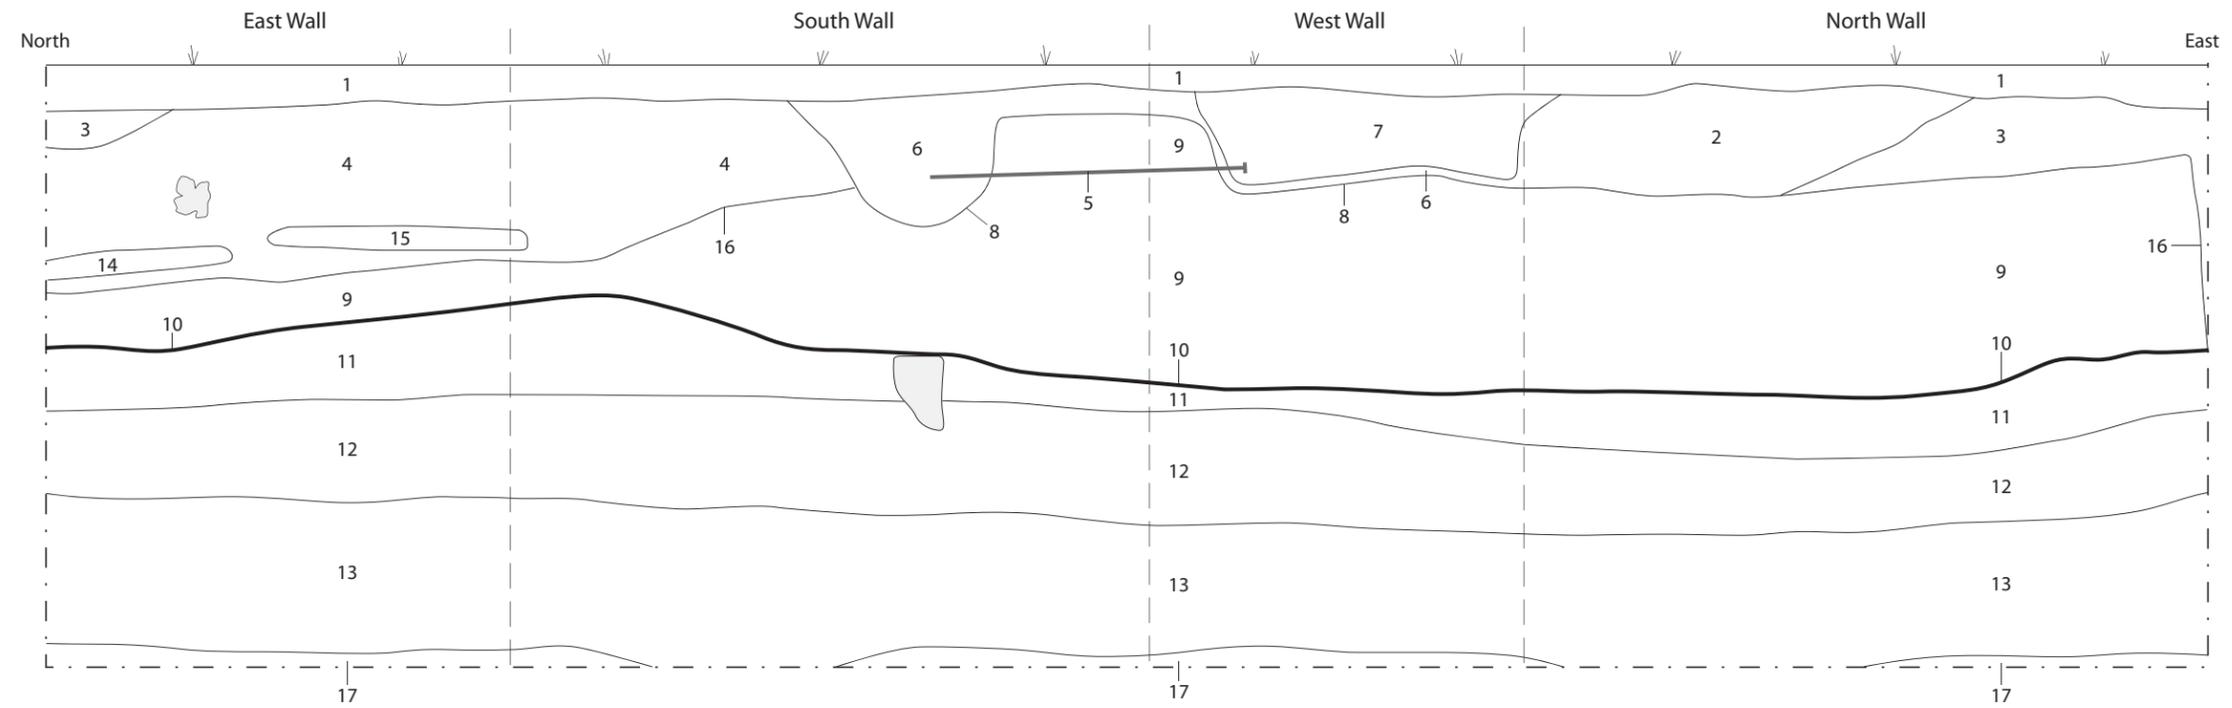
Trench 2
Dry Well Profile

Context	Description [Interpretation]	Munsell
1	Compact mottled silt loam with gravel	10 YR 4/3, 10 YR 4/2
2	Dense concrete chunks and coal ash [fill]	10 YR 2/1, 10 YR 4/1, 10 YR 1/1
3	Dense coal ash	10 YR 2/1, 10 YR 6/1
4	Mottled sand loam with concrete debris and plastic [fill]	10 YR 4/4, 10 YR 4/3
5	1.5 inch cast iron pipe	--
6	Mottled coal ash/ sand/gravel [fill]	10 YR 2/1, 10 YR 3/1, 10 YR 3/2
7	Dense clay [fill]	5 YR 5/4
8	Cut filled by 5, 6, 7	--
9	Silty sand with occasional cut stone blocks [1907]	10 YR 4/4
10	Organic lens [moat floor, early 19th century]	--
11	Silty sand [B horizon]	10 YR 5/4
12	Fine silty sand [B horizon]	10 YR 6/4
13	Silty sand [B horizon]	10 YR 6/4
14	5-inch cast iron pipe	--
15	4-inch cast iron pipe	--
16	Cut filled by 4, 14, 15	--
17	Wet clayey sand with shale	5 YR 4/6

Figure 3.24. Trench 2: Profile of Drywell Excavation at West End of Trench.

In the course of documenting the excavation for the drywell at the western end of the trench, several distinct contexts were identified (Figure 3.24; Photograph 3.41). A fill layer of coal ash [2], judged to be a 1960s-era demolition deposit, is the only context from which provenienced artifacts were retained (see below). Beneath this was a sand fill layer [9] that contained a few large cut stone blocks similar to those used in the fort wall foundations. This deposit is thought to date from the first decade of the 20th century and to have resulted from the leveling of the moat. The blocks of stone may be part of the counterscarp wall dispersed within this deposit. Below the sand fill was a thin band of organic material [10] which may be indicative of a moat floor. A sequence of sand layers [11-13, 17] below this possible moat floor appeared to

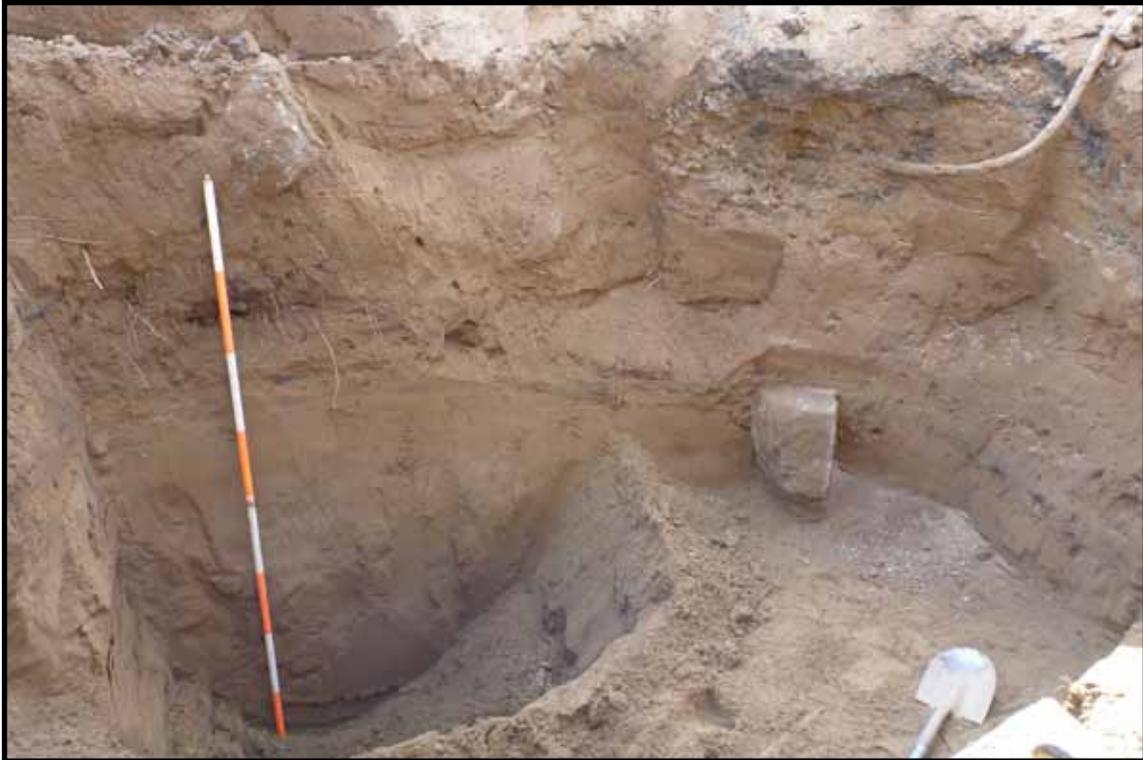
Photograph 3.41. Trench 2: view looking south showing the soil profile at the western end of the trench in the location of the drywell; note the large cut stones in the profile which may be fragments of the countescarp wall demolished in 1907; scale in feet (Photographer: Joshua Butchko, March 2012) [HRI Neg.#11063/D13-107].

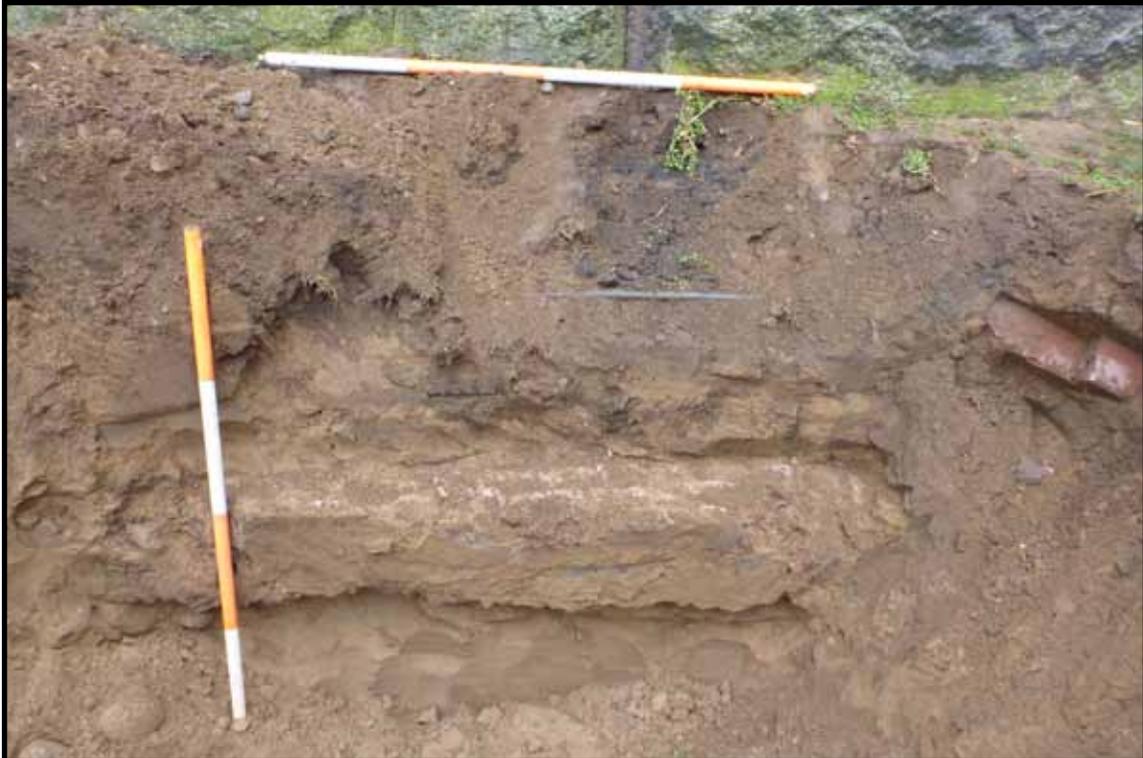
Photograph 3.42. Trench 2: view looking east showing the eastern end of the trench adjacent to the fort wall; note the granite facing of the fort wall at top and the footings for the fort wall below; scales in feet (Photographer: Joshua Butchko, March 2012) [HRI Neg.#11063/D13-37].

The excavation opened up at the eastern end of the trench, immediately outside the fort wall opposite the Stair C location, was taken to a depth of five feet below the ground surface. This portion of Trench 2 aimed both to establish the depth of the footings of the fort wall and provide space for the contractor to drill/hammer a pipe under the main fort wall to connect with pipes being laid in the Stair C excavation area (Photograph 3.42). The top of the footings for the fort wall were identified two feet below the ground surface, projecting out roughly two feet from the face of the wall above and extending down for only about one foot.

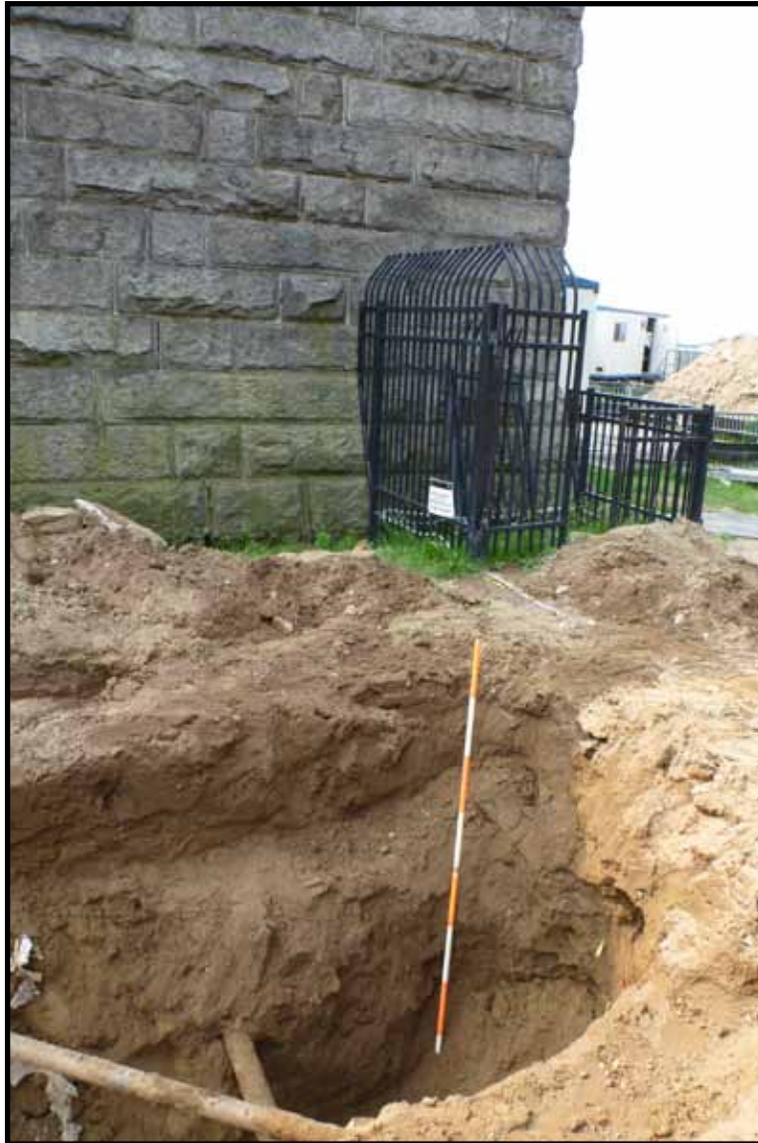
Photograph 3.43. Trench 2: view looking south southwest showing part of the central section of the trench heavily disturbed by utilities; northwest corner of the star-shaped fort beyond; scale in feet (Photographer: Joshua Butchko, June 2012) [HRI Neg.#11063/D20-32].

The excavation of the main portion of Trench 2 between the fort wall and the drywell was greatly complicated by buried utilities and recent construction (Photograph 3.43). The western end of the trench, nearest to the drywell, encountered large concrete footers poured in 2004 as well as several modern utilities. In addition, an underground storage tank, roughly 10 by 30 feet in plan, was also found within the trench alignment. Eventually a portion of the trench was re-routed to pass between the underground storage tank and the fort wall. No intact cultural deposits or historic structural remains were noted within the central section of Trench 2; all soils consisted of recent fill deposits.
