REPORT ON
ARCHAEOLOGICAL WORK FOR
CREATING A DAY SPA IN THE
GOVERNORS ISLAND HISTORIC DISTRICT
BUILDINGS 111, 112 and 114
GOVERNORS ISLAND, NEW YORK, NEW YORK
OPRHP Project Review No. 15PR01840
LPC ID 19-27959

This is a report on archaeological work conducted in conjunction with the creation of a day spa at Buildings 111, 112 and 114 on Governors Island. This project involved excavation within the Governors Island National Historic Landmark District and the New York City Landmark District. This report is being prepared to comply with environmental review regulations and meets the standards of both the New York State Office of Parks, Recreation and Historic Preservation (SHPO) and the New York City Landmarks Preservation Commission (LPC). The work was conducted on behalf of QC Terme, Srl by Linda Stone, RPA.

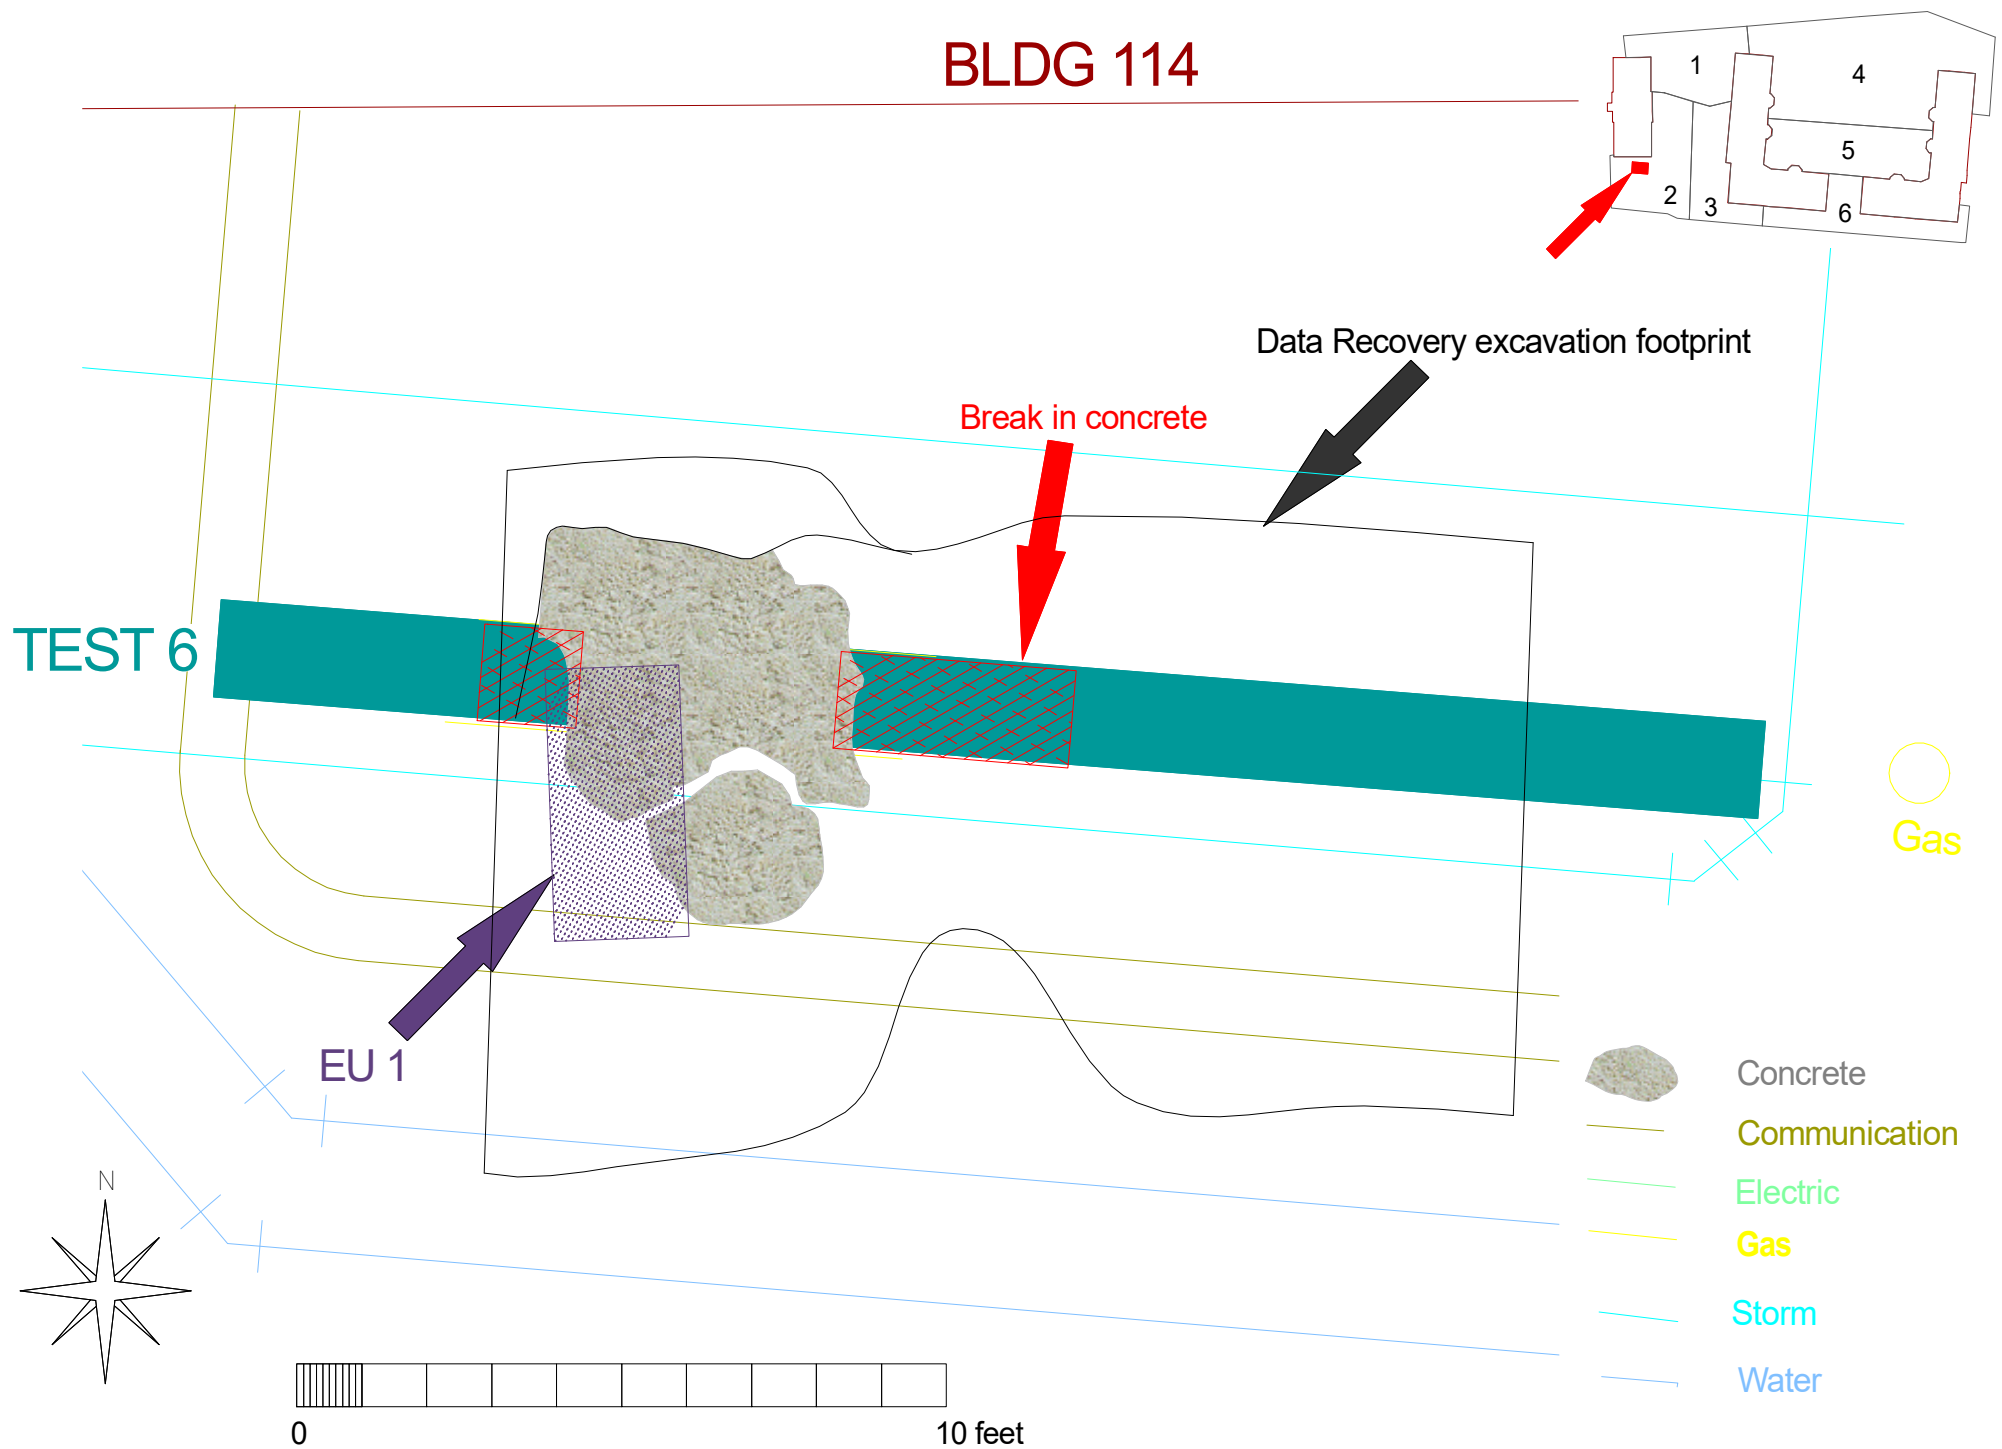
Figure 4 Data Recovery 1 planview.

Test 6, excavated during pre-construction testing in July 2018, contained a concrete feature throughout the trench at 2.8 feet (85 cm) below ground surface (approximately 10.5 feet ASL). It had two breaks, presumably to accommodate utilities crossing the area (see Figure 4). This afforded the opportunity to assess the thickness of the concrete. It was 9-inches (23 cm) thick. Artifacts recovered from those cuts at levels adjacent to and beneath the concrete provide a *TPQ* of c. 1860 based on a clear glass sherd (FB 11), although it seems most likely the utilities were laid in the 1930s when Building 114 was constructed. Data Recovery 1 was planned to further examine this feature identified in Test 6.

Coordinates had been recorded for Test 6 and field drawings showed the locations of the breaks in the concrete. To confirm in the field, a larger swath was removed. The excavated area measured approximately 16 feet (4.9 m) east-west and 10 feet (305 cm) north-south, covering the footprint of most of the original test (see Figure 4). This exposed the entire portion of the concrete between the two breaks documented in the test.

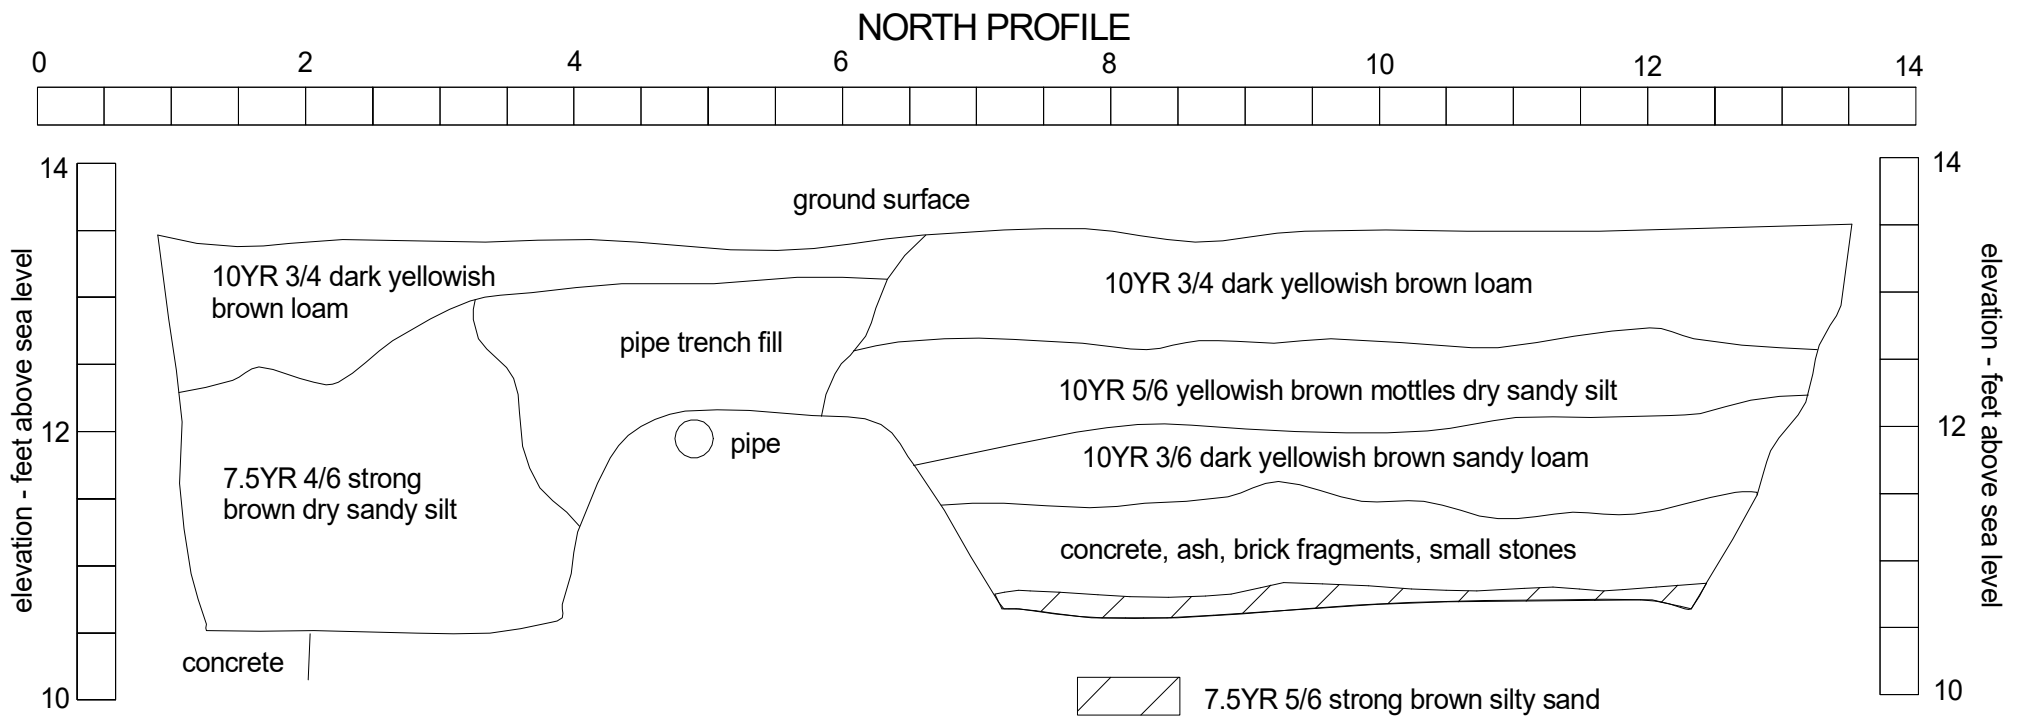
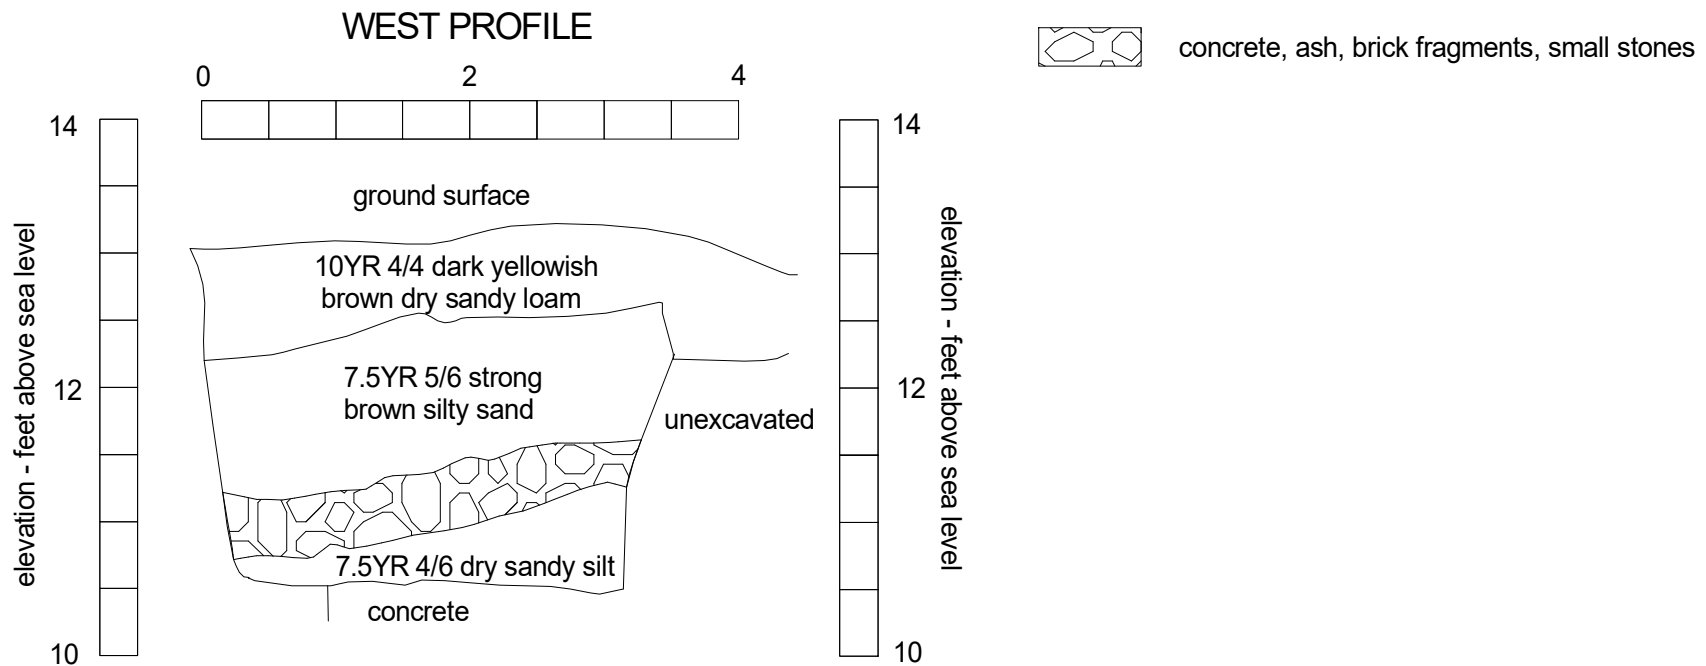
Figure 5 Data Recovery 1 - North and West Profiles of the data recovery excavation footprint.

Prior to excavation of an archaeological unit, the trench profiles were examined. The north profile of the backhoe excavation cut revealed a pipe in the center of the profile (see Figure 5). This pipe's location corresponded to the eastern break in the concrete of Test 6. The deposits to the east and west of the pipe were markedly different. To the east, in the area initially explored in the test, the decaying concrete layer began approximately 2 feet (61 cm) below ground surface (approximately 11.5 feet ASL). The area to the west of the pipe was more homogeneous above the level of the

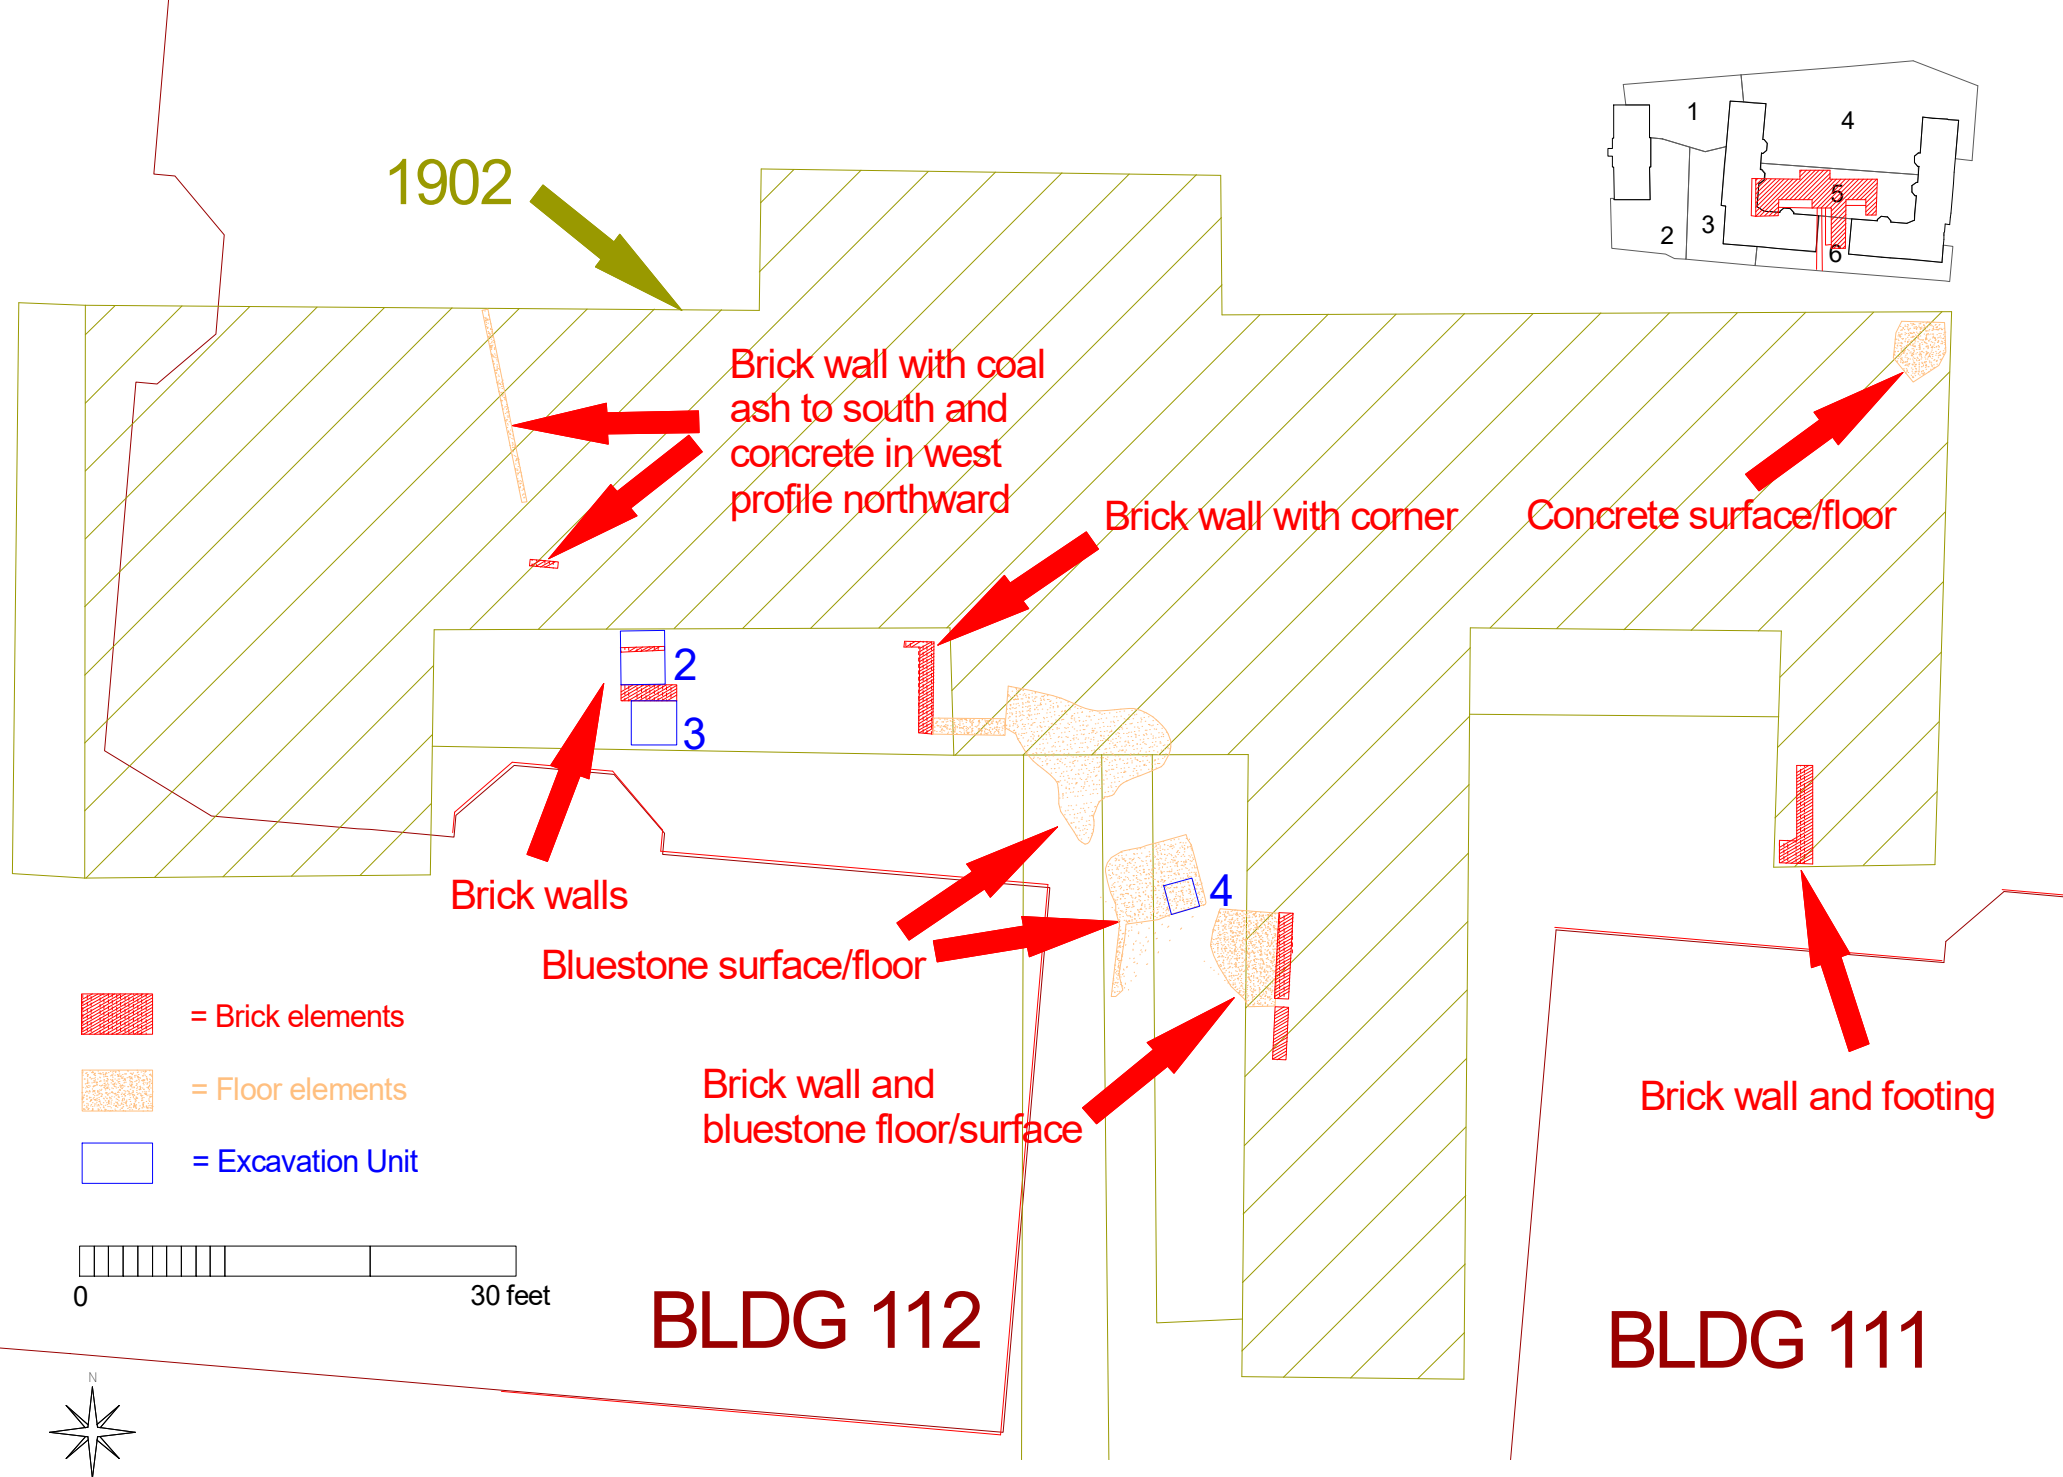
Figure 6 Post Hospital excavation units and findings planview with a tracing of the Post Hospital from the 1902 Hilton map.

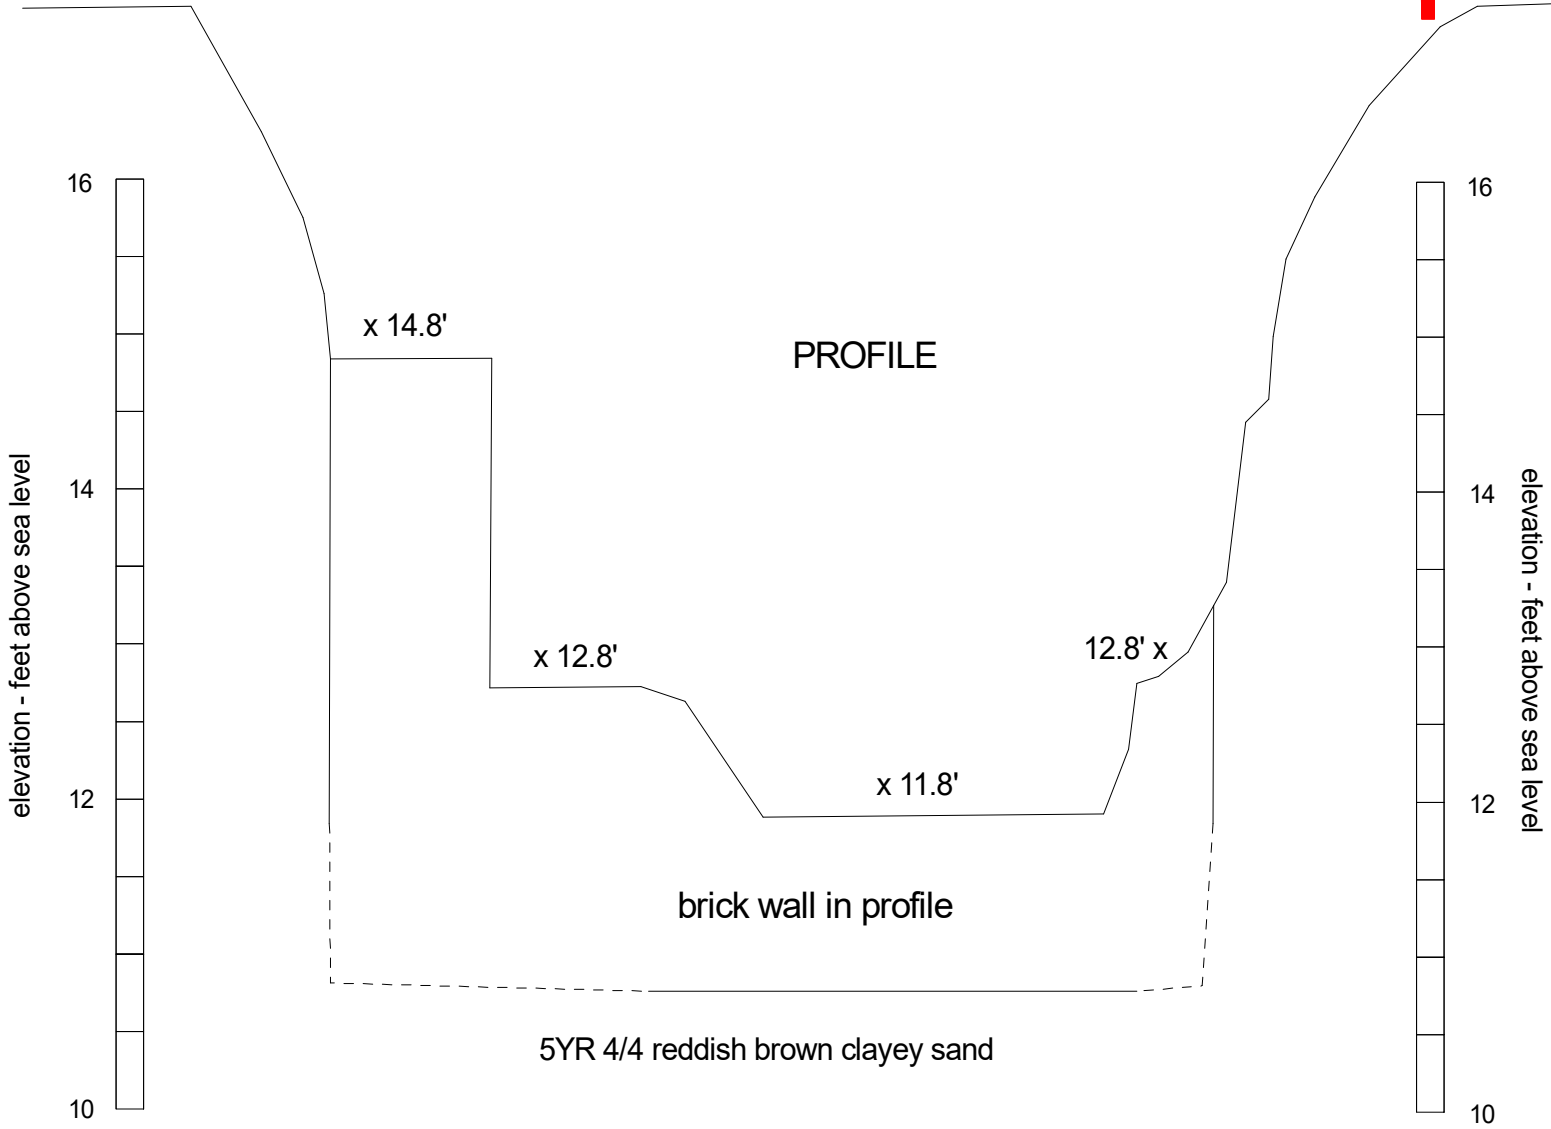
Figure 8 Plan view (bottom) and profile (top) of the brick wall segment in 111 SW Trench.

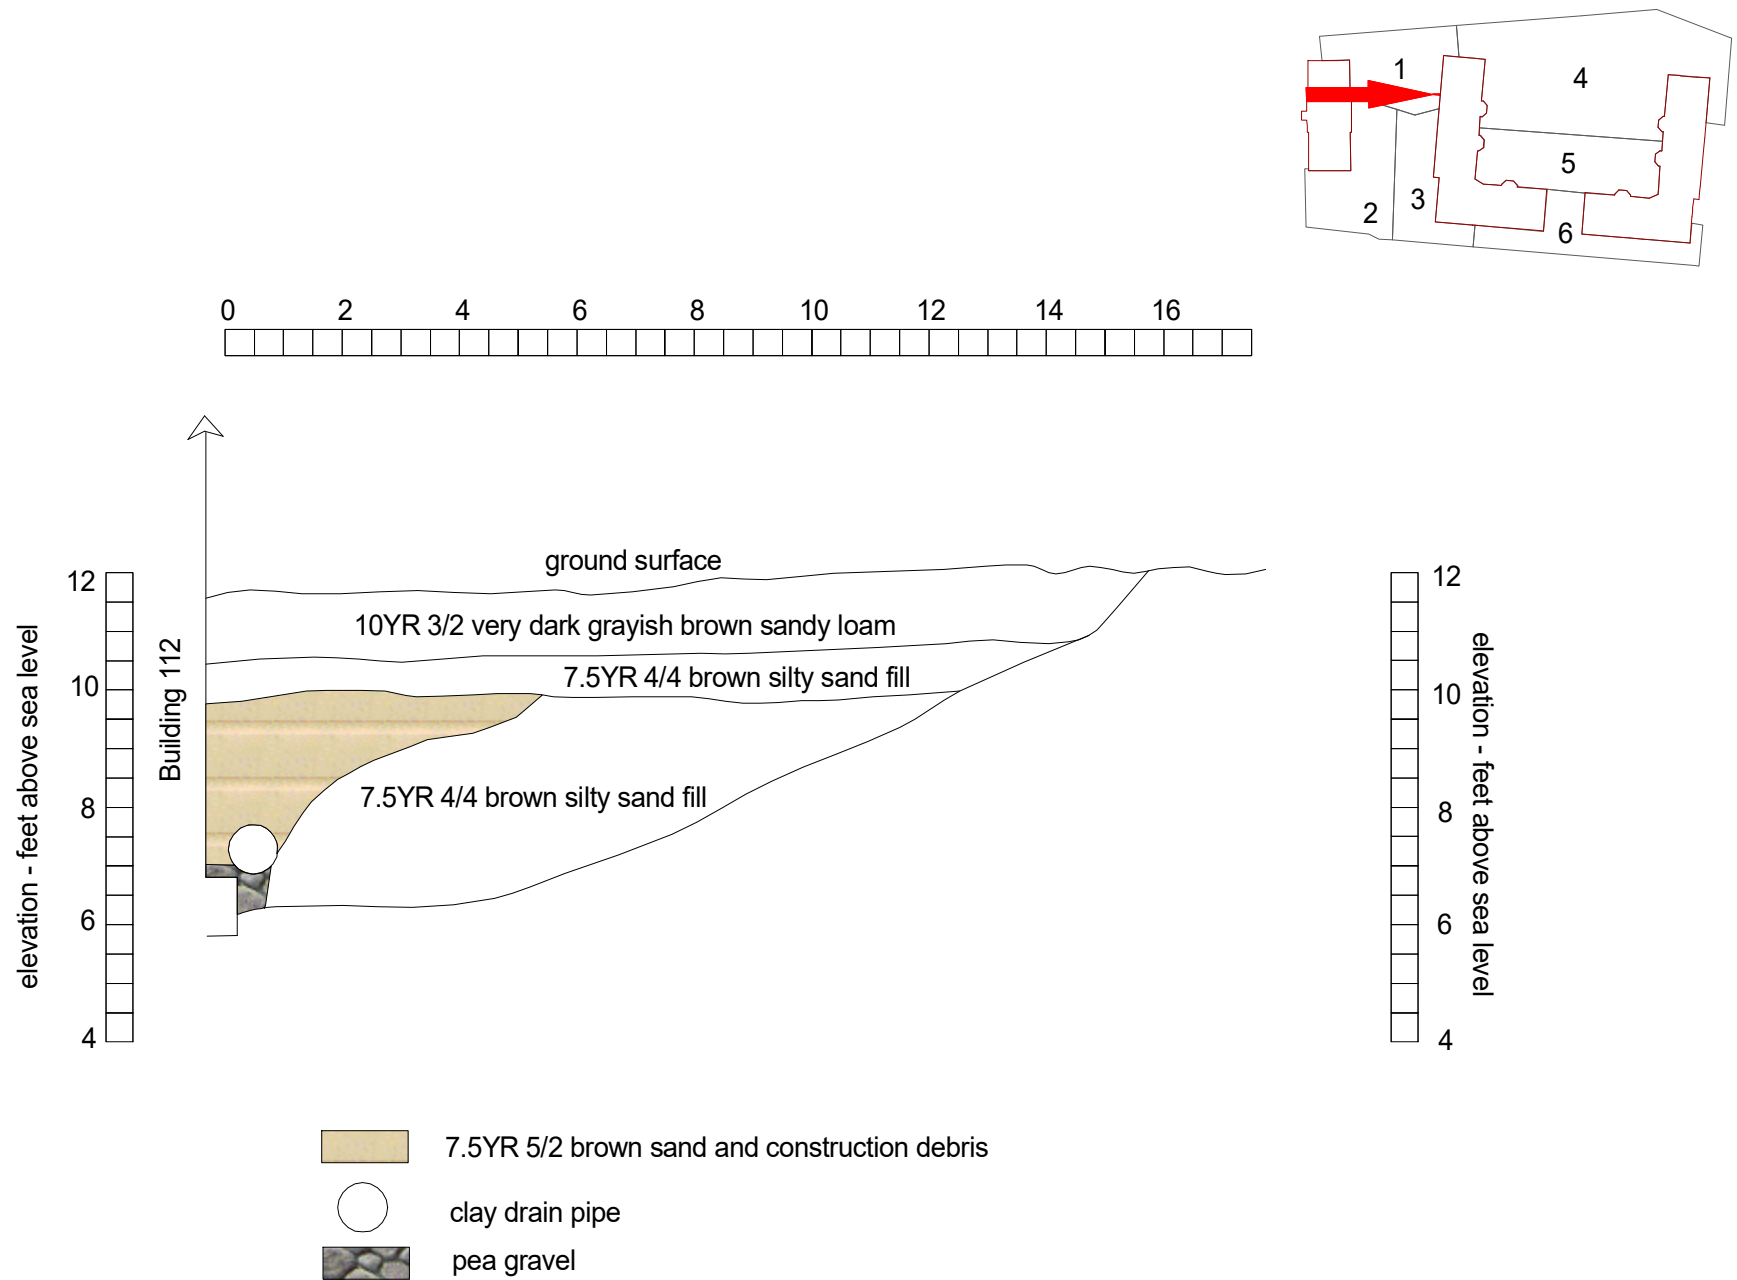
Figure 14 South Profile of West Pool 112 Tunnel Trench showing building drainage with pea gravel.

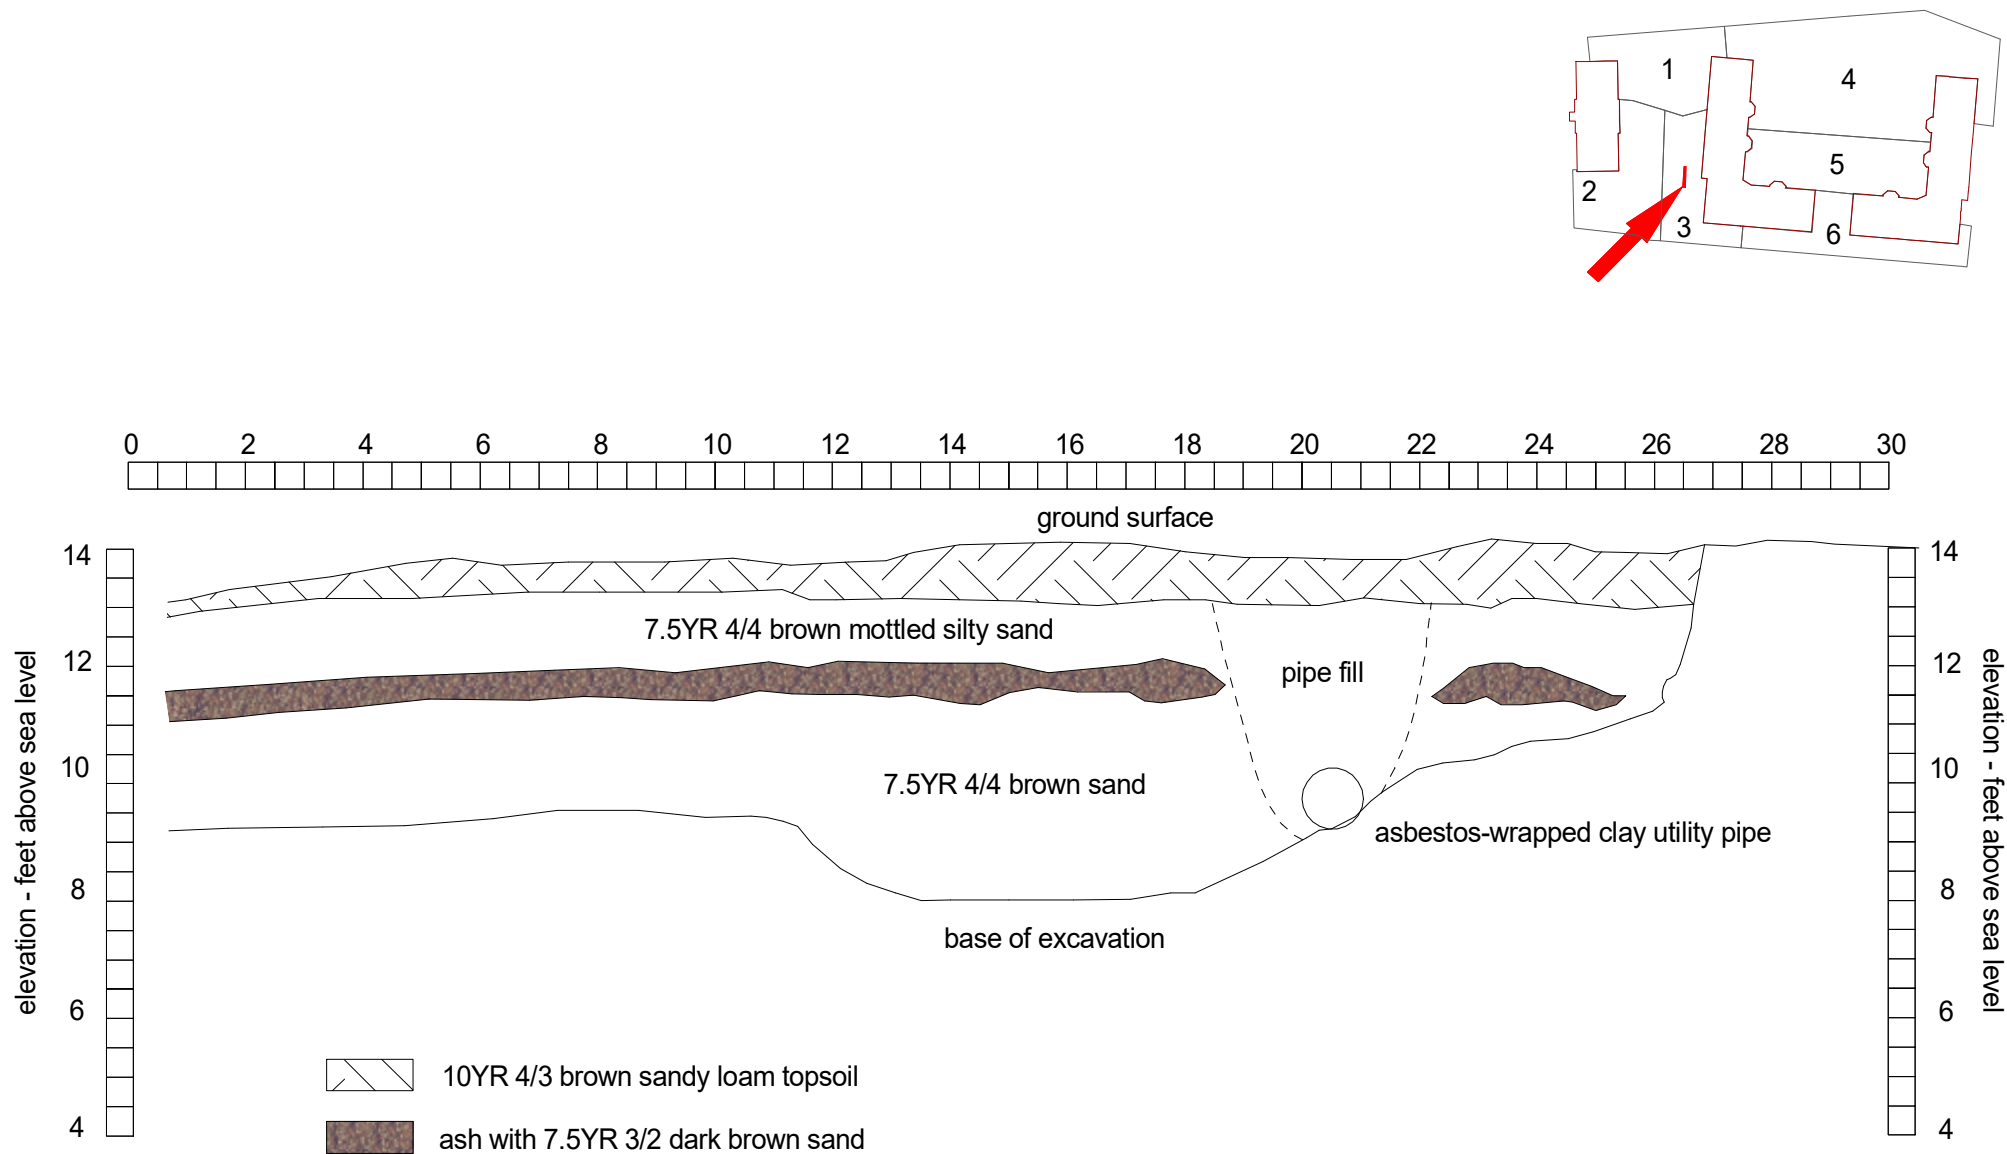
Figure 18 East Profile of SW Trench 1 Segment 3 showing coal ash deposit.

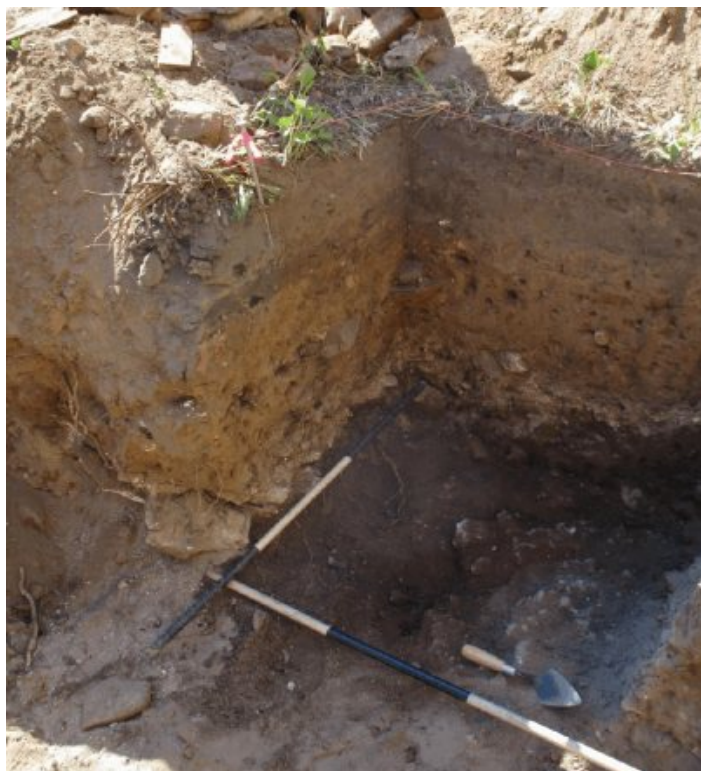
Photo 1 Concrete feature in the base of Excavation Unit 1 in the northern part of the unit beneath the trowel, facing southwest (Image 3650: September 27, 2019).

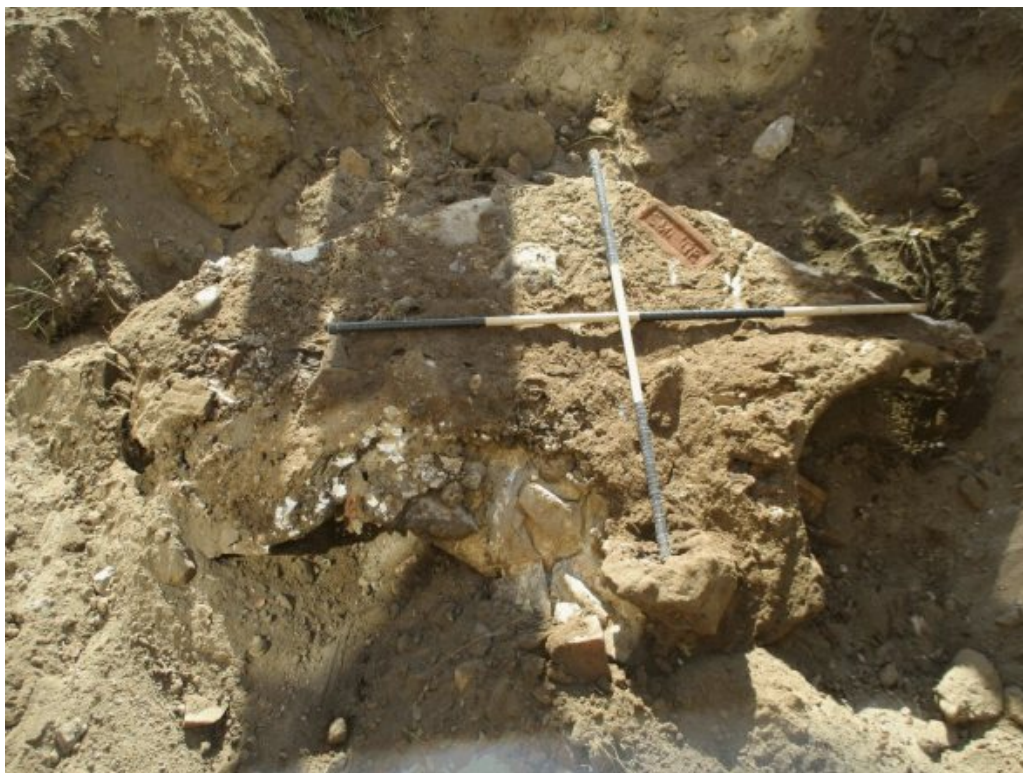
Photo 2 The underside of the concrete feature in Data Recovery 1 showing the semicircular edge on the lower right and the imbedded Empire brick in the upper left (Image 3672: September 30, 2019).

The concrete surface in the base of EU 1 was not level or even. The concrete extended into the north profile of the exploratory trench, but its southern limit was further south than EU 1, and it extended east of EU 1 as well. Further, it appeared there was a separation with at least two pieces of concrete *in situ*. Therefore, the backhoe was directed to remove additional material from the levels above the concrete to identify a clear edge of the concrete within the limits of the planned contractor excavation footprint. Once the overburden was removed and the area was cleaned by hand, it was clear that there was no real edge to the concrete at all. Not only was the top of the concrete not a level surface, it did not appear to even be a surface at all. It looked more like an excess pour of concrete that trailed off to the south and east. Therefore, the backhoe was directed to pry off the concrete, if possible. This proved the concrete was, in fact, an overpour from around a circular structure such as a catch basin or manhole cover which was not present. There was a semi-circular ridge where the concrete was thickest, indicating the source of the overpour. An intact "EMPIRE" marked brick was adhered to the underside of the concrete (see Photo 2).

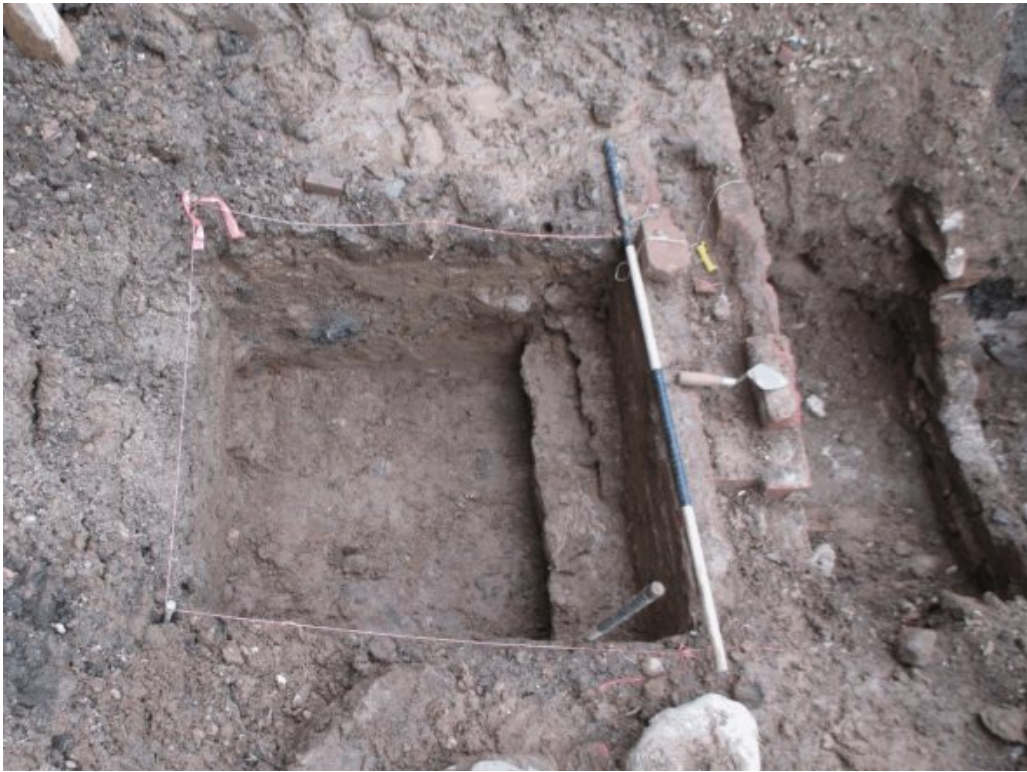
Photo 3 Data Recovery 2, Excavation Unit 3 (left) and part of Excavation Unit 2 (right), showing the three-course brick wall segment and its concrete spread footer in the center of the photo and the one-course brick wall at the right, facing west (Image 3728: December 4, 2019).

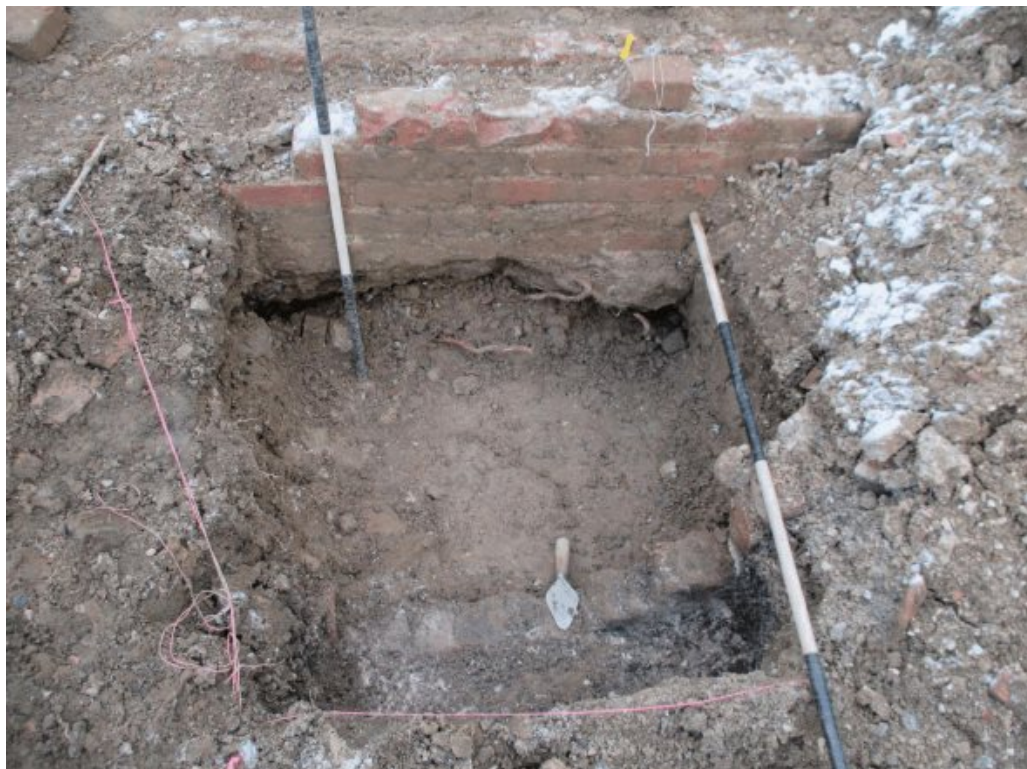
Photo 4 Excavation Unit 2 showing the base of the three-course brick wall on its north side, revealing no spread footer, and the one-course brick wall beneath the trowel, facing south (Image 3698: December 3, 2019).

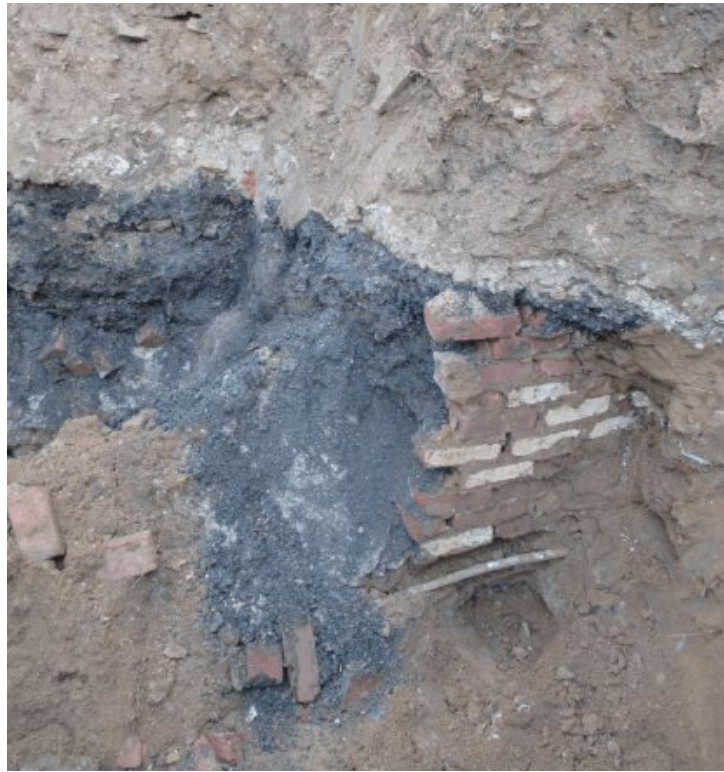
Photo 5 CB 4 Trench completed excavation with the previously compromised one-course thick brick wall and the metal pipe at its base, as well as the coal ash deposit to its south, facing southeast (Image 2569: November 25, 2019).

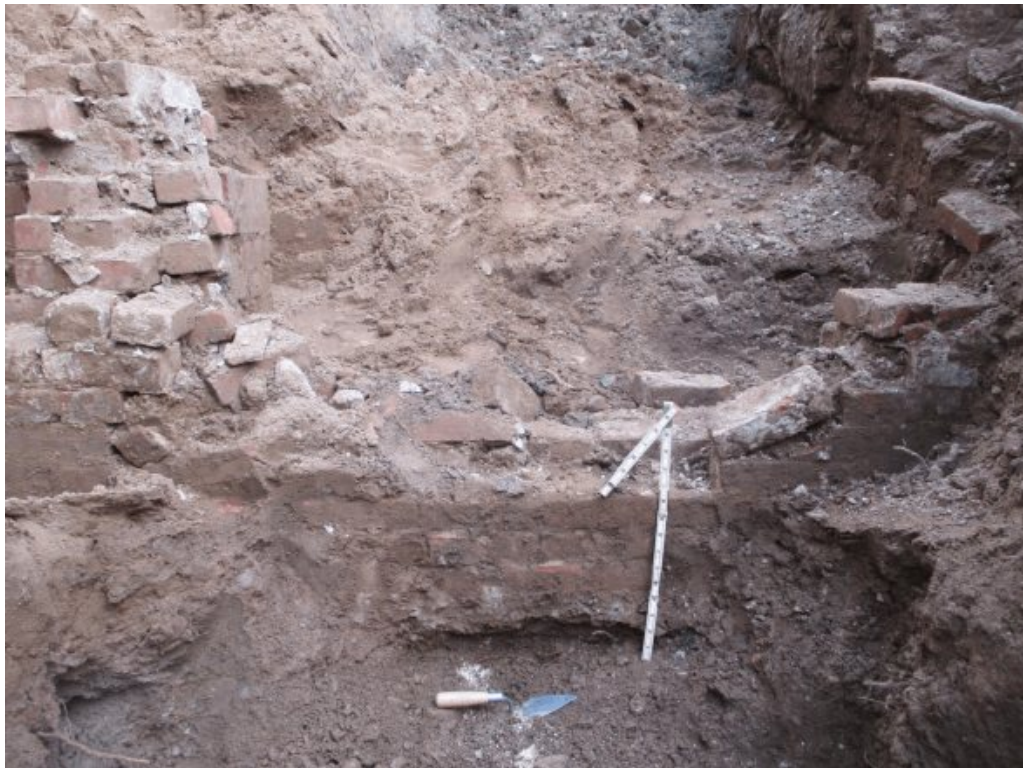
Photo 6 Three-course brick wall segment crossing #111 SW Trench, facing west (Image 2988: February 27, 2020).

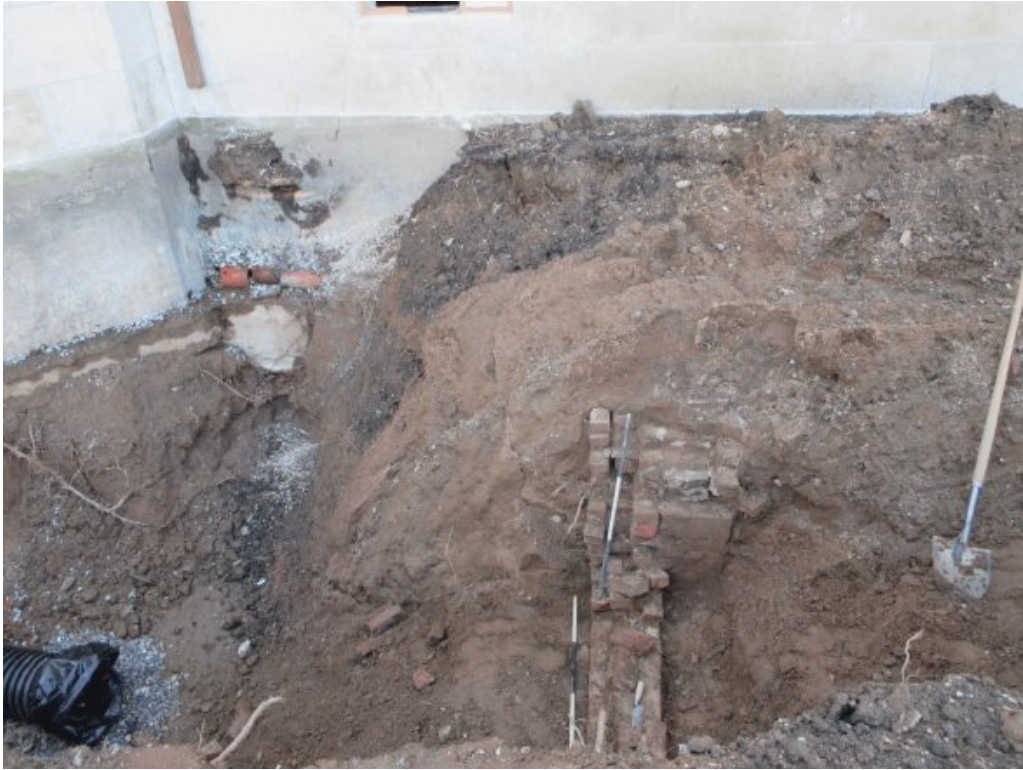
Photo 7 Three-course brick wall segment crossing #111 SW Trench, showing possible footing, facing south (Image 2957: February 27, 2020).

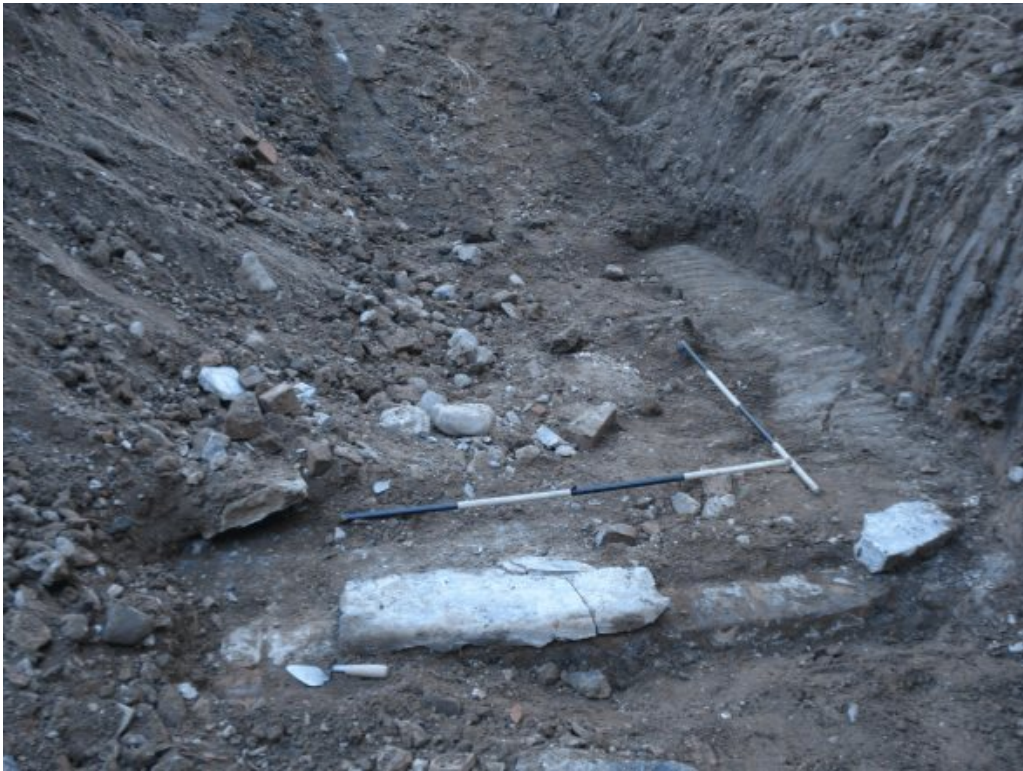
Photo 8 One-course thick brick wall segment covered with stone crossing Secondary Electric Trench, showing part of a stone floor extending from there eastward (right side of photo), facing east (Image 7930: November 18,2020).

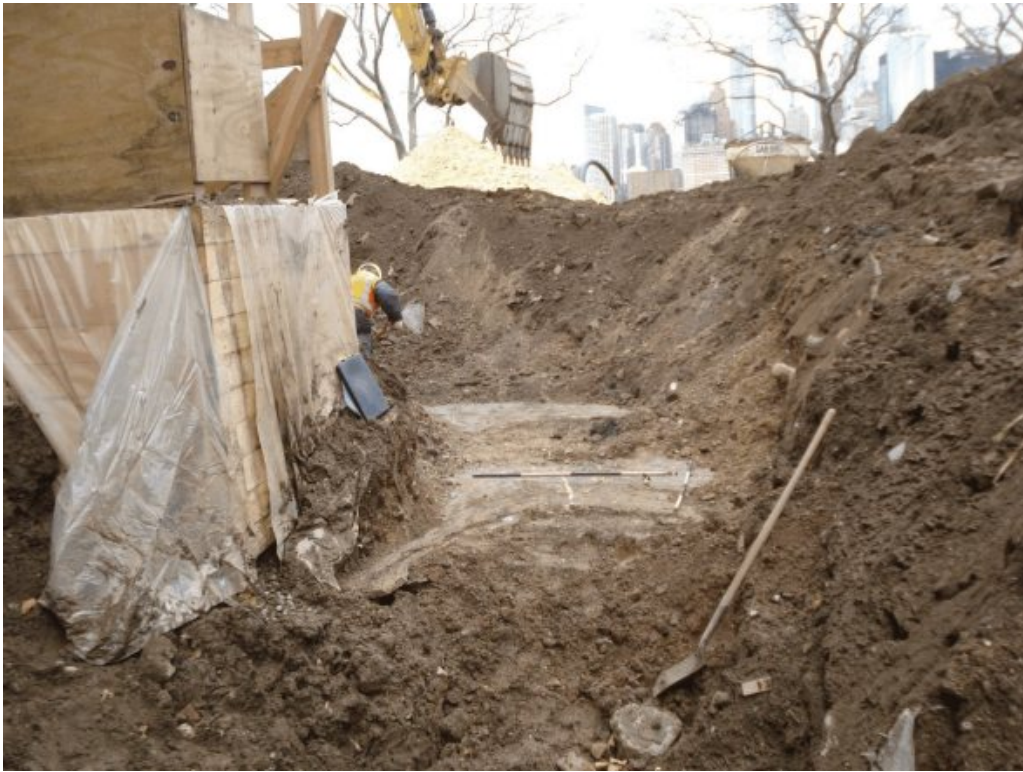
Photo 9 Two sections of bluestone surface/floor identified in Secondary Electric Trench, facing northwest (Image 7964: December 2, 2020).
