REPORT ON
ARCHAEOLOGICAL WORK FOR
CREATING A DAY SPA IN THE
GOVERNORS ISLAND HISTORIC DISTRICT
BUILDINGS 111, 112 and 114
GOVERNORS ISLAND, NEW YORK, NEW YORK
OPRHP Project Review No. 15PR01840
LPC ID 19-27959

This is a report on archaeological work conducted in conjunction with the creation of a day spa at Buildings 111, 112 and 114 on Governors Island. This project involved excavation within the Governors Island National Historic Landmark District and the New York City Landmark District. This report is being prepared to comply with environmental review regulations and meets the standards of both the New York State Office of Parks, Recreation and Historic Preservation (SHPO) and the New York City Landmarks Preservation Commission (LPC). The work was conducted on behalf of QC Terme, Srl by Linda Stone, RPA.

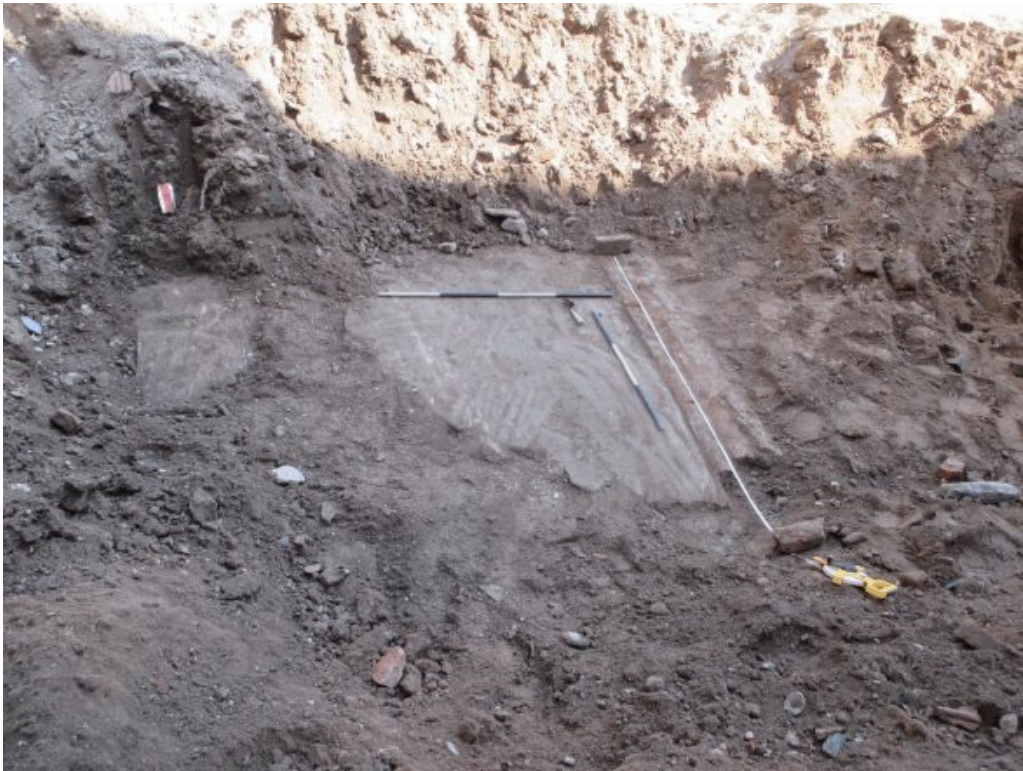
Photo 10 Three-course thick brick wall segment abutting concrete covered bluestone surface/floor identified in AD 1 - AD 2 Trench, also showing the previously installed concrete-encased secondary electric duct bank to the west beneath the marking tape, facing north (Image 3306: May 21, 2021).

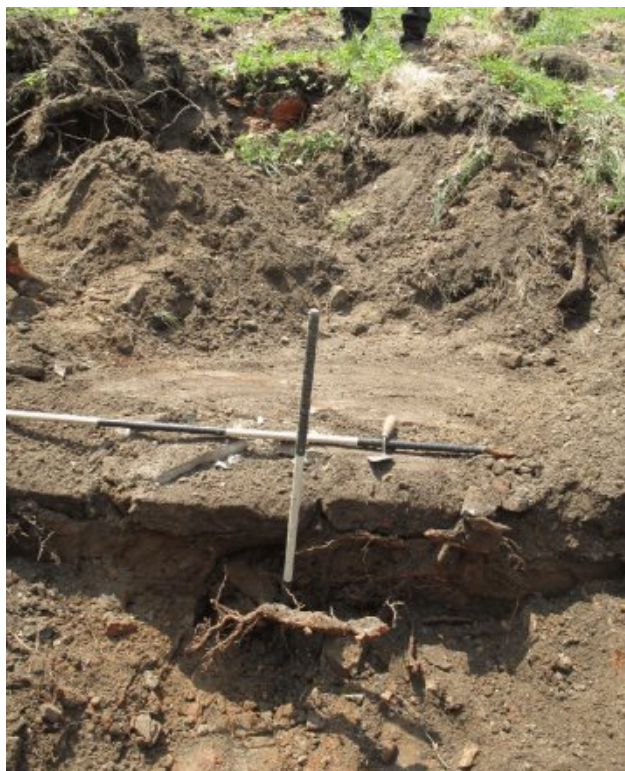
Photo 11 Two layers of concrete surface/floor identified after a large tree was removed in the East Courtyard, facing south (Image 1640: July 9, 2019).

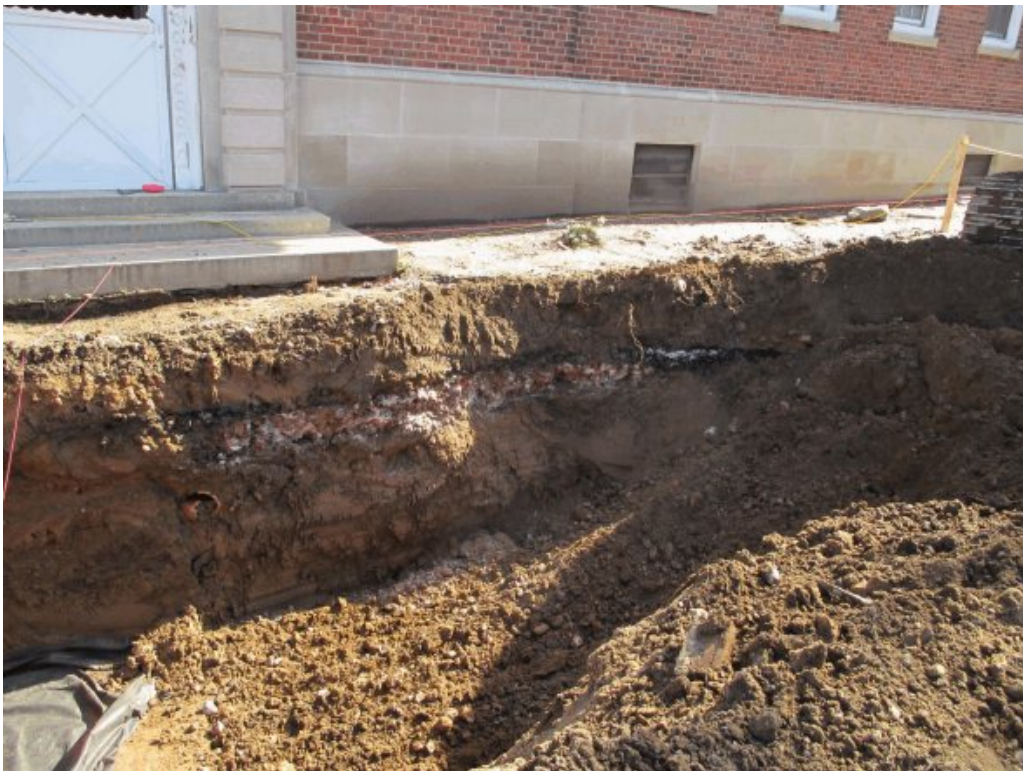
Photo 14 Old Carder Road in CB 12 East Profile, facing southeast (Image 2222: October 23, 2019).

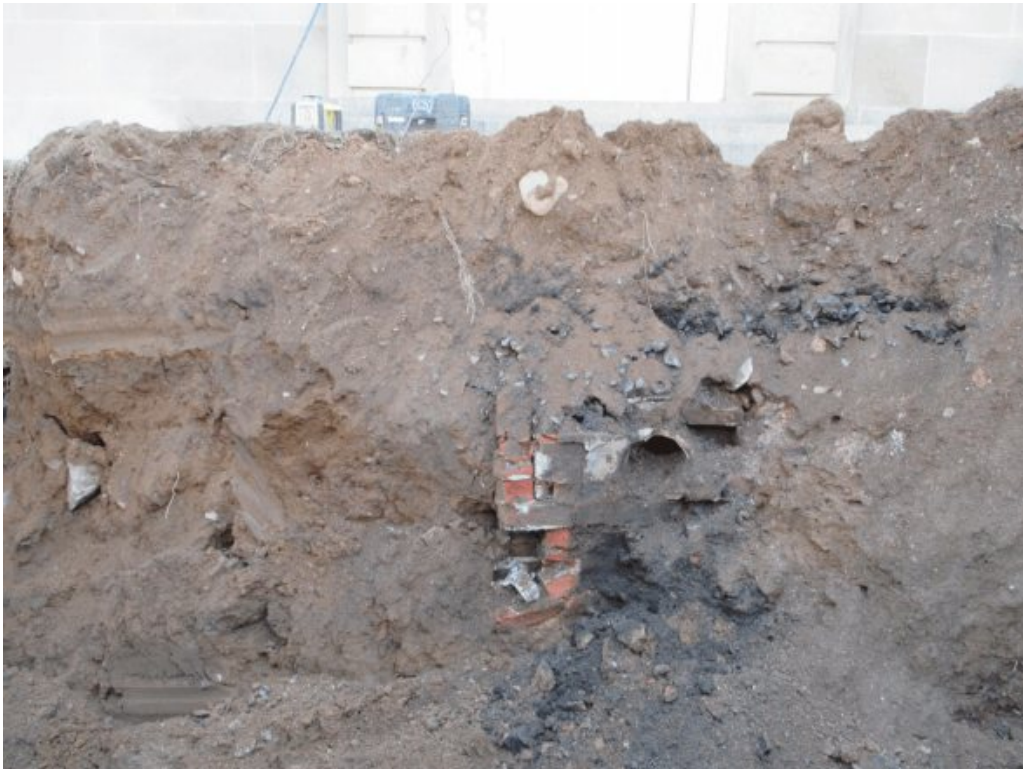
Photo 15 Defunct Brick Utility Encasement CB 11 Trench E Profile, facing east (Image 2059: September 27, 2019).

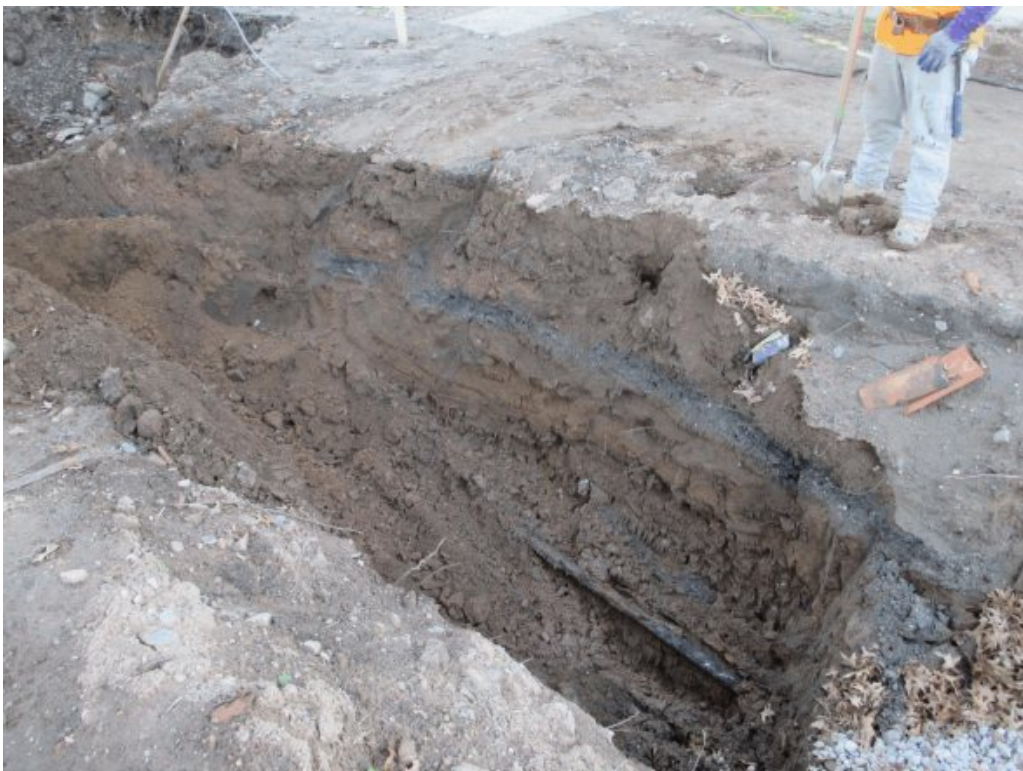
Photo 16 SW Trench 1 Segment 2 East Profile, facing northeast (Image 2230: October 24, 2019).

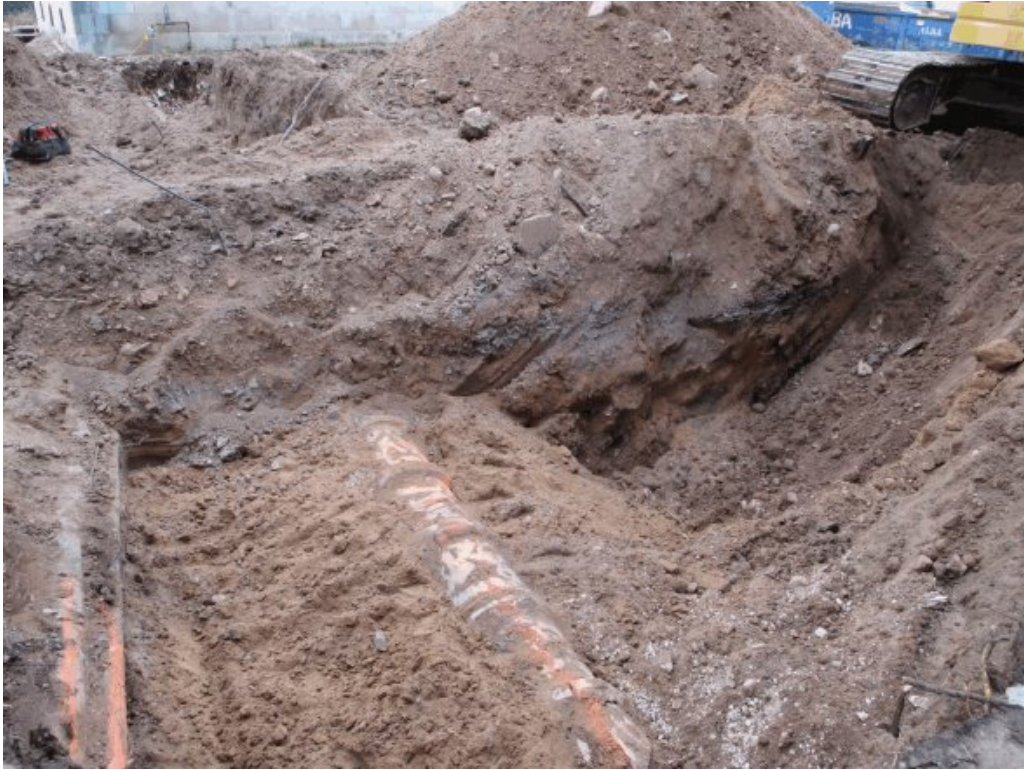
Photo 17 SW Trench 1 Seg 3 E Profile and Ceramic Utility Exposure Trench crossing, facing west (Image 2169: October 17, 2019).

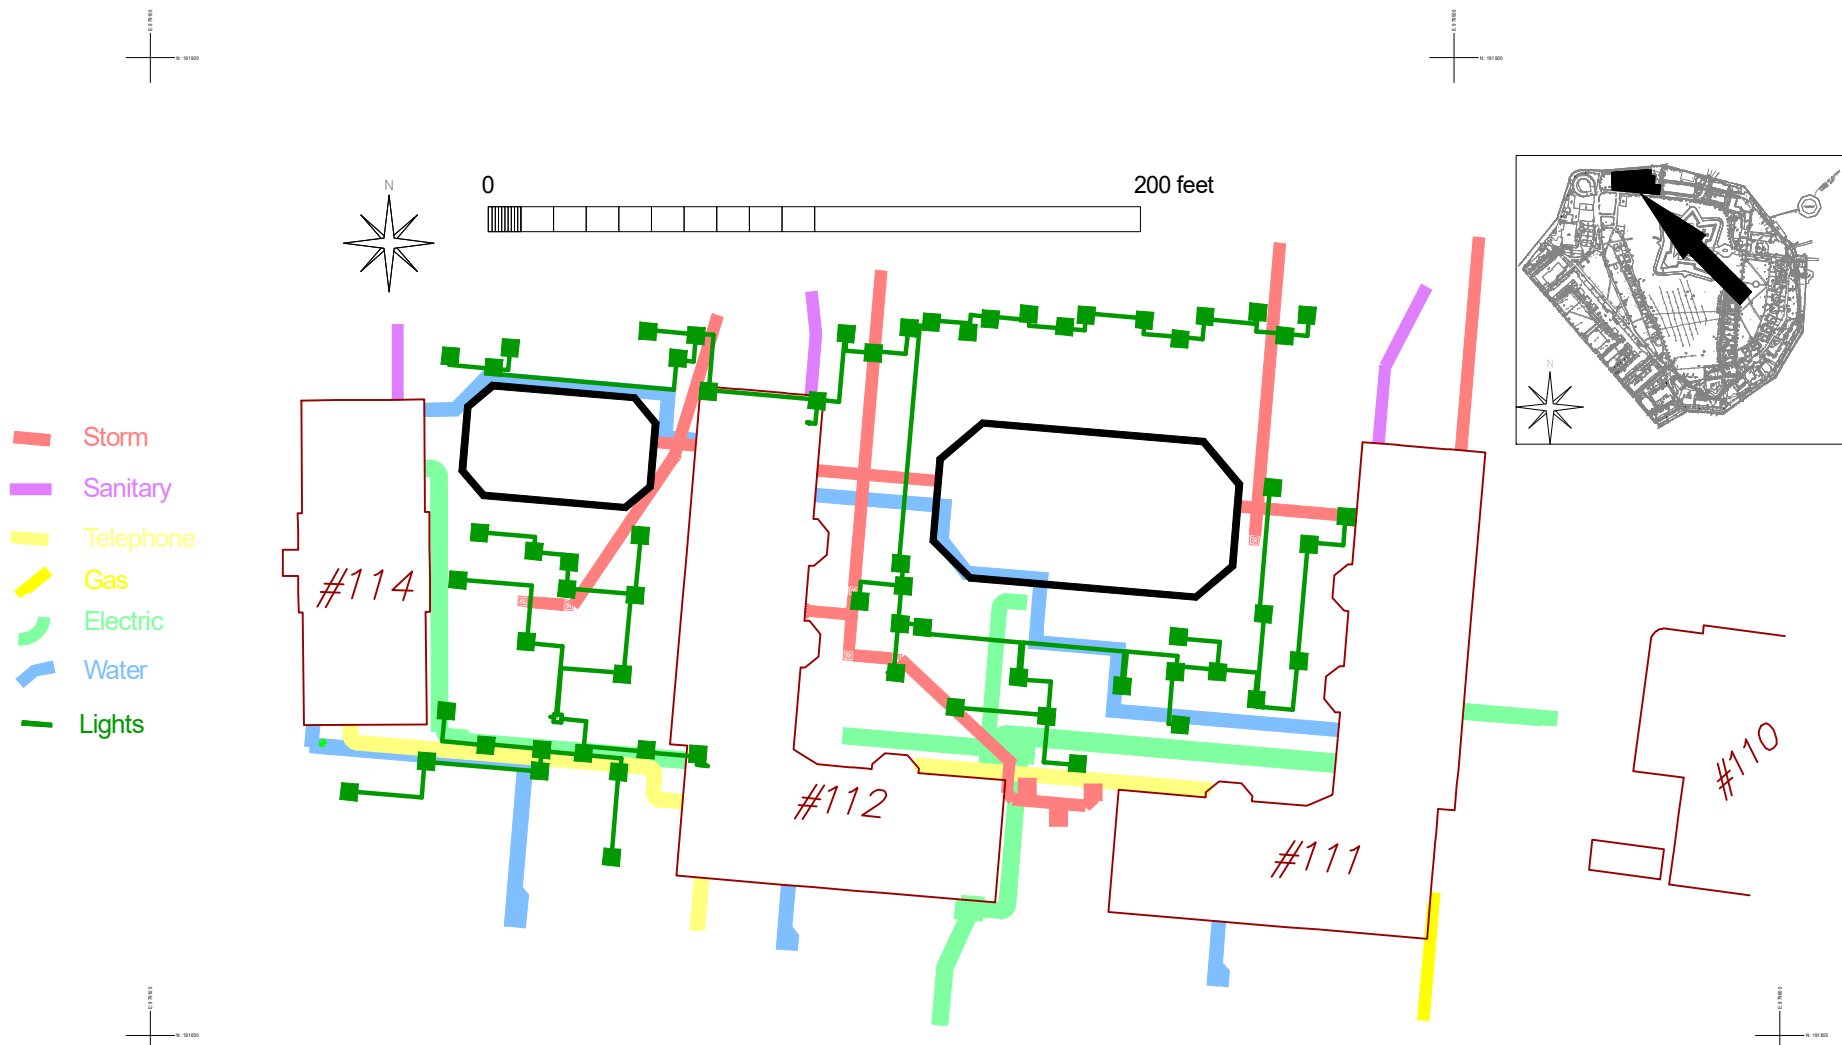
Figure 2 Location of planned utility excavation and pools for the Governors Island spa in and around Building #s 110, 111, 112 and 114.

The two main fences will be located along Carder Road on the northern side of the buildings and along Andes Road to the south (see Figure 2). The Carder Road fences are outside the original shoreline and out of archaeological concern. The Andes Road fences will be in two segments; one between the closest corners of Buildings 111 and 112 and the other between the southwest corner of Building 112 heading westward along the Andes Road sidewalk and then directly north to the southwest corner of Building 114 (see Figure 2). Only one of these segments, the piece headed westward along Andes Road between Buildings 112 and 114, crosses the path of one historic map-documented structures not previously the subject of archaeological testing. That is Building 45 (one of several Engineer Buildings) depicted on the 1879 Army map.

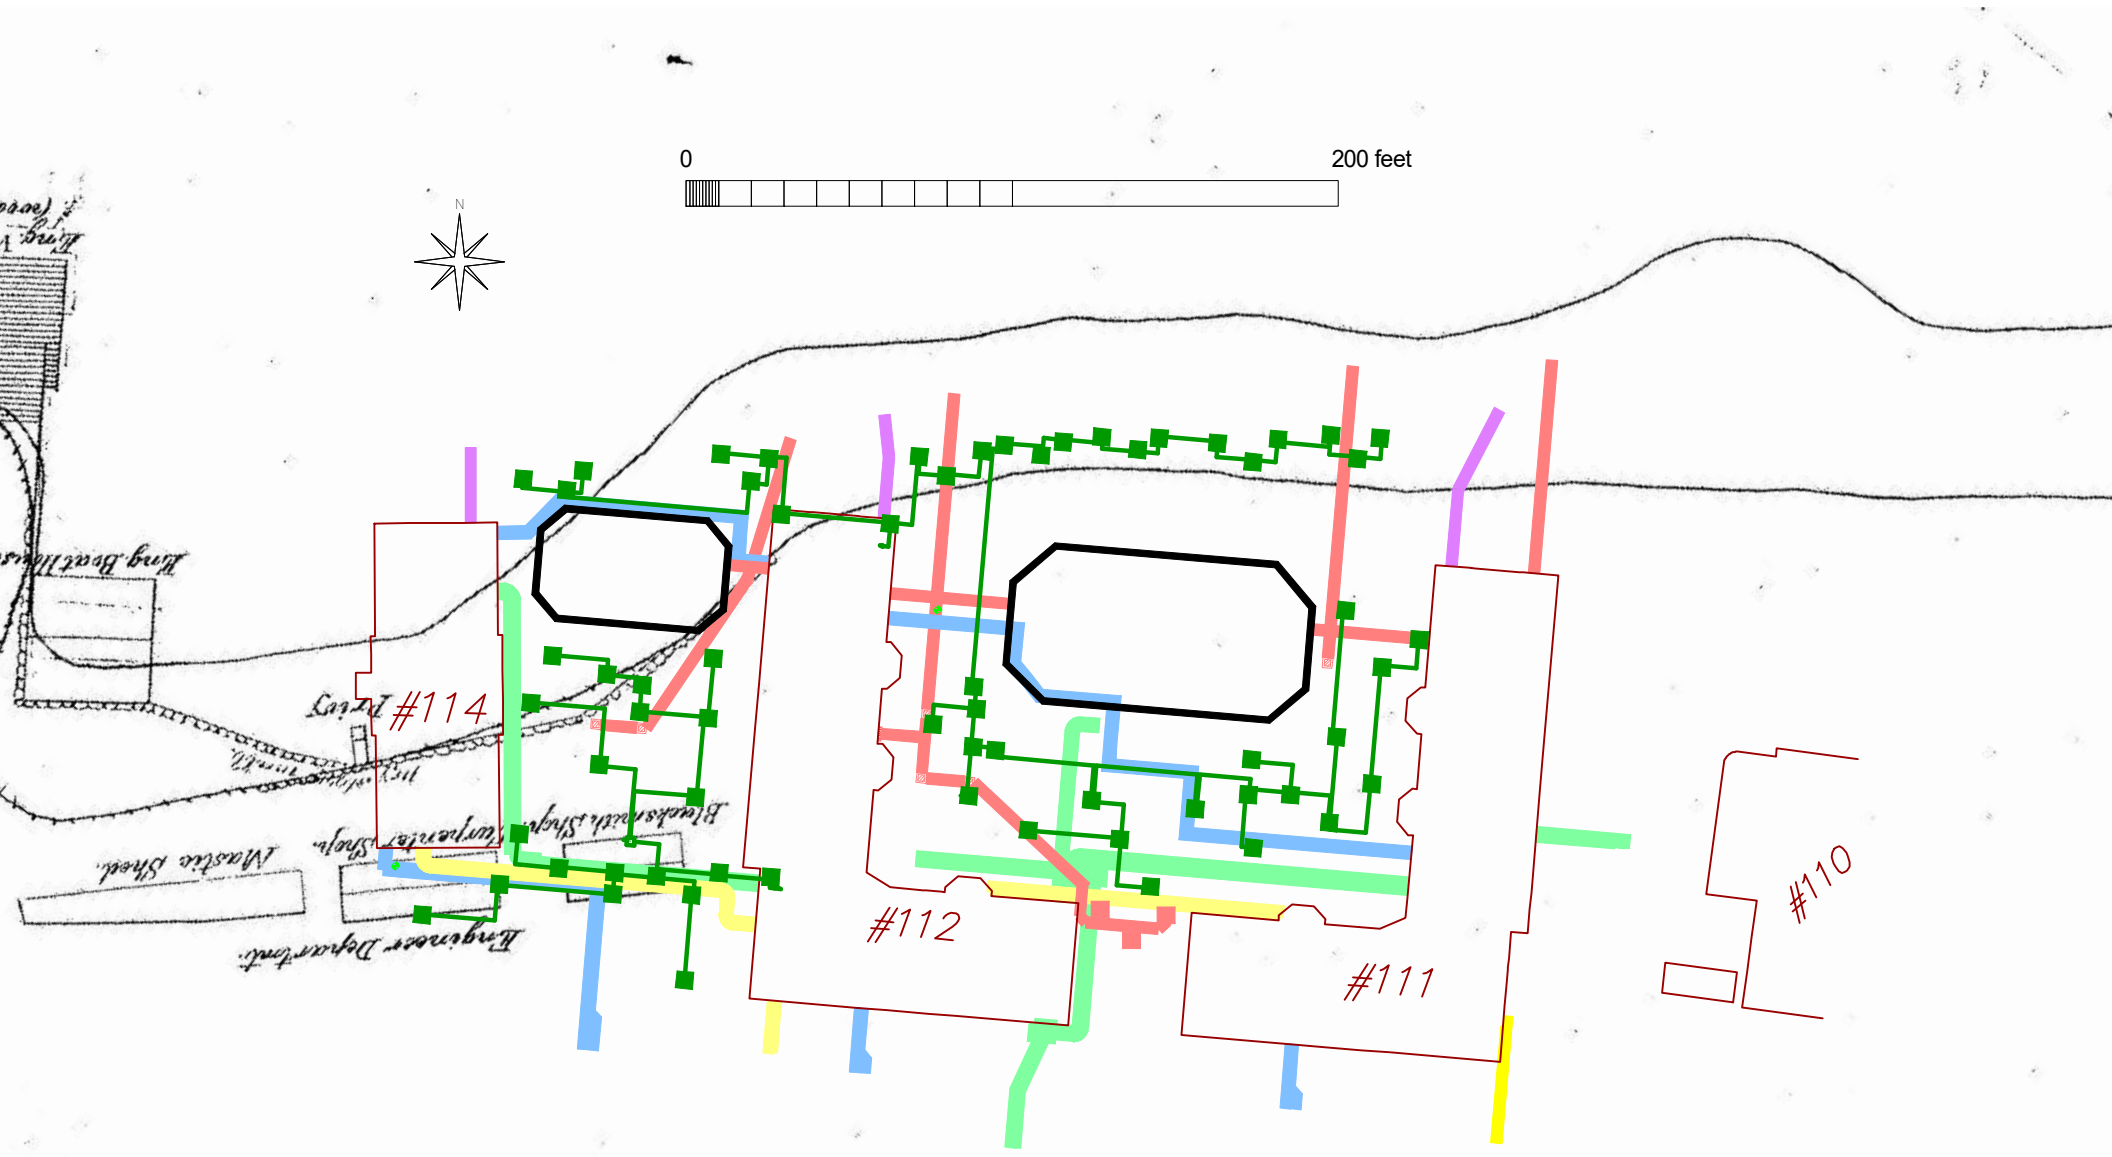
Figure 5 Part of the 1867 Barnard map showing the spa pools and utilities.

building number 44 on Figure 6 and building number 57 on Figure 7, 2) the area of the parallel telephone, electric and water lines and the nearby lighting to identify possible remains of the 1867 Blacksmith shop on Figure 5 and building number 41 of Figure 6, 3) at the western pool and storm drainage line to identify possible remains of building 142? on Figures 8 and 9, 4) the storm drainage line east of Building #112 to identify possible remains of building number 42 on Figure 6, 5) the water line parallel and south of the large pool to identify possible remains of the Post Hospital and 6) the eastern end of the planned electrical line east of Building # 111 to identify possible remains of the former MS. Qrs/number 61 on Figure 7.

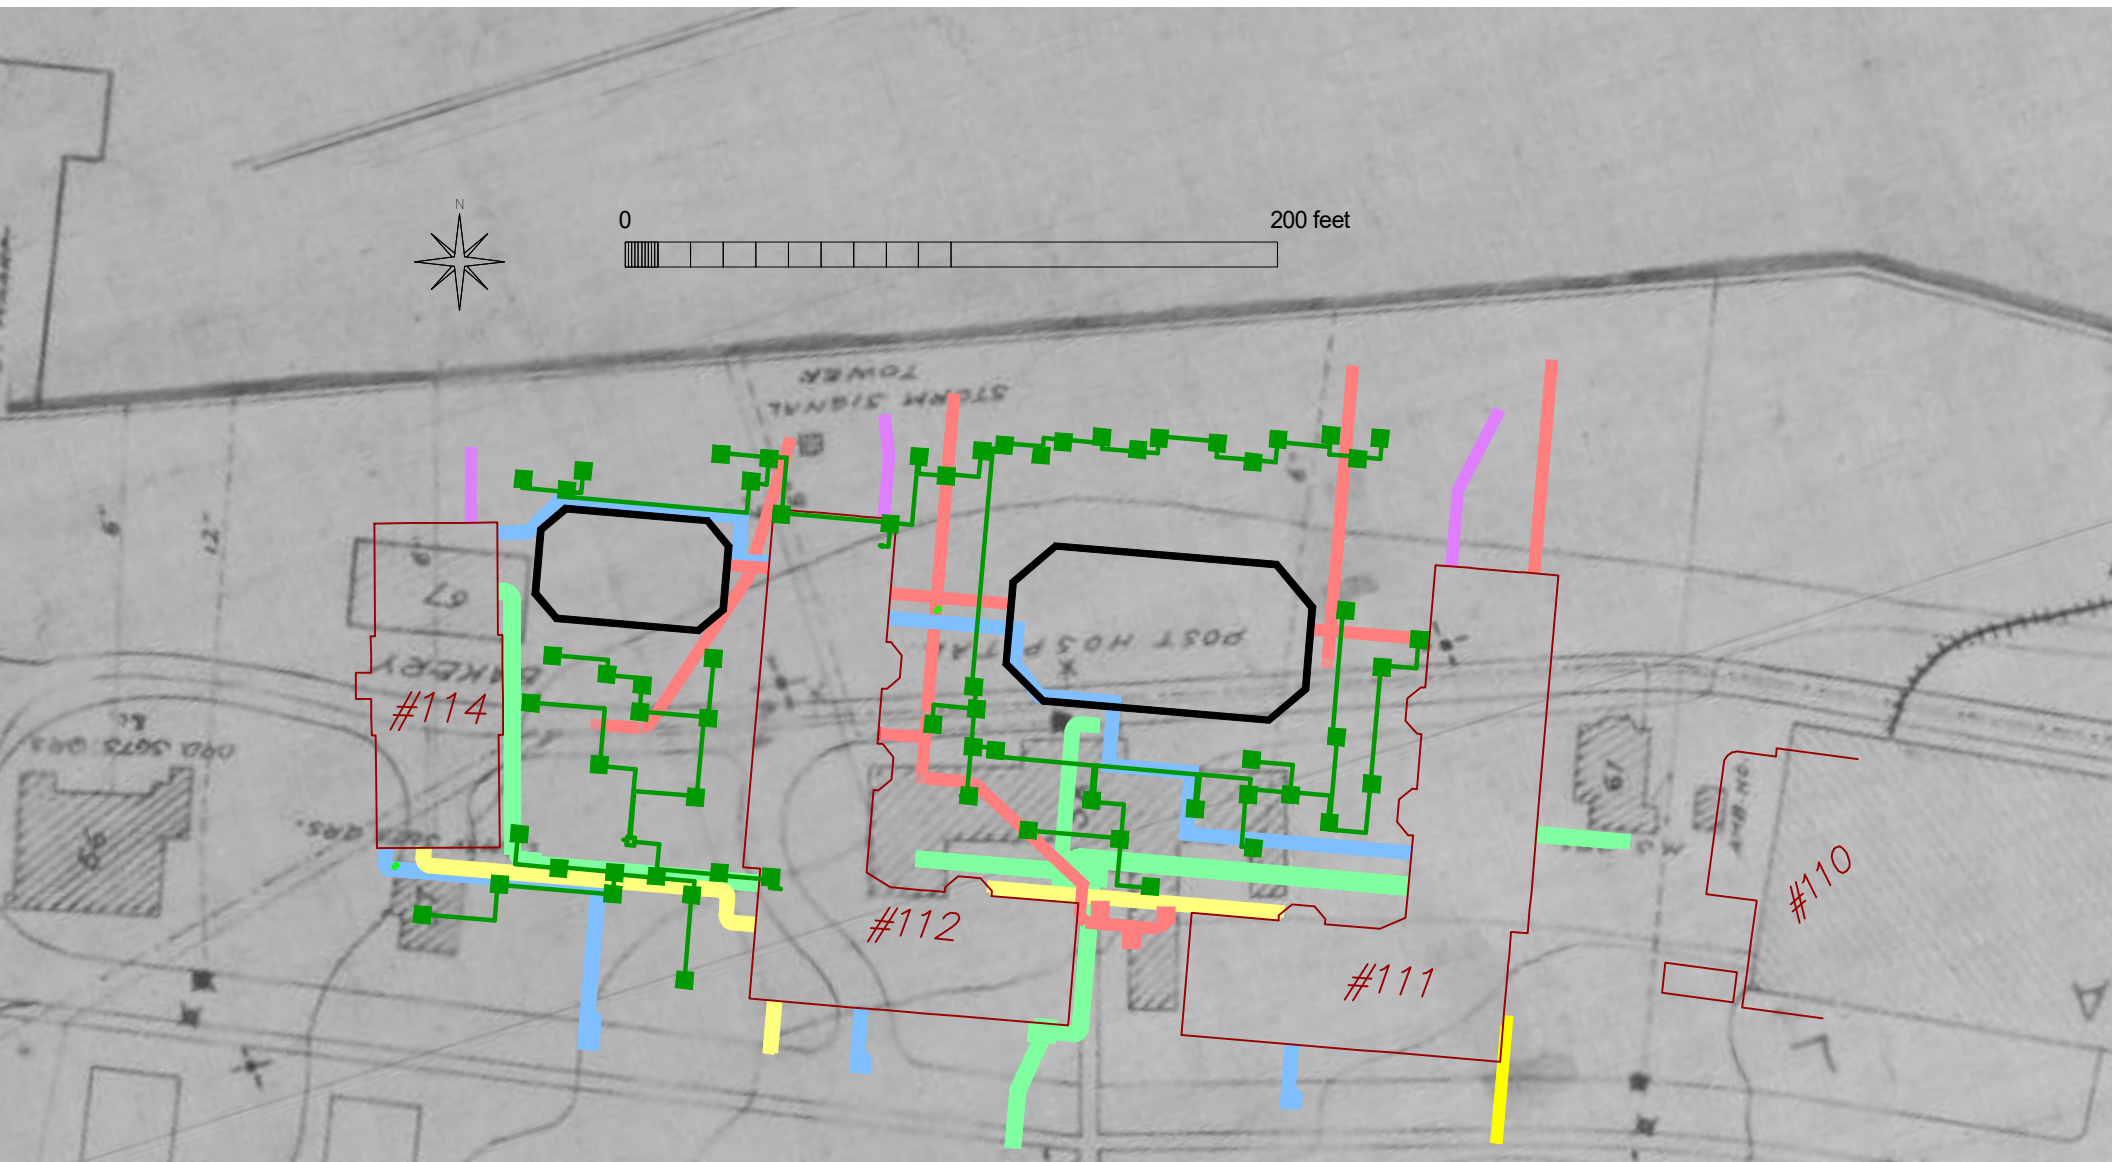
Figure 7 Part of the 1906 Hilton map showing the spa pools and utilities.

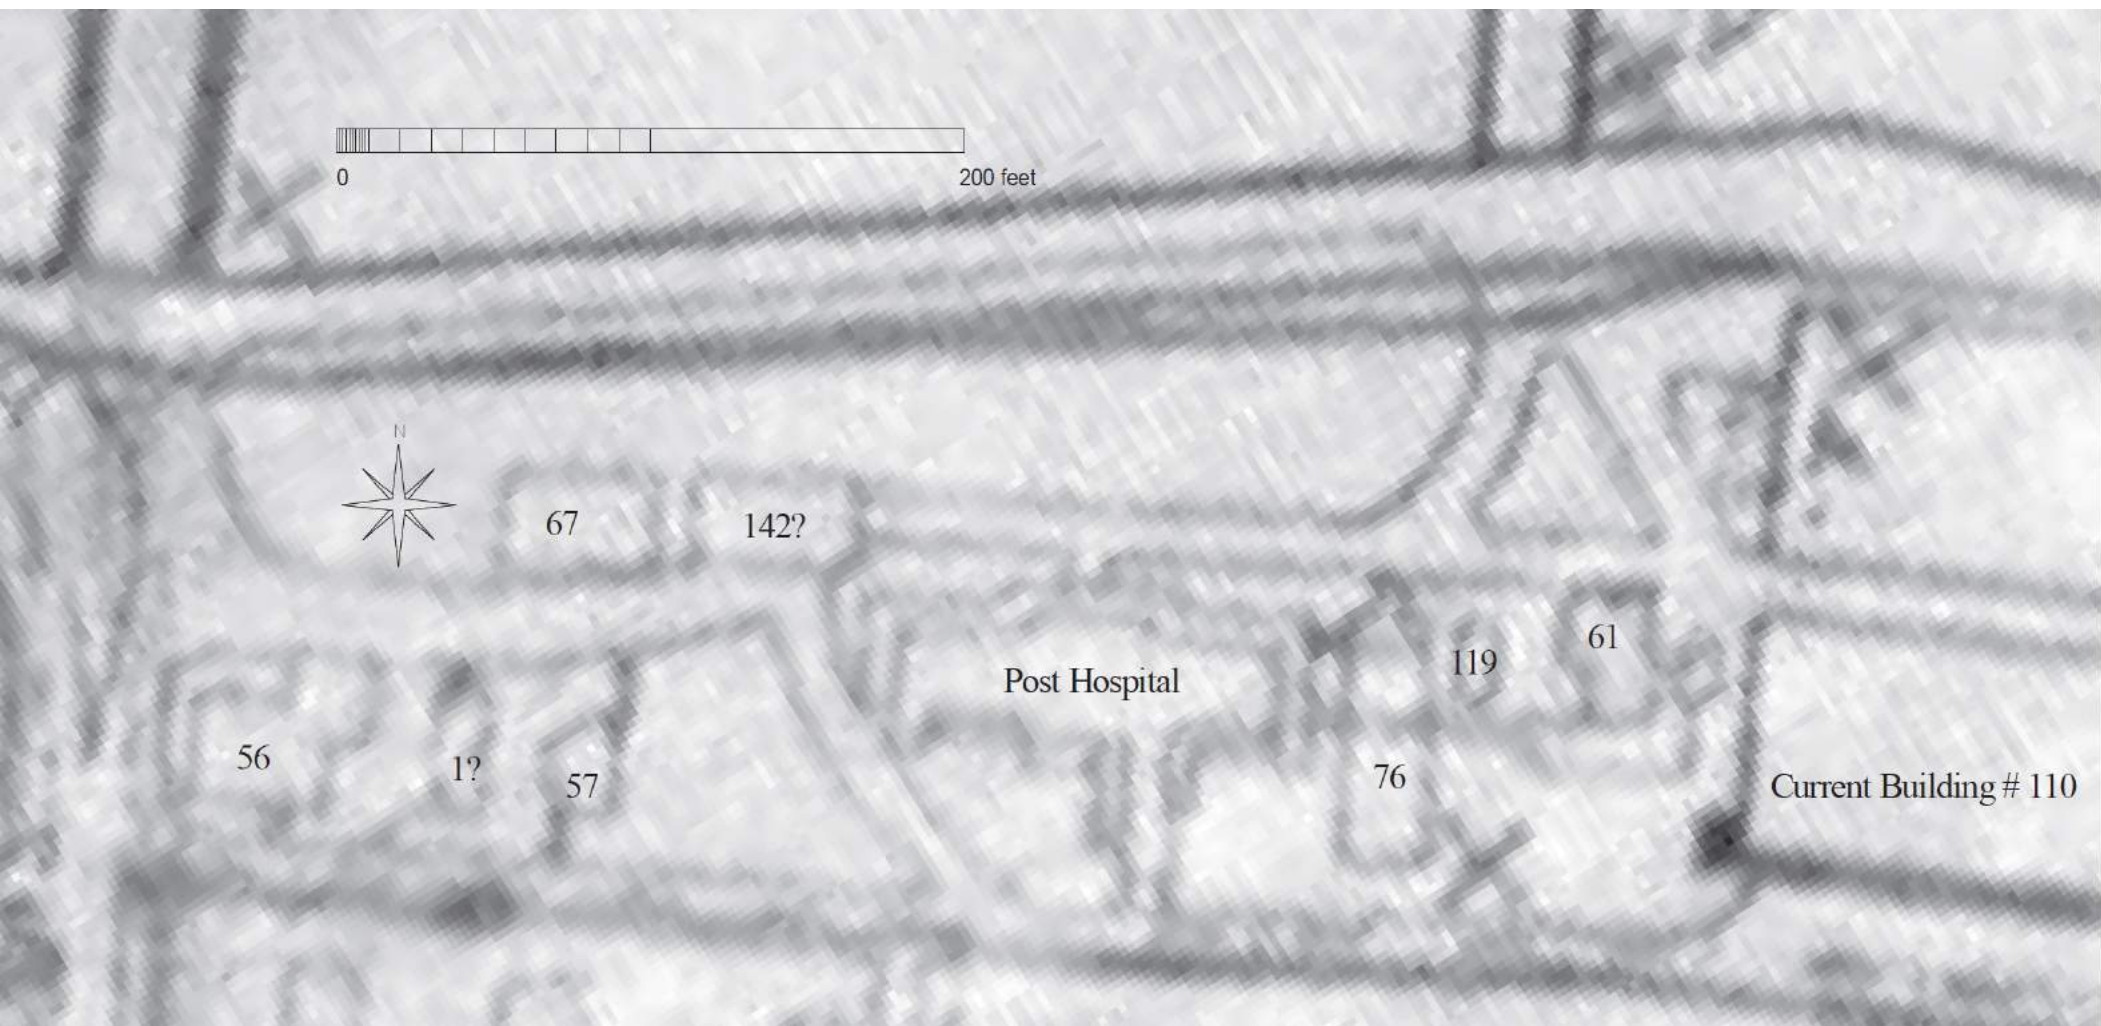
Figure 8 Part of the 1919 Utility map showing the area of the Spa APE and building numbers from the 1928 map.

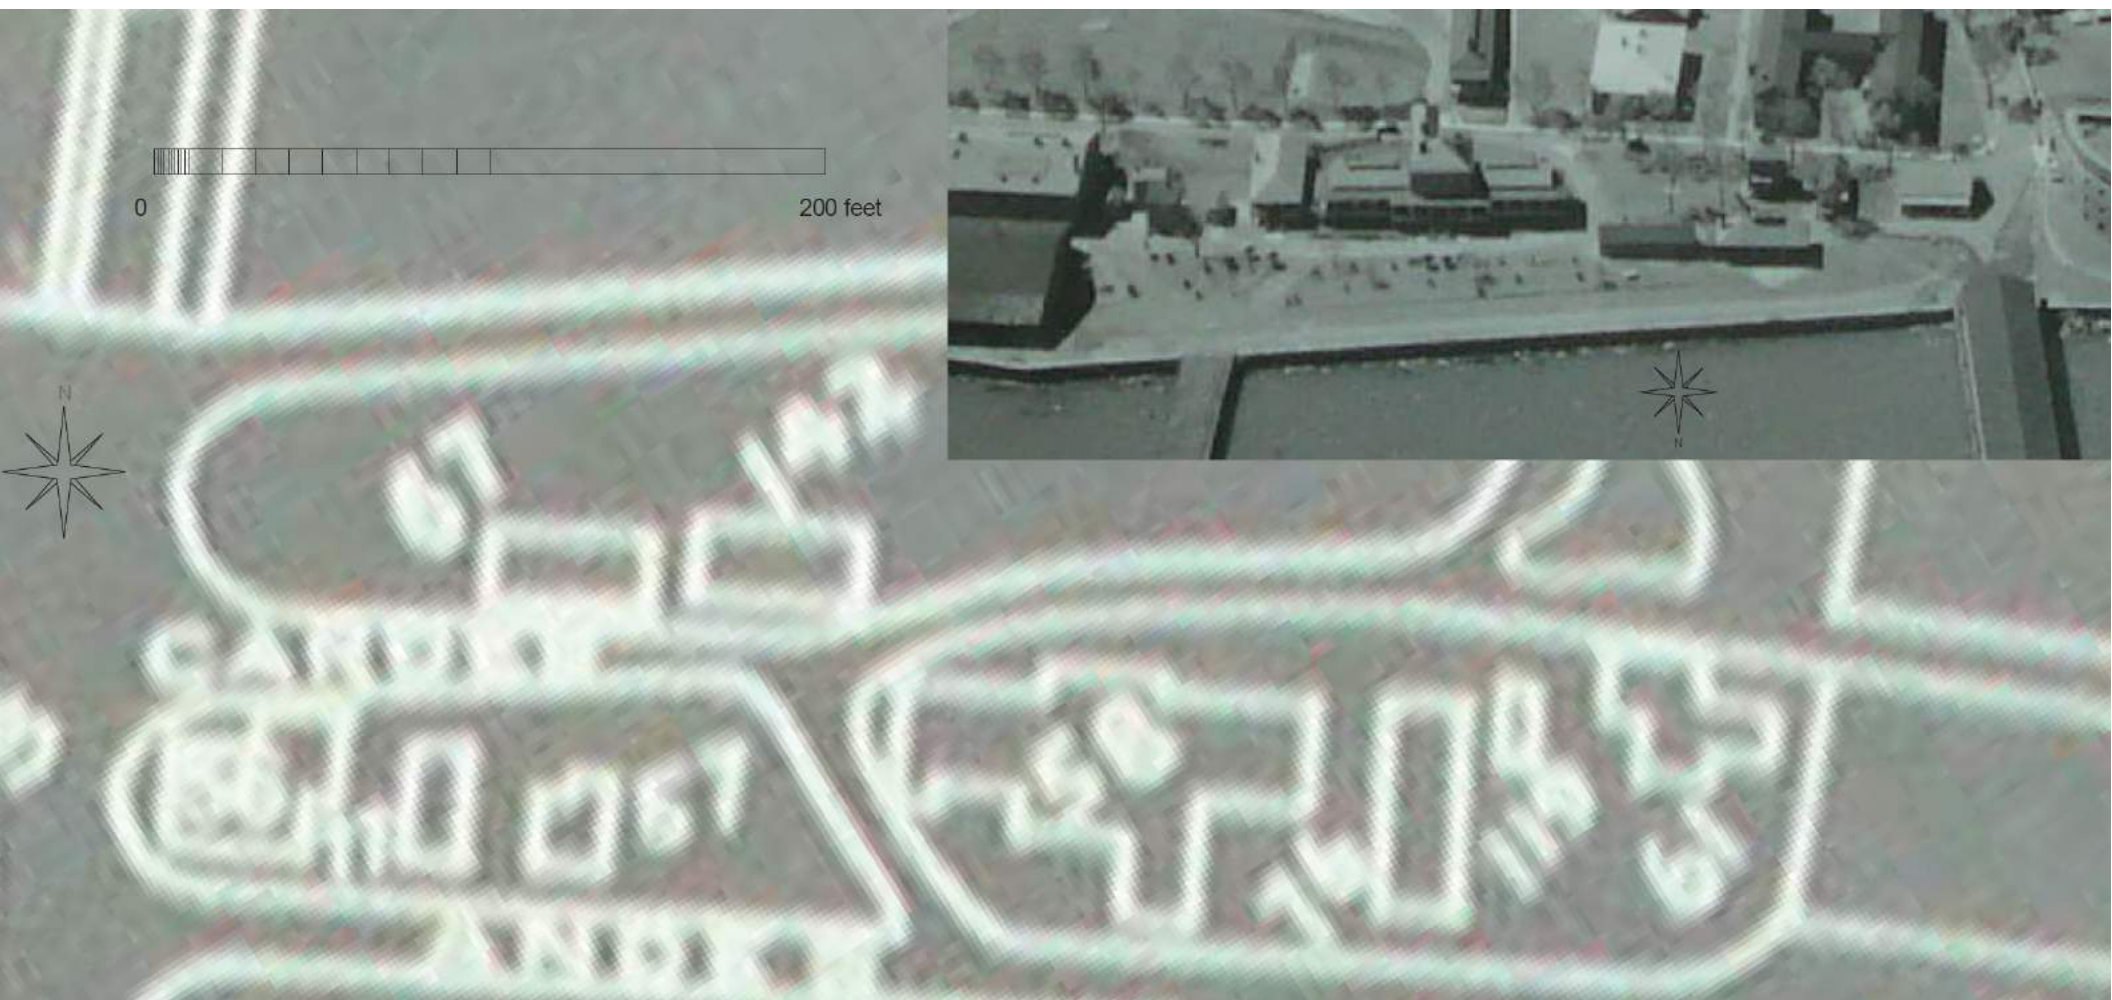
Figure 9 Part of the 1928 Fort Jay map showing the area of the Spa APE with an inset of the 1928 aerial photo.

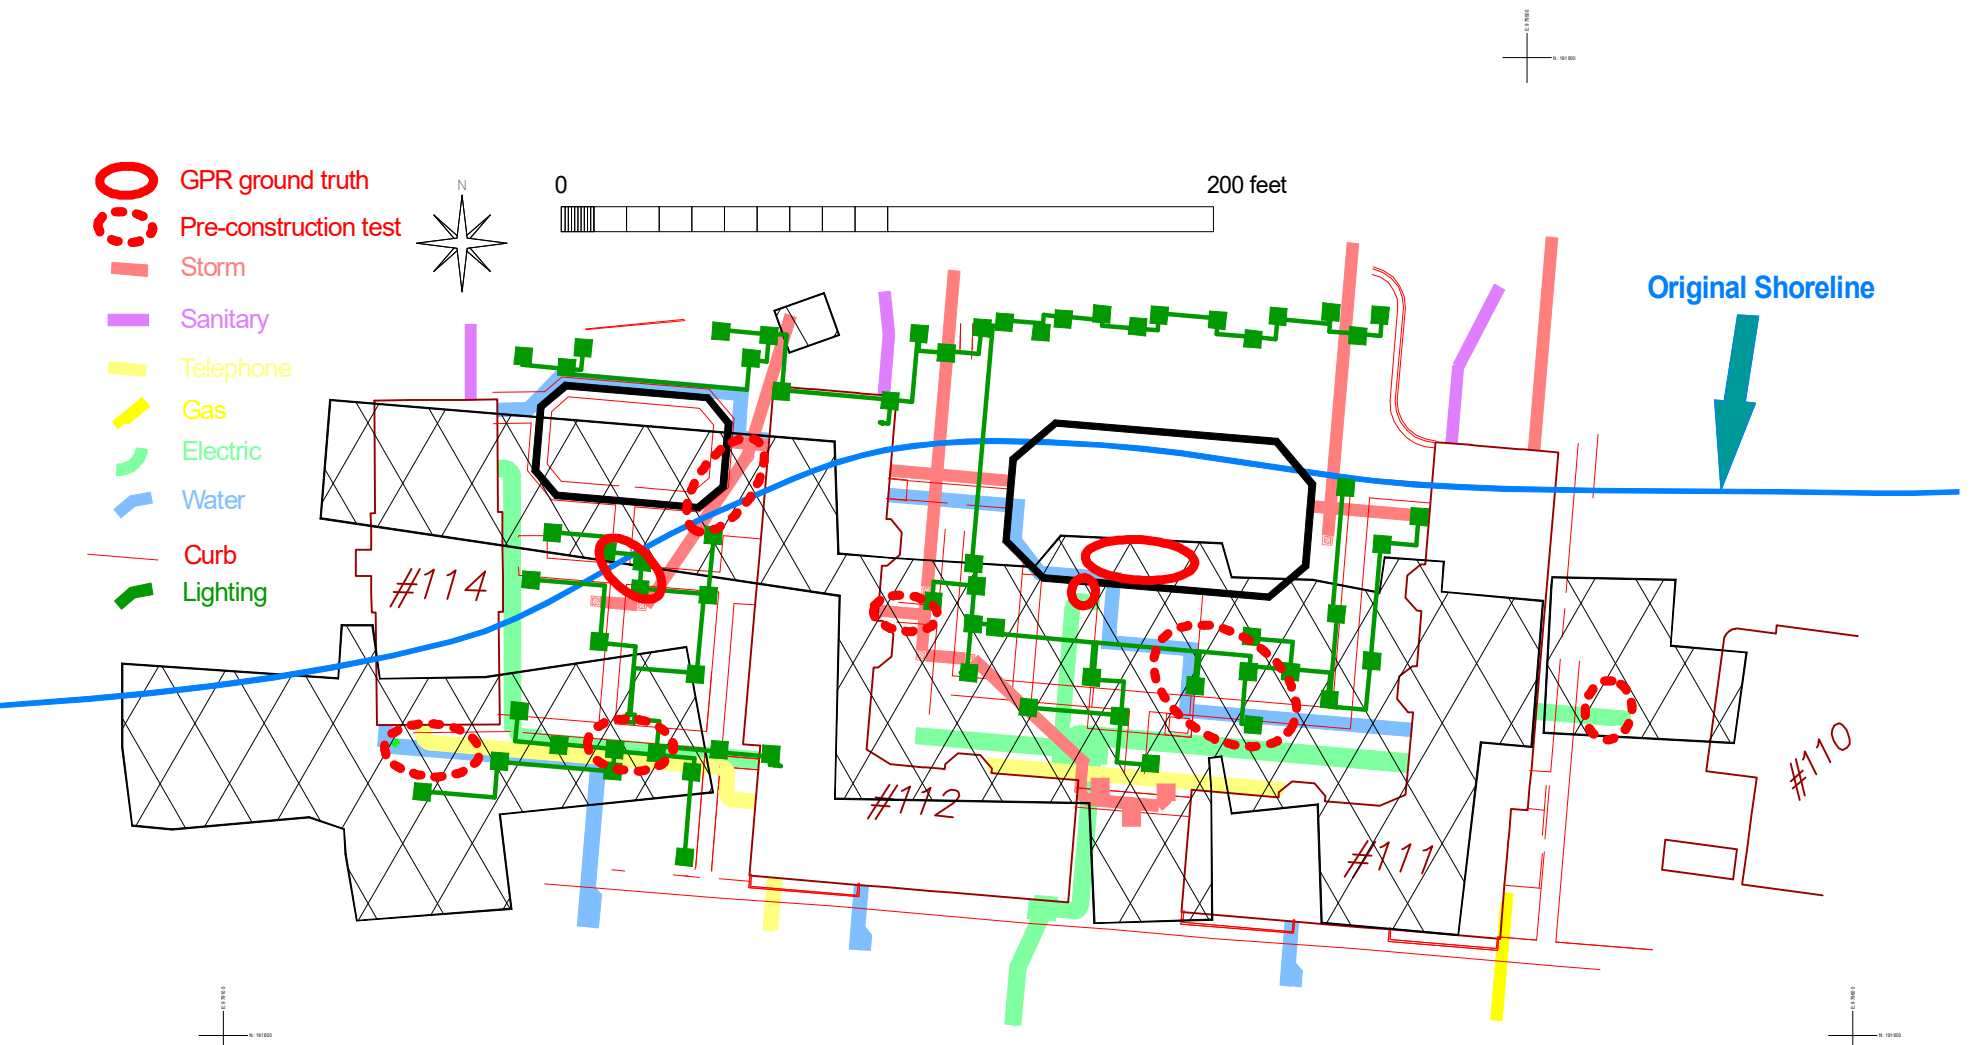
Figure 12 Areas of high archaeological potential (hatched) and recommended archaeological testing (ovals) for the Governors Island spa APE.

Ground truthing would consist of selecting a finite location within the anomaly commensurate the the size of the planned spa impact (see Figure 12). For example, archaeological work would be confined to the footprint of only the portion of the planned impact rather than the entire anomaly footprint. Of the three areas identified associated with the former hospital, the two larger anomalies (the tunnel and surface) would require a test trench of no more than 3 feet (91 cm) wide by 10 feet (305 cm) long to assess the presence or absence of remains of the hospital in that area. A smaller test pit would cover the area of where an unknown anomaly was found where an electrical line will be placed. Up to three similarly sized test pits³, one for each light, should also be adequate to identify potential archaeological resources in the former building number 142? area where lights are planned. The depth of these proposed excavations would be sufficient to determine the identity of the anomaly as specified in the GPR survey (see Figure 11).

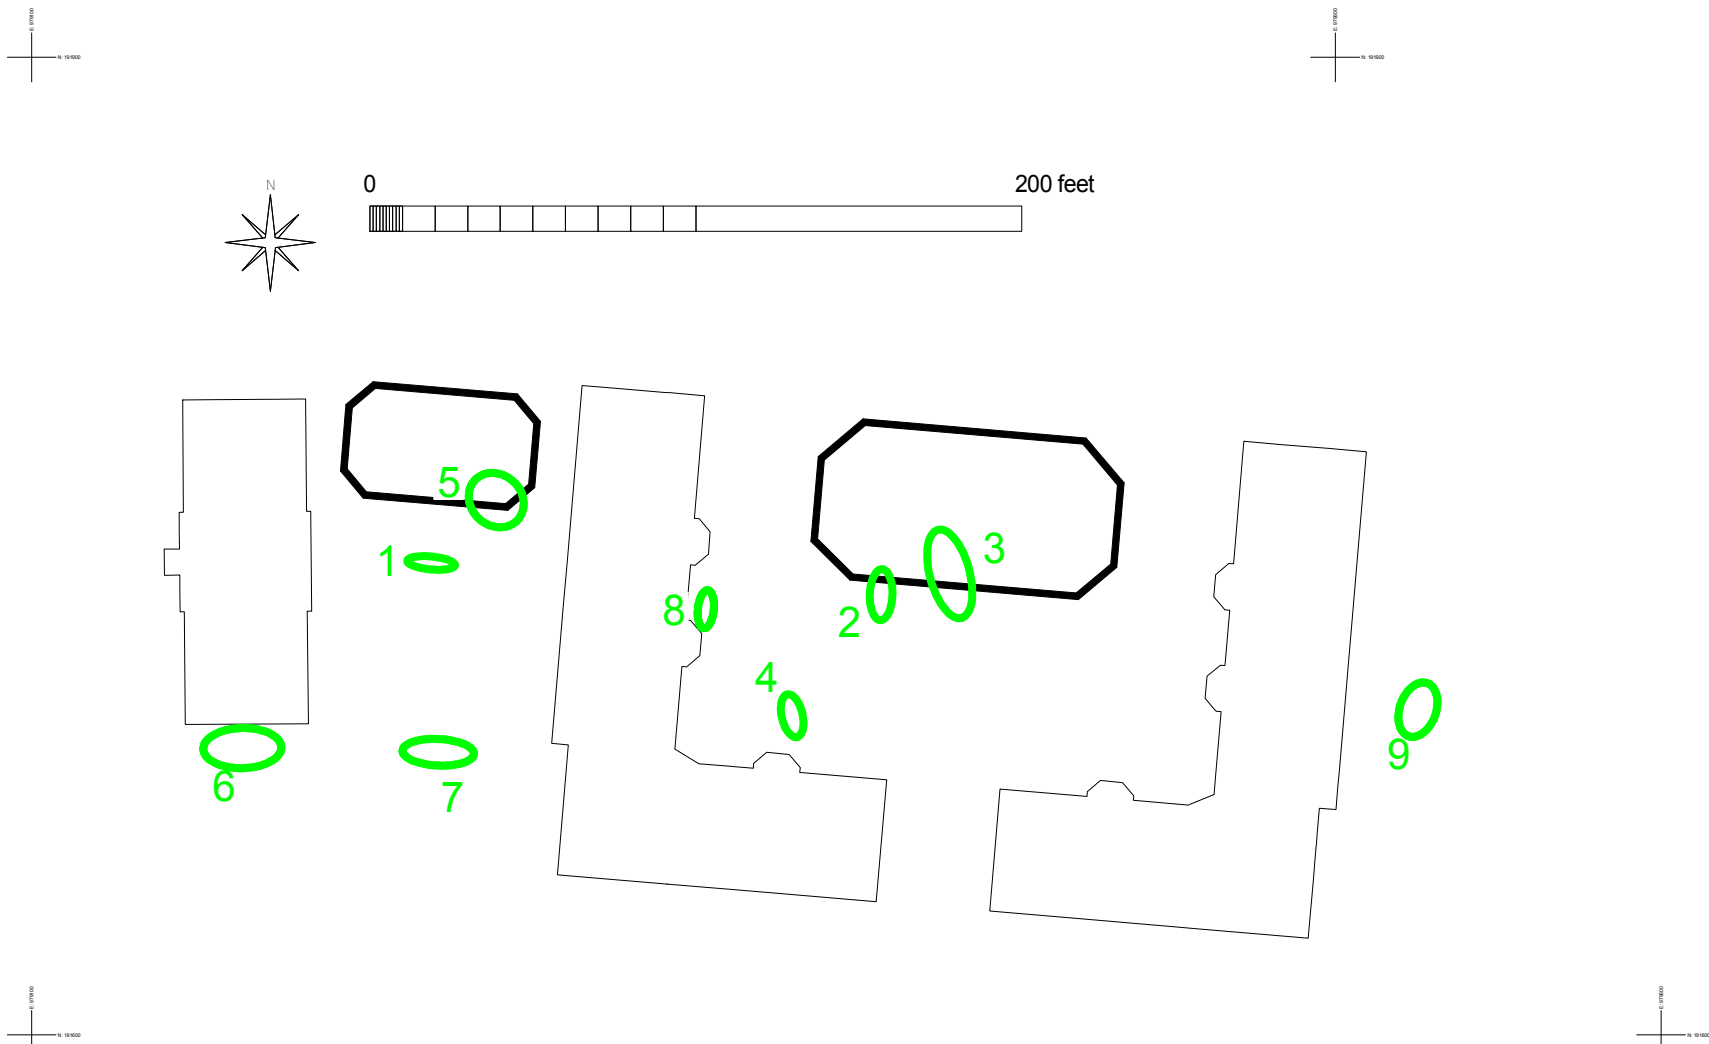
Figure 1 Pre-construction archaeological testing locations for the Governors Island spa.

TEST	POTENTIAL RESOURCE	FINDINGS	RECOMMENDATION
1	GPR void 38" bgs, orig.shore, 1919 Building #67	Not found.	Monitoring
3	GPR tunnel 27" bgs & unknown anomaly 18-24" bgs, 1906 road	Not found. However, test contained some compaction.	Monitoring
4	GPR surface 24" bgs, 1919/1928/1906 hospital	Two courses of part of a possible brick wall or surface, or a displaced section thereof, in the eastern profile of the trench buried approximately 3.2' below ground surface.	No further excavation planned for utility line, but monitoring recommended.
5	1919/1928 Building #142?	Not found.	Monitoring
6	1867 carpenter shop, 1879 Building #44, 1906 Com Sgt Qrs, 1919/1928 Building #1?	A 9-inch thick layer of concrete throughout most of the trench at 2.8' below ground surface.	Data recovery, plan below.
7	1967 blacksmith shop, 1879 Building #43	Not found.	Monitoring
8	1879 Building #42	Not found	Monitoring

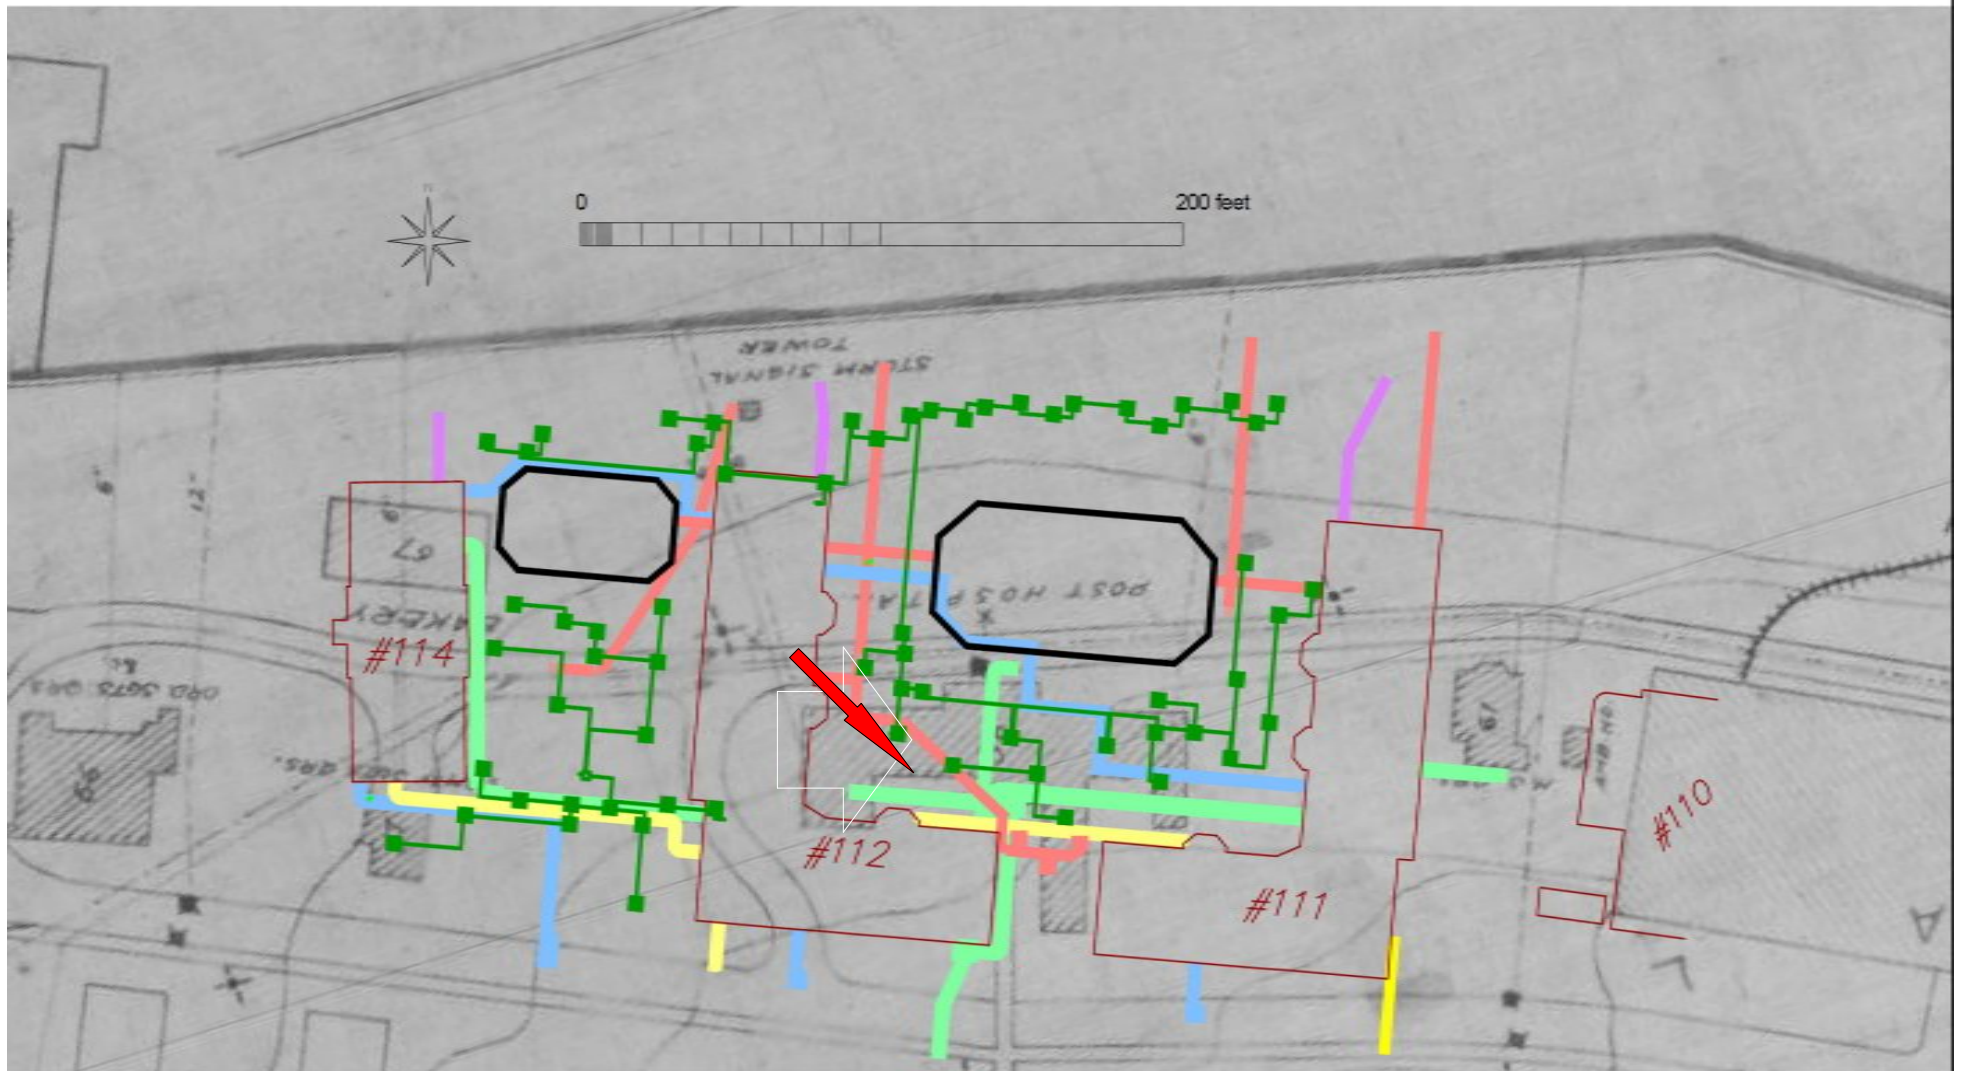
Figure 7 Part of the 1906 Hilton map showing the spa pools and utilities.
