ARCHEOLOGICAL TESTING FOR TWO MILLER FIELD ROAD IMPROVEMENTS,
GATEWAY NATIONAL RECREATION AREA, STATEN ISLAND, NEW YORK,

GATE PACKAGE 185

James W. Mueller and Dana C. Linck

United States Department of the Interior
National Park Service
Denver Service Center
Eastern Applied Archeology Center
Rockville, Maryland
1991

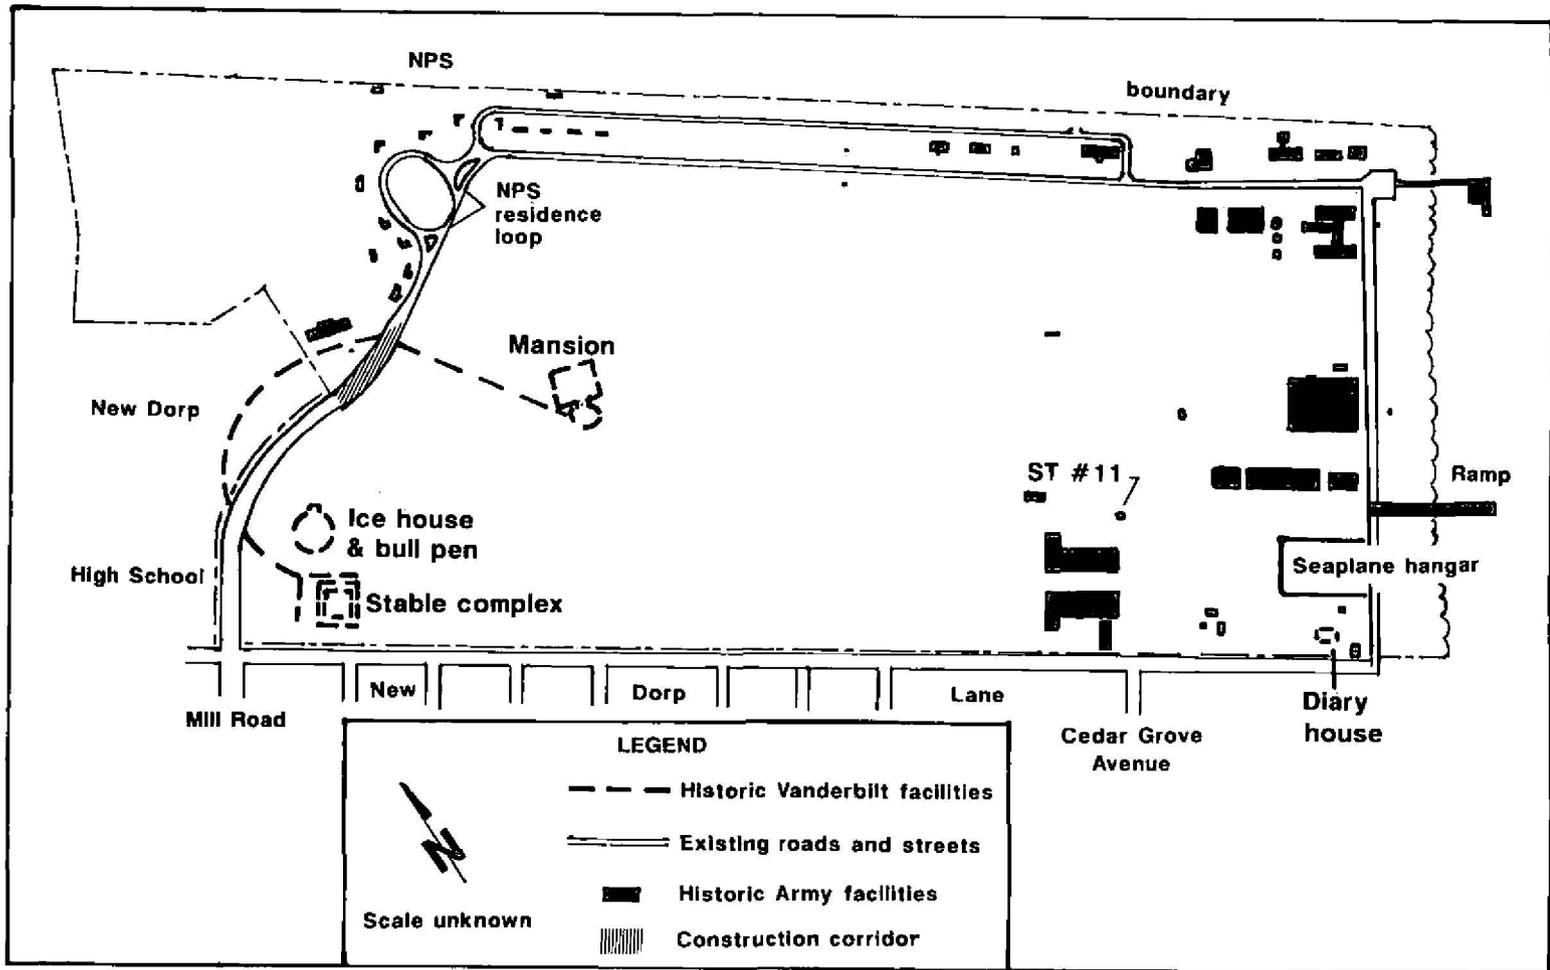
Figure 2. Historic Drawing of Miller Field (based on Unrau and Powell 1981: Figures A and D)

The four shovel tests in the northern road improvement (the "Construction corridor" on Figure 2) were located in the area of the first seven Vanderbilt facilities (above). The mansion was located toward the center of Miller Field, isolated slightly from the remaining clusters of Vanderbilt facilities. The next three facilities (the radio building, and the stable and ice house complexes) comprised a cluster in the northwestern area of Miller Field. Facilities numbered 5-7 (the water tower, gardener's complex, and pumping station) formed a group in the far northern area of Miller Field. In the southern area, the dairy house and dock were located quite distant from the southern road improvement (labelled as ST #11 on Figure 2). A Vanderbilt trotting course and clubhouse complex dating to 1874 in the southern part of the estate (Anonymous 1874) was probably destroyed by 1898 (Robinson 1898). ST #11 was located at the site of this horse complex, while the remaining shovel tests were generally located approximately 700 feet from the nearest Vanderbilt facility.

The mansion or white house was the main family residence. It was moved to the interior of their property (Figure 2) between 1875 and 1897 from the earlier location at the intersection of Mill Road and New Dorp Lane in the northwestern area (Anonymous 1874 and Robinson 1898). The mansion was adaptively re-used as an Officers' Club by the Army (Unrau and Powell 1981:23) and was dismantled in 1936 (Staten Island Advance 1936b and Milner 1978:67).

that was adjacent to the stable complex on Figure 3. The locations of the stable and ice house complexes was illustrated on Robinson's (1898) map and are labelled on Figure 2.

In the southern area, the dairy house was located (Figure 2) near the shoreline along New Dorp Lane (Green 1922 and Milner 1976: 67). Unrau and Powell (1981: 65, Figure A) also showed two nearby buildings that may have been part of the dairy complex in 1919.

The construction of Army housing in the northern area around the NPS residence loop (Figure 2) created serious disturbances to the Vanderbilt estate. The first disturbances in this area were the razing of the gardener's cottage/greenhouses and of the pumping station. This razing was followed by the construction of about 17 Army houses (Plate III, Appendix) that were completed by June 30, 1921. Sewer connections for the Bachelor Officers Quarters (Unrau and Powell 1981:28), as well as the 1936 demolitions of the water tower and mansion, were other disturbances.

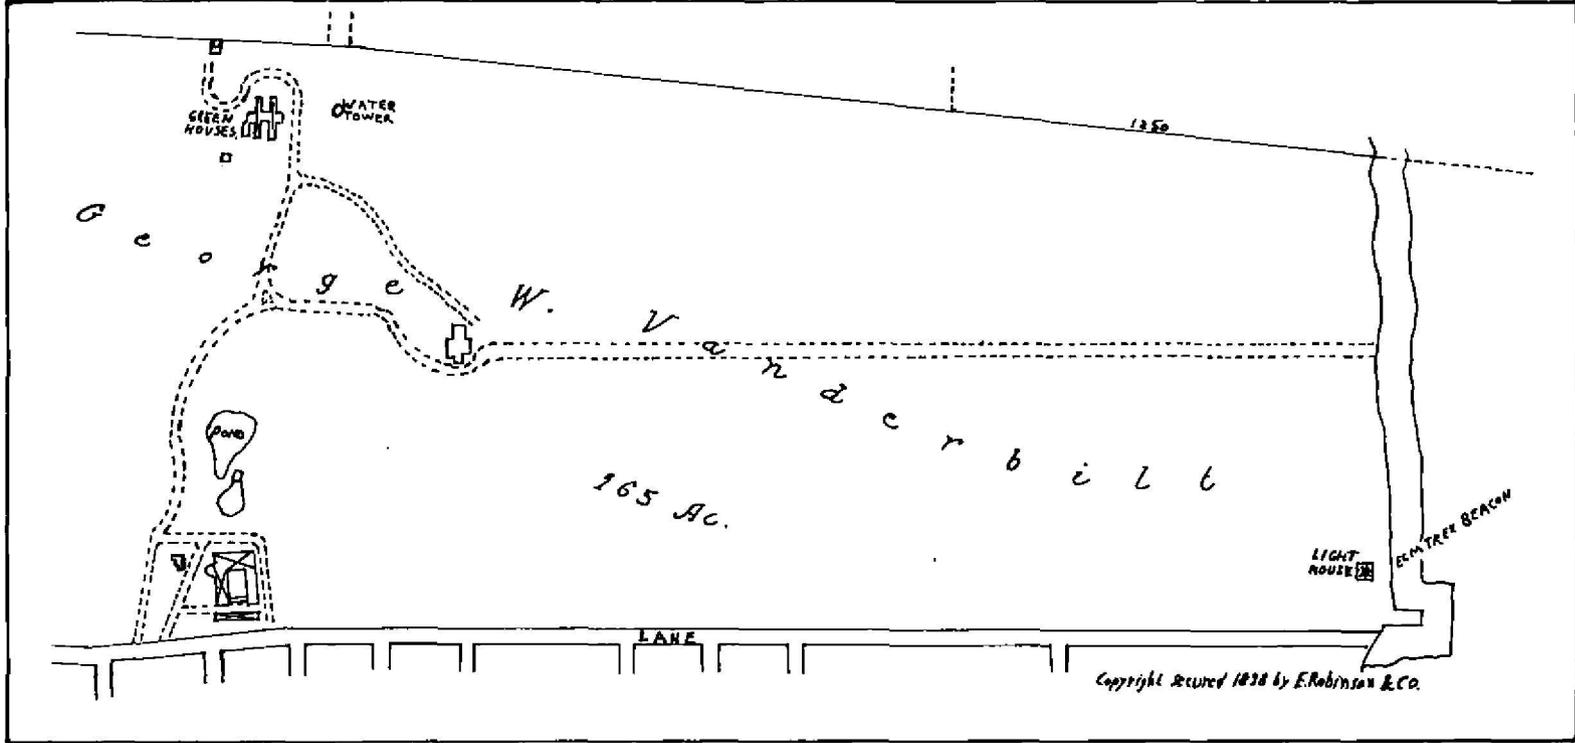
Figure 3. The Vanderbilt Estate in 1898 (a tracing of Robinson's 1898 sketch)

In the northern cluster, the greenhouses and the old water tower were also clearly identified by Robinson (Figure 3). The gardener's cottage and greenhouses were demolished between June 26, 1920, and June 30, 1921. The latter date marked the final payment for the general contract that specified their demolition. The gardener's cottage was a two-story building with a central, ridgeline chimney. The razing of the water tower was begun by January 18, 1936, as shown in a Staten Island Advance photograph of the same date.

A Vanderbilt dock was located (Whitlock 1910: 13) in the vicinity of the Elm Tree Beacon (Figure 3). The dock may have been destroyed during the construction of the seaplane ramps in 1920. The Beacon was a navigational aide that was in operation before the Vanderbilt period and was still in use during the 1919-21 construction of Miller Field (Greenwood and Torres-Reyes 1980: item 7, p. 2; and Green 1922).

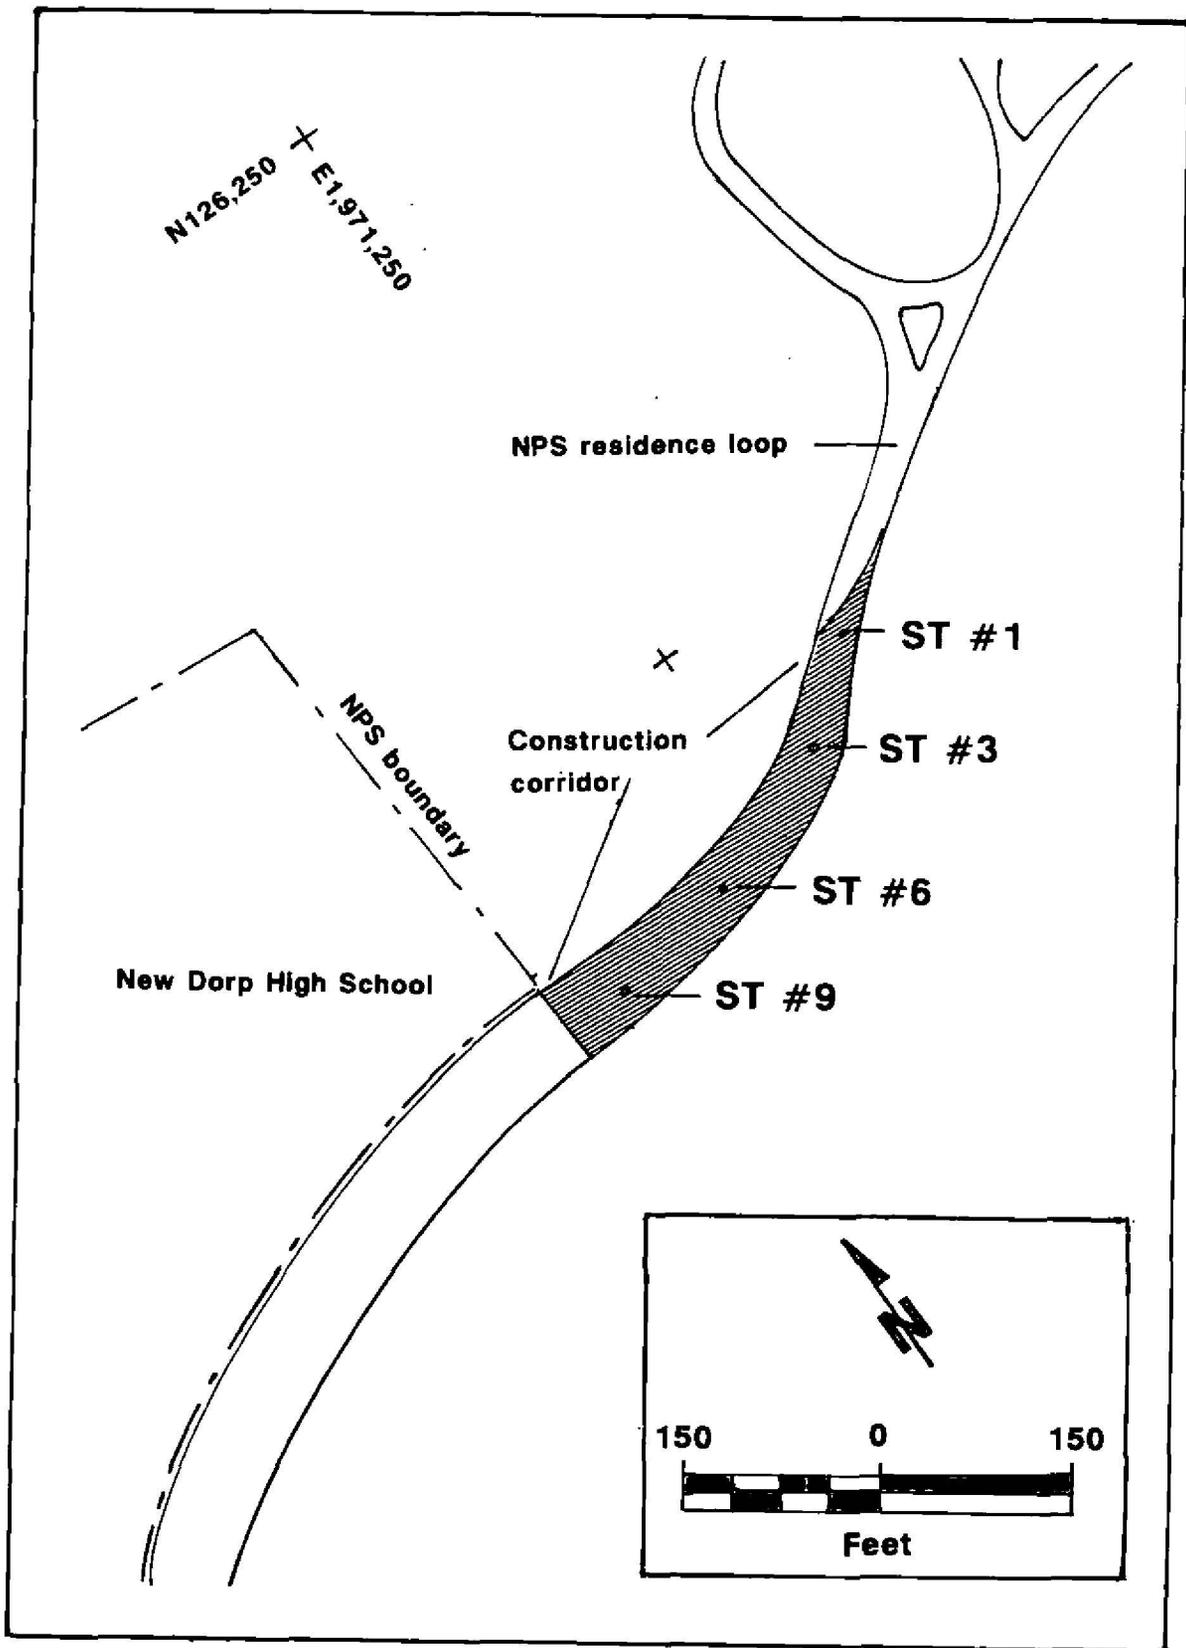
Figure 4. The Construction Corridor of the Northern Road Improvement (modified from NPS drawing 646/41,108; sheet 3/33; June, 1989)

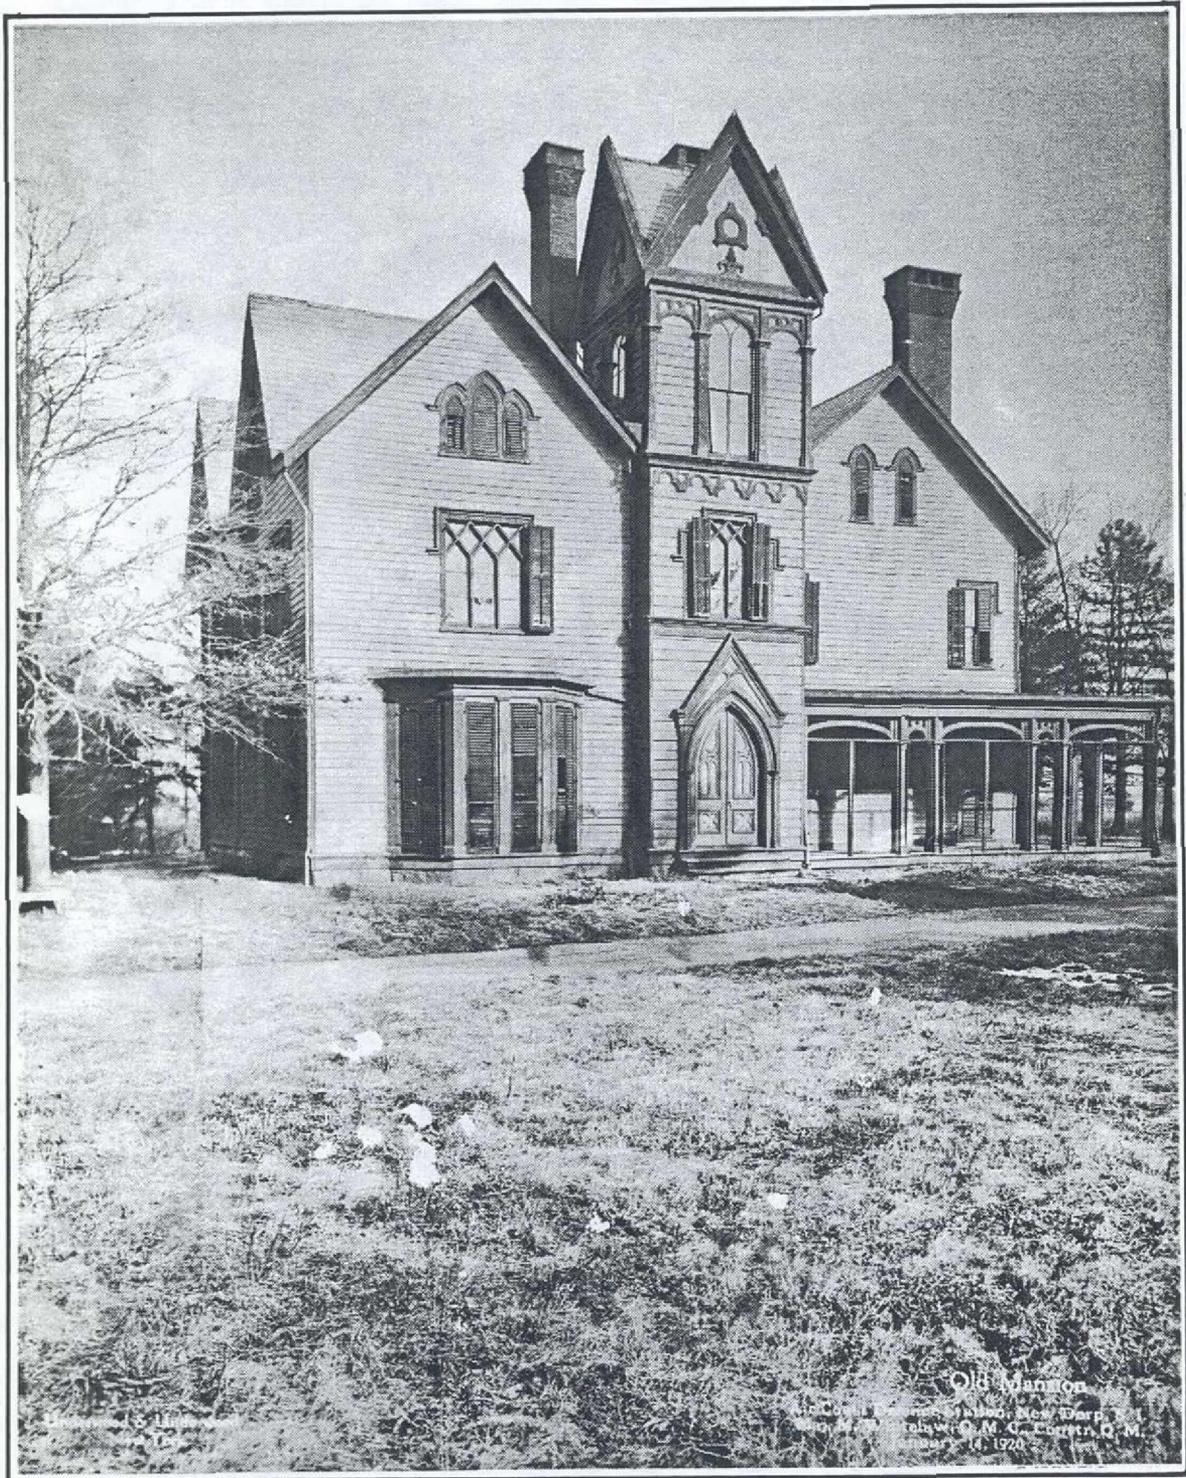
Plate I. The Vanderbilt Mansion in 1920 (Whitelaw #56).

Concerning construction dates, the mansion (Plate I, Appendix) was built soon after Cornelius Vanderbilt acquired the land in 1843 (Unrau and Powell 1981: 2). The construction of the remaining facilities generally occurred after 1874 (Anonymous 1874).

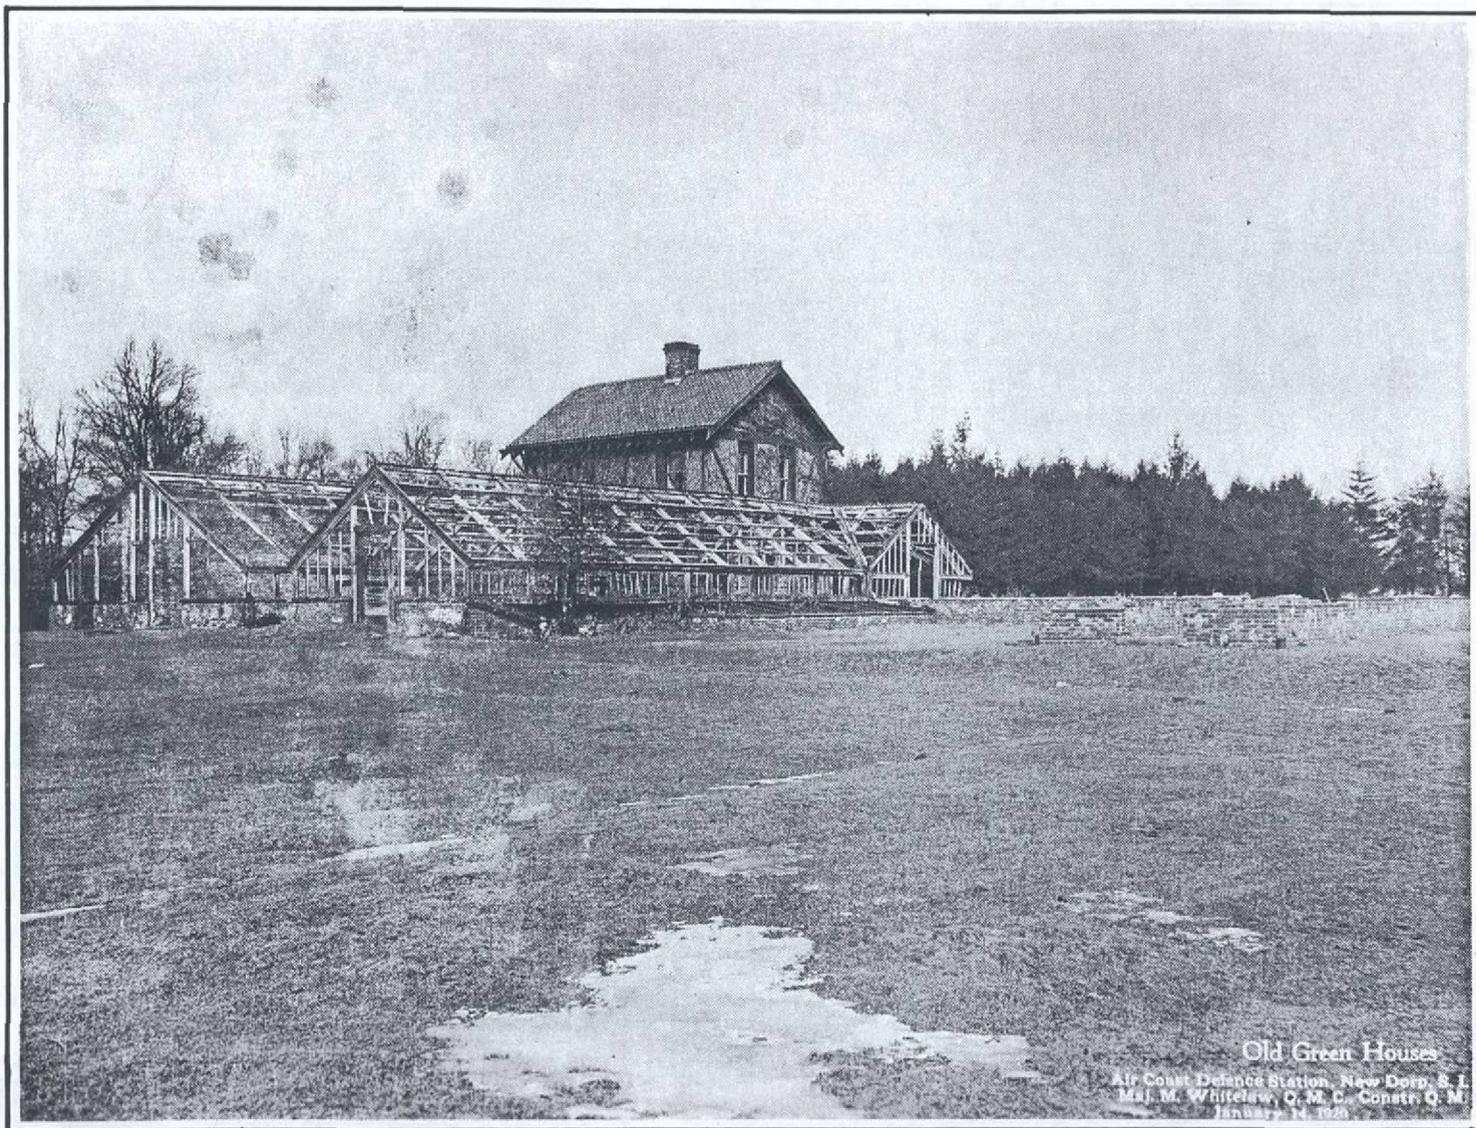
Plate II. The Vanderbilt Gardener's Cottage and Greenhouse Complex in 1920 (Whitelaw #64).

The stable complex ". . . was one of the last buildings erected during the Vanderbilt's time." (Unrau and Powell 1981: 4). All Vanderbilt buildings except the greenhouses and the main residence had roofs made of Spanish Tile. Many buildings on the estate were built of brick (Plates II and III, Appendix).

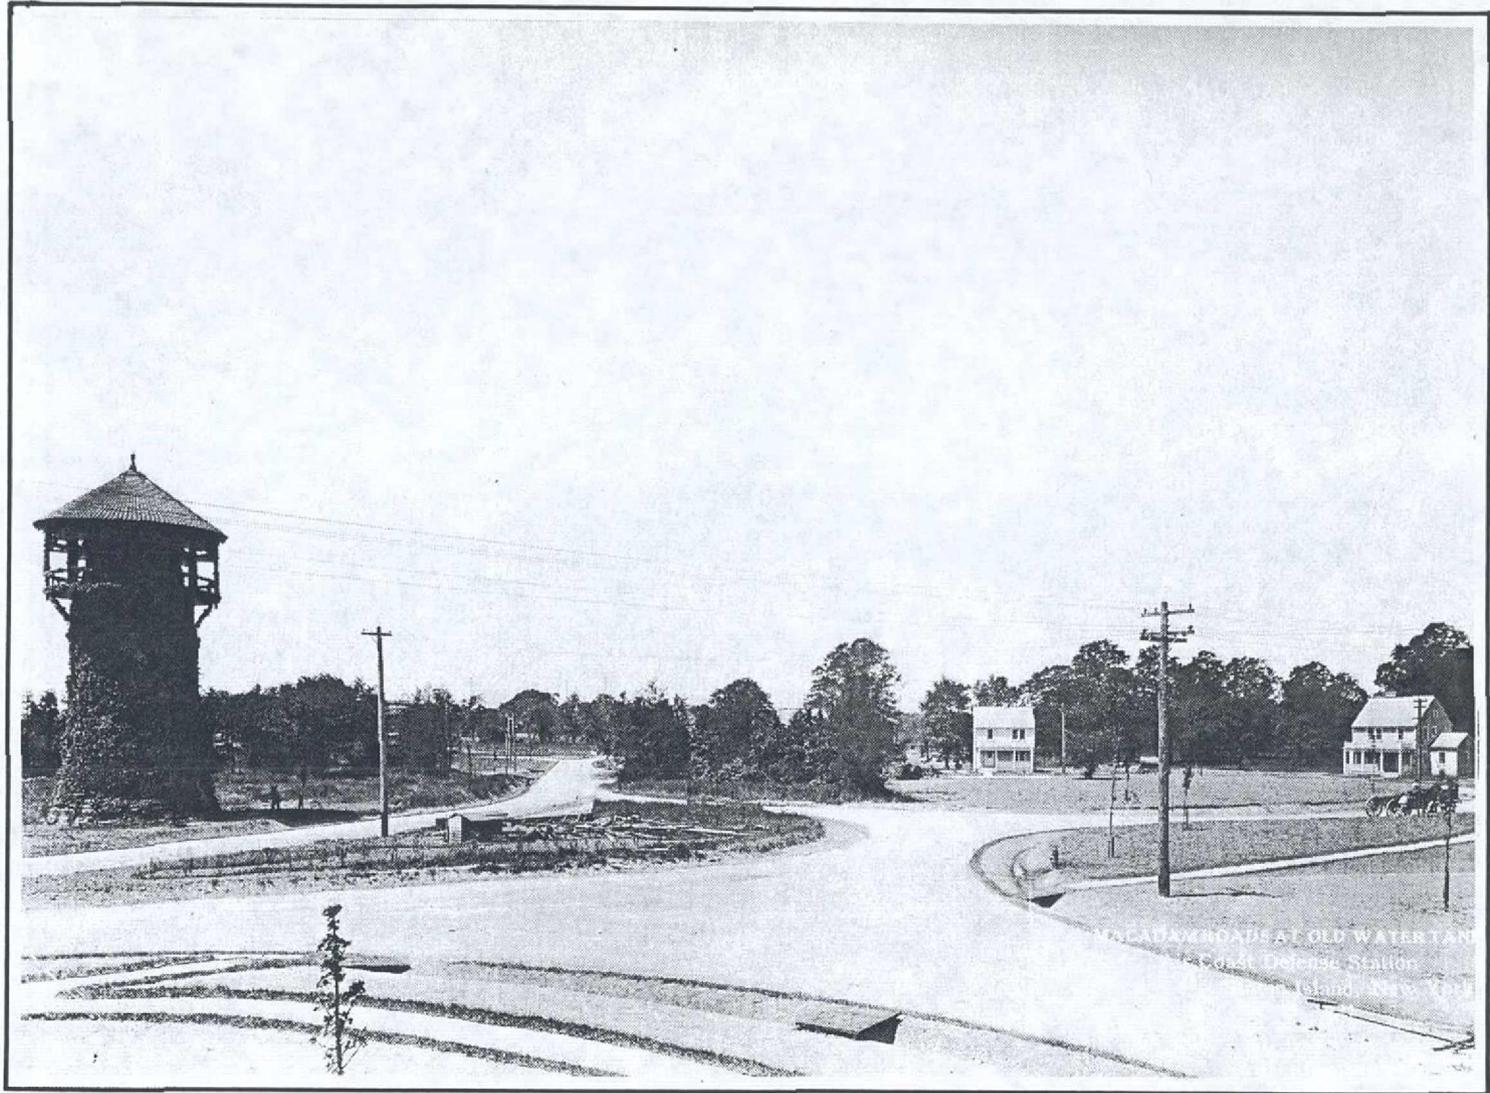
Plate III. The Vanderbilt Water Tower and Army Housing in 1921 (Whitelaw #96).
