GOVERNORS ISLAND HISTORIC DISTRICT

*Preservation and Design Manual: Part One*

# *Preservation & Design Standards*

*GOVERNORS ISLAND HISTORIC DISTRICT  
PRESERVATION & DESIGN MANUAL, PART II  
DESIGN & DEVELOPMENT GUIDELINES*

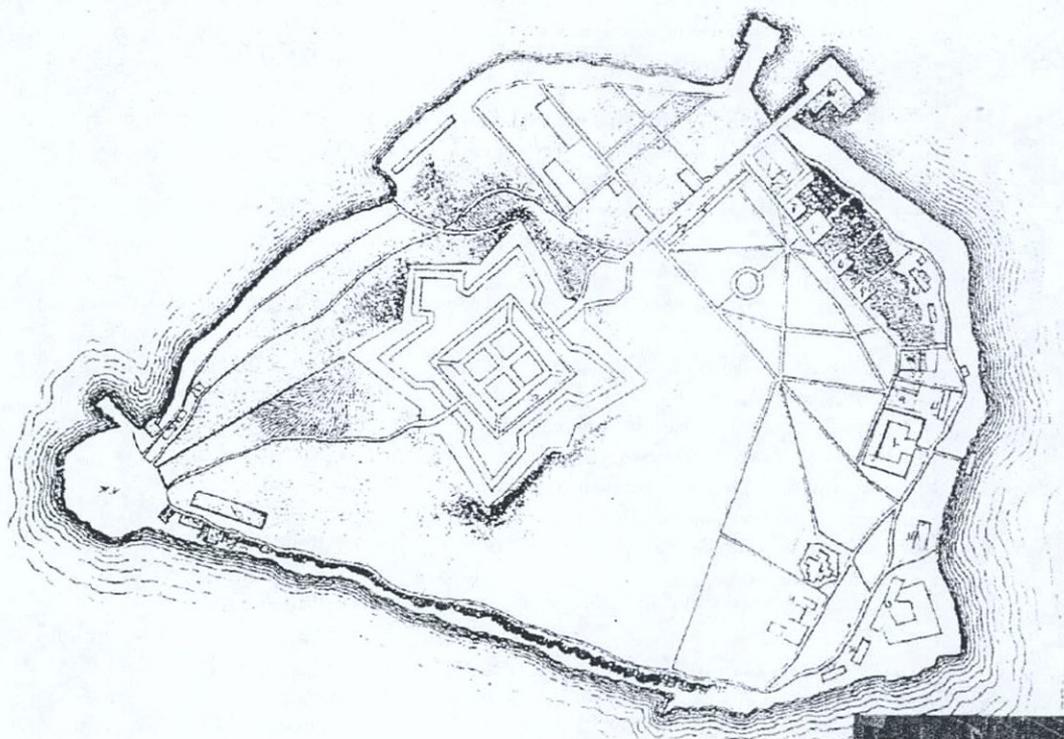
HISTORIC MAP OF GOVERNORS ISLAND

ABOVE:  
1876 MAP OF GOVERNORS ISLAND  
THE DESIGN OF  
MAJOR JOHN G. BURNETT

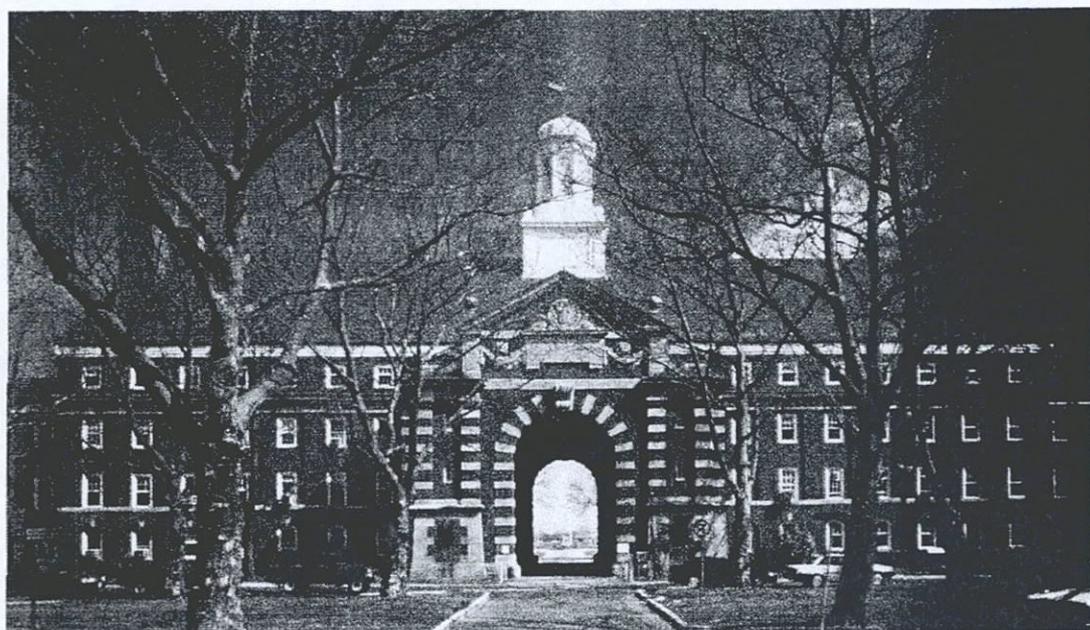
LEFT  
BUILDING #400, CONSTRUCTED DURING THE LATE 1920S WAS THE LONGEST MILITARY BUILDING IN THE WORLD. THIS BUILDING SEPARATES THE HISTORIC DISTRICT FROM NON-HISTORIC PORTION OF THE ISLAND.

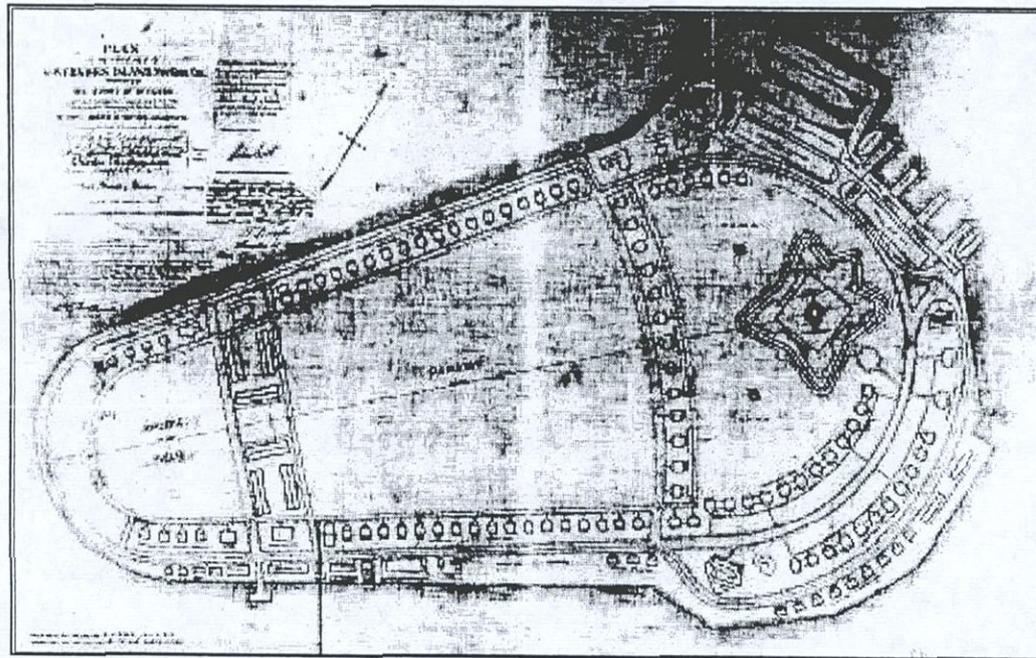
*McKim, Mead & White Architects' 1906 plan for improvements to Governors Island showing additional institutional and residential buildings south of Division Road, symmetrically placed on either side of an axis passing through Fort Jay.*

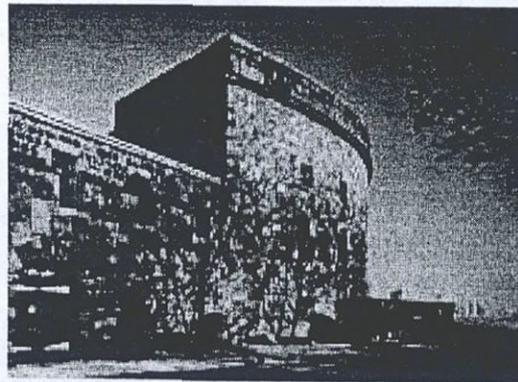
*Partial view of Castle Williams showing sandstone walls and deep recessed window openings.*

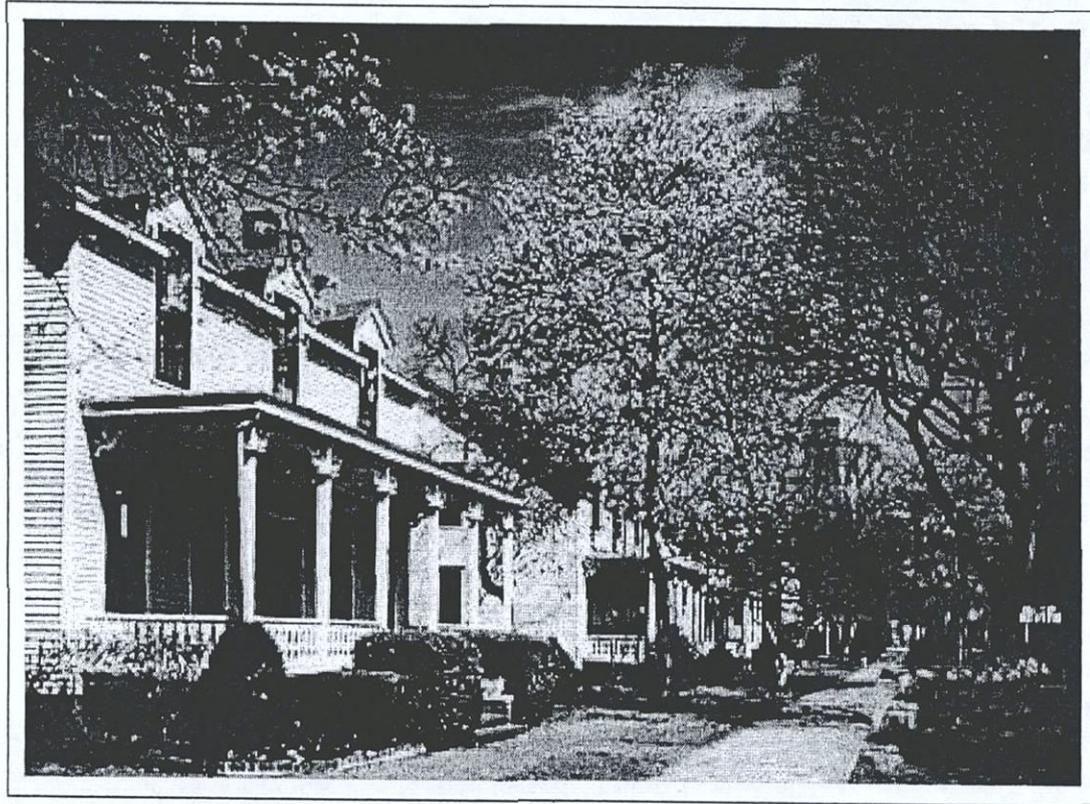
*Early 20th century frame residences in Nolan Park. Each grouping of residential buildings in the Historic District has a distinct character. A majority of the houses facing Nolan Park have wood siding, front porches, and decorative wood detailing.*

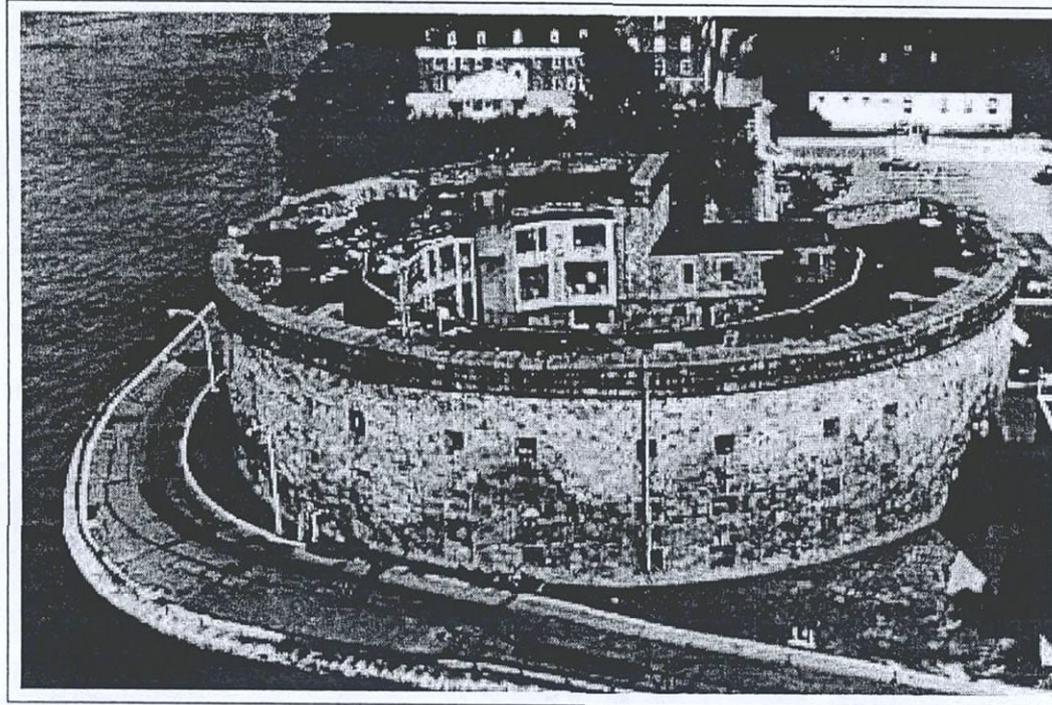
*Aerial view of Castle Williams, looking from the southwest. This unique structure was initially used as a defensive fort, later converted to an Army prison. Structural additions have been made to the interior of the structure to accommodate its many uses, but the exterior remain essentially intact.*

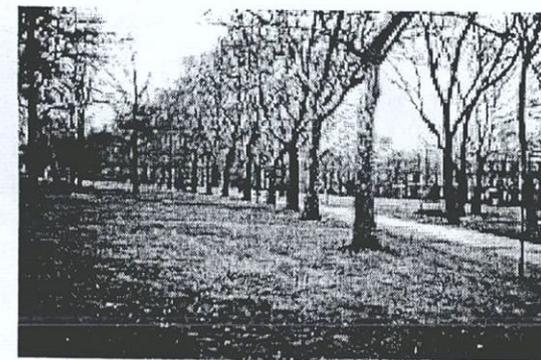
Fort Jay entry to the left, a category 1 resource, and historic, open landscape, a category 2 resource.

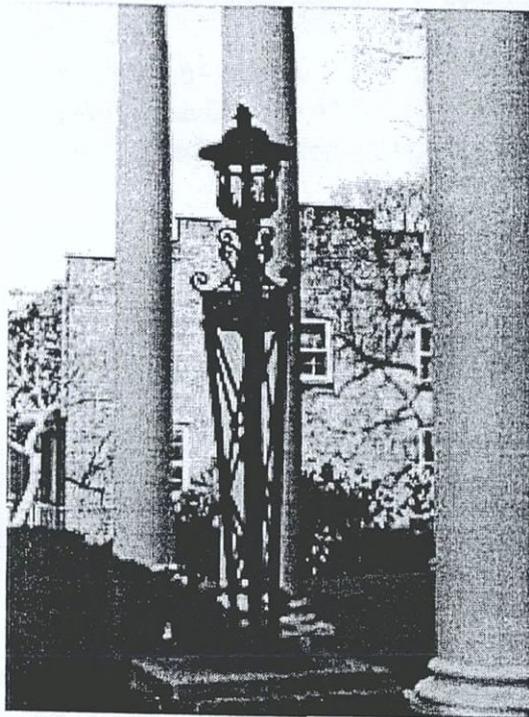
*Ornamental iron light standard found at the Admiral's House is an example of craftsmanship in metal. Other detailed ironwork can be found in historic fences.*

An illustration of the existing light standards can be found in *Knowing What to Save & What to Remove*.

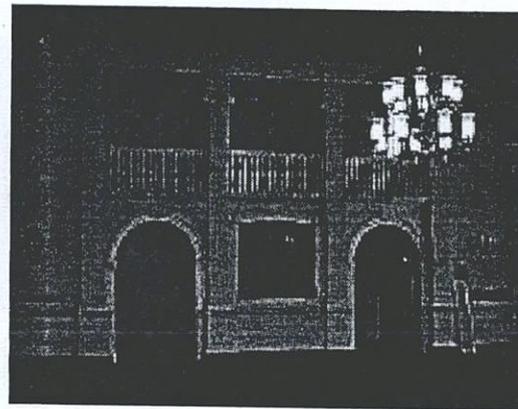
*Interior photograph of the second floor ballroom in South Battery showing an orchestra balcony and detailed woodwork.*

interiors have been identified as the first floor public spaces of the Admiral's House (building #1); the second floor ballroom of South Battery (building #298); and, the WPA murals and Admiral's offices (building #125.) Understanding the visual character of these buildings includes an evaluation of their interior spaces, sequences of spaces, features, and details.

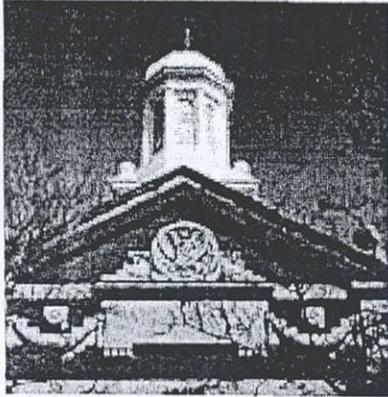
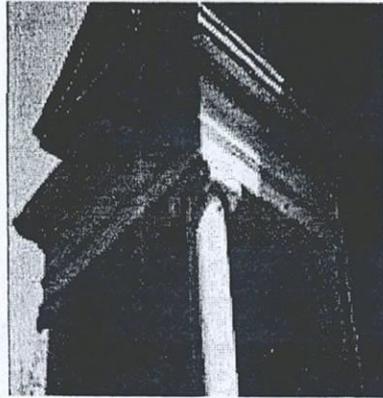
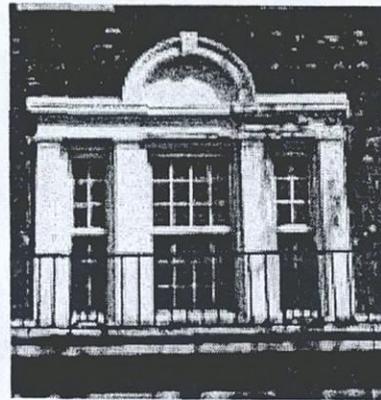
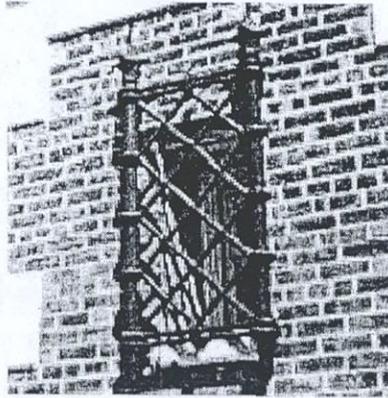
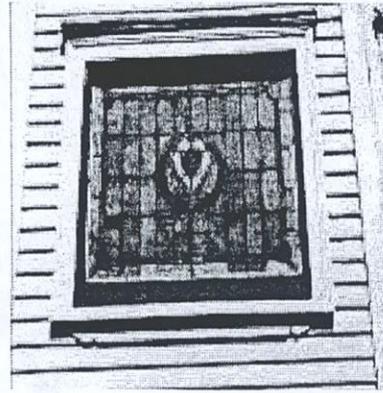
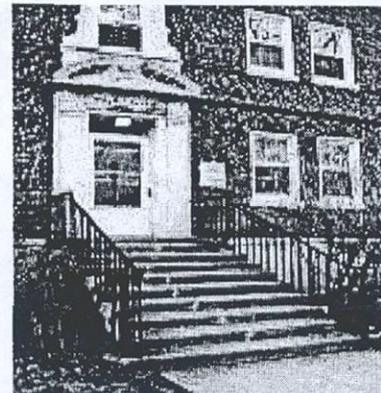
From left to right—Top Row:  
Pediment & copula-building #400  
Entry with pediment-building #2  
Palladian window-building #550  
Middle Row:  
Window grill-building #400  
Leaded glass window-building #408  
Entry Stair-building #12  
Decorative Porch-building #408  
Bottom Row:  
Commemorative Plaque-Nolan Park  
Decorative Fence-east seawall  
Stone masonry

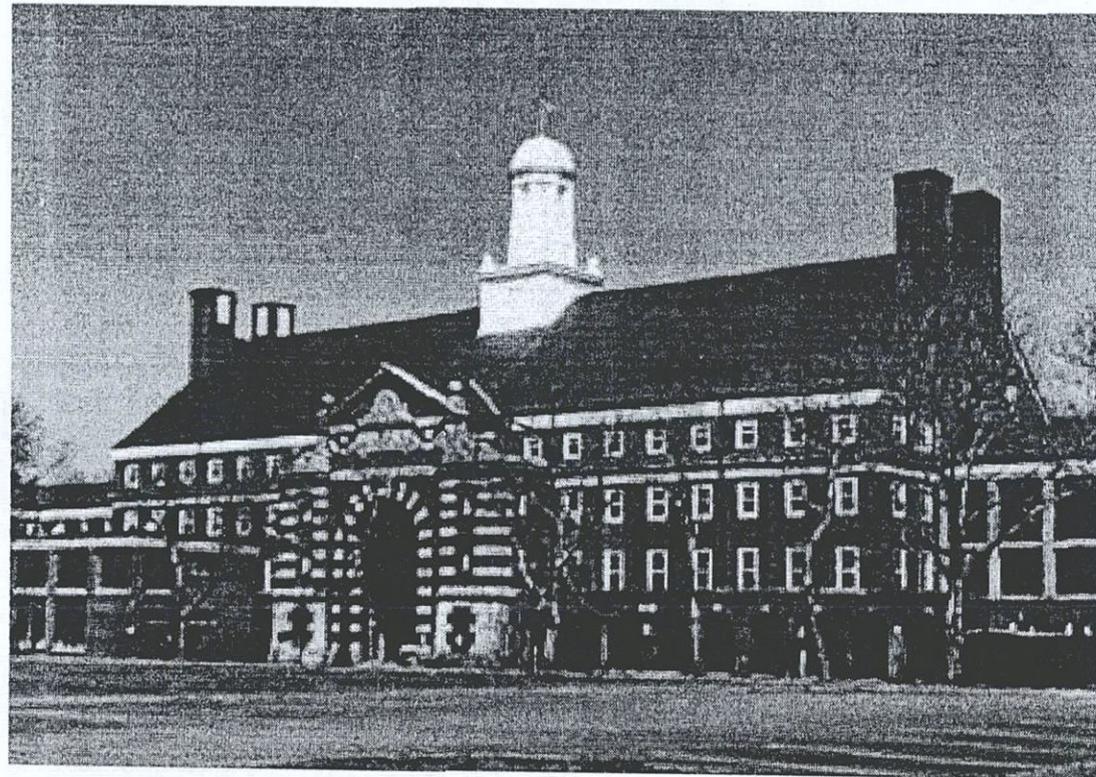
*Southwest elevation of Building #400 showing an addition adjacent to the entrance that is not compatible with the character of the historic structure.*

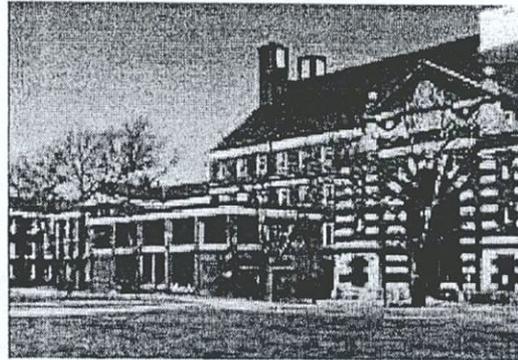
*Addition to Building #400 generally considered to be an intrusion into the historic district, and is of no historic significance.*

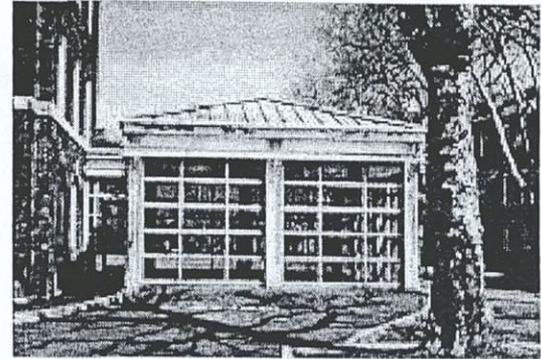
*Contemporary addition to a building in the historic district.*

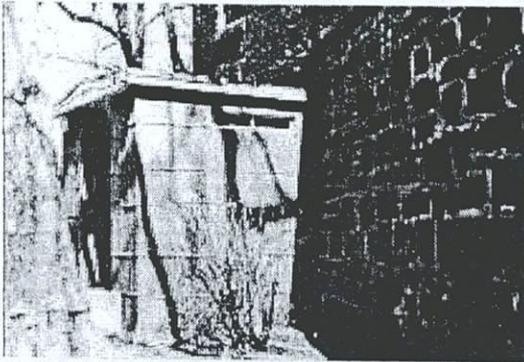
*A small addition placed on a secondary facade of a brick and stone building in the historic district. The surface of the addition attempts to emulate stone, unsuccessfully. The design is inconsistent with the existing structure. This addition is an intrusion.*

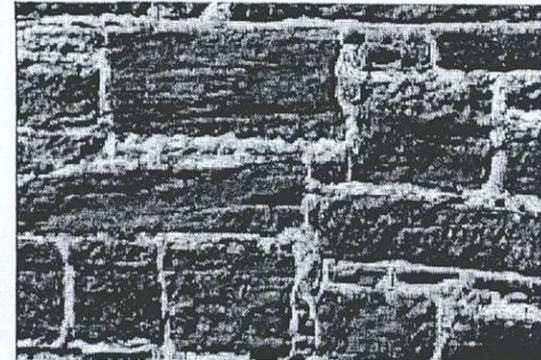
*A photograph of the original stone wall adjacent to the unsuccessful addition shown to the left. Synthetic designs could not duplicate the textures and varying patterns naturally created by stone.*

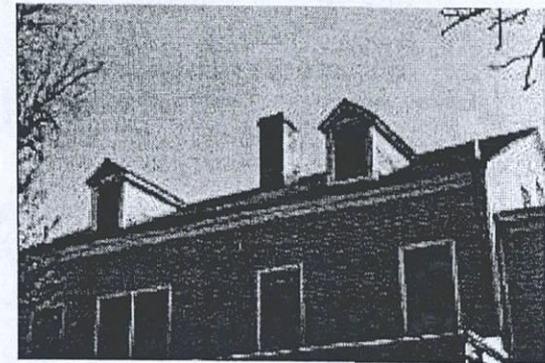
*Standard shiplap siding in the Historic District. Using aluminum or vinyl siding would be inappropriate.*

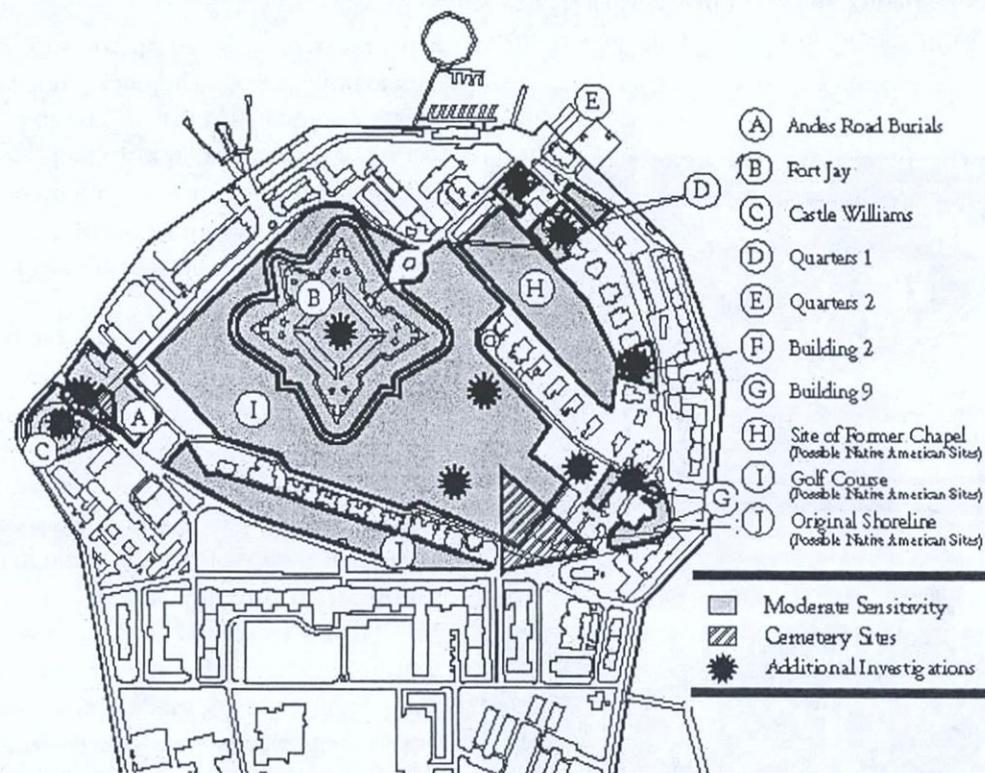
Plan showing identified and potential archeological sites within the Historic District (Beyer Blinder Belle Consortium)

There are specific areas within the Historic District in which there is a high or moderate potential of encountering archeological resources when there is ground disturbing activities. For any project that requires digging or excavation, including the installation of utility lines, care should be taken to avoid these resources.

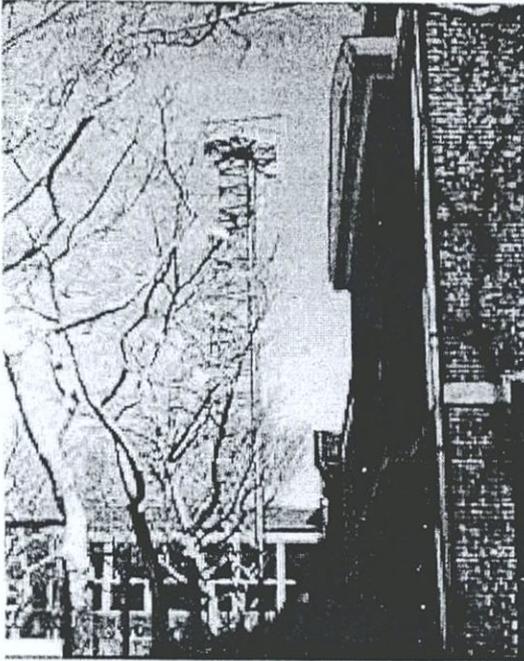
*Existing large scale communications unit located adjacent to building #400 illustrates the type of equipment that should not be located in the Historic District. The installation of small scale equipment on buildings or on the site would be reviewed by the Commission.*

*Standard #4: Large scale communication equipment, such as satellite dishes, telephone relays, radar, antenna, and other similar equipment and installations, will be located outside of the boundaries of the Governors Island Historic District, south of Division Road.*

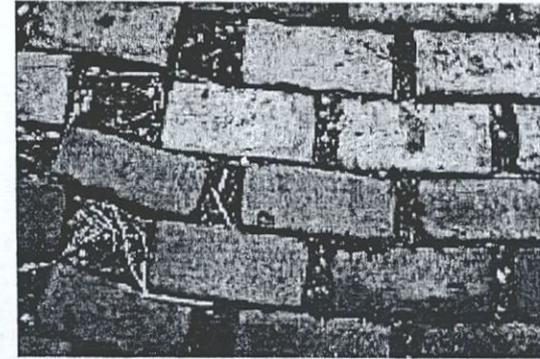
*Disrupted walkway. Repair would not require a permit.*

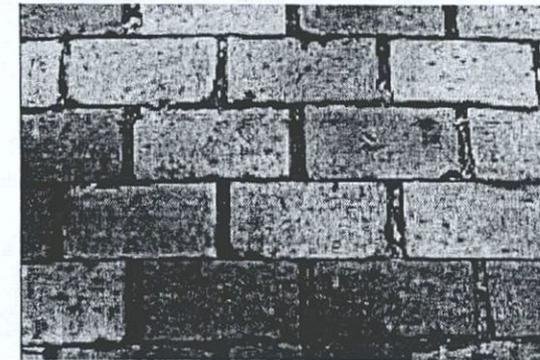
*Running bond walkway*

Walkways, driveways, and roads within the historic district have a variety of textures. This is a result of the different materials used, and the way they are used. Generally, brick pavers were used for pedestrian walkways, across open spaces, and leading to buildings. They have been placed in a variety of patterns, from basketweave and herringbone to a running bond. Brick walks can be found throughout Nolan Park, Colonels' Row, and leading to most of the free standing residential buildings.

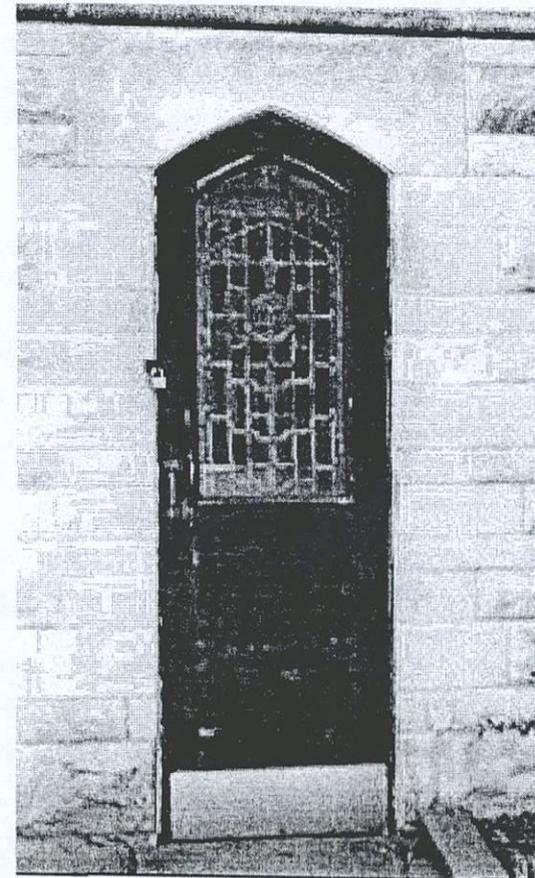
*Gothic Revival, leaded glass door.*

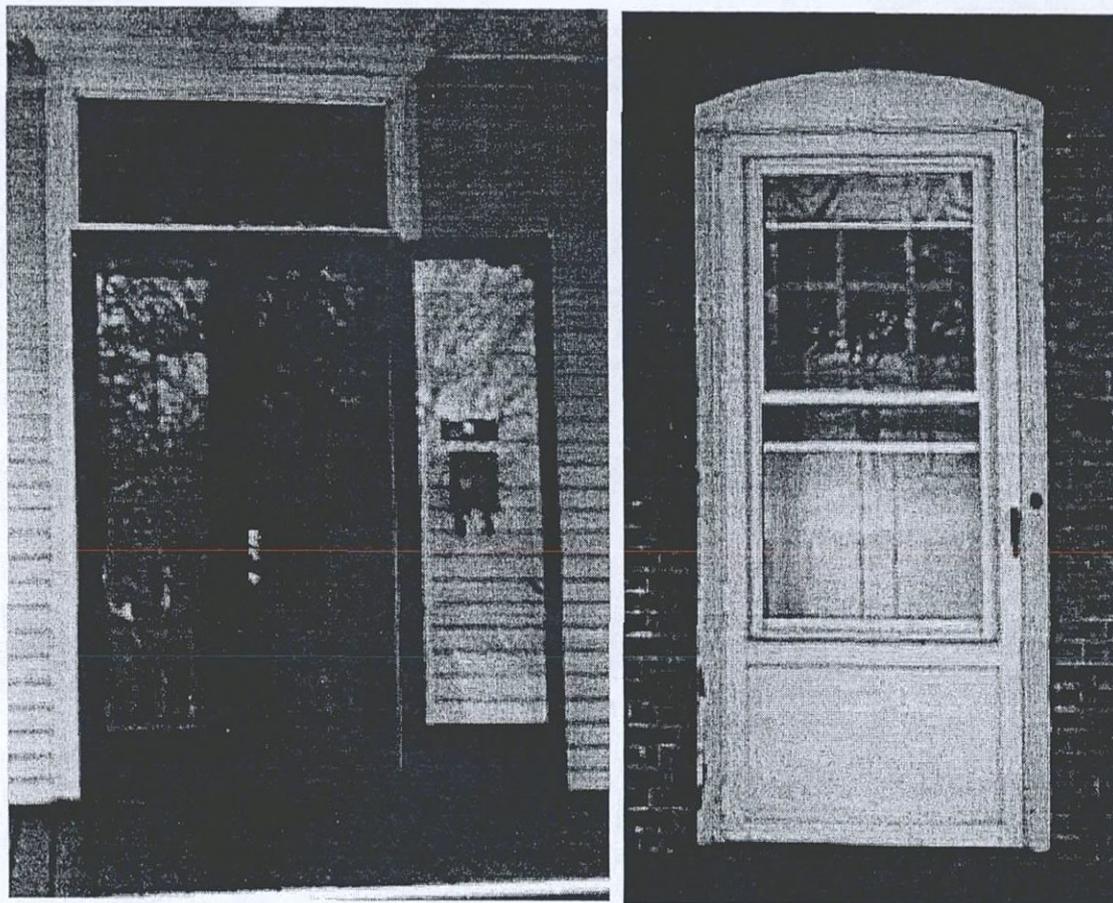
*Two illustrations of storm doors on Governors Island. The installation on the left uses a full height glass storm door that does not obscure the design and detail of the historic door. The installation on the right uses a partial height door that obscures the historic fabric.*

- abrasively cleaning doors, door frames, or surrounds;
- cladding door frames in aluminum, vinyl, or other material;
- reglazing door lites with tinted or colored glass, or painting out door lites;
- the installation of storm, screen, or security doors that obscure the design of the historic door; or,
- changing the configuration of the door, frame, or surround.

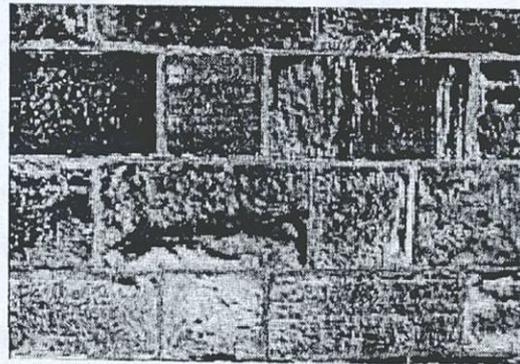
*Typical of damage resulting from the surface of the masonry being abraded. The protective surface is removed, subjecting the unit to moisture penetration, which causes further deterioration.*

Although it is feasible to clean a building without damaging its fabric, the materials, equipment and techniques commonly used normally do great harm. While abrasive cleaning of a material, such as masonry, will cause a visual change to the property, a more significant effect is how it changes the physical characteristics of the material, shortening its usable life and contributing to higher maintenance costs, and eventual destruction of the building. Once the protective exterior surface of the masonry units removed, the material will absorb moisture from the outside—rain, snow, high humidity.

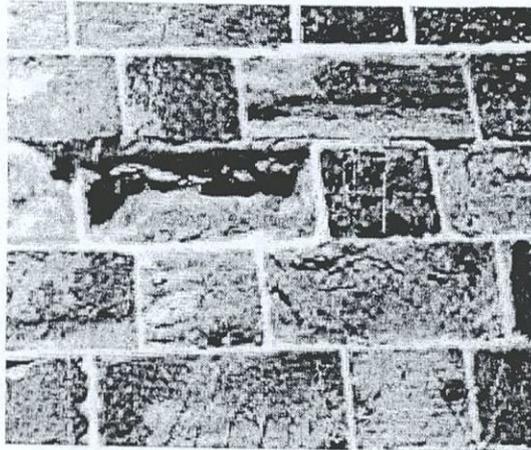
*Illustration of deteriorated stone typical of the effect trapped moisture will have on masonry surfaces. This could be caused by the use of improper mortar in tuckpointing and/or abrasive cleaning of the masonry.*

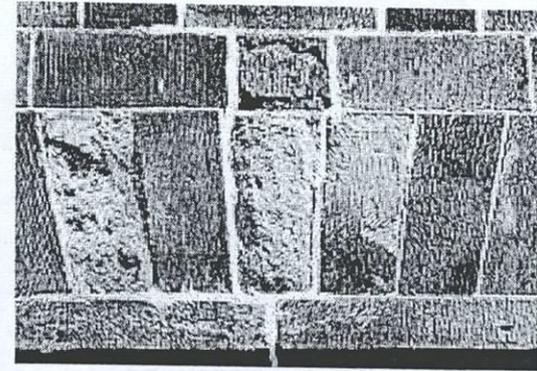
*Example of inappropriate mortar used on a stone wall showing the loss of surface material due to entrapped moisture, and the visual impact of poor masonry work. Such work can significantly increase maintenance costs.*

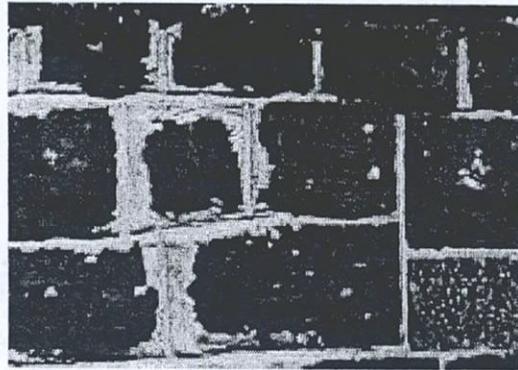
*There is no one mortar joint style used throughout the Historic District. In this case the stones are joined with a "butter joint". This is a thin layer of mortar placed on the stone like spreading butter. It is a very distinctive style of joint. Repairs to the joints have ignored the style and spread the mortar on the surface of the stone, changing its appearance and potentially damaging the material. New mortar joints should match the historic in style, color, texture, composition and appearance.*

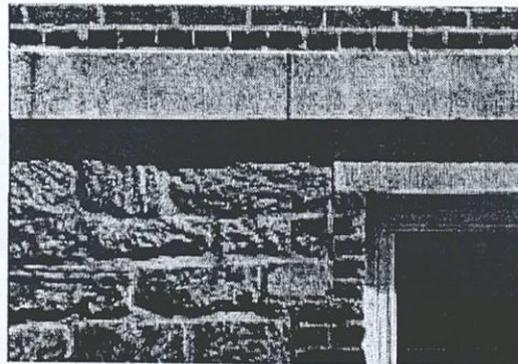
*Appropriate use of mortar on a historic stone and brick wall. This technique of using the mortar has preserved the unit masonry. The type of mortar used will allow moisture behind the masonry surface to escape, preventing damage.*

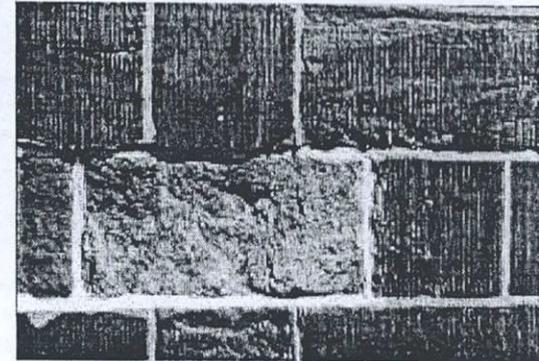
*Below is an illustration of how tuckpointing with an inappropriately strong mortar can entrap moisture and result in the surface material falling off.*

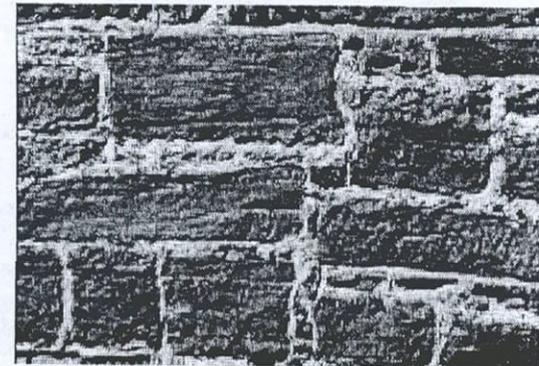
*Throughout the Historic District there are examples of rubble, ashlar, and dressed stone walls, all with their unique type of mortar joint. The rubble stone wall below has small pieces of stone set within the mortar bed joining the larger stones.*

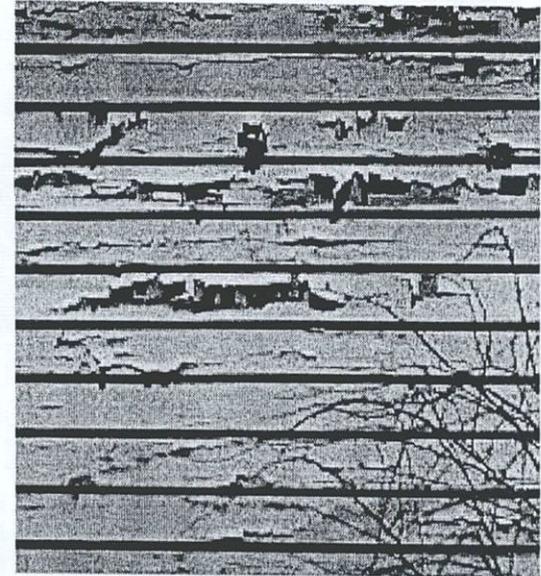
*Painted wood shiplap siding typical of frame buildings in the Historic District. Deteriorated paint is easily replaced. Deterioration is typically caused by excessive moisture generated inside the building.*

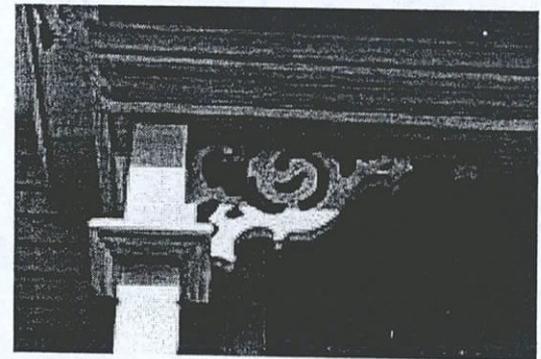
*Decorative wood trim on a Nolan Park house reflecting the Victorian architectural style of the building.*

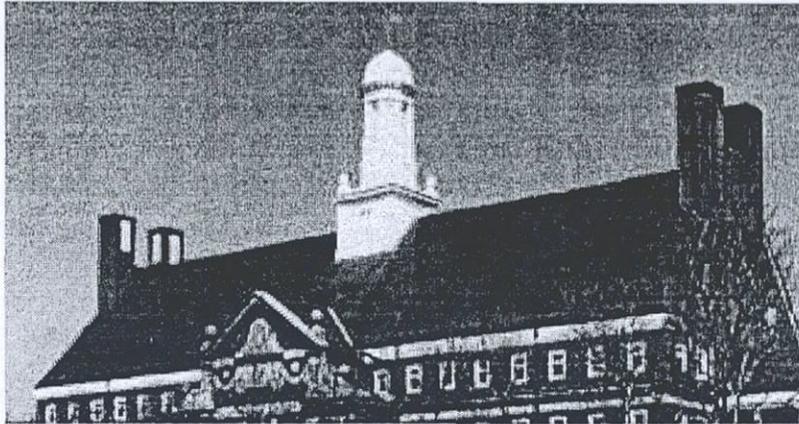
*Slate or composition roofs offer a strong monolithic form when viewed from a distance. Close up slate reveals a texture and color variation not available in composition shingles, adding to the character of the building. Existing slate roofs should be retained and, if necessary, repaired. New roofs should be executed in either the same material as the historic, or in a sympathetic material.*

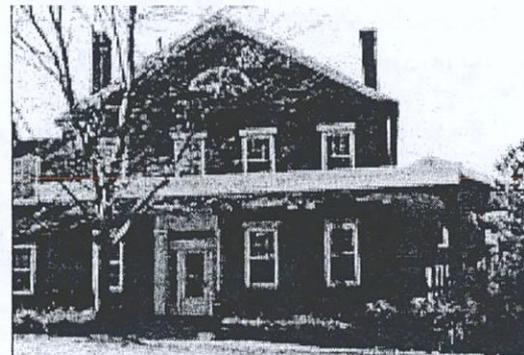
*Porch addition that includes decorative iron columns that are out of character with the original architecture and building style.*

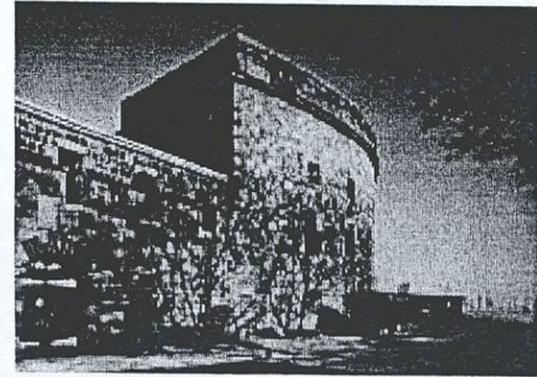
*The heavy stone of Castle Williams is a good material to reflect its initial use as a fortification, and later as a jail.*

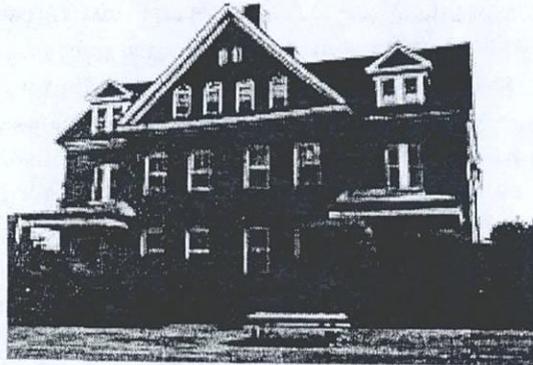
*Brick used in construction of the residential units along Colonels' Row illustrates the status of the residents and the importance of the buildings through the use of more expensive materials.*

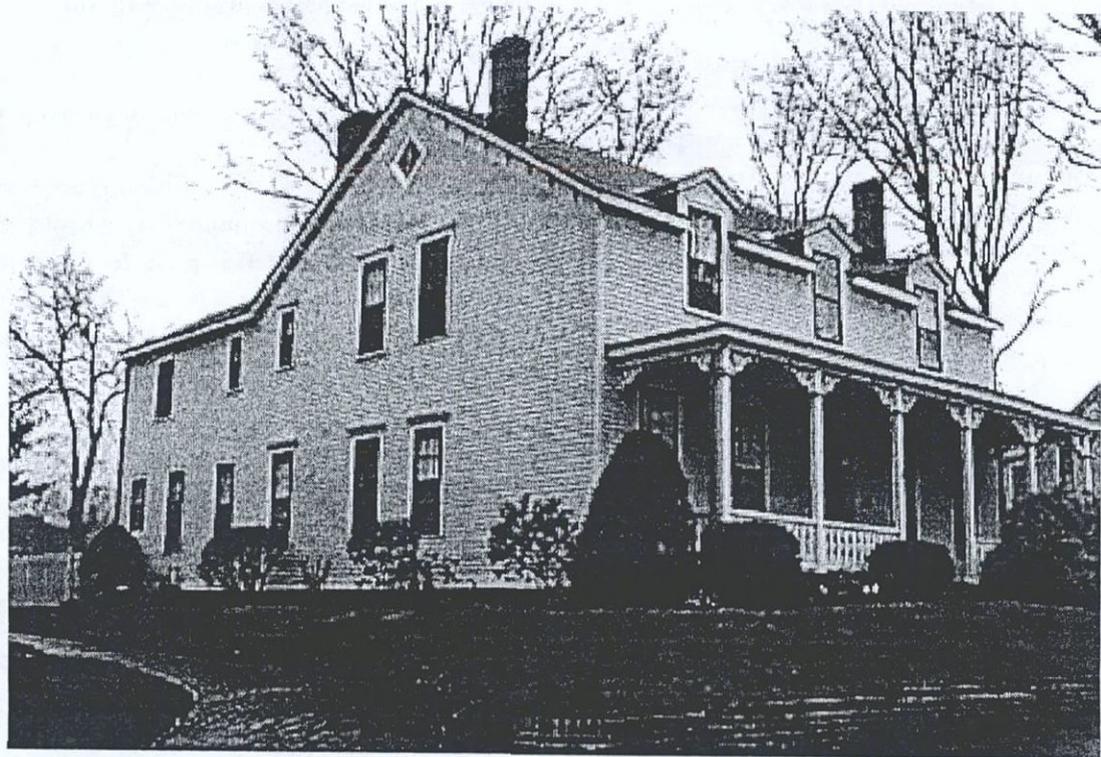
*Photograph of a wood-sided Nolan Park residence, illustrating the way materials have been used in the historic district to distinguish rank, style, and use.*

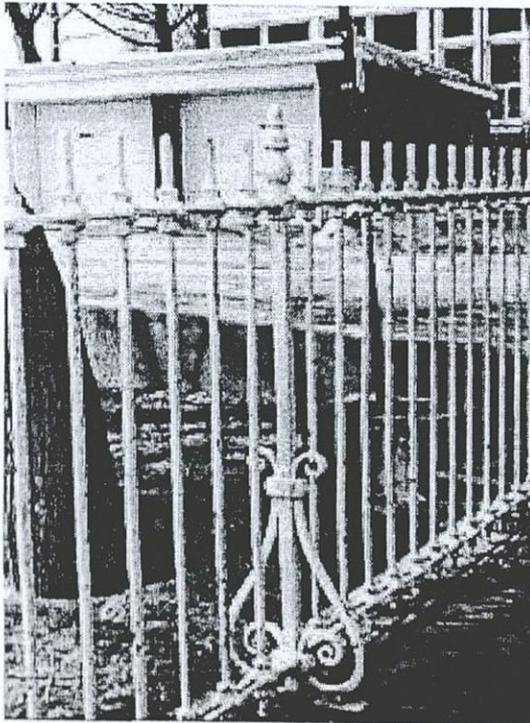
*A decorative iron fence located along a pedestrian walkway at the east side of the Historic District.*

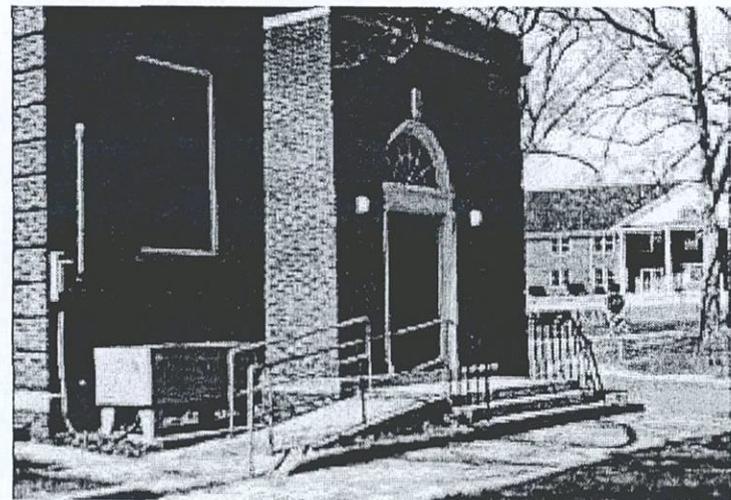
*A current handicap ramp installation within the Historic District. Although this ramp functions properly, it has a negative visual impact on the historic building (as does installation of the air handling unit next to the front entrance.) A more successful installation at this location could place the ramp behind a short brick wall. This would enhance the emphasis on the door entry, and diminish the added visual complexity created by the ramp (and the mechanical unit) adjacent to the entrance. Another solution would be to locate the program in the building that doesn't require ramp accessibility. Install an interior ramp, or place the ramp at a less public entrance.*

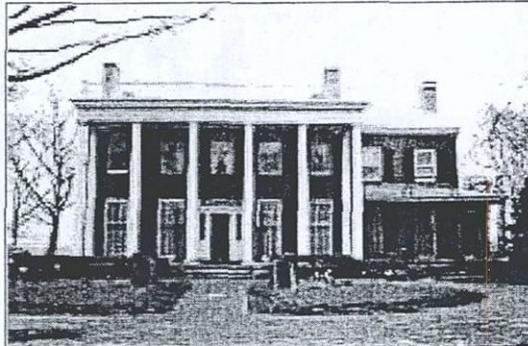
Front Elevation

Building #1, formerly "Commanding General's Quarters," is a two and one-half story house located along the east perimeter of Nolan Park. Rectangular in plan and constructed of brick on a stone foundation, the building sits on a bluff overlooking the confluence of the East River and Buttermilk Channel. The structure is topped with low sloped, standing seam terne metal, gable roofs. Six brick chimneys penetrate the roof. Porticoes with six two-story Doric columns are located on the east and west facades. The porticoes are surmounted by wood balustrades. A onestory porch, surmounted by an iron railing, is located at the southwest corner. Fenestration is comprised of six-over-six double-hung windows on the first floor, six-over-nine double-hung windows on the second floor, and paneled wood doors. All windows have sandstone sills and lintels. The main entrance faces Nolan Park and is flanked by cast iron lampposts. Other names used for this structure include Admiral's House, Admiral's Quarters, Quarters One.

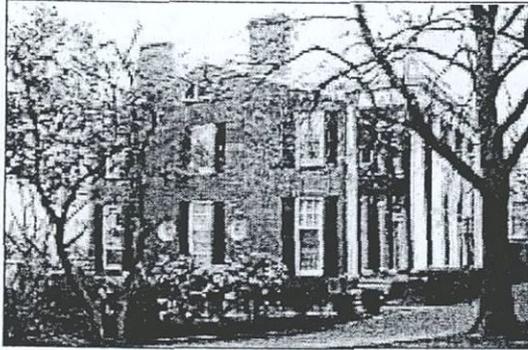
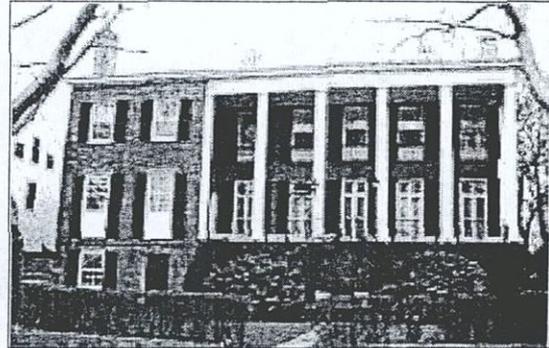
Side Elevation

Rear Elevation

Exterior elements of the building that should be preserved include the basic building form, scale, and materials; its setting; front entry; multi-paned windows and panel doors; millwork; columns; shutters; portico roof at south side entry; rear portico and steps; open porches; chimneys, lighting fixtures, foundation landscaping; and, brick walkways leading to the front entry and surrounding the building.

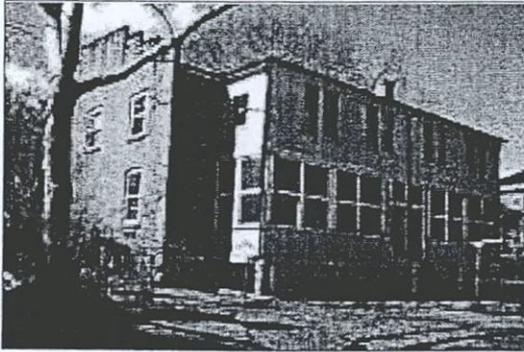
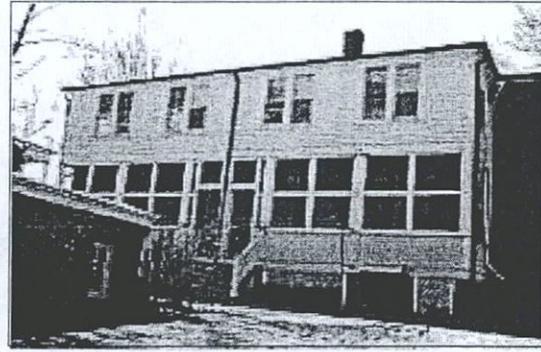
Side Elevation

Rear Elevation

Exterior elements of the property that should be preserved include its scale and form; brick walls, stone foundation walls; brownstone sills; steppe gable end; and, wood windows and doors.

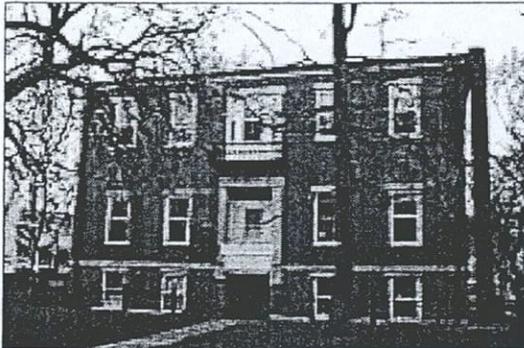
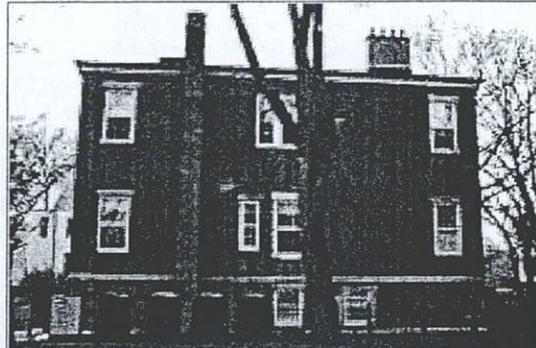
Rear elevation

Side Elevation

Exterior elements of the building that should be preserved include the current form and scale of the building, and its stone and brick basement walls, brick walls, limestone window sills and heads, and granite belt course. In addition, the front steps and portico, front and rear door surround, wood windows, wood cornice with dentils, ironwork at the balconies, and areaway with curb and fencing.

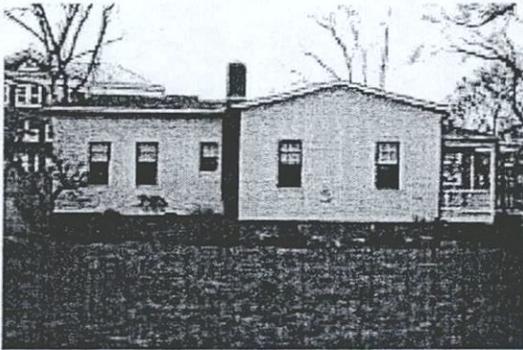
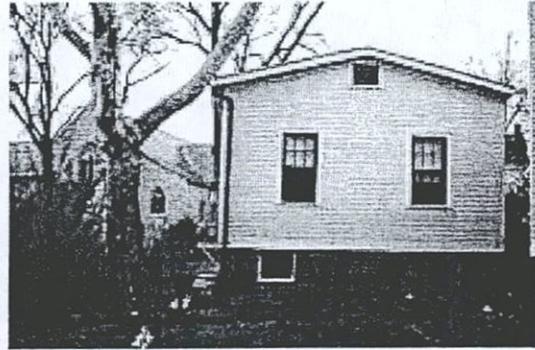
Side Elevation

Rear

The exterior of Building #11 has a great deal of its original exterior materials and appearance. It retains its original siding materials, and the large front porch date back to the 19th century. The interior of the building appears to have been substantially rehabilitated in the 1930's.

Exterior elements of the building that should be preserved include the basic building form, scale and materials; wood siding, brick basement walls; eaves; front porch; wood windows; and front door.

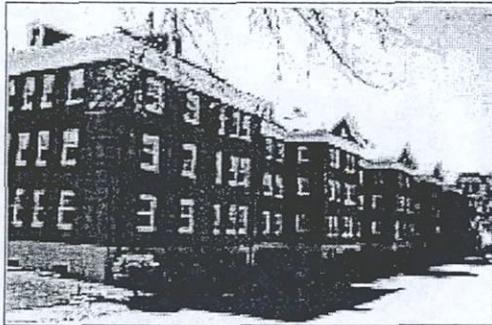
Front Elevation

Building #12 is a four and one-half-story Neo-Georgian style building composed of fifteen sections, with a total of 93,000 SF, located on a land-fill site overlooking Buttermilk Channel. The central portion of the building forms a large U-shaped courtyard facing the water. This 14-family housing unit is built of red brick masonry over cement foundation and a limestone watertable. The gable roof is covered with slate shingles. Fenestration consists of six-over-six double-hung metal windows with metal frames, limestone window sills, and wood paneled doors. Separate entrances, serving each of the 14 family housing units, face south towards the channel and have decorative limestone door surrounds.

The exterior of Building #12 has retained most of its original masonry material and appearance. All of the original window units have been replaced by six-over-six double-hung aluminum windows.

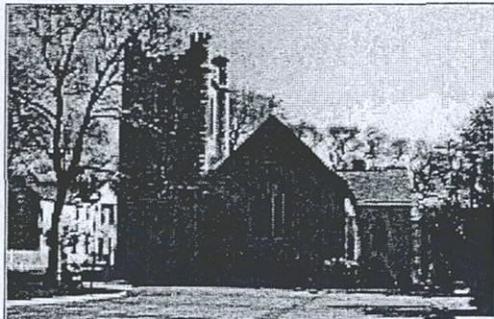
Front Elevation

Building #13 is a two-story church on a raised basement. Walls are rock-face limestone laid in regular coursing. Built in 1905 in the neo-Gothic style, the building is roughly cruciform in plan with a substantial three-story tower at the northwest corner providing the primary entrance. Steep intersecting gables are covered with slate with copper gutters, ridges, and flashing. Most windows are lancet arched with ornamental carved limestone tracery; 35 leaded and stained glass sash are covered with protective glazing. The raised basement most recently contained church offices and a day care facility.

Exterior elements of the building that should be preserved include the original form, scale, and style of the Chapel; masonry facades; leaded and stained glass windows; front and side entry doors and surrounds; and, roofing.

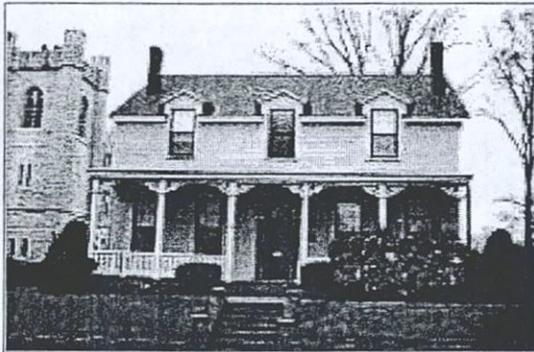
Front Elevation

Building #14 is a two-story, "Victorian Vernacular" style, single-family house built of wood frame construction on brick foundation walls. Exterior clapboard walls rise to meet a slender boarded cornice at the bracketed eaves, which are penetrated by gabled projections above the windows. The full-width front porch faces east; its soffit is articulated with scrollwork brackets extending away from the column capitals, and its railing features decorative balusters. Aluminum storm windows protect the six-over-six double-hung wood windows. The paneled wood entrance door has a glazed transom and an aluminum storm door. Building #14 is L-shaped in plan, with a screened in porch to the rear. The building was originally constructed to a standardized plan identical to buildings #15, #16, #17, and #18.

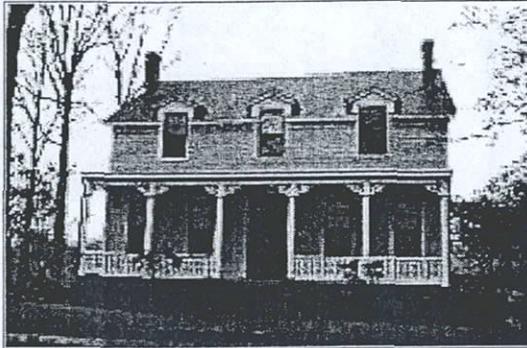
Front Elevation

Building #15 is a two-story, "Victorian Vernacular" style, single-family house built of wood frame construction on brick foundation walls. Exterior clapboard walls rise to meet a slender boarded cornice at the bracketed eaves, which are penetrated by gabled projections above the windows. The full-width front porch faces east; its soffit is articulated with scrollwork brackets extending away from the column capitals, and its railing features decorative balusters. Aluminum storm windows protect the six-over-six double-hung wood windows. The paneled wood entrance door has a glazed transom and an aluminum storm door. Building #15 is L-shaped in plan, with a screened in porch to the rear. The building was originally constructed to a standardized plan identical to buildings #14, #16, #17, and #18.

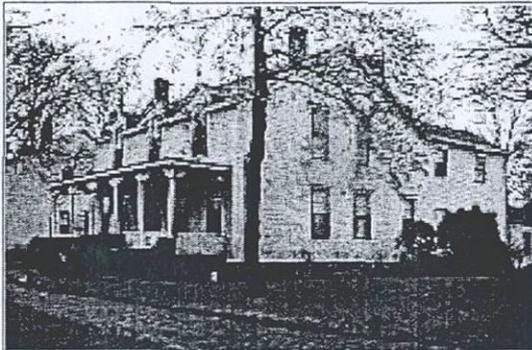
Front Elevation

Building #16 is a two-story, "Victorian Vernacular" style, single-family house built of wood frame construction on brick foundation walls. Exterior clapboard walls rise to meet a slender boarded cornice at the bracketed eaves, which are penetrated by gabled projections above the windows. The full-width front porch faces east; its soffit is articulated with scrollwork brackets extending away from the column capitals, and its railing features decorative balusters. Aluminum storm windows protect the six-over-six double-hung wood windows. The paneled wood entrance door has a glazed transom and an aluminum storm door. Building #16 is L-shaped in plan, with a screened in porch to the rear. The building was originally constructed to a standardized plan identical to buildings #14, #15, #17, and #18.

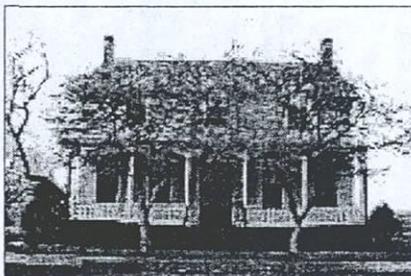
Front Elevation

Building #17 is a two-story, "Victorian Vernacular" style, single-family house built of wood frame construction on brick foundation walls. Exterior clapboard walls rise to meet a slender boarded cornice at the bracketed eaves, which are penetrated by gabled projections above the windows. The full-width front porch faces east; its soffit is articulated with scrollwork brackets extending away from the column capitals, and its railing features decorative balusters. Aluminum storm windows protect the six-over-six double-hung wood windows. The paneled wood entrance door has a glazed transom and an aluminum storm door. Building #17 is L-shaped in plan, with a screened in porch to the rear. The building was originally constructed to a standardized plan identical to buildings #14, #15, #16, and #18.
