GOVERNORS ISLAND HISTORIC DISTRICT

*Preservation and Design Manual: Part One*

# *Preservation & Design Standards*

*GOVERNORS ISLAND HISTORIC DISTRICT  
PRESERVATION & DESIGN MANUAL, PART II  
DESIGN & DEVELOPMENT GUIDELINES*

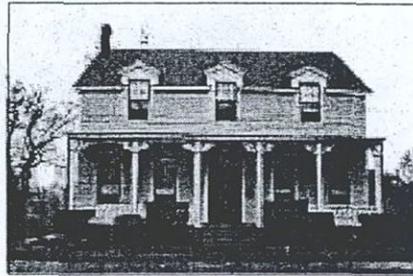
Front Elevation

Building #18 is a two-story, "Victorian Vernacular" style, single-family house built of wood frame construction on brick foundation walls. Exterior clapboard walls rise to meet a slender boarded cornice at the bracketed eaves, which are penetrated by gabled projections above the windows. The full-width front porch faces east; its soffit is articulated with scrollwork brackets extending away from the column capitals, and its railing features decorative balusters. Aluminum storm windows protect the six-over-six double-hung wood windows. The paneled wood entrance door has a glazed transom and an aluminum storm door. Building #18 is L-shaped in plan, with a screened in porch to the rear. The building was originally constructed to a standardized plan identical to buildings #14, #15, #16, and #17.

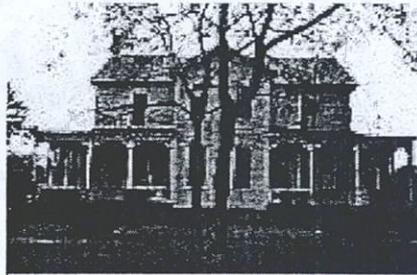
Front Elevation

Building #19 is a two-family, two-story-with-attic "Victorian Vernacular" style house built of wood frame construction on brick foundation walls. Exterior clapboard walls rise to meet a slender boarded cornice. Eaves, gables and cross gables are bracketed. Wrap-around front porches flanking the projecting wing have square posts with decorative brackets supporting a bracketed soffit and a shallow hip roof; its railings feature decorative balusters. Side porches have been screened in. Aluminum storm windows protect the one-over-one double-hung wood windows. Paneled wood entrance doors are protected by aluminum storm doors. Building #19 is cross-shaped in plan, with one-story octagonal wings added to the north and south sides, and garages added to the west. (The two sides of Building #19 have been commonly denoted as #19A and #19B. For the purposes of this building summary, it is considered one building.)

Exterior elements of the building that should be preserved include the form, scale and style of the original building and the octagonal and side porch additions; the original wood clapboard siding; brick basement walls; eaves; front porches with decorative brackets and balusters; wood windows and surrounds; front doors and surrounds; trim; eaves and gable brackets; chimneys; and, stained glass window.

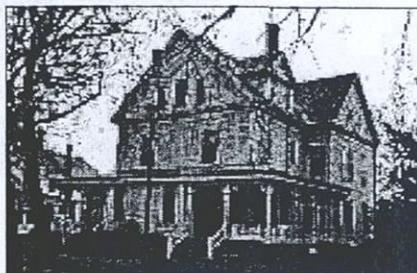
Front Elevation

Building #20 is a two-family "Victorian/ Colonial Revival" style residential structure located at the end of the west side of Nolan Park. Originally built as a large, single family officer's quarters in 1904, it was rehabilitated for two families around 1936. The main building is a rectangular shaped three-story wood frame structure covered with wood clapboards. The foundation has two different materials—brick to the west and schist to the east of the structure. Screened-in wood porches with decorative wooden columns and baluster run along the east facade, behind which are located the two main entrances, one for each family. The original balusters had turned posts. Fenestration consists of six-over-six double-hung wood windows and paneled wood doors. Although altered, Building #20 remains in harmony with the other small-scale frame residences surrounding Nolan Park. It has a shared original fire stair in the rear which is the only means of access to 3rd floor servants quarters and basement.

Exterior elements of the building that should be preserved include the basic building form and scale; the original exterior materials—wood clapboard siding, brick and schist basement walls; eaves; front porches with decorative brackets and balusters; wood windows and surrounds; front doors and surrounds; trim; eaves and gable brackets; chimneys; and stained glass window.

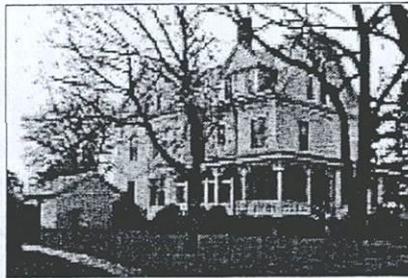
Left Front Elevation

The exterior of Building #20 has most of its original materials and appearance. It retains its original

siding materials, and the large front porches and decorative scrollwork appear to be original. The additions are of a scale and age compatible with the original building, and contribute to its character.

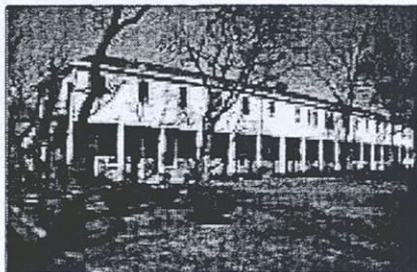
Front Elevation

(later renamed Fort Jay) that replaced the original earthworks of old Fort Jay. During its long history, this building has been adapted and reused many times. In 1878 the Headquarters of the Military Division of the Atlantic and the Department of the East were transferred to Fort Columbus, and Building #25 became the office of the post commander and was enlarged with the second story addition, then an open porch. Between 1936 and 1938, the porch was partially enclosed, and in 1953 more portions were enclosed. These sections were enclosed with clapboard siding and windows with granite sills.

The recent enclosures of the porch; window air-conditioning equipment; storm windows; and the concrete areaway and areaway railing on the building detract from its integrity.

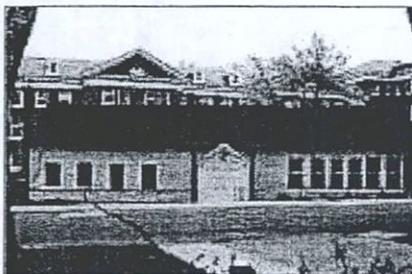
Front Elevation

Building #40 is a one-story rectangular frame structure set on a painted brick foundation. The original wood siding was laid vertically, then subsequently covered with asbestos shingles. In more recent years (post 1983), these have been replaced by horizontal clapboard. The gabled roof is covered with asphalt shingles. The portion of the building used for worship purposes has multi-paned wood windows set behind storm sash. The remainder of the building has one-over-one windows set behind storm sash.

Building #40 has been significantly altered from its original appearance. At one time all the windows were replaced, and the basement windows have been filled in on the south side. The building appears to have been modernized in the 1950s and then again in the 1980s.

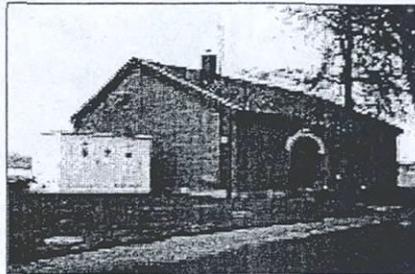
Front Elevation

Building #96 is a modern one-story structure used for workshops. This structure is rectangular in plan, constructed mainly of brick masonry over a concrete foundation and topped with a metal gable roof. This structure has a series of metal and brick storage and utility sheds surrounding it. It has an excellent, unobstructed view of Buttermilk Channel from the north, south and east sides as well as a view of the Nolan Park area.

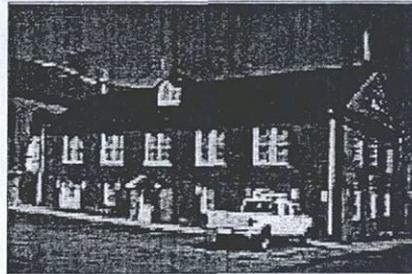
Front Elevation

Building #104 is a two-and-one-half story utilitarian building constructed of brick masonry bearing walls on a granite water table set on a rubble stone foundation. The building is closely related in scale, materials and architectural details to the other structures in the Arsenal complex. Three wood-framed dormers project from the gable roof—two on the east elevation and one on the west elevation. A three-story brick masonry tower with a hipped roof is centered on the east elevation. The first floor level of the tower contains elliptical, arched entryways. These have been fenced in to protect air-conditioning equipment. Sandstone soffits run the full perimeter of the building. Windows consist primarily of aluminum six-over-six double-hung sash.

time. While the clock tower suggests its original function as an ordnance storehouse, the fenestration in the second floor diminishes the appearance of that phase of its history.

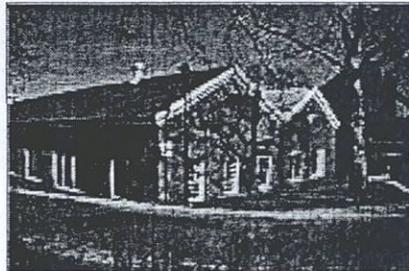
Front Elevation

Building #107 was built as a New York Arsenal storehouse. This long, single story brick-masonry utilitarian structure was built in several sections. It has parallel double gable roofs with wood eaves and fascia. The foundation is bluestone rubble on the west and concrete on the east. Windows are typically six-over-six double hung aluminum sash, but windows on the north elevation are nine-over-nine-over-nine triple-hung sash which were added in 1996. An entrance vestibule was added to the west elevation in 1980.

Building #107 retains its original form and masonry shell. Otherwise, it does not retain many of its original materials. The interior has been gutted. The concrete floor is exposed and the walls are unfinished. The exterior brickwork is intact, but the windows have been replaced—some as recently as 1996.

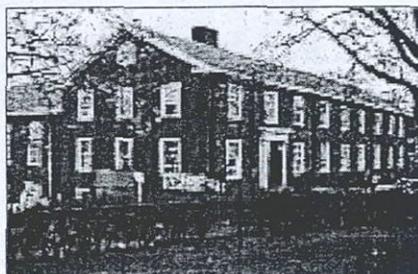
Front Elevation

Building #108 is a two-story brick "Neo-Georgian" style office building with a full basement, an L-plan, and neo-Georgian detailing. It is masonry bearing construction with a cross-gable, asphalt-shingle roof. A raking wood cornice defines the roofline. Windows are six-over-six double-hung aluminum replacement sash. The primary entrance is on the south elevation and is flanked by Tuscan columns supporting a flat entablature. A modern, elevated deck is situated along the north wing.

Alterations to the exterior of Building #108, including the addition of a deck on the north side of the building, the installation of handicapped ramps on the south and west facades, infilling two windows with brick and vents, replacement of original window sash and doors, has somewhat diminished the integrity of detail on the structure, but its overall importance remains.

Exterior elements of the building that should be preserved include its form and scale; pedimented entrances, transom, wood cornice, louvered oculus, and broken pediments on gable ends.

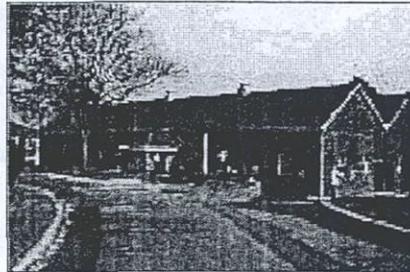
Front Elevation

Building #109 is a rectangular-plan, one-story tall utilitarian brick office and storage building that rests on a raised stone basement. It was originally constructed in wood in 1918 and rebuilt in brick after 1945. Ornamental details include brick quoins, diamond panels on the side walls, splayed brick lintels, and lunettes in the gable ends. The building has a double-gable roof form sheathed in asphalt shingles and penetrated by two chimneys. Windows are six-over-six double-hung wood sash set behind modern storm sash. The entrance has a rustic, wood door surround.

Modern exterior alterations to the building include the addition of a "rustic" wood entrance on the west facade, a mechanical room and retaining wall on the south facade, and concrete steps at the east entrance. Interior alterations are extensive. The interior of the building was completely remodeled and all visible historic fabric removed.

Exterior elements of the building that should be preserved include the low scale of the building along Andes Road; brick masonry exterior; quoins; water table; dentil band course; diamond panels; and, lunette windows.

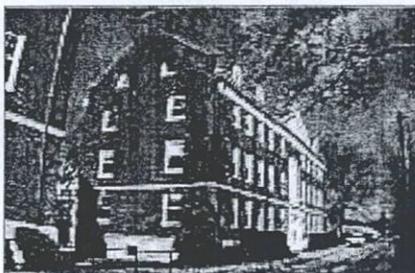
Front Elevation

Building #111 is a three and a half story, brick-on-reinforced-concrete-frame, L-shaped residential structure, built in the Neo-Georgian style. The limestone base supports brick walls laid in a Flemish bond. Keystones at the first floor window surrounds, windowsills and a beltcourse at the second floor are of limestone. Prominent chimneys punctuate the flat brick gable end walls. Its simple gable roof is punctured with small dormer windows and a pedimented gable over the central primary entry bays along Andes Road. The roof has been recently replaced in slate. The main entrances are articulated by large 1-1/2 story limestone surrounds with broken pediments, and an arched stucco panel in which is set a large double-hung Palladian window. Entrance doors are paneled wood set behind storm doors with entrance steps of granite. Windows throughout the building are relatively recent six-over-six and eight-over-eight double hung metal replacements. The L-shape of Building #111 and its mirror-twin, #112, form a landscaped courtyard to the north. The courtyard elevations reveal that the Andes Road wing is a half-floor higher than the ell. The courtyard facades feature prominent two story wood bays topped by parapets.

The exterior of Building #111 possesses much of its original appearance. The masonry walls are in good condition and largely intact. The recent re-roofing was carried out in a careful manner. The loss of the original wood windows detracts from the building's integrity.

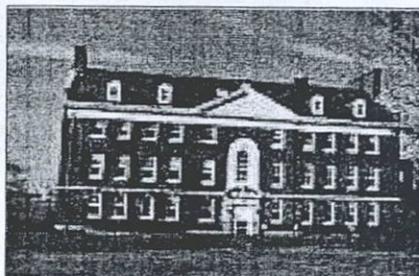
Front Elevation

Building #112 is a three and a half story, brick-on-reinforced-concrete-frame, L-shaped residential structure, built in the Neo-Georgian style. The limestone base supports brick walls laid in a Flemish bond. Keystones at the first floor window surrounds, windowsills and a beltcourse at the second floor are of limestone. Prominent chimneys punctuate the flat brick gable end walls. Its simple gable roof is punctured with small dormer windows and a pedimented gable over the central primary entry bays along Andes Road. The roof has been recently replaced in slate. The main entrances are articulated by large 1-1/2 story limestone surrounds with broken pediments, and an arched stucco panel in which is set a large double-hung Palladian window. Entrance doors are paneled wood set behind storm doors with entrance steps of granite. Windows throughout the building are relatively recent six-over-six and eight-over-eight double hung metal replacements. The L-shape of Building #112 and its mirror-twin, #111, form a landscaped courtyard to the north. The courtyard elevations reveal that the Andes Road wing is a half-floor higher than the ell. The courtyard facades feature prominent two story wood bays topped by parapets.

The exterior of Building # 112 possesses much of its original appearance. The masonry walls are in good condition and largely intact. The recent re-roofing was carried out in a careful manner. The loss of the original wood windows detracts from the building's integrity.

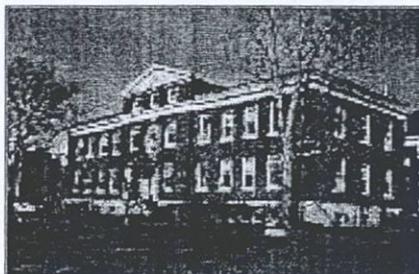
Front Elevation

Building #114 is a rectangular-plan, two-story brick "Neo-Georgian" style building with Neo-Georgian details. It was designed by the architecture firm Rogers and Poor and constructed in 1934. The building rests on a raised limestone foundation. It has a two-and-one-half story central pavilion flanked on either side by two-story wings. The gable roof of the central pavilion is standing seam metal. The wings each have flat roofs with metal parapets. The building has two main entrances—one with limestone pediment and granite steps on the east, and another with a columned limestone porch on the west. The double-hung wood windows have eight-over-eight sash with limestone sills and brick lintels with the exception of the central windows. The central windows have are four-over-four double-hung sash.

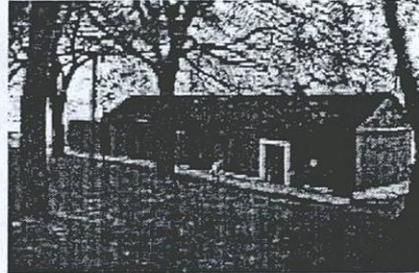
Front Elevation

Building #130 is a long, narrow, one-story brick structure originally built in 1843 as a workshop for the New York City Arsenal and gradually expanded for use as storage and office space. The utilitarian building is masonry bearing wall construction with common bond brick walls that rest on a brick foundation. The gabled roof is sheathed with asphalt shingles. Historic additions to the building were demolished in 1971 and replaced by a modern, flat-roof extension.

Exterior elements of the building that should be preserved include its form and scale; brick masonry facades, one original window and south facade cornice and pediment.

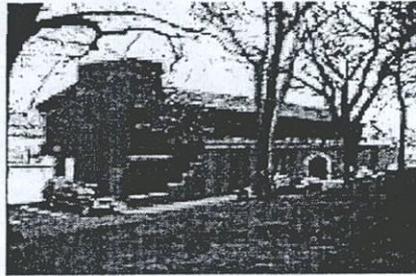
Front Elevation

Building #134, Station New York, is a two-story rectangular steel-frame structure with a brick veneer screen wall laid in American bond and set on a concrete foundation. The gabled roof is covered with metal. The entrance has aluminum and glass doors and the windows have aluminum and glass sash. Building #134 was built in 1986 to replace several other shore facilities.

Building #134, though not historic, is a sensitively designed background structure. Although not built of compatible materials generally, a brick wall with an arched entryway screens the building from the historic buildings above. Its low profile and siting do not cause it to obstruct the views from Nolan Park. Since its construction there have been no known alterations.

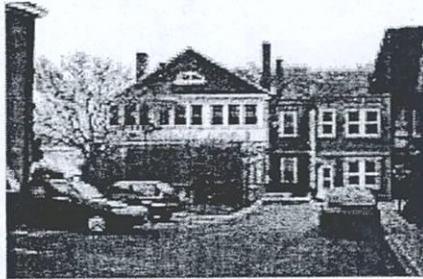
Rear Elevation

The storehouse section has been heavily modified. The ground level is rusticated granite with arched openings; the second level brick; and the third level a modern, asphalt-covered mansard with wall dormers dating to 1977. Paired windows have six-over-six, double-hung wood sash behind storm windows. A one-story shed has been added to the south facade.

Non-contributing exterior elements that can and should be removed from the building include: Storehouse—mansard roof, shed addition, infilled arches, fire escapes, privacy fencing, HVAC equipment, wood steps, exterior lighting, alarms, storm windows, surface wiring, and parking mirrors; House and Extension—projecting rear addition, storm doors, storm windows, window air conditioners, and surface wiring.

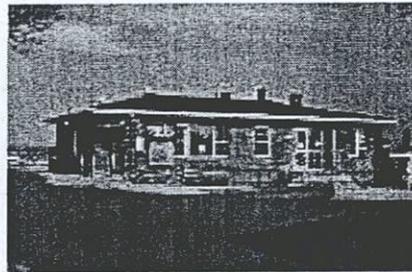
Front Elevation

Building #148 is a one-story rectangular structure of red brick, laid up in common bond, and built on a brick foundation marked by header courses. Brick quoins accent the corners. The window openings have splayed brick lintels and brick header sills. Glass block has been placed in some of the window openings while others have six-over-six double-hung wood sash set behind storm sash. The hipped roof is covered by asphalt shingles and has a prominent ventilator. The entrance doors, picture windows, and concrete steps are of relatively recent date.

Building #148 has not retained much of its original material and appearance, except for its exterior decorative brick work and the roofline. Relatively recently a new entrance was created on the east side of the building with a large concrete landing and steps, new concrete windows and doors. A clock window on the southeast corner of the east facade, a handicap access ramp at the southeast corner, windows on the south facade infilled with glass block, and a picture window on the east facade all detract from its integrity. A complete reworking of the interior has left no visible historic fabric.

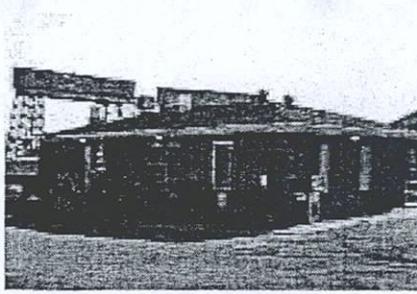
Rear Elevation

Exterior elements of the building that should be preserved include the decorative brick work, quoins and soldier course at water table.

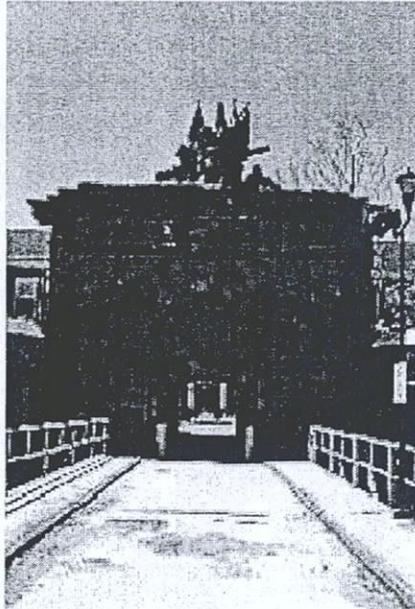
Entrance to Fort Jay

Fort Jay maintains much of the character of its original setting at the top of a clear gradual slope. The impressive earthworks, walls, and ramparts of the Fort attest to the careful thought and work that was put into one of the country's earliest defensive systems. The gatehouse includes the remains of the original drawbridge and gate.

Exterior elements of the Fort that should be preserved include all elements of the exterior of the Fort—the masonry walls at the scarp and counterscarp; the "glacis"; the moat; the gatehouse with sculpture above; and, the gun mounts along the ramparts.

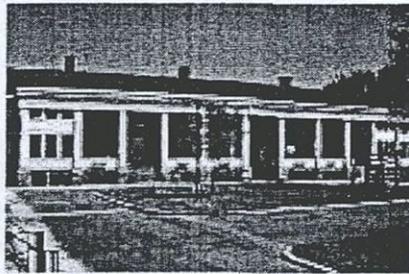
Front Elevation

Buildings #202, #206, #210 and #214 comprise the Fort Jay Family Housing. Located inside the Fort Jay walls, these four structures form the interior quadrangle in the center of the fort. Rectangular in plan and constructed of brick on a granite and sandstone foundation, these Greek Revival buildings are topped with hipped roofs with white-painted cornices. The two-story portico, consisting of twelve brownstone (now painted) Doric columns, faces the interior courtyard. Although the buildings have suffered several alterations, the overall character of the 19th century quadrangle is well preserved.

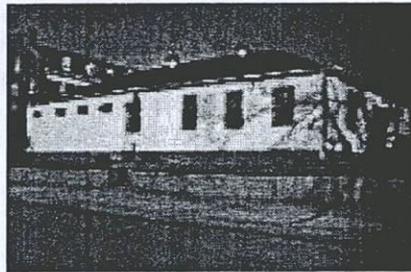
Front Elevation

BUILDING #251  
TAMPA MEMORIAL LIBRARY

Building #251, known as the "Tampa Memorial Library," is a one-story wood frame utilitarian structure set on a painted, brick masonry foundation and under a hipped roof. The northern half of the building is clad in asbestos shingles and contains small clerestory windows, while the southern half is clad in aluminum siding and has large, eight-over-eight double-hung windows. There are entrances in the northern and southern ends of the building.

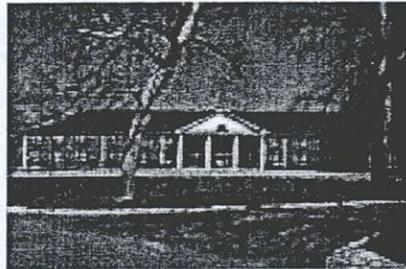
Front Elevation

BUILDING #293  
MOTEL/GUEST HOUSE

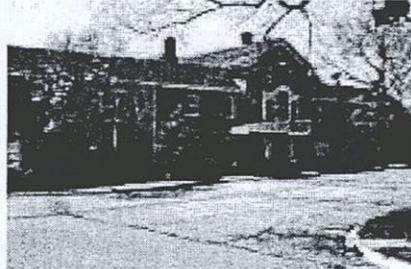
Front Elevation

**BUILDING #298  
SOUTH BATTERY**

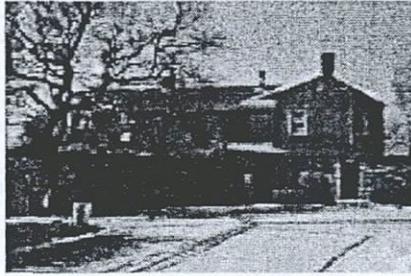
Rear Elevation

The original red sandstone section of the Battery played a very significant role as one of the Island's three batteries of defenses. The remnants of that original fortification include red sandstone walls that now serve as a retaining wall for Building #298, above. Building #298, together with the remains of the South Battery, are greatly altered from their original forms, yet retain a high degree of significance due to the central role these structures played in the history of Governors Island.

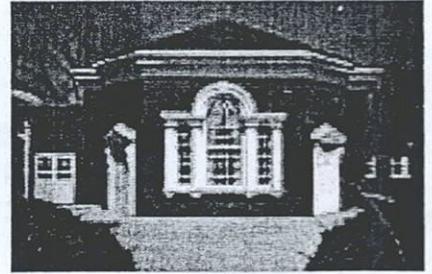
Second Floor Rear Elevation Showing Ballroom Window

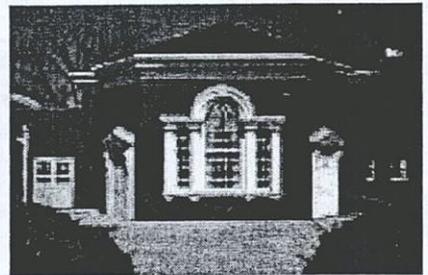
Second Floor Rear Elevation Showing Ballroom Window

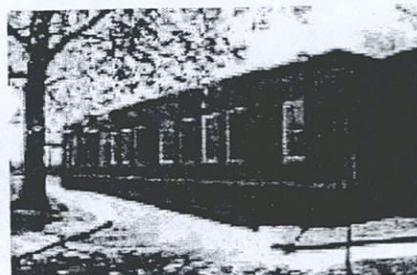
Rear Elevation

Addition

Building #301 has undergone significant alterations with the construction of two large additions and replacement of all of the windows. However, these alterations have been sensitively executed.

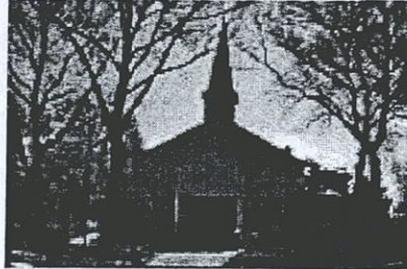
Front Elevation

BUILDING #309  
CATHOLIC CHAPEL

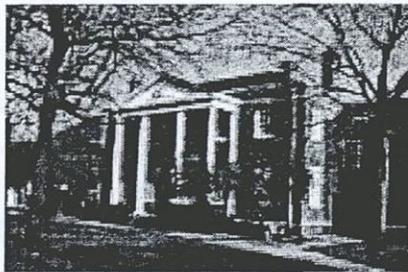
Front Elevation

BUILDING #324  
YMCA

Building #324 is a rectangular Neo-Georgian style structure with a two-story central section flanked by one-story wings. The red brick facing is laid up in Flemish bond. A limestone beltcourse bearing the date "1926" marks the foundation. The center section has an asphalt-covered hipped roof and a projecting two-story wood entrance portico with a gabled pediment. The portico is approached by granite steps. The entrance has a limestone surround and paired paneled wood doors. A panel reading "Army YMCA" is placed above the door. The flanking wings have asphalt-covered pyramidal roofs and pedimented doorway surrounds of wood. The window openings have splayed brick lintels; those that have not been boarded up retain six-over-six double-hung sash. On the rear elevation of the central section, the frame second story has been covered with aluminum siding. An outdoor swimming pool is raised above grade to the south of the building.

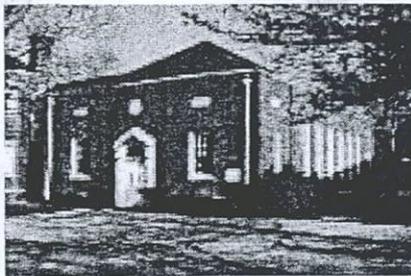
Rear Elevation

Exterior elements of the building that should be preserved include its form, scale, and style; brick masonry; wood door surrounds and half round transoms; wood entrance porticos with columns and pediments; window openings; and, limestone door surround at the main entrance under the portico.

Over the years, Building #324 has undergone several alterations—a brick pump house (Building #318) at the northeast corner of the property; a wood addition on the east facade; and, many of the windows infilled with brick or concrete.

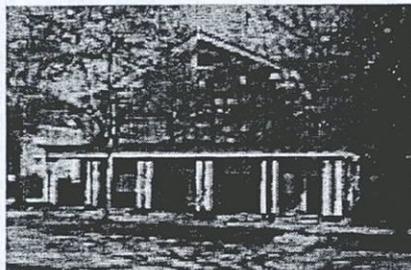
Front Elevation

BUILDING #330  
THEATER

Building #330 is a two-story Neo-Georgian style theater building on a concrete foundation faced with a reddish-brown brick laid in American bond. The main block of the building has brick quoins at the corners and a slate-covered hipped roof. On the north side is a two-story gabled projection above the entrance portico. This projection has three blind arches at the second floor with cast stone keystones and impost blocks, brick quoins and a raking wood cornice outlying the gable. A metal sign bar bearing the letters "THEATRE" extends across the arches. A one-story wood entrance portico with a flat roof extends across the north front and shelters the freestanding ticket booth and the entrances to the theater. Openings along the east and west sides of the building have wood six-over-six double-hung windows and auxiliary entrances/exits. A projecting wing with a hipped roof has been added at the south end of the building.

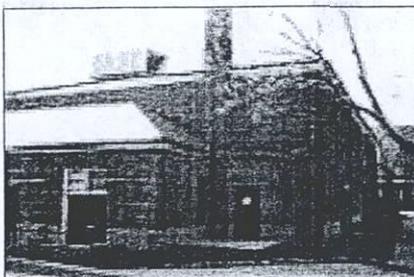
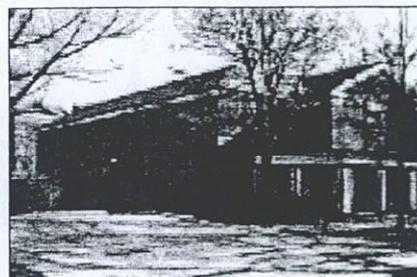
Building #330 has retained a great deal of its original material and appearance. Over the years there have been alterations including two brick additions to the rear.

*Rear Elevation*

*Side Elevation*

Exterior elements of the building that should be preserved include the building scale and basic form; the front facade, except for the railings; brick masonry quoins at the corners and piers along facades; door surrounds and blind arches at the side entrances; and, the fascia at cornice and porch.

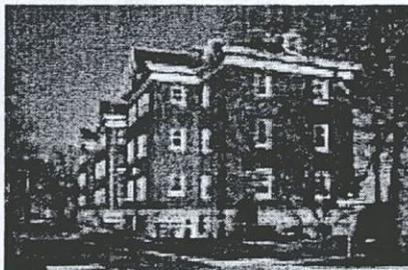
Front Elevation

BUILDING #333  
DETACHMENT BARRACKS

Building #333 is a three-story Neo-Georgian style structure arranged in a U-shaped plan and constructed of brick on a sandstone/concrete foundation. A limestone beltcourse separates the first story from the upper floors. The building has asphalt shingle covered gable roofs. A central projection contains an entrance porch composed of stone columns and pilasters supporting an iron balustrade. The entrance has a granite sill with Palladian windows located above. Two-story open galleries are located along the courtyard facade. Fenestration consists of aluminum six-over-six double-hung windows and paneled wood doors.

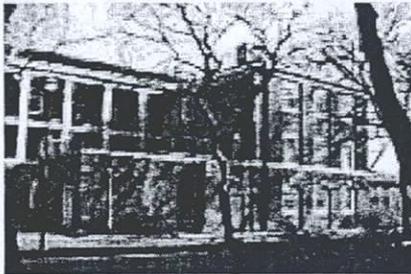
*Partial Rear Elevation*

Exterior elements of the building that should be preserved include its scale, form, and basic design; brick and limestone masonry and detailing; wood cornice and gable rakes; entrance porch, including columns and pilasters; wood elements and iron balcony; half-round windows; and, open galleries.

All four facades of Building #333 are designed to be primary facades and are rich in detail and articulation. The interior of Building #333 has been extensively modified over the years, and all of the building windows have been replaced.

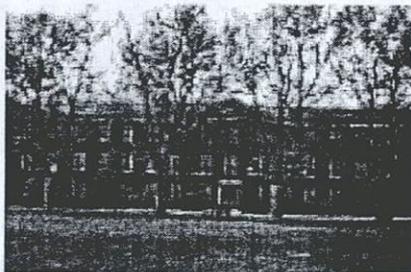
**BUILDING #400  
LIGGETT HALL**

Front Elevation, looking south from Colonels' Row

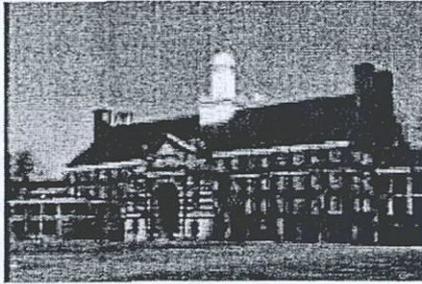
Rear elevation, looking north from Division Road

Modifications were made to the building over time, including an extensive set of interior alterations carried out during the 1960s and 1970s to reconfigure the quarters and improve living conditions. The building was renamed Liggett Hall, after First Army commander Lieutenant General Hunter Liggett, in 1957.

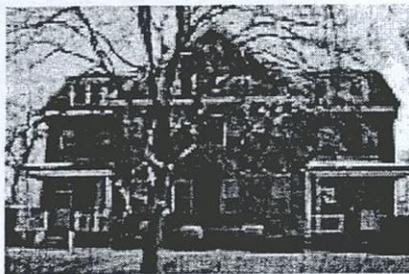
Front Elevation

**BUILDING #403  
OFFICERS' HOUSING**

Building #403 is a two-and-one-half story red brick Colonial Revival style house that rests on a schist foundation. It is one of a group of eight brick buildings located adjacent to each other on the Colonels' Row, all of which exhibit Colonial-Revival style details. It has an L-shaped plan and is masonry bearing wall construction. An asphalt-shingle gable roof with raking denticulated wood cornice tops the structure. Fenestration consists of two-over-two, double-hung wood windows set behind storm sash with prominent brick keystones and lintels. The building also retains its historic parred paneled wood doors. A full-length porch with Tuscan columns and a standing-seam metal roof is present on the front (west) elevation. Garages were added at the rear of the quarters in 1931.

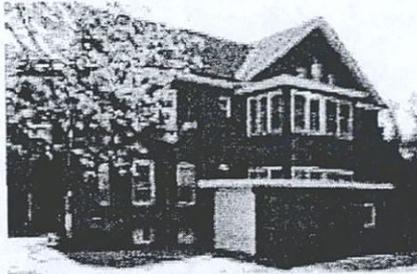
Rear Elevation

The exterior of Building #403 is in good condition, retaining most of its original fabric. An enclosed sun porch has been added to the rear of the building off the kitchen, and a garage was built on the north side of the building.

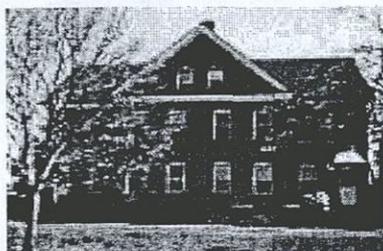
Front Elevation

**BUILDING #404  
OFFICERS' HOUSING**

Building #404 is a two-story double Colonial Revival style house that rests on a schist foundation. It is one of a group of eight brick buildings located adjacent to one other on the Colonels' Row. The entire row exhibits colonial-revival details. All were built according to the standardized Quartermaster's Plans and Specifications. Building #404 has a rectangular plan and symmetrical facade arrangement with a cross-gable roof that has prominent denticulated cornices. The roof is sheathed in asphalt shingles. The structure is red pressed brick masonry-bearing construction. Fenestration consists of two-over-two double-hung wood windows set behind storm sash. Building #404 also retains its historic paneled wood doors set behind storm doors. Garages were added to the rear of the quarters in 1931. Front porches have been removed from the building and their entrances reconfigured.

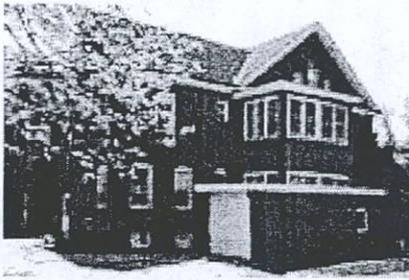
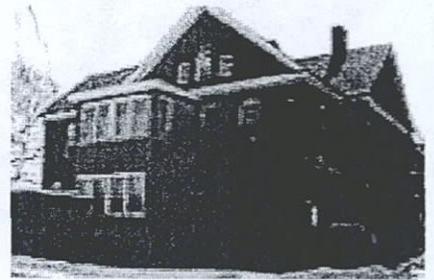
Rear Elevation

Side Elevation

Exterior elements of the building that are important to preserve include its overall scale and design; brick masonry exterior; schist foundation; wood cornice; segmental-arched and round arched window openings with ornamental lintels and sills; Palladian windows in north & south gables; two-over-two double-hung windows; and, paneled wood entrance doors.

The exterior of Building #404 is in good condition, retaining most of its original exterior fabric. The two original porches have been removed and replaced by small copper hoods installed over the front doors, and a two-story brick enclosed sun porch was added to the north side of the building.

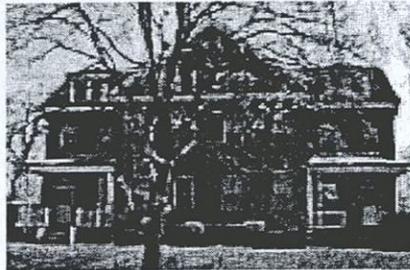
Front Elevation

**BUILDING #405  
OFFICERS' HOUSING**

Building #405 is a two and one-half story red brick, double Romanesque Revival style house that rests on a schist foundation. It is one of a group of eight brick buildings located adjacent to one another on Colonels' Row. Building #405, along with buildings #406, #407 and #408, was built as a double-unit officer's quarters, according to the standardized Quartermaster's Plans and Specifications. This building has a symmetrical plan with a projecting central gable on the front facade. Two hipped-roof wings project from the rear of the building. Wood denticulated cornices help define the roof form. The house is red pressed brick masonry-bearing construction. The cross-gable roof is covered with asphalt shingles. The building retains its original paired front porches, which are supported by slender, paired Tuscan columns. The detailing of the porch and the shape of the window openings and the front stairs varies from the standard plan. Fenestration consists of one-over-one double-hung wood windows and paneled wood doors.

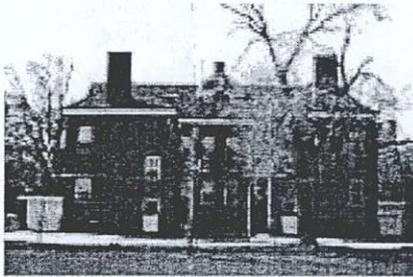
Rear Elevation

The exterior of Building #405 is in good condition, retaining most of its original fabric.

Exterior elements of the building that should be preserved include its overall design, scale, and form; brick masonry exterior; schist foundation; wood cornices; segmental-arched and round-arched window openings; ornamental lintels and sills; one-over-one double-hung wood windows; paneled wood entrance doors with transoms; and, wood porch elements.

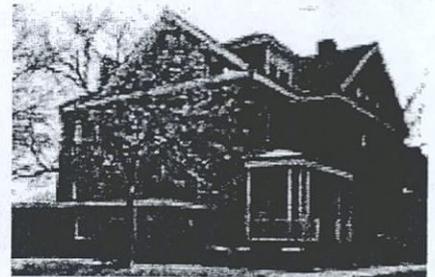
Setting

Building #405 faces the small park encompassing Colonels' Row with the rear facades facing the parade ground. It is surrounded by sloped brick walkways, which should be preserved, and mature trees.

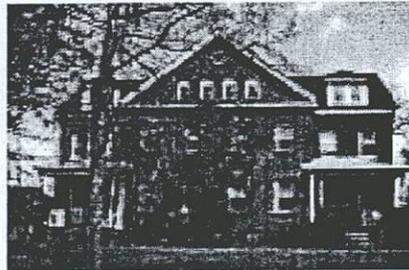
Front Elevation

Building #406 is a two and one-half story red brick, double Romanesque Revival style house that rests on a schist foundation. It is one of a group of eight brick buildings located adjacent to one another on Colonels' Row. Building #406, along with buildings #405, #407 and #408, was built as a double-unit officer's quarters, according to the standardized Quartermaster's Plans and Specifications. This building has a symmetrical plan with a projecting central gable on the front facade. Two hipped-roof wings project from the rear of the building. Wood denticulated cornices help define the roof form. The house is red pressed brick masonry-bearing construction. The cross-gable roof is covered with asphalt shingles. The building retains its original paired front porches, which are supported by slender, paired Tuscan columns. The detailing of the porch and the shape of the window openings and the front stairs varies from the standard plan. Fenestration consists of one-over-one double-hung wood windows and paneled wood doors.

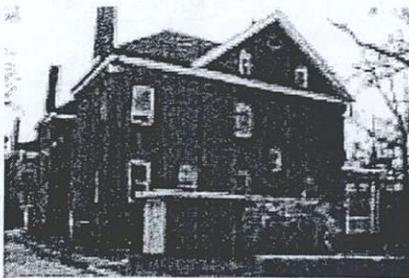
Rear/Side Elevation

The exterior of Building #406 is in good condition, retaining most of its original fabric.

Exterior elements of the building that should be preserved include its overall design, scale, and form; brick masonry exterior; schist foundation; wood cornices; segmental-arched and round-arched window openings; ornamental lintels and sills; one-over-one double-hung wood windows; paneled wood entrance doors with transoms; and, wood porch elements.

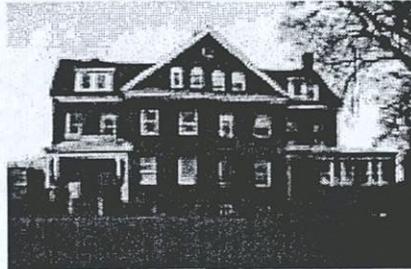
Front Elevation

Building #407 is a two and one-half story red brick, double Romanesque Revival style house that rests on a schist foundation. It is one of a group of eight brick buildings located adjacent to one another on Colonels' Row. Building #407, along with buildings #405, #406, and #408, was built as a double-unit officer's quarters, according to standardized Quartermaster's Plans and Specifications in 1894. This building has a symmetrical plan with a projecting central gable on the front facade. Two hipped-roof wings project from the rear of the building. Wood denticulated cornices help define the roof form. The house is red pressed brick masonry-bearing construction. The cross-gable roof is covered with asphalt shingles. The building has paired front porches. Slender, paired Tuscan columns support one original porch. The porch to the south has been expanded and enclosed to create a sunroom. The detailing of the porch and the shape of the window openings and the front stairs varies from the standard plan. Fenestration consists of one-over-one double-hung wood windows set within segmental- and round-arched openings featuring spayed brick lintels and slate sills. The building retains its historic paneled wood doors.

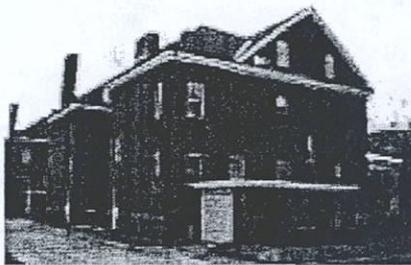
Rear Elevation

The exterior of Building #407 is in good condition, retaining most of its original fabric, however the interior underwent significant WPA-era alterations. Although a small garage and enclosed sun porch have been added to the structure, it still succeeds in conveying its historic appearance. The front porch of Unit B was torn down & replaced with a brick enclosed sunroom w/ a sunken garage below and a front vestibule were removed. An attached garage was built toward rear of Unit A. Unit B was completely gutted and reconfigured around 1938. Unit A is more intact with a greater number of historic details.

Exterior elements of the building that should be preserved include its basic design, scale, and form; brick masonry exterior; schist foundation; wood cornices; segmentally-arched and non-arched window openings; ornamental lintels and sills; paneled wood entrance doors; and, wood porch elements.

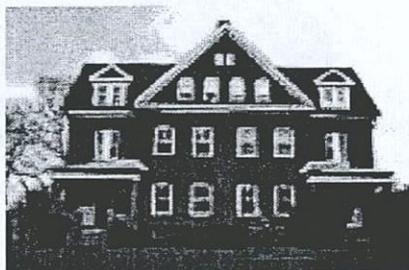
Front Elevation

Building #408 is a two and one-half story, brick double Romanesque Revival style house on a rusticated schist foundation that was constructed as an officers quarters. It is one of a group of eight brick buildings located adjacent to one another on Colonels' Row. Building #408, along with buildings #403, #404, #405, #406 and #407, was built according to standardized Quartermaster's Plans and Specifications in 1895. This building has an irregular-shaped plan and consists of a red pressed brick masonry bearing walls topped with an asphalt-shingle cross gable roof with paired gabled dormers. Prominent cornices help to define the roof form. Segmental-arched and round-arched window openings have splayed brick lintels and slate sills. Differences in #408 mainly appear in the width of the back stairs, which are wider than on other buildings. Other differences appear in the design of the attic dormer windows and in the details of the porch. The building retains its two-over-two double-hung historic wood windows, set behind storm sash, and paneled doors. The building possesses paired porches situated on either side of a projecting center wing. Square brick replacement piers support the porches. A garage was added to the northeast side in 1931. The southeast side garage was added later, and is located on the basement.

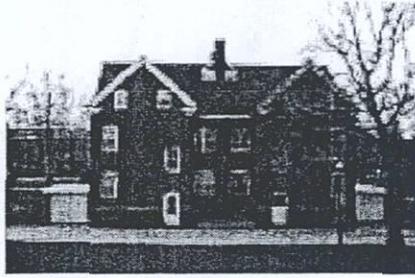
Rear Elevation

The exterior of Building #408 is in good condition, retaining most of its original fabric. The original wood front porches of each unit have been rebuilt in brick.

Exterior elements of the building that should be preserved include its design, scale, and form; brick masonry exterior; schist foundation; wood cornices; segmental-arched and round-arched window openings; ornamental lintels and sills; paneled wood entrance doors with transoms; wood porch elements; and, two-over-two double hung wood windows.

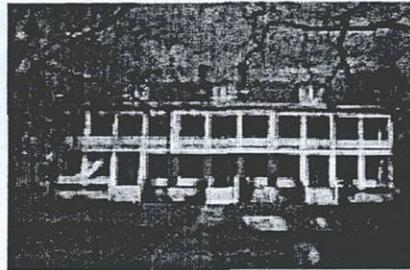
Front Elevation

Building #409 is a two and one-half story Colonial Revival style residence resting on an ashlar limestone foundation that was built as Bachelor Officers' Quarters. It is one of a group of eight brick buildings located adjacent to each other on Colonels' Row. Buildings #403 to #410 were built according to the standardized Quartermaster's Plans and Specifications between 1893 and 1927. Building #409 is T-shaped in plan and consists of a brown brick masonry bearing walls topped with a slate-covered hipped roof with hipped-roof dormers. Four brick chimneys punctuate the roof. Window openings have splayed brick lintels and are two-over-two double-hung wood sash set behind storm sash. The building retains its historic paneled wood entrance doors with transoms. A full-length wood porch covers the front (west) elevation. It is accessed by three sets of wood steps. The front porch has several square brick replacement columns on the first floor that support wood Tuscan columns on the second level.

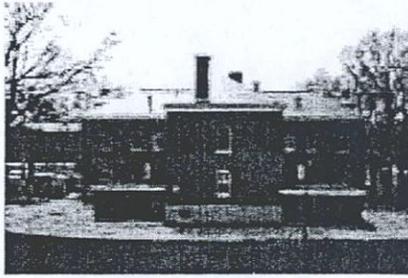
Rear Elevation

The exterior of Building #409 is in good condition, retaining most of its original fabric. The interior was gutted and the floor plan extensively redesigned. All of the windows have been replaced. On the south facade four twentieth century brick piers have replaced the original wood columns.

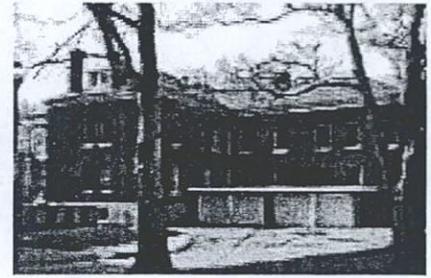
Partial Side Elevation Showing Added Garages

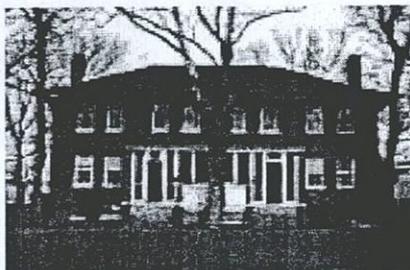
Front Elevation

Building #410 is a two-family, rectangular plan, brown brick modified Arts and Crafts style dwelling. It is located at the northwest end of the row of larger officer's residences along Hay Road. It is two-story brown brick masonry bearing wall construction with a raised brick foundation and an asphalt-shingle hipped roof with wide eaves. The double central entrance faces west and is enclosed by small screened-in wood porches. Brick chimneys are present on either end of the building. The structure retains its paneled wood doors and six-over-six double-hung wood windows set behind storm sash with limestone sills. The building was built as duplex officers' quarters and is the only example of this plan on the Island.

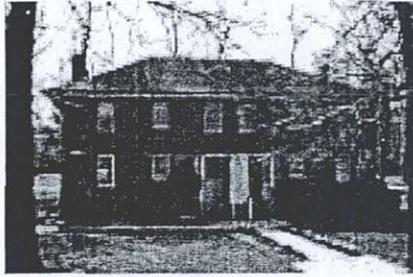
Rear Elevation

The exterior of Building #410 is in good condition, retaining most of its original fabric. The only alterations are the screening in of the front porches and the additional of small wood porches to the rear.

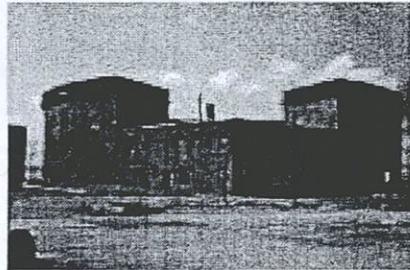
Front Elevation

Castle Williams was originally built on an outcropping of rock 100 feet out into the channel as part of the federal Second American System of fortifications in 1805. Lt. Col. Jonathan Williams, Chief Engineer of the U.S. Army and first Superintendent at West Point, designed the fortification with multiple circular tiers, reflecting French engineer's Montalembert's theories. The circular design had less wall space to defend and offered greater protection to guns and men. Rather than having vulnerable, exposed cannon on parapet walls, the fort contained casemate emplacements that allowed heavy guns to be fired in small, protected interior spaces. The use of casemates, multiple tiers of armament, and close apertures of the embrasures were features that made the fortification so innovative for its time. Castle Williams was designed as part of a larger defensive system for the Island, which also included Fort Jay and the South Battery.

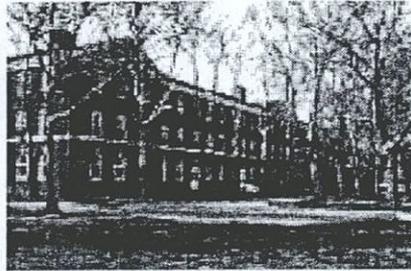
Front Elevation

Building #550 is a U-shaped, three-story, brick Neo-Georgian style building on a concrete foundation. The central section faces Short Avenue, and the wings face Clayton and Division Roads. It is constructed of reinforced concrete with a common-bond, brick veneer. The first story is separated from the upper floors by a limestone band course. A cast stone course is also present above the third-floor windows below the roofline. The intersecting gable roofs have a relatively shallow pitch and are clad with asphalt shingles. The entrance is located within a projecting wing centered within the main facade. A columned entrance porch supporting an iron balustrade frames the paired panel and glass doors. Two-story open galleries are present along the courtyard facade. Windows are heavily ornamented. First-floor windows are positioned within blind arcades and have limestone keystones. Second- and third-floor windows are set within squared openings with limestone sills.

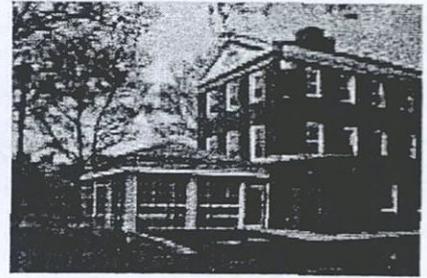
Partial Elevation Showing Recent Additions

Significant exterior alterations to Building #550 include the addition of new steel and glass entry structures on the east and courtyard facades, and the enclosure of the brick arcade and porch on the south side of the courtyard. Remodeling activity has removed all visible historic fabric from the interior. All windows are replacement, metal, six-over-six double-hung sash. Gable-end pediments are covered in stucco with lunettes.

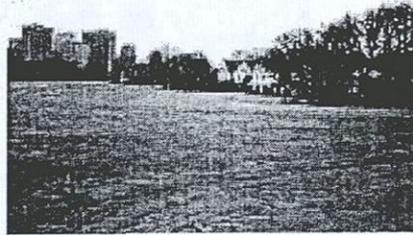
Glacis extending from Ft. Jay

The open space defined as the Fort Jay Glacis is important to understanding the evolution of development on the island. The open lawn area is its primary character defining feature.

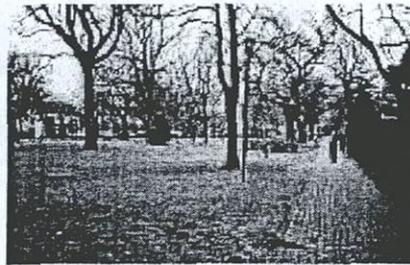
The open spaces defined as Nolan Park and Colonels' Row Green are important to understanding the evolution of development on the island. The brick walkways and mature trees lining those walkways are defining features, as is the uncluttered lawn areas.

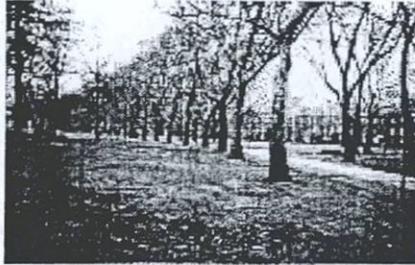
Colonel's Row Green

Colonels' Row Green sits on landfill, just south of the island's original shoreline. It is thought to be work carried out through the WPA during the late 1930s.

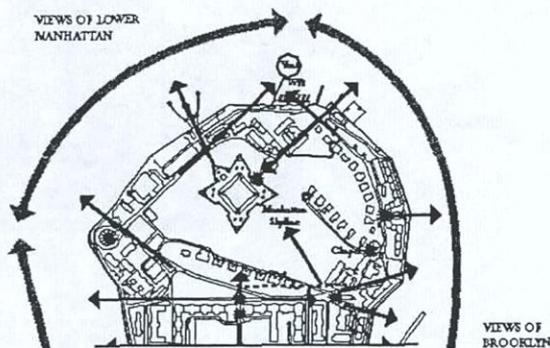
VISTAS & VIEWS

Vistas and Views from and to Governors Island represent one of the most important elements in defining its character. Sited directly south of Lower Manhattan the northern portion of the Island has arresting views of the New York skyline. The broad vistas extend north, east, and west of the Historic District toward Manhattan, Liberty and Ellis Islands, and across Buttermilk Channel.
