Phase IB Archaeological Field Investigation

4830 Arthur Kill Road Block 7584, Lot 85 Staten Island, Richmond County, New York

LPC Project # 12DCP014R

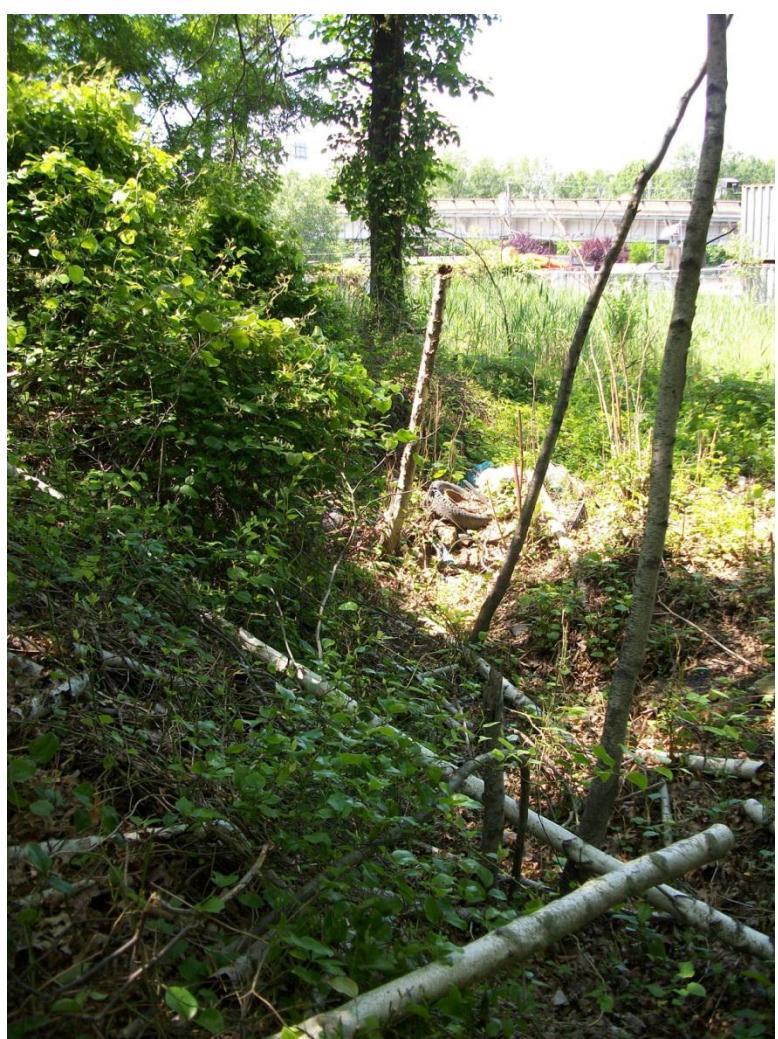
Photograph 1: Example of disturbance visible within project site, with South Bridge Street in background. View looking north.

As noted in the Phase IA report, the eastern section of the project site where the Phase IB testing occurred is undeveloped woodland, with trees and light to heavy understory (Figure 4). Earthmoving associated with development along adjacent South Bridge Street appears to have affected the northern side of this area, with disturbance from grading and filling visible bordering the abutting buildings, and disturbance from other earthmoving and dumping visible within parts of the central portion of this area (Photograph 1). There is a steep unnatural embankment of soil here (Photograph 2). At the time of the Phase IB testing, there was standing water in several locations. The southern edge of this area appeared to be less disturbed than the northern portion, although debris piles and other evidence of earthmoving were visible, particularly nearest the parking lot on the western side of the project site (Photograph 3).

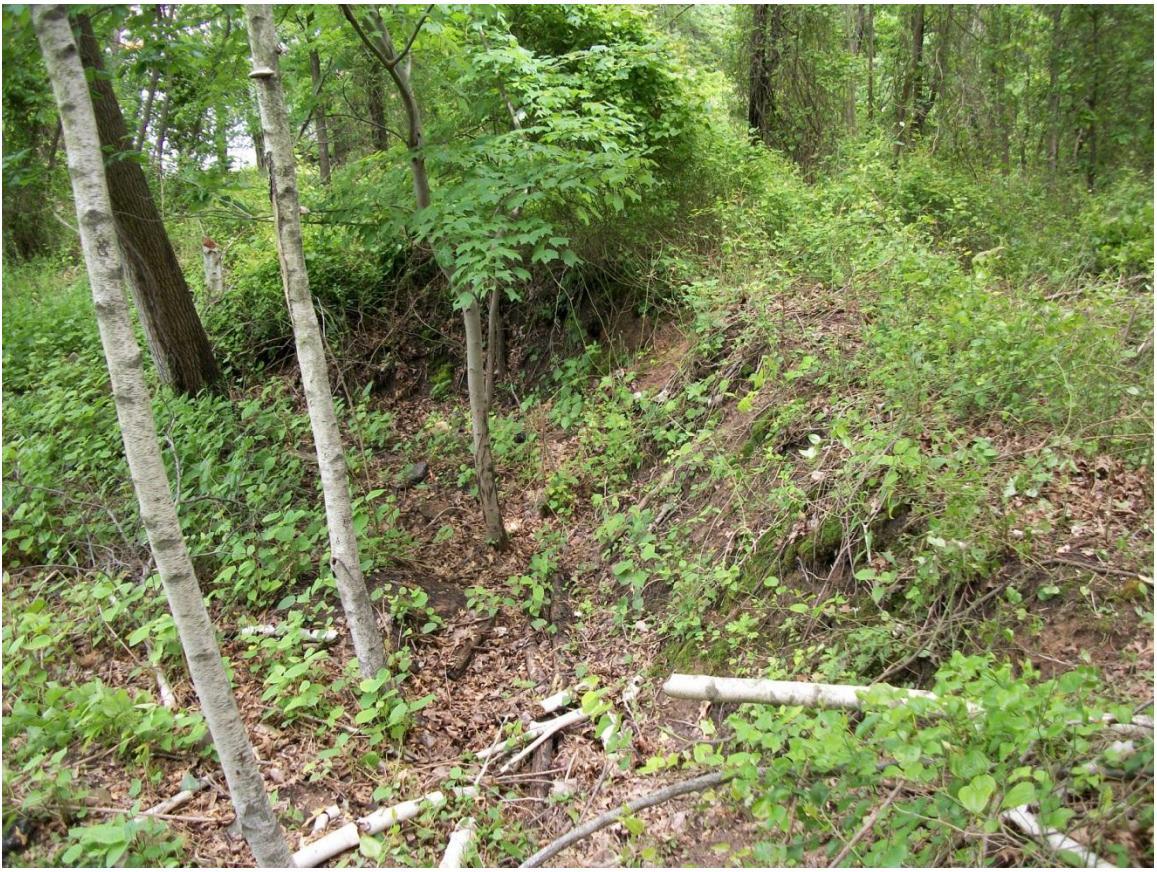
Photograph 2: Cut embankment near ST 5. View looking east.

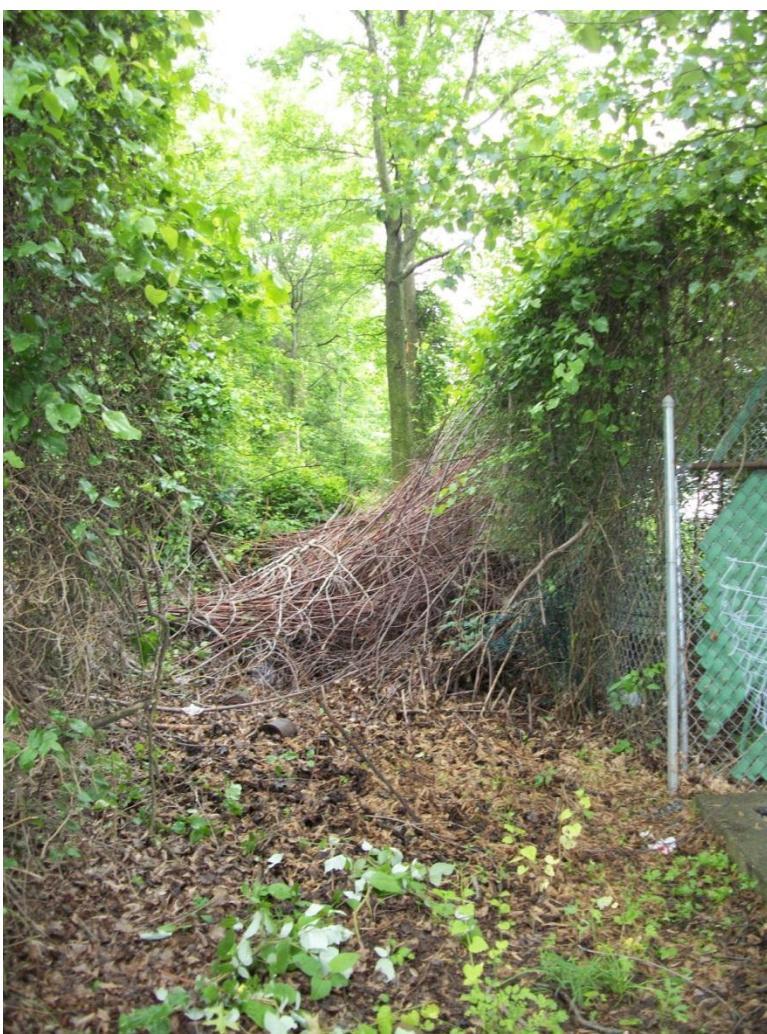
Photograph 3: Disturbance at southwest end of testing area. View looking south with Celerant Technology parking lot to right beyond chain link fence.

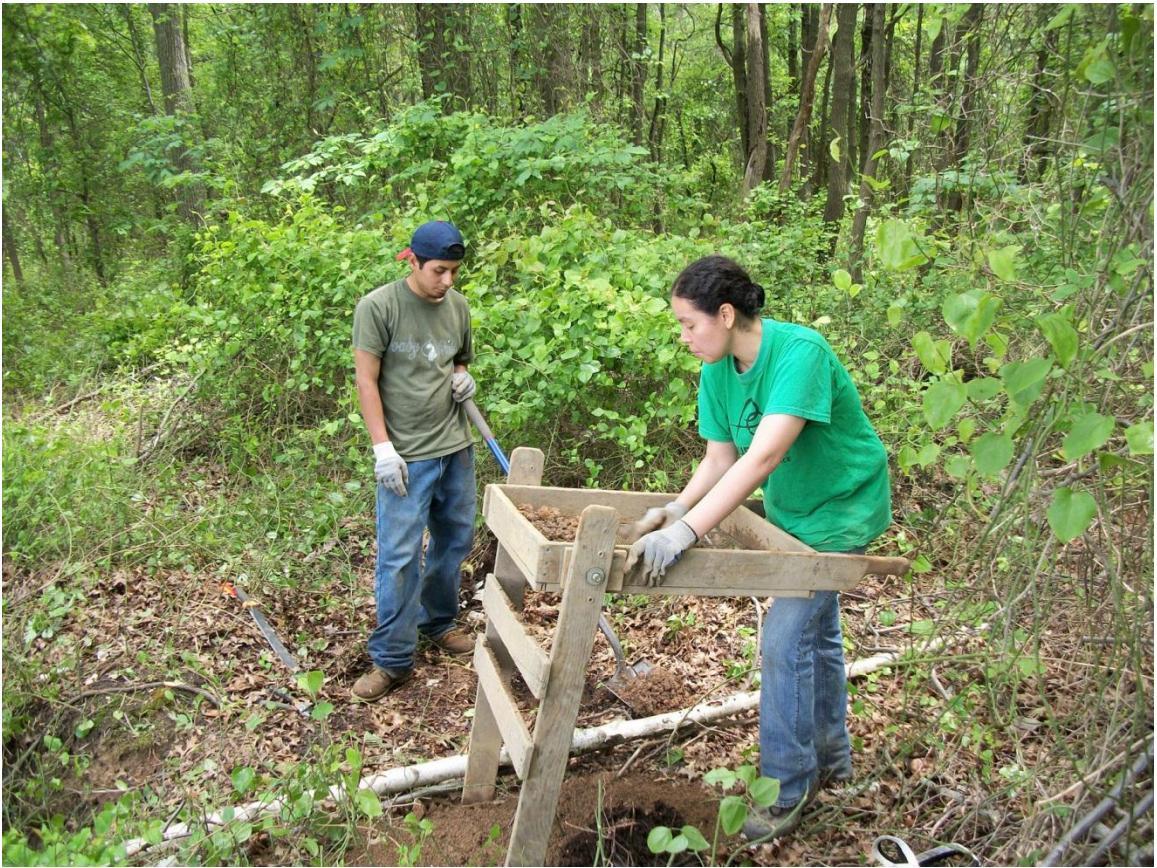
Photograph 4: Archaeological technicians excavating ST 5. View looking east.

Transect 1 was located along the southern edge of the project site, and included STs 1-8 (Figure 4; Photograph 4). This transect contained STs with generally intact stratigraphic profiles containing an A, B, and C horizon (Appendix A). However, several of the STs may have had pockets of disturbance within these horizons that were not visible as they were being excavated. STs 1, 3, 5, 7, and 8 all had one or more historic or modern artifacts found in the A or B horizons. All of the historic artifacts were small fragments and none appeared to represent a primary deposition. No precontact artifacts were found in any of the STs on this transect.

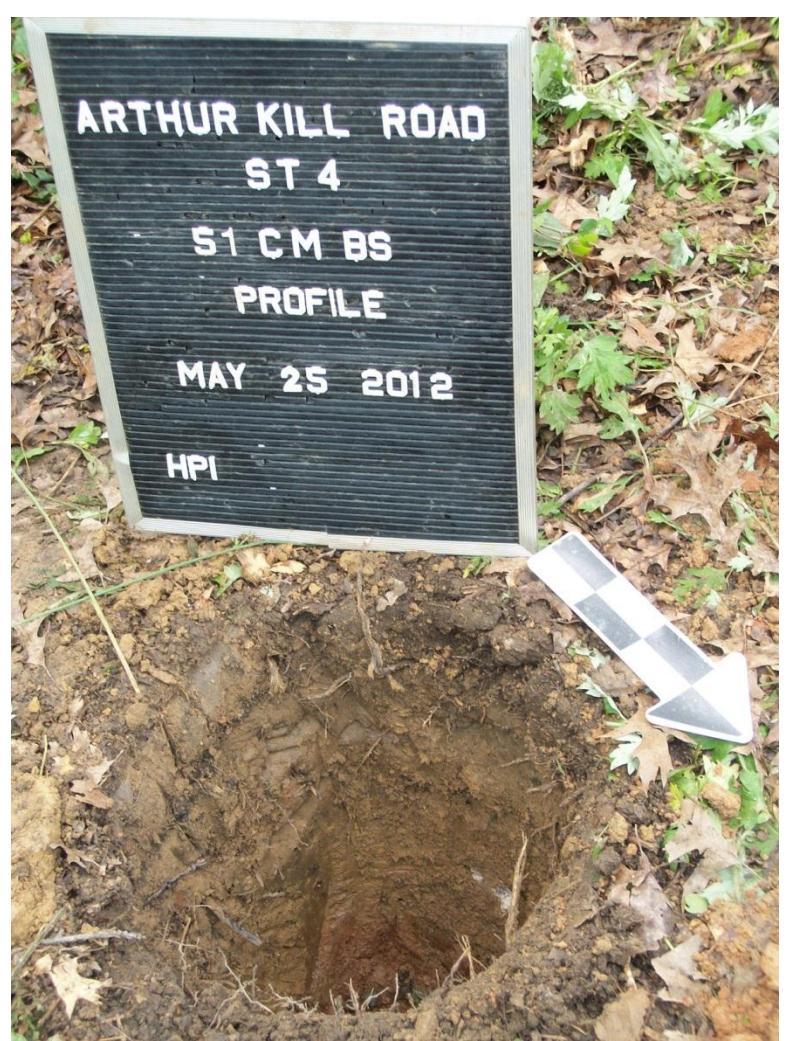
Photograph 5: Profile of ST 4. View looking southwest.

Level	Horizon	Depth (cm)	Soil Color	Soil Texture	Artifacts/Comments/
					Reason for Termination
1	Humus/A	0-10	10 YR 2/2	Loam	NCM
2	В	10-27	10 YR 4/4	Loamy sand	NCM

A typical stratigraphic profile for this transect was ST 4 (Photograph 5), below.

Level	Horizon	Depth (cm)	Soil Color	Soil Texture	Artifacts/Comments/
					Reason for Termination
3	С	27-51	10 YR 5/3 mottled	Coarse sand	NCM, sterile subsoil
			w/2.5 YR 5/4
