Phase IB Archaeological Monitoring for Housing Preservation and Development of 1019-1029 Fulton Street and 18-22 Putnam Avenue, Block 1991, Lots 1-7, 16, and 106, Brooklyn (Kings), New York (DOB: 321385880) Project

Prepared by: Leah Mollin-Kling, MAA, R.P.A., Alyssa Loorya, Ph.D., R.P.A. Chrysalis Archaeological Consultants, Inc.

October 2019

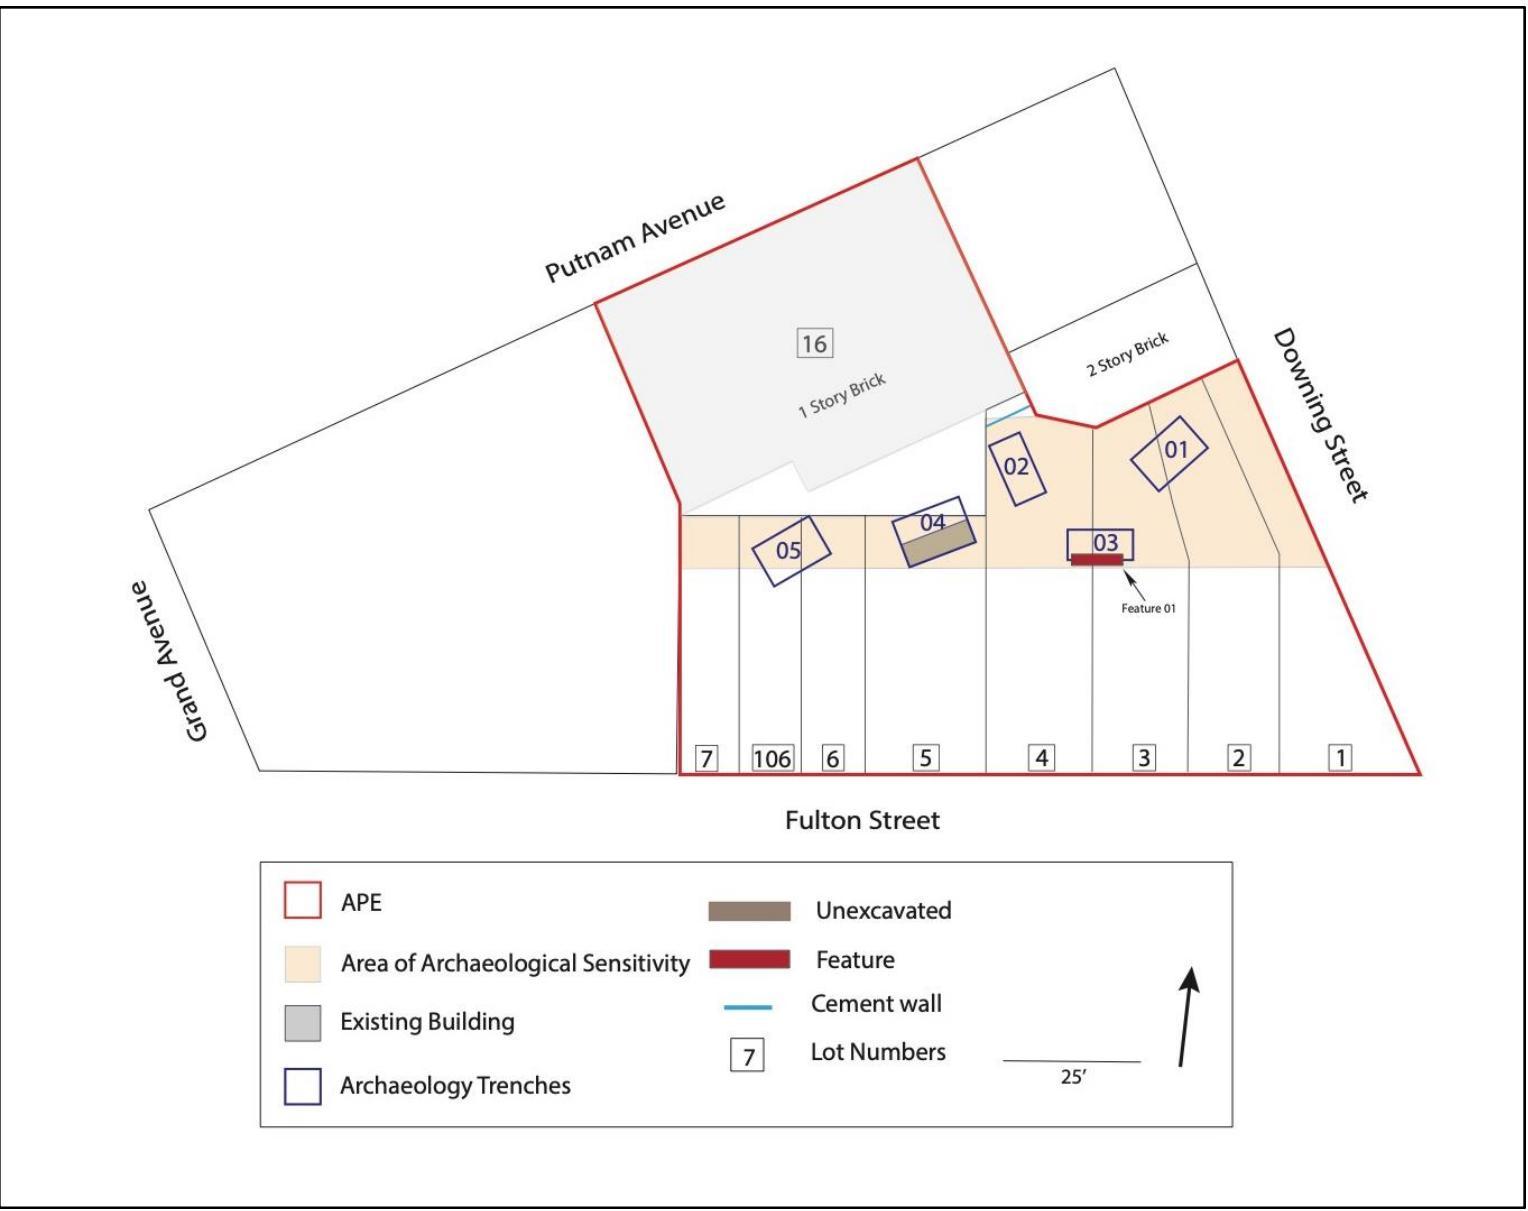
Map 04: Field Map.

A total of five Phase IB exploratory trenches (01-05) in lots 2-5, and 106 were archaeologically monitored (Map 04) (Table 01). The trenches were placed in what would have been the rear yards of the original nineteenth century row houses fronting Fulton St. The backyard areas were specifically identified by HPI in their Phase IA assessment as having the potential to yield historic shaft features, discrete archaeological deposits, and/or other associated rear-yard elements.

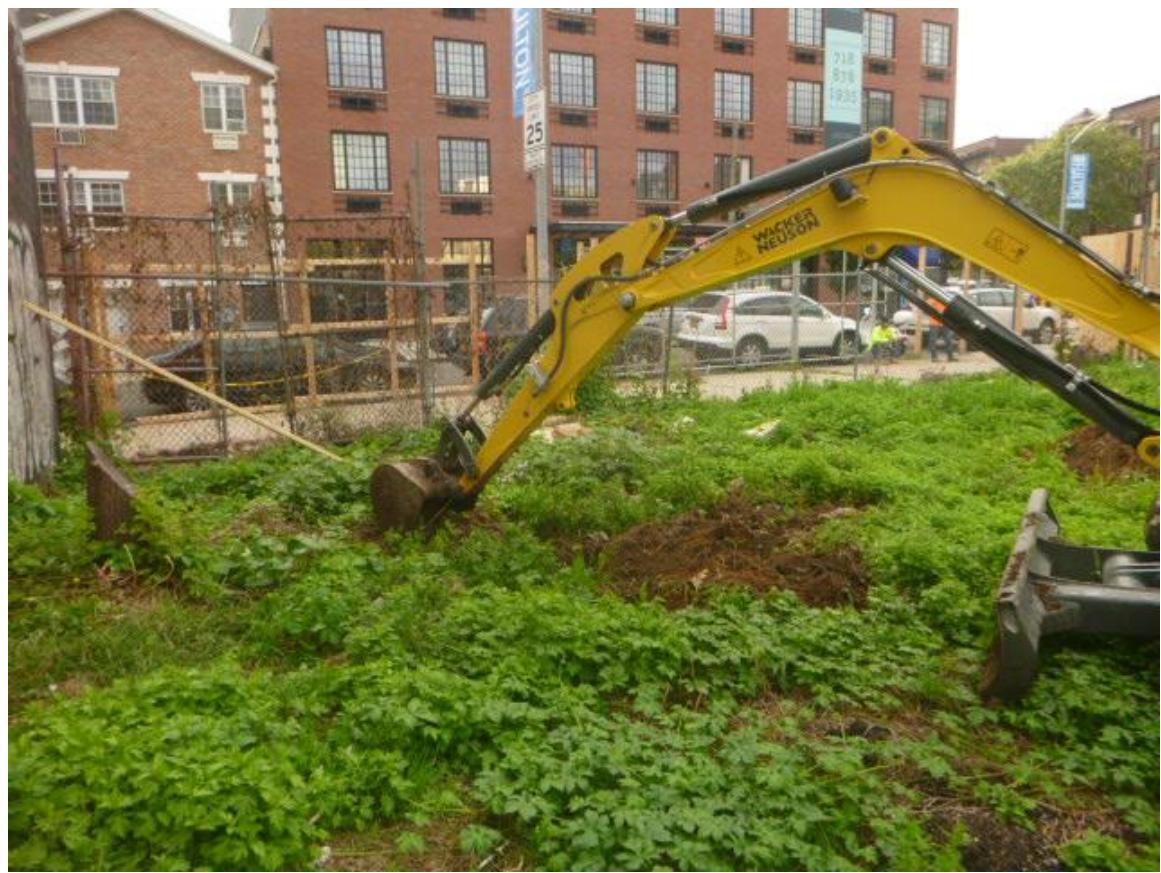
Trench 01 was located along the northern boundary of Lot 2 near the northwest corner of the APE as it abuts a vacant two-story brick building fronting Downing Street (Map 04) (Image 01). The trench was opened 5.5' south of the brick building in order to avoid damage to the structure or its integrity.

Image 01: Location of Trench 01 (looking east).

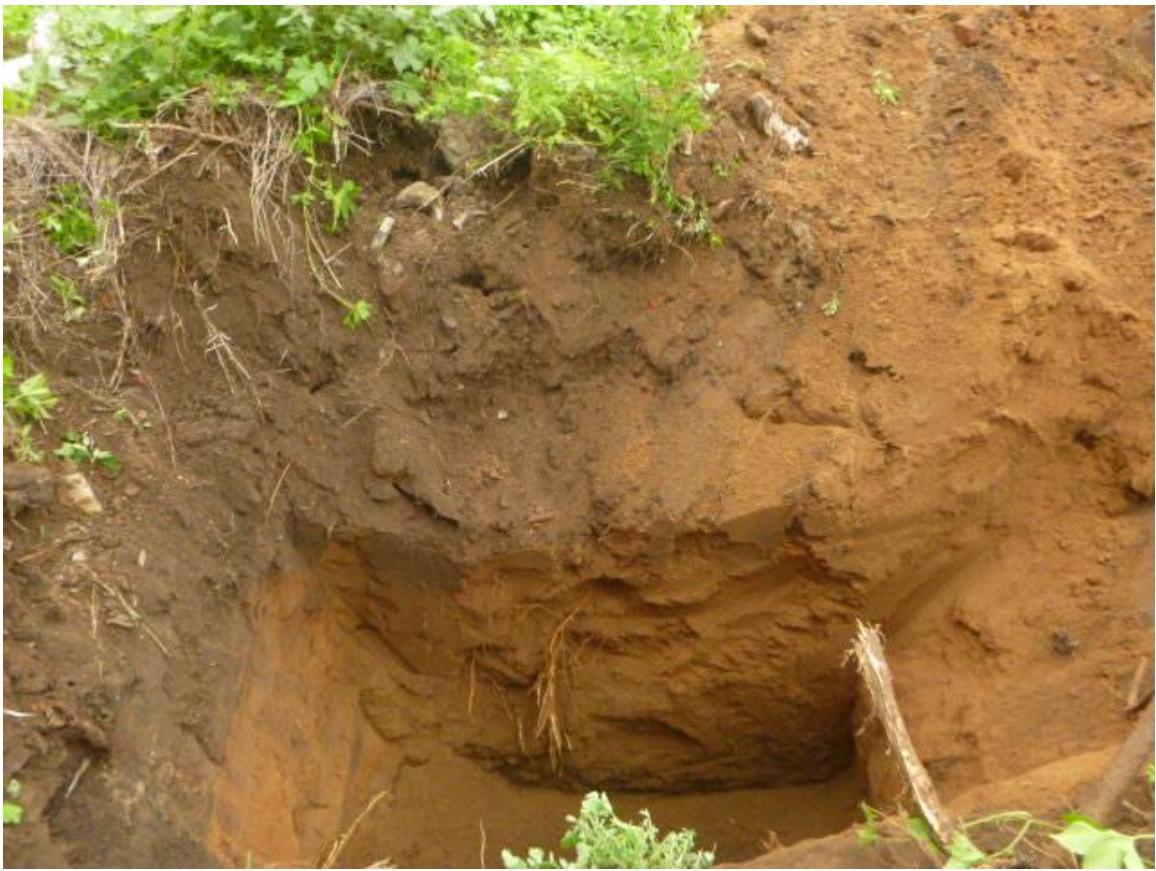
Intact stratigraphy was found during the excavation of Trench 01 underlaying a thick layer of fill (Table 02) (Image 02). The fill was characterized by significant inclusions of demolition materials, indicating that Lot 2 has been disturbed. As a result, intact archaeological resources are not expected to remain in Lot 2.

Image 02: Stratigraphic profile, north wall – Trench 01.

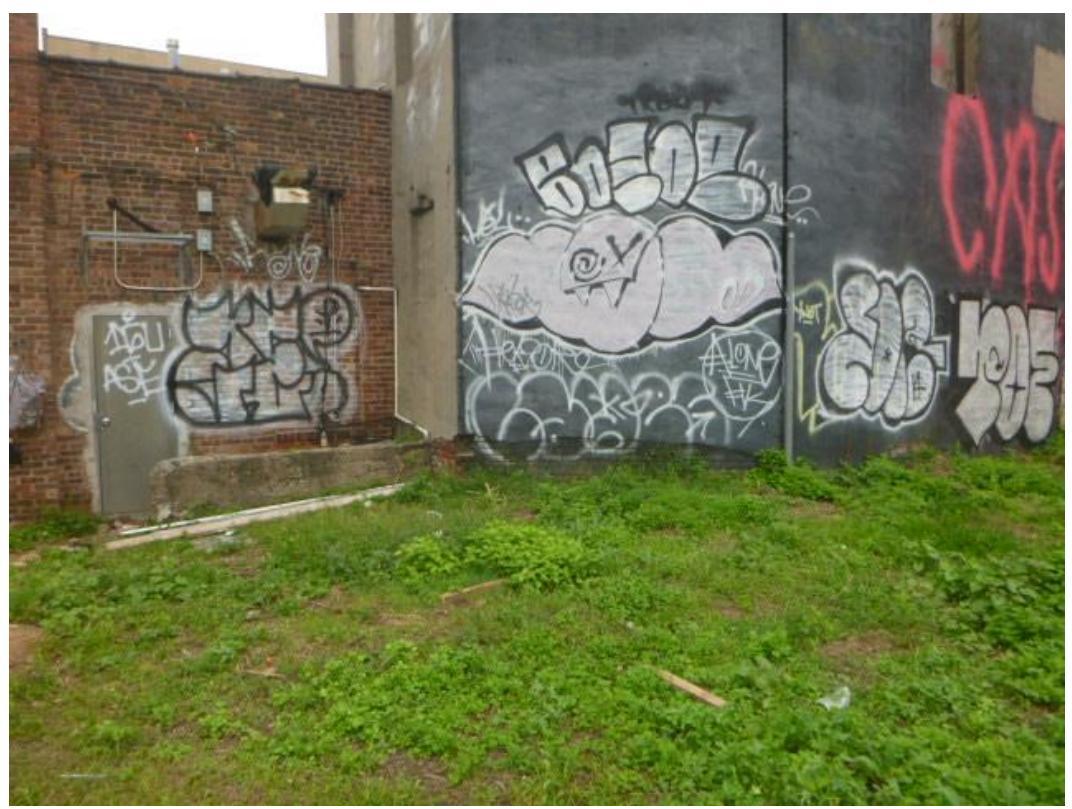
Trench 02 was placed along the northern boundary of Lot 4 near its intersection with the backwall of the building in Lot 16 fronting Putnam Avenue and the two-story brick building fronting Downing Street (Map 04) (Image 03). The trench measured 12' by 6' and was oriented roughly north/south instead of east/west to avoid impacting the structural integrity of the surrounding buildings (Image 04).

Image 03: Location of Trench 02, pre-excavation (looking north).

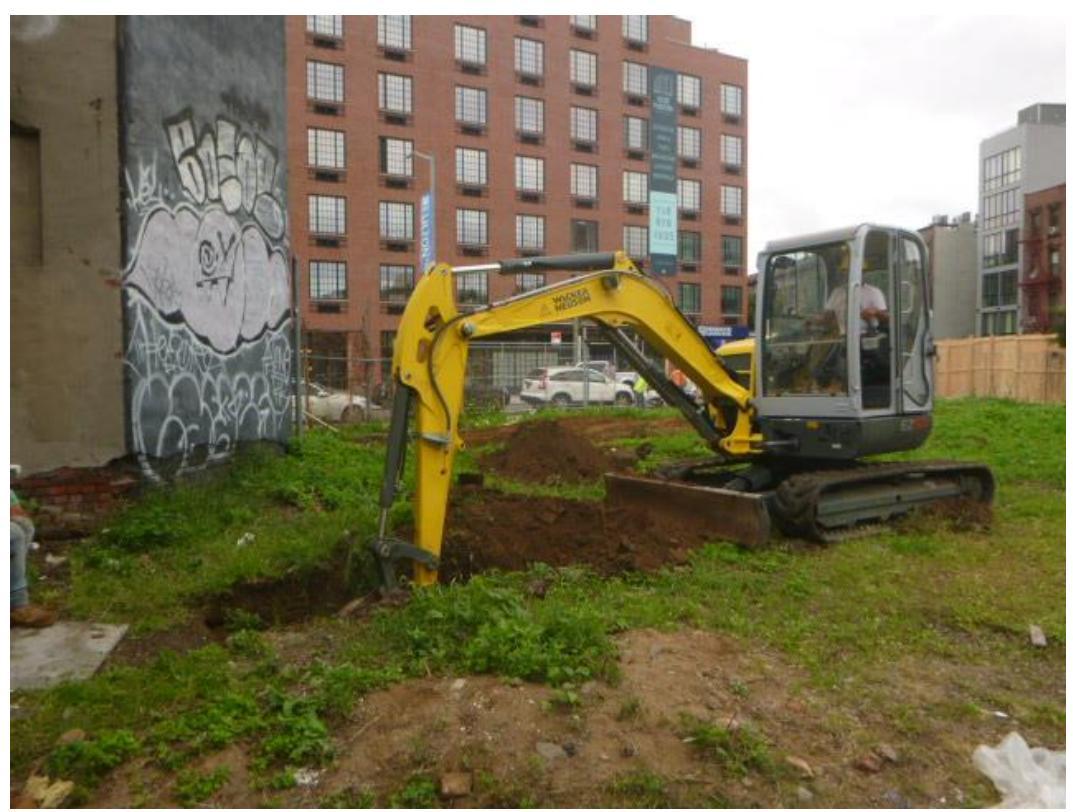
Image 04: Excavation in progress, Trench 02 (looking east).

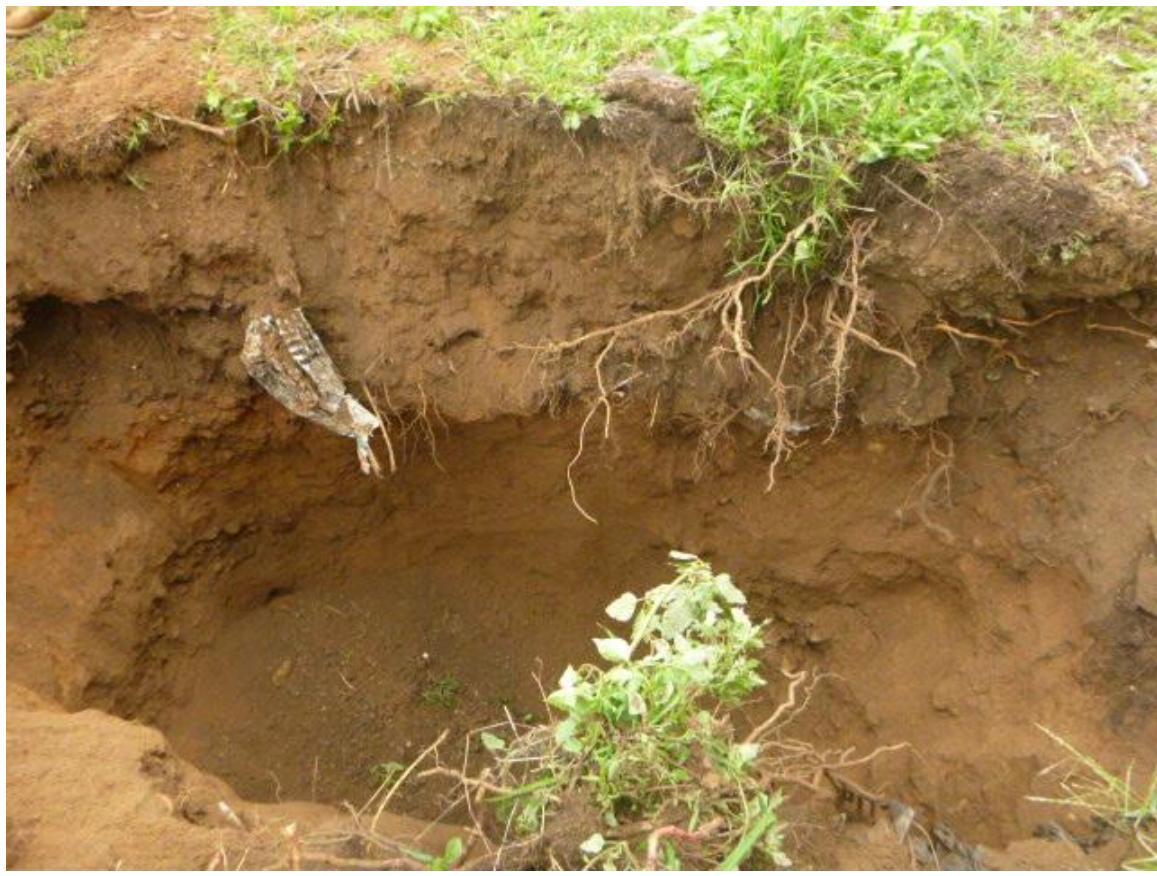
Similar to Trench 01, Trench 02 featured a fill layer with demolition materials over sterile subsoil (Table 03) (Image 05). The fill in this trench was shallower than in Trench 01 and only one subsoil layer was encountered. No significant cultural resources were encountered during the excavation of Trench 02.

Image 05: Stratigraphic profile, west wall – Trench 02.

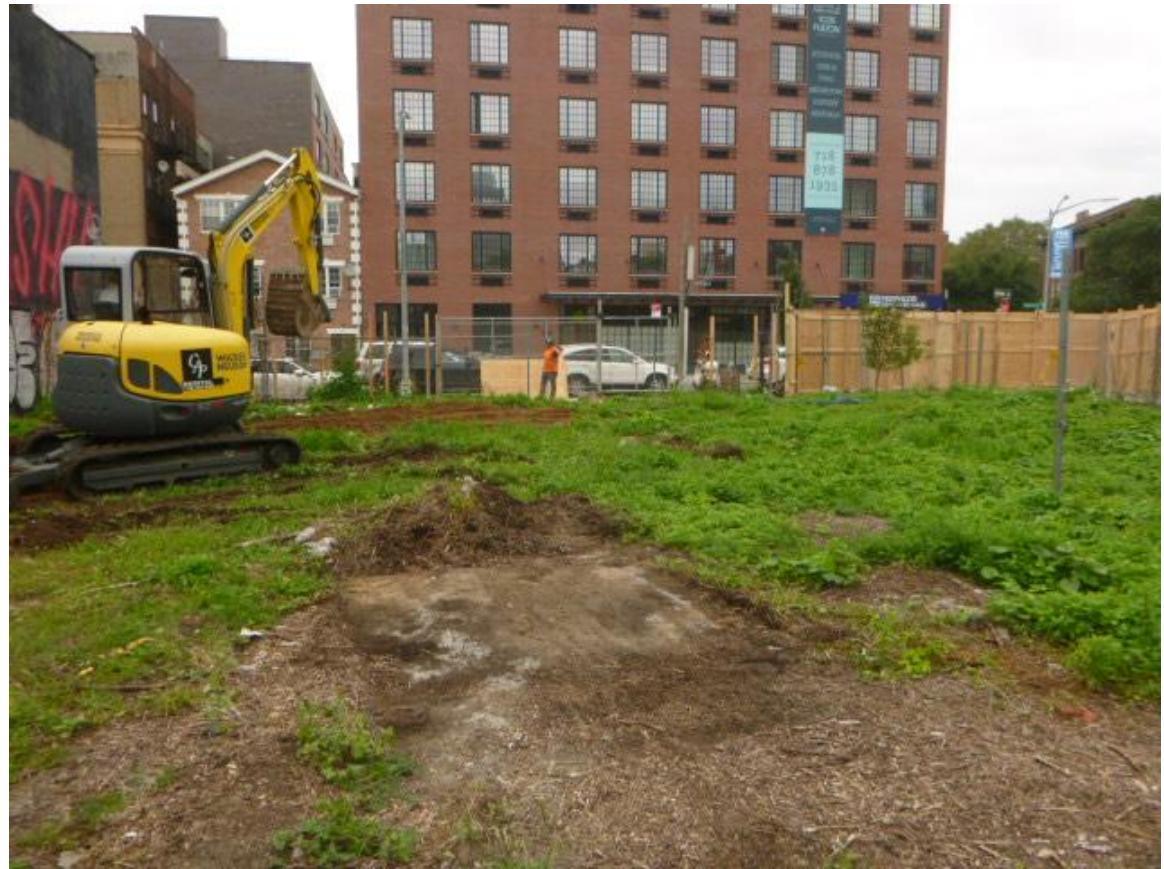
The placement of Trench 03 differed slightly from the method utilized in the other four exploratory trenches in the APE. Instead of being placed along the northern edge of what would have been the rear yard area of Lot 3, Trench 03 was placed along its southern boundary (Map 04). This location corresponds roughly to the middle of the project area and does not abut any existing structures (Image 06).

Image 06: Interior of APE and location of Trench 03, pre-excavation (looking east).

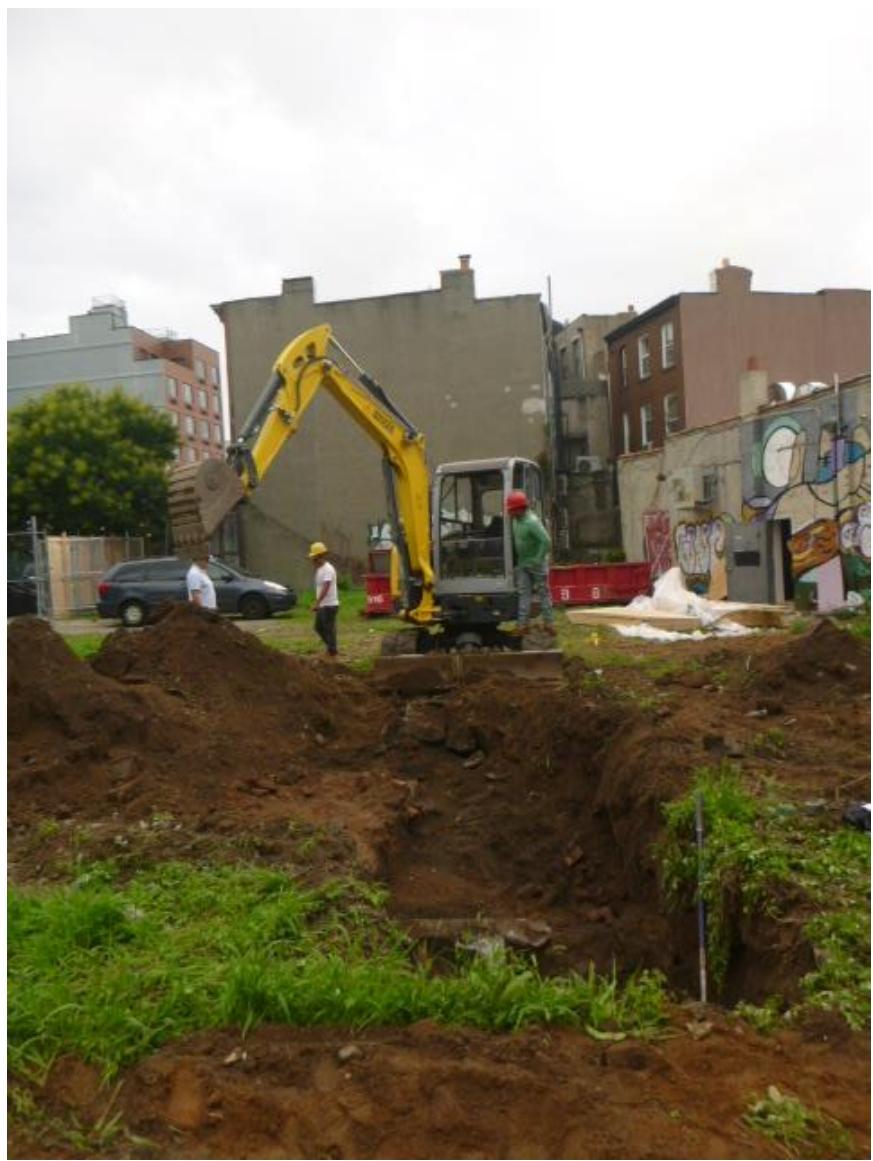
The planned dimensions for Trench 03 in the AWP was 16.25' by 12', although due to the discovery of Feature 01, only 12' by 5.67' of the trench was ultimately excavated. Upon discovery of Feature 01, horizontal excavation of Trench 03 ceased (Image 07).

Image 07: Dimensions of Trench 03 (looking west).

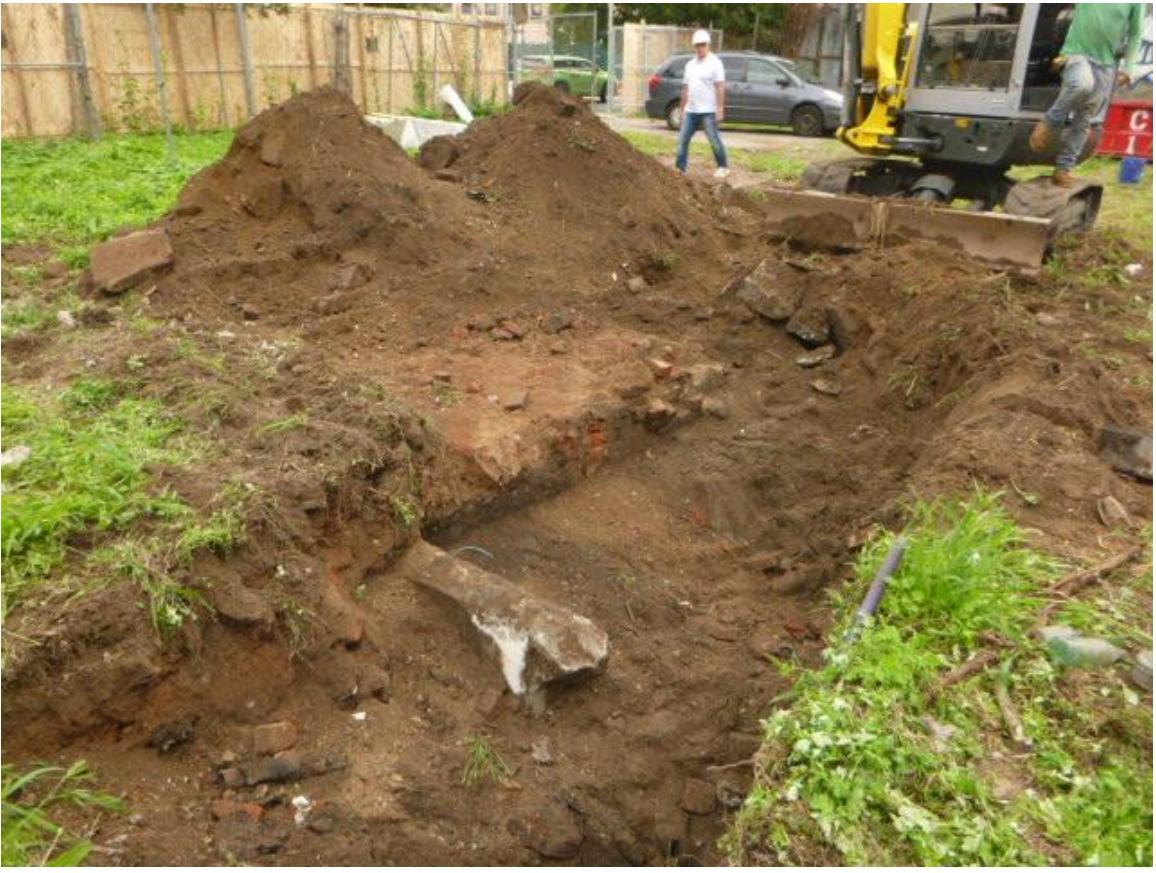
Feature 01, an intact segment of brick wall, was encountered in the southern wall of Trench 03 (Image 08). Prior to discovery of the feature, a mix of historic and modern materials were uncovered in the backdirt pile and observed in situ in the northern wall of the trench. No discrete or intact historic deposits were encountered, however. The demolition fill surrounding Feature 01 was a mix of nineteenth- and twentieth-century materials, indicating a high level of modern disturbance to the area surrounding the brick wall.

Image 08: Discovery of Feature 01 in Trench 03 (looking west).

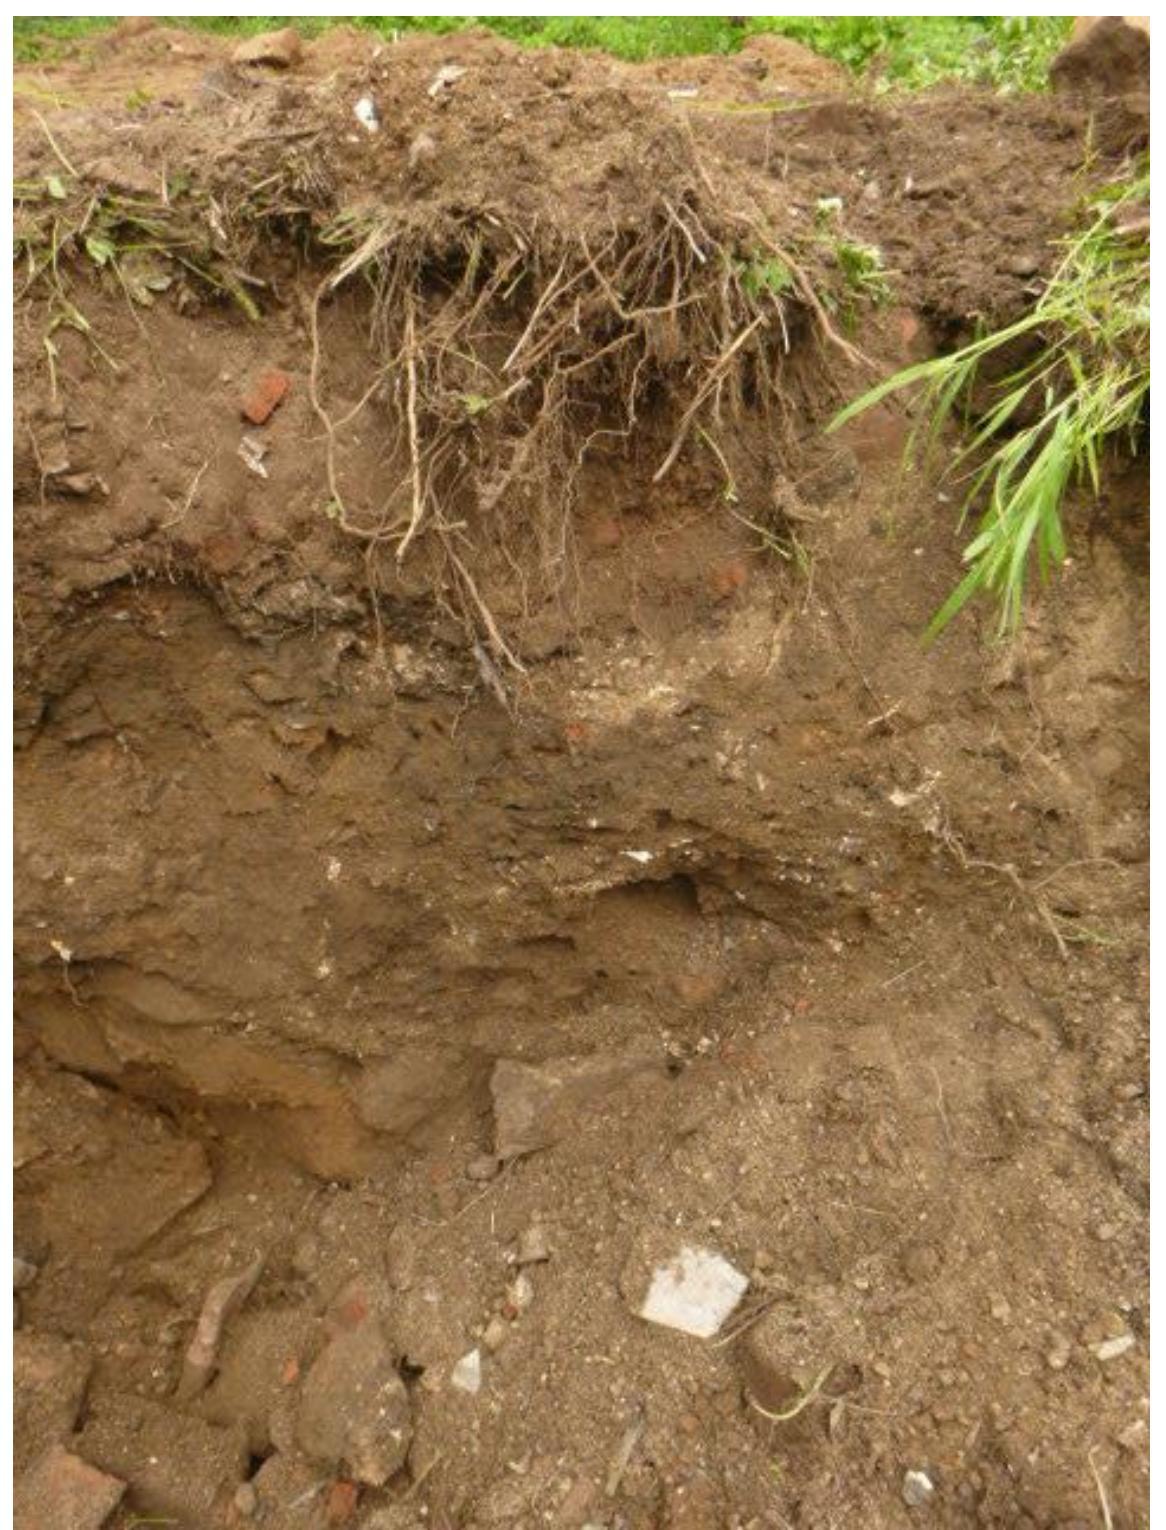
The stratigraphy of the northern wall of the trench consisted of slightly different fill and demolition layers than in any other exploratory trench (Table 04) (Image 09). Sterile subsoil was encountered underneath the demolition layer in the western third of the trench only. The bottom of the demolition layer was not observable in the remainder of the trench.

Image 09: Stratigraphic profile, east wall -- Trench 03.

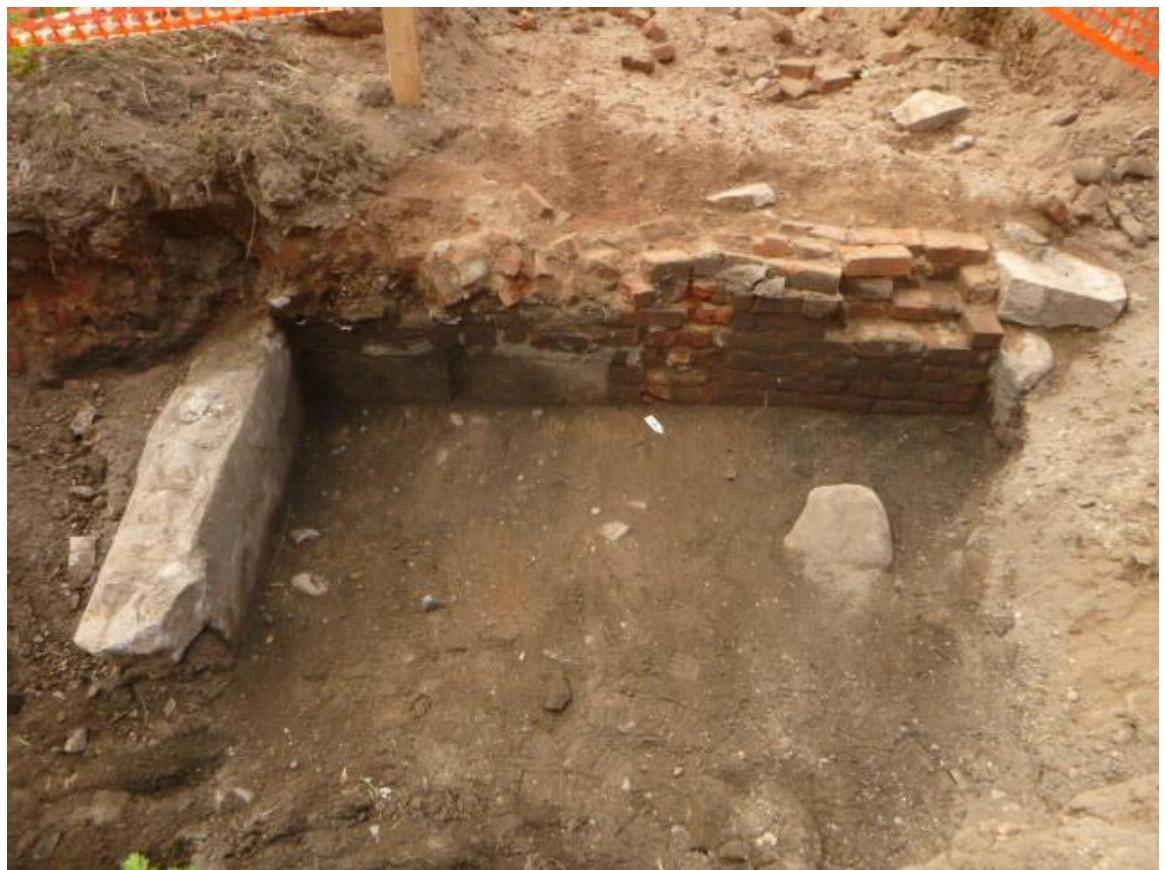
Feature 01 is a linear, east-west running brick wall that was encountered in the south wall of Trench 03 in Lot 3 at a depth of 67.83' NAVD 88 (1.1' bgs) during archaeological trenching (Images 10 and 11) (Figure 01). There are eight visible courses in the wall and the bricks are connected via a very friable, pale yellow mortar. Large, semi-angular foundational stones provide the western terminus of the brick wall. A long and thin north/south oriented cement footing or other foundational element provided the feature's eastern terminus. The Feature was excavated to a depth of 65.83' NAVD 88 (3.1' bgs). Horizontally, the Feature measures 9.34' from the eastern edge of the cement foundation element to the western edge of the foundation stones. The interior dimension of the feature, which corresponds to the actual brick portion, measures 7' in length.

Image 10: Feature 01 in Trench 03.

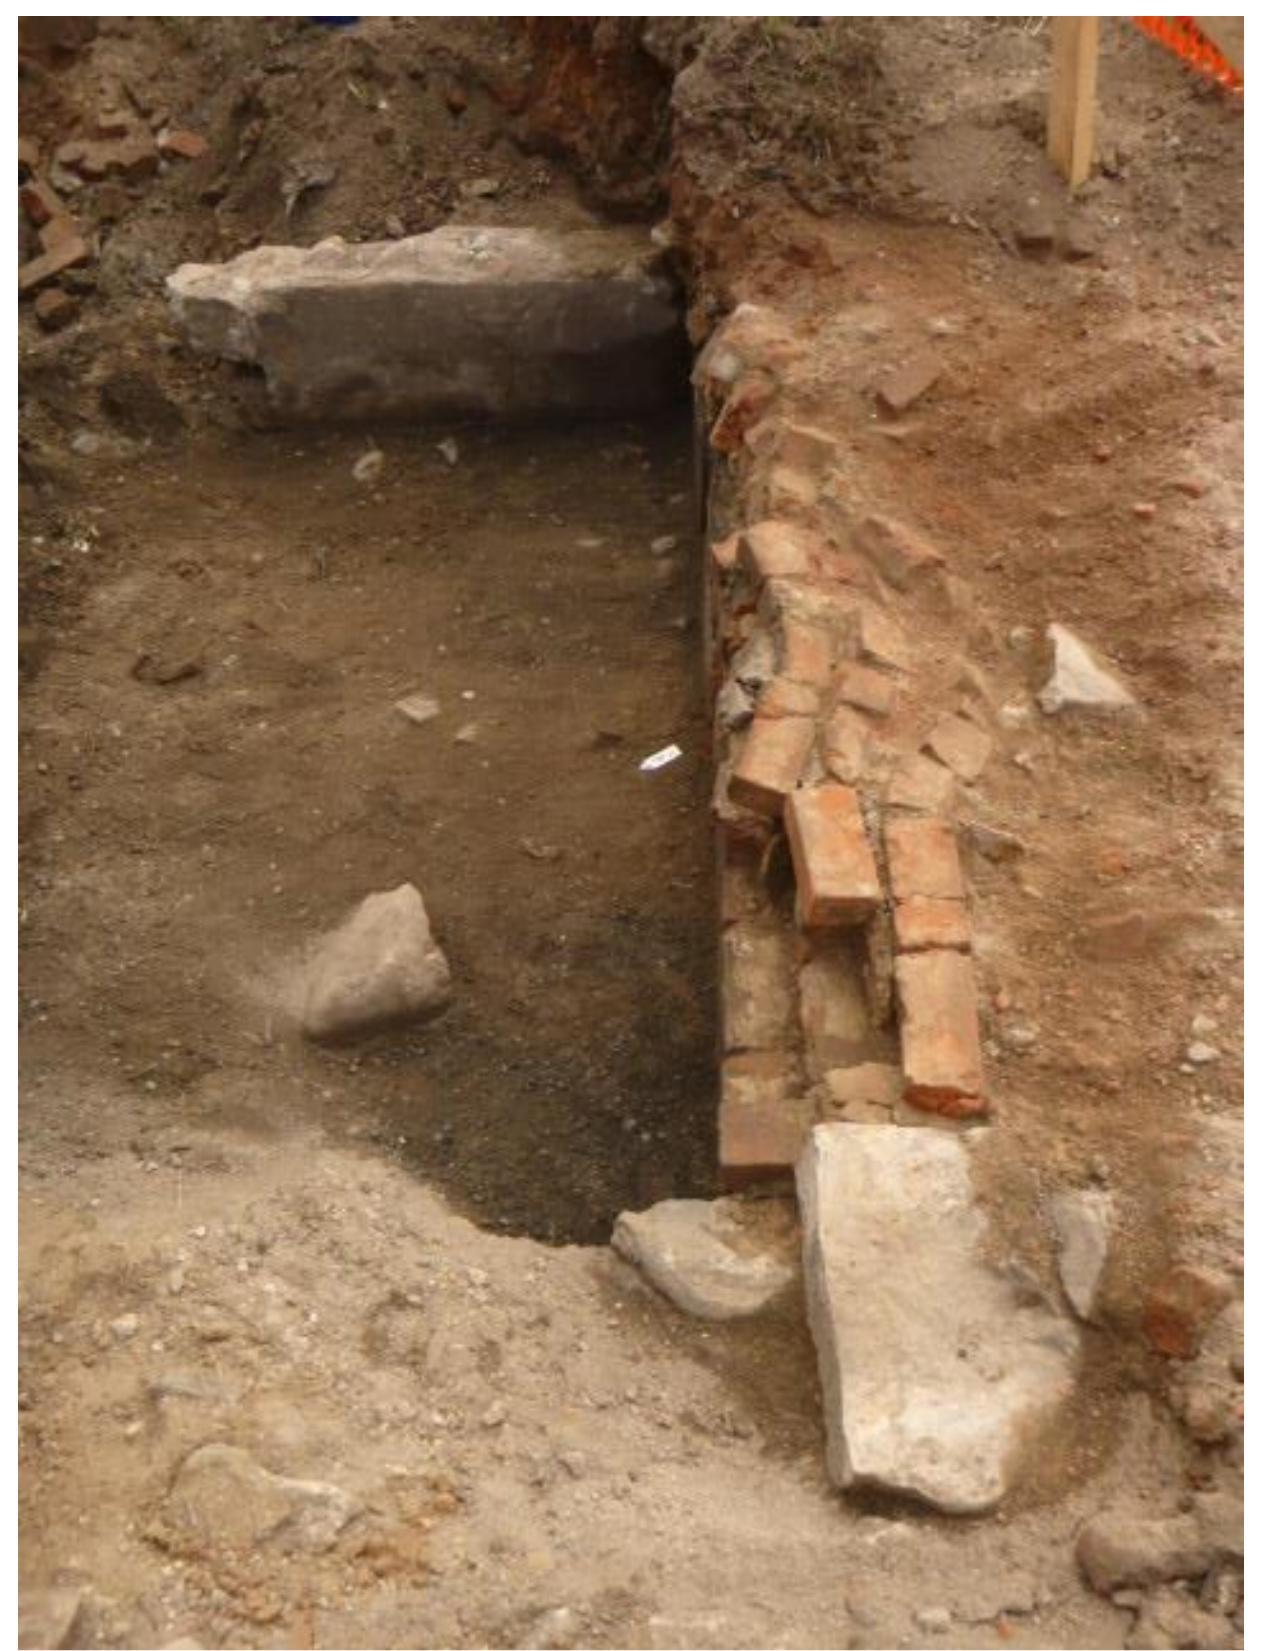
Image 11: Feature 01 in plan view.

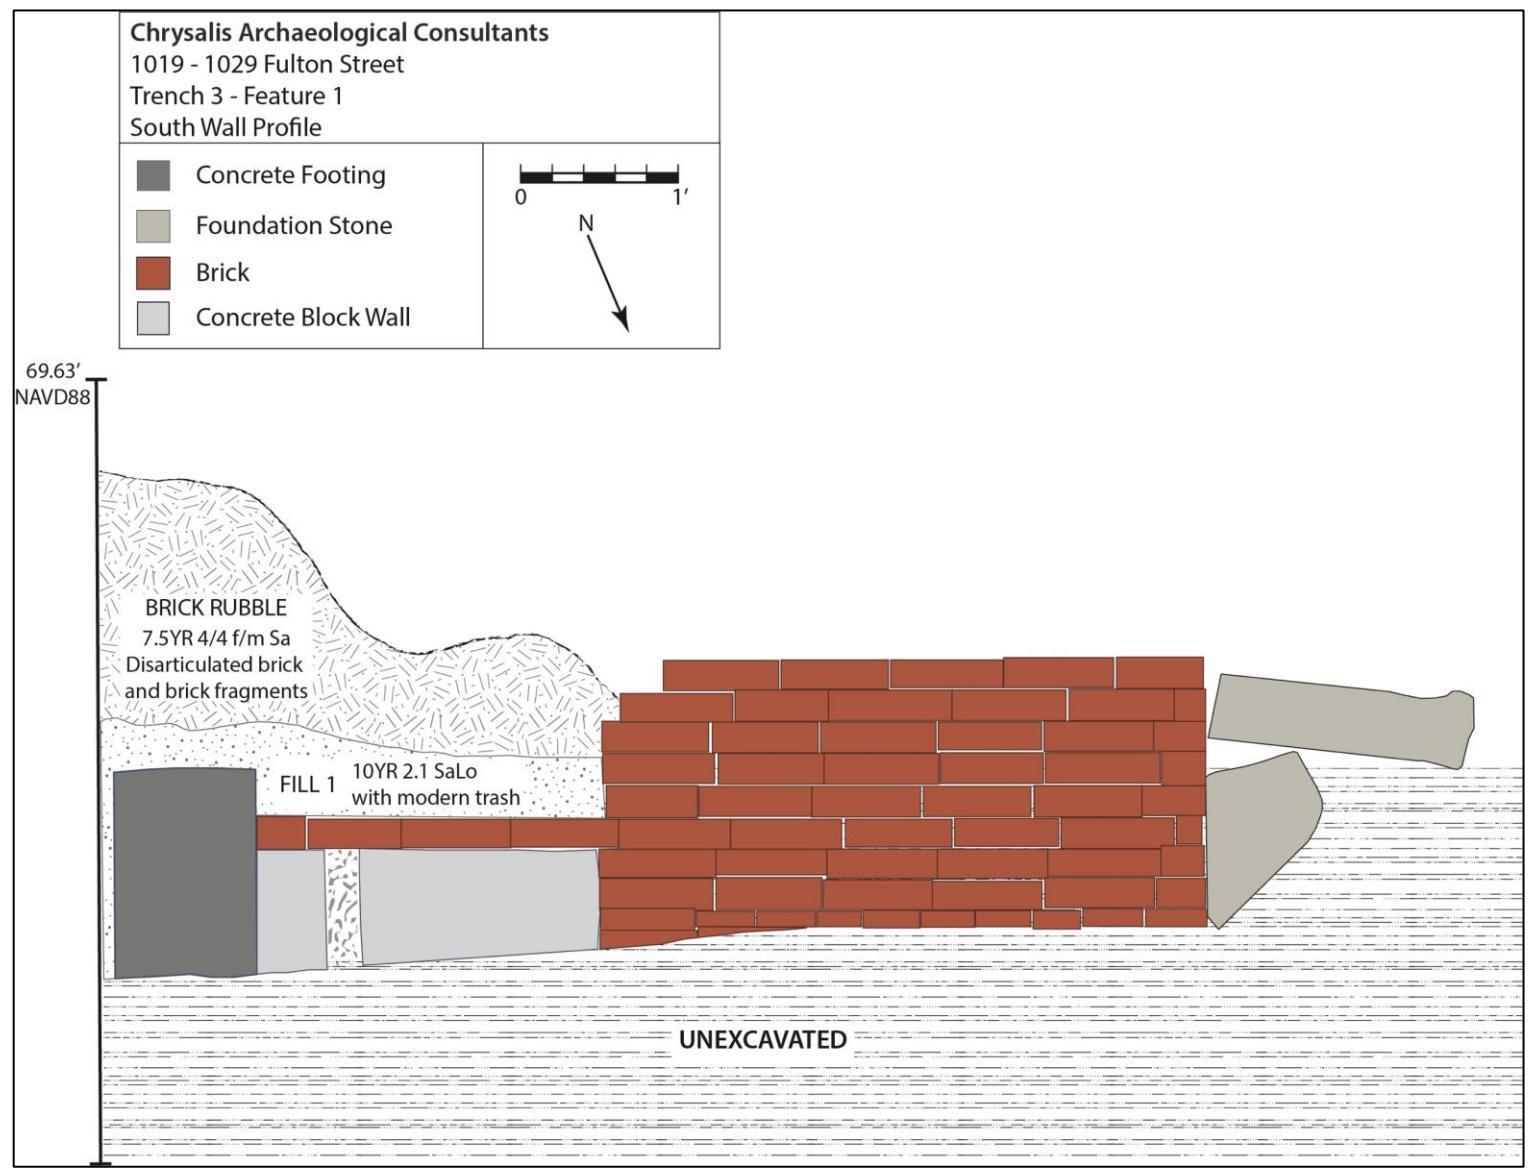
Figure 01: Feature 01 plan view.

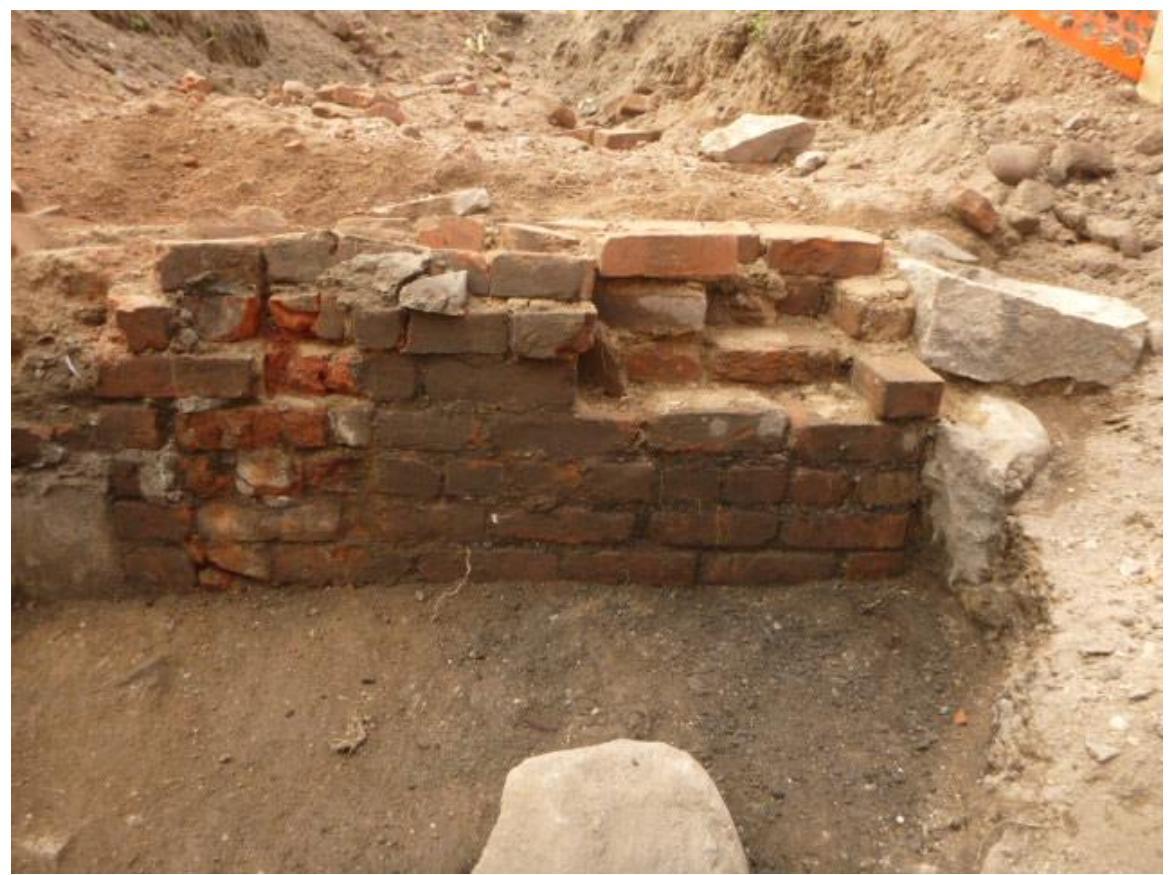
While no surficial evidence of the wall is extant, below ground the wall is intact in its western half (Image 12) and partially disarticulated in its eastern half (Image 13), probably the result of later additions (Figure 02). A concrete foundational element was found at the eastern edge of the brick wall and extending southwards at a depth of 67.14' NAVD 88 (Image 14). The concrete element abuts the brick wall, but does not otherwise interact with it, indicating that the element is of a later construction. The top of the concrete element appears to have been damaged due to above surface demolition in much the same way as the adjoining brick wall.

Image 12: Intact western half of Feature 01 (looking south),

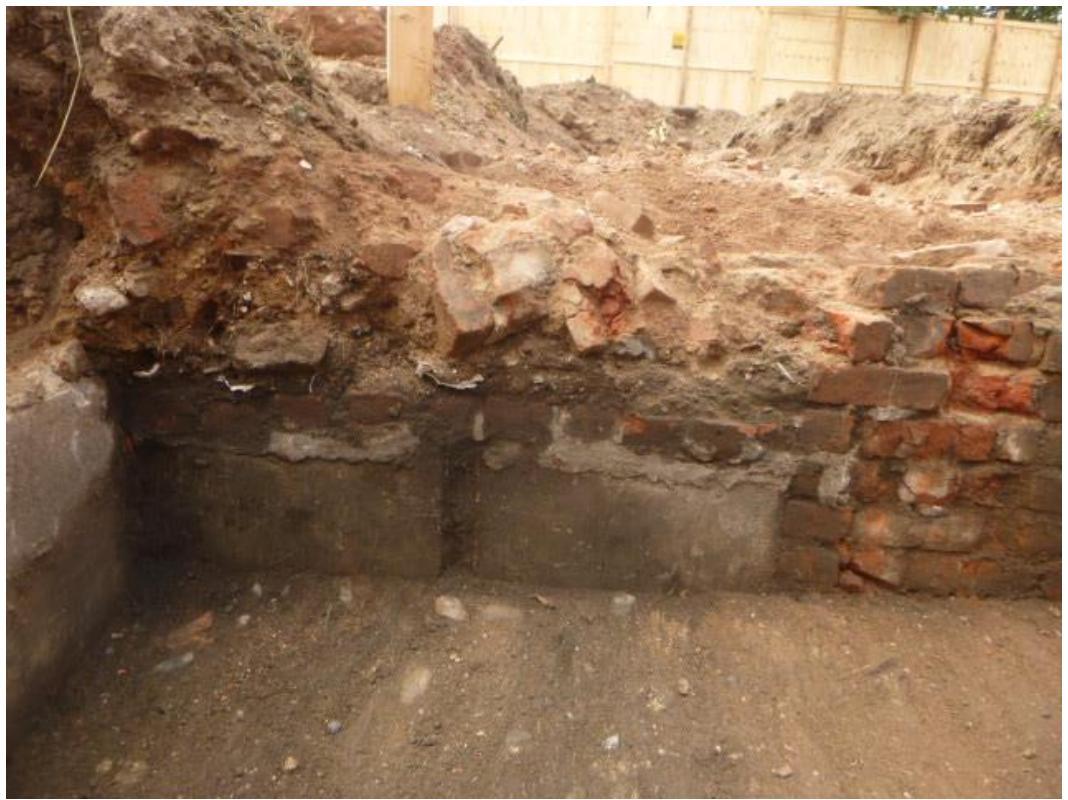
Image 13: Disarticulated eastern half of Feature 01 (looking south).

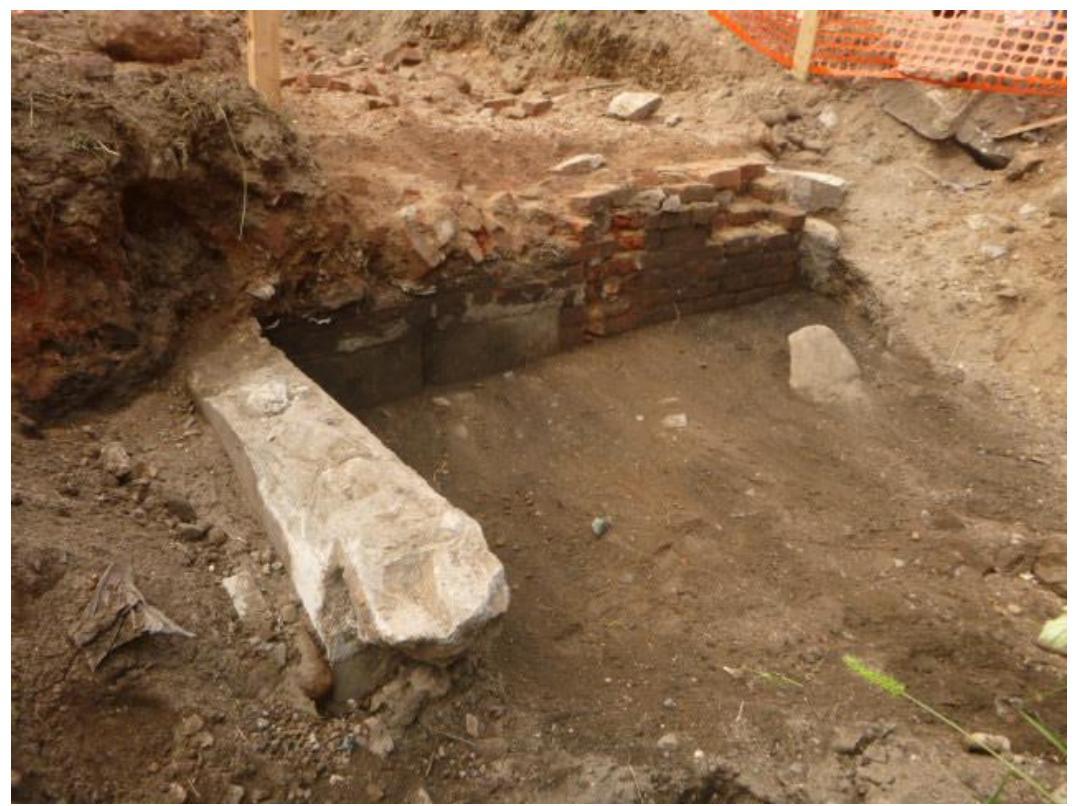
Image 14: Close up of the concrete footing in Feature 01 (Looking southwest).

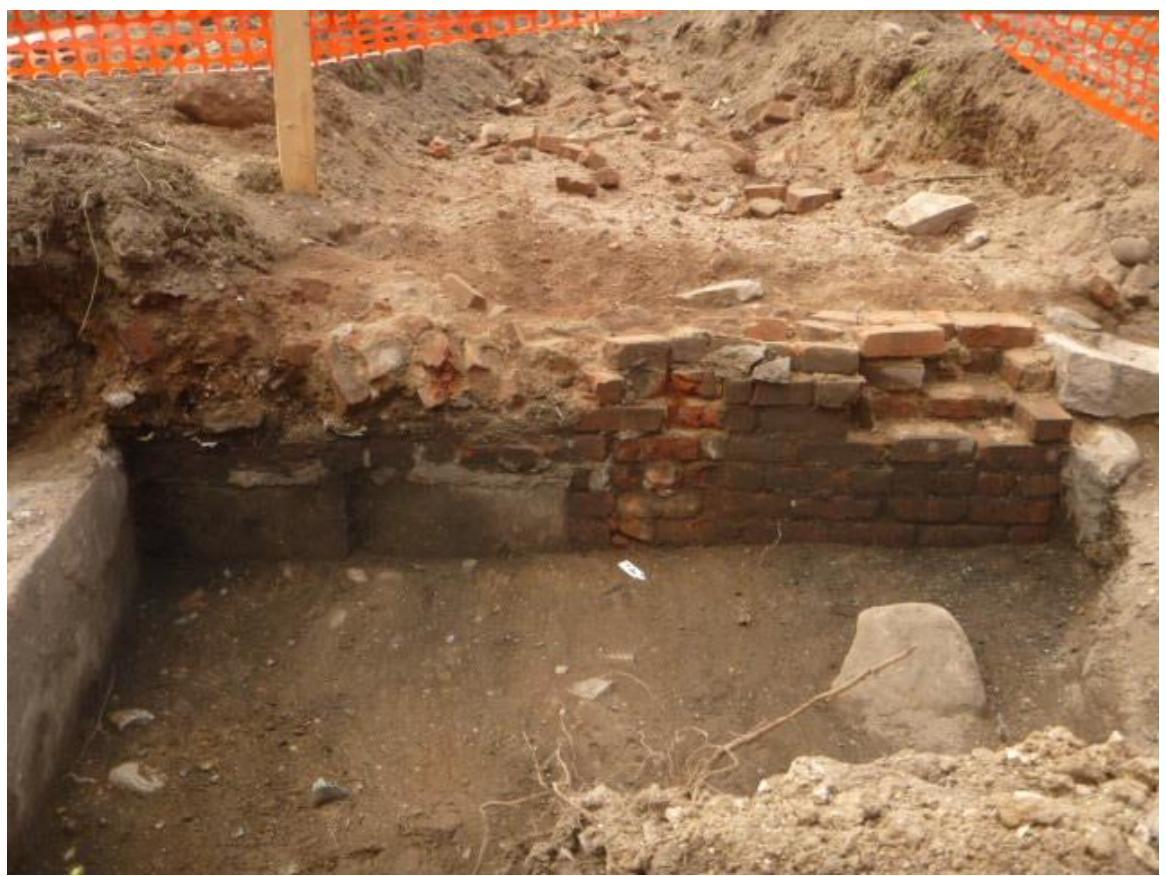
Image 15: Close-up of Feature 01 in profile.
