Phase IB Archaeological Monitoring for Housing Preservation and Development of 1019-1029 Fulton Street and 18-22 Putnam Avenue, Block 1991, Lots 1-7, 16, and 106, Brooklyn (Kings), New York (DOB: 321385880) Project

Prepared by: Leah Mollin-Kling, MAA, R.P.A., Alyssa Loorya, Ph.D., R.P.A. Chrysalis Archaeological Consultants, Inc.

October 2019

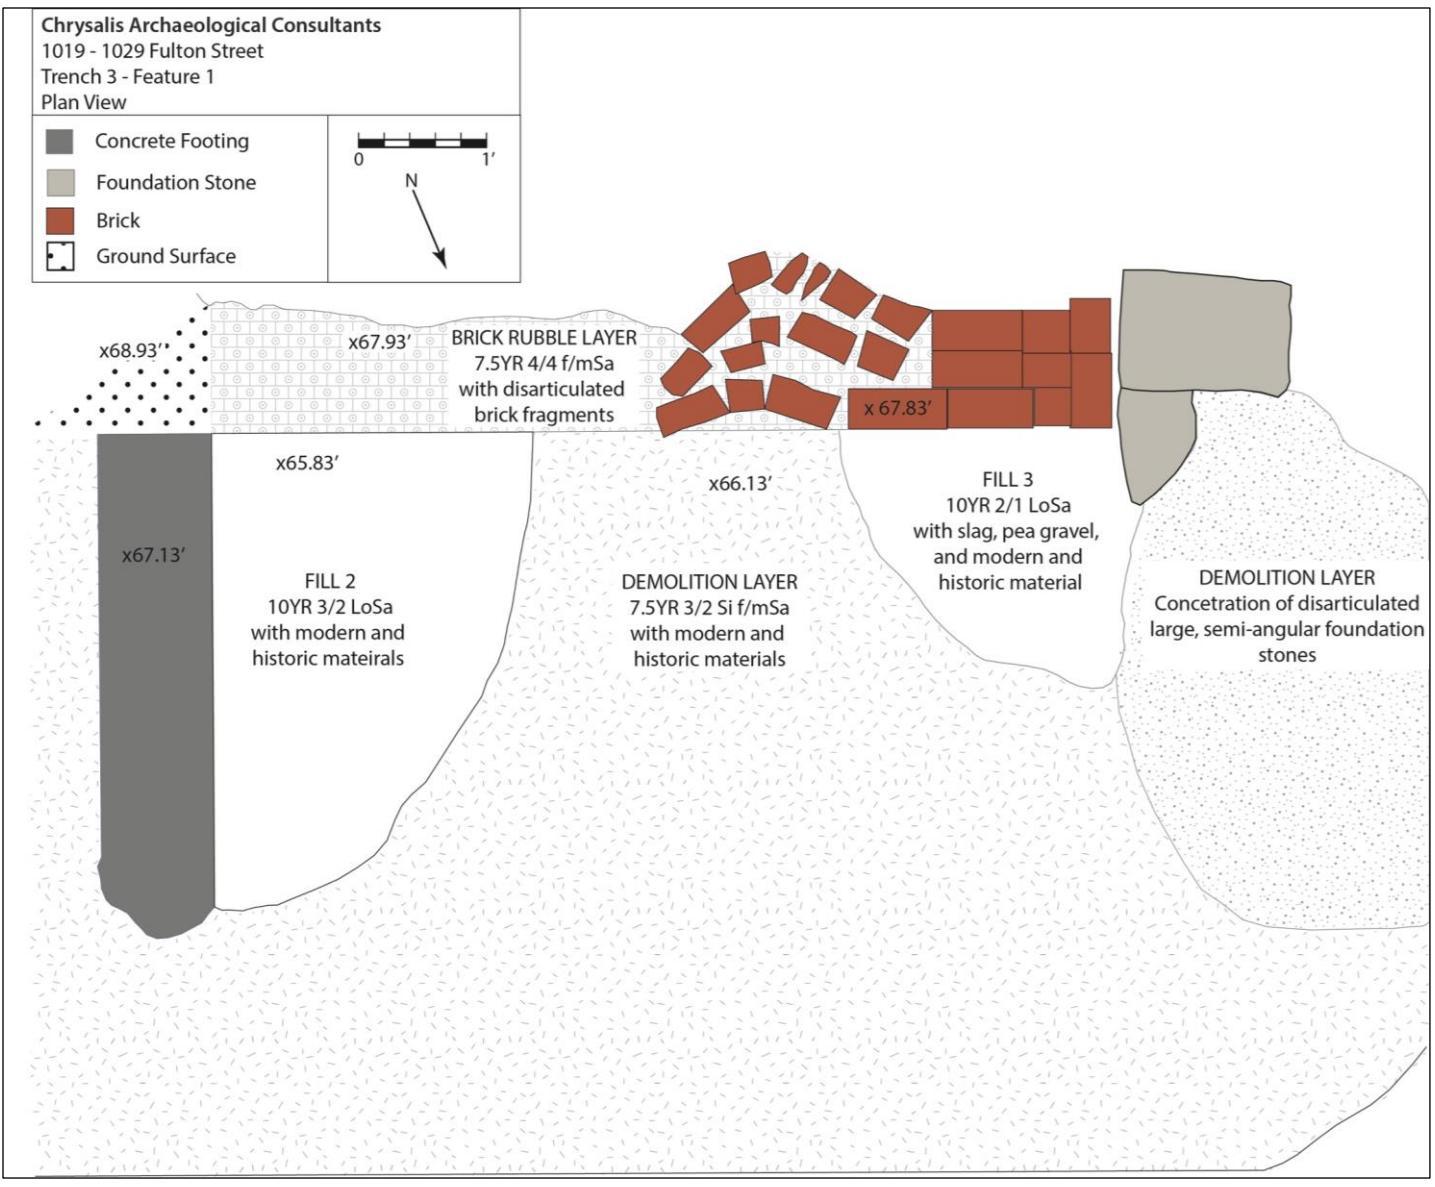
Figure 02: Feature 01 profile (south wall of Trench 03).

No intact stratigraphy or undisturbed historical deposits were found during Phase IB archaeological testing for the Project, resulting in no artifacts being retained for analysis. However, during the archaeological assessment of Feature 01, a near-complete embossed beer bottle was noted in the Demolition Layer associated with part of the feature and yields soft dates for the historical components of this fill layer (Figure 02).

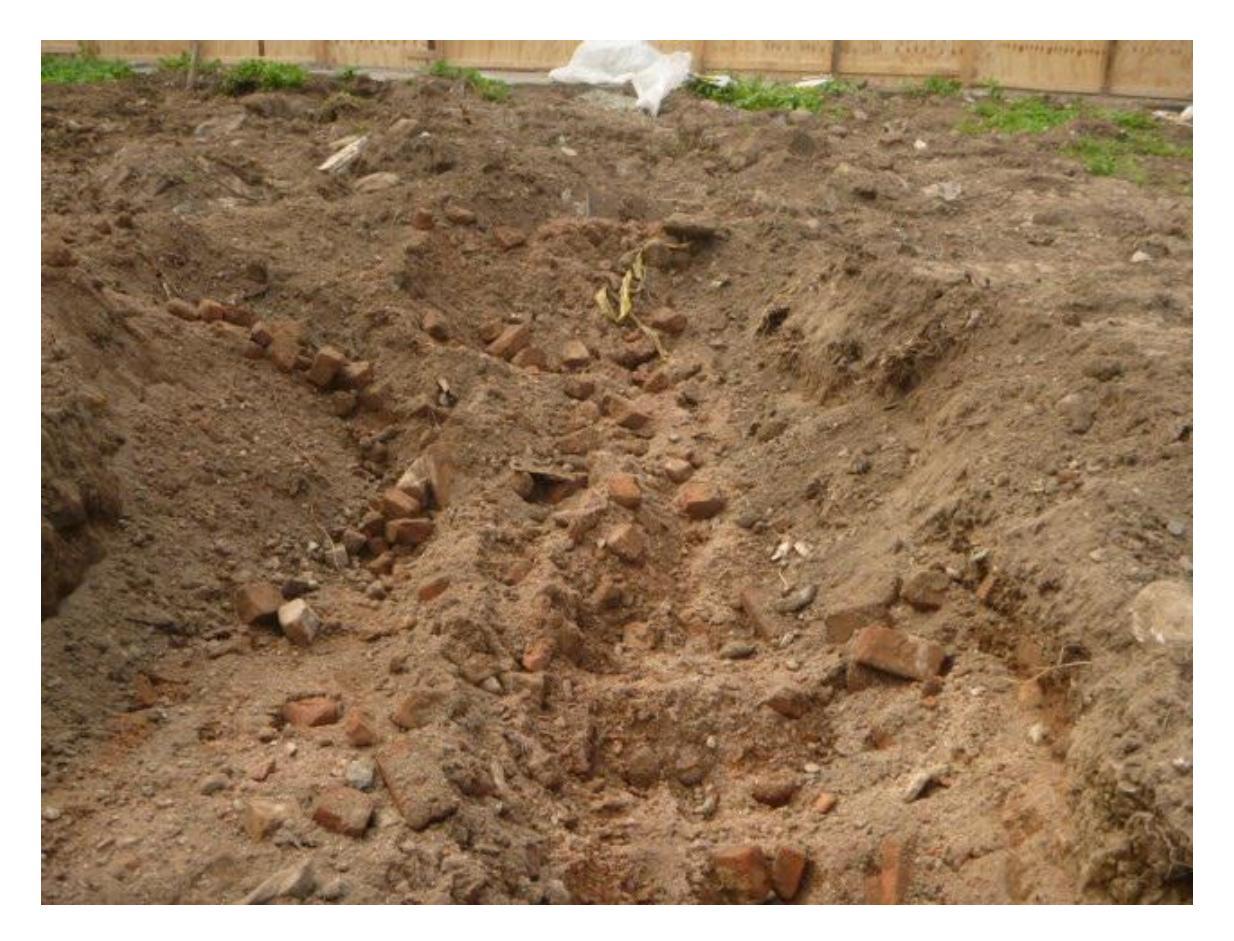
Based on the orientation of the wall relative to the dimensions of Lot 3 and the existing row houses to the west of the project area, it appears as though Feature 01 is a remnant of the foundation of the house and/or basement that once stood on the lot. Exploratory scrapping via backhoe to the south of the eastern edge of Feature 01 yielded a concentration of brick rubble in line with the brick wall, although no articulated section was found (Image 16). It appears as though Feature 01 is the only remaining portion of the brick foundation.

Image 16: Rubble layer south of Feature 01.

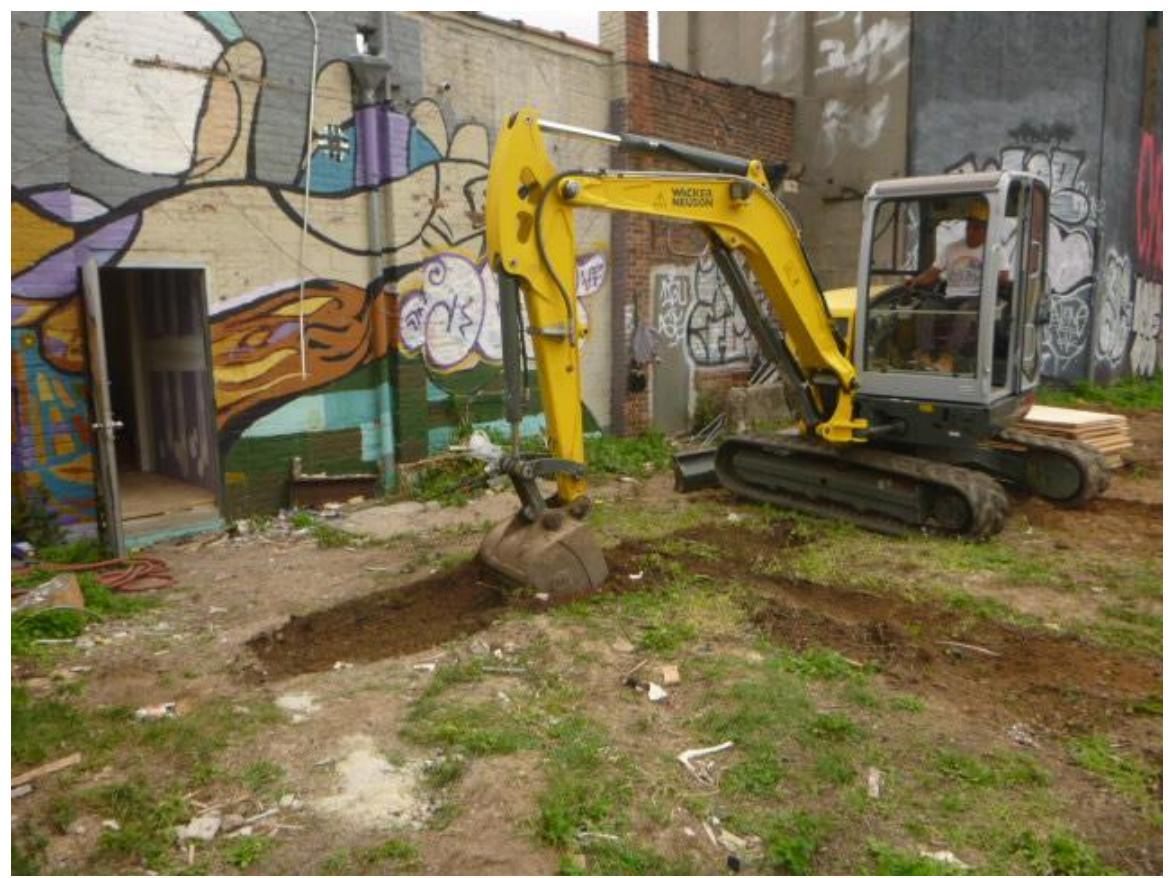
Trench 04 was placed in the rear yard of Lot 5 and 7.8' south of the southern wall of the one-story building in Lot 16 and west of Trench 02 (Map 04) (Image 17). An extremely compact layer of gravel fill was encountered directly underneath the topsoil across the entirety of the trench, which appears to correspond to the gravel-topped driveway element that exists at the site's gated entrance (Image 18). The gravel fill layer was slightly less compact to the north and, as the backhoe's flatheaded bucket attachment had trouble breaking through the layer, only half of the trench (4.5' in width) could be excavated. The excavated dimensions of the trench were 4.5' by 13' (Image 19).

Image 17: Location of Trench 03, excavation in progress (looking north).

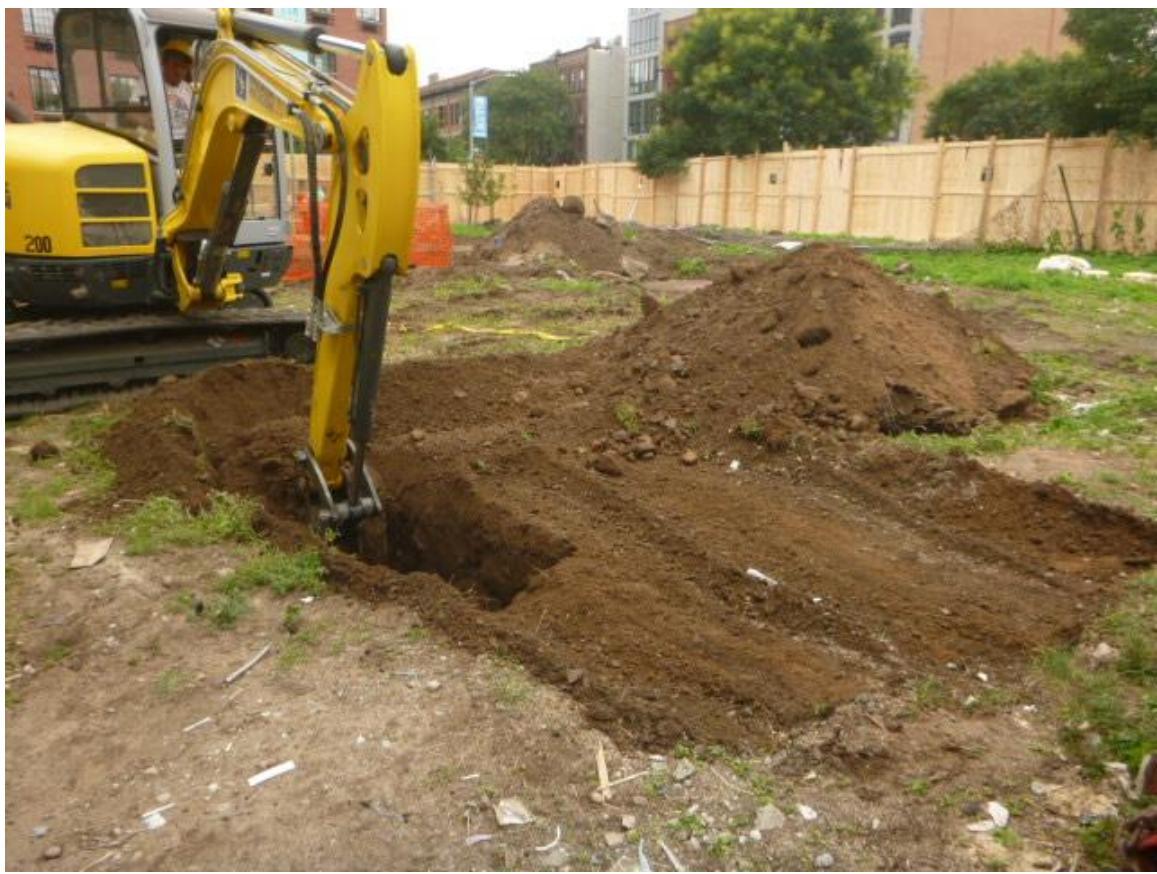
Image 18: Compact gravel layer impacting the excavation of Trench 04 (looking southeast).

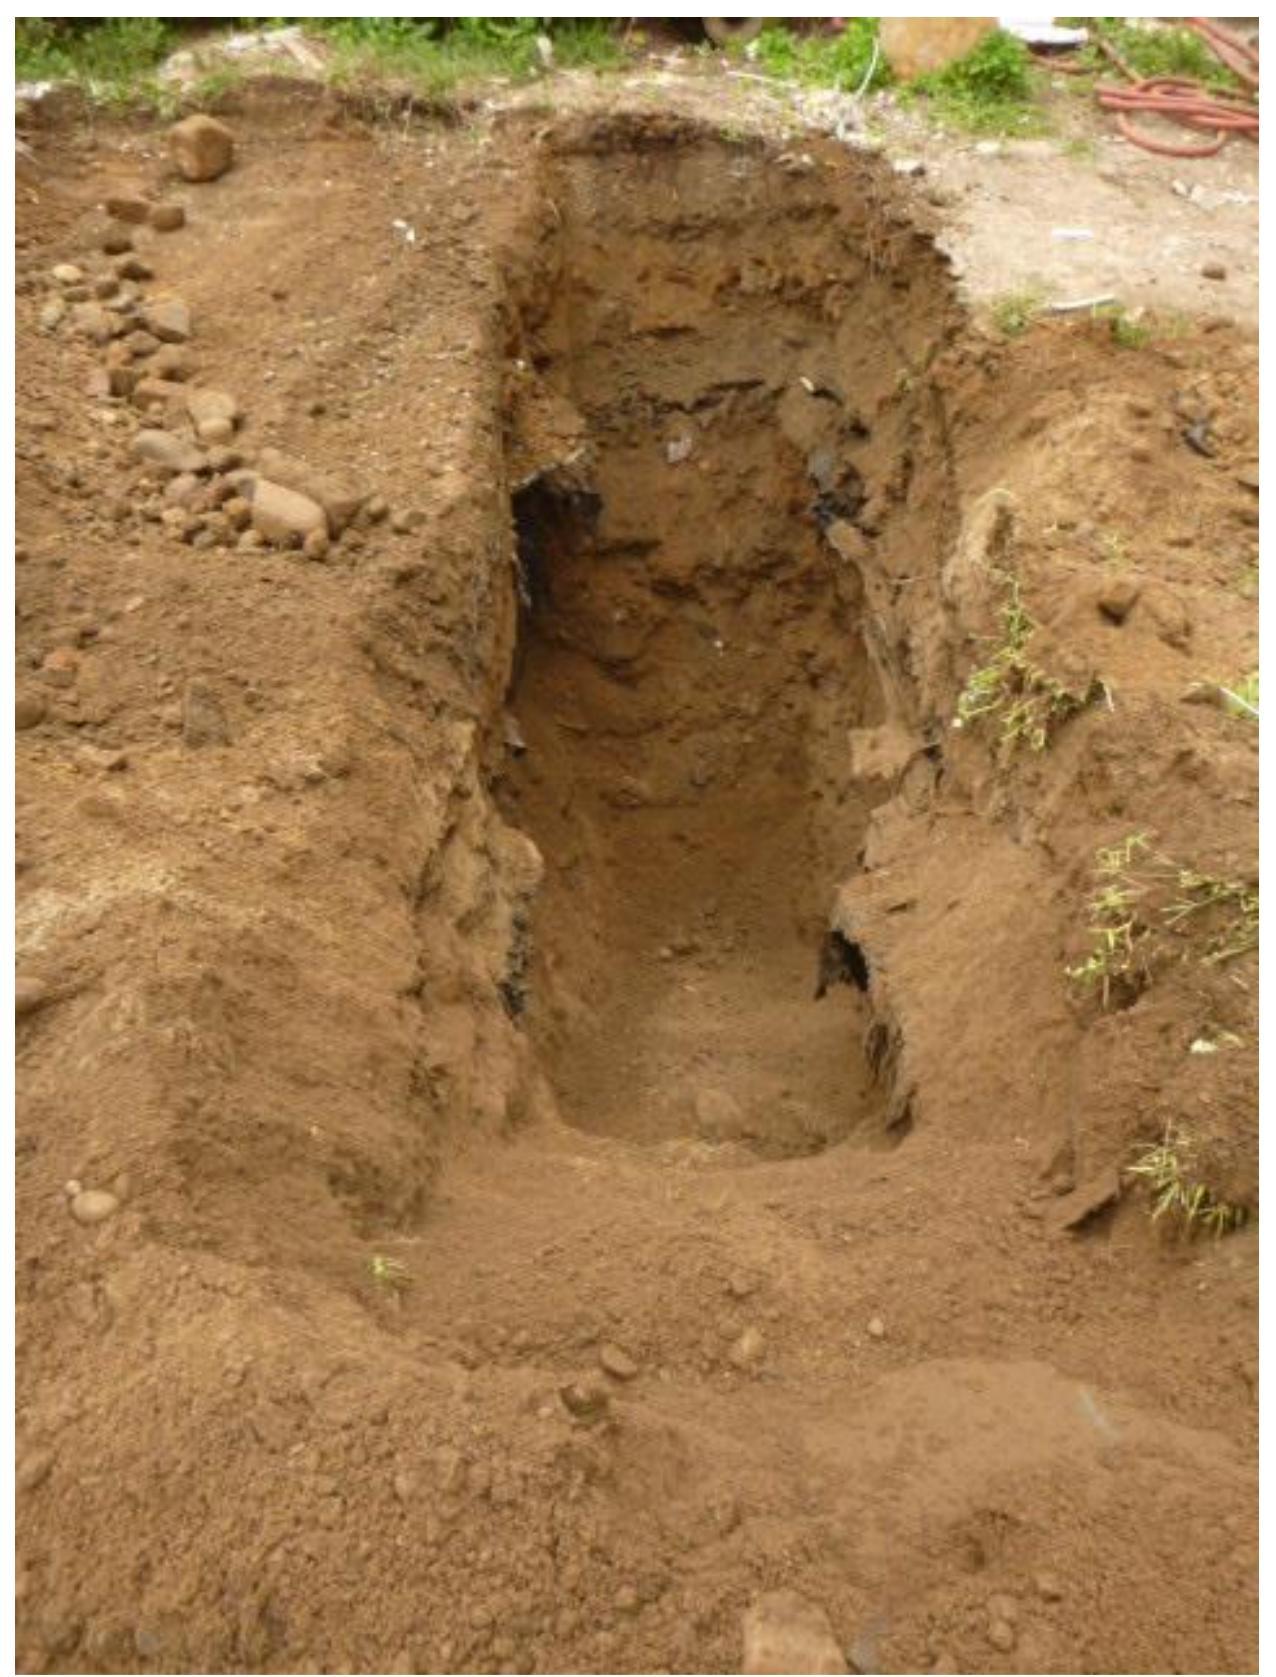
Image 19: Trench 04, post-excavation (looking west).

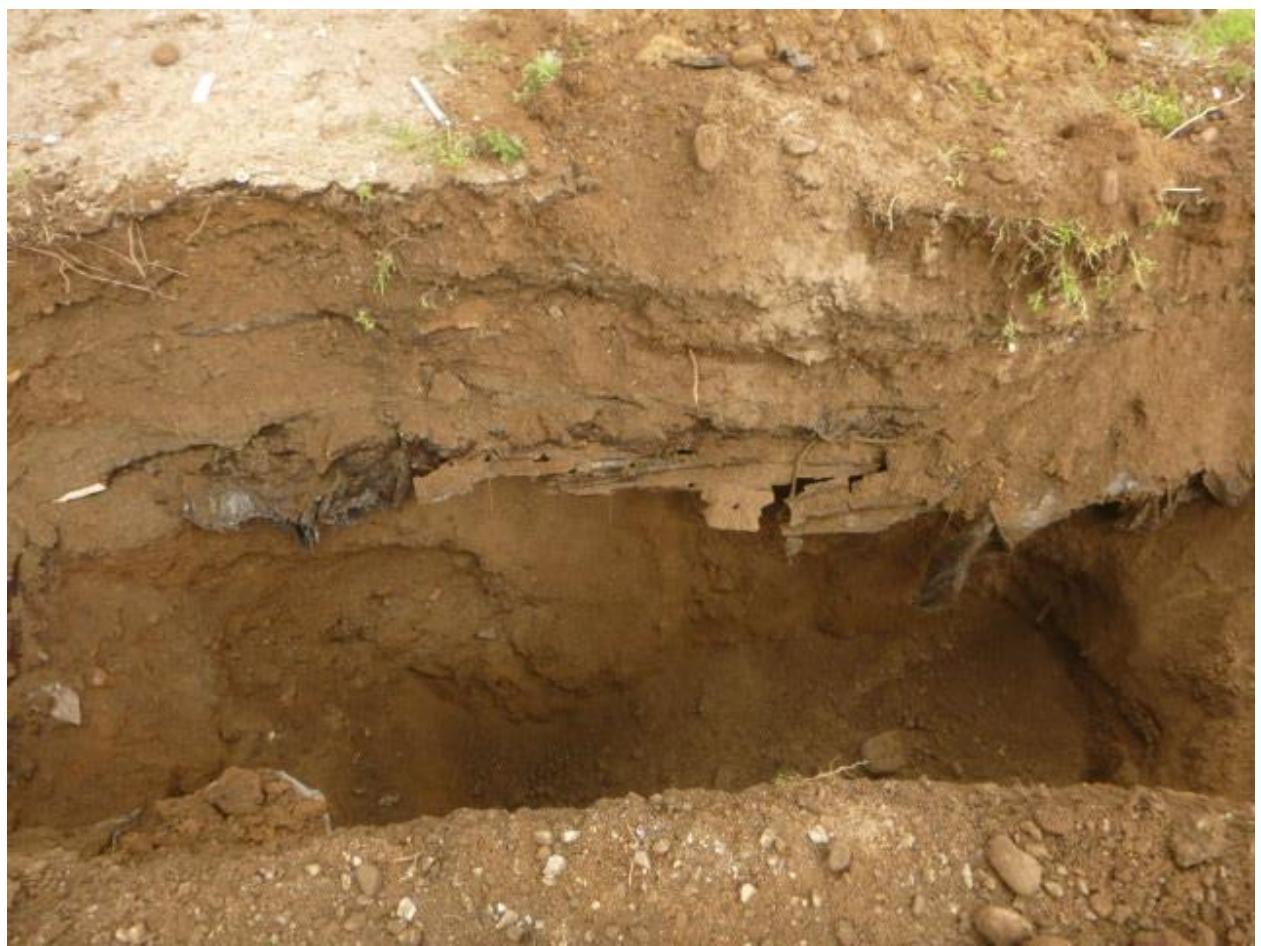
Several layers of fill and fill mixed with redeposited subsoil were found in the stratigraphic profile of Trench 04 (Table 05) (Image 20). Subsoil layers not extant in other trenches in the APE were also encountered beneath the fill layers, suggesting that the level of disturbance in this area of the APE is greater. No significant archaeological resources were encountered during the excavation of Trench 04.

Image 20: Stratigraphic profile, north wall – Trench 04.

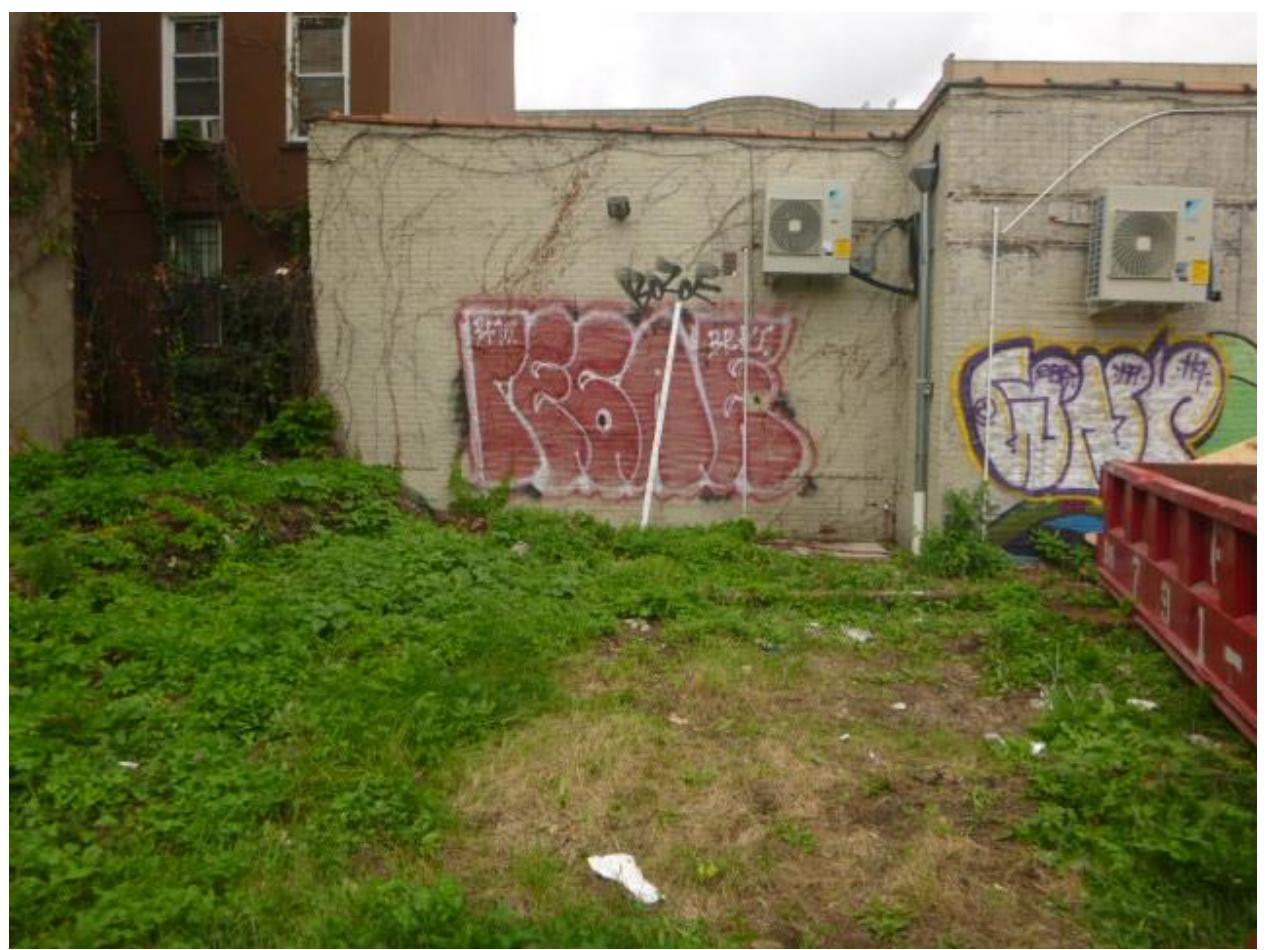
Trench 05 was excavated in what would have been the rear yard of Lot 106 (Map 04) (Image 21). The east/west oriented trench was placed 4' south of the southern wall of the building in Lot 16 and measured 12' by 8' (Image 22).

Image 21: Location of Trench 05, pre-excavation (looking north).

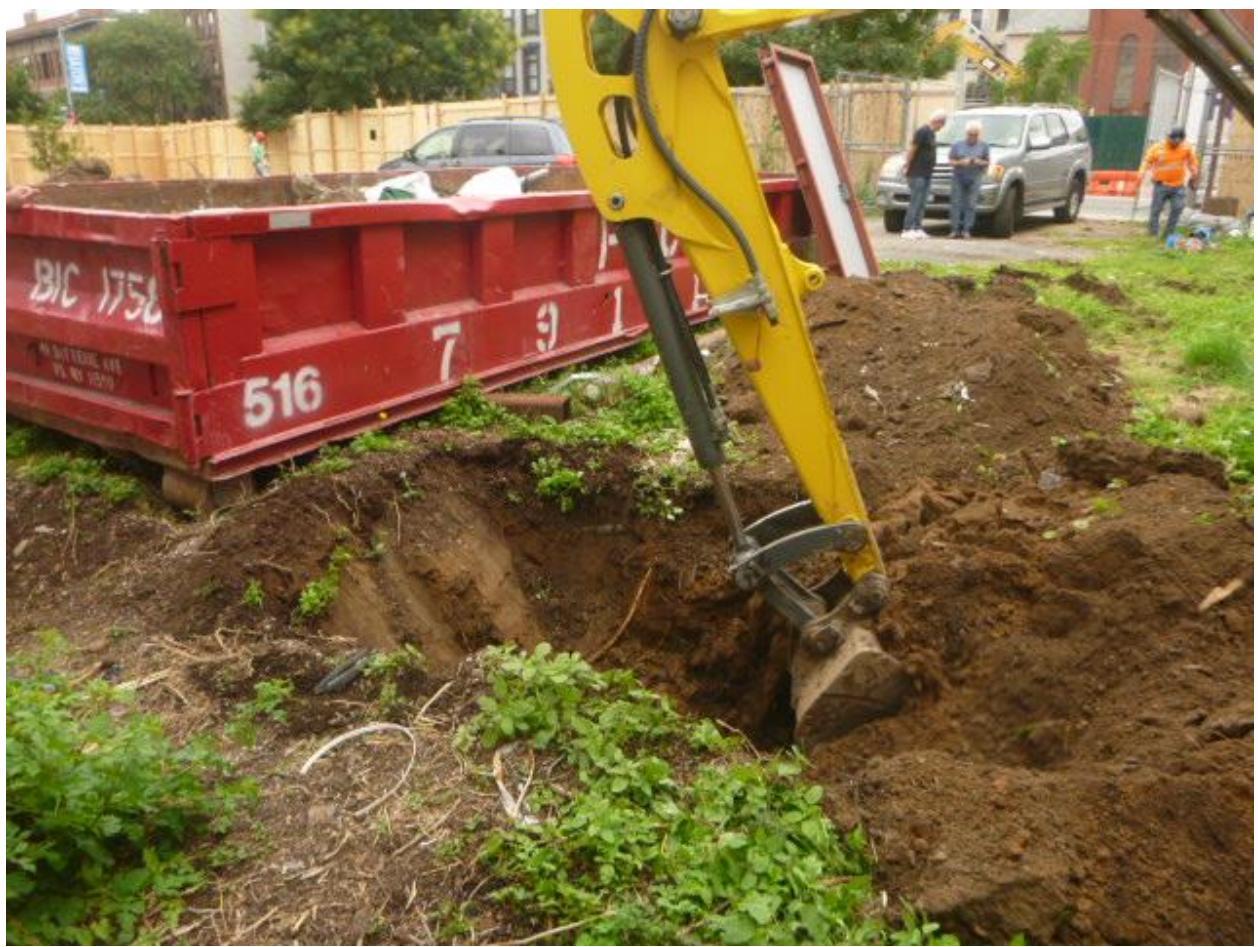
Image 22: Trench 05, excavation in progress (looking south).

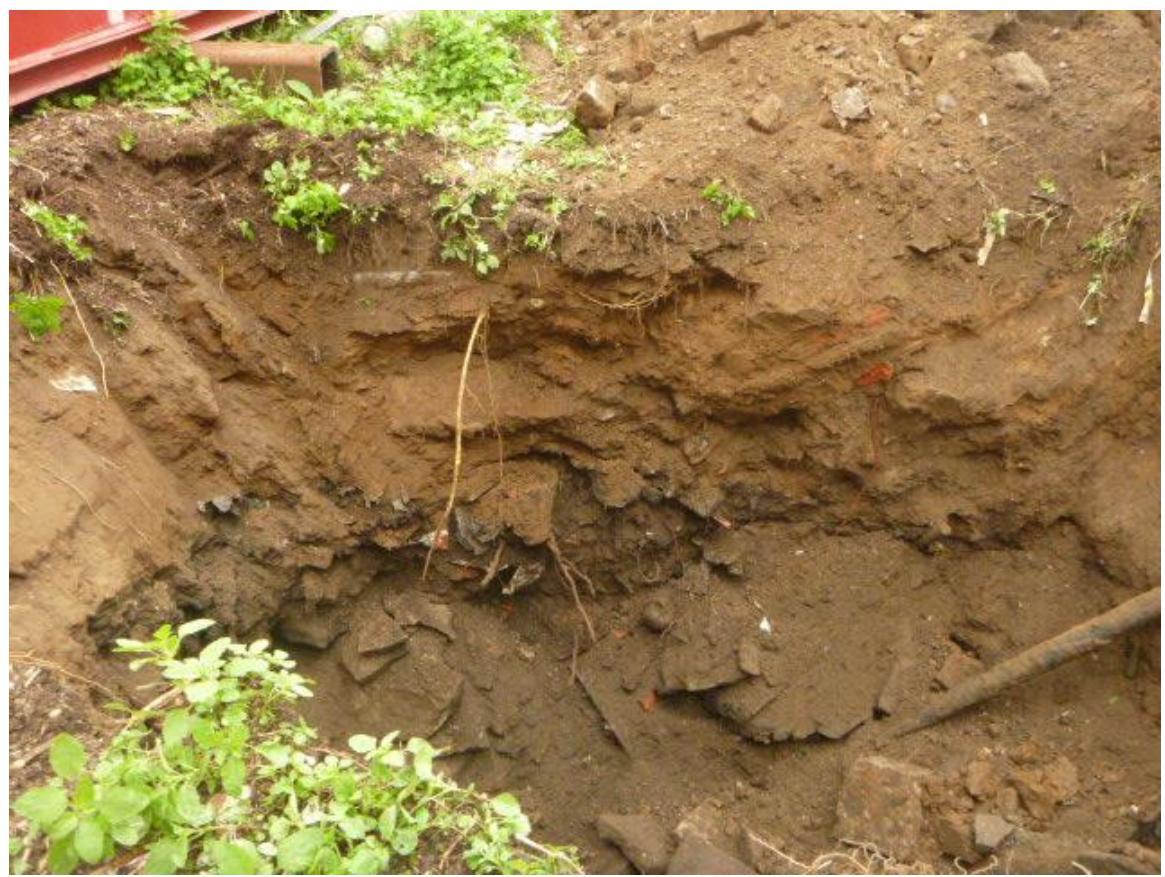
Trench 05 featured the thickest and most robust demolition and fill layer in the APE (Table 06) (Image 23). The demolition layer extended to 61.70' NAVD 88 (7' bgs) and included whole rubber car tires, carpet, iron pipe fragments, and large sections of ceramic water and/or sewer pipes in addition to the modern and historic materials found across the fill/demo layers in other trenches in the APE (Image 24). No intact or significant archaeological resources were encountered during the excavation of Trench 05.

Image 23: Stratigraphic profile, south wall – Trench 05.

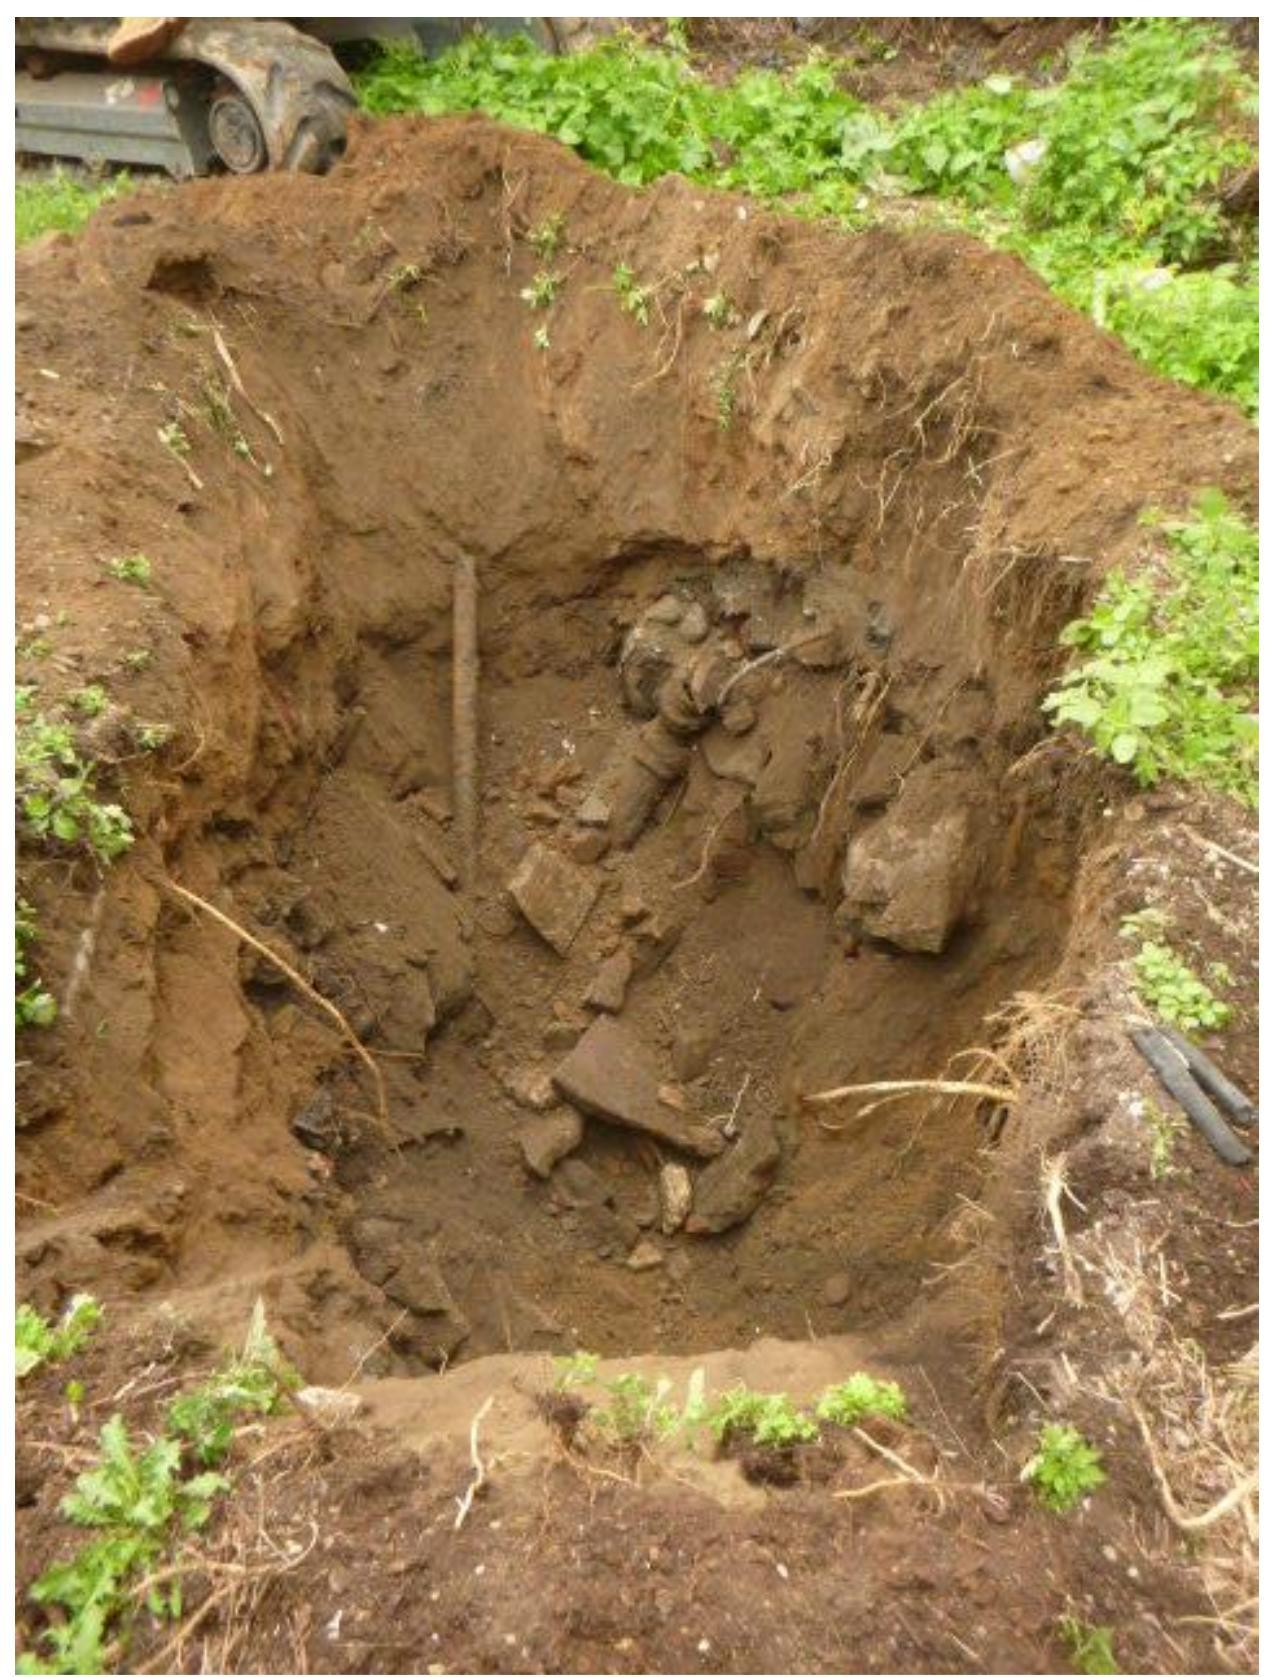
Image 24: Concentration of demolition materials in Trench 05.
