ARCHAEOLOGICAL TESTING REPORT WASHINGTON/BATHGATE URBAN RENEWAL AREA BRONX, NEW YORK BLOCK 3046

Prepared for: The Briarwood Organization 36-35 Bell Boulevard P.O. Box 610523 Bayside, New York 11361

Prepared by: Greenhouse Consultants Incorporated 40 Exchange Place, 13th Floor New York, New York, 10005

April 1999

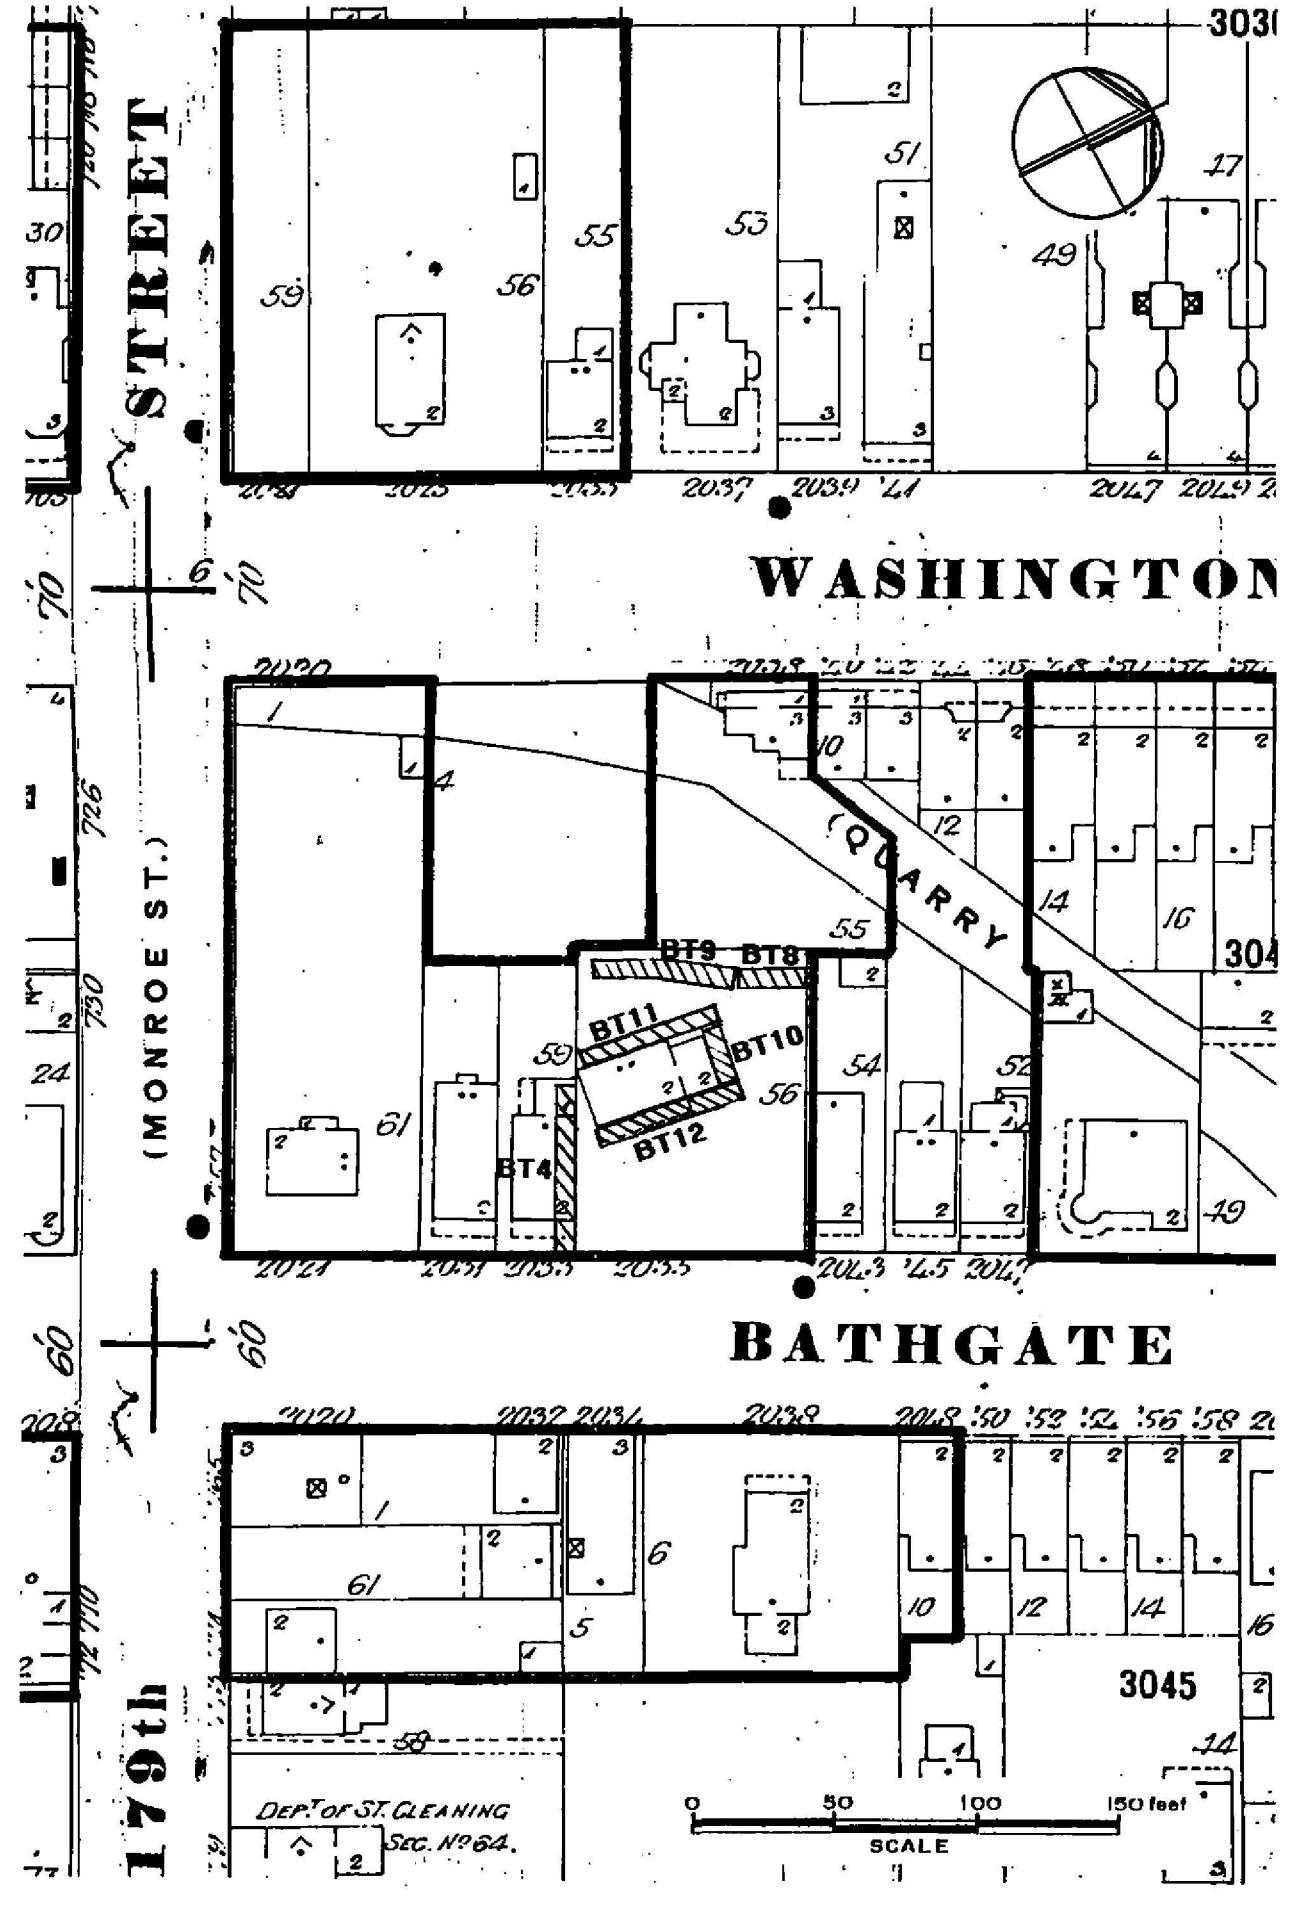
Location of Backhoe Trenches 4 and 8-12 within the project area.

The subsurface archaeological testing at the Washington/Bathgate Urban Renewal Area Housing Project in The Bronx, New York began on June 2, 1997 and was completed June 4, 1997. As stated in the scope-of-work for this testing, the technique used to examine buried deposits, and thereby determine the presence or absence of archaeological resources, was the mechanical excavation of trenches. A total of six trenches were excavated by backhoe, the results of which were closely monitored by archaeologists. This testing strategy was designed by the principal investigator, and approved by the staff of the New York City Landmarks Preservation Commission. See Figure 2 for the locations of the trenches.

Backhoe Trench 4 was placed within Lot 59 just south of the boundary with Lot 57. It was planned to be just within Lot 57, but a relatively new fence had been erected on this boundary somewhat disturbing the location. Since Lot 59 had formerly been part of Lot 57 it was decided to test just south of the fence which appeared less disturbed. Backhoe Trench 8 was placed at the rear of present Lot 56, also previously part of Lot 57. Trenches 10, 11 and 12 surrounded the north, west and east sides of the former dwelling in Lot 57.

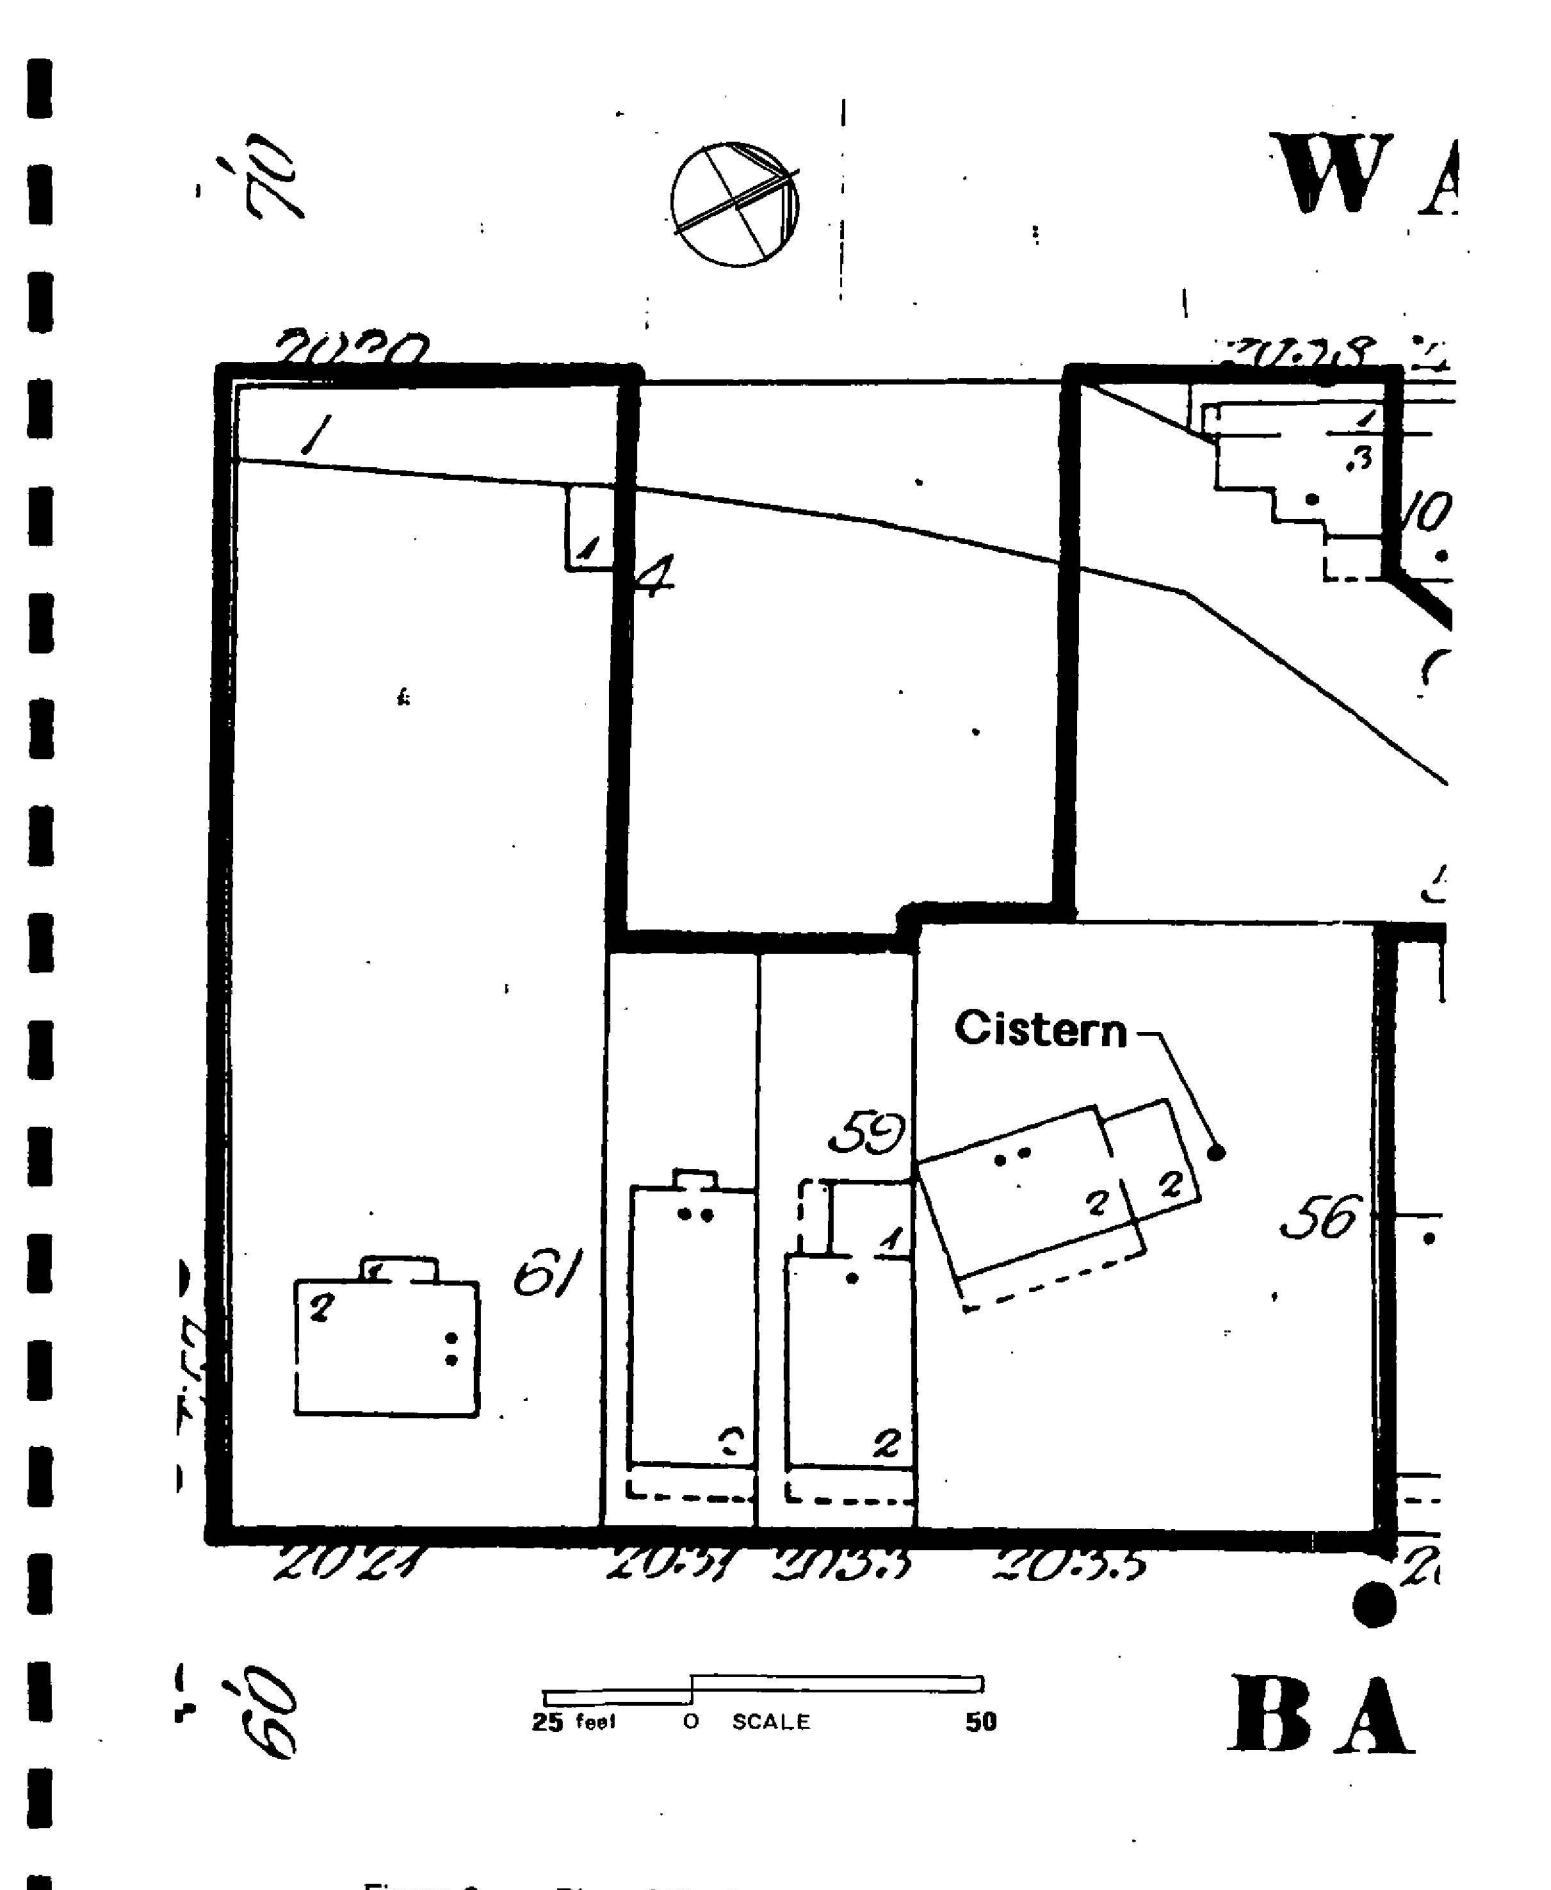
The only feature found was the stone and mortar cistern in Backhoe Trench 10.

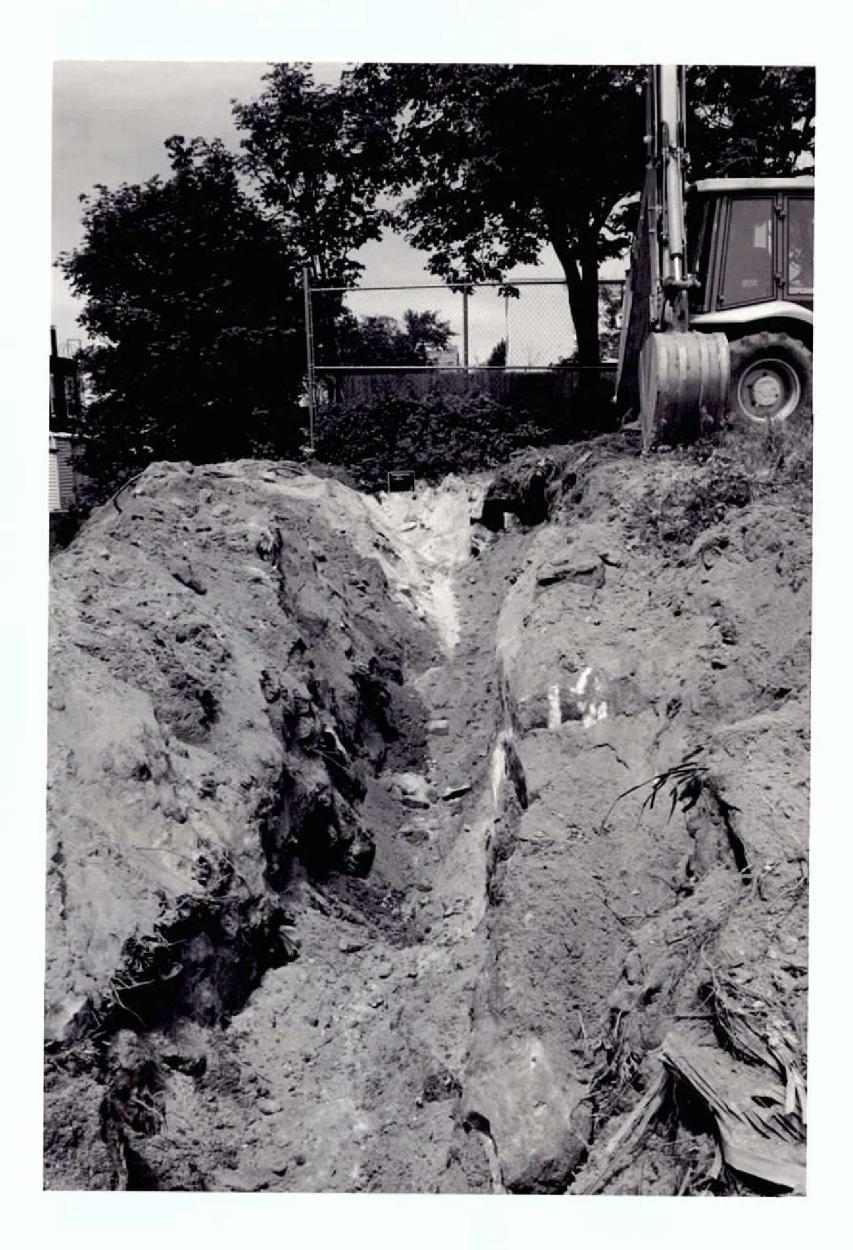
Backhoe Trench 9 was recorded in two halves, north and south. This division was due to logistical considerations. There were fences to the north and south so the backhoe operator excavated the north half, then backfilled this section and used it as a platform to excavate the south half. This strategy avoided destroying the fences. The north half had four deposits. The top layer was a very dark greyish brown silty loam with rootmat that was 0.8 feet thick. Beneath this was a silty sand with pebbles that was 1.9 feet thick. The color was a mottled combination of very dark grevish brown and light grey. The third layer was a light grey sand that was 0.5 feet thick. The fourth and deepest layer was a white sandstone that was decomposing in places. This deposit began at 3.2 feet below grade and extended to beyond the bottom of the trench at 6.7 feet. The four deposits were identified as topsoil, the former plowzone or A horizon, the subsoil or B horizon, and bedrock. The southern half of Backhoe Trench 9 included three deposits. The top layer was a very dark greyish brown silty loam with rootmat. It was 0.9 feet thick. The second layer was a brown silty sand that was 2.1 feet thick. The third and deepest layer was a light grey coarse sand. It began at 3.0 feet below grade and extended beyond the bottom of the trench at 3.7 feet. Excavation was halted at this point since the deposit was sterile and deeper exploration to the north found only bedrock beneath this layer. The three layers were identified as topsoil, former plowzone or A horizon, and subsoil or B horizon.

View of Backhoe Trench 9 looking northeast.

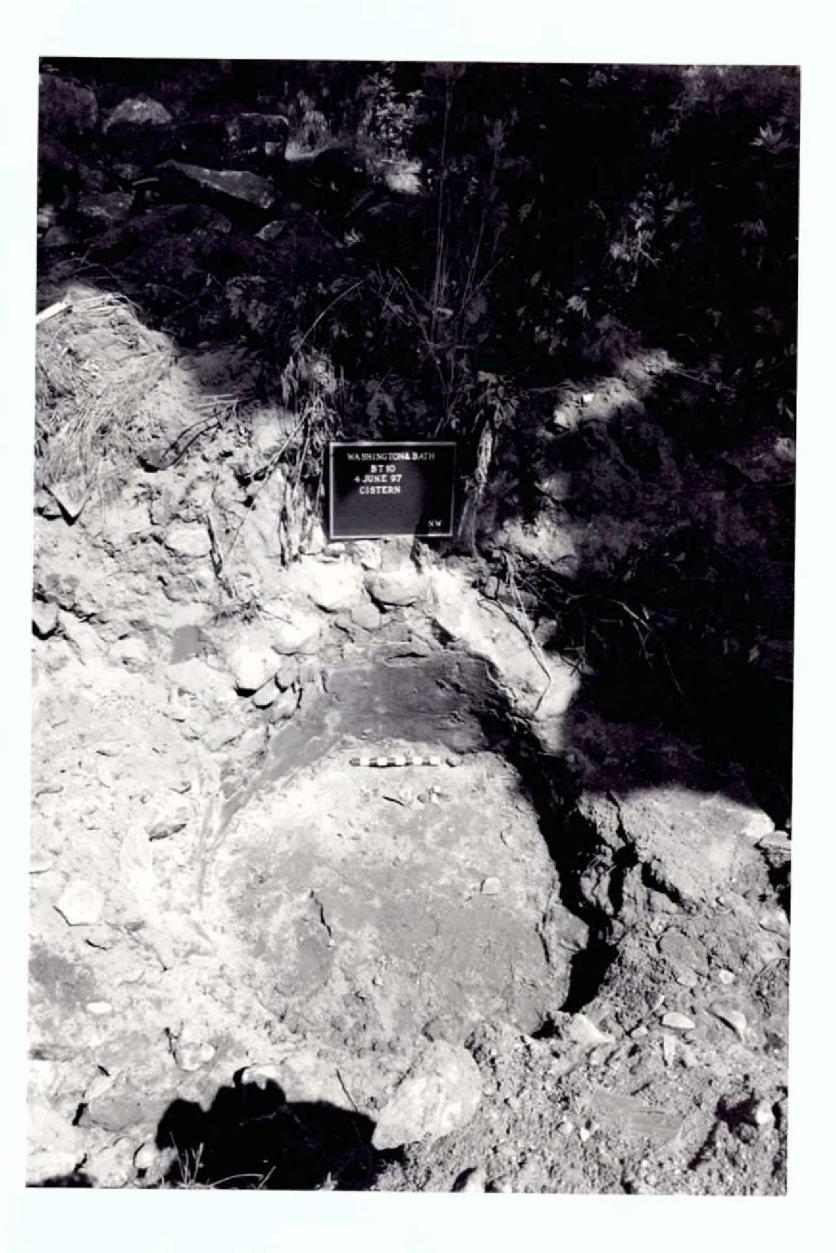
Plate 5 Detail of Backhoe Trench 10 looking northwest showing cistern.

Five deposits were recorded in Backhoe Trench 10. Three of these are similar to the deposits discussed above, while the others are a feature and its fill. The top layer was a brown silty loam that was 1.8 feet thick. Beneath this layer was a dark yellowish brown sandy silt that began at 1.8 feet and extended at least 0.2 feet. Just beneath the top of the second layer was a circular feature constructed of stone and mortar. The diameter was 3.9 feet. This feature was cut into the third layer. The top layer of fill within the feature was a dark yellowish brown silty loam that was 0.6 feet thick. The third layer of the trench consisted of profuse building rubble in a very dark greyish brown silt. The feature was identified as a cistern given its construction and location about two feet from the wall of the house. The first layer was identified as a topsoil and the other deposits as fill.

Backhoe Trenches 4 and 8 through 12 were designed to search for evidence of features used by the Brown family. Any cisterns, wells or privies would likely have been filled during or shortly after 1896-1899 when water and sewer lines became available. During 1890, seven members of the Brown family, including matriarch Emma Brown lived here (Greenhouse Consultants 1997:19-22). Backhoe Trench 10 produced evidence of a stone and mortar cistern, located adjacent to the northeastern corner of the structure. The fill of this cistern included domestic artifacts dating to the nineteenth century. The only obvious twentieth century artifacts, part of an automobile headlight, could have fallen in from above during the backhoe trenching. Recovery of the remainder of the Brown family.

We recommend that the fill of the cistern found in Lot 57 be completely excavated prior to construction of a new structure. This excavation would recover the archaeological data represented by this feature prior to its destruction.

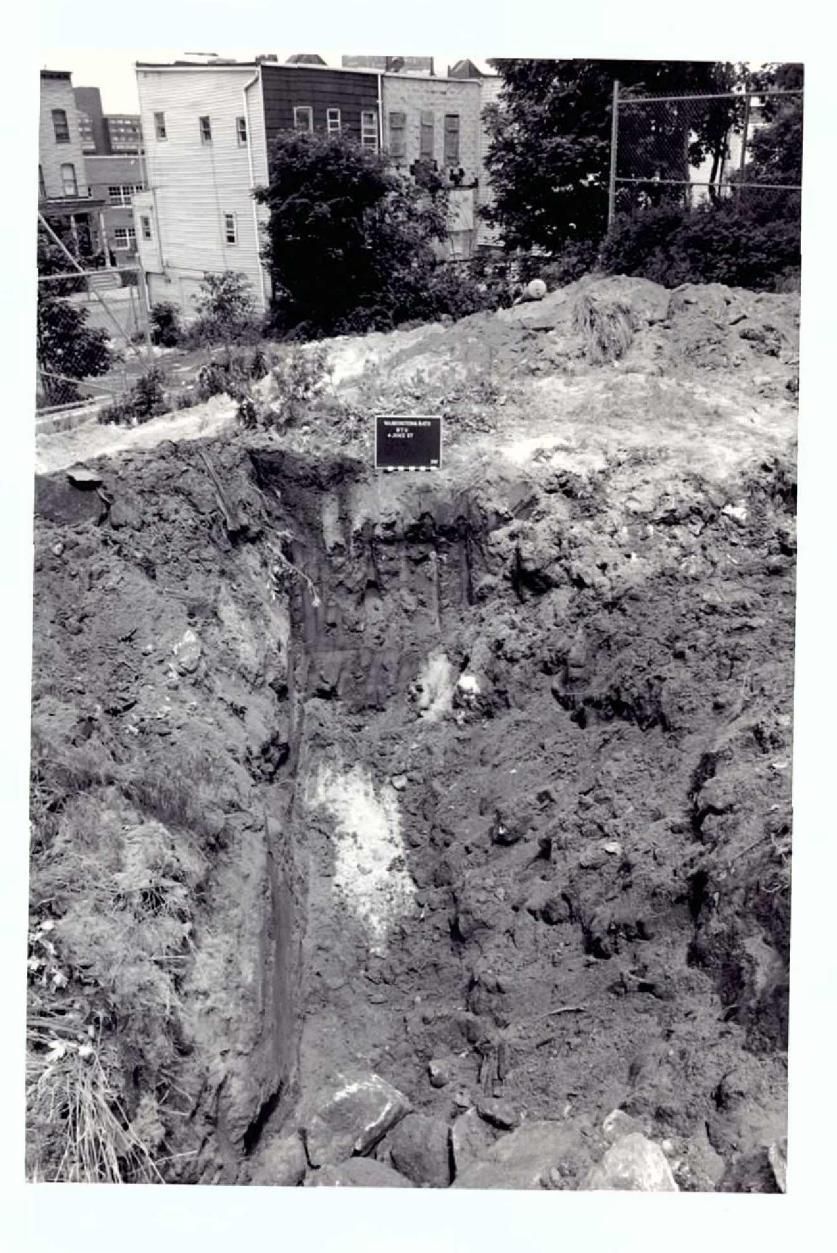
Backhoe Trench 11 included three deposits. The top layer was a very dark greyish brown silty loam. It was 1.5 feet thick. The second layer was a dark yellowish brown sandy silt that was four feet thick. Beneath this was a light grey decomposing sandstone. It began at 5.5 feet below grade and extended beyond the bottom of the trench at 6.0 feet. The top layer was identified as mixed topsoil and A horizon. The second layer was identified as subsoil and the third as bedrock.

View of Backhoe Trench 11 looking north.
