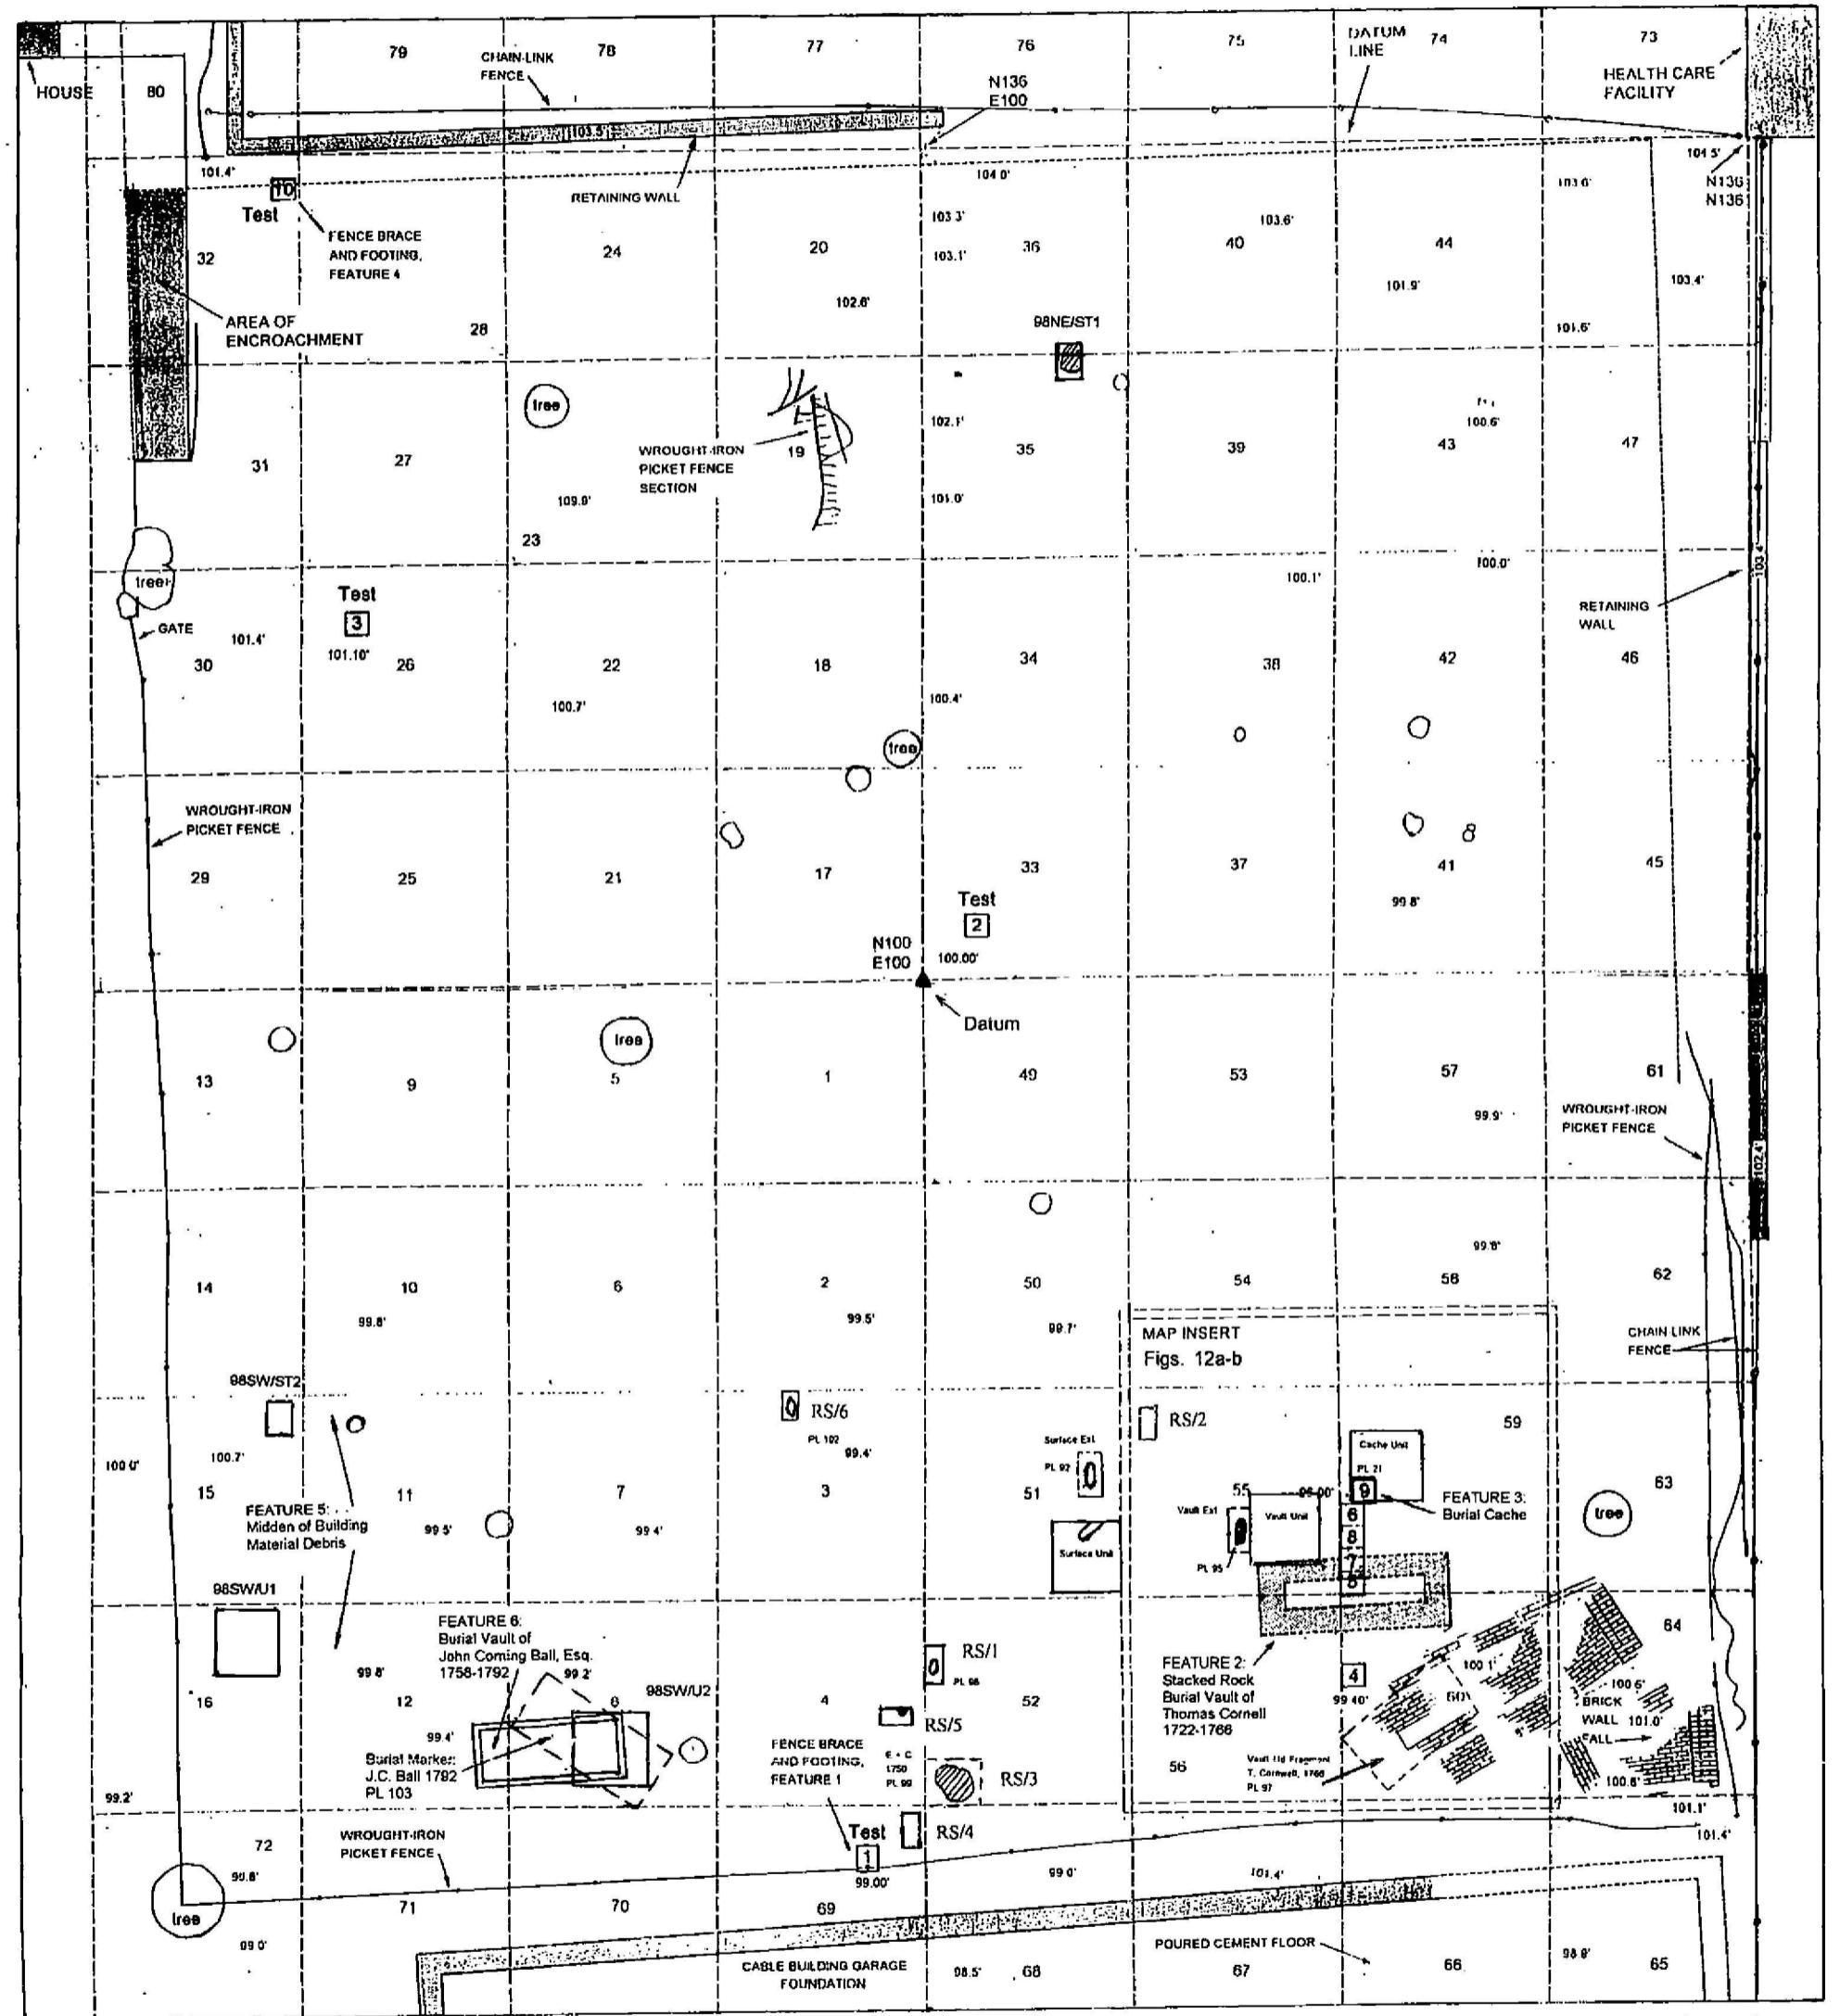
Figure 1. Comprehensive Archaeological Site Map for the Richard Cornell Cemetery, Far Rockaway, Queens, New York Showing: Site Features: 1) wrought-iron fence footing, 2) stacked-rock burial vault wall of Thomas Cornell 1722-1766, 3) burial cache which contained a large fragment of the Thomas Cornell burial marker, 4) wrought-iron fence brace and footing, 5) midden of building debris, 6) vault wall from burial of John Coming Ball, Esq. (1758-1792); Shovel Tests 1993-96: Test 1, Feature 1 (N61.2, E97.3), Test 2 (N102, E102), Test 3 (N115, E75), Test 4 (N69, E118), Test 5, Feature 2 (N73, E118), Test 6 (N76, E118), Test 7 (N74, E118), Test 8 (N75, E118), Test 9, Feature 3, (N77, E118.5), Test 10, Feature 4 (N134, E72); Excavation Units 1993-96: Vault Unit (N74.60, E114.20), Surface Unit (N73.32, E106), Cache Unit (N77, E118.5); Remote Sensing Tests (R/S 1-6); the location of the Burial Vaults of Thomas Cornell and John Coming Ball, Esq.; burial markers located during archaeological assessment (PL 21, 92, 95, 97, 98, 99, 103); and tests conducted in 1998: 98NE/ST1 (N126,105.70), 98SW/ST2 (N80.50, E71.50), 98SW/U1 (N66.90, E70.00), 98SW/U2 (N65.30, E84.80).

NOTE: All tests are shown on Figure 1, the comprehensive archaeological site map. Each stratum or level within a stratum, excavated at the cemetery site over the duration of the archaeological project (1993-98) has been provided a sequential numerical *provenience designation* (PD). This method continues here beginning with PD 57. All elevations given below are measurements from the contemporary ground level at the location of the test. Contemporary ground elevations associated with particular tests and relative to the site datum (Elev. 100.00') can be drawn from the composite archaeological site map where elevations are shown across the full extent of the site. This does not apply in the northeast quadrant of the site, though, since that area has been regraded following the recording of elevations shown on the map for this area. Current ground elevations in this area now reflect a simple continuation of surrounding elevations with the site sloping gradually upward towards the north.

With the primary goal of locating historic burial markers, archaeological probing at one foot intervals was planned and conducted in this quadrant of the site. This led to the excavation of a single 1'x1.5' shovel test, 98NE/ST1, (N126.50, E105.70), where a substantial object was encountered during probing (Figure 1).

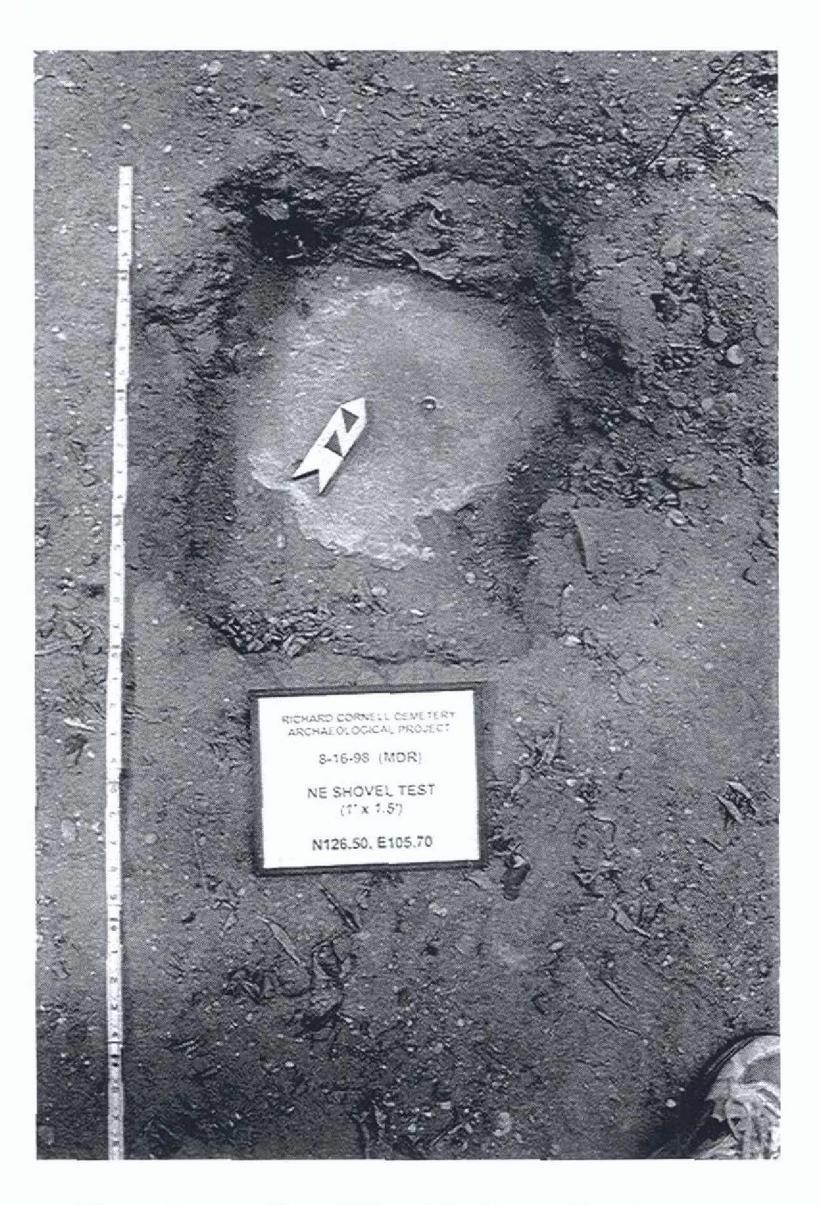
Figure 2. Shovel Test 1 in the northeast quadrant of the site impeded by poured concrete slab: 98NE/ST1, (N126,105.70).

Shovel Test 1 98NE/ST1 N126.50, E105.70 1'x1.5'x.6'

Stratum 1 (0'-.6') PD 57, very sandy loam. This deposit consists of the remaining portion of the deep deposit removed in the summer of 1997 to regrade this quadrant of the site. This stratum terminated at the top of the object located during probing, a large concrete slab. The concrete slab was recorded at .6' below the newly regraded surface level and with this the test was documented and called off. Screening the soil yielded minimal quantities of historic glass and burned coal fragments which were not saved or inventoried.

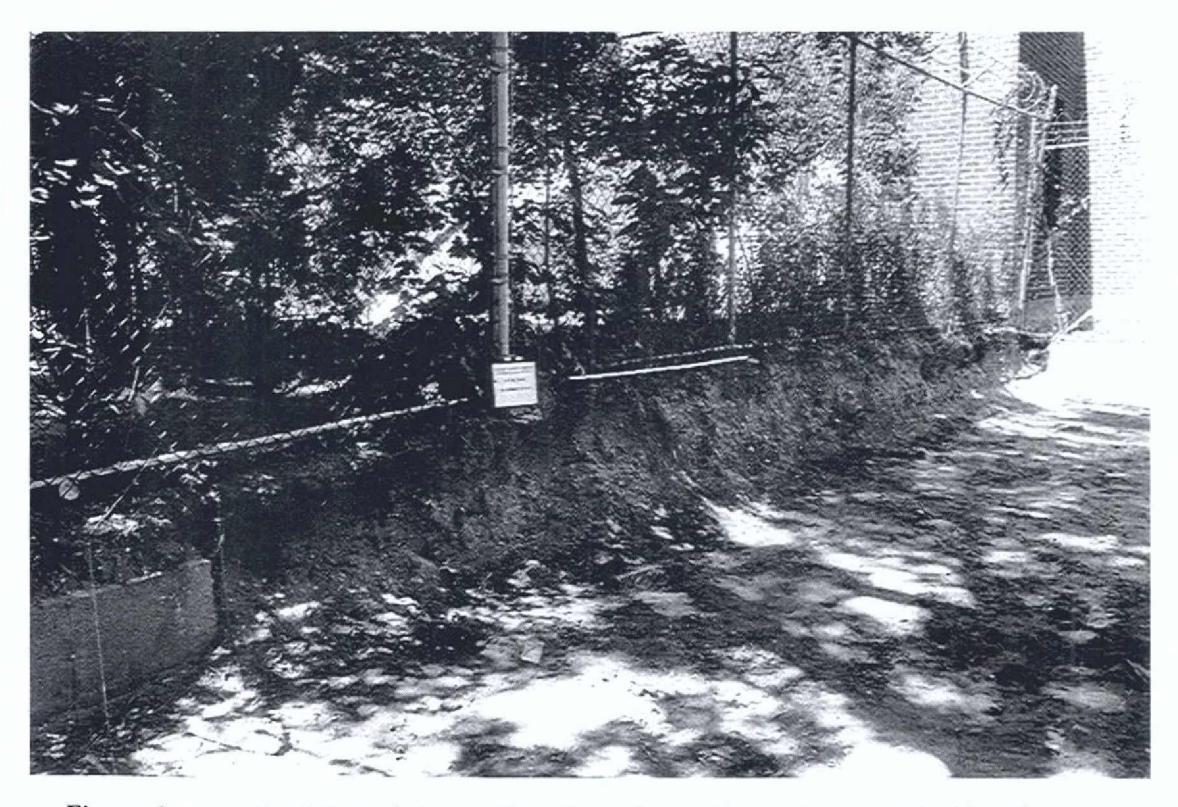
Figure 3. Partial retaining wall and eroding soil cut along north side of cemetery.

SPECIAL NOTE: As documented in the *Final Report*, an existing retaining wall along the northern boundary of the site extends only from the northwest corner to approximately the middle of the north side of the site, from that point on the retaining wall has been removed (Figures 1 and 3), that is to say, there is presently no retaining wall from the middle of northern side of the cemetery to the northeast corner of the site. This is significant because north of the site the contiguous property continues at an elevation approximately 3-4' above the current elevation of the cemetery. With the removal of the deposits in northeast corner of the site, where no retaining wall exists, the property line has been, in effect, destabilized. The shear 4' high soil cut face along this portion of the cemetery boundary resulting from the removal of the deep deposits up to the property line has begun to erode, already partially undermining a chain link fence which separates the two properties. It is evident that a solution will have to found to shore-up this portion of the cemetery property line. As discussed hypothetically in a preliminary and the final report, the actual removal of the deep deposits in the northeast corner of the site in 1997 now necessitates rehabilitating or replacing the northern retaining wall. The Cornell Cemetery Corporation is currently considering several options to this end.

The poured concrete retaining wall along the north side of the site has been given special attention here. A regrading effort in the northeast quadrant of the site has resulted in the replacement of a steeply graded deposit which rose to meet the property line to the north of the cemetery--where the retaining wall has been removed--with a quickly eroding shear soil cut along the property line. While the deep deposit limited the accuracy of historic restoration efforts, hence spoiling the aesthetic integration of the site, the removal of the deposit now necessitates finding a solution to the destabilization that has resulted from its removal. Clearly, the retaining wall will have to be extended to the northeast corner. Various option are under consideration for constructing a new retaining wall running the entire length of the north property line or else constructing a new section to replace the missing section in the northeast corner.

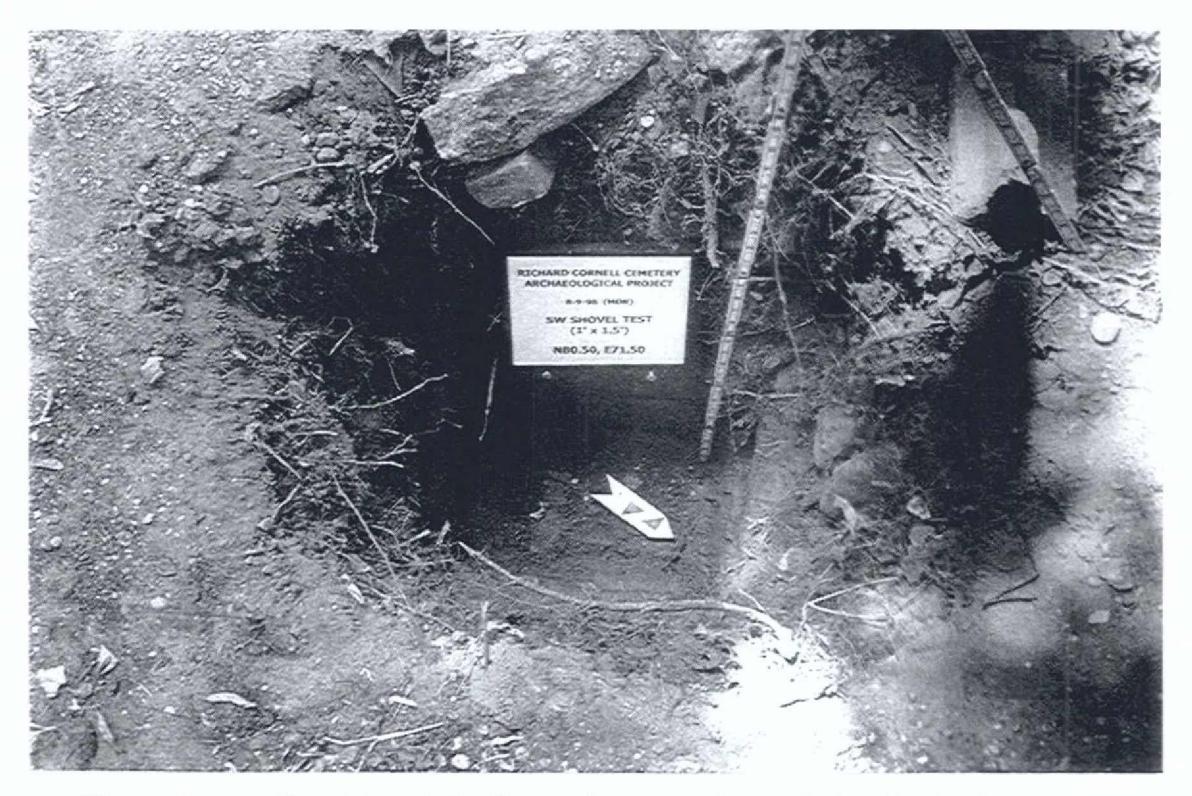
Figure 4. Shovel Test 2 in the southwest quadrant of the site, in the area of the midden: 98SW/ST2, (N80.50, E71.50).

Shovel Test 2_ 98SW/ST2 N80.50, E71.50 1'x1.5'x2.7'

The test, which penetrated the midden mentioned above, revealed three distinct strata.

Stratum 2 (PD 59), .4'-1.6', is a sandy loam deposit. This provenience penetrates the body of the midden lens resting on the original cemetery surface and included large poured concrete fragments, historic glass and ceramics.

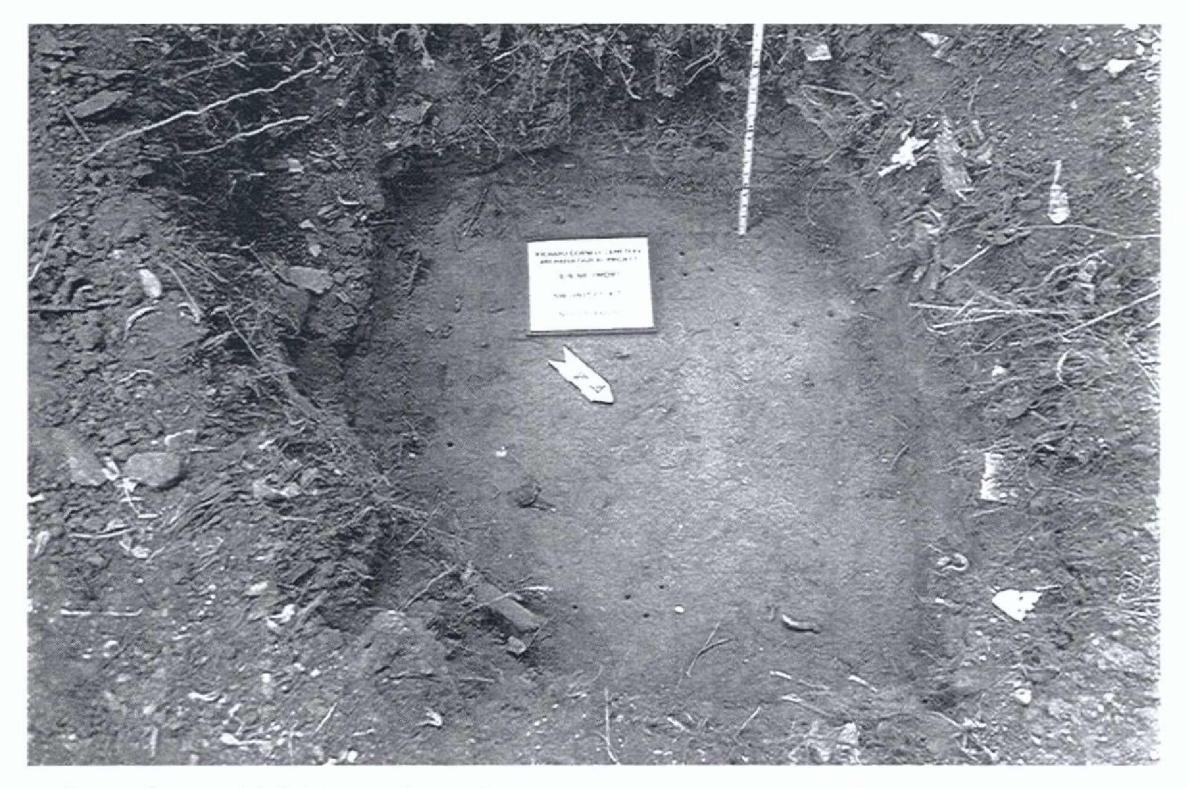
Figure 5. Unit Excavation 1 in the southwest quadrant of the site, in the area of the midden: 98SW/U1, (N66.90, E70.00).

This unit was located near the southwest corner of the site in the area of the midden of building debris discussed above. The 3'x3' unit penetrated through the midden and again confirmed that the midden is primarily comprised of large poured concrete fragments (Figures 5 and 6, north and east coordinates were inadvertently reversed on the descriptive photo plate). This test is basically a larger version of Shovel Test 2 discussed above. Three distinct strata were identified.

Stratum 1, (PD 61), 0'-.4', is a very sandy loam extending from and including the contemporary cemetery surface and terminating at the beginning of the midden deposit at .4'. No significant artifacts were collected from this provenience. Stratum 2, (PD 62), 4'-1.9', is a sandy loam deposit. This provenience penetrates the body of the midden lens resting on the original cemetery surface and included large number of poured concrete fragments, historic glass and ceramics. Artifacts collected:

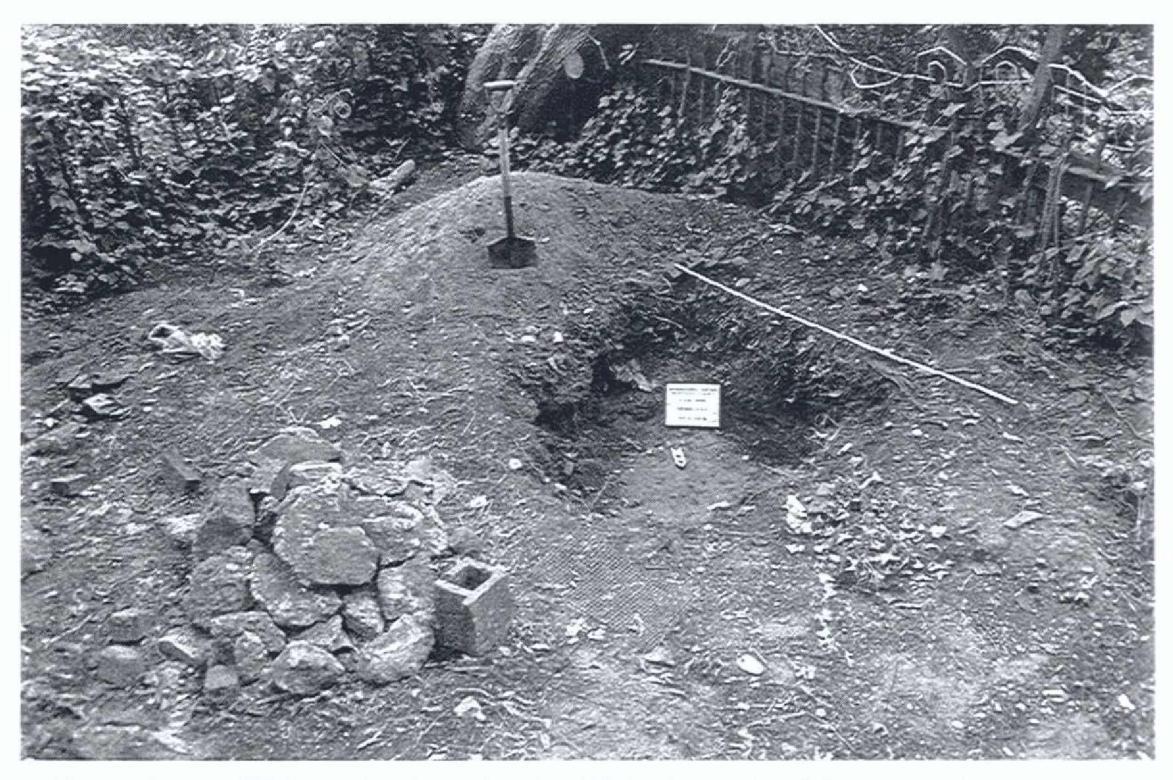
Figure 6. Wide-angle photo showing Unit Excavation 1 in the southwest quadrant of the site, in the area of the midden, showing concrete fragments recovered from test: 98SW/U1, (N66.90, E70.00).

As for the midden, it consists of mixed 20c. building materials, mainly large fragments of poured concrete (20-40 lbs.) which may well be the remains of a retaining wall section that has been removed along the north side of the cemetery in the northeast corner. Any future regrading of the cemetery surface, indeed the only regrading conceivable, would focus on this mixed midden area, approximately 4-5' wide, 15-20' in length and one foot deep extending along the west side of the cemetery.

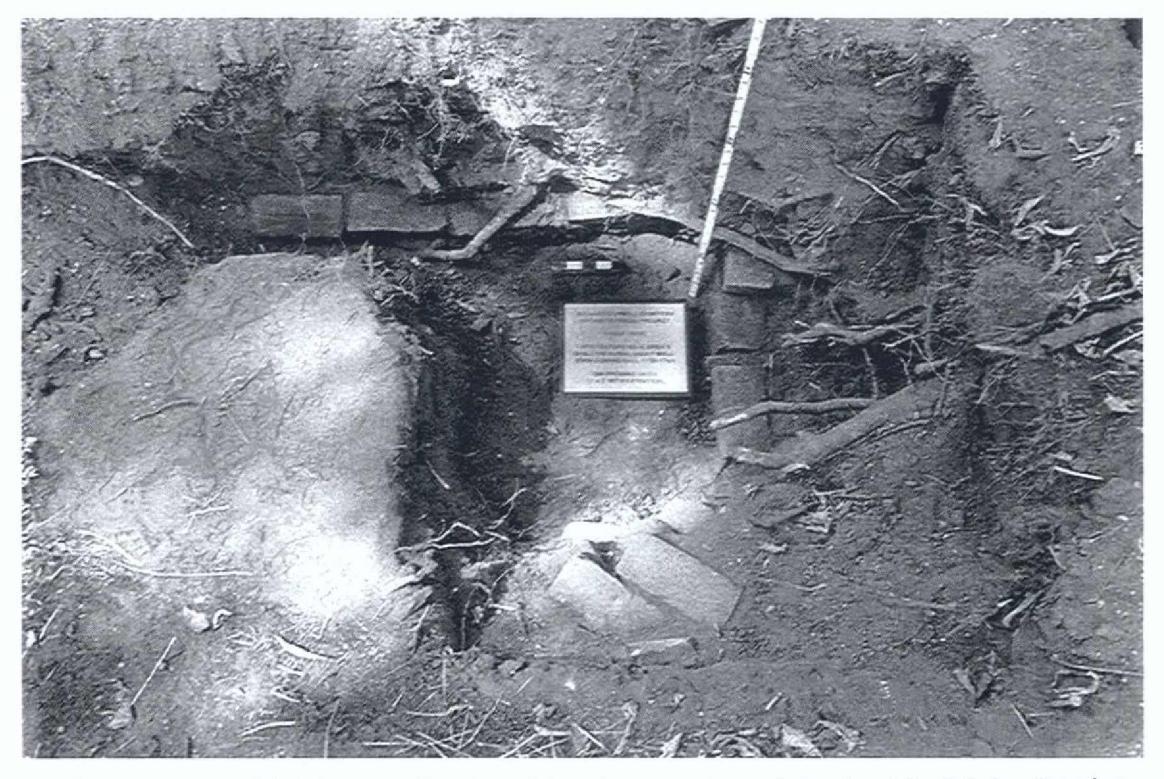
Figure 7. Unit Excavation 2, minimal excavation of the burial of John Coming Ball, Esq. (1758-1792): 98SW/U2, (N65.30, E84.80).

This test was relocated from the northeast quadrant of the site to the burial place of John Coming Ball, Esq. (1758-1792) located in the southwest quadrant of the site in Area 8 (see map, Figure 1). (This is the location where in the summer of 1996 the inscribed lid to the burial was uncovered. In turn, this discovery led members of the Cornell Cemetery Corporation to conduct a review of historic documents concerning the identity of John Ball who travelled to Far Rockaway from South Carolina in ill health and died there on October 31st, 1792 in the home of Abigail Cornell. (see Appendix 6, *Final Report (1996)*). The test unit was excavated primarily to determine the exact location of the burial for the final location of the inscribed marble lid and in part to examine and describe the construction of the burial. Results revealed that the burial marker rested on a shallow coursed brick wall (three courses were exposed during excavation and probing determined at least 2 more). There was no evidence for the use of mortar in the construction of the burial vault walls. The excavation proceeded to a maximum depth of .51' along the sides of the burial matrix. Vertical excavation then ceased and the unit was leveled off for final documentation. Attention was given to avoiding human remains and no human remains were encountered.

Results from minimal test unit excavation of the burial of John Coming Ball, Esq. determined that the wall upon which the inscribed marker rested is very shallow at 1.5' below the contemporary surface and is constructed of stacked brick with a minimum of 5 courses. There was no evidence of mortar used in the construction of the wall.

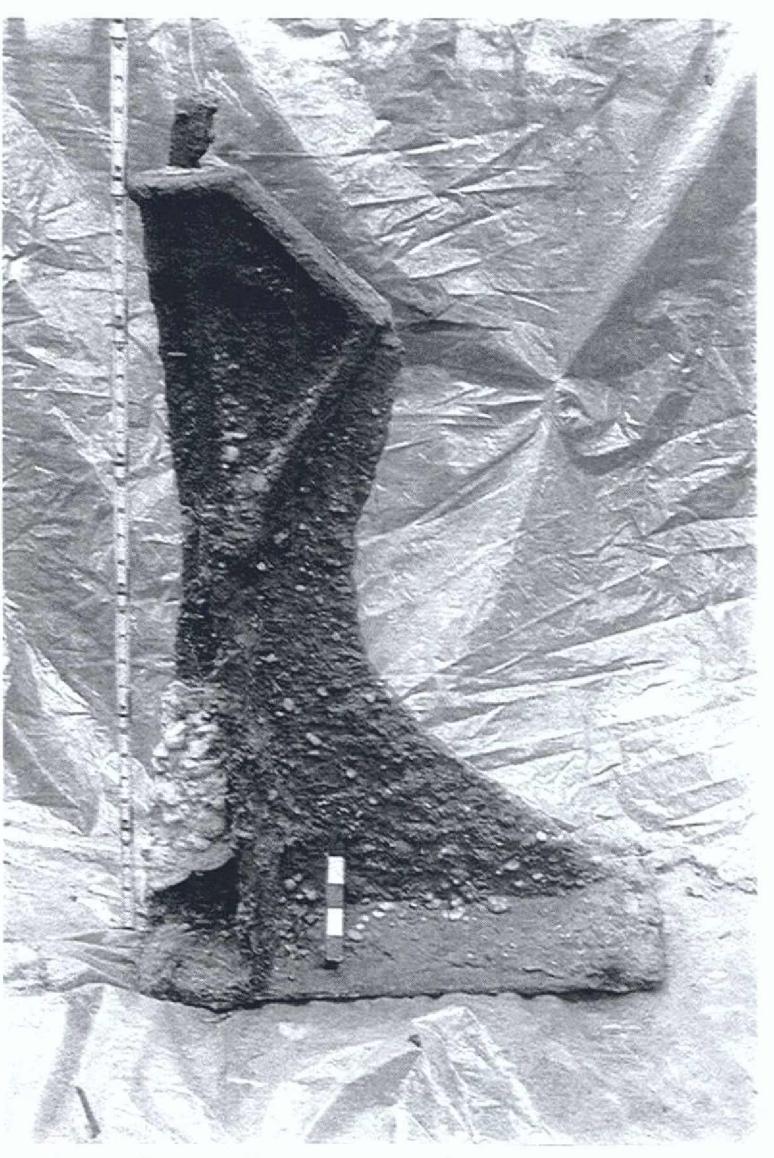
Figure 8. Cast-iron fence footing recovered during 1997 cemetery surface regrading.

Of special interest was the recovery of a complete cast-iron perimeter fence footing (Figure 8) during the removal of soil from the northeast quadrant of the site in 1997. A footing along the southern fence line was documented earlier through the excavation a shovel test and probing (see *Final Report (1996*), Figure 29). Line drawings based on a combination of direct observation and probing and presented previously show the footing's size and design as very similar to the footing recovered in 1997. With recovery of the footing it becomes clear there are at least two footing types: those with a flat ground-level top (the type studied through excavation and probing and documented earlier), and those with a slanted ground-level top (the type recovered during the regrading effort in 1997).
