STAGE 1B ARCHAEOLOGICAL SURVEY OF THE OAKWOOD BEACH WATER POLLUTION CONTROL PLANT EXPANSION PROJECT BOROUGH OF STATEN ISLAND, NEW YORK CITY RICHMOND COUNTY, NEW YORK

Prepared for: Stone and Webster Engineering Corporation One Penn Plaza New York, New York 10119 Prepared by: William I. Roberts IV and Jesse Ponz Greenhouse Consultants Inc. 54 Stone Street, 7th Floor New York, New York 10004

July 1990

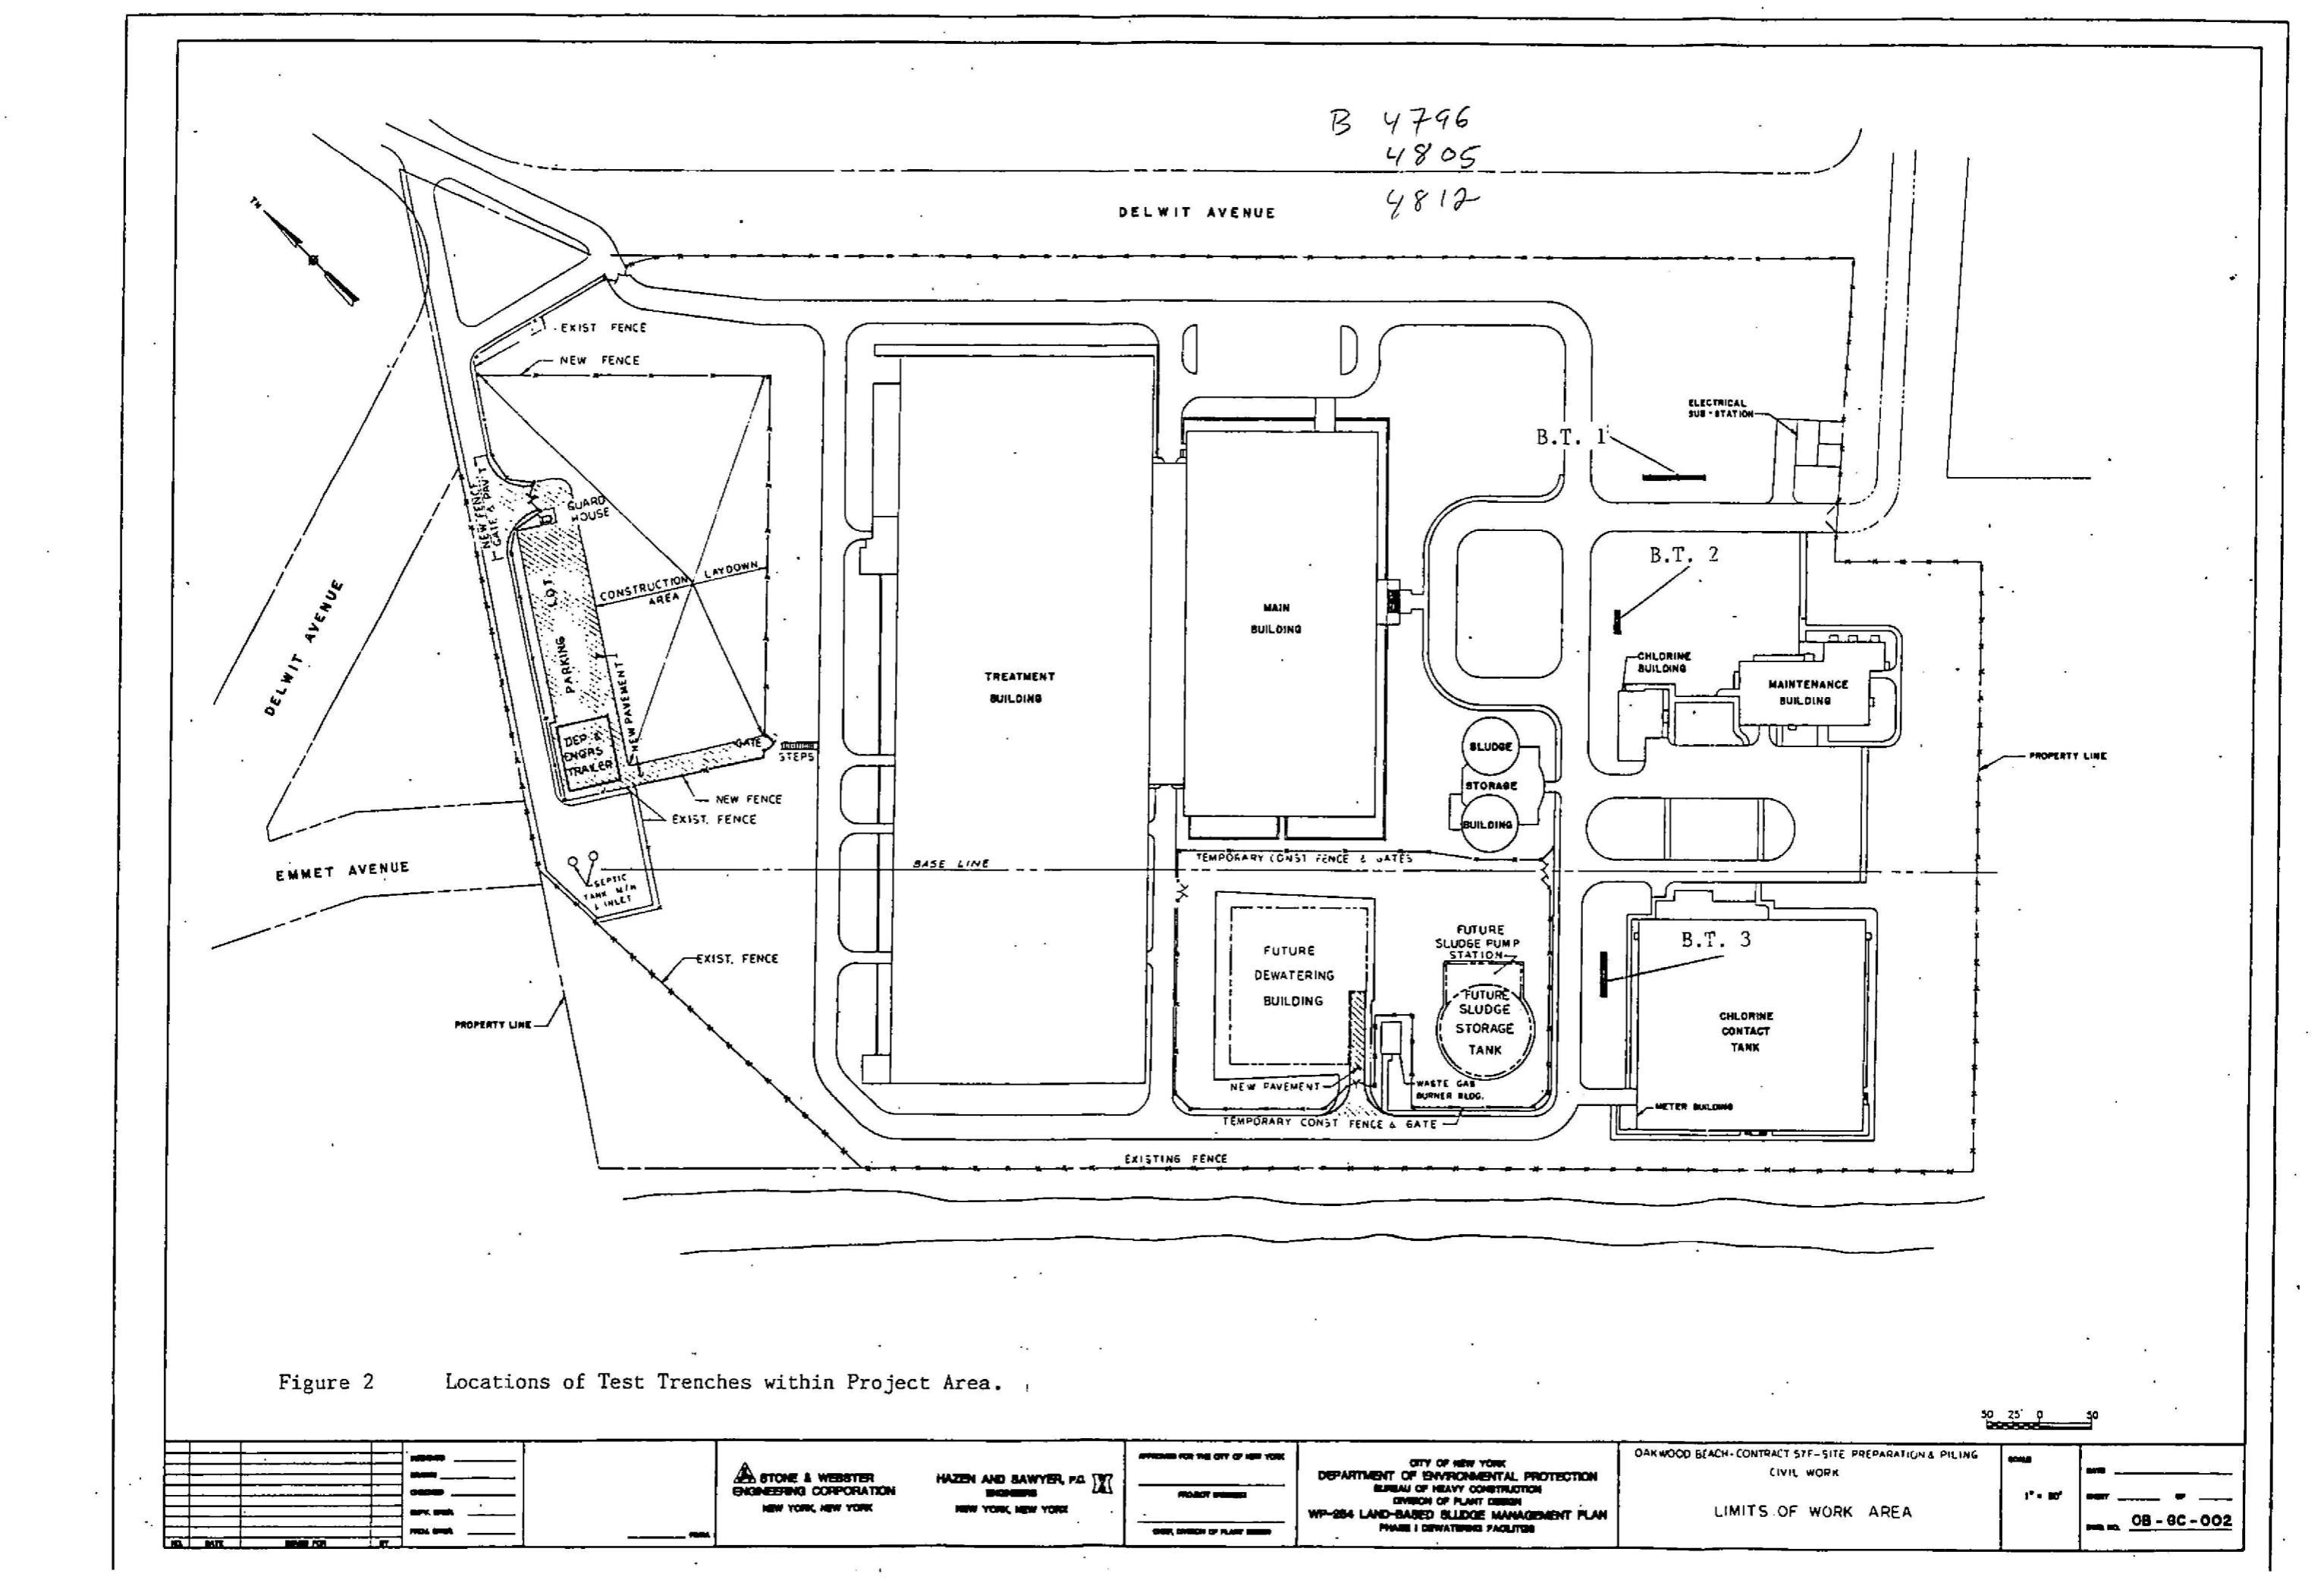
Figure 2 Locations of Test Trenches within Project Area.

The location of trenches was determined both by where planned construction impacts to potential archaeological resources were expected, and the avoidance of existing obstacles at the Oakwood Beach Water Pollution Control Plant. Three trenches were planned along the proposed new electrical conduit which is expected to be installed at 8 feet below present grade. Backhoe Trenches 2 and 3 were moved several feet from their original locations to a position parallel and adjacent to the proposed electrical conduit so as to avoid damage to a paved road and parking lot. Backhoe Trench 1 was similarly moved to a position parallel and adjacent to the electrical conduit at the discretion of Stone and Webster engineers to avoid existing services. See Figure 2 for the locations of the backhoe trenches.

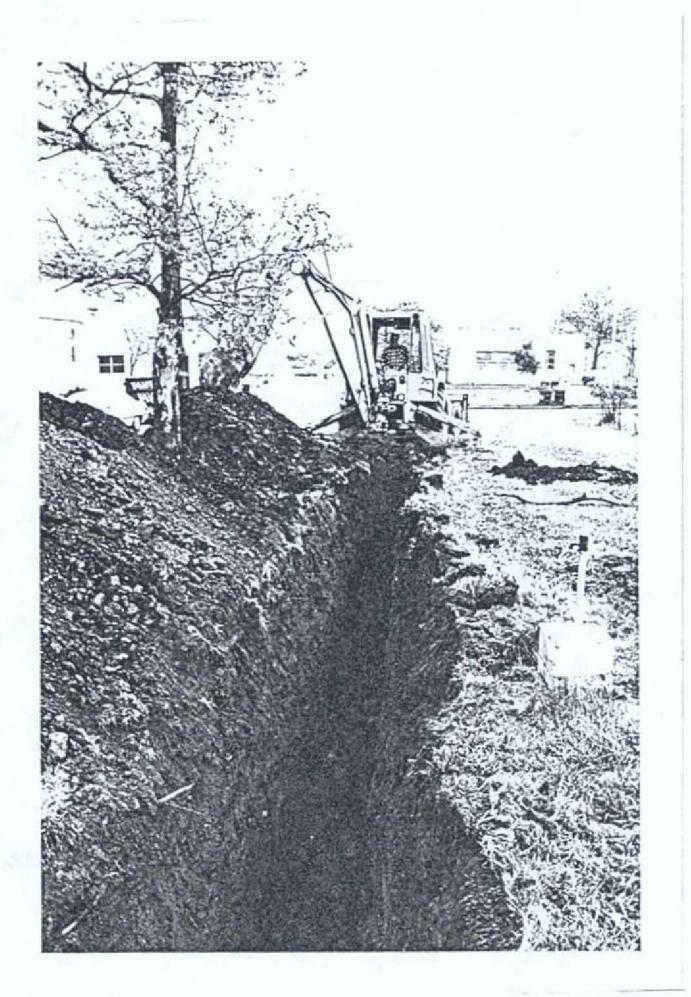
Plate 1: View of backhoe excavation in action in Backhoe Trench 3.

The use of mechanical means of excavation expedites the removal of large quantities of fill. A total of 5,300 cubic feet of soil were removed from the trenches, the dimensions of which varied from 20 feet to 60 feet long, by 5 feet wide, and 8 feet to 9 feet deep. Plate 1 illustrates the backhoe in operation.

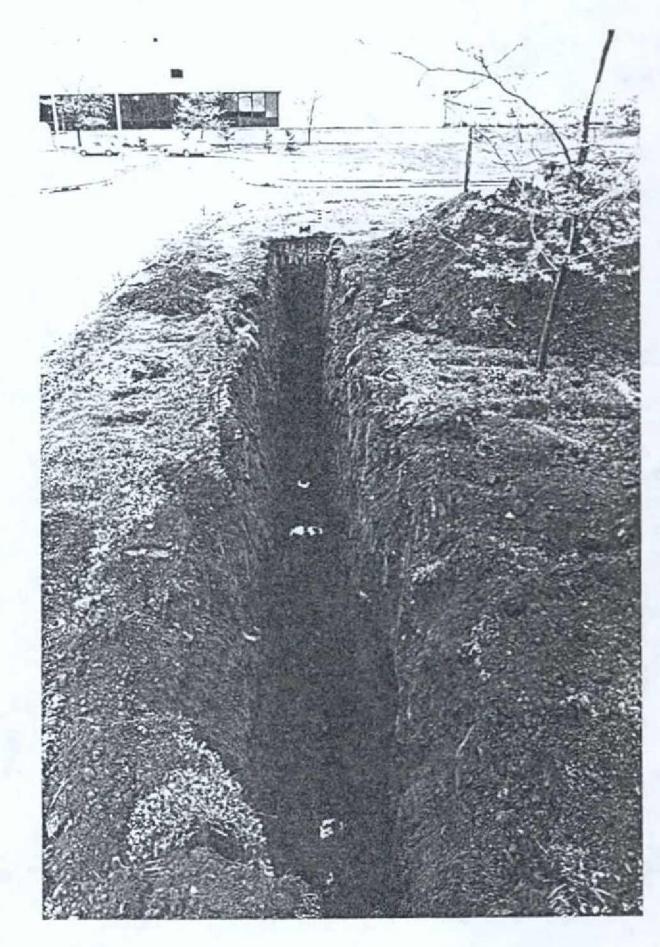
Plate 2: View of Backhoe Trench 1 facing northwest. Scale in tenths of feet.

The layers of fill of Backhoe Trench 1 were consisted of a range of soils including clays, silts, and sands. Soil color also exhibited a large degree of variance, and included dark yellow brown (10 4/4), grey brown (2.5 Y 5/2), and dark brown (7.5 YR 3/4). Cultural materials recovered included items representing food consumption activities (such as bottle glass and metal cans) and building materials (including bricks and fragments of ceramic tile). See Plate 2 for a view of Backhoe Trench 1.

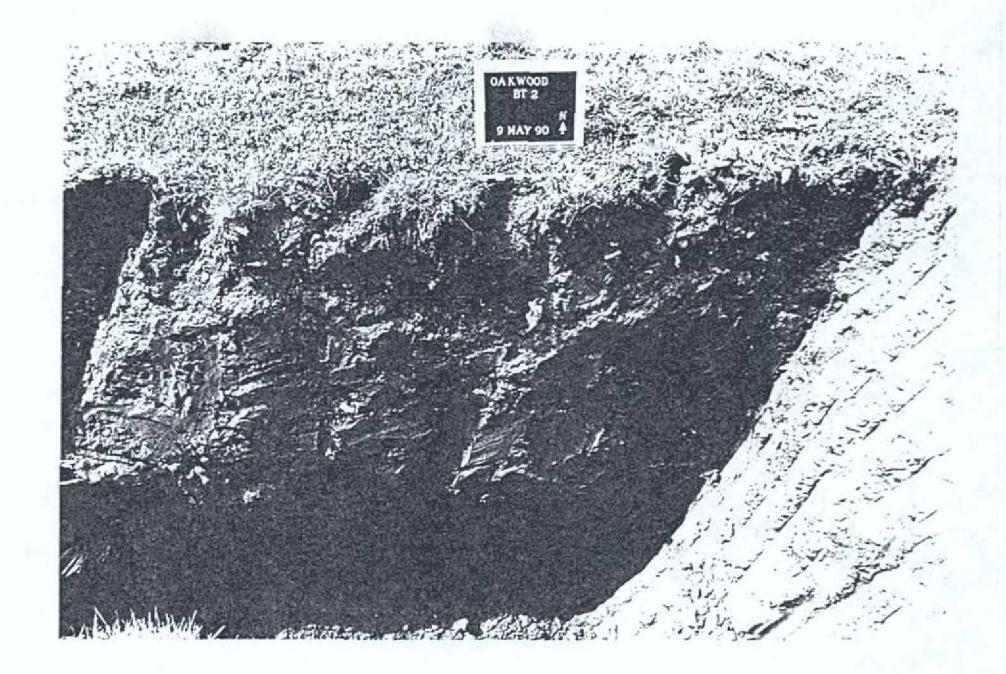
Plate 3: View of Backhoe Trench 2 facing northwest. The dark stratum at the bottom of the trench is an organic silt with decomposing reeds representing the original marsh surface.

The layers of fill in Backhoe Trench 2 varied in thickness from 0.8 feet to 5.1 feet, and ranged in soil type from clayey silt to silty sand. Soil colors included very dark grey brown (10 YR 3/2), strong brown (7.5 YR 4/6), and brown-dark brown (7.5 YR 4/4). The artifacts recovered from these strata were similar to those recovered from the fill layers in Backhoe Trench 1 representing everyday activities and building materials. The bottommost stratum of the trench, encountered at a depth of 7.5 feet below surface, was a layer of dark brown (7.5 YR 3/4) sandy silt with black organic silt (10 YR 2/1) including decomposing reeds. This layer, approximately 1.5 feet thick, represented a layer of natural soil from the marsh, and was devoid of cultural material. See Plate 3 for a view of Backhoe Trench 2 including this stratum.

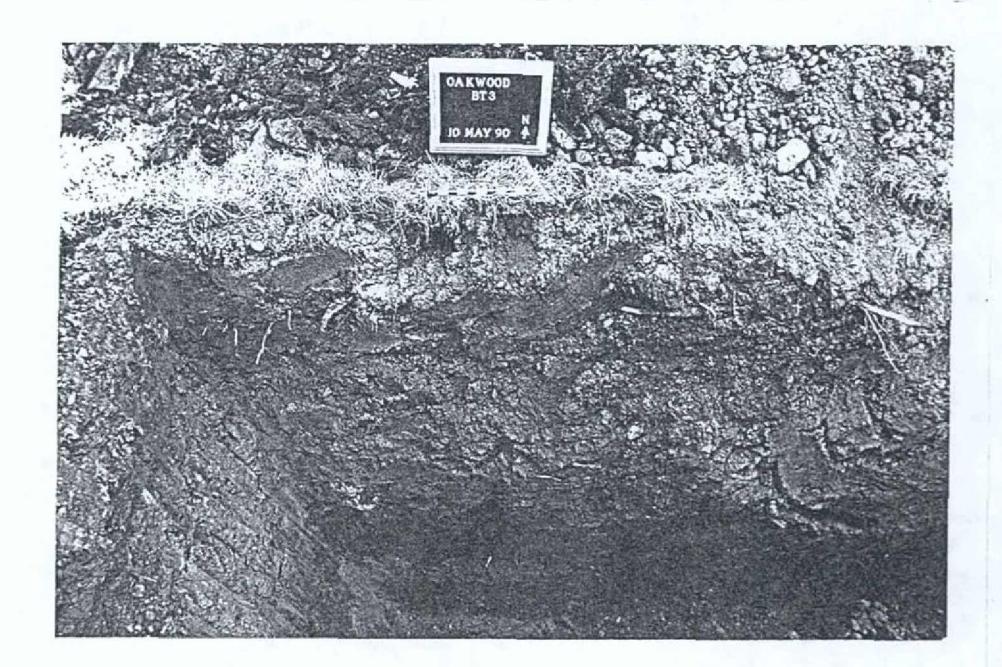
Plate 4: View of Backhoe Trench 3 facing northwest. The dark stratum at the bottom is one of the layers that contained glass bottles and other debris from a former dump.

The layers of fill in Backhoe Trench 3 were all comprised of silty sand, but significantly varied in color and the types and quantities of cultural materials contained therein. The upper layer of fill, approximately 1.4 feet thick, was dark brown (10 YR 3/3) in color, and yielded a small quantity of cultural materials associated with domestic use. The intermediate fill layer was yellow red in color (10 YR 4/6) and exhibited very few finds of cultural material. The bottommost level of fill which was black (10 YR 2/1) in color continued down to the bottom of the trench. This stratum, which varied in thickness from 3.3 feet to 4.3 feet, yielded a number of whole glass containers most of which date to the twentieth century. See Plate 4 for a view of Backhoe Trench 3 including these strata.
