ARCHAEOLOGICAL TESTING REPORT NICHOLAS AVENUE AND RICHMOND TERRACE PROJECT BOROUGH OF RICHMOND, NEW YORK

prepared for: Land Planning and Engineering Consultants, P.C. 2178 Forest Avenue Staten Island, New York 10303

> prepared by: Greenhouse Consultants Incorporated 40 Exchange Place, 13th Floor New York, New York 10005

> > January 2000

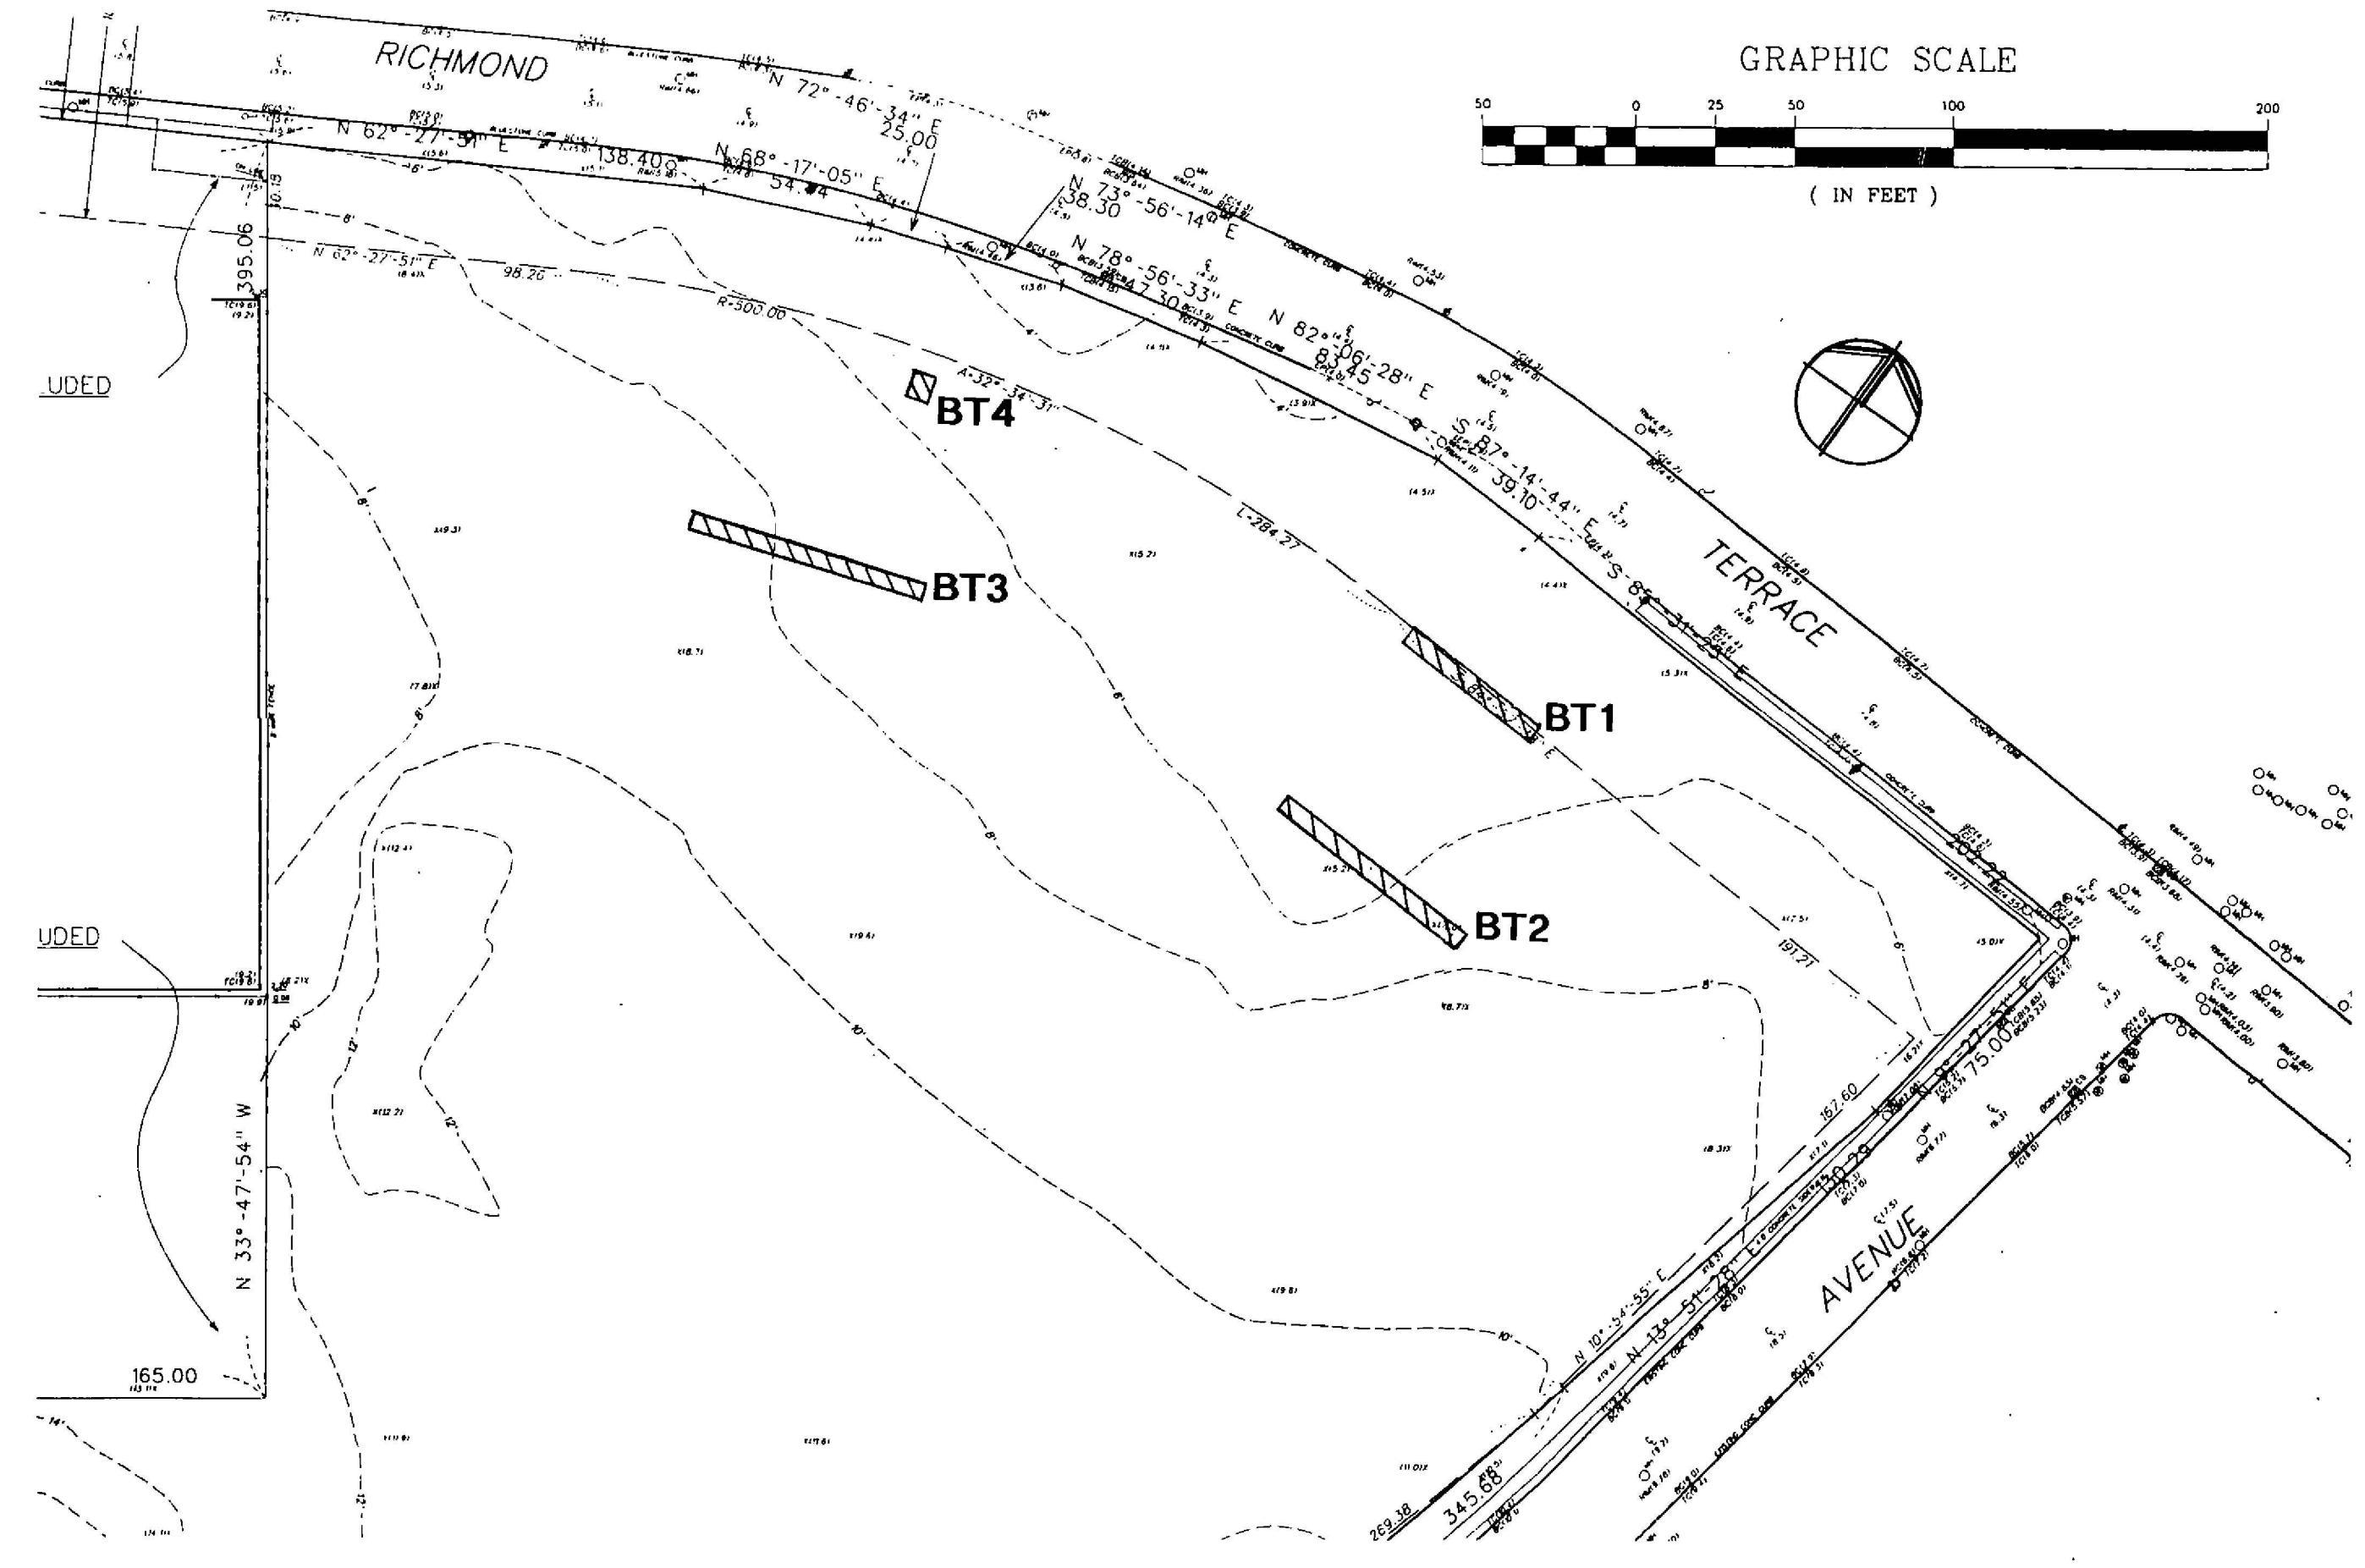
Locations of Backhoe Trenches 1 through 4 within the project area.

The program of archaeological testing based on the background research report was designed by Greenhouse Consultants Incorporated and approved by the staff of the New York City Landmarks Preservation Commission. This program included four backhoe trenches 25 to 75 feet long by five feet wide. Two were designed to test the former Johnson lot, with one trench just behind the former house location, and the other within the rear yard. The other two trenches were similarly located within the former Lynch lot.

Due to existing conditions it proved impossible to manuever the backhoe into position to completely excavate Backhoe Trench 4. This trench was situated just behind the former Lynch house location. The majority of the planned location was covered by a mound of rubble with concrete and asphalt visible on the surface. Standing water lay to the south and west. Sizeable trees were growning on and around the mound of rubble. The backhoe could not get up the slope on the east side of the mound. Trees blocked the north side, and the water blocked the south and west sides. This left only the eastern end of the planned location accessible. Backhoe Trench 4 was therefore limited to eight feet by 7 feet in size.

Backhoe Trench 2 was moved slightly to the north to avoid another pile of concrete tubble. It was not reduced in size and still crossed the rear yard of the Johnson lot. Backhoe Trenches 1 and 3 were completed as planned.

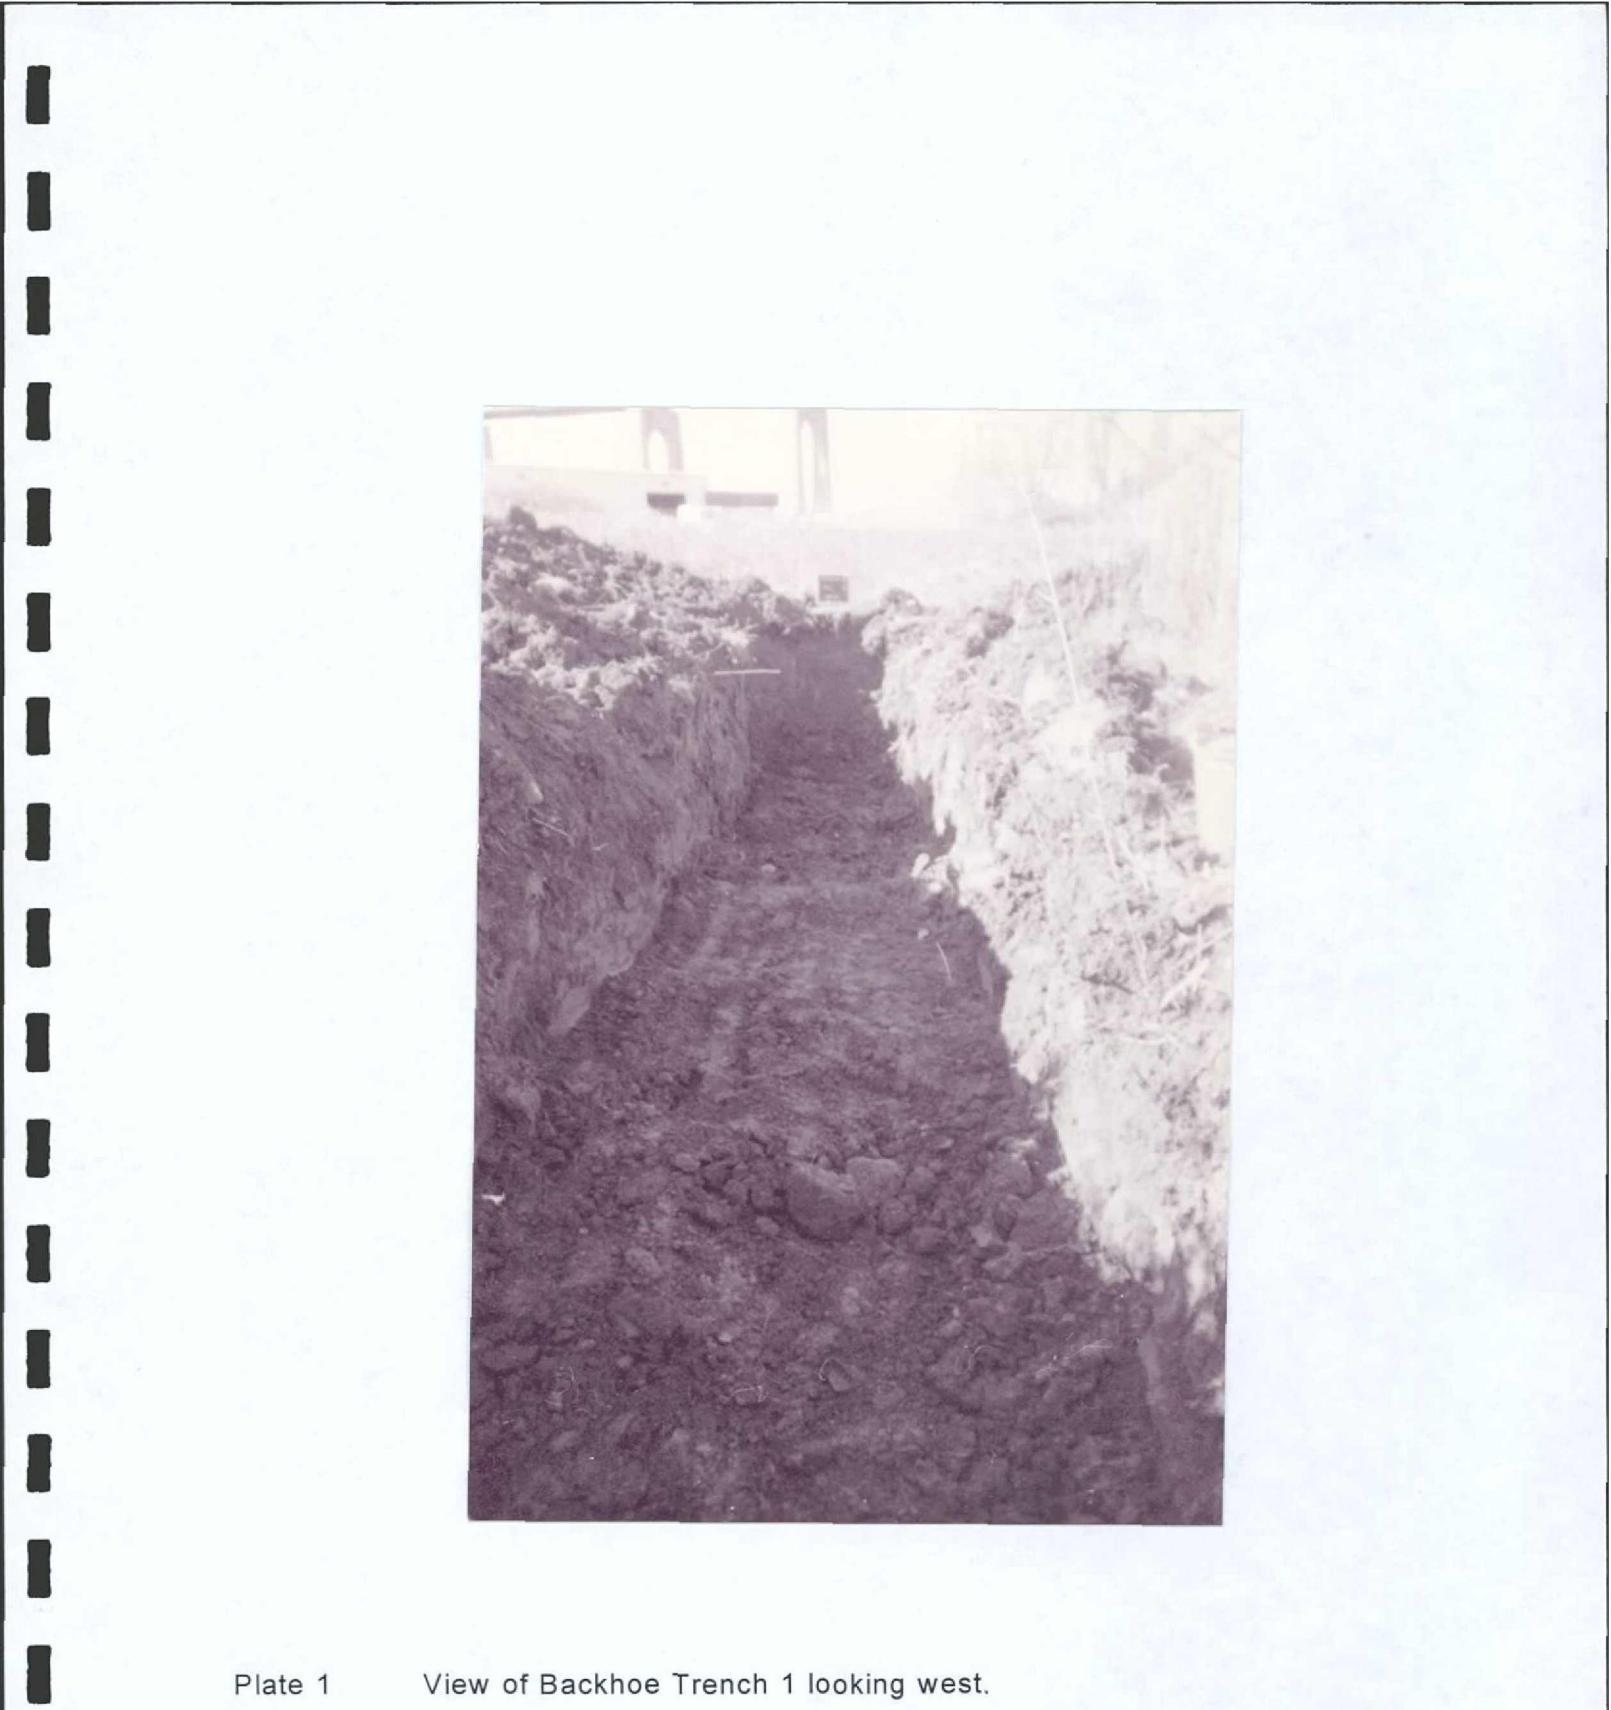
Plate 1 View of Backhoe Trench 1 looking west.

Three to four layers were recorded in each of the four backhoe trenches. Backhoe Trench 1 included four layers, while the others had three.

The fourth deposit found in Backhoe Trench 1 consisted of red brick rubble in strong brown clayey silt. This deposit was found only at the east end of the trench where it replaced layer two. It began at 0.5 feet and extended to 3.2 feet below grade. This deposit was identifed as destruction rubble from the former Johnson house.

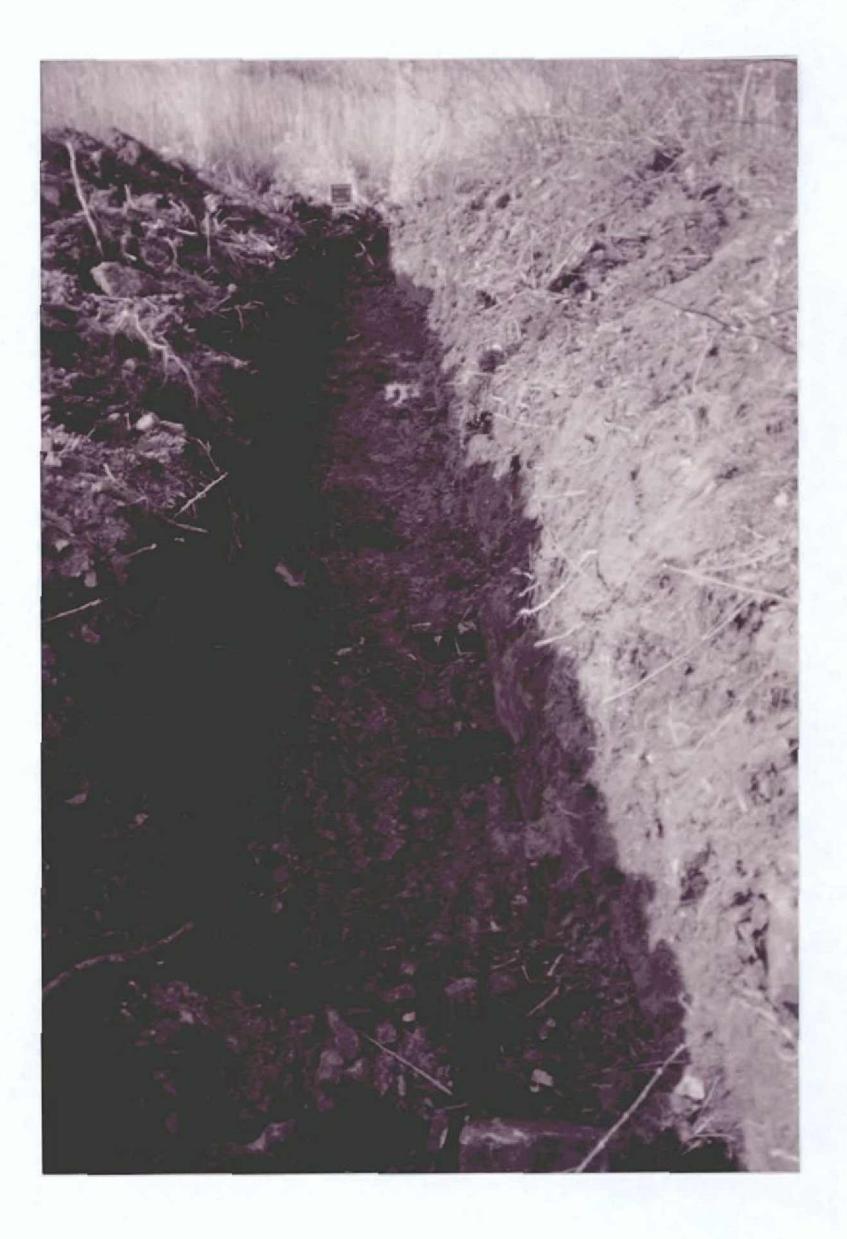
Plate 2 View of Backhoe Trench 2 looking west.

Historic period artifacts were seen in the top layers of Backhoe Trenches 1, 2 and 3. A sample of ceramics was collected from Backhoe Trench 2. Most of the artifacts seen in Trenches 1 and 3 were obviously modern, including styrofoam and other plastics, so these were discarded. The ceramics collected from Trench 2 date to the late nineteenth century, the period when this lot was in use by the Johnson family. Howver, since there were no discrete features or concentrations of artifacts, and the deposit was in the surface layer, it is not seen as potentially significant.

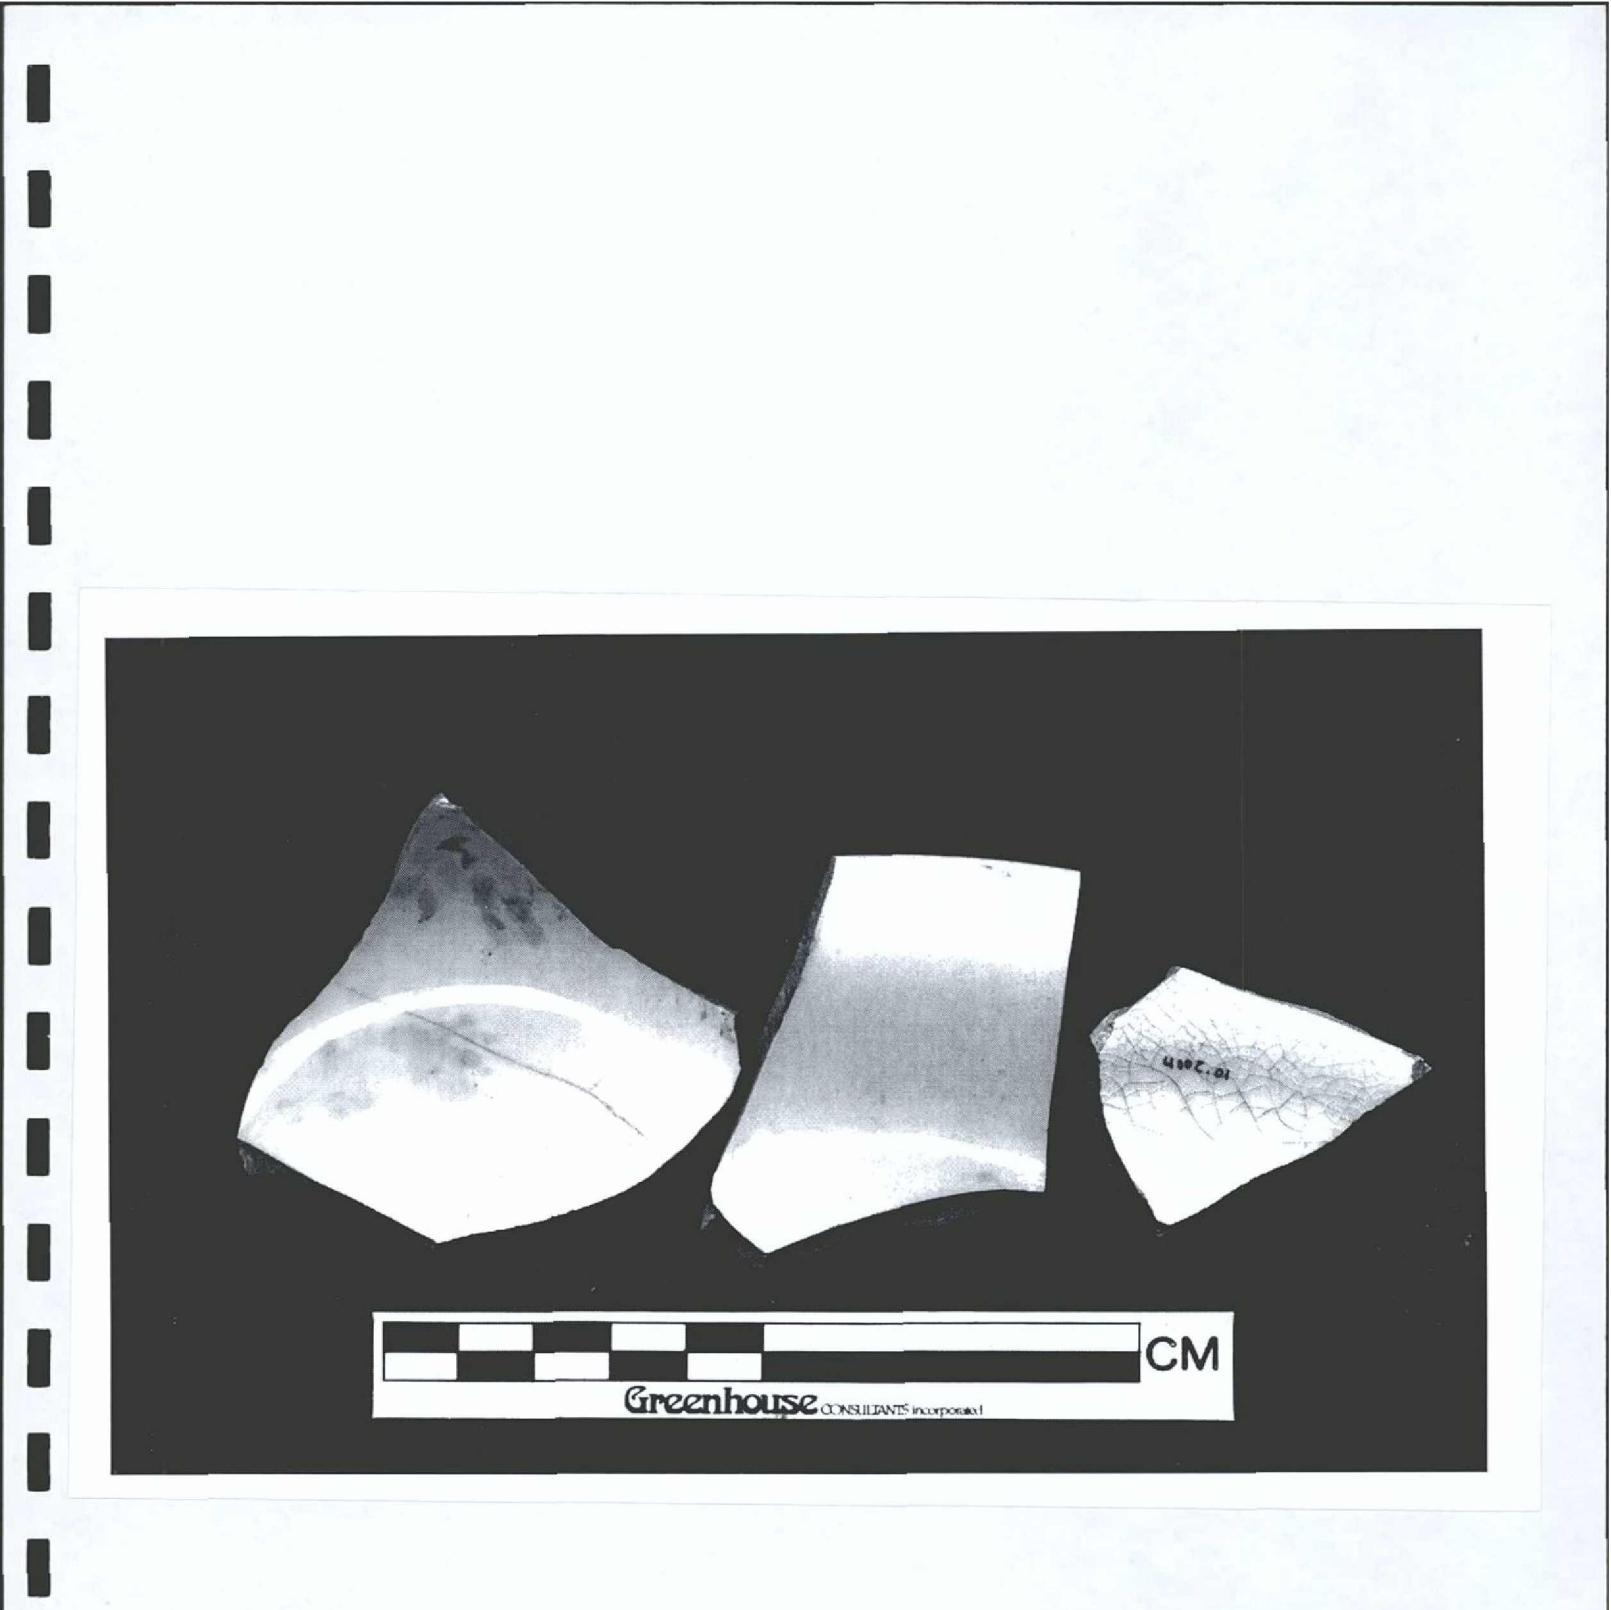
Four artifacts, all ceramics were recovered from the first layer of Trench 2. Catalog #1 was an ironstone sherd base with footring, Catalog #2 was an ironstone bowl rim. Catalog #3 was and ironstone sherd decorated in underglaze and overglaze handpainted and transfer printed polychrome floral. See Plate 5, Catalog Nos. 3, 2 and 1. Catalog #4 was a plate rim with an embossed dot and ribbon pattern, decorated with a blue sprigged grape and leaf bouquet. Sprigged relief decoration is known as Chelsea type, since Chelsea was the first pottery to engage in this work. Decoration of this type was popular in the 1860s through 1880s (Punchard 1996:76, 134). See Plate 6.
