FIELD SURVEY ADDENDUM

ARCHAEOLOGICAL ASSESSMENT of the POILLION-SEGUINE-BRITTON-HOUSE

HARBOR VIEW HEALTH & BEAUTY SPA-

by HISTORIC SITES RESEARH PRINCETON, NEW JERSEY

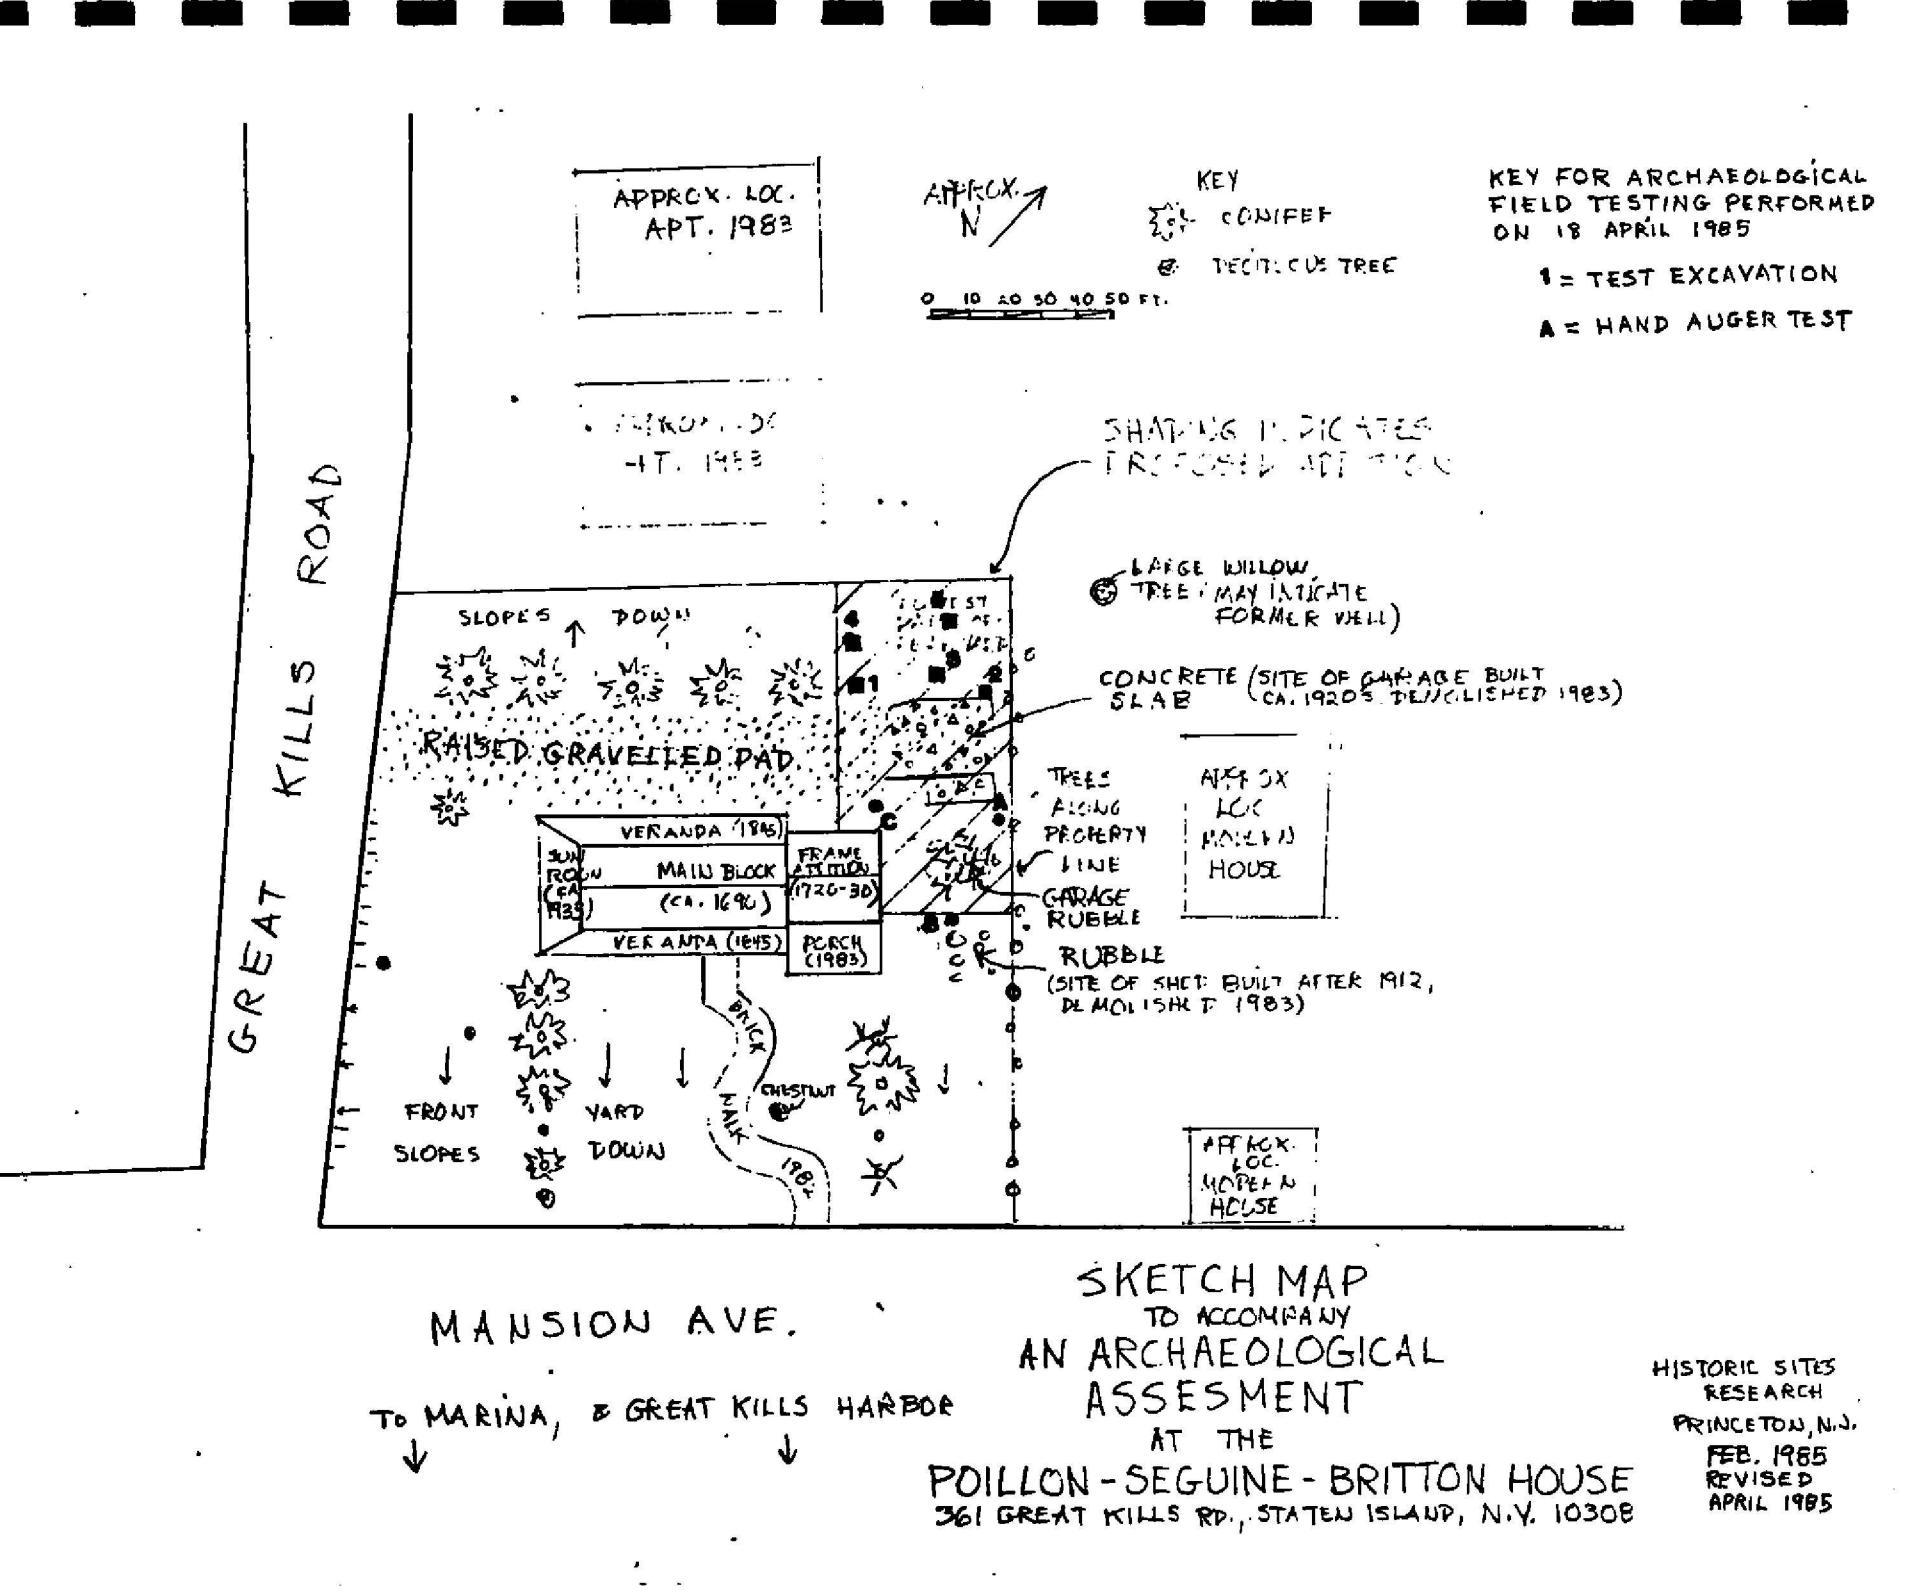
Stratigraphy from tests 1 through 5 is shown in profile drawings, and interpreted in terms of artifact content in Section II of this addendum report. Three auger tests were dug in the area which will be disturbed only by the construction of a new building that is proposed to rest on a slab at grade level. Consequently, soil will be disturbed less than 1 foot deep, except for bearing walls around the periphery. These auger tests penetrated from 18 to 25 inches deep, and showed that cultural strata do not exist here. No artifacts were found in the auger tests.

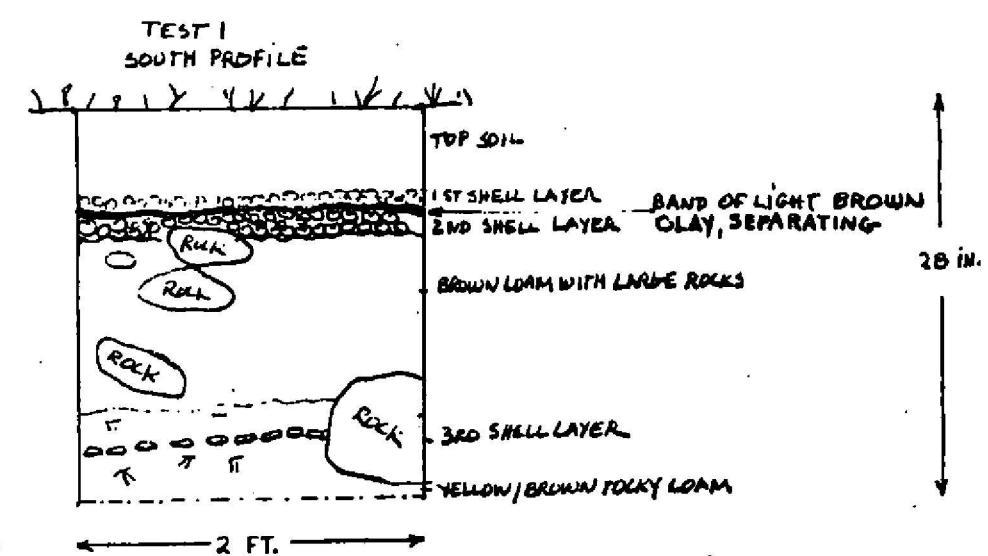
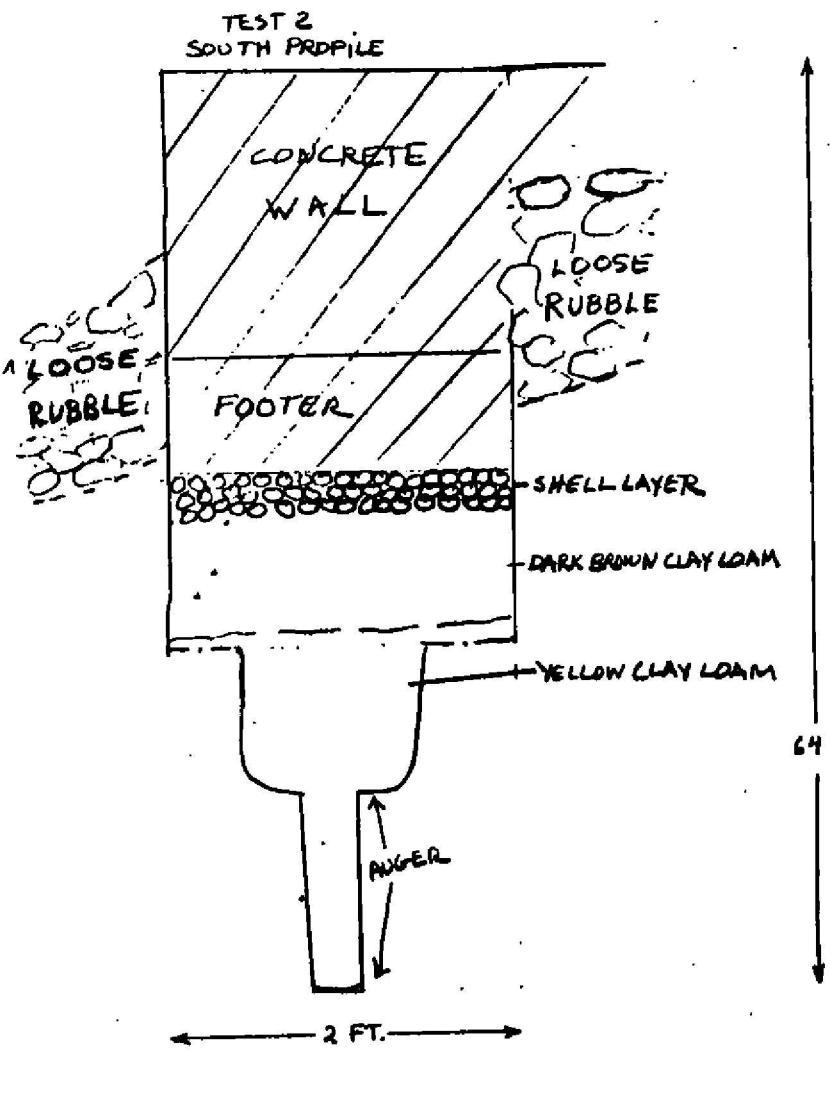
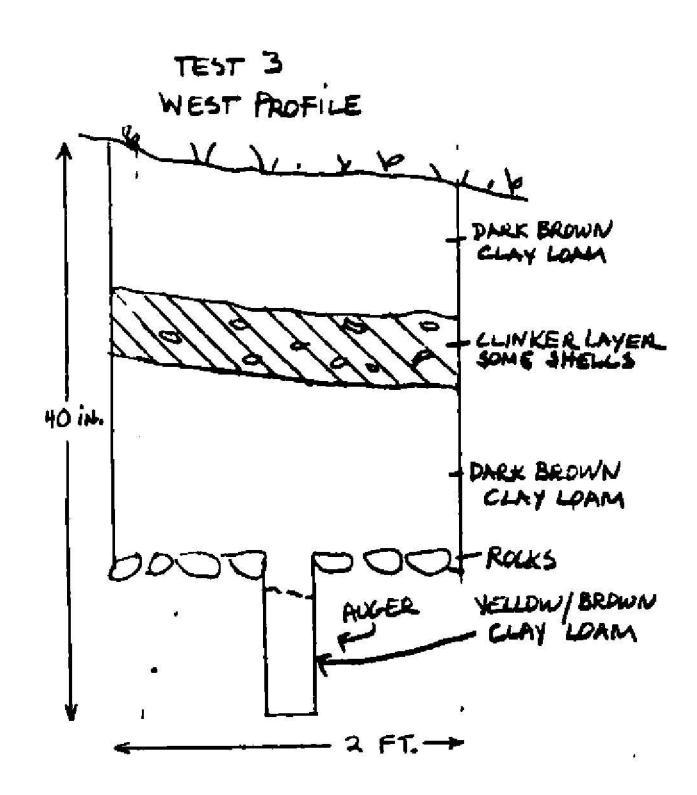
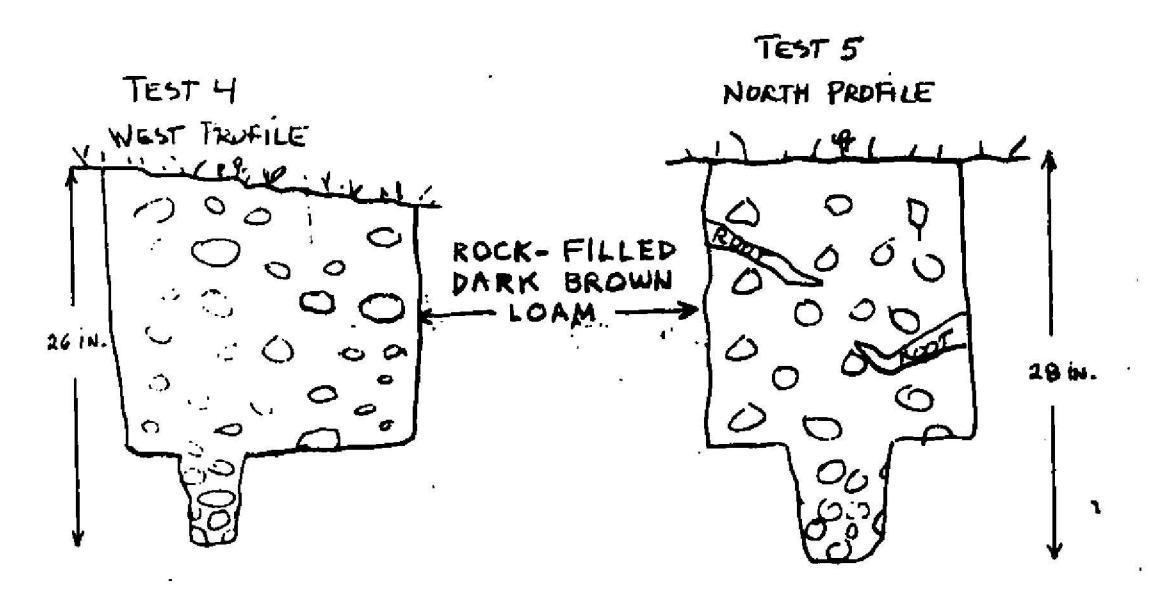
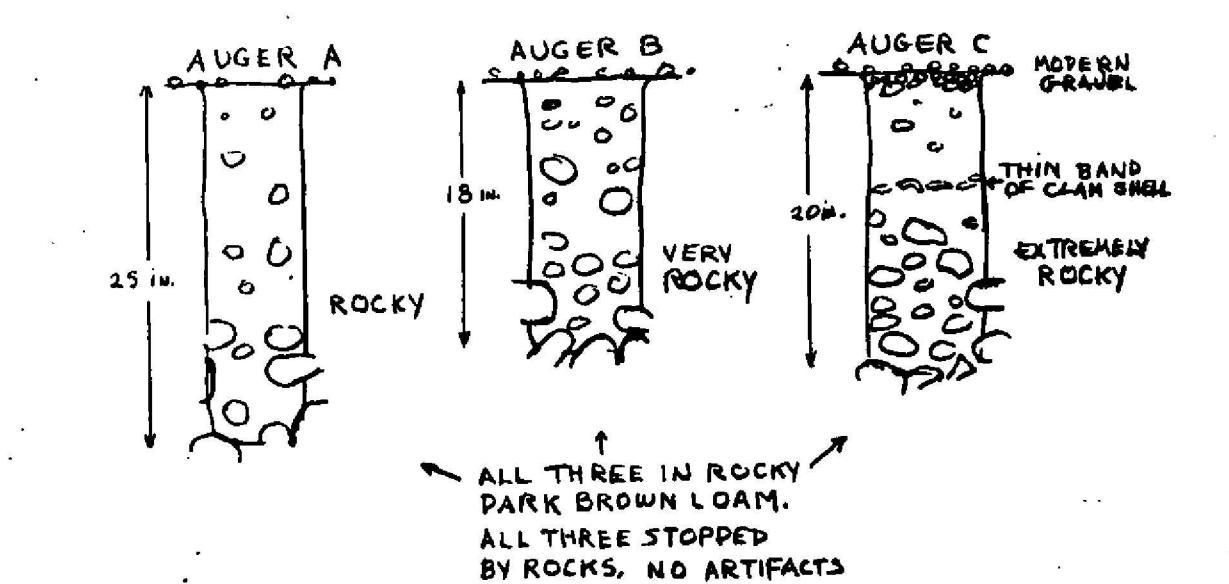
## TEST PIT PROFILES

Test 1 yielded artifacts which were associated with three discrete shell layers. The first two were between 6 and 9 inches below the present surface, separated by an inch of brown loam. This separation was not visible during excavation and the artifacts are cataloged as Lot 1. Among the shells were broken ceramic sherds, kaolin pipe fragments, animal bone and a few nails and pieces of glass. The soil underlying the shell to a depth of 28 inches was primarily rocky loam with several large boulders. At 28 inches a thin band (1 layer thick) of clam shell was encountered, which contained the base of an oriental bowl. In the same layer were sherds of 19th century whiteware, indicating that the soil was probably deposited as fill and was not temporally stratified.

Test 2 was placed against the north edge of the concrete foundation that is to be removed in an area not completely buried under rubble too heavy to be moved. A shell strata containing artifacts in Lot 4 indicate it as of modern origin. Artifacts were also present 12 to 17 inches below the surface. This layer (Lot 5) contained a combination of 19th century ceramic wares and some food debris. No cultural material was present below 17 inches.

Test 3 consisted of three recognizable upper soil strata: (1) an upper layer of dark brown loam, (2) a band of clinker and

ash, and (3) another layer of dark brown loam. Below that was sterile yellow brown clay loam subsoil. The artifacts listed in Lot 6 were recovered from below the clinker (14 to 28 inches). Tests 4 and 5 contained only a scattering of late 19th to early 20th century material.

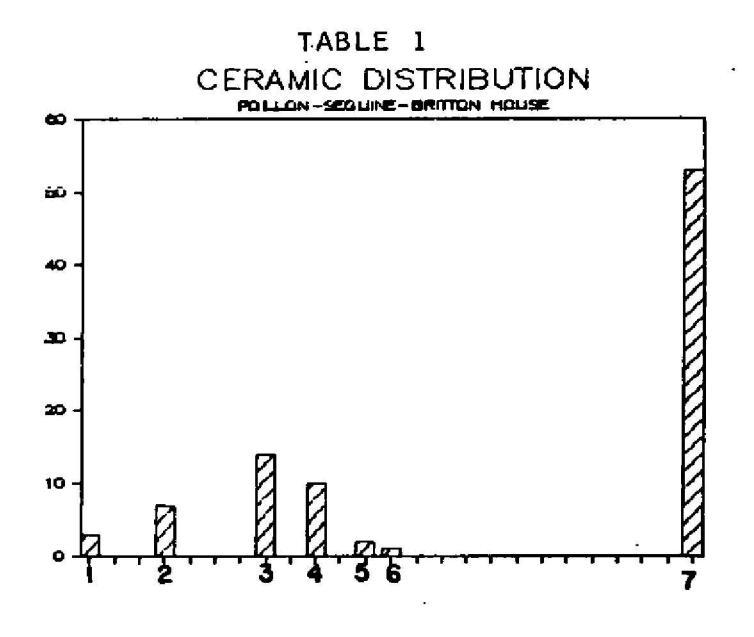
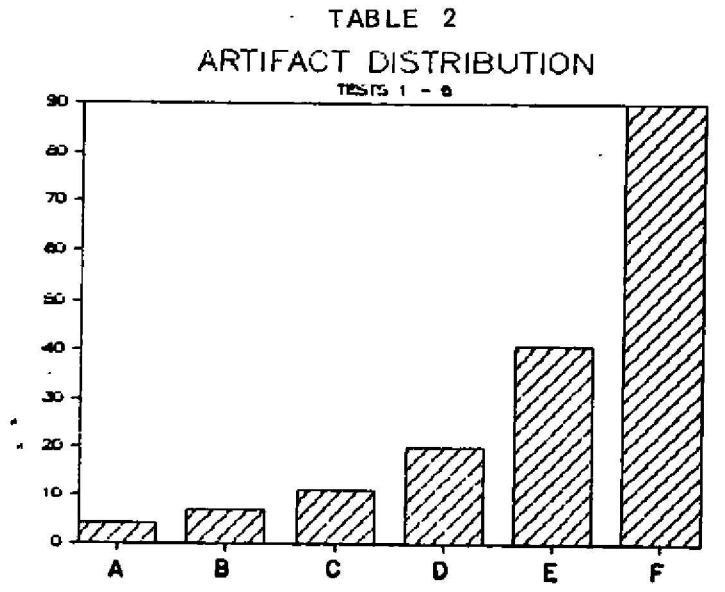
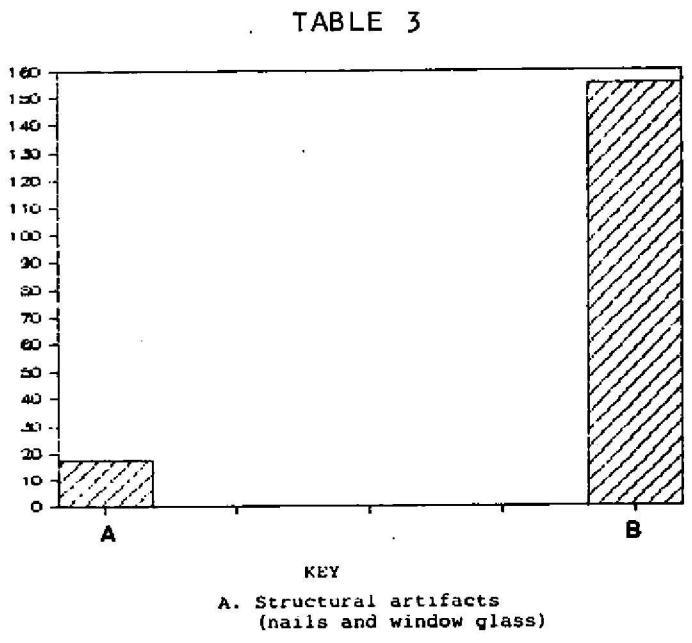
B. Domestic artifacts

Based on the distribution of artifacts and the soil profiles, Tests 1,2, and 3 mark the northern edge of the 19th century deposits and resources do not extend to the northern edge of the property. Table 1 presents the ceramic distribution compiled from all tests. It shows 19th century whiteware as the most common type of ceramic sherds. The other types represented are typical of the late 18th and early 19th century. In no instance could these types be found stratigraphically separated. Table 2 shows the overall types of material present at the site, and Table 3 demonstrates the statistical difference in presence of structural artifacts (nails and window glass) from domestic artifacts (ceramics, food debris, smoking pipes, and bottle glass). The low proportion of structural material (10% of the entire sample) suggests that the tests were not in proximity to previous structures.

A	<b>4 KAOLIN PIPES</b>
B	7 WINDOW GLASS
С	11 CUT NAILS
D	20 BOTTLE GLASS
E.	41 ANIMAL BONE
£	90 CERAMICS
