# REPORT ON ARCHAEOLOGICAL MONITORING OF EXCAVATIONS FOR GRADING AND IRRIGATION AT THE PARADE GROUND GOVERNORS ISLAND, NEW YORK, NEW YORK

September 29, 2017

This is a report on archaeological monitoring conducted during grading and irrigation line excavations for creating play fields in the Fort Jay Parade Ground on Governors Island, New York. The Parade Ground is within both the Governors Island National Historic Landmark District and the New York City Landmark District. The work was completed to comply with environmental review regulations. It meets the standards of both the New York State Office of Parks, Recreation and Historic Preservation (SHPO) and the New York City Landmarks Preservation Commission (LPC). The project was conducted for Bedford Carp Construction, Inc under the auspices of The LiRo Group by Linda Stone, RPA.

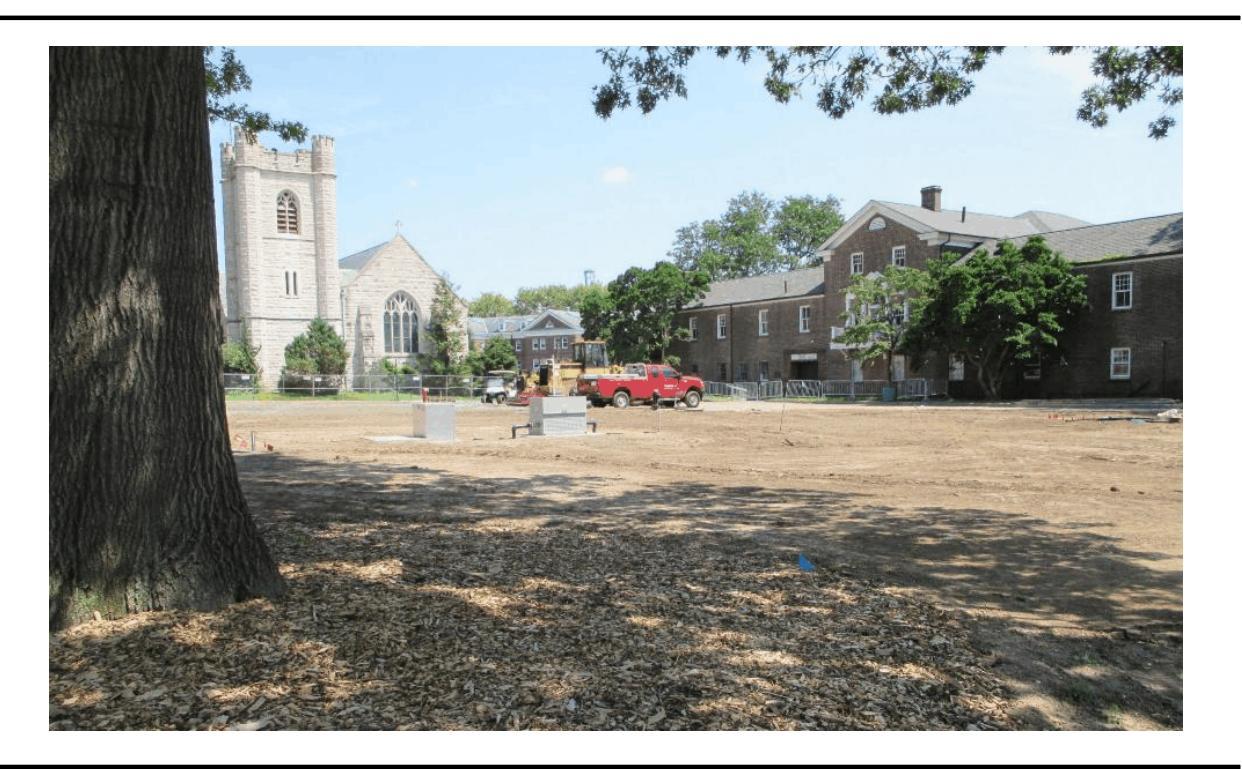
Southeast Corner of the Parade Ground upon completion of grading and irrigation connections, facing southeast (Image 1037: July 31, 2017).

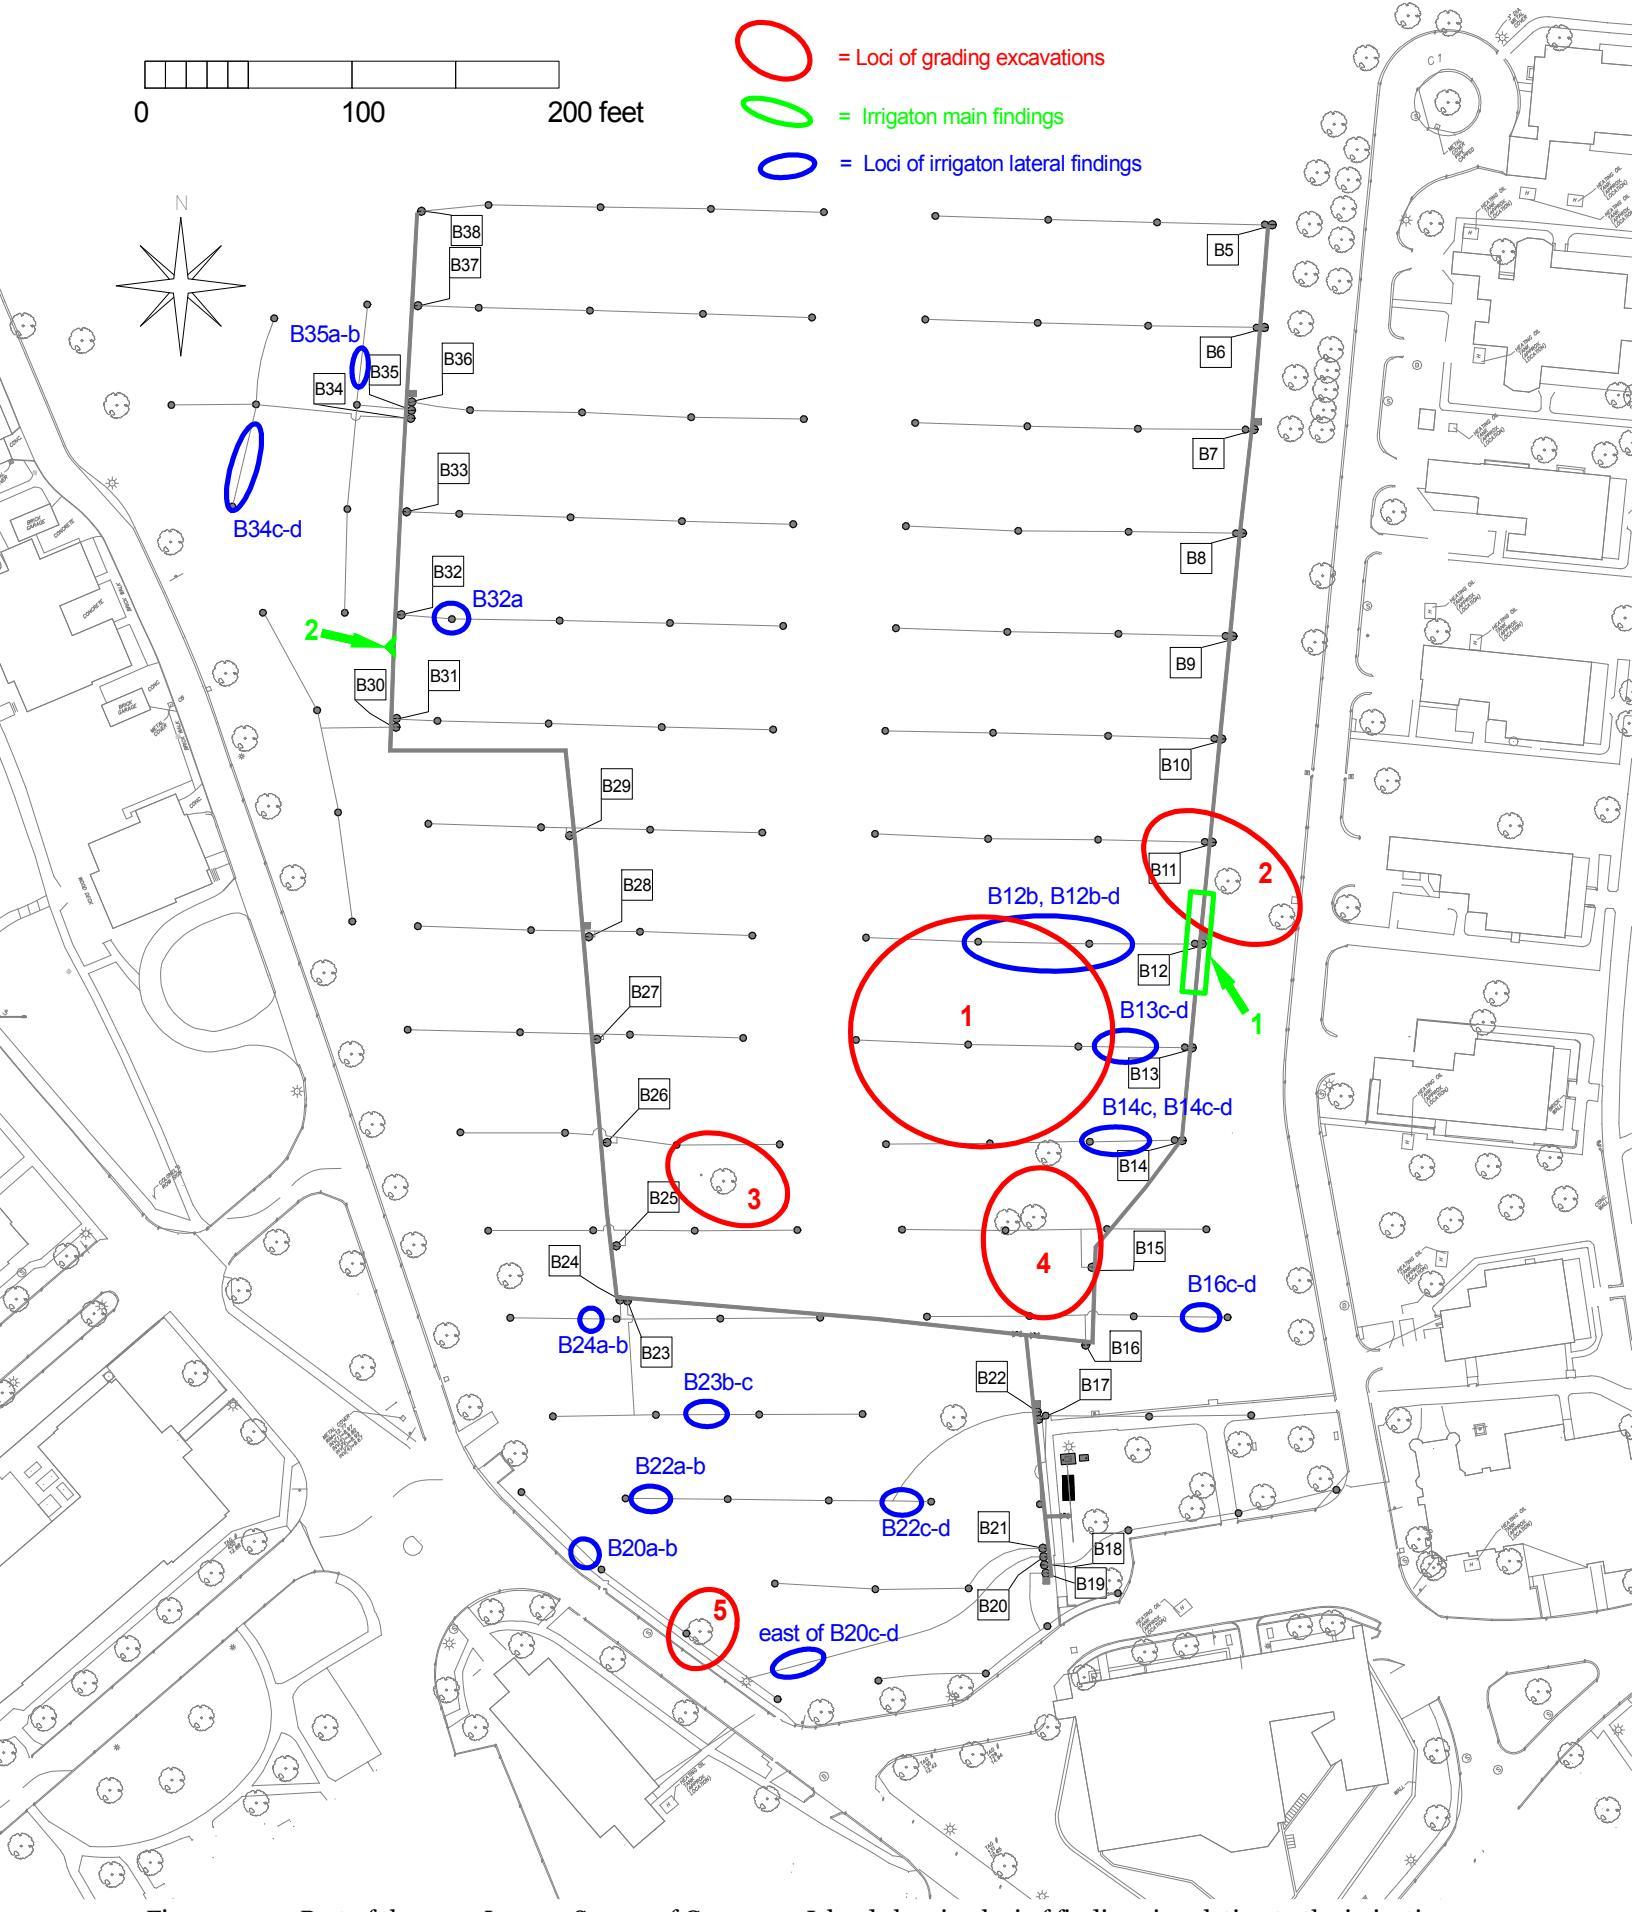
Figure 4

obstructions were documented at sprinkler head locations during lateral pulling; B12b, B14c, B32a and B34d (see Figure 4). Thirteen other obstruction locations were noted between sprinkler heads and were documented, but no excavation was conducted since the contractor did not need to open the ground in those places; B12b-c, B12c-d, B13c-d, B14c-d, B16c-d, B20a-b, 60 feet (18m) east of B20c-d, B22a-b, B22c-d, B23b-c, B24a-b, B34c-d and B35a-b (see Figure 4).

Part of the 2012 Langan Survey of Governors Island showing loci of findings in relation to the irrigation plan.

Irrigation main excavation monitoring revealed both two archaeological features and also the extent of the existing top soil in some places. These features are part of a brick path and its construction staging area (Irrigation Locus 1 on Figure 4), approximately 24 feet (731 cm) south of B11, and part of a possible footing or foundation (Irrigation Locus 2 on Figure 4), approximately 10 feet (305 cm) south of B32, which could have been belonged to the former battery/magazine.

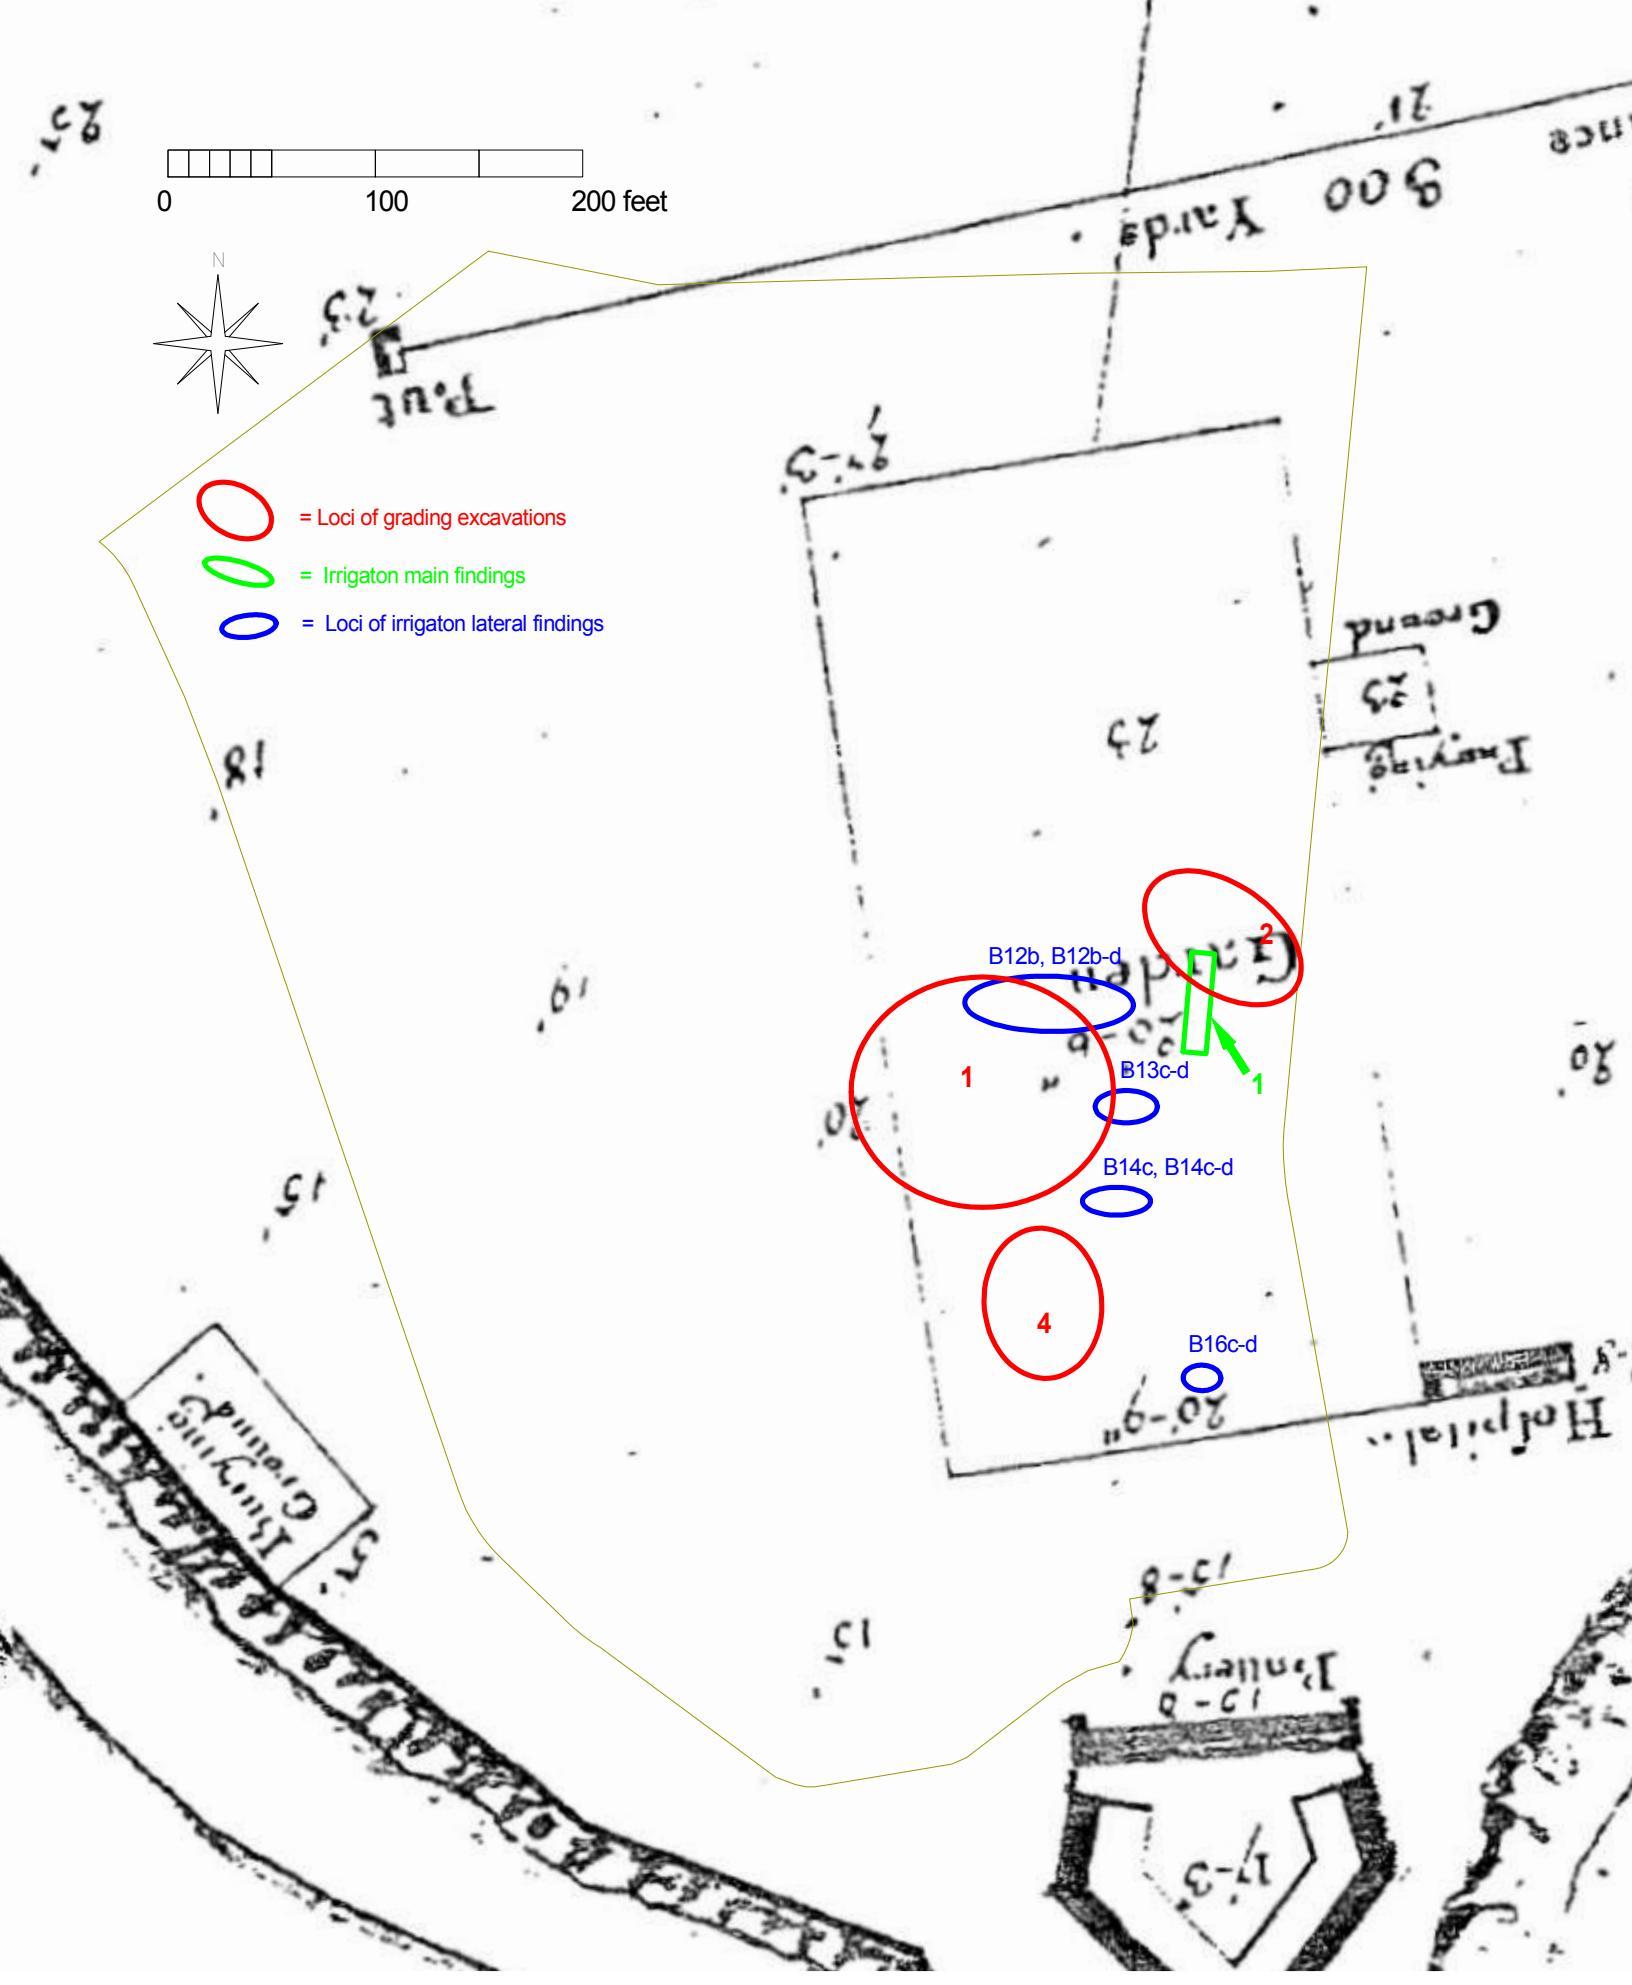
Figure 5

Part of the 1813 Mangin map of Governors Island showing the Parade Ground project area with the location of findings potentially associated with the Garden.

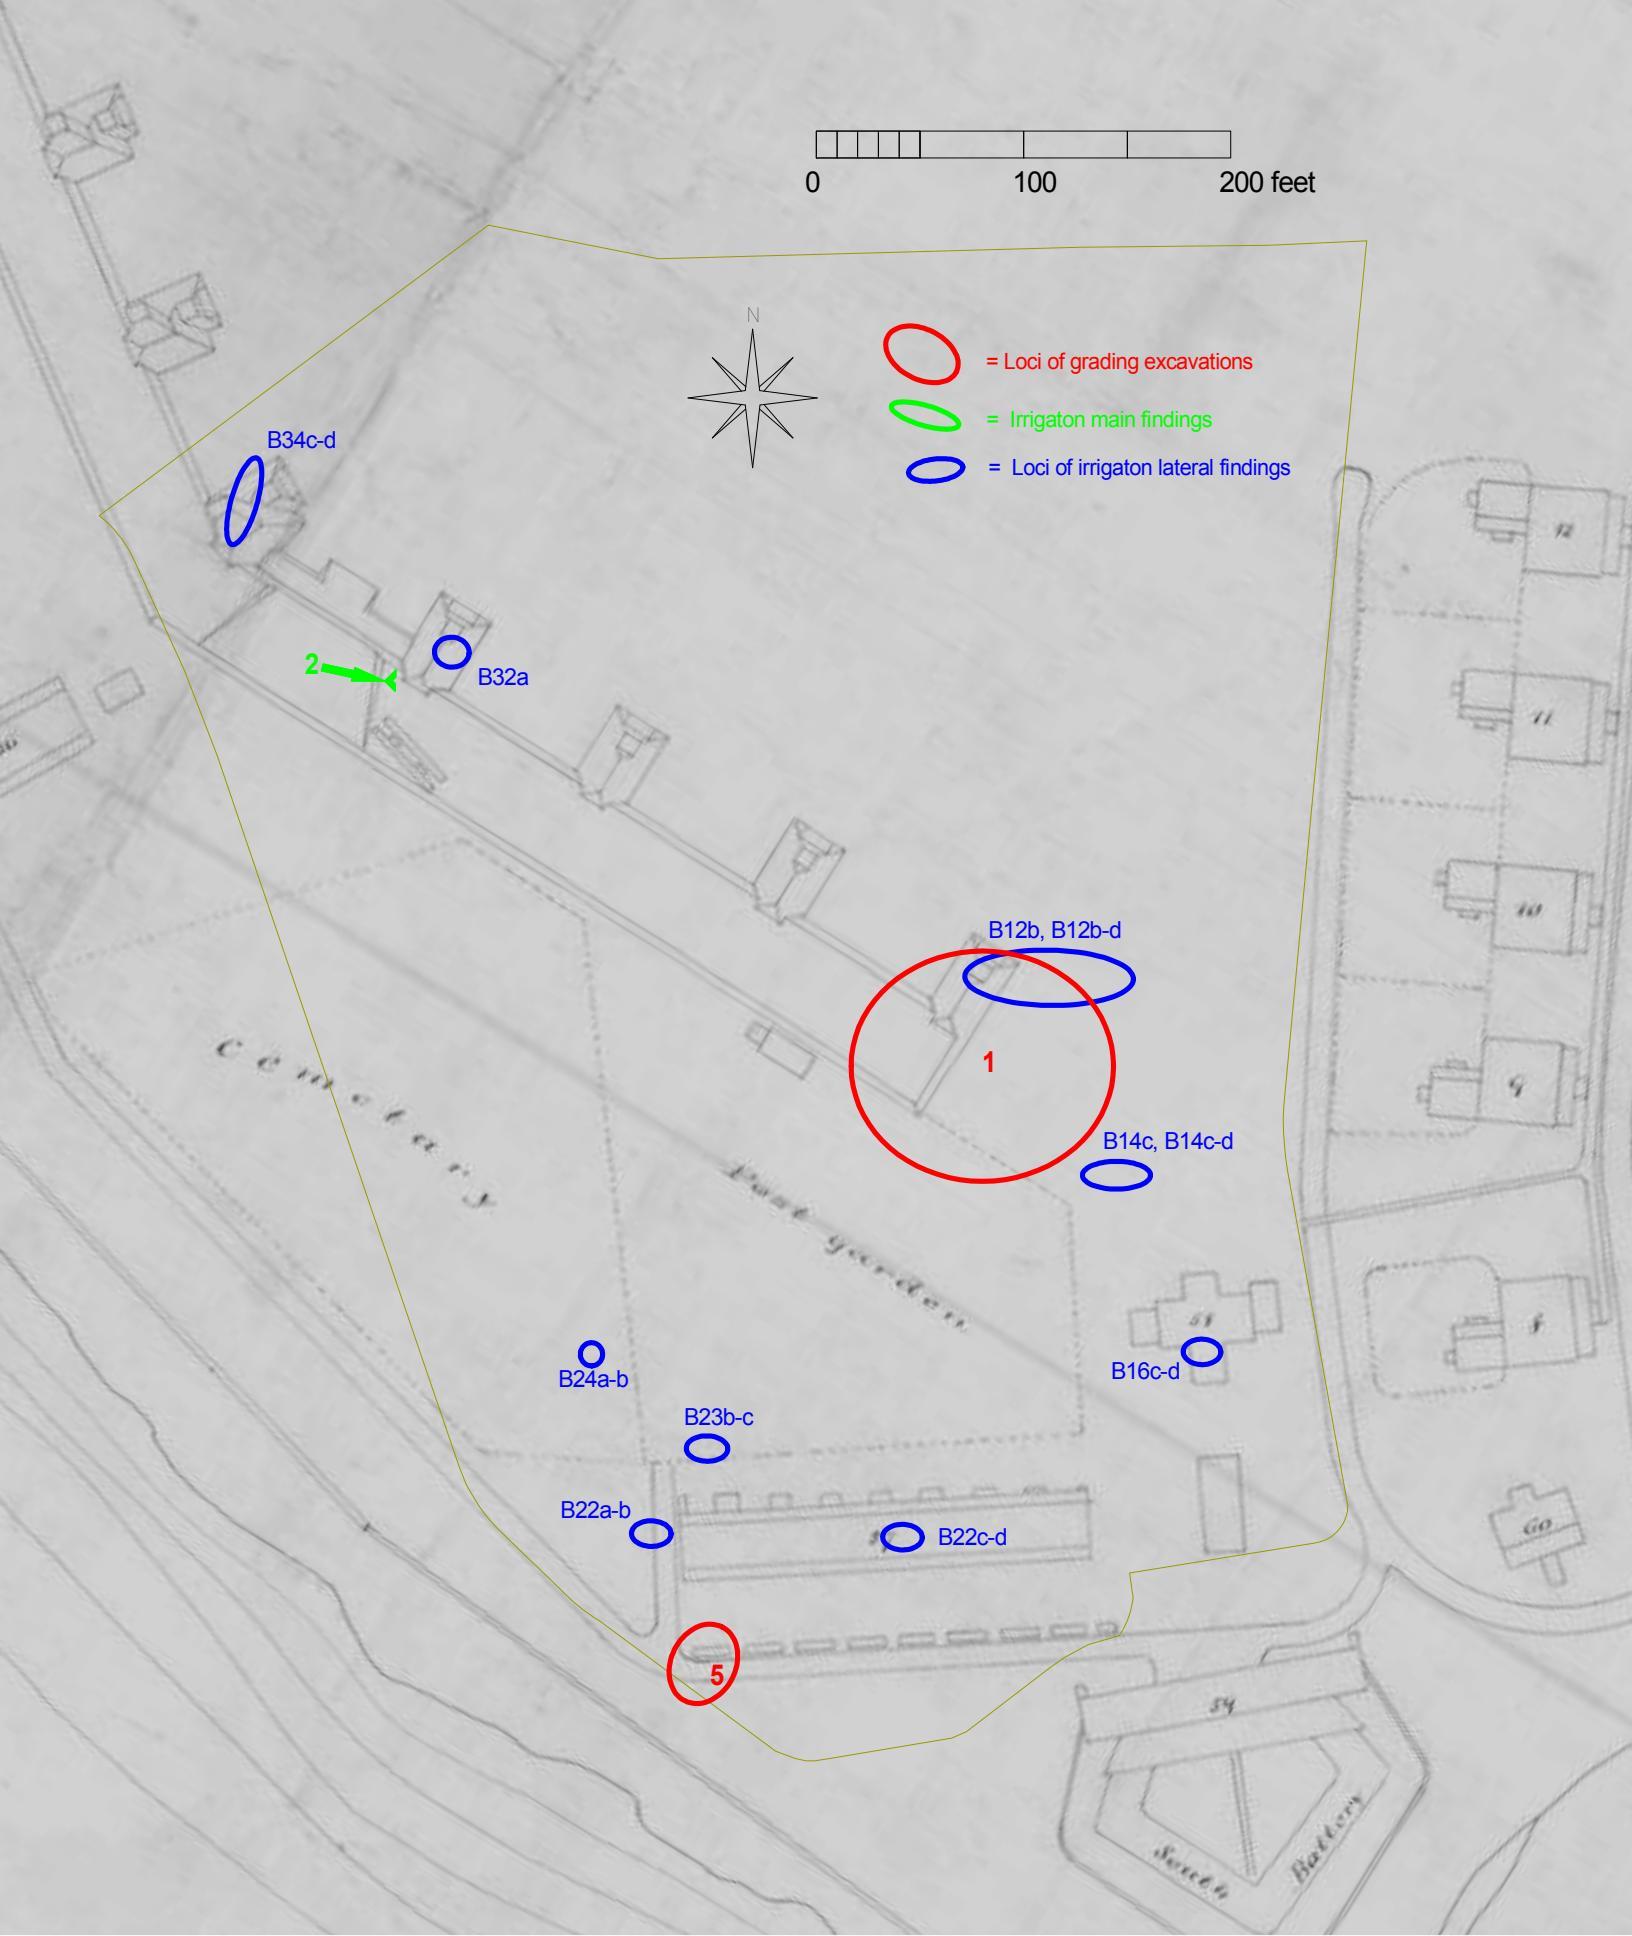
Figure 7

The 1879 map also depicts the partially completed battery/magazine. Several loci of findings from this project are potentially associated with it (see Figure 7). The most substantial of these is the possible footing or foundation corner identified in Irrigation Locus 2. Although no artifacts were found in association with the portion of the feature exposed in the irrigation main trench, the mortar used had very large aggregate, indicative of an older structure. Furthermore, based on the size of the feature, the walls of this structure would have been 2.5 feet (76 cm) thick. Both of these facts are consistent with a battery and magazine.

Part of the 1879 Army map of Governors Island showing the Parade Ground project area with the location of findings potentially associated with features and structures on this map.

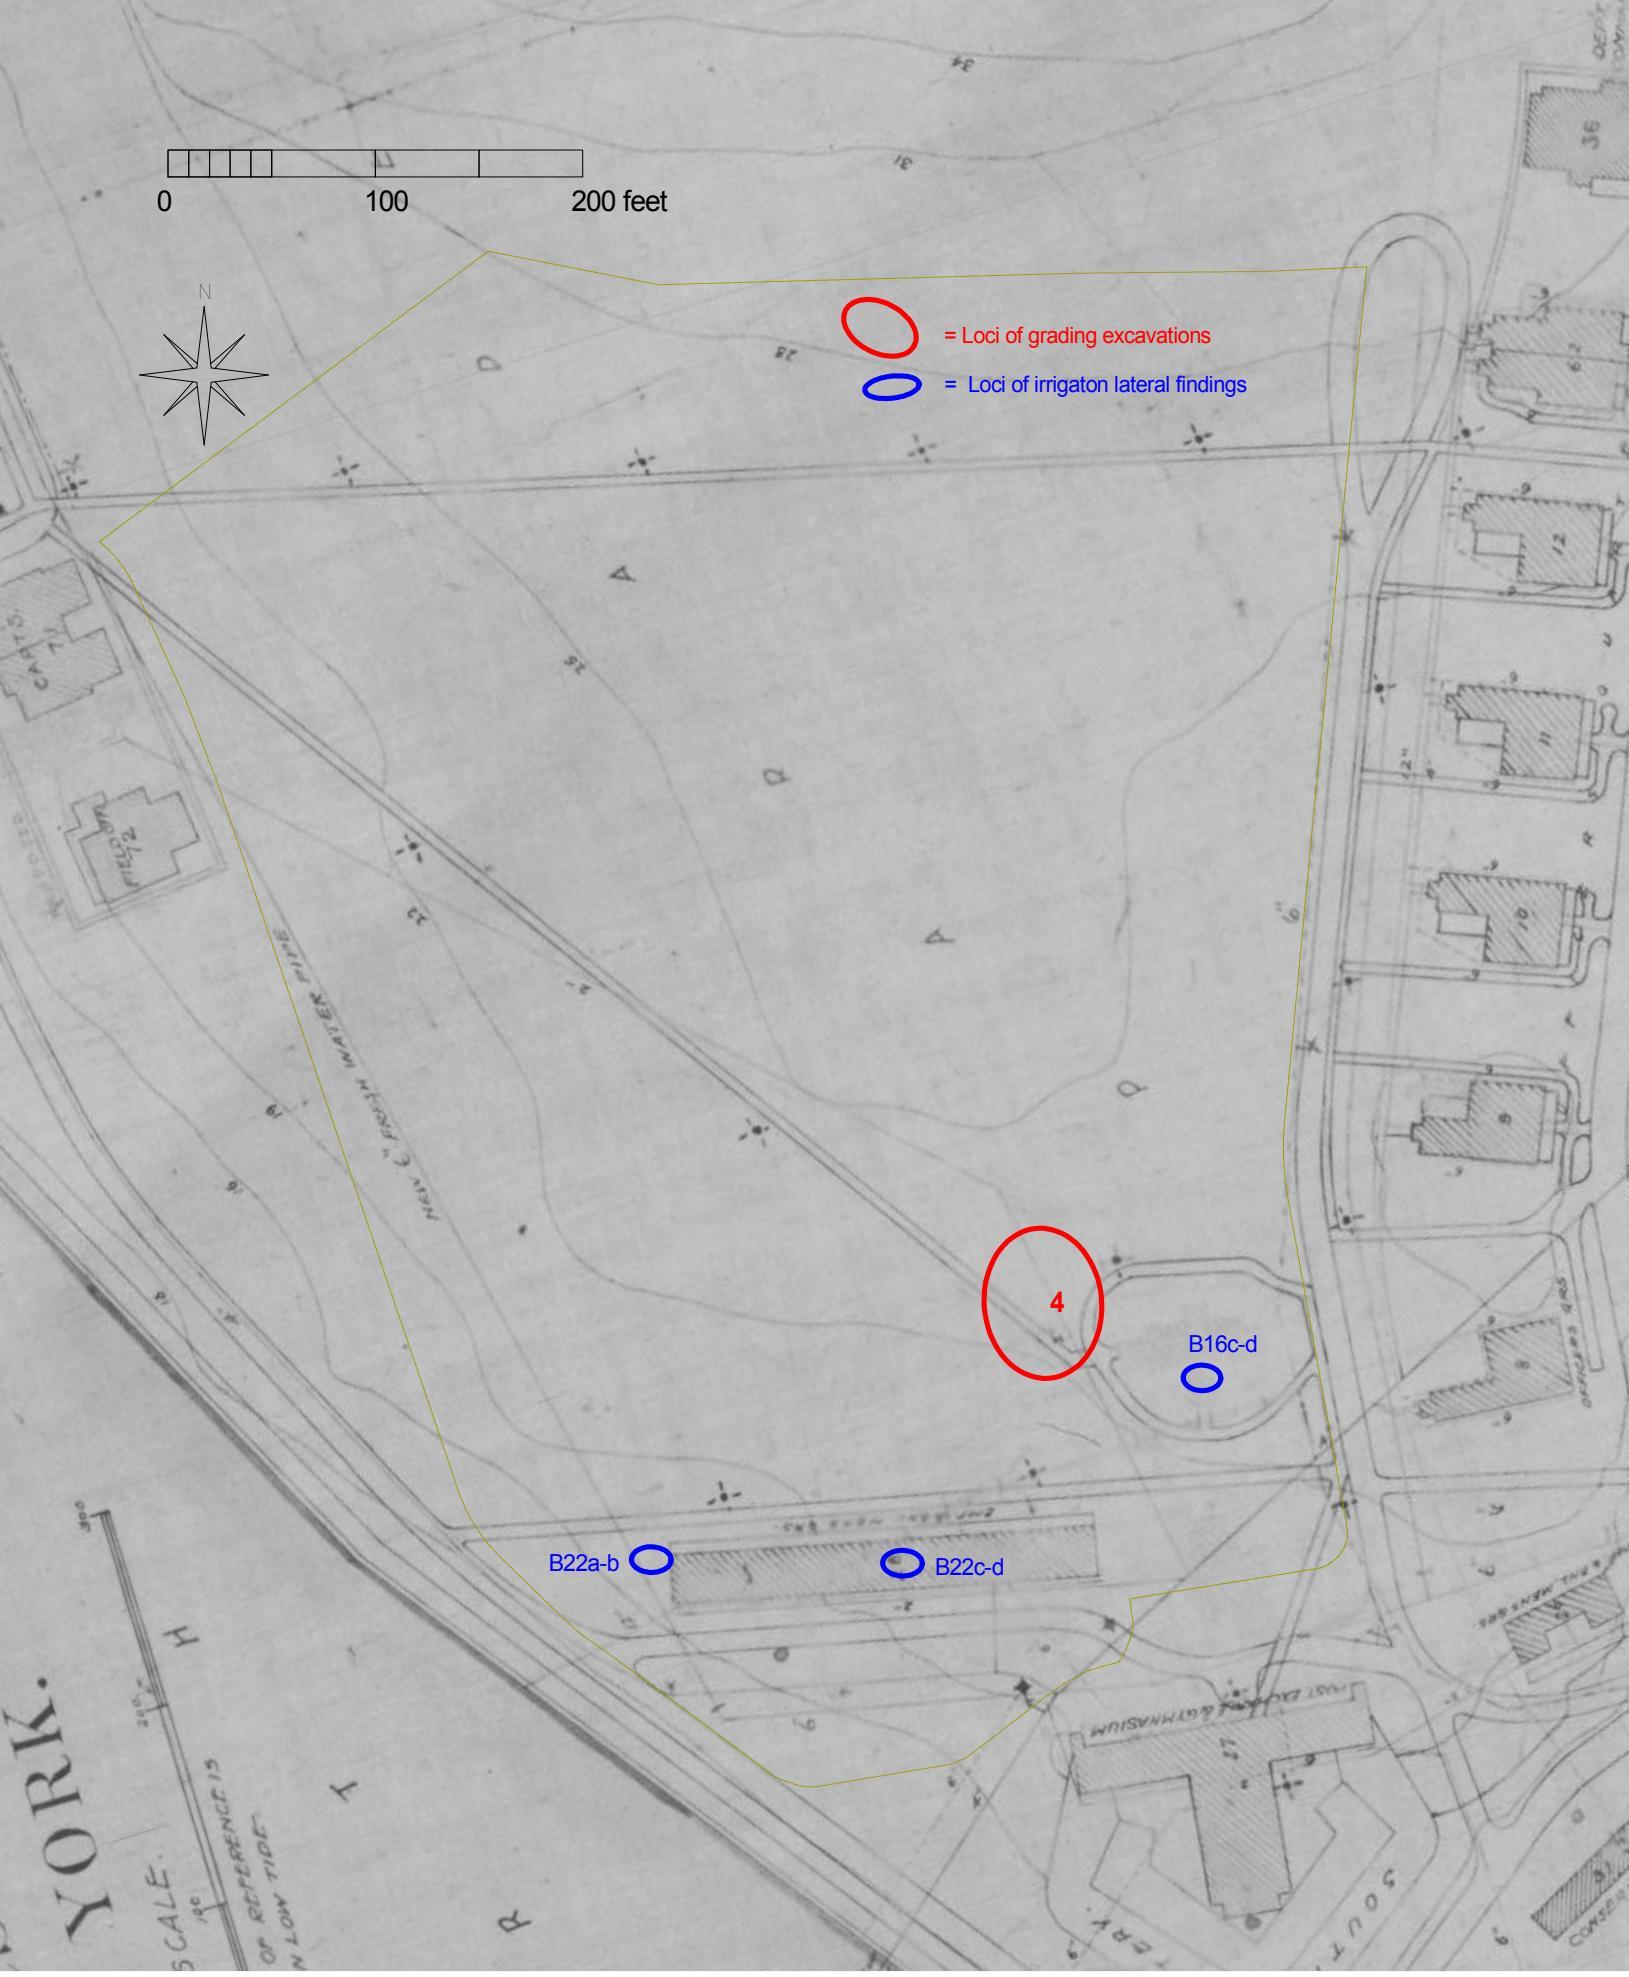
Figure 8

Part of the 1906 Hilton map of Governors Island showing the Parade Ground project area with the location of findings potentially associated with features and structures on this map.
