PHASE IB ARCHEOLOGICAL INVESTIGATION Bloomingdale Park Athletic Field Improvements

Ramona Avenue and Lenevar Avenue Borough of Staten Island Richmond County, New Yor

HAA # 5238-11

Prepared by: Hartgen Archeological Associates, Inc.

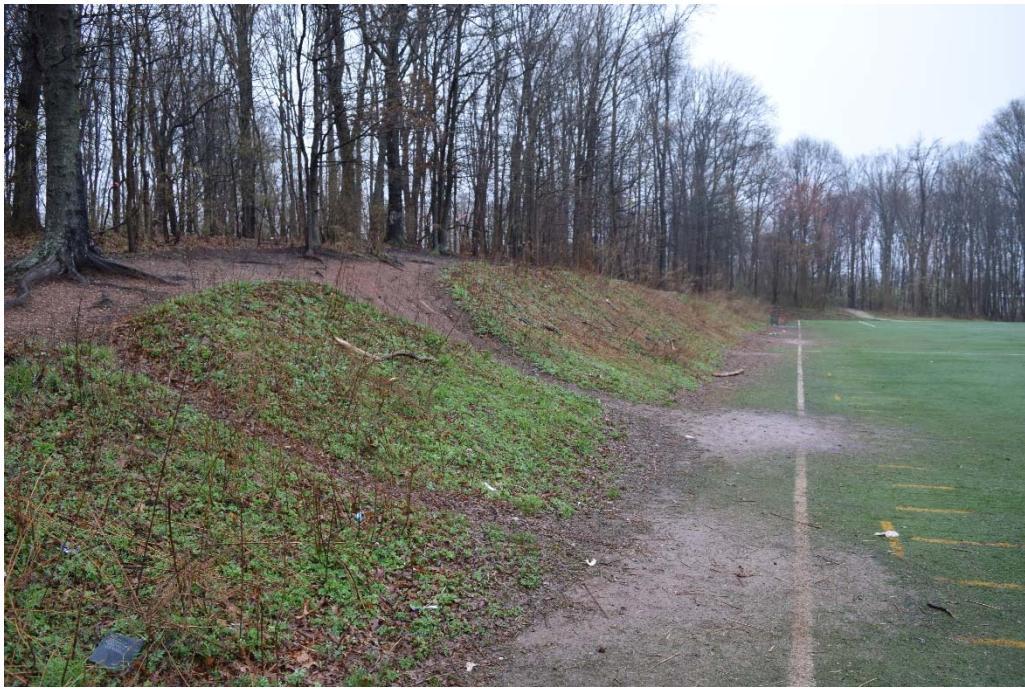
Photo 1. View northeast along a cut slope which is eroding on to the synthetic turf field. This area has no archeological potential due to disturbance caused by the cut.

Fourteen shovel tests were excavated in two areas. Tests 1-5 were excavated along the northern edge of the existing synthetic turf field at the top of an eroding slope (Photos 1-2). These tests were placed in locations set back from the eroded edge where the potential to encounter intact soils appeared highest. The stratigraphy was natural and consisted of a shallow (6-12 cm), dark, loamy topsoil about a reddish brown, gravelly loam subsoil. There was no plowzone. No artifacts were encountered.

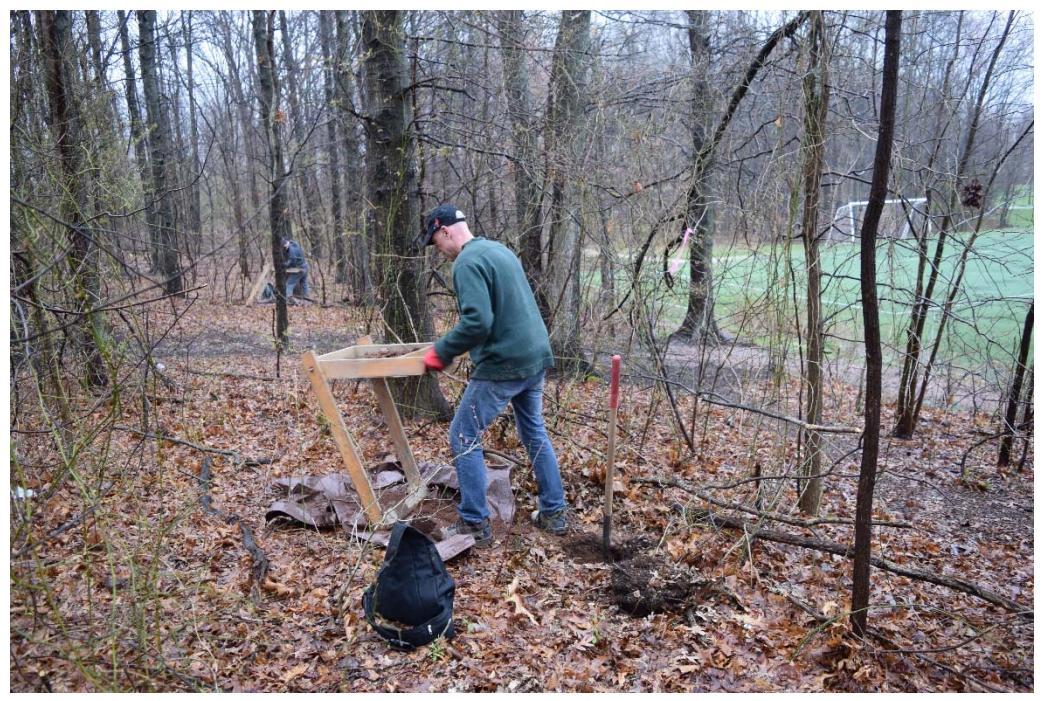
Photo 2. View northeast of shovel tests being excavated along the top of the eroding slope. The soils were undisturbed in this area. However, no artifacts were encountered.

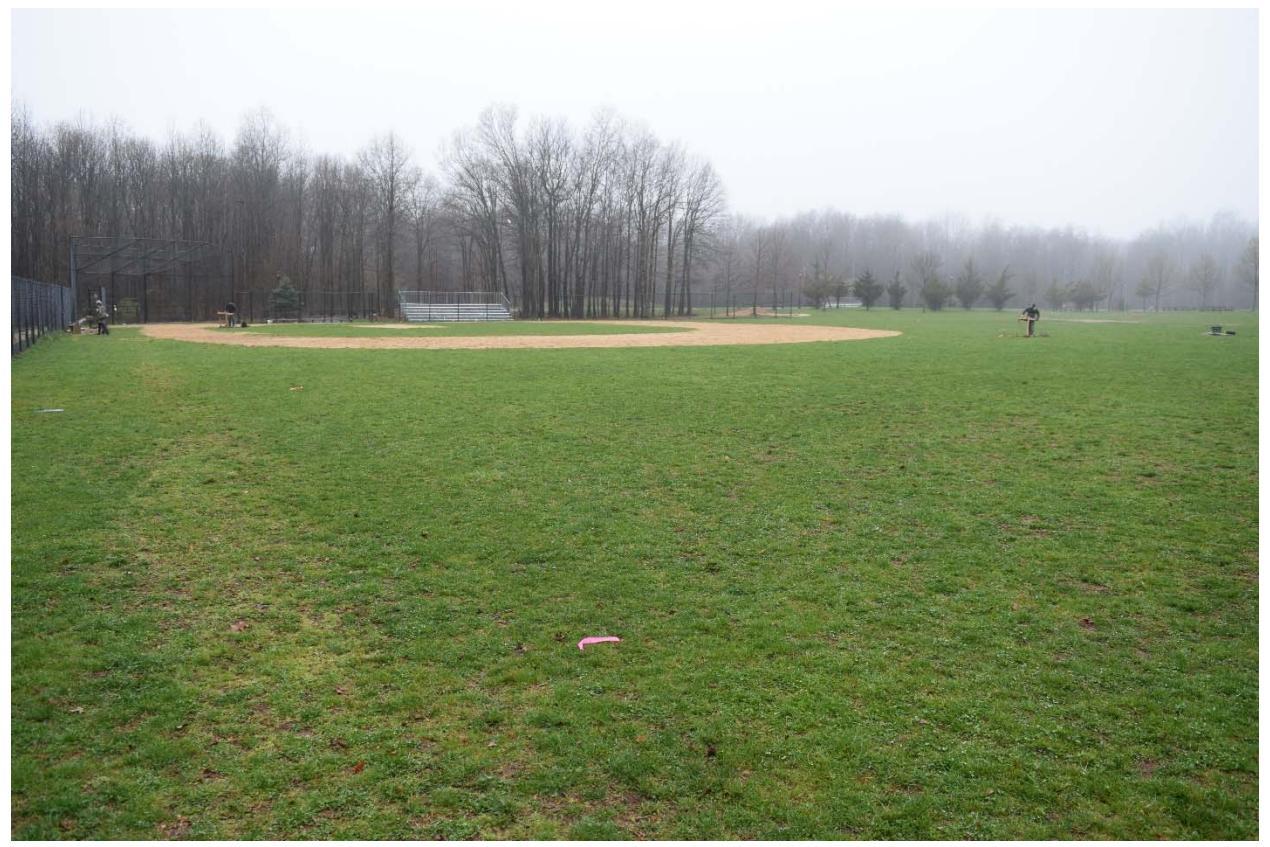
Photo 3. View southwest along the alignment of a proposed drainage system. The pink flags in the ground mark test locations. Tests revealed that the soils in this area were extensively disturbed when the field was constructured.

Tests 6-14 were placed within an existing natural turf baseball field along the alignment of proposed collector lines (Photo 3). These tests encountered highly heterogeneous soil compositions. Tests 6, 7, 10, and 11 contained an upper level of dark brown fill bearing a mix of historic and modern artifacts. Tests 8 and 9 contained a deep sand fill selected to improve infield drainage. Tests 12 and 13 contained a pea gravel fill. The subsoil was similar to that found in Tests 1-5, a dark reddish brown, gravelly loam. No precontact artifacts were recovered. The only historic period artifacts were recovered from fill strata.
