REPORT ON ARCHAEOLOGICAL WORK IN SUPPORT OF RUFUS KING PARK ENTRANCE CONSTRUCTION AND FENCE RECONSTRUCTION QUEENS, NEW YORK Contract Q023-216MA

Report on Archaeological Work in Support of Rufus King Park Entrance Construction and Fence Reconstruction, Queens, New York Contract Q023-216MA Prepared for NYC Parks Department By Linda Stone, RPA August 3, 2021

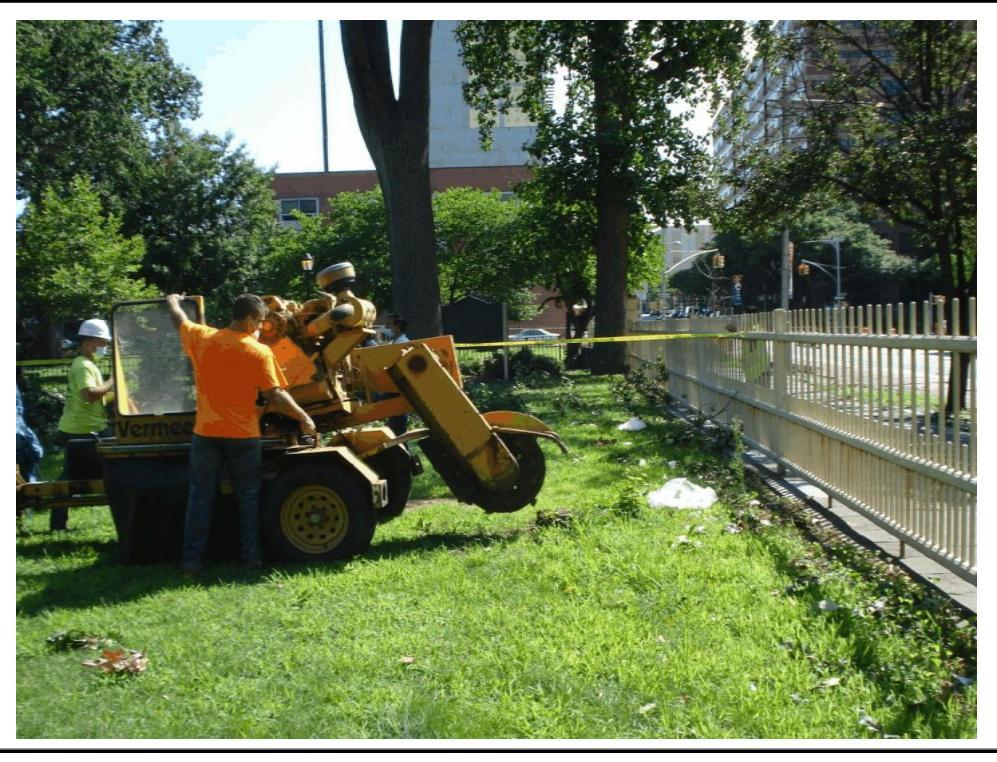
Stump grinding underway along Jamaica Avenue inside of Rufus King Park (Image 7783: August 5, 2020).

The tree excavations included both the removal of stumps (n = 9) and planting new trees (n = 5). Stump removal was completed using a stump grinding machine (see Cover photo) which created an excavation footprint of approximately 5 feet (152 cm) in diameter. The stump at one of the nine locations (Tree #183) was not accessible by the stump grinding machine and was later extracted with a backhoe bucket. The purpose of stump grinding was to eliminate any tripping hazard, not necessarily to remove the entire stump. Therefore, although all locations were monitored during stump grinding, many locations did not require excavation below 1 foot (30 cm). Locations extending deeper include Tree #s 15, 32, 197 and 198. All new trees requiring excavation of 1 foot (30 cm) or more were located along Jamaica Avenue with two at each corner and one mid-block. Excavation footprints for the new trees were approximately 3 feet (91 cm) across and averaged 1.6 feet (48 cm) deep.

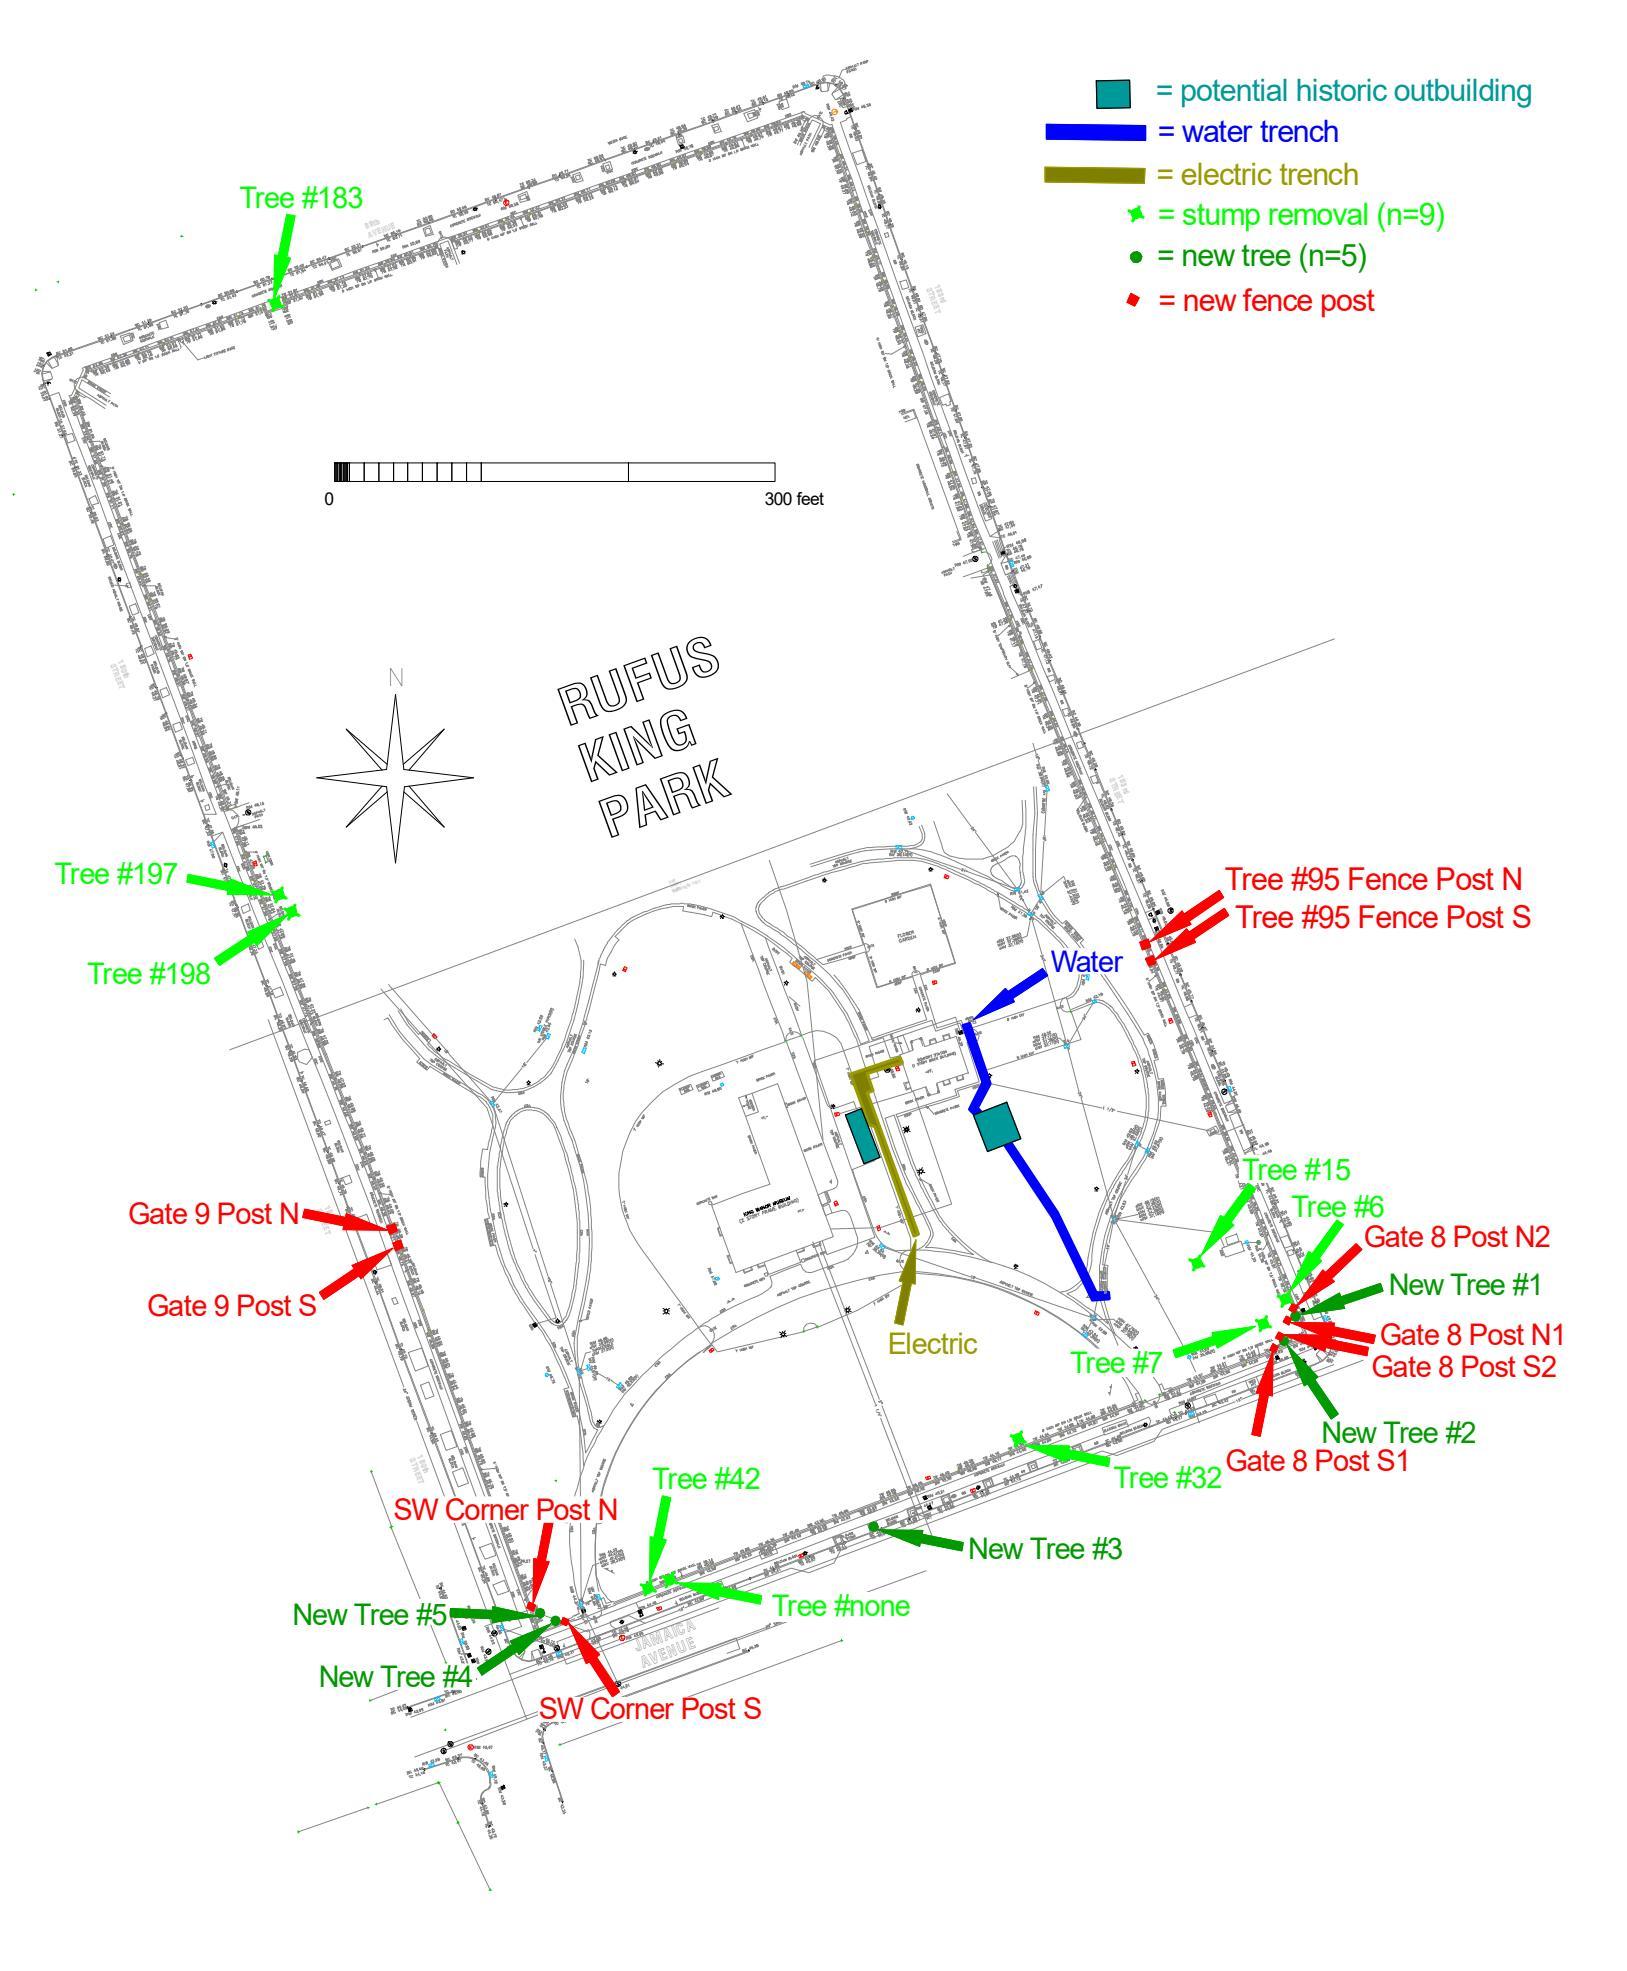
Figure 1 Rufus King Park showing the locations of the fence, utility and tree work conducted as part of Contract Q023-216MA.

Contractor excavations were monitored at multiple locations. Two trenches were excavated as were numerous small pits, either for either fence posts or tree plantings (see Figure 1). The contractor predominantly employed hand excavation to complete the work. However, a small backhoe was used to pilot the tree planting holes and a jackhammer was used to break up overlying paving and some of the more densely compacted fill deposits. Archaeological monitoring documented fill and redeposited material that was, at times, stratified. No potentially significant archaeological deposits or features were encountered and no artifacts were collected. The following is a discussion by excavation type of the work at each location, including the stratigraphy recorded and artifacts observed.

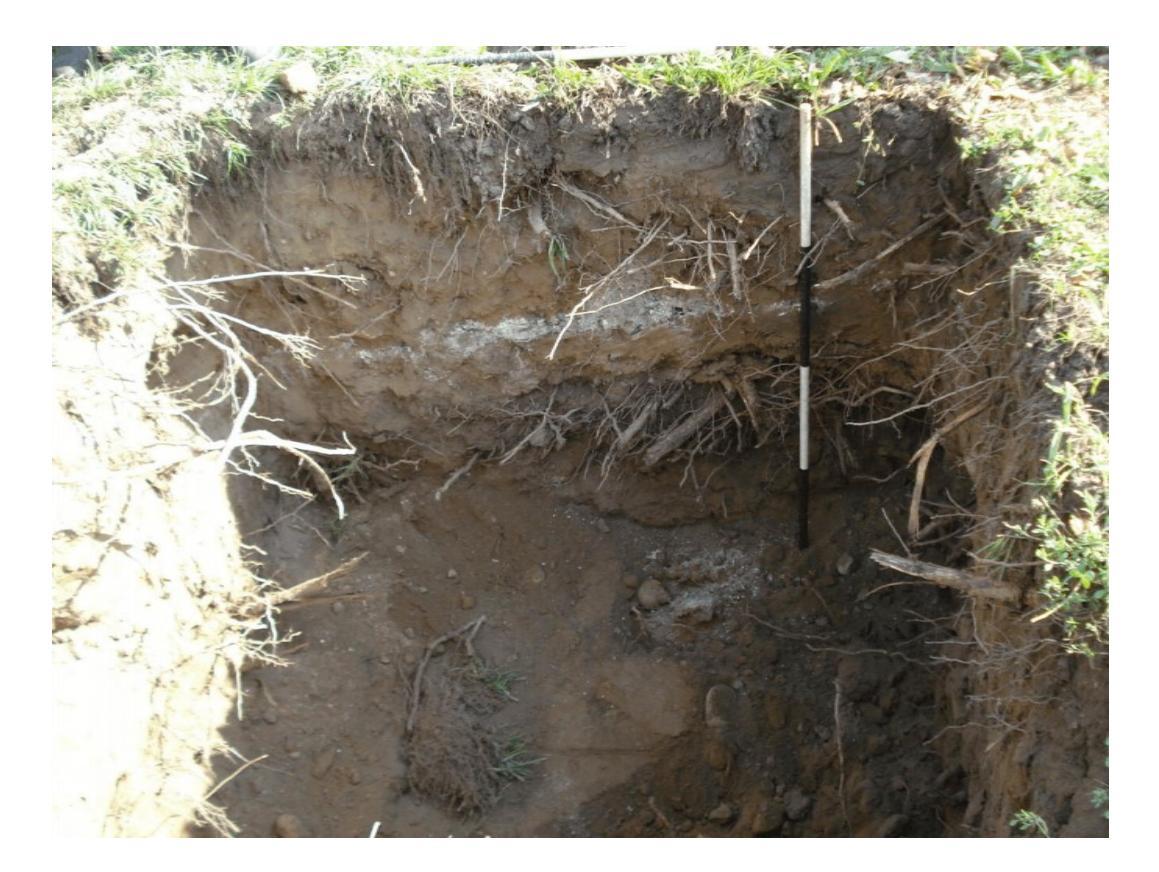
Photo 1 Gate 8 Post N1 upon completion showing the coal ash layer sloping down toward the south, facing northeast (Image 7850: August 14, 2020).

The two inner Gate 8 posts contained more complex stratigraphy with multiple fill episodes documented. Strata within the northern of those (N1) sloped down southward (see Photo 1). Directly beneath the topsoil was yellowish brown (Munsell 10YR 5/4) sandy loam with roots, bisected by white coal ash through most of the excavation. The coal ash was found at 2 feet (61 cm) below ground surface in the north and at 1.4 feet (43 cm) below ground surface in the south (42.7 & 43.3 feet ASL). However, the yellowish brown deposit extended to 3.4 feet (104 cm) below ground surface throughout the post pit. It was underlain with brown (Munsell 7.5YR 4/4) silty loam. The base of excavation was reached at 40.7 feet ASL. No artifacts were observed during the excavation, although the backdirt contained clear bottle glass and brick fragments which were not retained. Similar deposits were also documented in Gate 8 Post S2. However, here the white coal ash stratum was directly beneath the topsoil and petered out at the southern edge of the excavation. The deposits beneath the ash were mottled fill, noted in at least three lenses, ending with the same brown silty loam documented in the adjacent test. The base of the fill was 3 feet (91 cm) below ground surface (41.7 feet ASL).

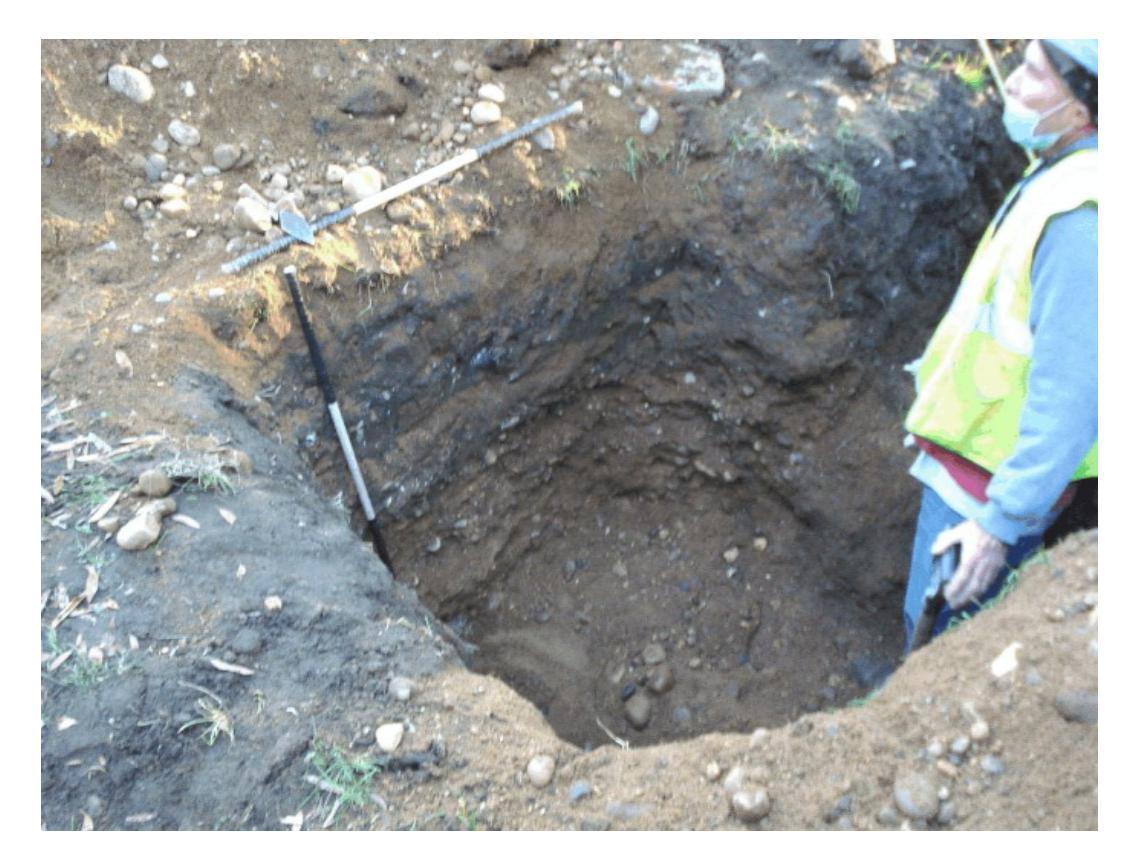
Photo 3 Dry well pit upon completion showing the general stratigraphy in the water line excavations, facing southwest (Image 7924: November 2, 2020).

The dry well spur was approximately 20 feet (6 m) from the southern terminus of the water trench. A 5foot (152 cm) connector trench was excavated to the dry well pit. Stratigraphy within the trench and pit was the same as documented throughout the water line trench (see Photo 3). However, because the dry well was excavated deeper, to 4 feet (122 cm) below ground surface (40 feet ASL), more of the yellowish brown sand was exposed. This continued to the base of excavation and was devoid of cultural material. The dark yellowish brown fill layer, which comprised most of the exposed material within the water line excavation here, contained several Belgian blocks that appeared to be part of an earlier park surface. This extended into the south profile of the dry well pit.

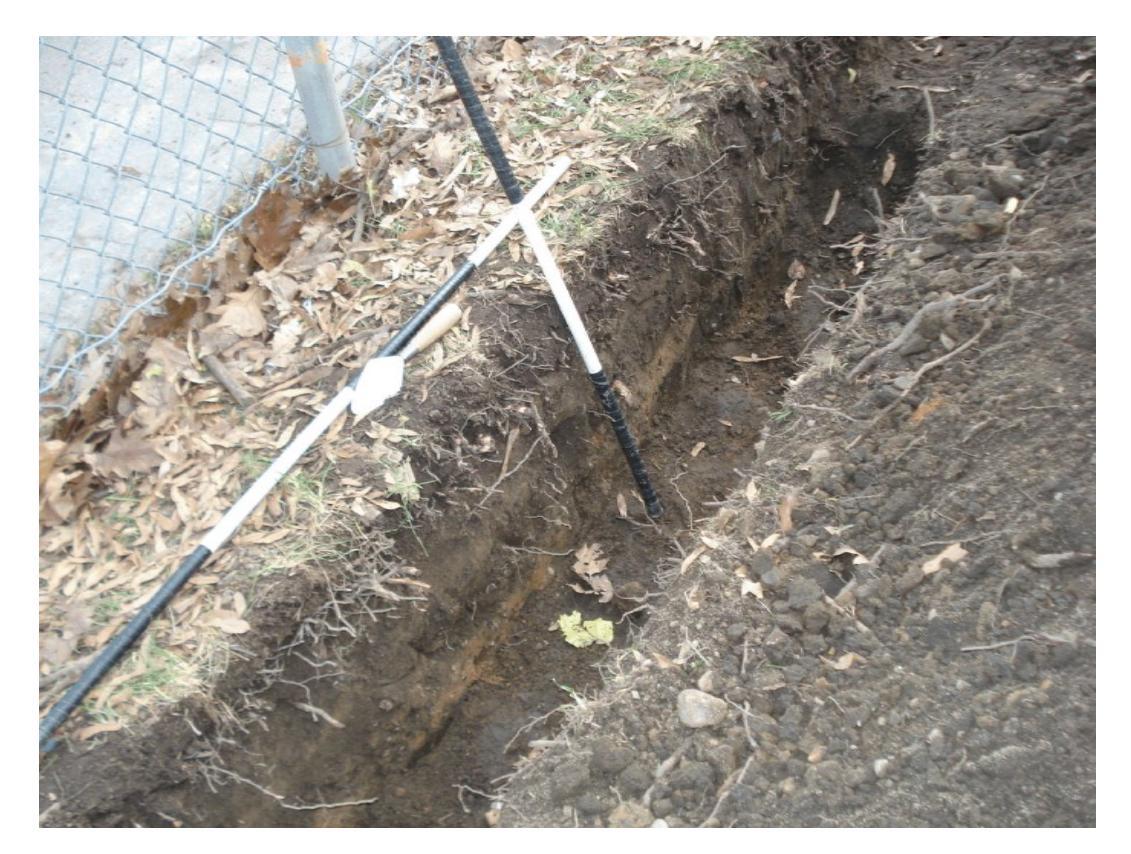
Photo 4 Electrical line trench showing the general stratigraphy with the proximity to the pavers seen at the upper left, facing southeast (Image 8010: December 30, 2020).

The east-west electrical trench segment went through a paved pathway and connected the electrical line excavation completed in the grass to the Comfort Station. In this area, pavers covered the concrete, however the concrete extended to the base of excavation at the Comfort Station itself. The concrete extended to between 7 to 9 inches (18 - 23 cm) below ground surface (46.2 - 46.0 feet ASL) in the remainder of the segment. The deposit beneath the concrete, which was entirely disturbed fill, was more than likely a result of work conducted in 2007 and 2016 (Appendix A: Figure 2). No archaeological features nor any artifacts were present.
