REPORT ON ARCHAEOLOGICAL MONITORING OF TEST PITS AS PART OF THE MOLD ABATEMENT PROJECT AT BUILDING 214 WITHIN FORT JAY ON GOVERNORS ISLAND NEW YORK, NEW YORK

Prepared for: National Park Service Northeast Region

Submitted by: Linda Stone, MA, RPA 249 East 48th Street, #12B New York, New York 10017

December 14, 2006

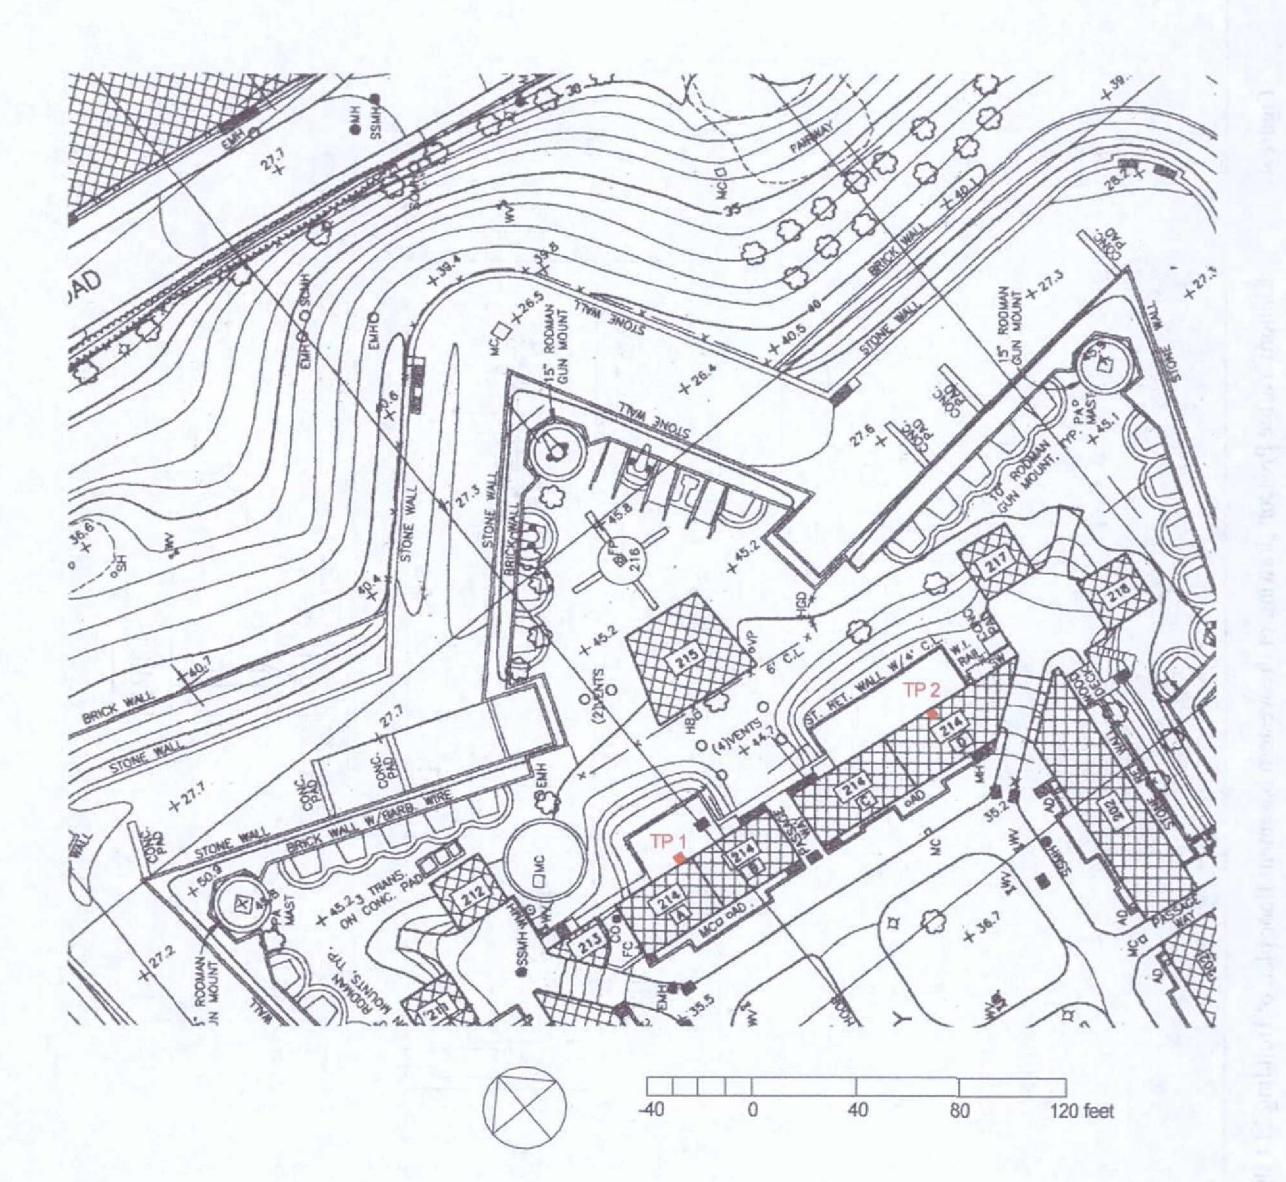
Location of Test Pits at Building 214 in Fort Jay on Governors Island.

The National Park Service, the New York State Historic Preservation Office (SHPO) and the New York City Landmarks Preservation Commission (LPC) had previously indicated archaeological monitoring of the test pits for the mold abatement work would be appropriate for this project. Two test pits were planned by the engineers, one inside of Building 214 and the other outside of the building in the areaway (Figure 3).

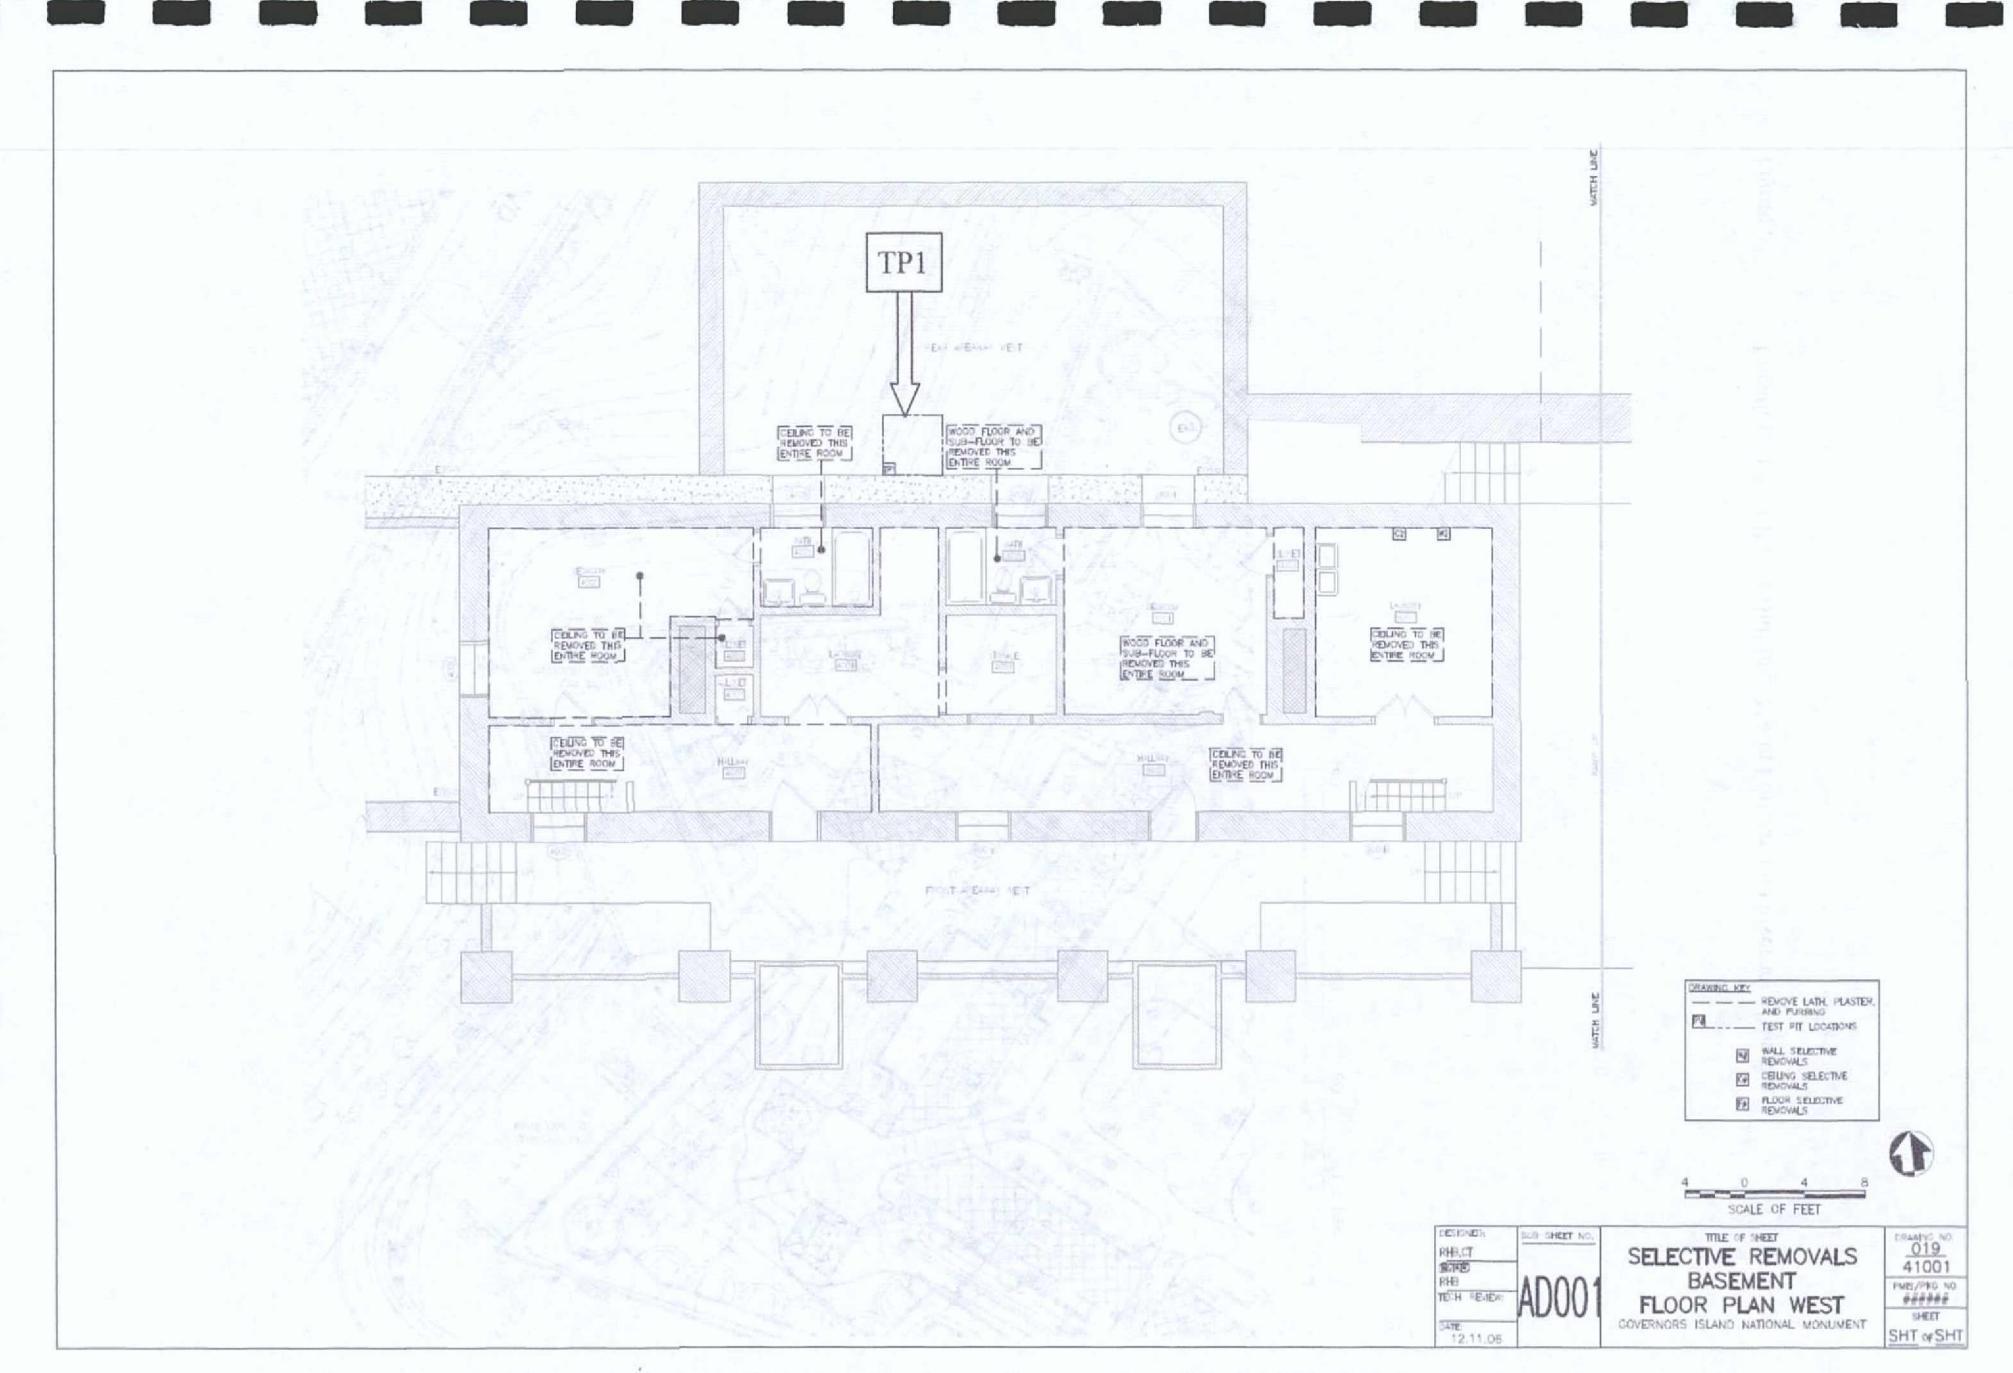
Einhorn Yaffee Prescott drawing of the western basement floor plan of Building 214 showing the location of Test Pit 1.

Test Pit 1 (TP1) was located on the exterior of Building 214 within the areaway, 11.4 feet east of the end of the areaway (see Figure 4 and Photo 1). It measured three by three feet. The stratigraphy is summarized in Table 2.

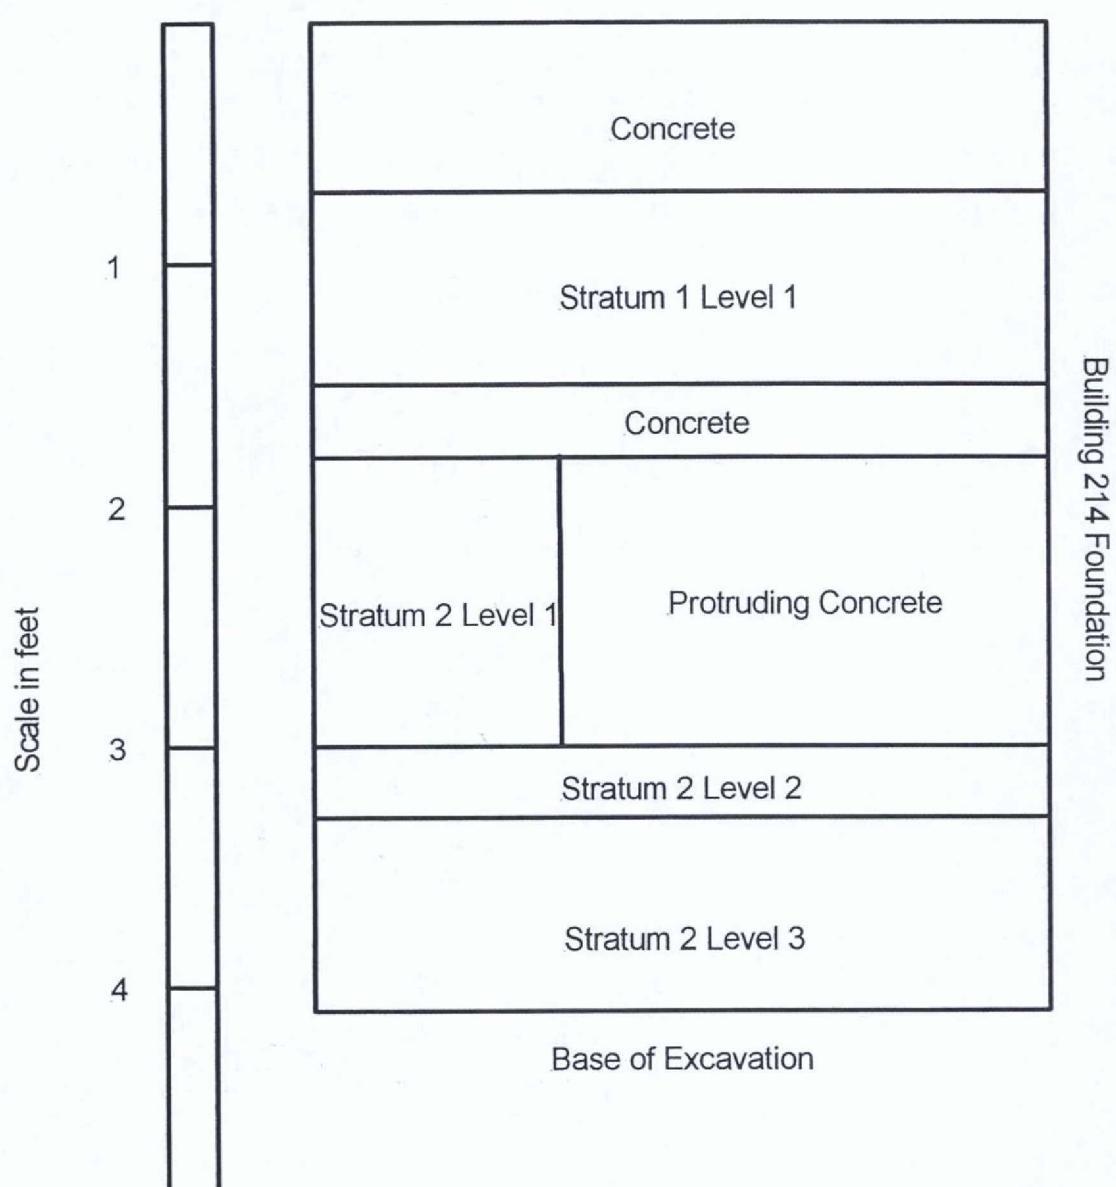
East profile of Test Pit 1.

The second layer of concrete was underlain by mottled silty sand that was finer than Stratum 1. Artifacts were recovered from Stratum 2 Level 1. At first, it seemed the artifacts were within soils located from about 1.3 feet (40 cm) north of the foundation of Building 214 to the northern end of TP1. However, the concentration became constant throughout the test pit all the way to the base of the level, although no specific artifact-related feature was identified. As excavation continued, additional concrete was encountered within the upper part of Stratum 2 at the

southern portion, along the east side, of TP1 (see Figure 5 and Photo 2). This could explain why the initial impression of the artifact deposit was concentrated in the northern part of TP1. Level 1 was 1.3 feet (40 cm) thick and arbitrarily ended at 3.0 feet (91 cm) below ground surface. At that point in time the archaeological consultant stopped excavations and contacted the NPS to discuss an appropriate course of action.

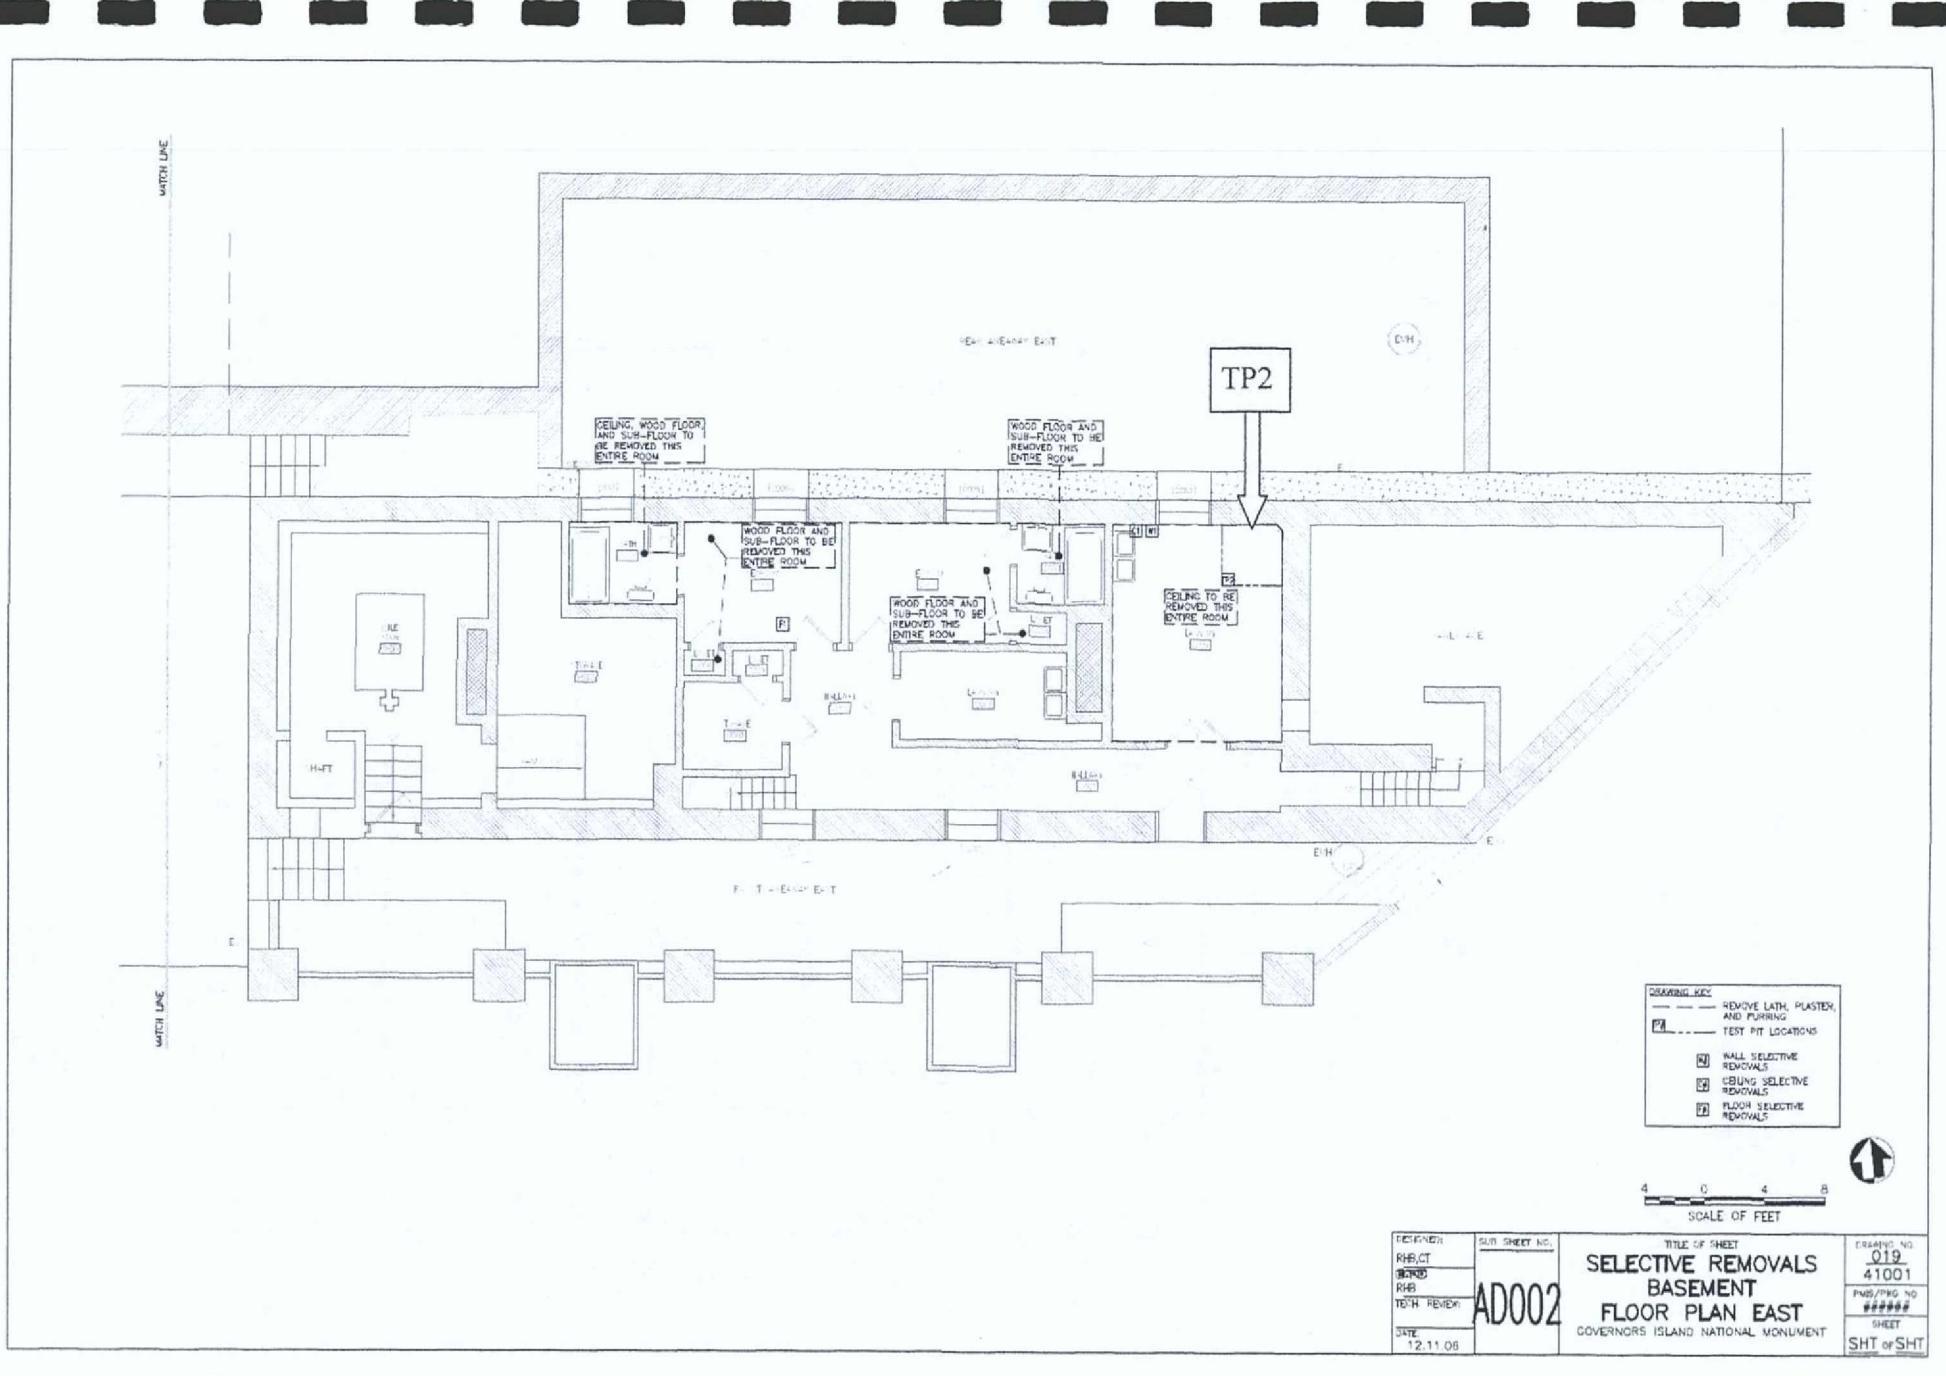
Figure 6

Einhorn Yaffee Prescott drawing of the eastern basement floor plan of Building 214 showing the location of Test Pit 2.

Test Pit 2 (TP2) was located inside the eastern wing of Building 214 (see Figure 6). It measured about 3.5 feet square and was in the northeast corner of the room. Table 3 is a summary of the stratigraphy. Beneath the overlying concrete was an ashy silt. Within this deposit was a pipe that extended along the perimeter of the test pit at both walls. The pipe can be seen in Photo 4 with a three-foot long photo stick resting on it near the top of the picture.

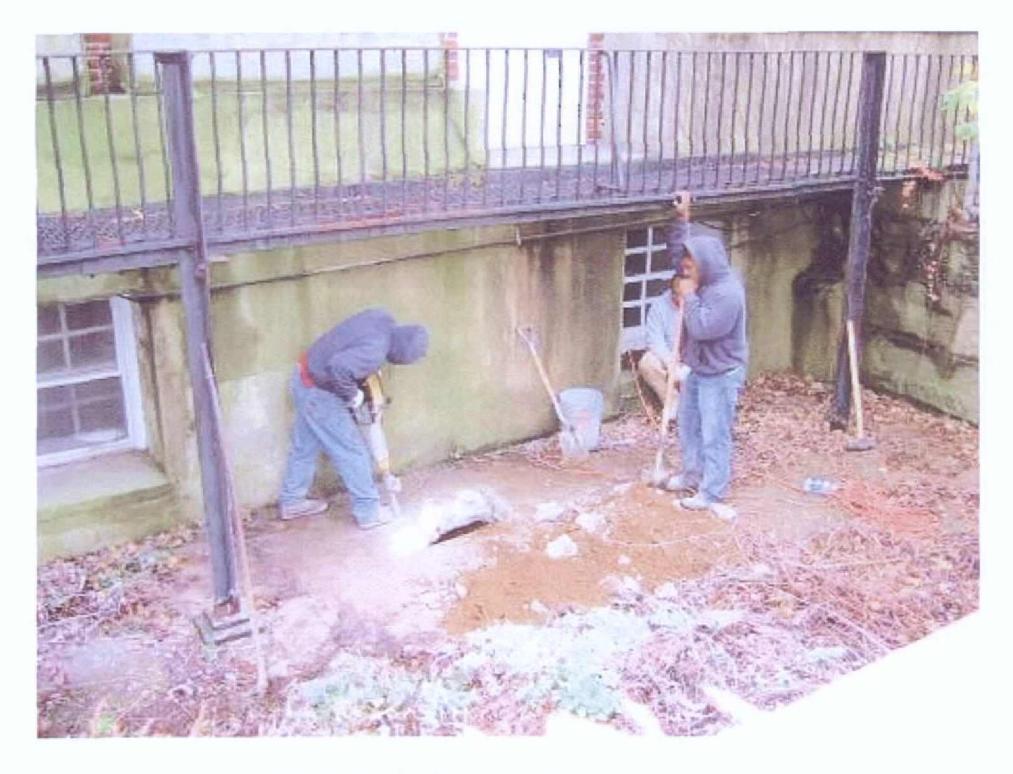
Photo 1 Test Pit 1 being jackhammered.

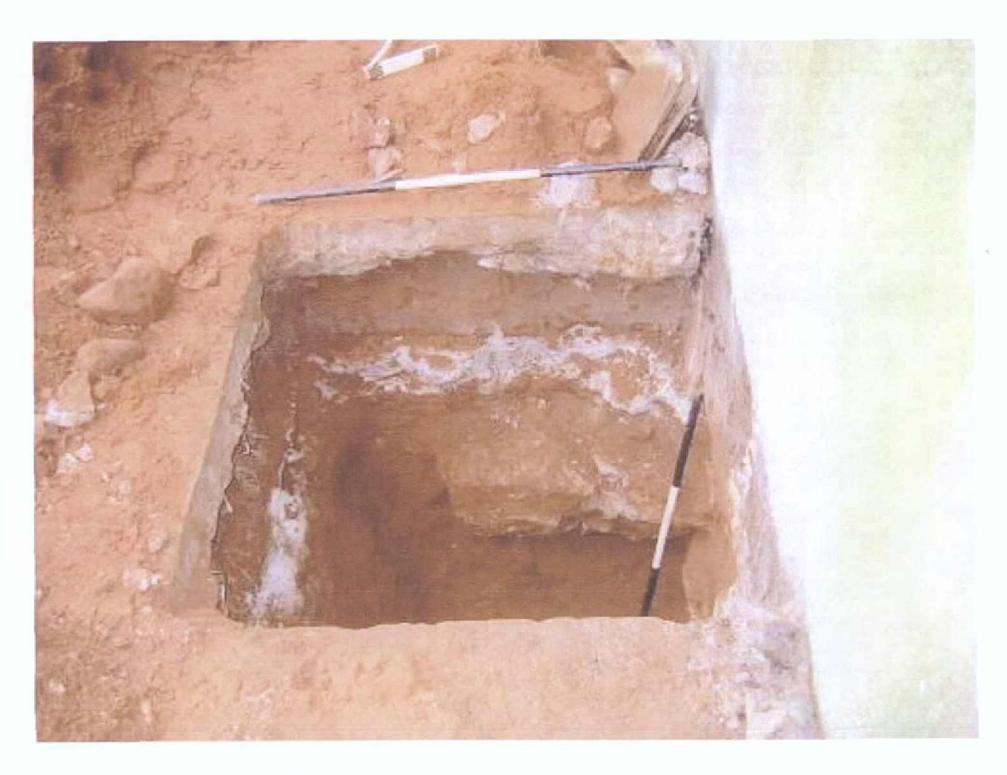
Photo 2 Test Pit 1 at the completion of excavation facing east.

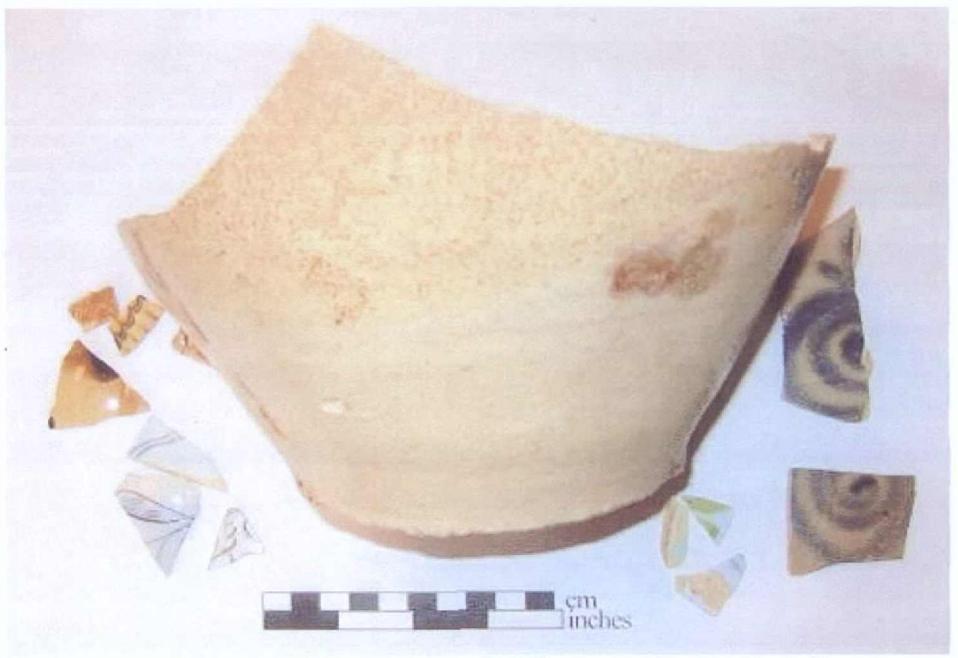
Photo 3

Sample of ceramics from TP1 Stratum 2 Level 2, including stoneware, tin-glazed earthen ware and slipware.

The artifacts collected are primarily a domestic kitchen-type assortment of material. The collection includes faunal bone and shell representing food remains as well as a wide variety of glass and ceramic sherds representing food storage and table wares. However there are also some brick fragments, window glass, nails and other metal hardware. Some of the ceramic pieces are less fragmentary than others. Level 2 contained a very large base from a stoneware vessel. There was also an associated sherd that mends with the base as well as a variety of other ceramic sherds (see Photo 3).

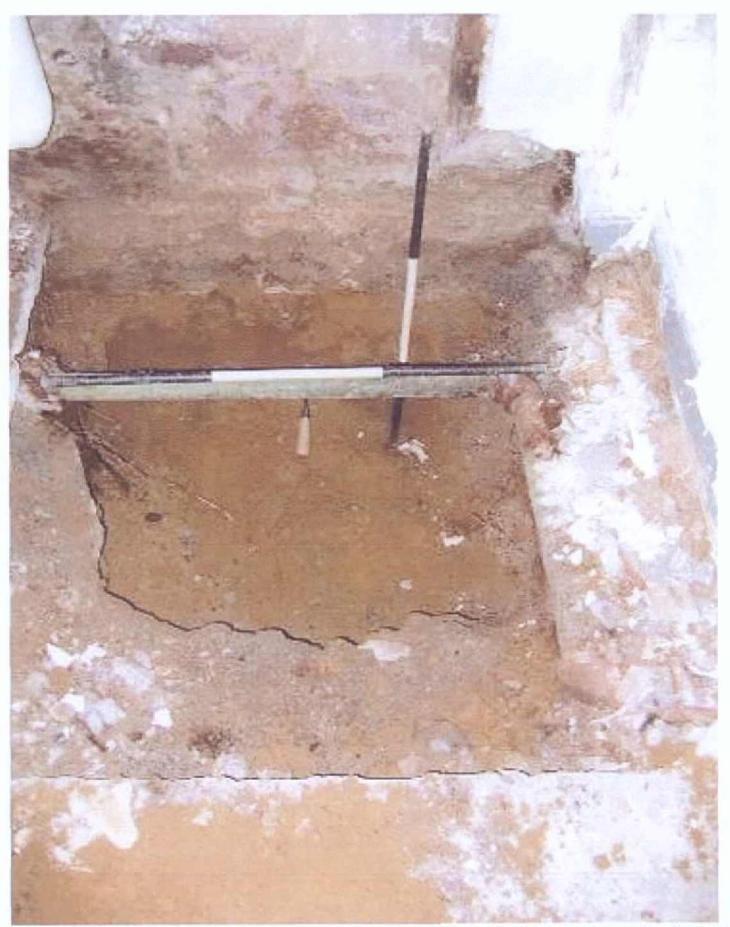
Test Pit 2 at completion of excavation facing north (black and white sticks are 3 feet long).

· · . 1. S. . . × * . . . 15 cm) and about a foot (30 cm) in length. The stones were mainly sandstone, like those used in the foundation of Building 214, as well as some granite. The basal stratum was a culturally-sterile strong brown sand. This is similar to subsoil seen elsewhere on the Island (Stone 2006: 4-5). The base of excavation was stepped down toward the north as seen on Photo 4. The southern part of the test pit remained unexcavated at Stratum 2. A small pit was excavated for engineering purposes in the northeast corner of TP2 in Stratum 3. This can be seen in Photo 4 at the base of the vertical photo stick. The soil within the small pit was homogeneous with the rest of Stratum 3. No artifacts were observed or recovered from Test Pit 2.
