REMOTE SENSING SURVEY
IN CONNECTION WITH THE
NEW YORK AND NEW JERSEY HARBOR NAVIGATION STUDY
UPPER AND LOWER BAY
PORT OF NEW YORK AND NEW JERSEY
KINGS, QUEENS, NEW YORK AND RICHMOND COUNTIES, NEW YORK
ESSEX, HUDSON, MONMOUTH AND UNION COUNTIES, NEW JERSEY

FINAL REPORT

December 2002

Panamerican Consultants, Inc.
15 South Idlewild Street
Memphis, Tennessee 38104

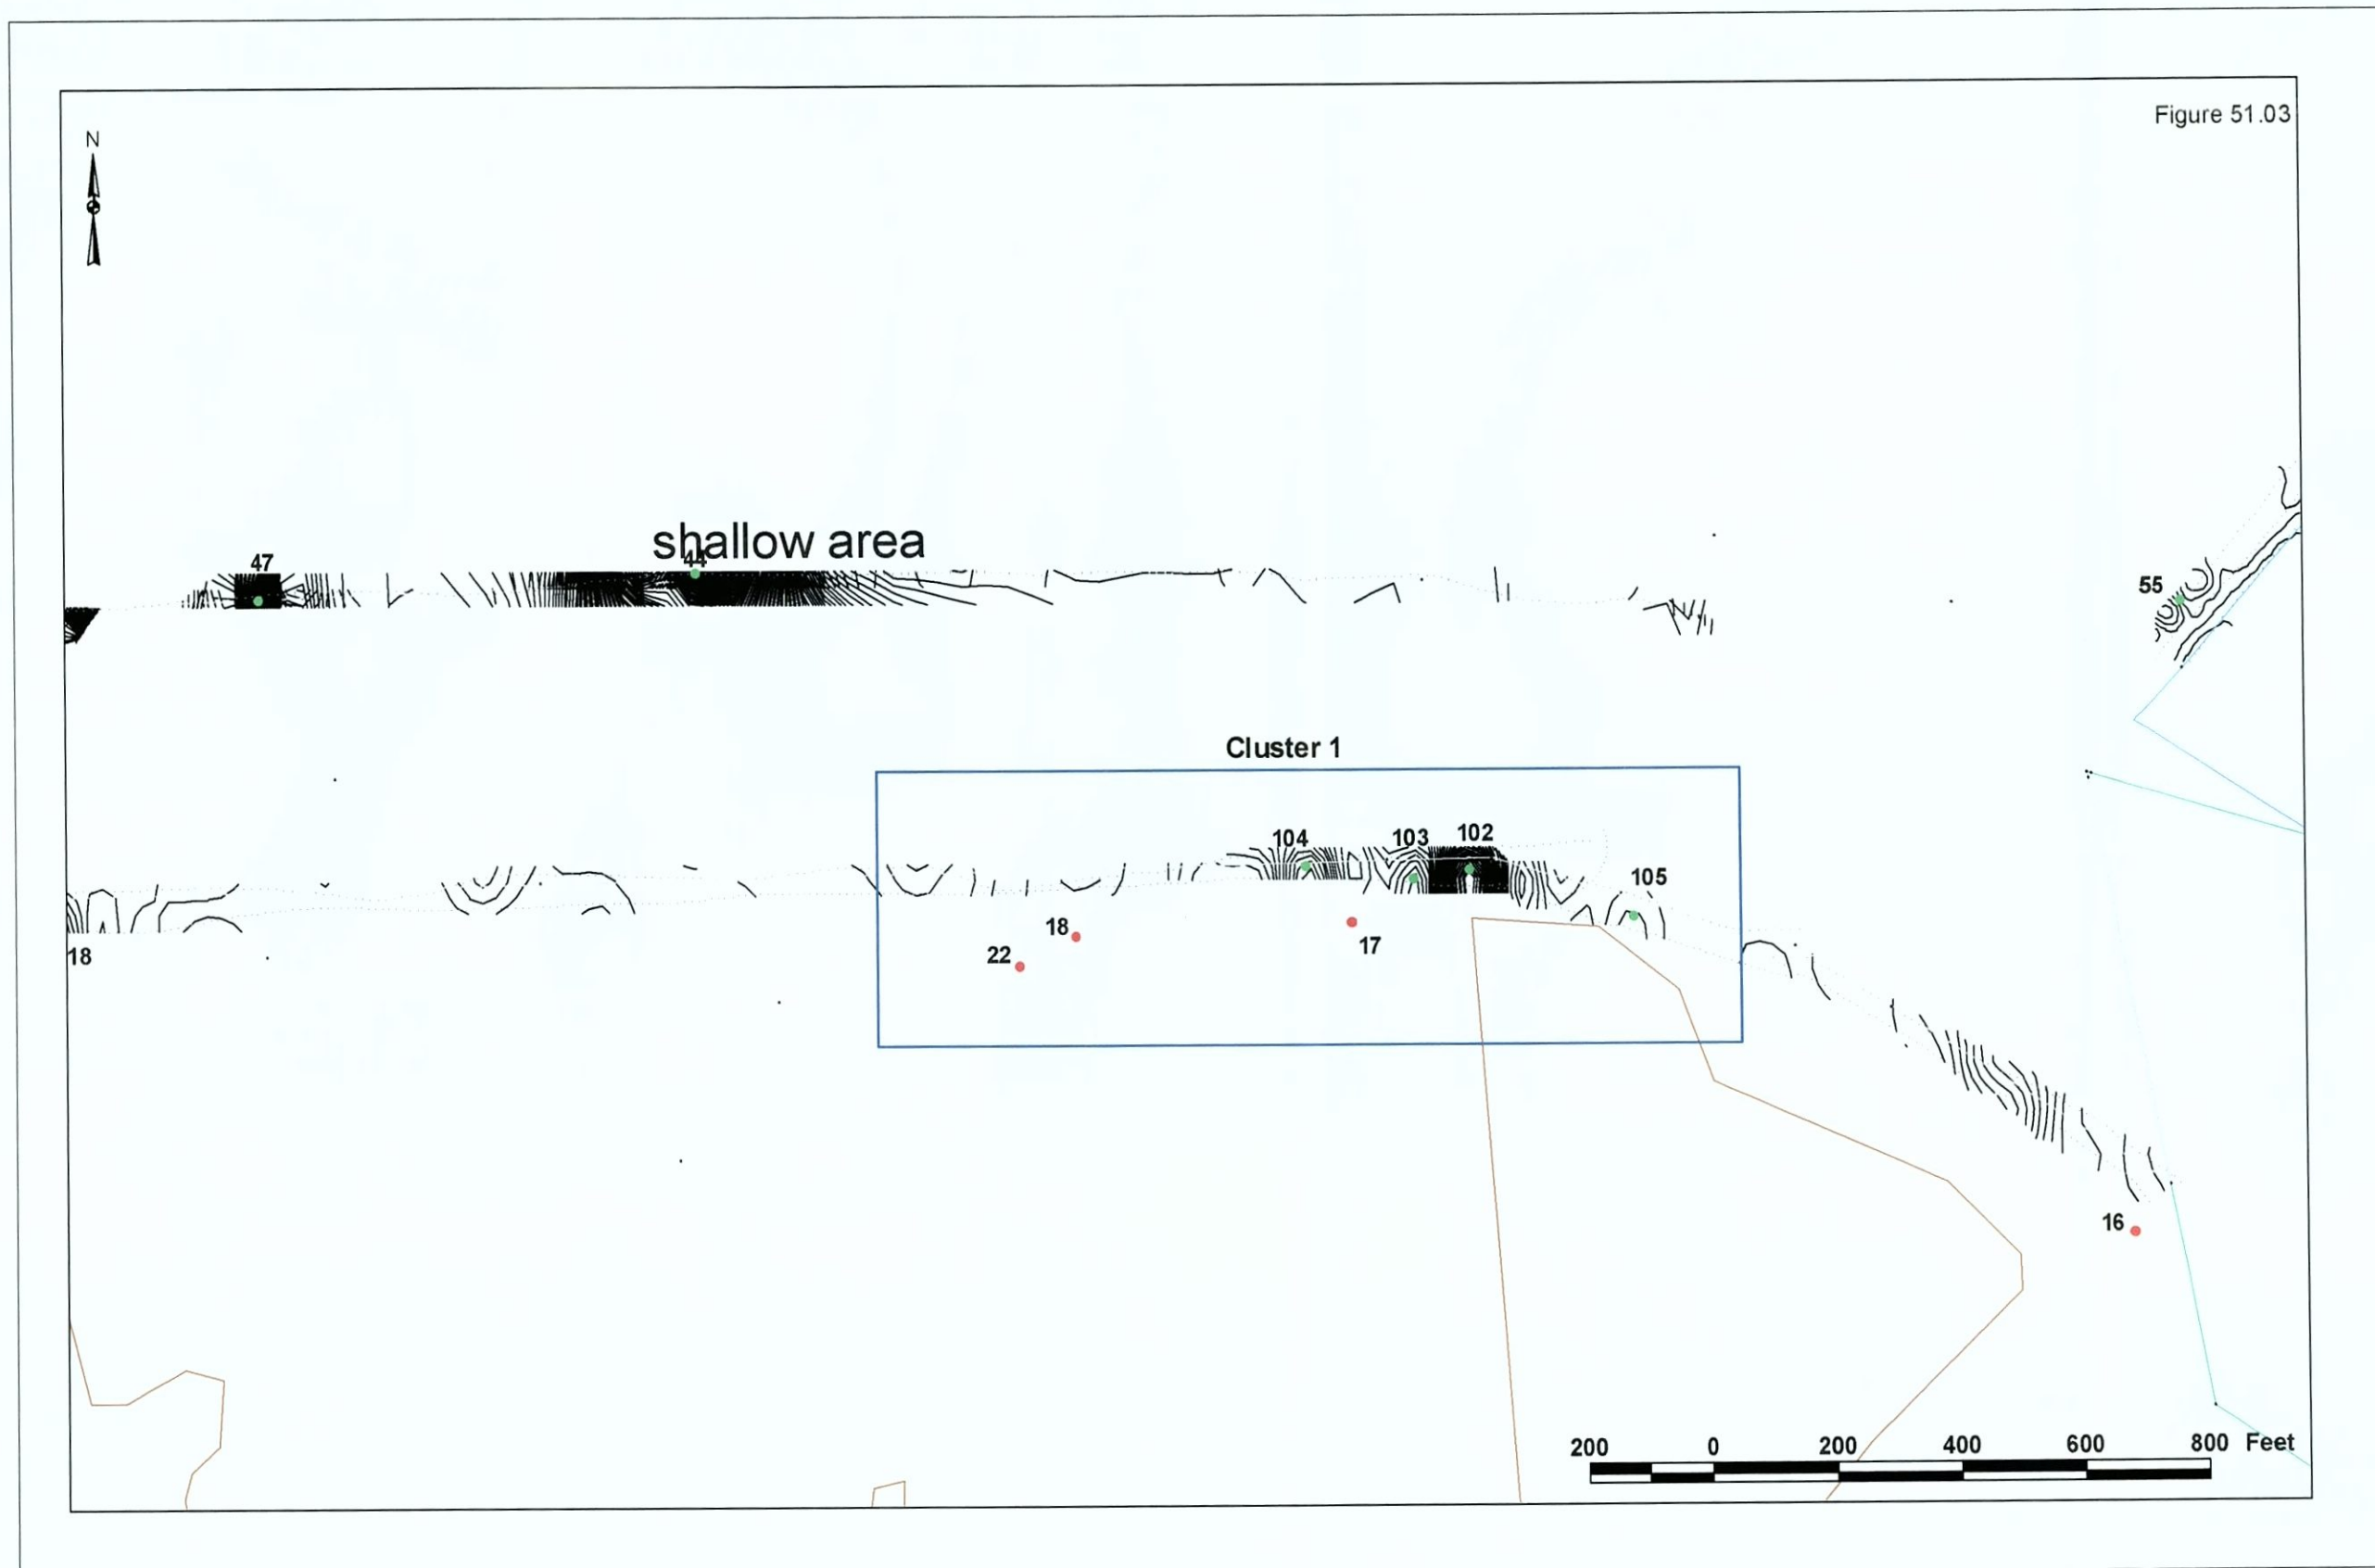
Figure 51.03

Figure 51.03. Magnetic contour map of the project area.

Anomaly 44 is located in Arthur Kill (see Figure 51.03), and appeared across one trackline. It was located at 584456 East and 660984 North. It had a positive gamma value of zero and a negative gamma value of 987, with a maximum gamma deflection of 987 and duration of 701 feet. The source of this anomaly is likely the remains of three wooden tugs identified and recorded by James (1987) (Figure 53). It is not associated with a sidescan target. This anomaly meets the established criteria for the existence of a shipwreck but is not recommended for further investigation, as the wrecks have already been recorded.

Anomaly 102 is located in Arthur Kill (see Figure 51.03), and appeared across two tracklines. It was located at 586138 East and 660338 North. It had a positive gamma value of zero and a negative gamma value of 124, with a maximum gamma deflection of 124 and duration of 292 feet. The source of this anomaly is a pier and wreck that are part of the group of derelict vessels at the west end of Shooter's Island (Figure 60). It is associated with a sidescan target (#17). This anomaly is part of Cluster 1, and recommendations are discussed in the cluster section below.

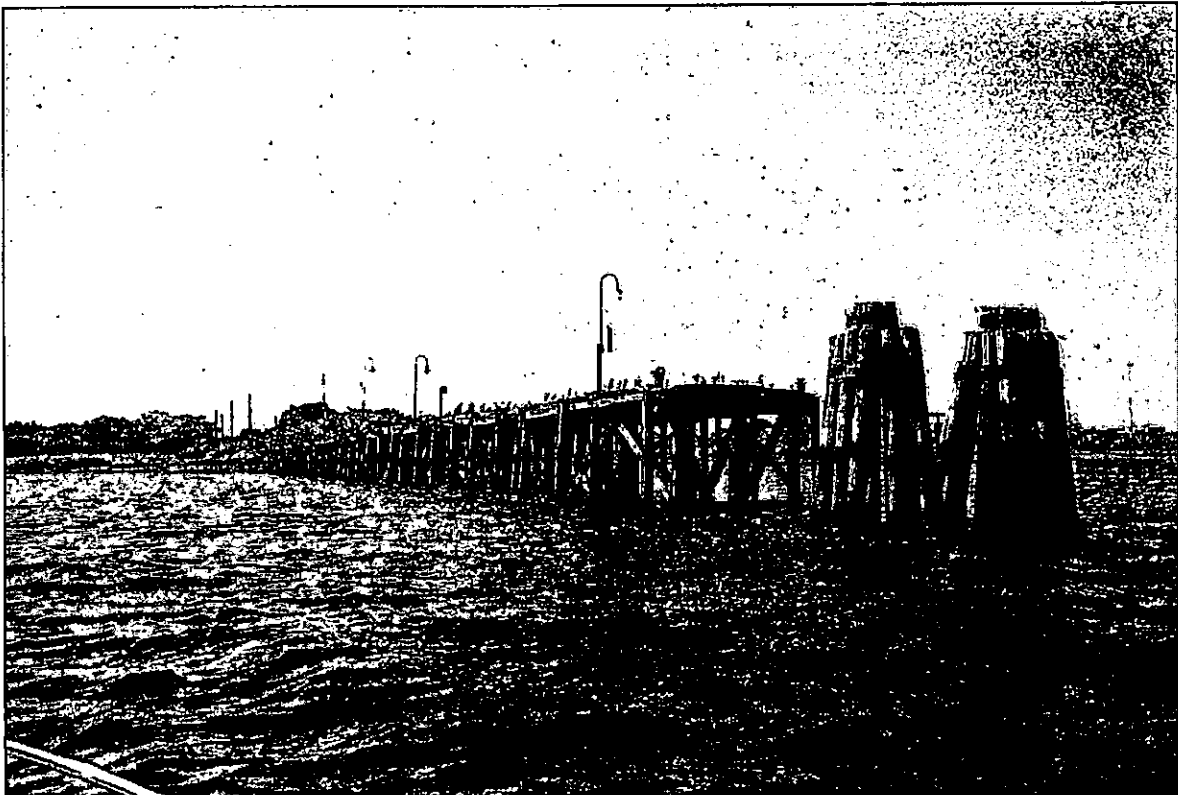
Figure 2. Photograph of wooden pier structure located in the project area.
