Landmarks Preservation Commission
May 13, 1980, Designation List 133
LP-1069

178 EAST 73RD STREET BUILDING, Borough of Manhattan.
Built 1902; architect John H. Friend.

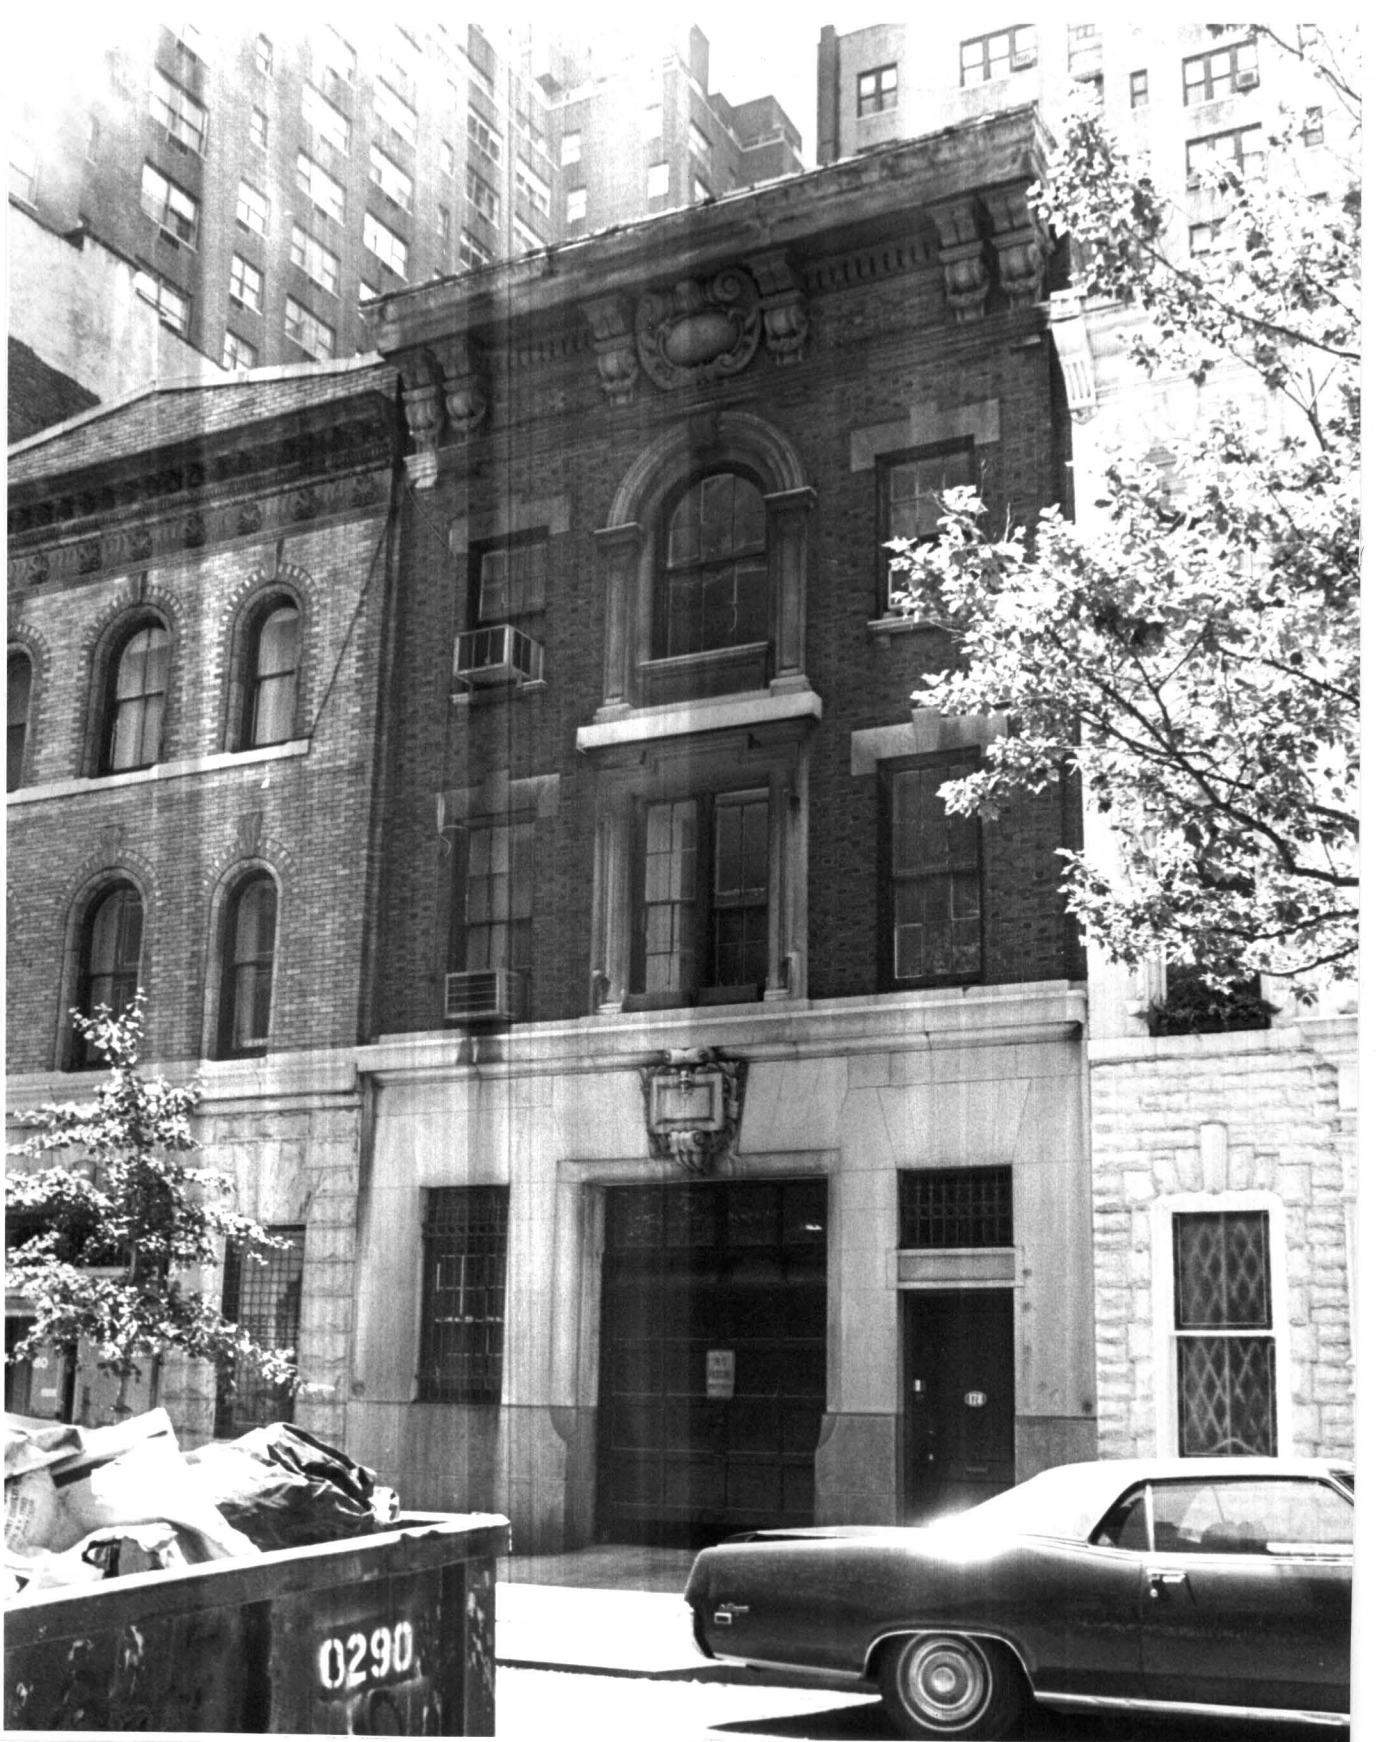
178 East 73rd Street
Architect: John Friend

The building at No. 178 is designed in a form characteristic of contemporary carriage houses. A three-story structure, it has a smooth limestone base and upper stories faced with brick laid in Flemish bond with neo-Georgian style random burned headers. The ground floor is articulated by three crisply cut rectangular openings: a chamfered central vehicular entrance capped by a keystone in the form of a stylized cartouche; a pedestrian entrance to the right that is capped by a stone transom bar and transom light; and a window that is set to the left. A modest stone cornice separates the utilitarian ground floor from the residential stories above. The focal point of the upper stories is the central window bay. The central window on each of the upper stories is set within a classical limestone enframing--crossed on the second floor and round-arched on the third floor. The flanking double-hung windows are capped by stone drip lintels with splayed keystones. The building is crowned by a galvanized-iron cornice with garlands hanging from the console brackets. A bold cartouche at cornice level gives added emphasis to the central bay.
