19 WEST 16th STREET BUILDING, Borough of Manhattan, Built c. 1846. Architect unknown.

Landmark Site: Borough of Manhattan Tax Map Block 818, Lot 24.

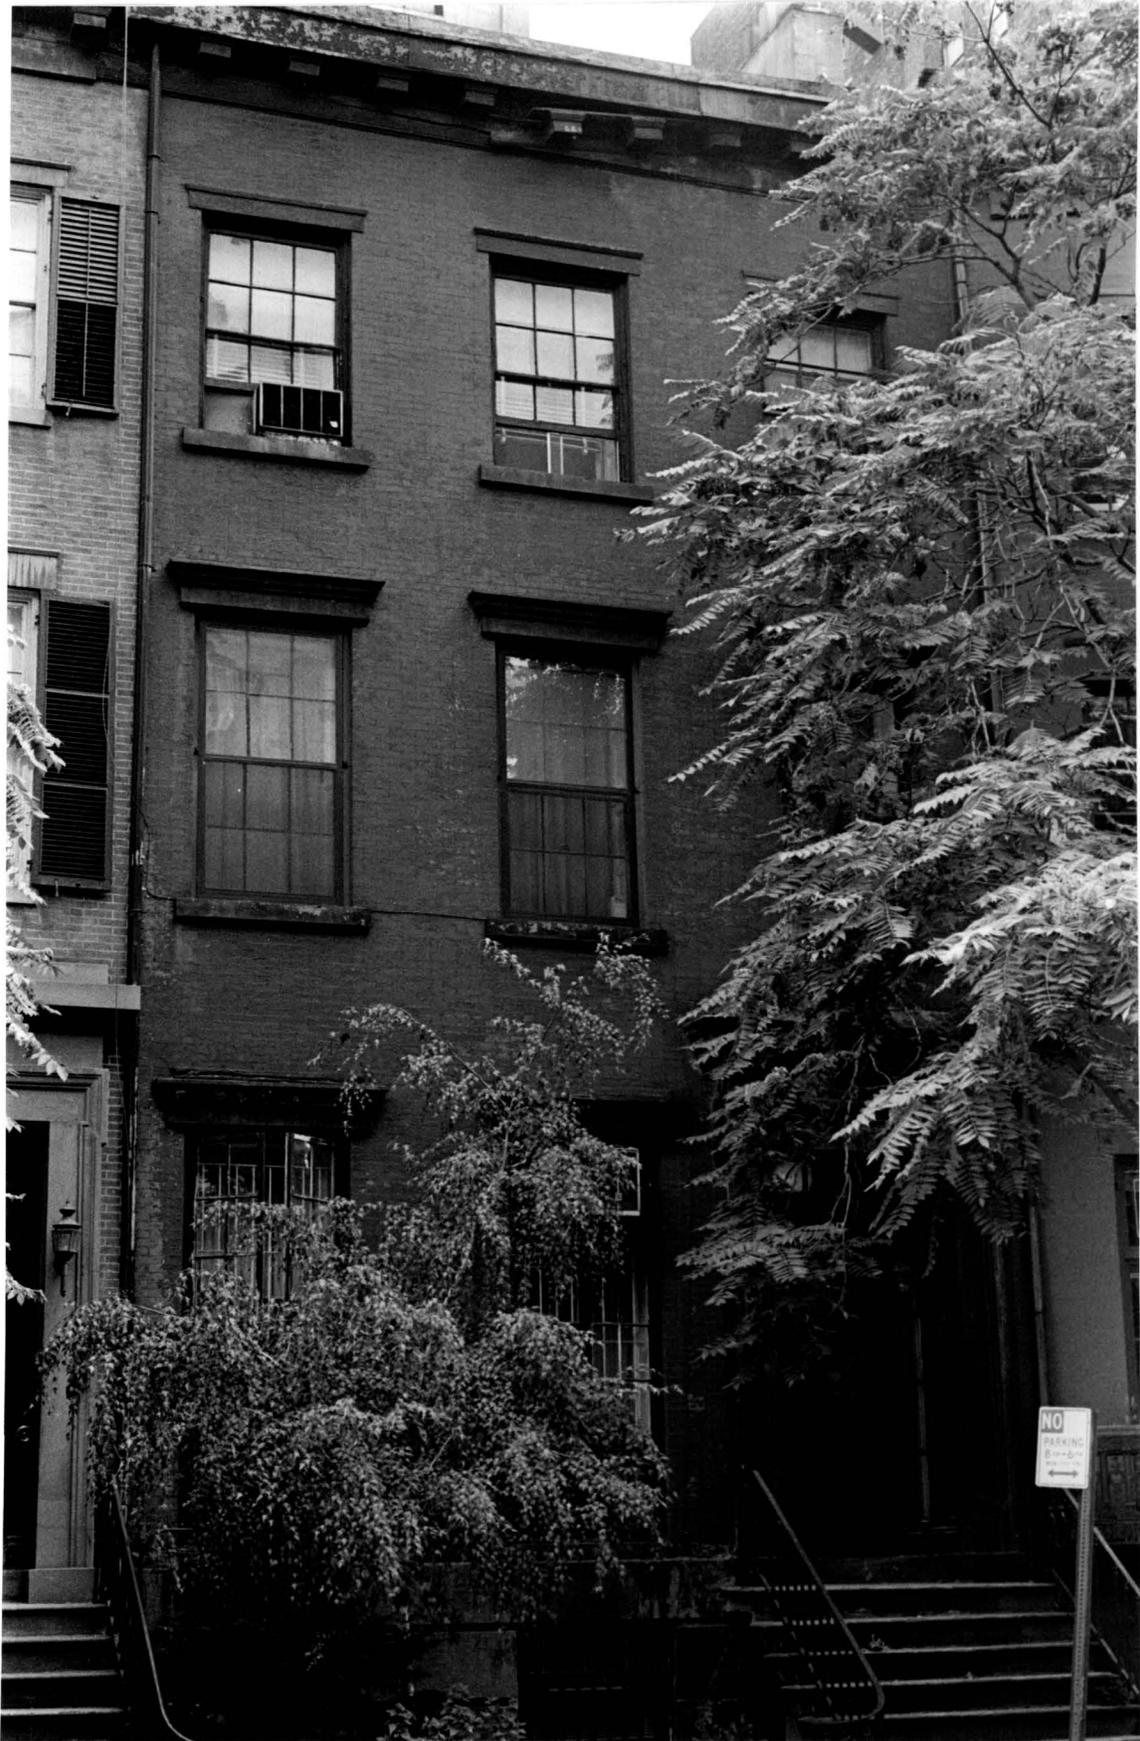
19 West 16th Street Building: 19 West 16th Street, c.1846  
Photo Credit: Kevin McHugh

This Greek Revival rowhouse, of three stories with a basement, is located in the middle of the block and extends twenty-five feet along the north side of West 16th Street between Fifth and Sixth Avenues. Faced in brick (now painted deep red) with a stone basement and stone and wood trim, the building retains much of its original appearance.

bases of casement doors that opened onto an iron balcony (now removed, the evidence of its supports is apparent in the masonry below the windows). The casement windows have four panes each in the center bay and five panes each in the western bay. Each window opening is crowned by a projecting stone lintel. The second story has three smaller window openings containing six-over-six wood sash enclosed by aluminum storm windows. Each bay has a stone sill and a molded stone lintel. The third-story window openings are even smaller, but continue the six-over-six pattern seen below, with sills and flat lintels. The facade is surmounted by a modillioned metal cornice, now painted black.

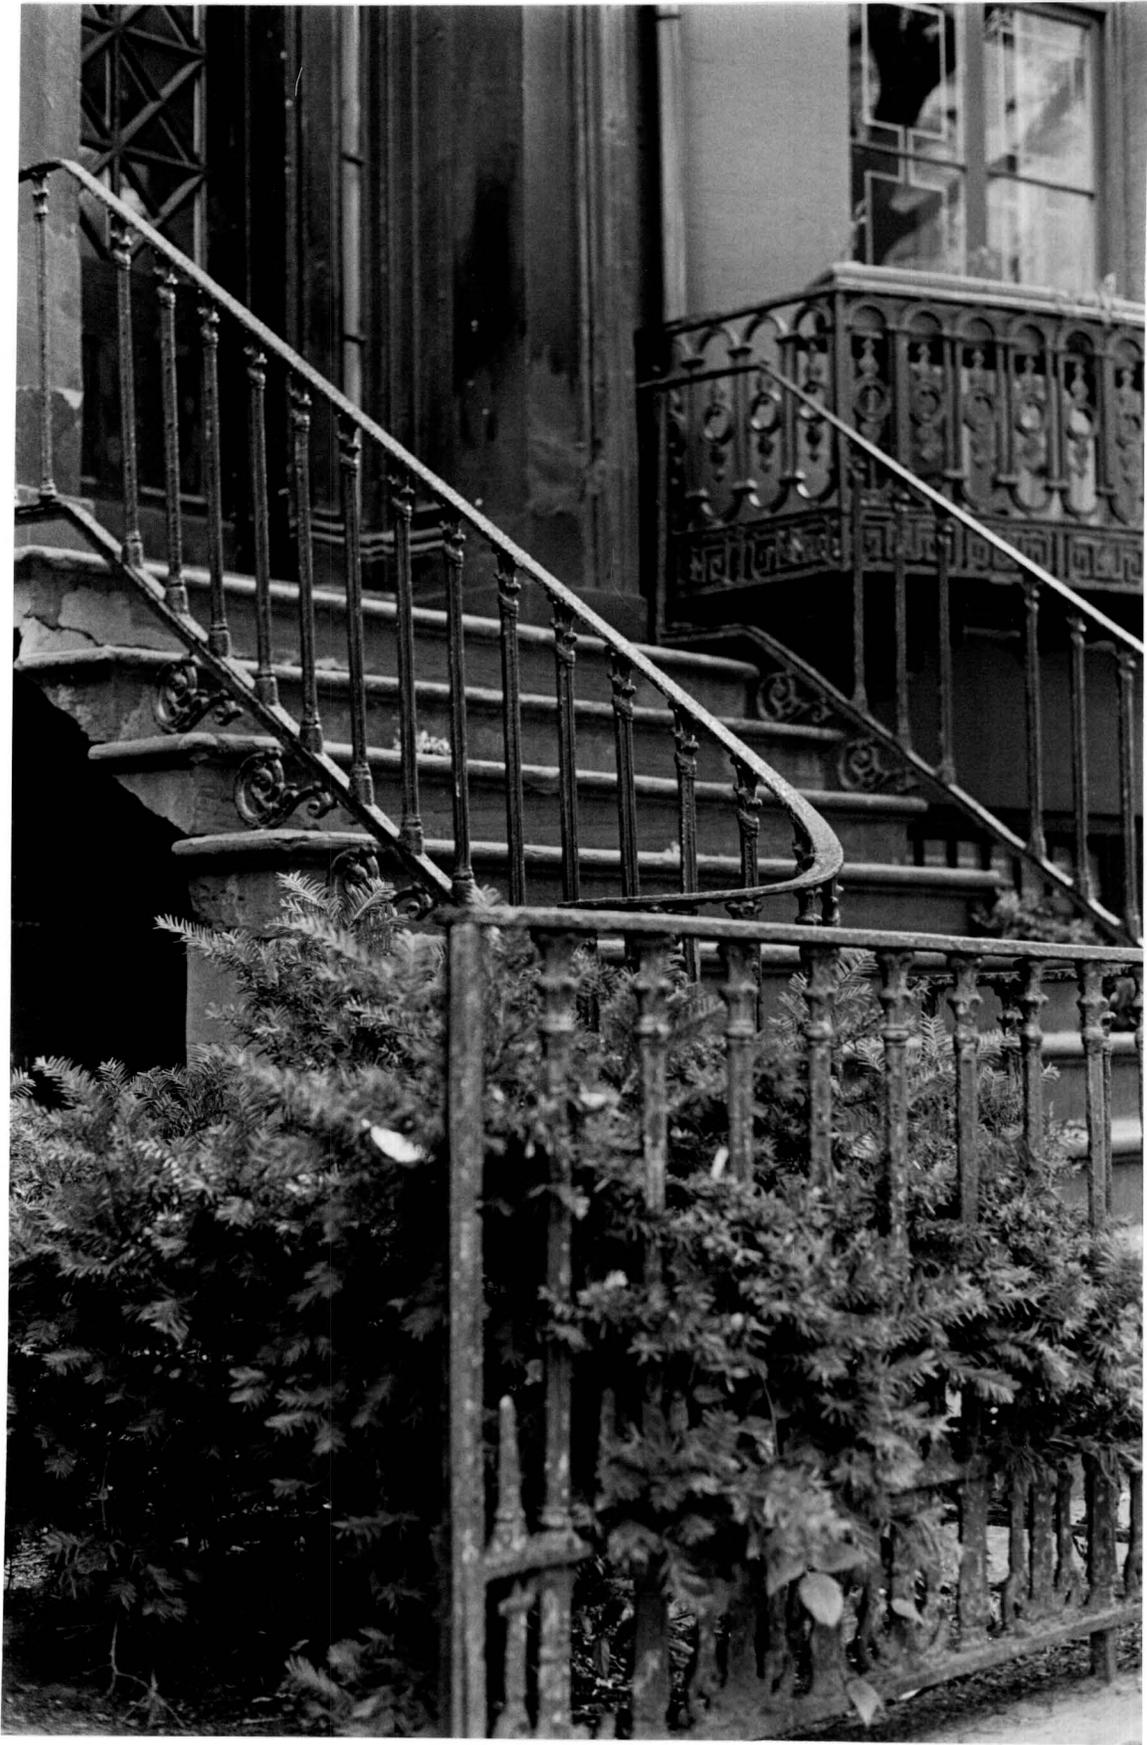
19 West 16th Street Building (ironwork detail)  
Photo Credit: Kevin McHugh

Faced in rusticated stone, the basement is fronted by an areaway paved in concrete with open garden space which is enclosed by an ornate iron fence with stylized classical detail. Underneath the original stone stoop with iron railings is an entryway (now sealed with a wood panel). To the west are two window openings containing eight-over-eight wood sash windows with iron grilles. Surmounting the stoop at the parlor story is the recessed entrance containing a wood door (painted black) that has eight windows with diagonal muntins. This door is flanked by wood Corinthian pilasters, in turn flanked by four-pane sidelights, supporting a wood entablature capped by a transom containing three panes. A glass lantern has been attached to each pilaster. The entrance is framed by a projecting eared surround of stone supporting an entablature. The remainder of the parlor story contains two window openings containing sealed panels along the bottom and paired wood sash casement windows; the panels were originally the

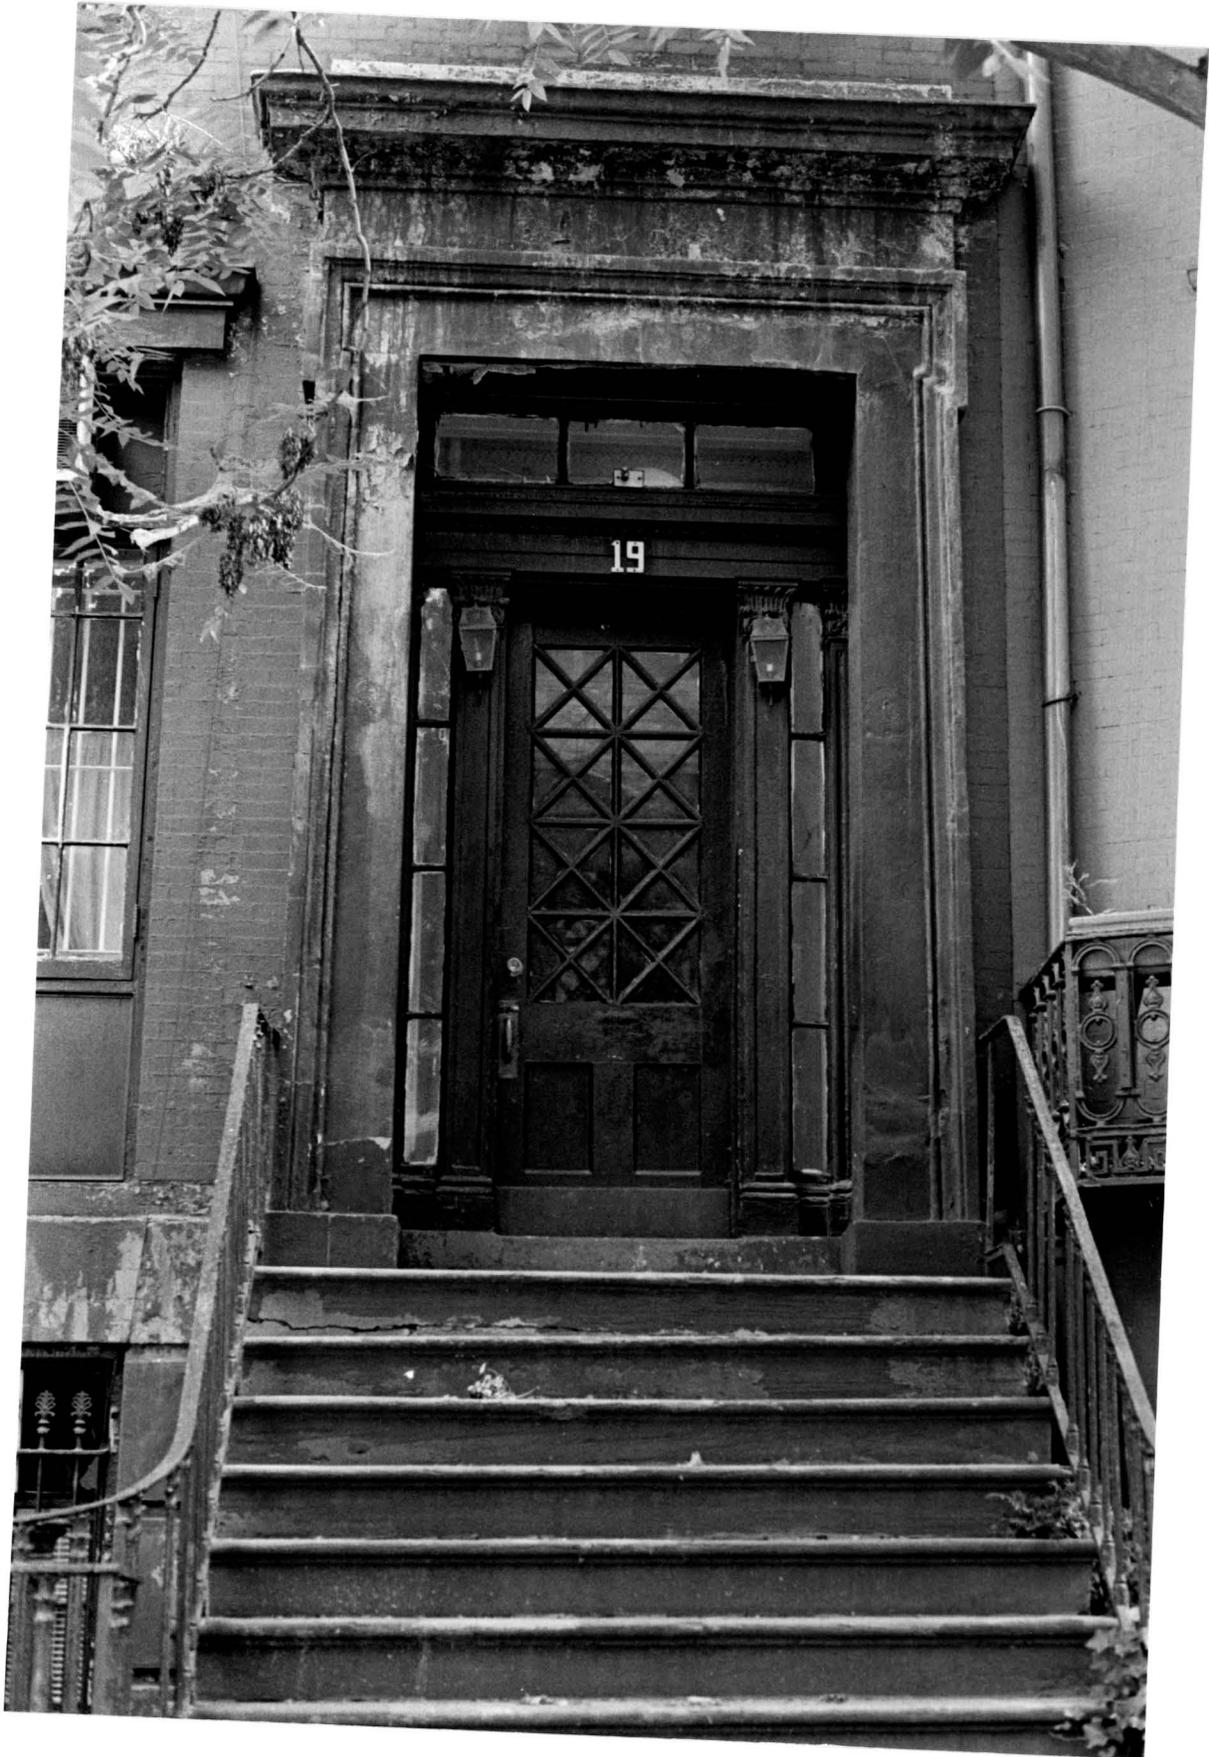
19 West 16th Street Building (entrance detail)  
Photo Credit: Kevin McHugh

The houses on West 16th Street, including No. 19, also demonstrate the aesthetic of unity that is found in the Greek Revival style, utilizing consistent cornice lines, regularly setback building lines, and repetition of building materials and architectural details. Like its neighbors, No. 19 is generous in size, being twenty-five feet in width, elegantly proportioned, and ornamented with rich architectural detail that reflects a high quality of workmanship, all of which sets it apart from more modest houses of the period. The regularity of the square-headed openings and plain wall surface is enlivened by ornate cast-and-wrought-iron railings bordering the stoop and areaway and fronting the tall parlor-story windows as a narrow balcony. Greek-inspired details are found in the Corinthian pilasters at the doorway supporting an entablature, in the broad modillioned cornice, and in the eared and battered stone entrance surround, a distinguishing architectural feature initially derived from Egyptian sources which was a popular element of the Greek Revival style in the 1840s.
