YORKVILLE BANK, 1511 Third Avenue (aka 1511-1515 Third Avenue and 201-203 East 85th Street), Borough of Manhattan.

Built 1905 and 1923-24; Architects Robert Maynicke (1905) and P. Gregory Stadler (1923-24)

Landmark Site: Borough of Manhattan, Tax Map Block 1531, Lot 1

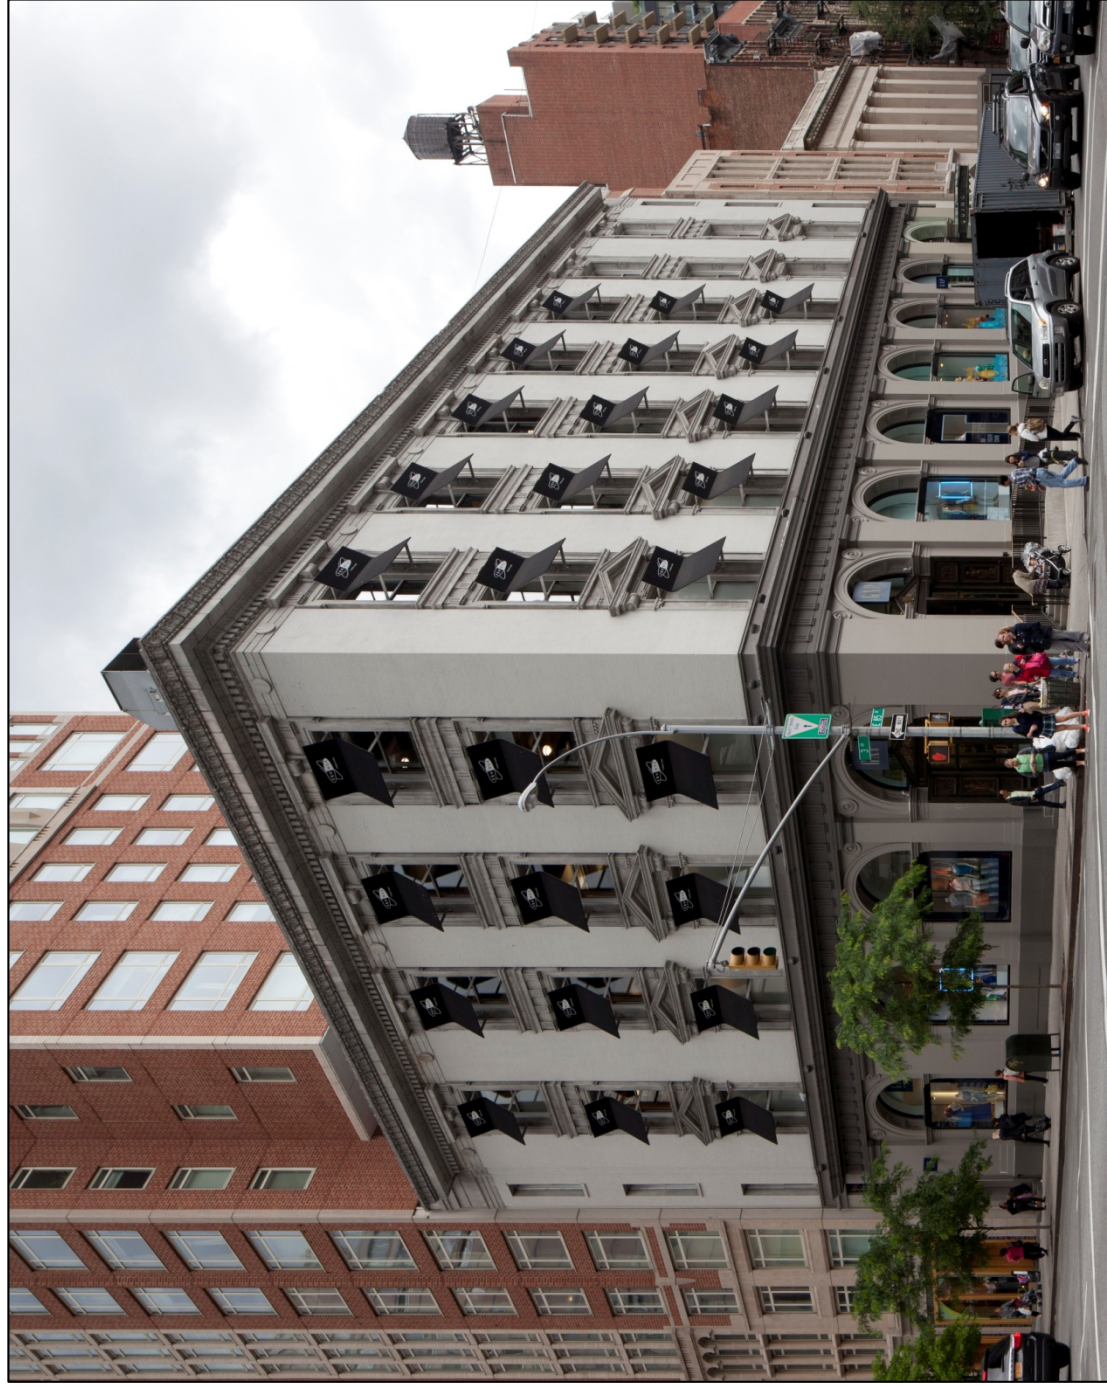
Yorkville Bank, 1511 Third Avenue
Built: 1905; Addition: 1923-24
Architect: Robert Maynicke; P. Gregory Stadler (addition)
Photo: Christopher D. Brazee, 2012

Historic: The Yorkville Bank is a four-story Italian Renaissance Revival-style building clad in granite at the foundation, limestone at the one-story base, white brick with terra-cotta trim at the upper stories, and terra cotta at the cornice. The building comprises a four-bay facade on Third Avenue and a seven-bay facade on East 85th Street, both symmetrical and featuring tall arched openings at the base, a heavy denticulated and molded cornice at the first story, and substantial window surrounds on the upper stories linked in continuous vertical bays by spandrel panels adorned with metopes or paneled impost blocks with guttae. The ground-story openings are separated by substantial Doric piers, and the arches spring from smaller engaged Doric piers whose capitals, with molding and guttae, form the imposts; each arch has a coffered return and is flanked by roundels. The second-story window surrounds feature molded pediments supported on paneled pilasters topped by scrolled brackets terminating in guttae, while the third- and fourth-story surrounds feature molded and paneled enframements, with molded lintels supported

on scrolled keystones above the fourth-story windows. The restrained cornice is composed of a banded frieze accented by plain roundels, and above that dentils and foliated molding beneath a deep overhang, and a crowning band of acanthus leaves resting on bead-and-reel molding. The Third Avenue facade ends in a narrow fifth bay featuring a secondary entrance at the ground story and simple punched window openings on the second through fourth stories; there is a historic one-over-one double-hung window with a decorative grille at the second story. The secondary entrance is surrounded by a paneled enframing with a transom panel flanked by scrolls and topped by a molded pediment. The East 85th Street facade ends in a narrow eighth bay similar to the final bay on the Third Avenue facade, except that in place of a secondary entrance there are two punched window openings on the ground story; the lower opening contains a small window and louver and the upper opening contains a historic one-over-one double-hung window with a decorative grille. A secondary entrance in the seventh bay of this facade was added during the 1923-34 renovation to serve the offices on the upper floors of the building. The building's corner entrance is composed of two identical pairs of cast-bronze doors, one facing Third Avenue and one facing East 85th Street. The doors feature panels depicting Classical allegorical figures and motifs on both the interior and exterior faces. The doors are surmounted by cast-bronze pediments containing Classical motifs and escutcheons bearing the monogram "YB" and crowned by an acroterion. The doors have large ring-style handles. Originally, the upper-story windows were two-over-two double-hung sash, probably wood or metal-clad wood, while the ground-story arched windows were divided by a transom bar and two vertical mullions, probably all of cast bronze. In 1923-24, the building was extended by one and a half bays (or 26 feet) along Third Avenue and one and a half bays (or 25 feet) along East 85th Street, making the new avenue frontage 77 feet and the new side street frontage 125 feet. The original design was repeated in the one full bay added to each facade, with the half bays relatively unadorned and accommodating secondary entrances. At this time the entrance to the bank was moved from its original location in the center bay of the Third Avenue facade to the current corner location comprising two entrances, one on Third Avenue and one on East 85th Street.²⁸

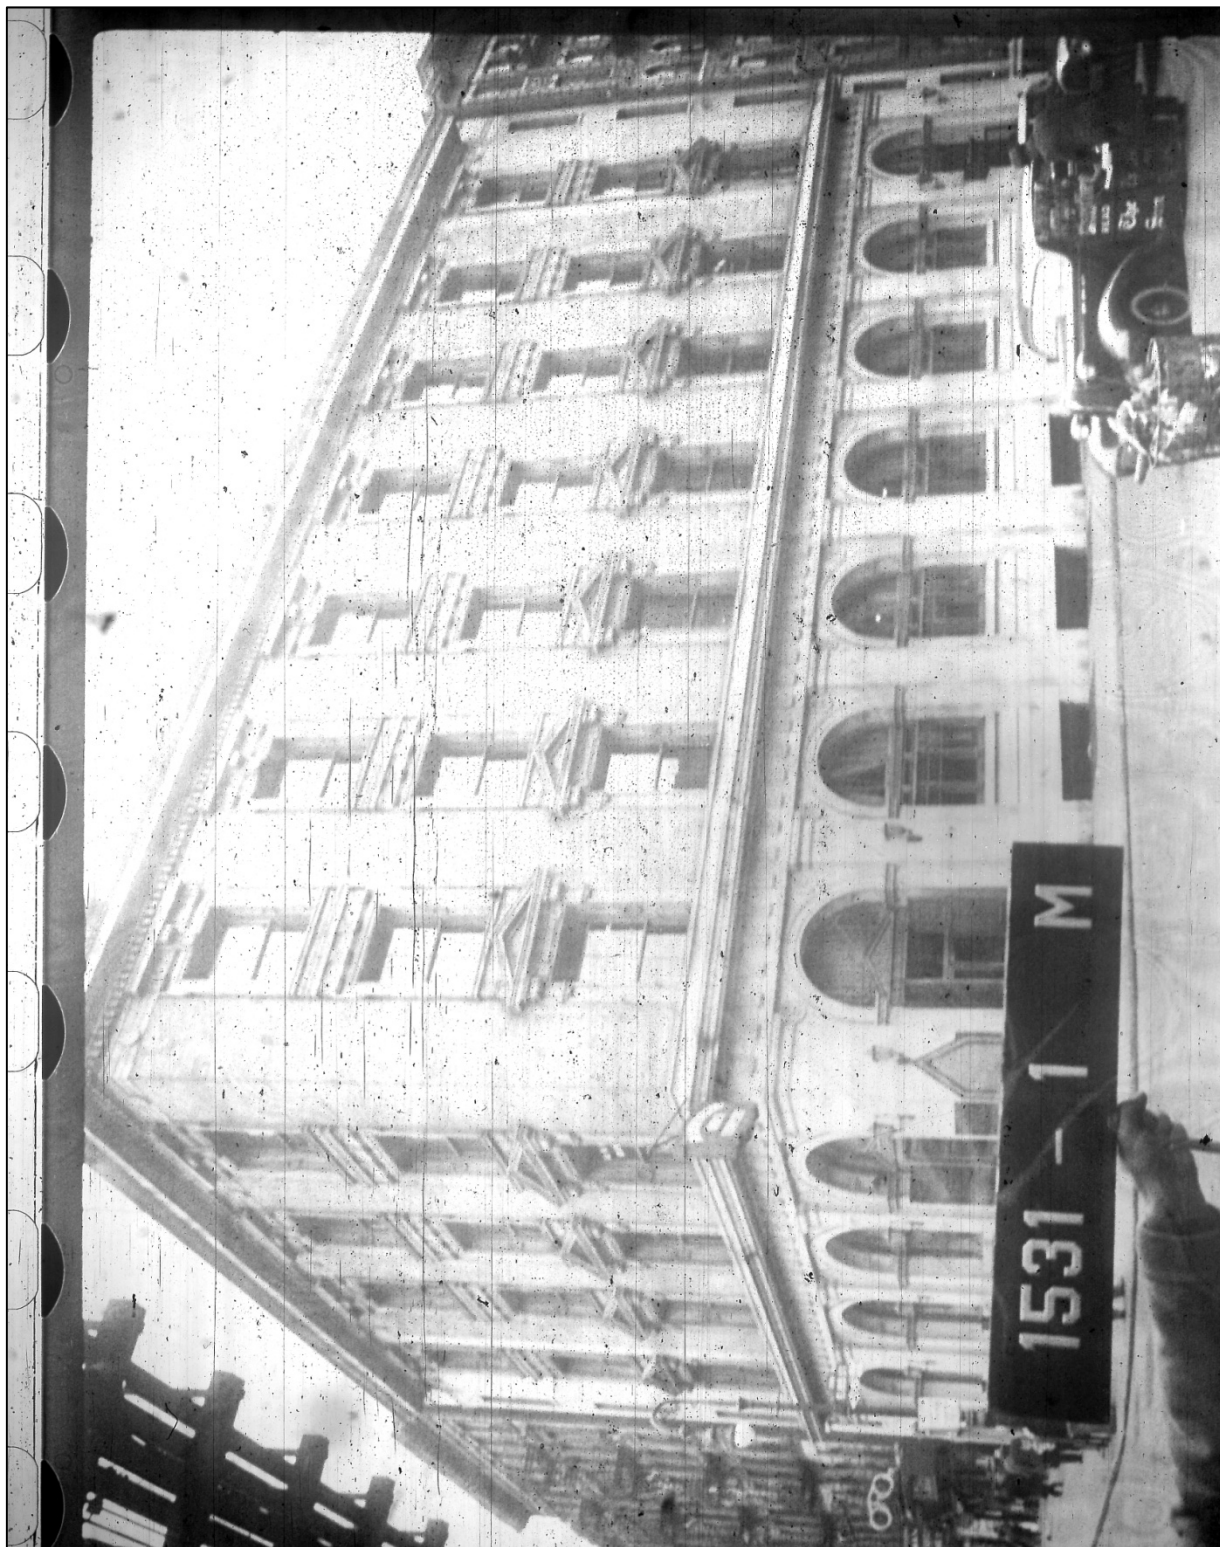
Yorkville Bank

Photo: NYC Department of Finance, c. 1939-41

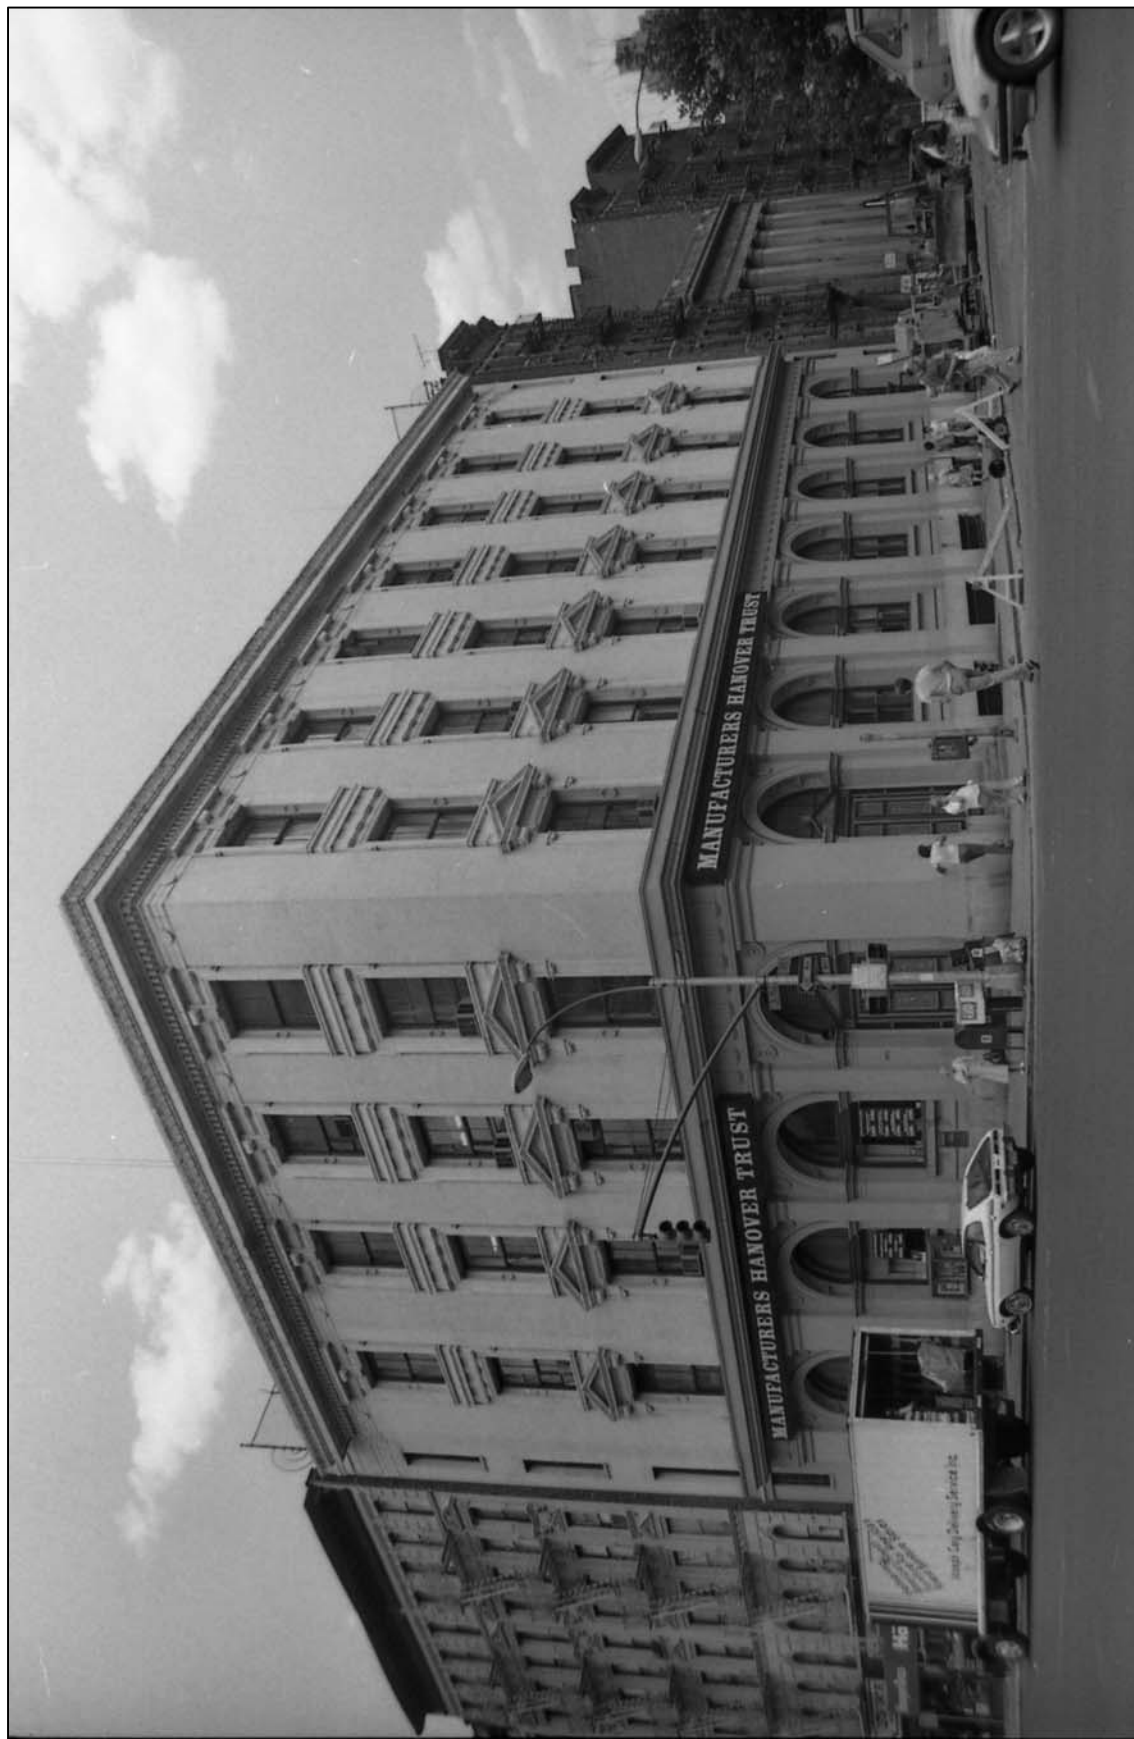
Yorkville Bank,
Photo: Landmarks Preservation Commission staff, 1983

Alterations: By 1983, several of the transoms at the ground-story arched windows had been altered with panels and/or louvers, and the windows below had also been altered with the removal of the original vertical mullions (two per window) and the installation of pairs of double-hung sash. Decorative metal grilles at the transoms above the entrance doors had also been removed or covered over by this time. The original "Yorkville Bank" inscriptions have been removed from the bronze panels above the entrance doors. The ground-story arched windows were further altered in 1990-91, when the Gap took over the ground floor for a retail store (Job No. 100145905). The windows and stone spandrels below, as well as the vents with decorative grilles in the foundation, were all removed, and plate-glass show windows with a thick metal transom bar were installed. While the new arched transom windows maintained the original window plane, the new show windows below the transom bar were brought significantly forward from the original window plane, altering the overall profile of the arched openings. The sixth arched opening on the East 85th Street facade was further altered by the extension of the window opening down to grade to accommodate a glass door; masonry infill was installed in the remainder of the enlarged opening. "Gap" signs were installed in the arches above the corner entrances, and one at the ground story near the end of each facade. The building was further altered c. 1996, when the Equinox sports club moved into the building's upper floors and

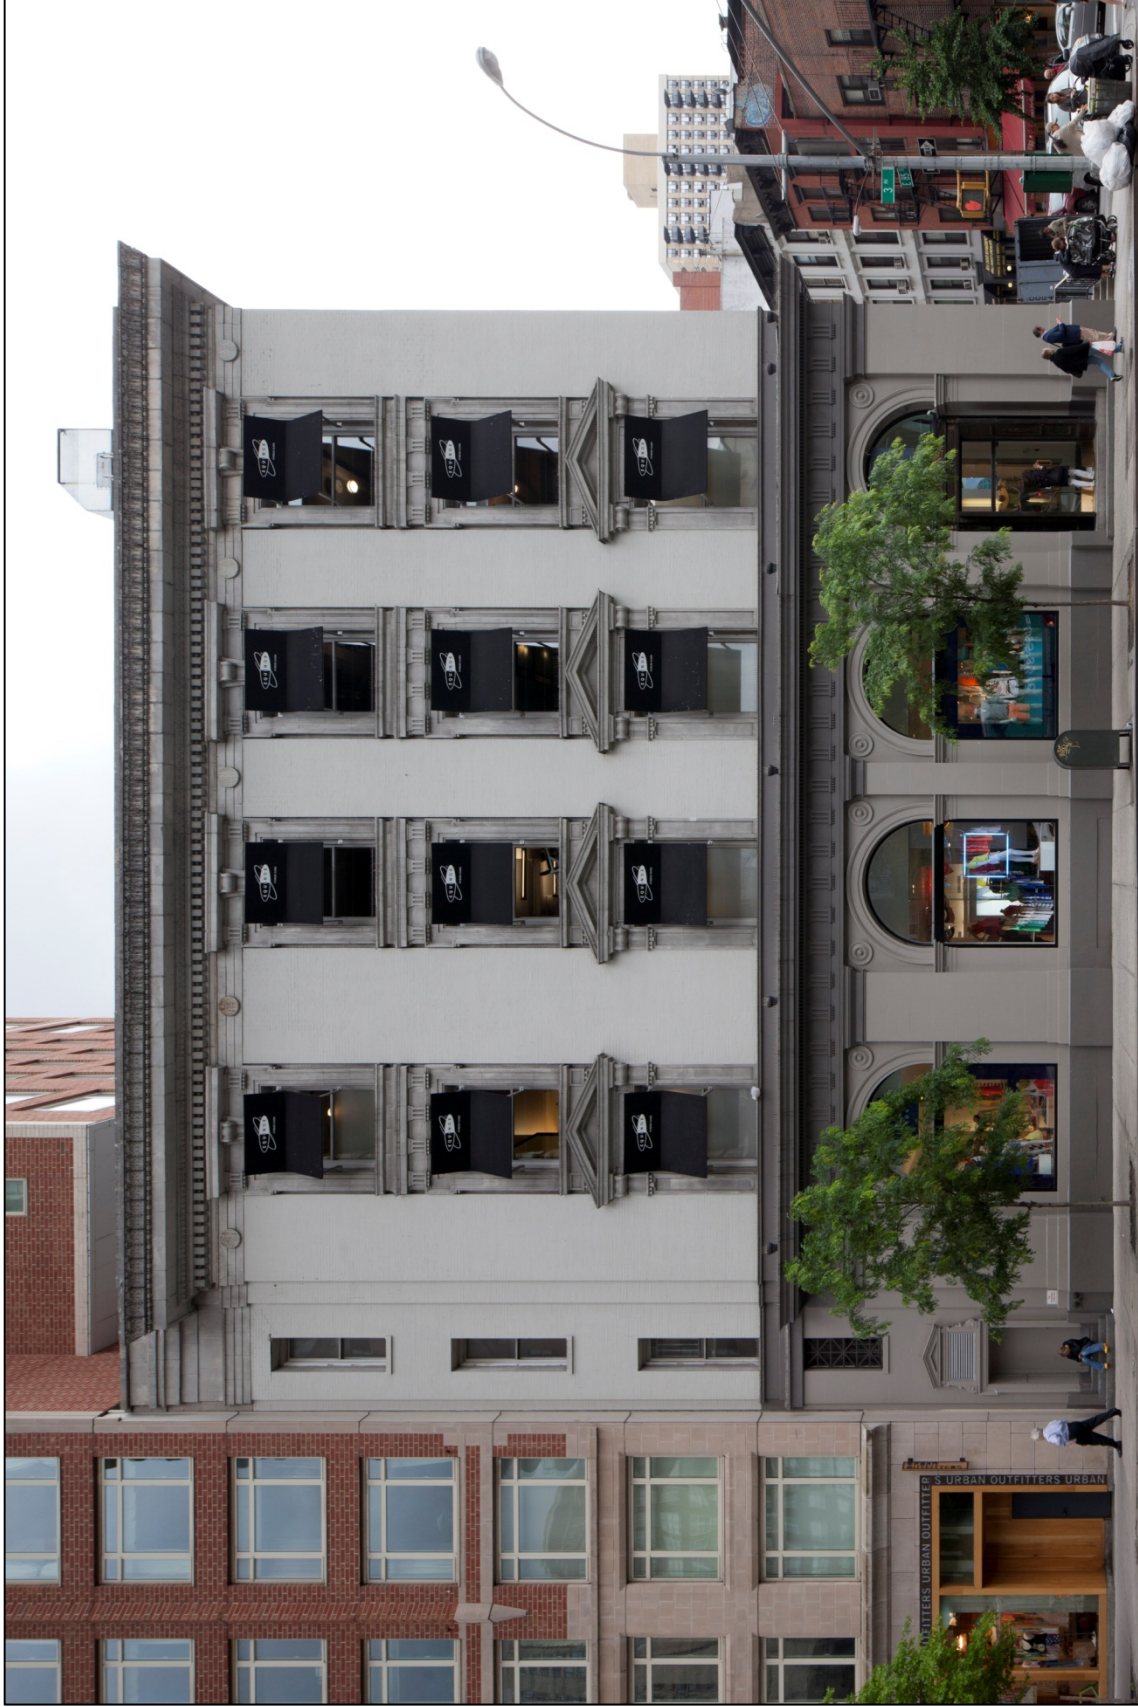
Yorkville Bank
Photo: Christopher D. Brazee, 2012

modified the secondary entrance on the East 85th Street facade. Large awnings with metal armatures were installed at nearly all of the upper-story windows; and a metal-and-glass canopy, tall metal light fixtures, sign boxes, and signage were added to the East 85th Street secondary entrance. An accessibility ramp was constructed at this entrance c. 1993, while another concrete accessibility ramp with steps and metal railings was installed at the main corner entrance on East 85th Street in 2012. The granite foundation and limestone base have been painted, as well as the brick of the upper stories. Mechanical equipment is visible on the roof. An apartment tower completed c. 2008 was constructed on the adjacent lot to the north, and a portion of this building cantilevers over the northern property line of the Yorkville Bank.

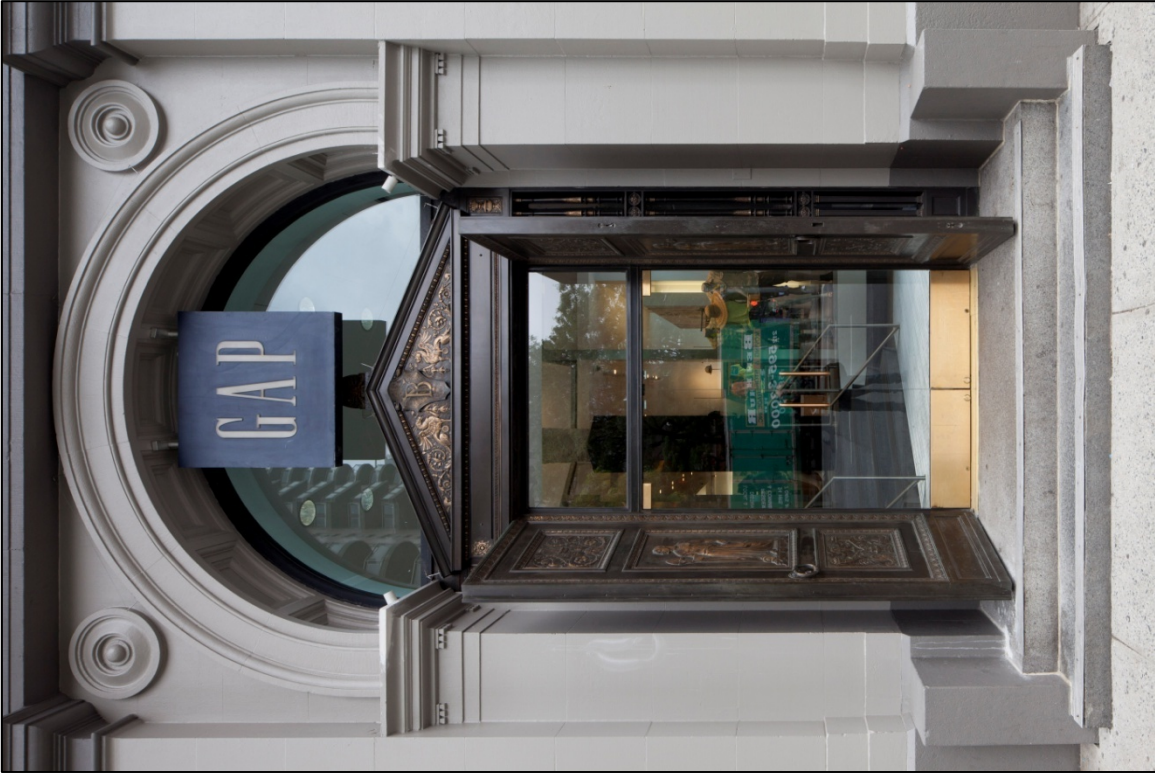
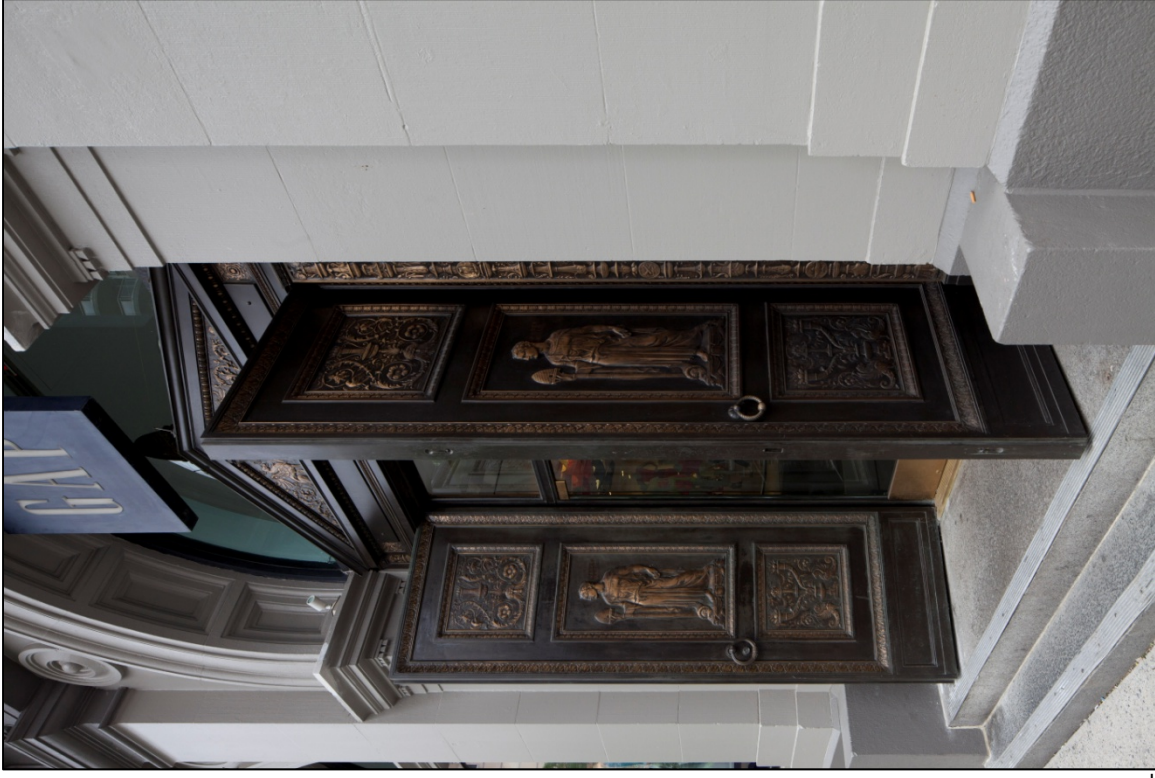
Cast-bronze doors fabricated by the John Polachek Bronze & Iron Co. of Long Island City

Stadler gave the bank a new entrance, removing the portico from the center bay of the Third Avenue facade and creating a new double entrance by inserting two pairs of doors into the existing arched openings at the corner of the building. The massive cast-bronze doors were fabricated by the John Polachek Bronze & Iron Company of Long Island City, with each leaf featuring a panel depicting an allegorical figure flanked by smaller panels above and below decorated with Classical grotesques. The male allegorical figure holds in one hand a staff supporting a beehive, the traditional symbol of thrift; in the other, a key, suggesting the prudence and security of banking; and rests his foot on a cornucopia, the symbol of plenty. Above his shoulder reads the inscription "Finance/ Savings". The female allegorical figure holds a locomotive engine in one hand, symbol of industry; and a caduceus in the other, the symbol of commerce; and a sailing ship is depicted at her feet. Above her shoulder reads the inscription "Commerce/ Industry".²⁵ Upon completion, the building's facades were sandblasted in order to blend the joints between old and new masonry.
