APPENDIX D: CULTURAL RESOURCES

STAGE 1A ARCHAEOLOGICAL ASSESSMENT

WILLIS AVENUE BRIDGE RECONSTRUCTION BRONX COUNTY AND NEW YORK COUNTY NEW YORK

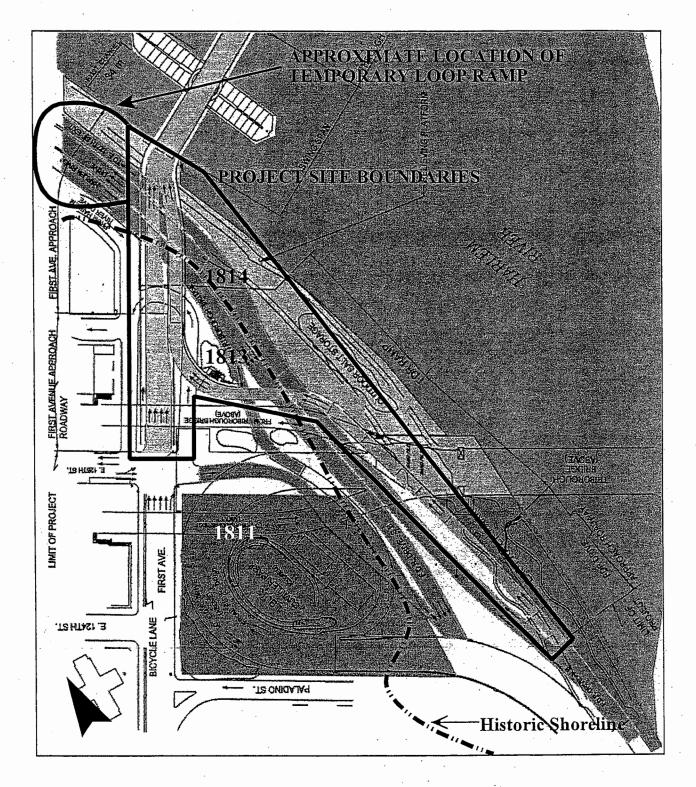
Manhattan Project Site Boundaries Showing Current New York City Block Numbers and Location of Historic Shoreline

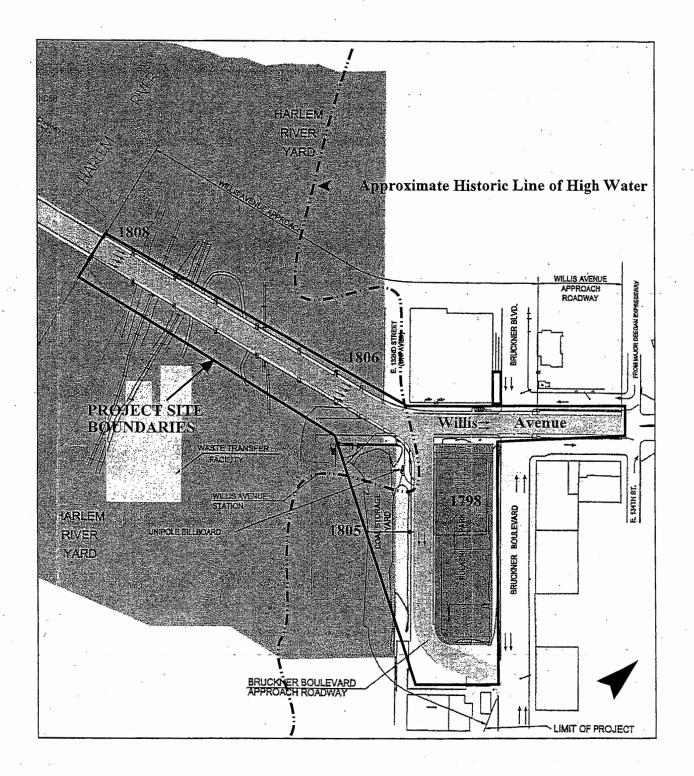
Bronx Project Site Boundaries Showing Historic New York City Block Numbers and Location of Historic Shoreline

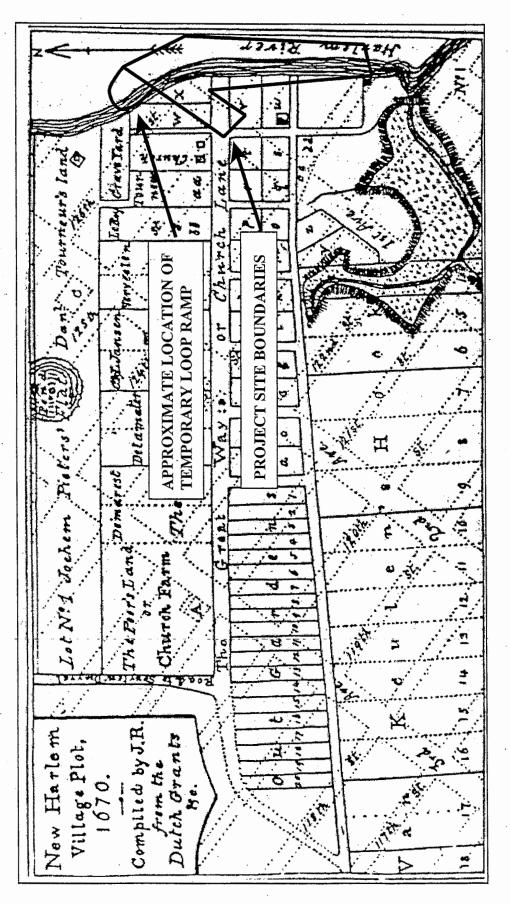
New Harlem Village Plot, 1670 Source: Romer and Hartman 1981:9

later more detailed maps place its eastern end in the footprint of First Avenue. Although this 1670 places the Church Grave Yard north and west of the project site,

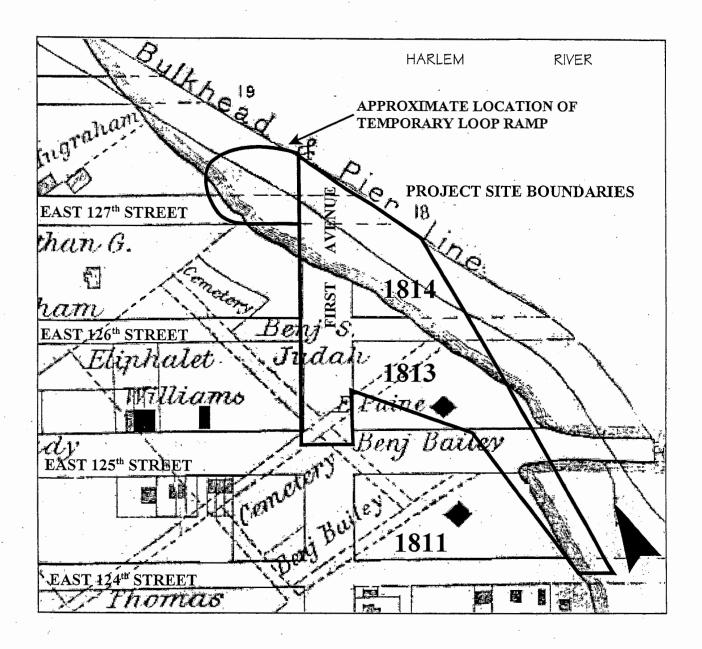
Map of New York and Vicinity
Dripps, 1867

This 1867 map places the Church Grave Yard west of the project site at East 126th Street, but later more detailed maps place its eastern end within the footprint of First Avenue. The Dutch Reformed Church cemetery at East 125th Street is shown extending into the footprint of First Avenue.

Both an 1867 and 1879 map present the cemetery, hereafter referred to as Cemetery 2, west of the project site with clearly demarcated boundaries (Dripps 1867; Bromley 1879; Figure 6). However, by 1885 the cemetery's mapped boundaries were changed, and it appears to have extended east possibly into the footprint of First Avenue (Robinson 1885a; Figure 7). An 1897 atlas places the cemetery well within the footprint of First Avenue (Bromley 1897). Later maps fail to label the feature as a cemetery, but do show the lot's property lines. Unfortunately, none of the maps show the lot lines consistently in the same place. The boundaries seem to fluctuate over time (Bromley 1916, 1925, 1934, 1955, 1974; Figures 8, 10).

Historic research identified the potential sensitivity for a cemetery associated with the earliest historic inhabitants of Old Harlem dating to the late 17th century. Cemetery 2 may have extended east into First Avenue just north of East 126th Street (Dripps 1867; Bromley 1879; Robinson 1885a; Figures 6, 7). It is unclear if the cemetery actually extended east into the project site, or was contained on land to the west. While unlabeled, its potential boundaries are still visible on 20th century atlases (Bromley 1925, Figures 8; Bromley 1974; Figure 10). Its western end would currently be under a two-story brick bus terminal.

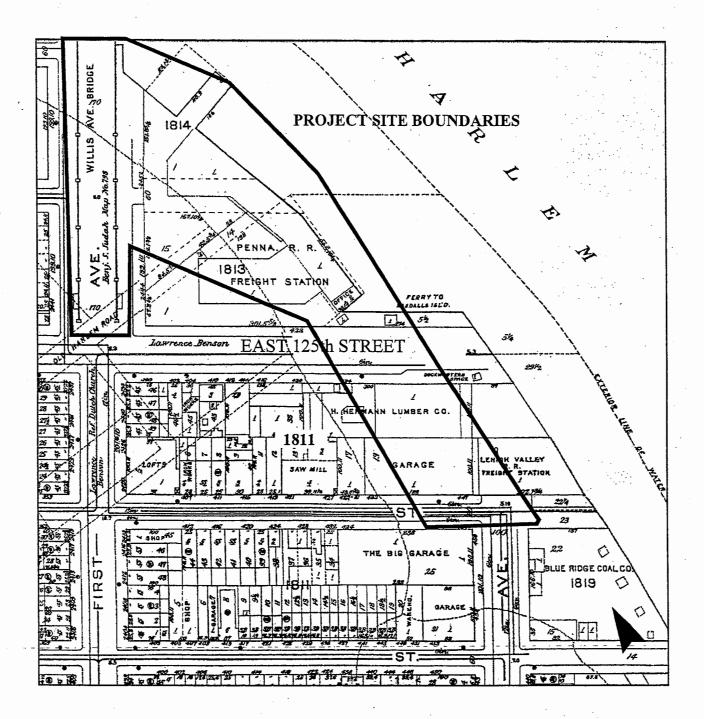
FIGURE 8

Atlas of the City of New York, Borough of Manhattan G.W. Bromley, 1925

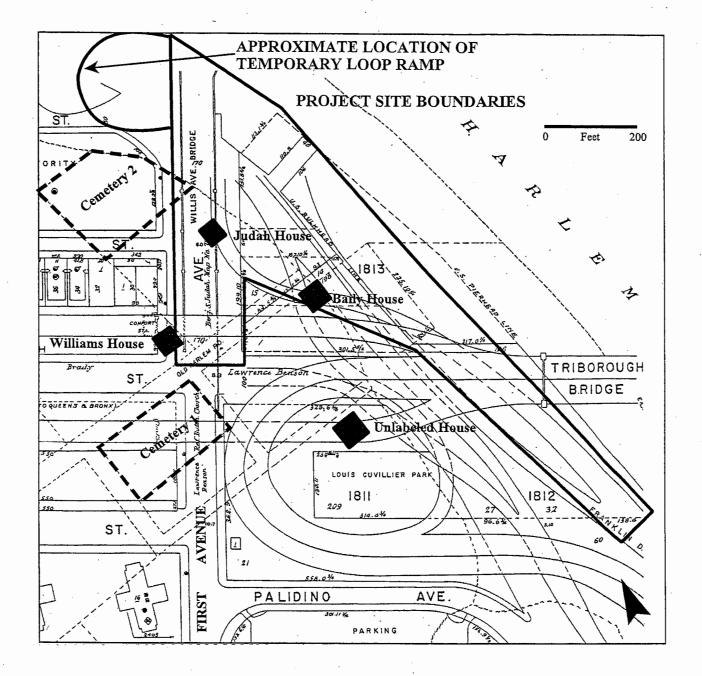
Historic Archaeological Features with Approximate Boundaries superimposed over the *Atlas of the City of New York, Borough of Manhattan* G.W. Bromley, 1974

Note: The locations of potential resources are approximate since the boundaries of the cemeteries and locations of the dwellings varied on historic maps.

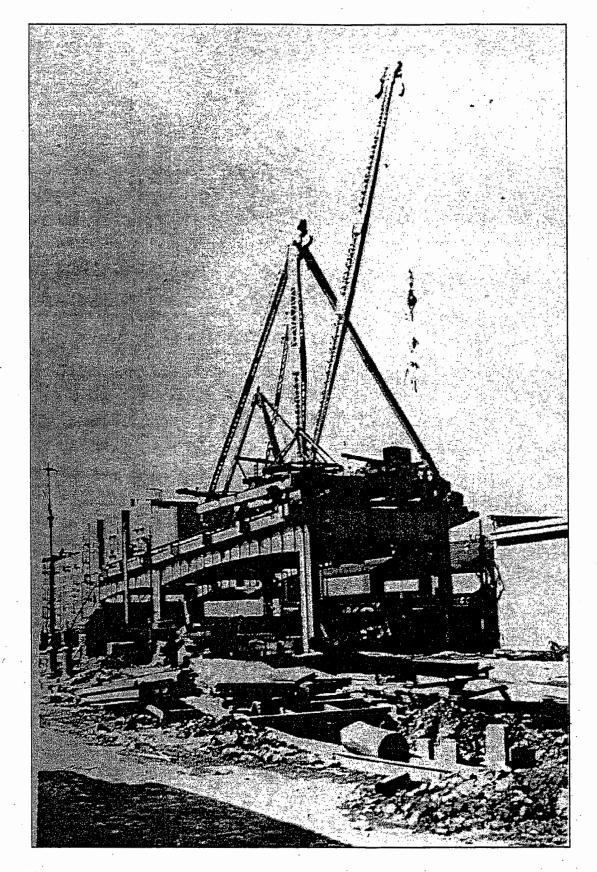
FIGURE 13

Construction of Triborough Bridge in Manhattan, March 10, 1936. Facing northwest at East 125th Street and First Avenue.

Even if the cemetery did extend north as far as the project site's southern limit on First Avenue, the extent of destruction caused by the construction of the Triborough Bridge approach would have severely impacted its location. Furthermore, a vast network of utility lines converge at this corner. Not only were buried utilities installed here at the turn of the century, but they were later dug-up and rerouted in conjunction with the construction of the Triborough Bridge (Figure 13). This intersection experienced enough subsurface impacts to negate any potential for this cemetery. However, the footprint of First Avenue south of East 125th Street, south of the project site boundaries, may still be sensitive for this resource.

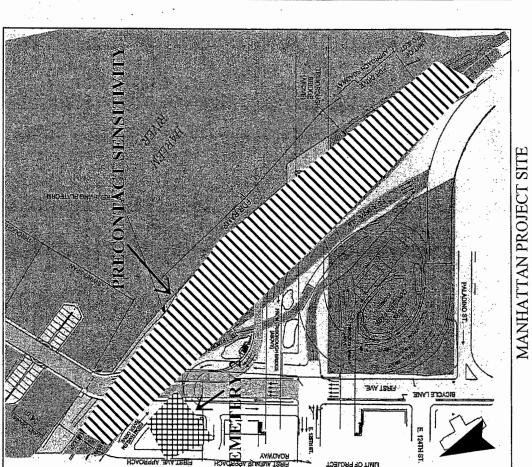
FIGURE 14

Areas of Potential Archaeological Sensitivity All locations are approximate

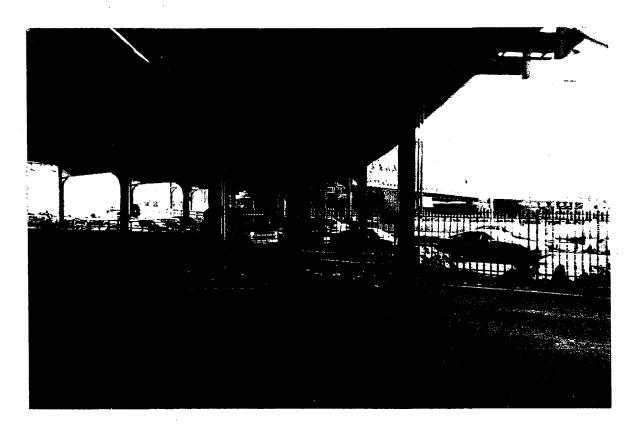
Photograph A. Beneath the Willis Avenue Bridge from First Avenue. (Facing northwest.)

Field visits were conducted in September and October, 2000. Photographs were taken of current conditions in the project site and obvious signs of disturbance were recorded (Photographs A - D).

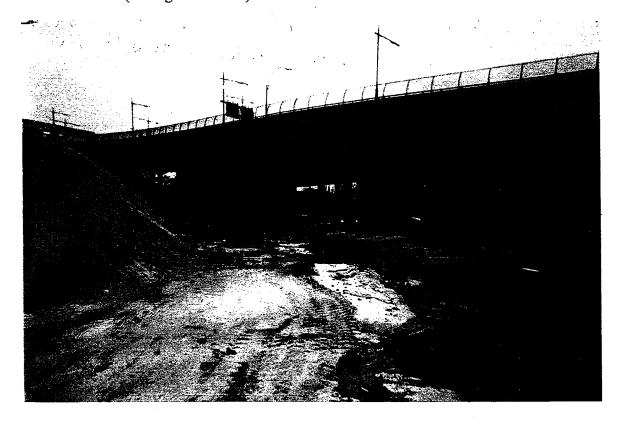
Photograph B. Facing south from beneath Willis Avenue Bridge to FDR Drive South.

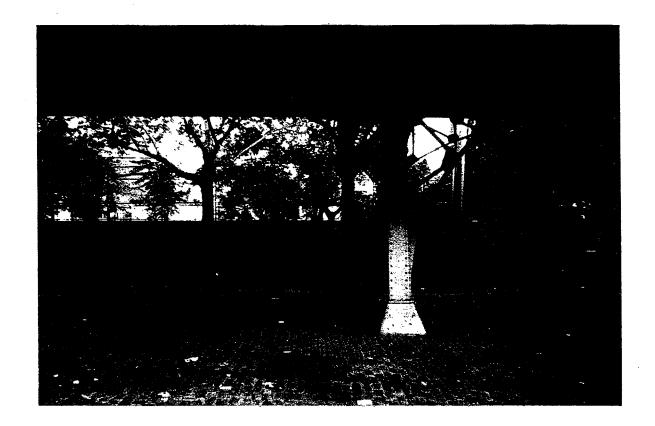
Photograph C. Facing south from Willis Avenue to north end of Block 1798, Pulaski Park.

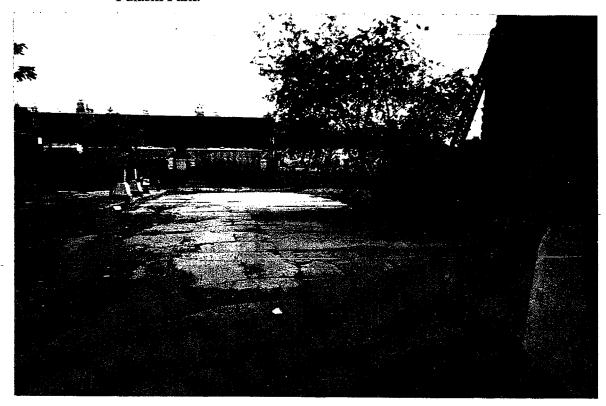
Photograph D. Willis Avenue in Bronx, facing west. Area of potential pre-contact sensitivity. Block 1805 at left, Block 1806 at right.

Subsurface work, below the level of modern fill, at the north end of Block 1805 in the footprint of Willis Avenue may potentially impact precontact resources. This area was identified as moderately sensitive for this resource type, since it was found to have levels of peat beneath the fill, and was historically a cove along the shoreline that would have remained untouched by dredging. After the cove was filled, modern impacts - such as utility installation, would have only extended into the landfill. Therefore, if impacts go beneath the depth of fill, which is about 15 feet deep in this location, there may be a negative impact on potential precontact resources. If subsurface work is limited to the first 15 feet below grade, then there will be no negative impact.

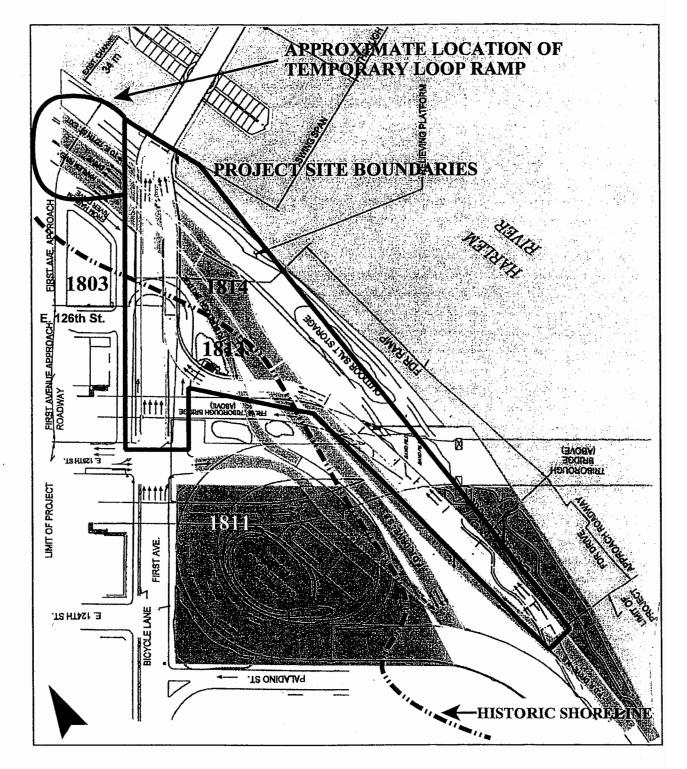
Manhattan Project Site Boundaries Showing Current New York City Block Numbers and Location of Historic Shoreline.

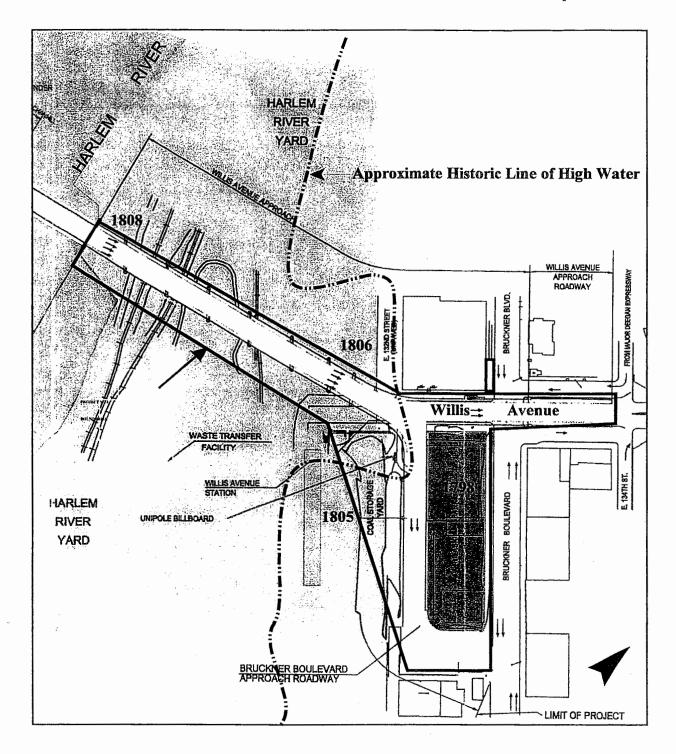
Bronx Project Site Boundaries Showing Historic New York City Block Numbers and Location of Historic Shoreline.

The former roundhouse was located within Block 1806, which is bounded to the west by East 131st Street, to the east by 132nd Street, to the south by Willis Avenue, and to the north by Alexander Avenue (Figure 3). Documentary research found that the block was under water until the second half of the 19th century. Cartographic resources indicate that the uneven shoreline was slowly filled in after the 1850s (Colton 1836; Conner 1853; Beers 1860, New York Department of Parks 1873; Figures 12 and 13).

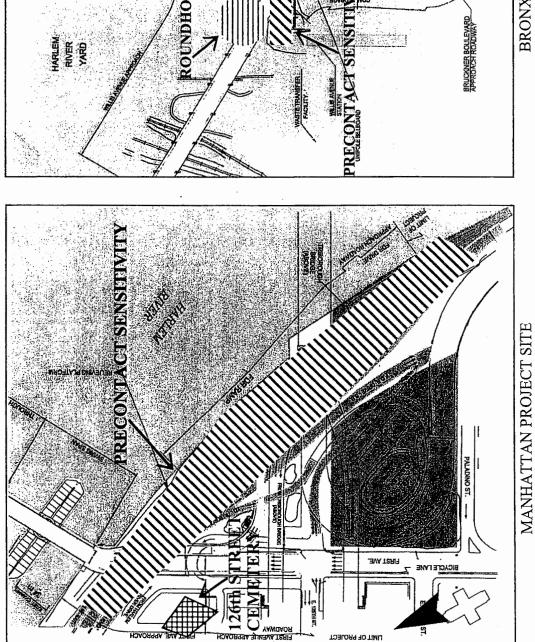
Areas of Potential Archaeological Sensitivity. All locations are approximate.

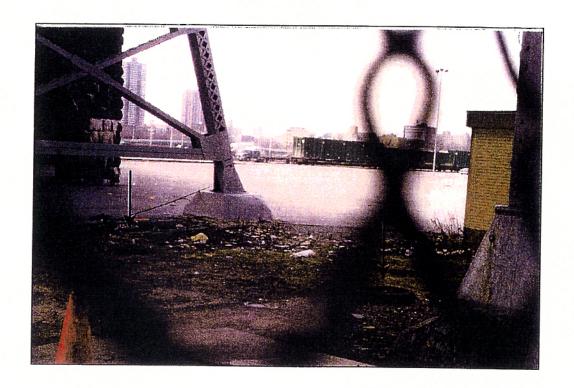
Photograph A: Two sewer manholes observed in area of potential sensitivity for a roundhouse. Facing southwest, Bronx Project Area.

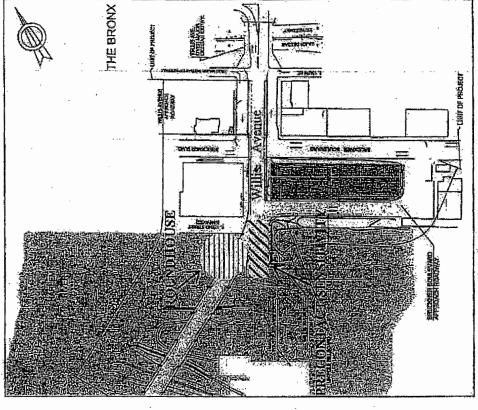
ATTACHMENT "B"

Areas of Potential Archaeological Sensitivity.
All locations are approximate.
